Performance of Tall Buildings During the 2/27/2010 Chile Magnitude 8.8 Earthquake -- A Preliminary Briefing --

Los Angeles Tall Buildings Structural Design Council

Performance of Tall Buildings During the 2/27/2010 Chile Magnitude 8.8 Earthquake -- Santiago --

Performance of Tall Buildings in Viña Del Mar 2/27/2010 Chile Magnitude 8.8 Earthquake

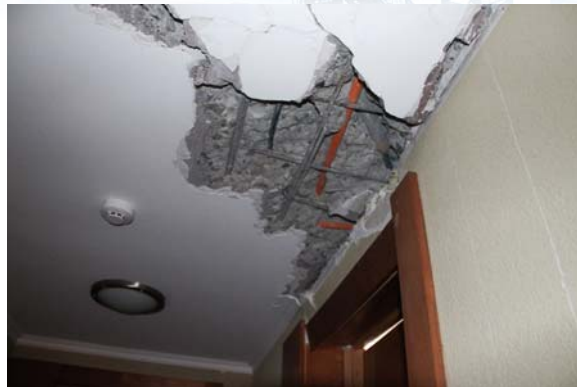
Antigona ⁶⁷

- Prevalent slab distress at "coupling"
- Over doorway openings
- Also slab flexural bending along wall edge

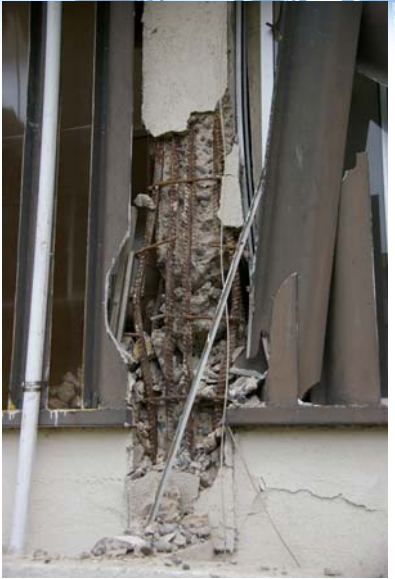
Festival¹⁰⁰

- End of wall failure at GF
- Horizontal reinforcing 90 hooks
- End of wall ties not apparent

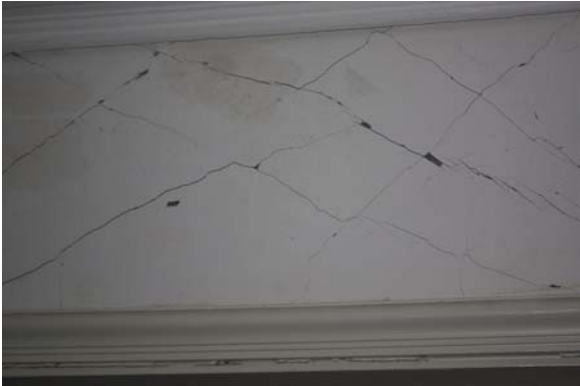
Rio Petrohue ¹⁸⁴

- Shear cracks in interior coupling beams over doors

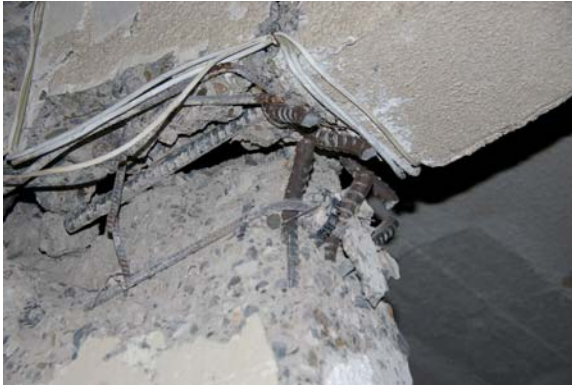
Rio Petrohue ⁶⁸

- Opposite face of basement shear wall with fractured vertical reinforcing

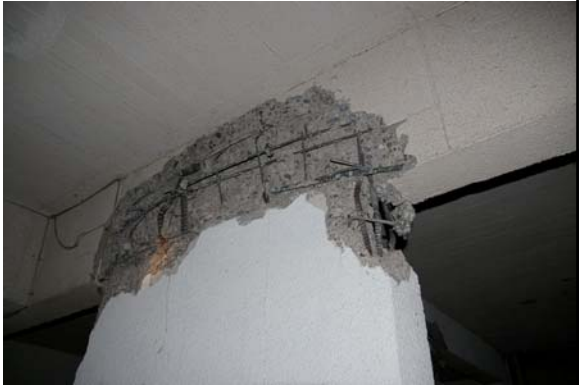
Rio Petrohue ⁶³

- Short shear wall in basement
- Crushing at both edges
- Beam reinforcing outside of wall "cage"
- Cross ties not apparent over the depth of the beam

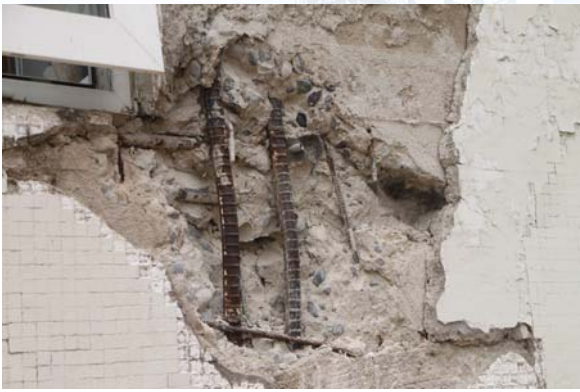
AntilcoTM

- Damage at beam to shear wall location
- Ties at vertical reinforcing not apparent

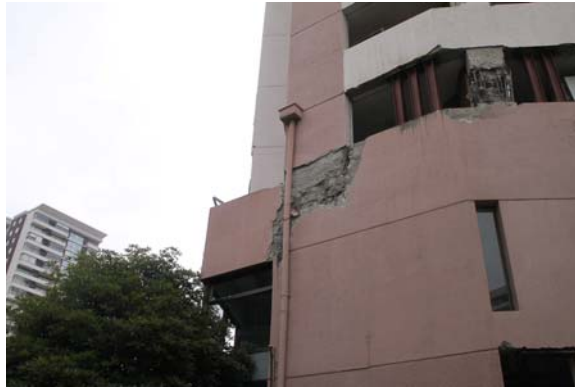
Torre Del Mar ,

- Damage at transfer of short upper wall transfer to wider lower wall
- Column damage also present at some locations

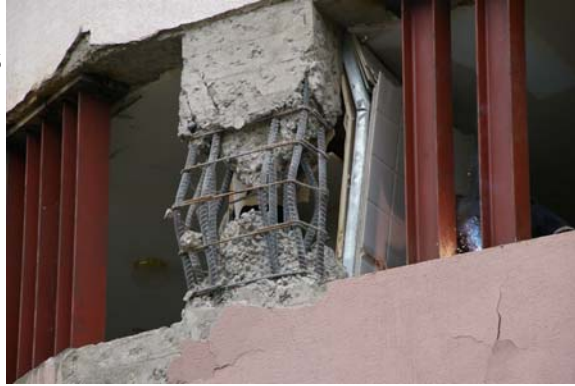
Torre Del Mar ³⁰

- Column reinforcing is tied with 90 hooks
- Cross ties are not apparent

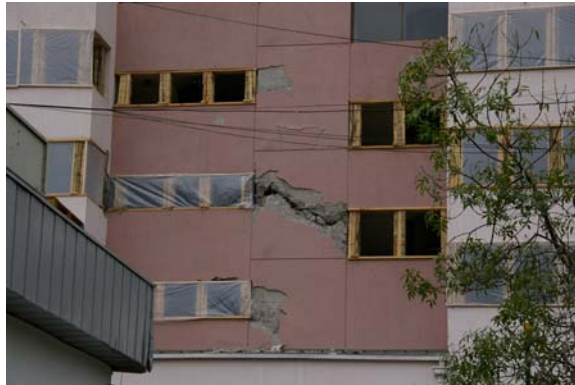
Torre Del Mar ⁴³

- Shear wall damage at offset of window openings at stair landings

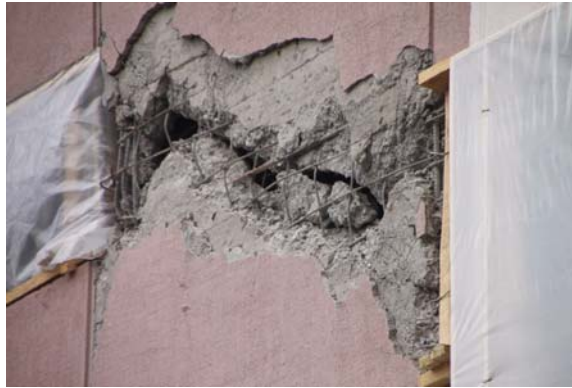
Torre Del Mar ¹⁰

- Shear wall damage at offset in windows at stair landings

Horizontal reinforcing outside vertical reinforcing in center and ends of shear wall

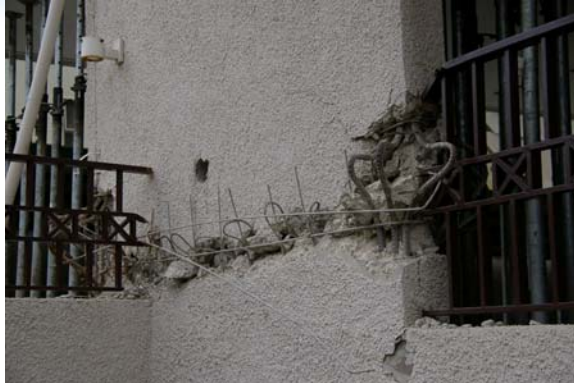
Toledo 108

- Shear wall overall crushing damage

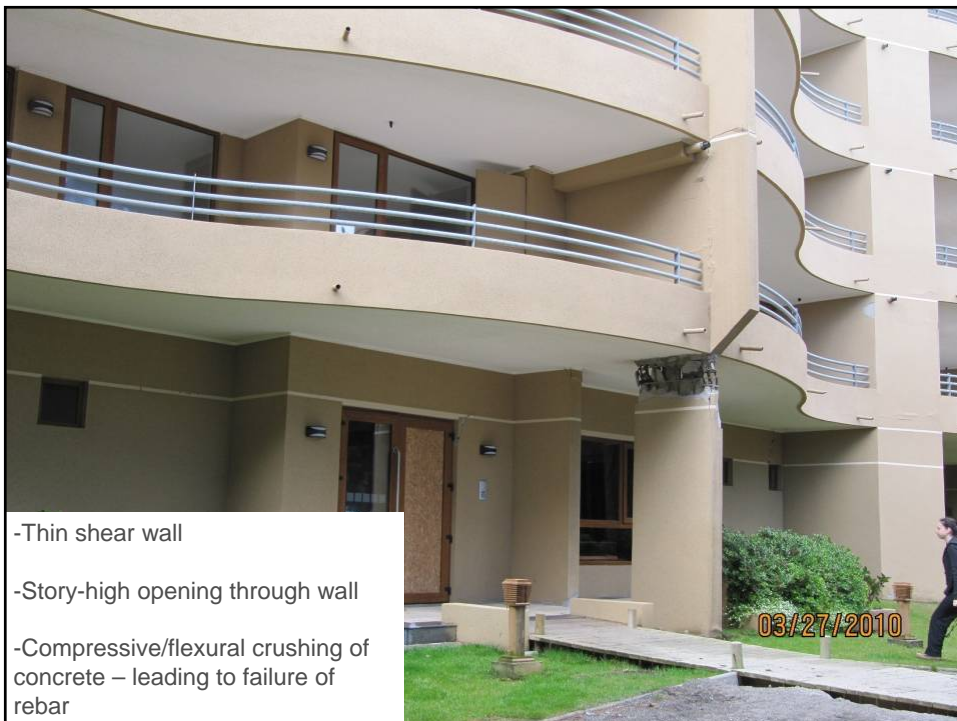
- Thin shear wall
- Story-high opening through wall
- Compressive/flexural crushing of concrete – leading to failure of rebar

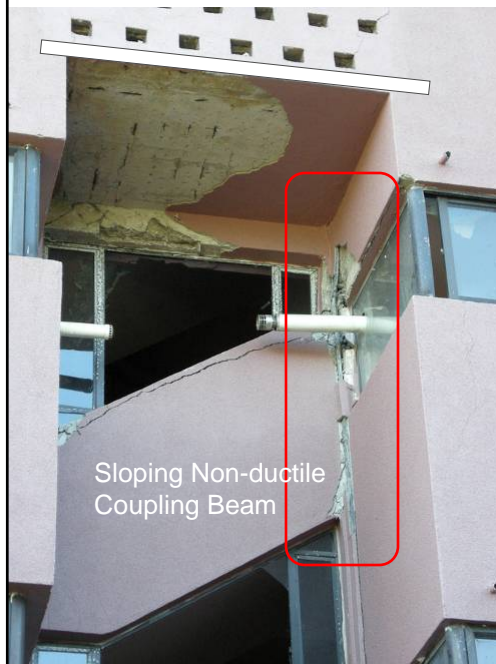
Exterior View

-Evidence of damage caused by unintended coupling demands

-Edges of stairways not detailed to accommodate these demands
