**FINAL REPORT OF SERIOUS INCIDENT OF MYANMAR NATIONAL
AIRLINES CESSNA GRAND CARAVAN (Reg: XY-AMC) AT MANAUNG
DOMESTIC AIRPORT ON the 16th of NOVEMBER 2016**

SYNOPSIS

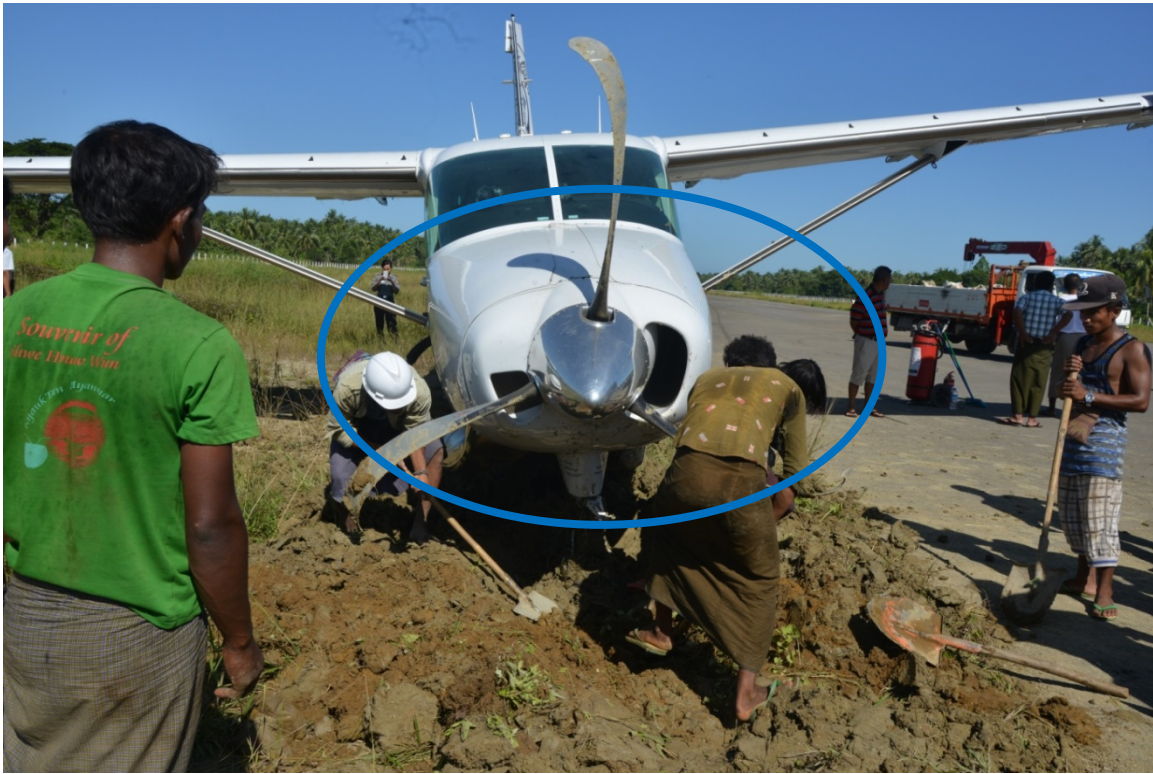
Figure: 2 The aircraft came to rest on the runway shoulder at the edge of the runway

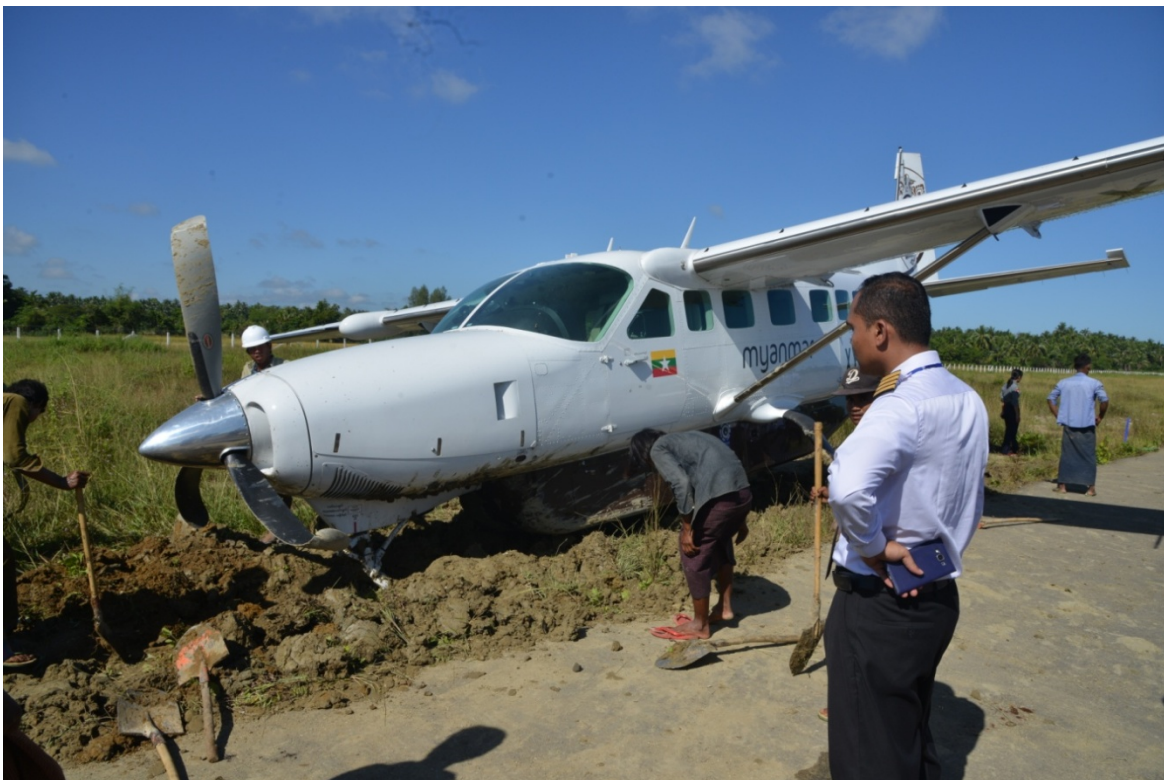
Figure: 3 The aircraft came to rest on the runway shoulder at the edge of the runway

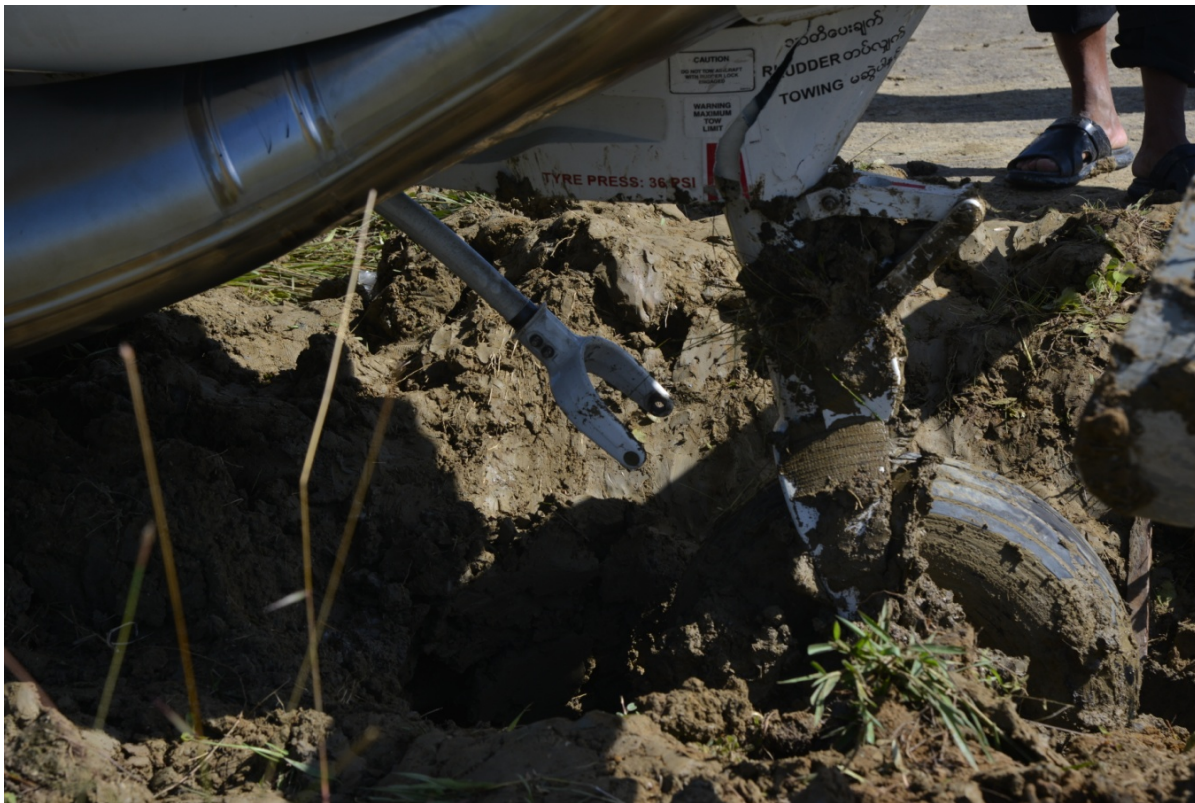
- (a) Nose Wheel Yoke was broken.
- (b) Propeller blades were twisted and broken.
- (c) Right Hand(RH) wind tip was dented.
- (d) Right Hand(RH) Main Wheel was damaged

Figure :4 The Nose Wheel bobbed down with broken yoke

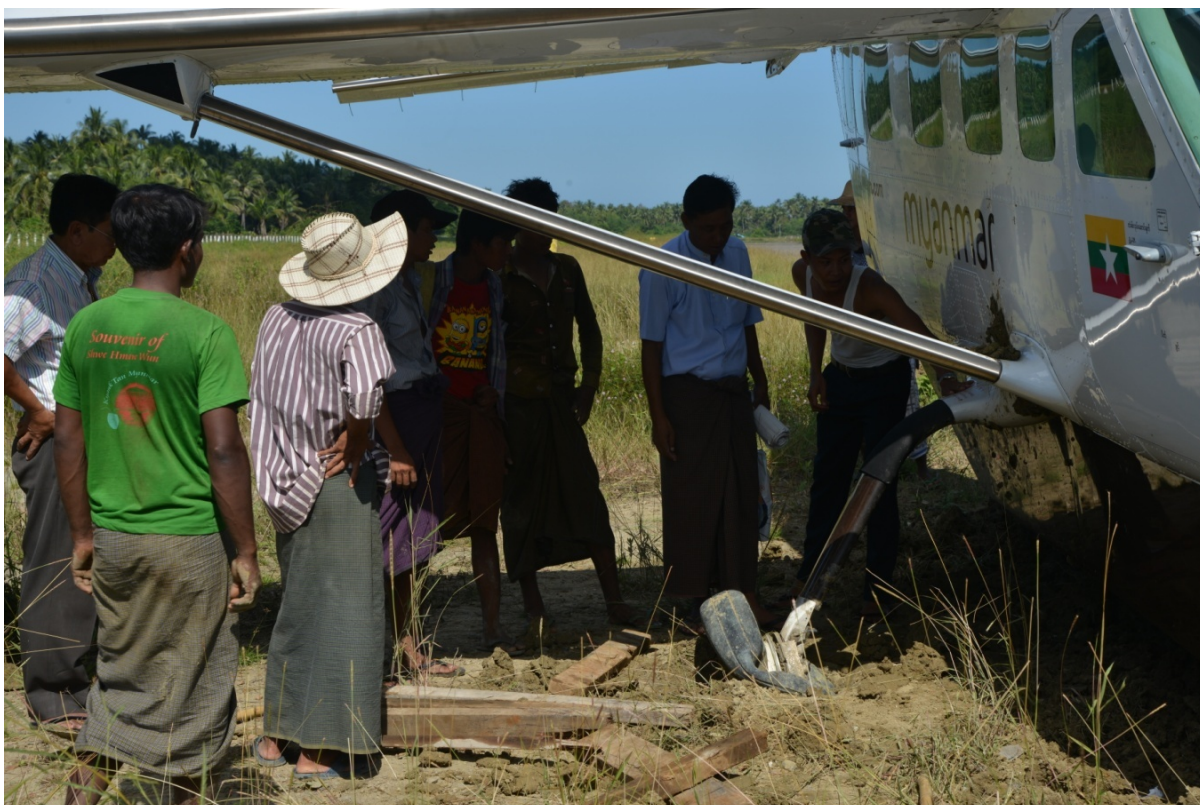
Figure : 5 The damaged the right hand Main Wheel

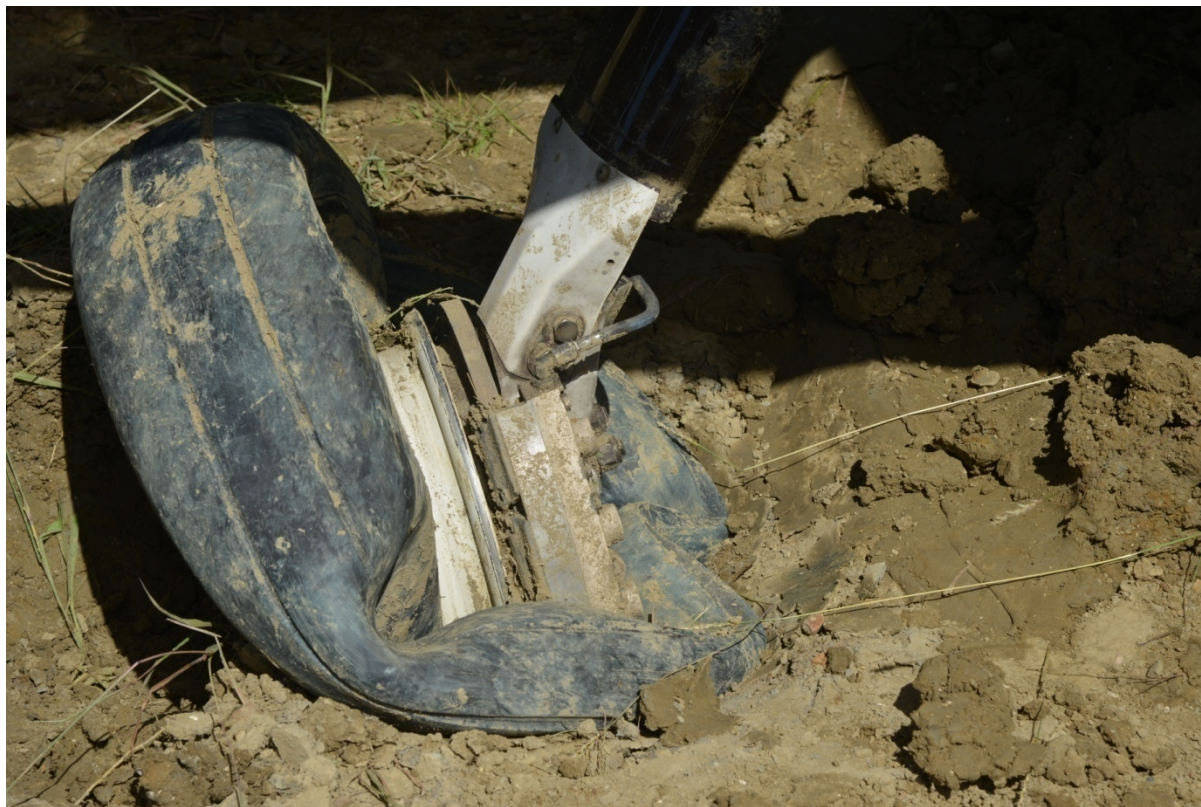
Figure :6 The Closer view of the damaged right hand Main Wheel

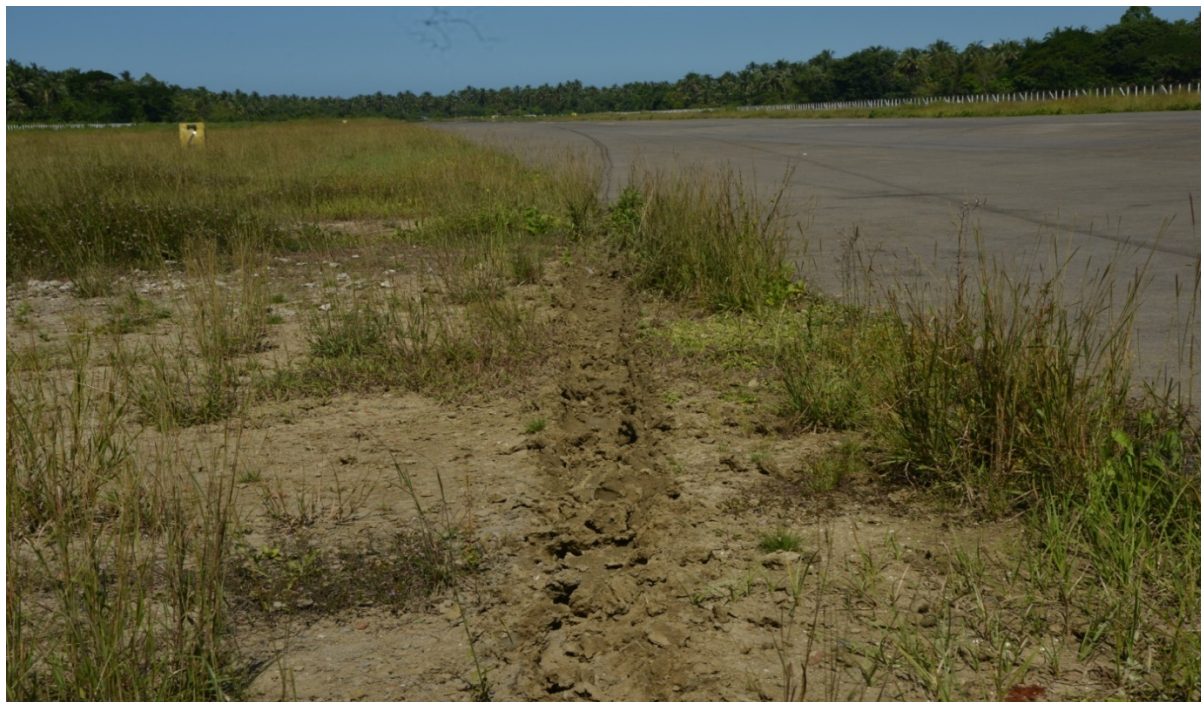
Figure :7 The Ground Mark of Right Hand Main Wheel (Viewed from Crash Site to Runway-16)

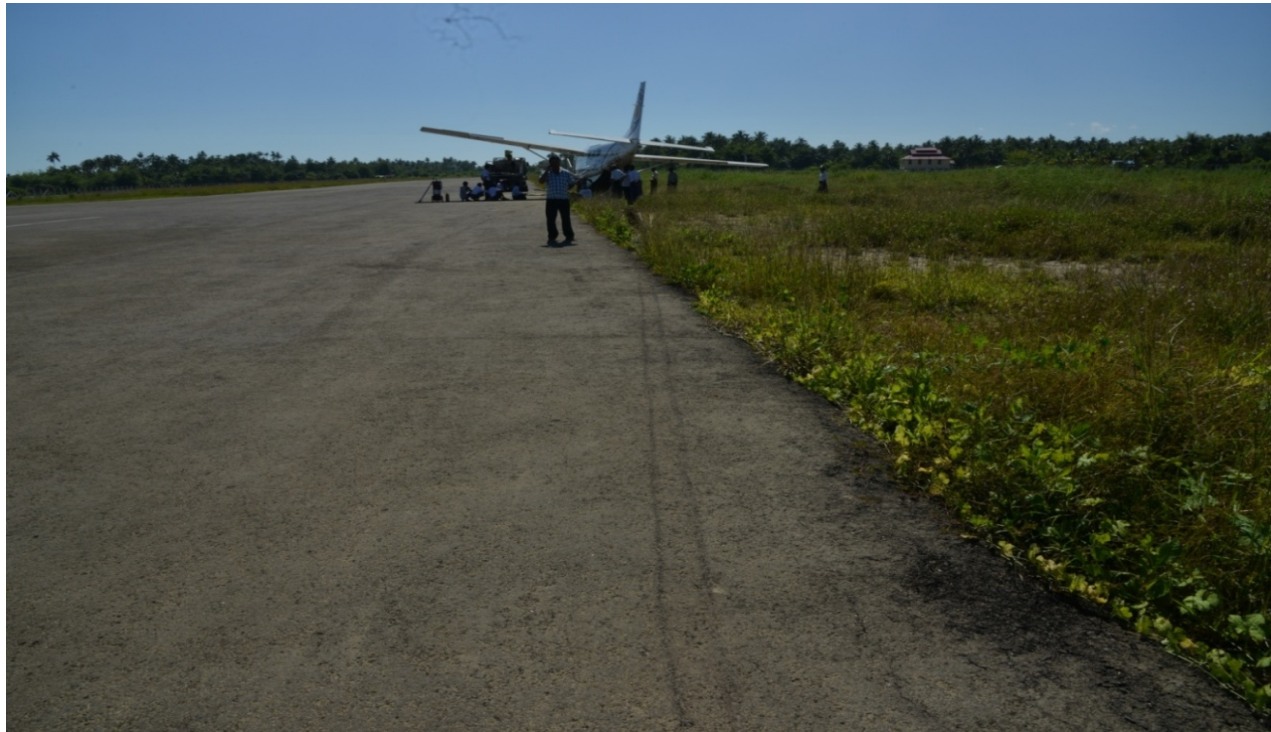
Figure :8 The Ground Mark of Right Main Wheel (Viewed from Runway-16 to Crash Site)

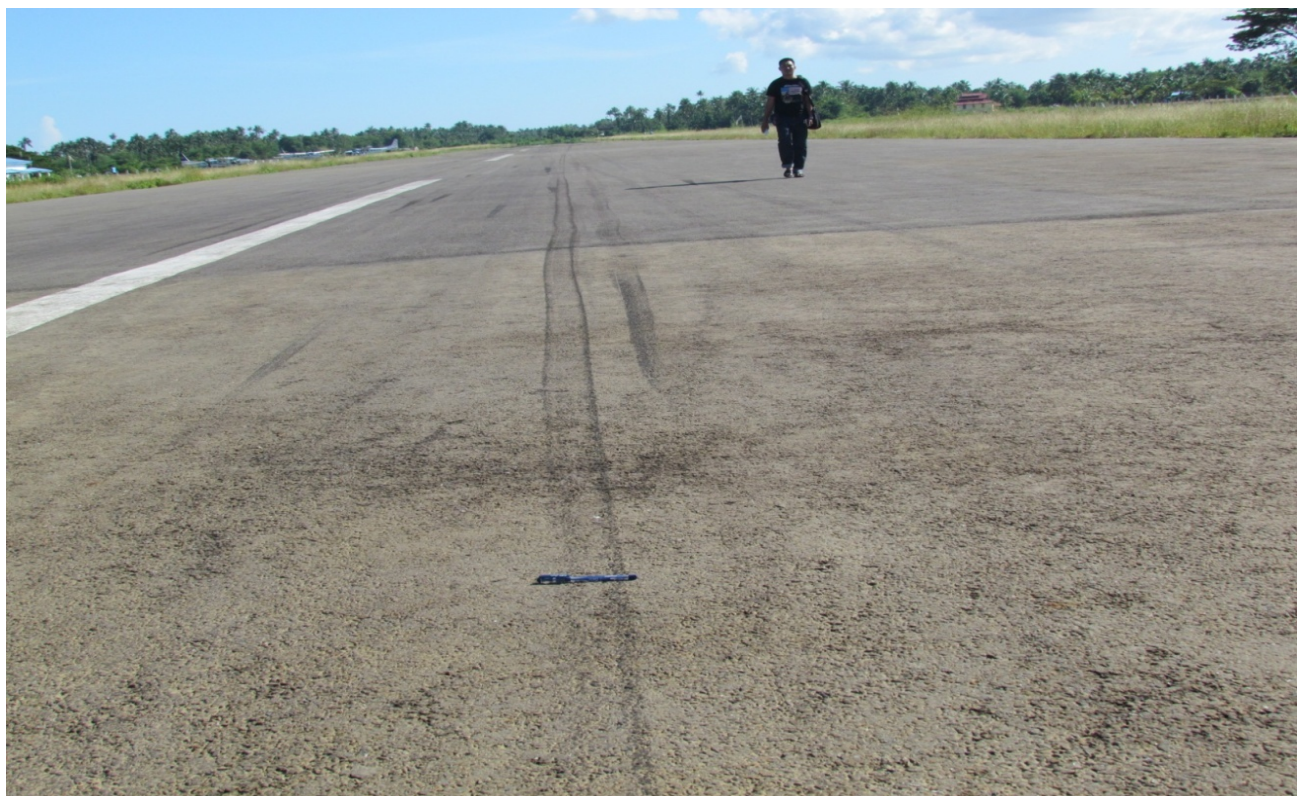
Figure:9 The Ground Mark of Right Hand Main Wheel (Viewed from Runway-16 to Crash Site)

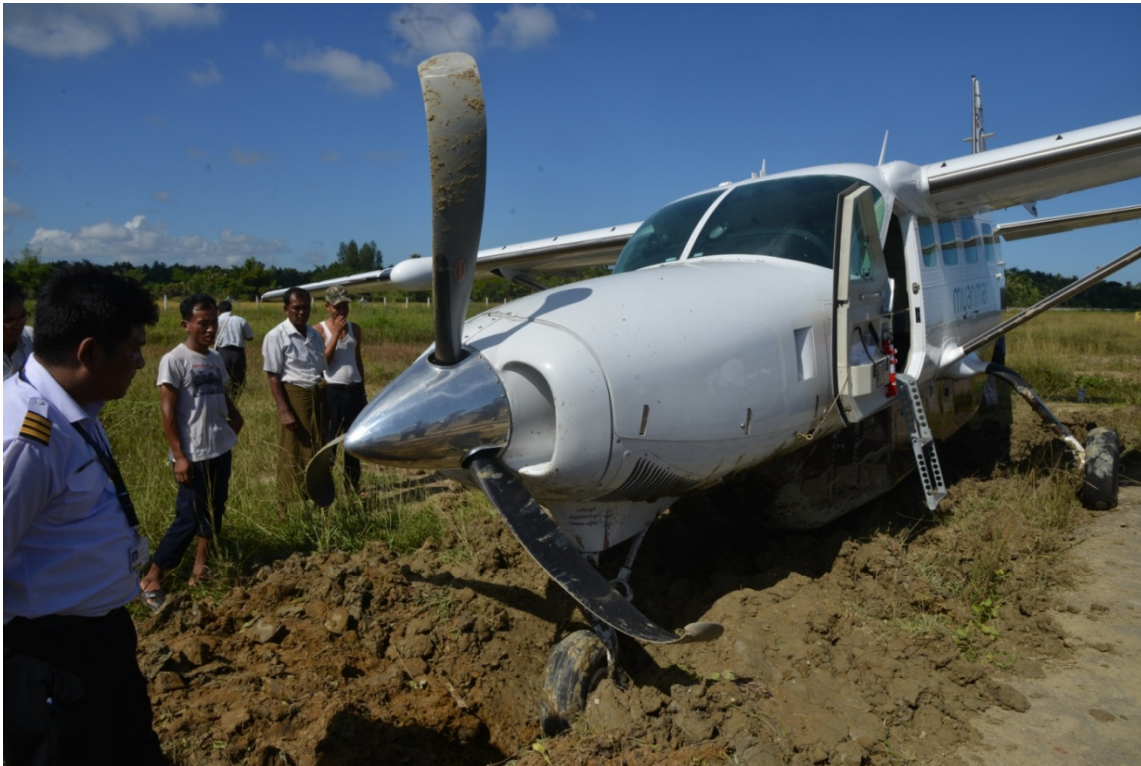
Figure:10 The twisted and damaged propeller

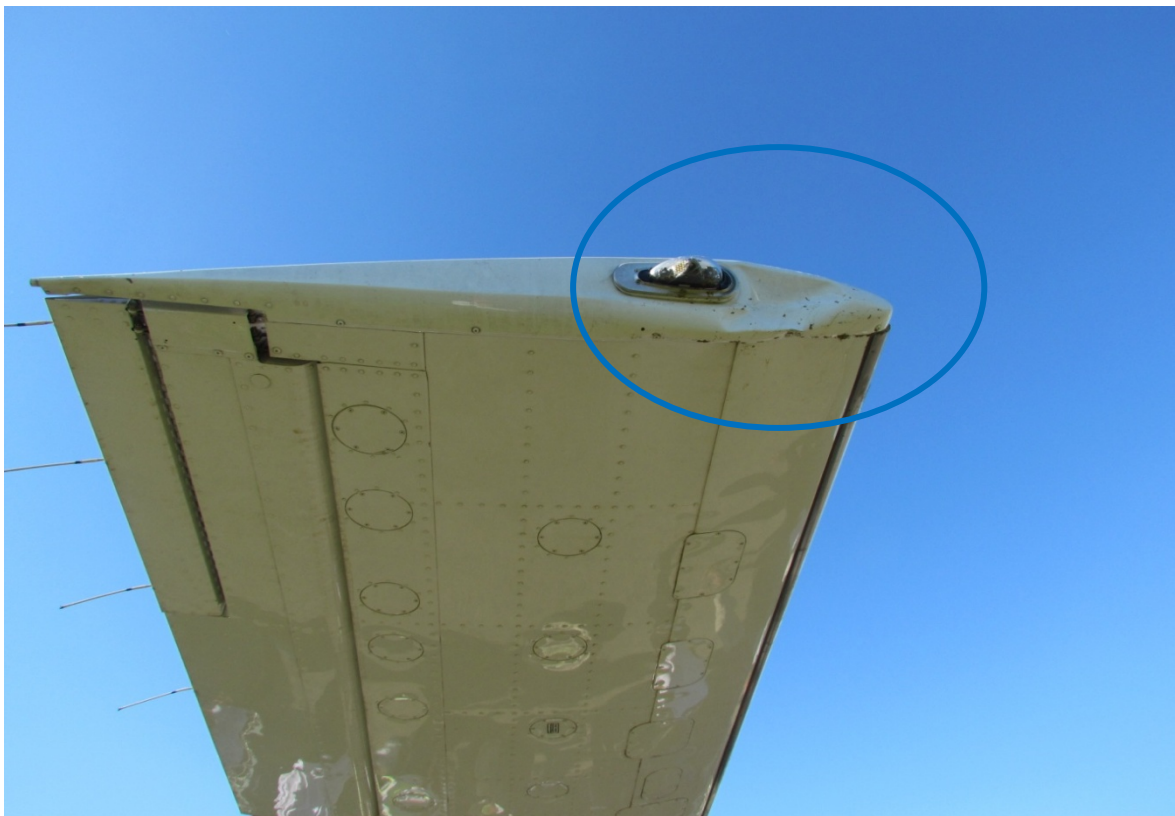
Figure:11 The dented Right Hand wing tip of the aircraft

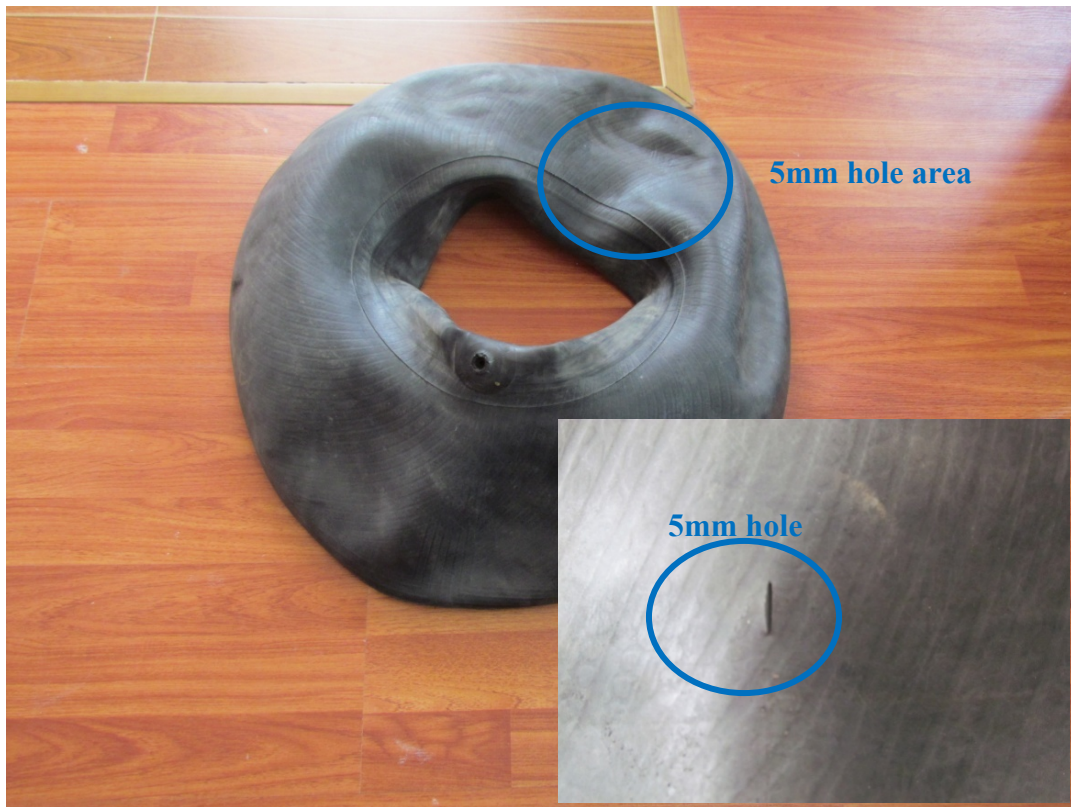
Figure:12 The 5mm hole and broken valve stem of the inner tube

- a) The two pilots were experienced, and had enough rest hours and familiar with Manaung Airport.
- b) The inner tube (850-10, P/N GL 85525B) being used by the operator was different from Cessna 208B illustrated part catalog(IPC) and alternative parts.
- c) Aircraft engine, control surface, brake system and navigation systems were working normally.
- d) The maximum landing weight was 8500 lb(3863.63 Kg);the landing weight on the flight was 7732lb(3514.5 Kg);it was within the limit.
- e) The pilot in command (PIC) could not maintain the directional control while the plane deviated from the runway centreline.

The pilot in command (PIC) could not maintain the directional control while on landing roll with a flat main wheel.

- 4.1 The pilots undergo the training regarding abnormal landing especially a landing with a flat tire in a simulator or a live aircraft.
- 4.2 Recommended inner tubes by the Aircraft manufacture should be used.
