DEPARTMENT OF THE AIR FORCE
HEADQUARTERS OGDEN AIR LOGISTICS CENTER (AFMC)
HILL AIR FORCE BASE, UTAH

February 14, 1995

Mr. Floyd Baham
Davis and Weber Counties Canal Company
138 West 1300 North
Sunset, UT 84015

The scope of work of this IPA was to investigate the possibility of over-irrigation on the golf course at Hill Air Force Base (HAFB), and its effect on degradation of the Davis-Weber Canal through seepage down the steep slope upon which the canal is located. A related issue dealt with the hydraulic consequences of a sudden (hypothetical) canal blockage due to a landslide, possibly caused by seepage and sloughing, and possible impact on an elementary school located 1,400 ft downhill from the canal.

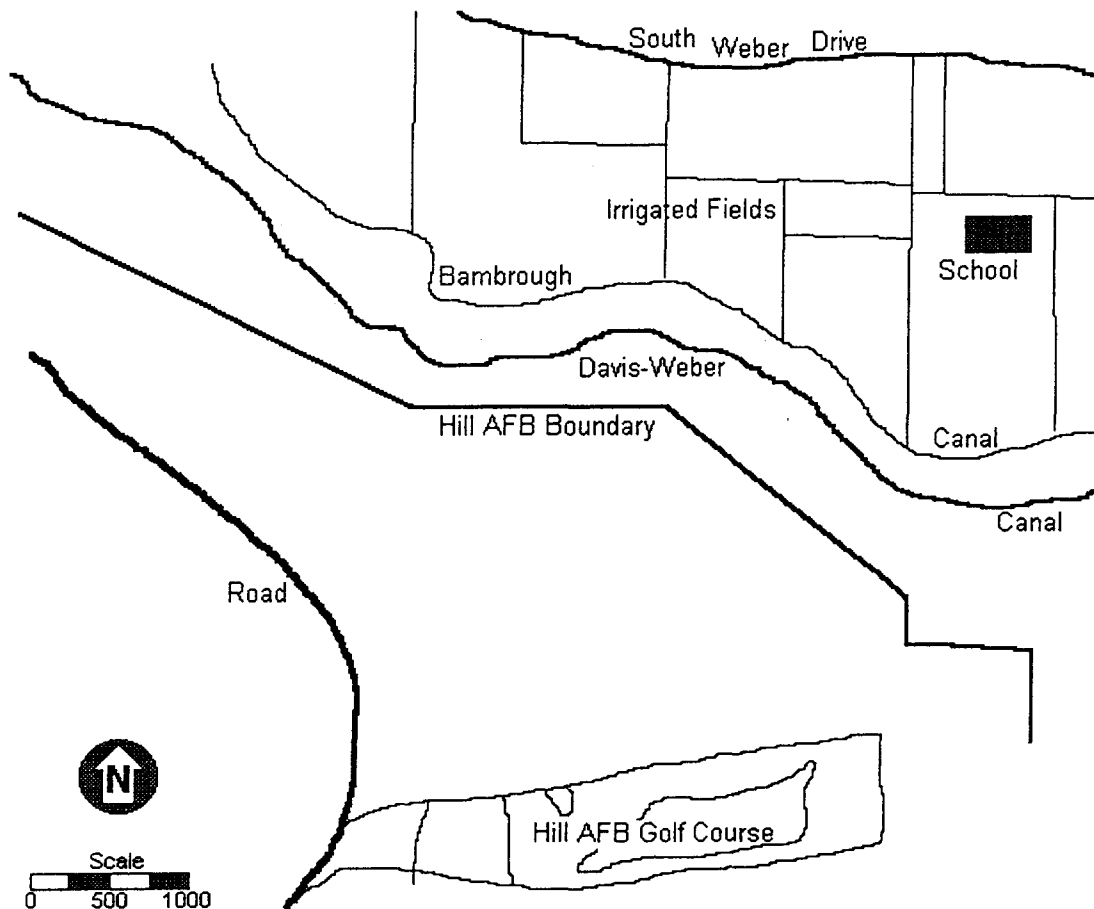
Figure 1. Plan View of the Hill AFB Golf Course and Davis-Weber Canal.

North of the Bambrough Canal the terrain flattens considerably, up to and beyond South Weber Drive. An elementary school is located approximately 1,400 ft north of the Davis-Weber Canal, a few hundred feet east of where the HAFB golf course begins. Irrigated fields cover most of the area immediately north of Bambrough Canal, and residential areas also exist in the vicinity of South Weber Drive. Figure 1 illustrates some of the features in this area.

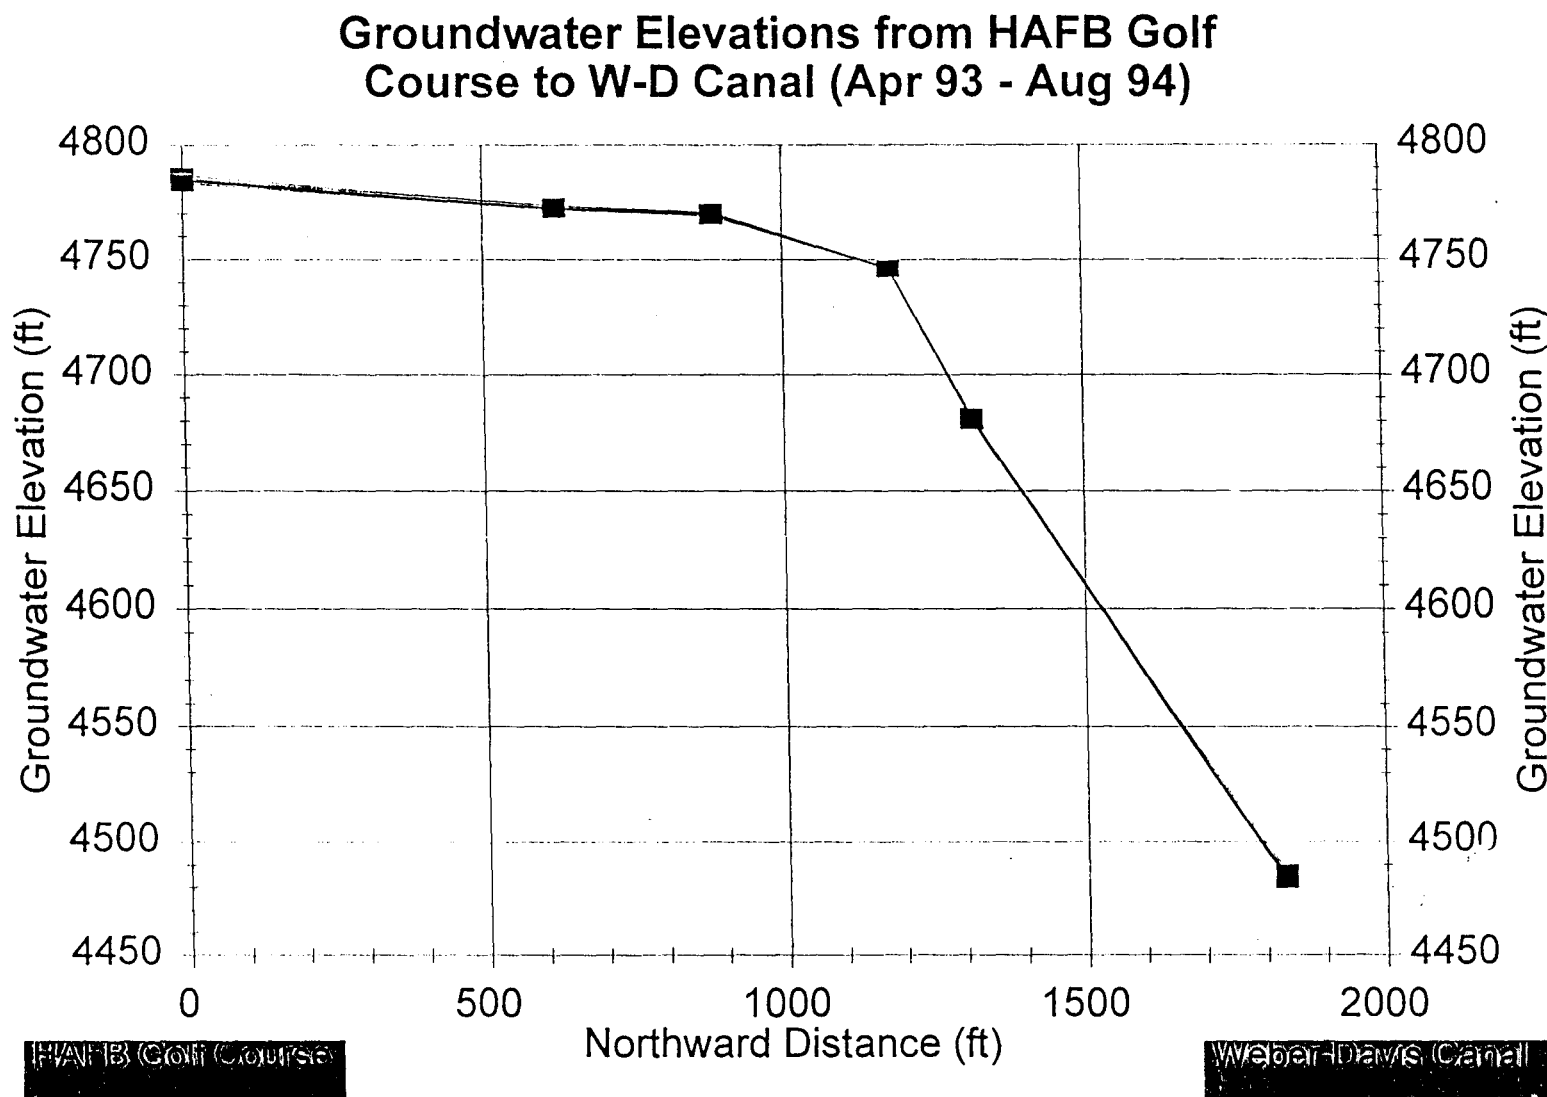
Figure 3. Groundwater Elevations at Six Sites from the Hill AFB Golf Course to the Davis-Weber Canal from April 1993 to August 1994 (data from Montgomery 1994).

It can be seen from Figure 3 that the profile does not change significantly with time over the study period; however, the spatial variation in groundwater elevation shows a marked decrease from the HAFB golf course to the Davis-Weber Canal. The profile has a steep drop in the area above the Davis-Weber Canal, which also has a steep ground surface slope. Nevertheless, these data show that there is some groundwater movement northward off HAFB and down the slope upon which the Davis-Weber Canal was constructed.

The irrigation of the golf course probably does not contribute significantly to this groundwater movement because of the static nature of the groundwater profile. If the golf course irrigation were to cause significant recharge to the shallow groundwater in this area, one would expect to see an increase in groundwater elevations during the period from about June to August when most irrigation water is applied. However, such an increase is not manifested in the data. Some of this movement may be due to other activities on the base, and some is probably due to natural groundwater flow in the area.

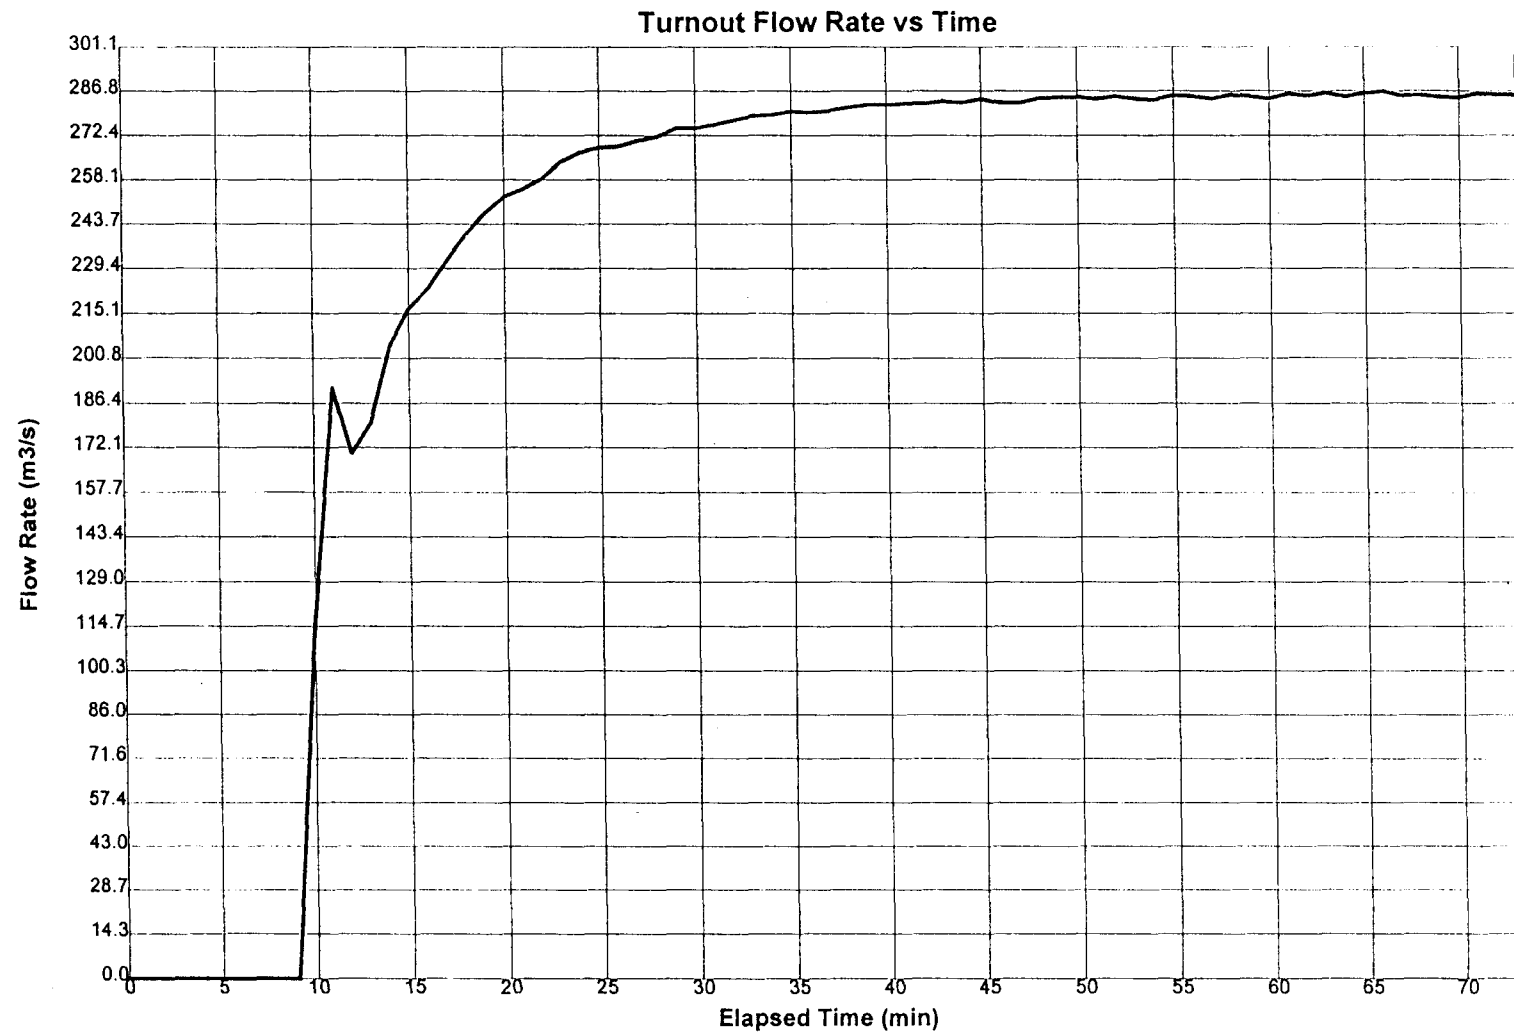
Figure 5. Spillage Flow Rate vs. Time in the Simulated Davis-Weber Canal.

Simulation results from the **CanalMan** hydraulic model (Merkley 1994) are given in Table 4 and Figures 4, 5 and 6 (the spike in the curve at about 11 minutes elapsed time in Figure 5 is due to a temporary numerical instability in the simulation, and would not be expected to occur in the real canal). The simulation began with a steady-state condition and 290 cfs inflow. The steady-state outflow

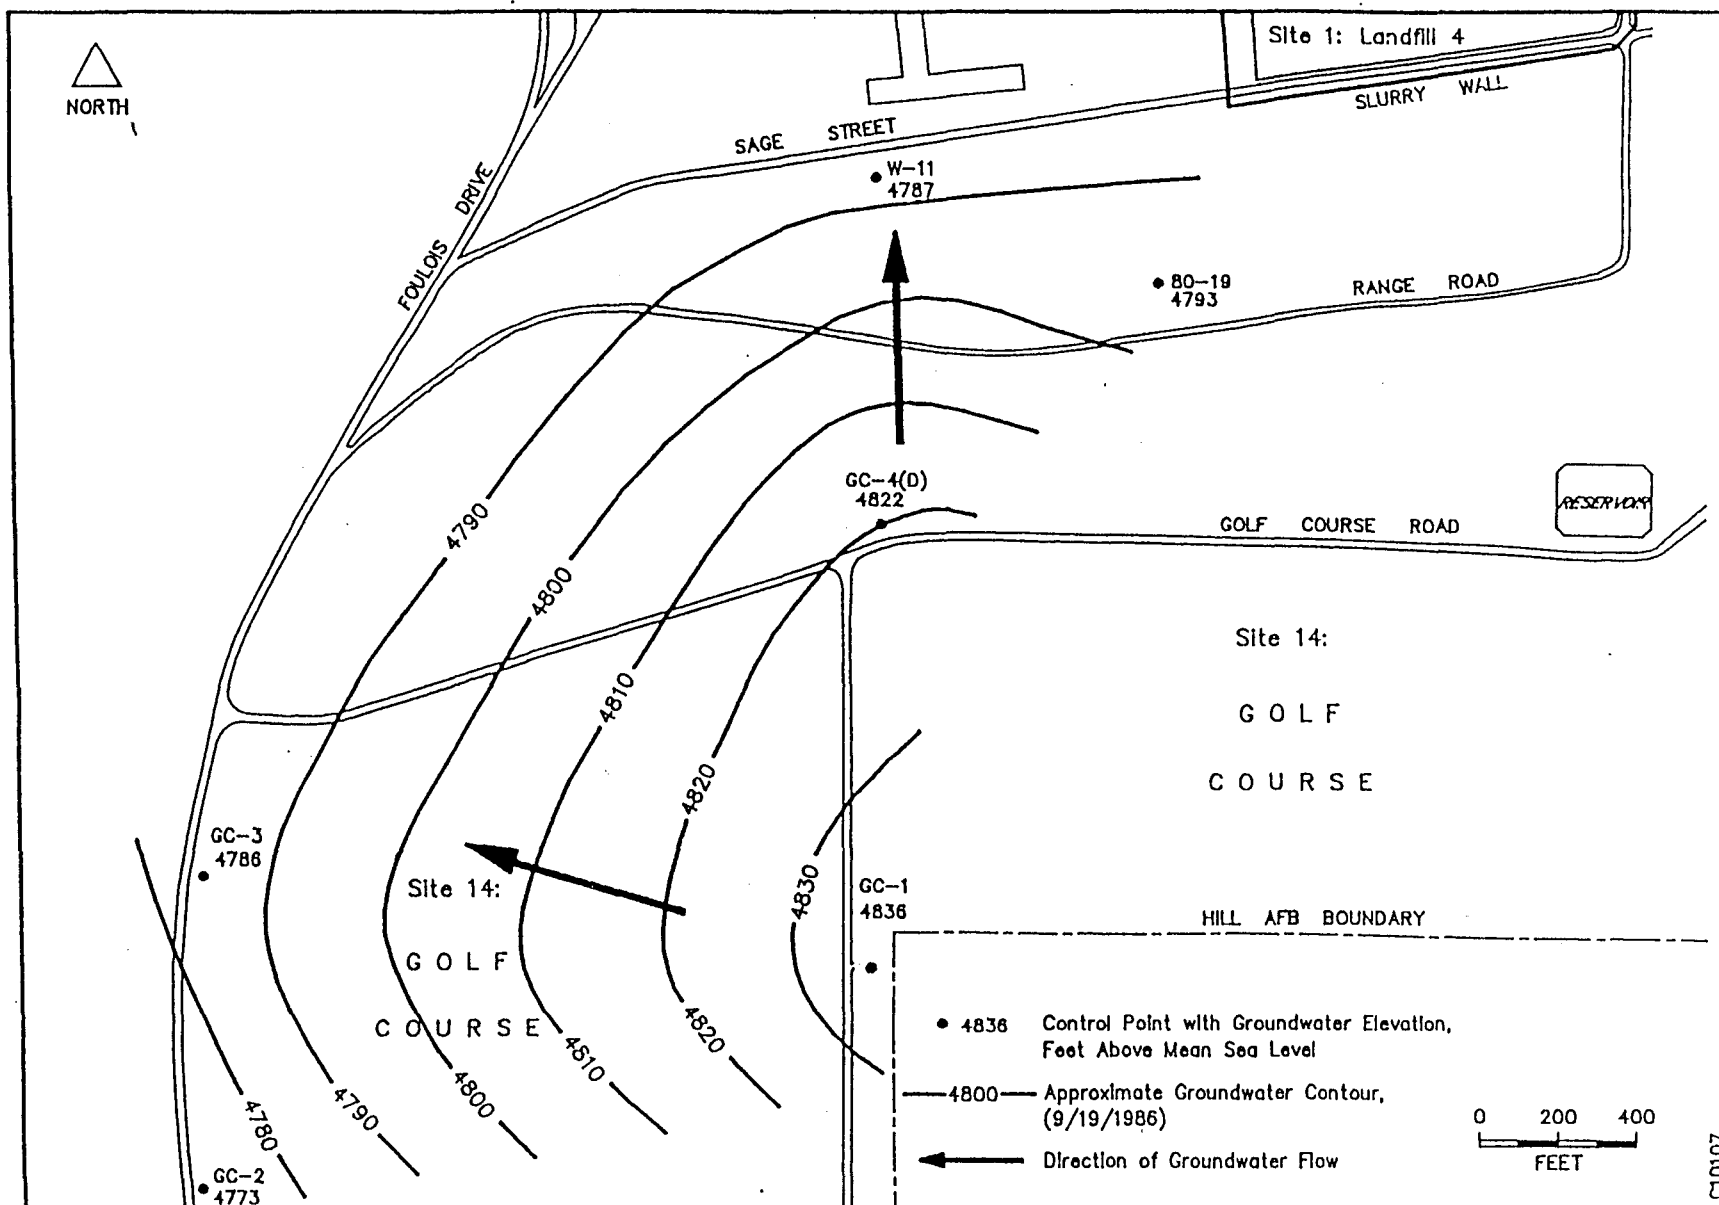
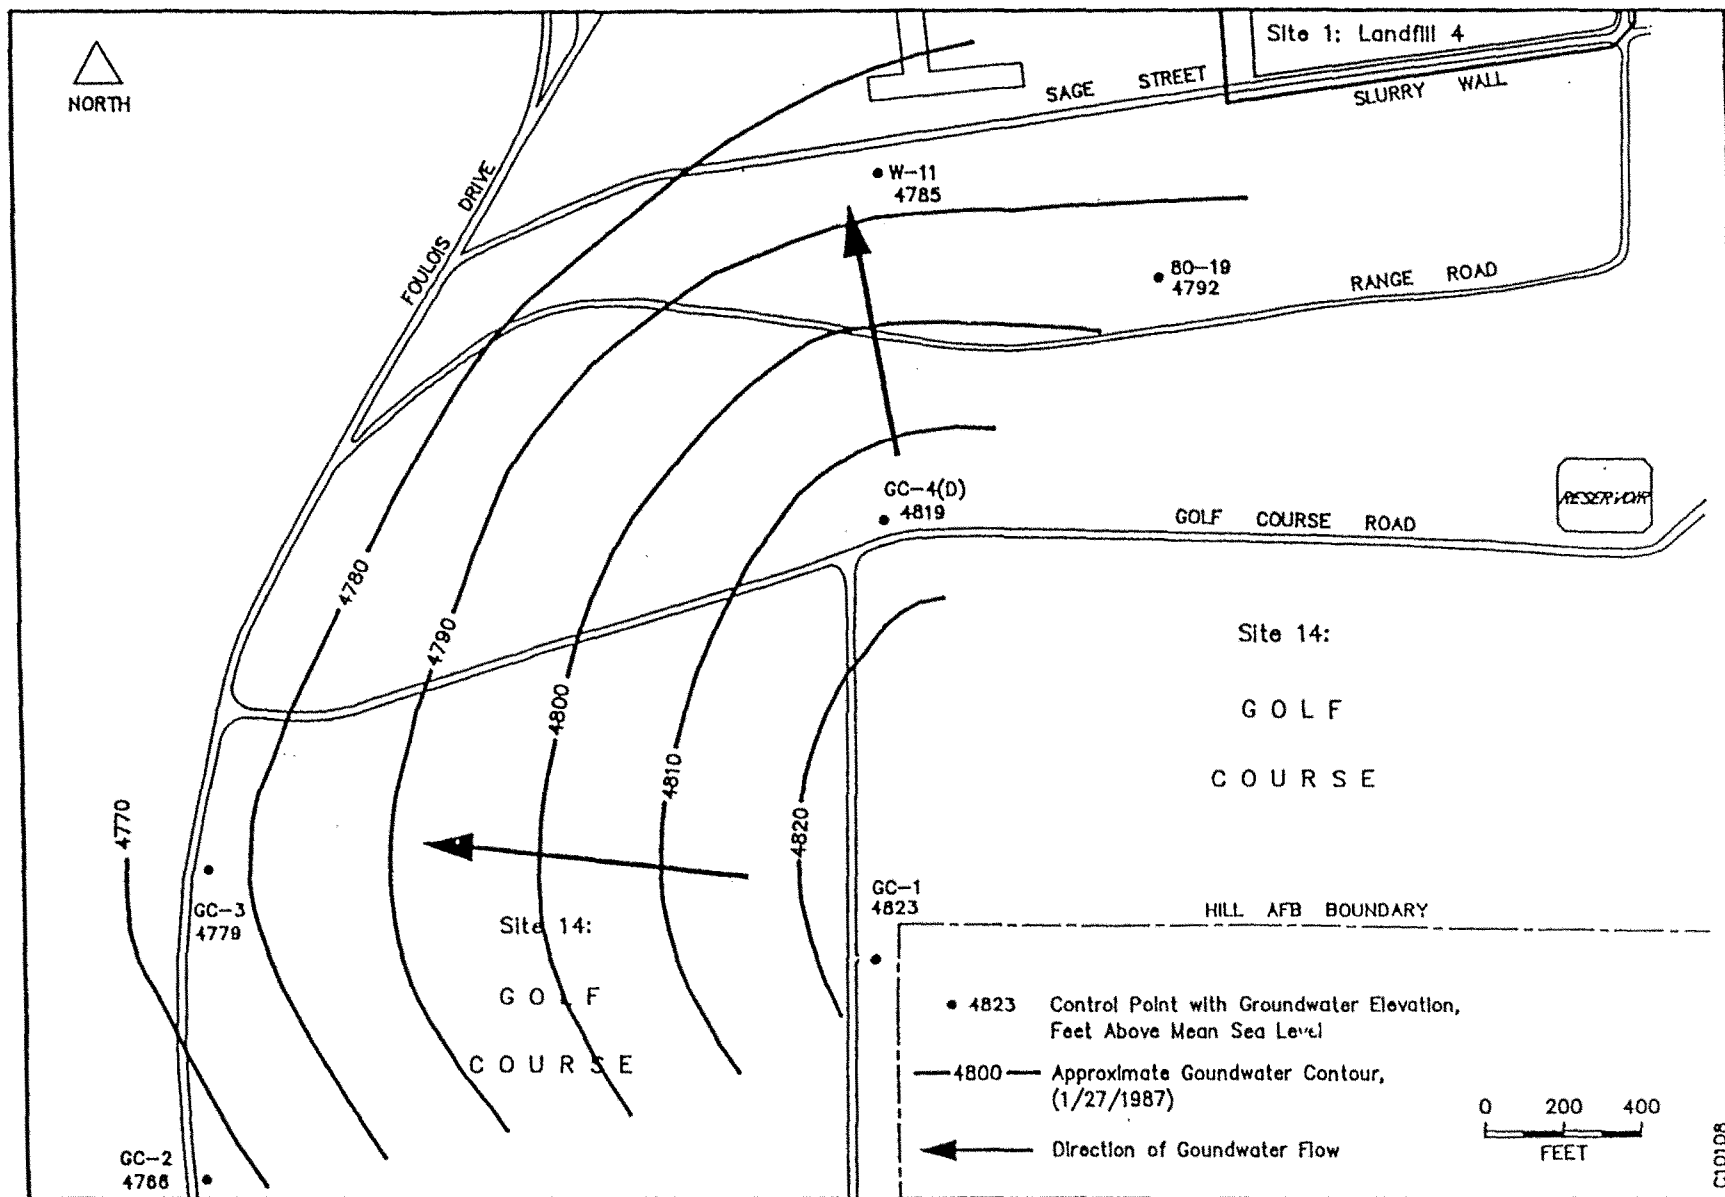
Static water levels at the golf course are shown in Figures 4.3.14-3 and 4.3.14-4. These figures represent measurements made 19 September, 1986, and 27 January 1987, which represent irrigation and non-irrigation periods, respectively. Analysis of the water level contours show groundwater flow directions to the west and north. Groundwater flow is perpendicular to the water level contour of equipotential lines. The westerly flow is baseward while the northerly flow is towards the slurry trench wall and waste site areas. These data confirm that groundwater underflow occurs at the golf course. Static water level contours were estimated in the area bounded by GC-4, Golf Course Road, Foulois Drive, and Range Road. No well data were available in this area. Therefore, the contours are based upon known hydrogeologic conditions of the study sites.

Further analysis indicates that recharge occurred during the golf course irrigation activities. Recharge can also be from private farmland located next to the golf course. The contribution from the farmland is unknown. No well data are available to the east of the golf course and the recharge potential is unknown. Recharge occurred mainly in the vicinity and west of test well GC-1. This is indicated by an eastward shifting of the water level contours such as the 4800 water level line after the irrigation season. The eastward shifting of the contours is an indication of declining recharge. On the other hand, less shifting of the contours occurred in the vicinity of GC-4. This can represent less recharge and/or changes in formation permeability characteristics. Variations in recharge were confirmed at
