AIR ACCIDENT/INCIDENT INVESTIGATION COMMISSION

SERIOUS INCIDENT - FINAL REPORT

Aircraft Mid-Air Collision with The Cable of a Tethered Military Balloon

Operator:	Jazeera Airways
Make and Model:	Airbus A320-214
Flight Number:	J9-787
Nationality and Registration:	State of Kuwait, 9K-CAK
Place:	Kuwait International Airport
State of Occurrence:	State of Kuwait
Date of Occurrence:	27 August 2017

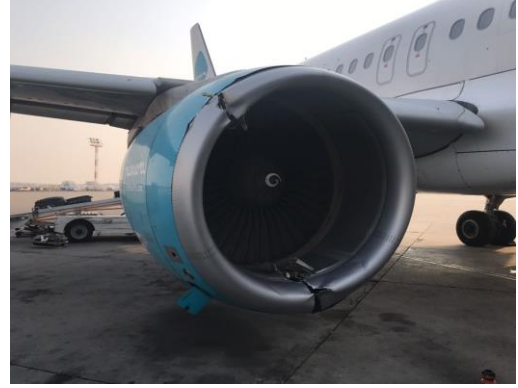
Figure 1. Engine inlet cowl damage

The Aircraft sustained damage and fractures to the right engine inlet and fan cowling. Two fractures for about one meter in the inlet cowl, and about 10 centimeters in the fan cowling.(Figure 1).

- (a) The Aircraft was certified, equipped, and maintained in accordance with the requirements of the Kuwait Civil Aviation Safety Regulations (KCASR).
- (b) The Aircraft was airworthy when dispatched for the flight.
- (c) The Aircraft sustained damage to the right engine inlet cowling and fan cowling because of the collision with the balloon cable.

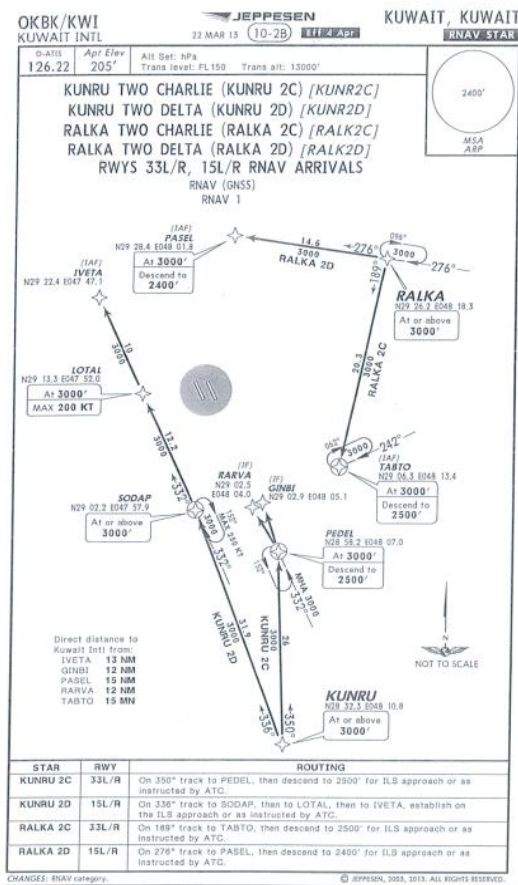
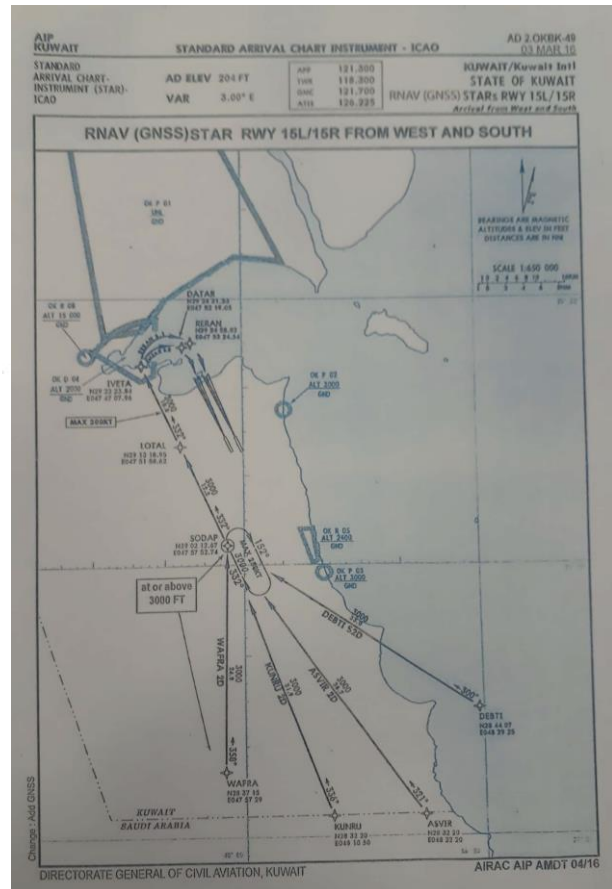
Figure 2. Comparison between Jeppesen and AIP approach charts

Through discussion it was also noted that the controllers were vectoring traffic coming from the south and south-west inside both restricted areas for landings on runway 15R. Unlike the Kuwait aeronautical information publication (AIP), some operator's Jeppesen charts given to the crew did not depict the restricted area. (Figure 2).

The Operator's manuals did not highlight the shortage of information in the Jeppesen manual. There was also no report submitted by the crew to highlight this deficiency.

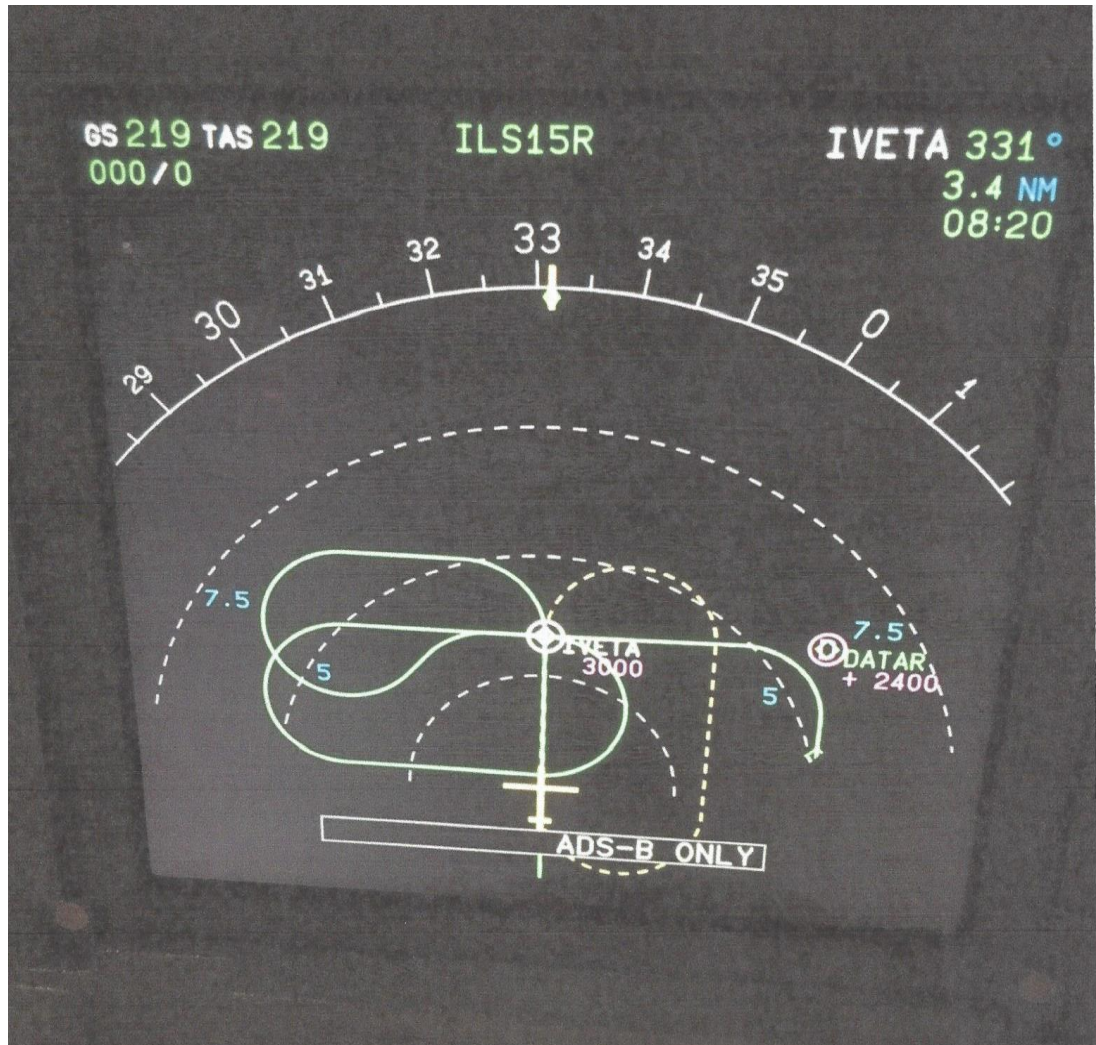
A simulator trial was carried out to simulate the circumstances of the flight with the aircraft flying on a track of 332 with autopilot engaged and proceeding to IVETA. Based on the information obtained during the investigation, a right turn holding pattern with an inbound course of 062 was inserted via the MCDU in the FMGS to simulate the action taken by the pilot. The information displayed to both pilots on the navigation display in their primary field of view was as below.

Presentation to the pilots for the entry procedure for right turn holding pattern at IVETA with an inbound course of 062 as computed by FMGS.
