Investigation of the M6.6 Niigata-Chuetsu Oki, Japan, Earthquake of July 16, 2007

Open File Report 2007–1365

U.S. Department of the Interior
U.S. Geological Survey

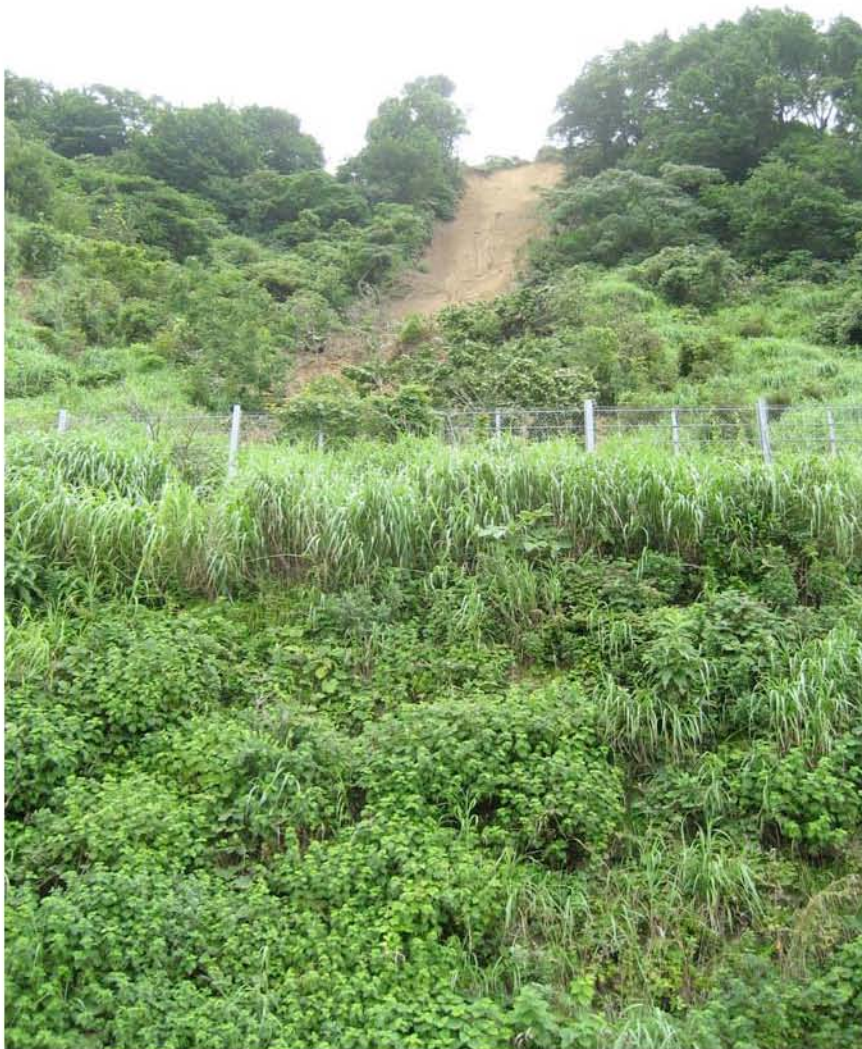
Figure 3.3: Coastal landslides on Highway 352 north of Kashiwazaki-Kariwa Nuclear Power Plant at road closure south of Route 373 (Site RK34-Slide 4; N37.48455° E138.62435°, photos taken 7/22/07 at approx. 10:45). This landslide is typical of many of those observed along the coast, and in this case did not damage transportation lines. Slide is approximately 10 m wide, 25 m long, and 0.5 m thick. Failure plane has approximate 50° inclination.

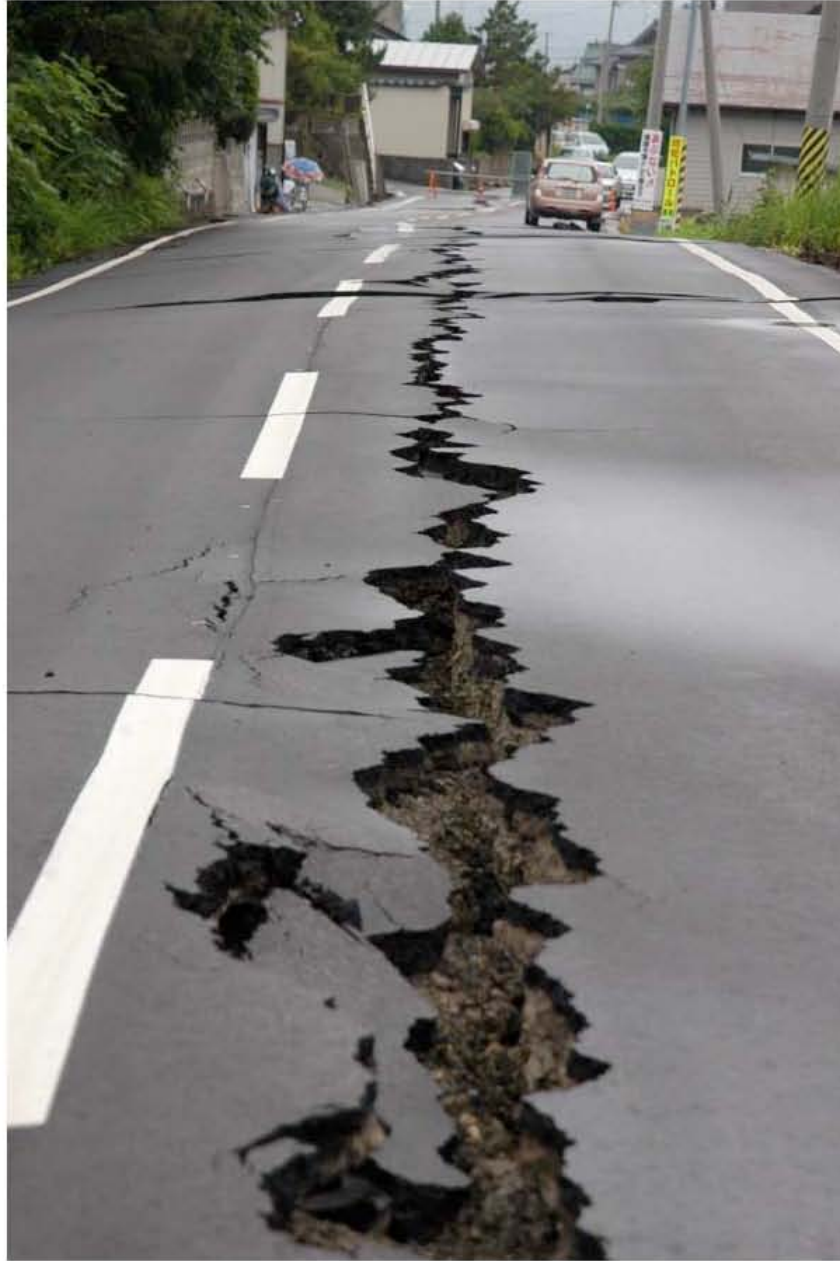
Figure 4.13: North side of Kai-Un Bridge area Sabaishi River - Lateral Spread on Road to Kashiwazaki Incinerator (Site RK6, N37.39343° E138.58555°, 7/19/2007). Lateral spreading on the north side of the river adjacent to the Kashiwazaki Municipal Incinerator damaged the access road of the facility.

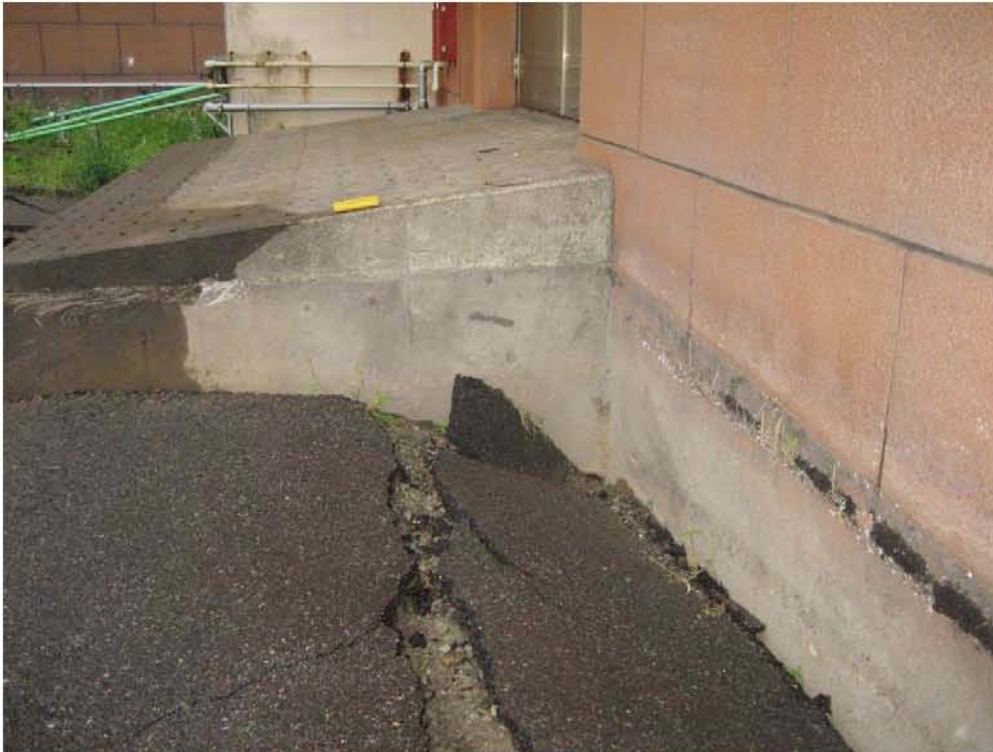
Figure 4.15: Kashiwazaki Wastewater Treatment Plant on the south side of Sabaishi River near the Sea of Japan (Site RK9 N37.38748° E138.56587°, 7/19/2007). Damage to the main building from liquefaction of ground resulted in meter-scale ground settlements.

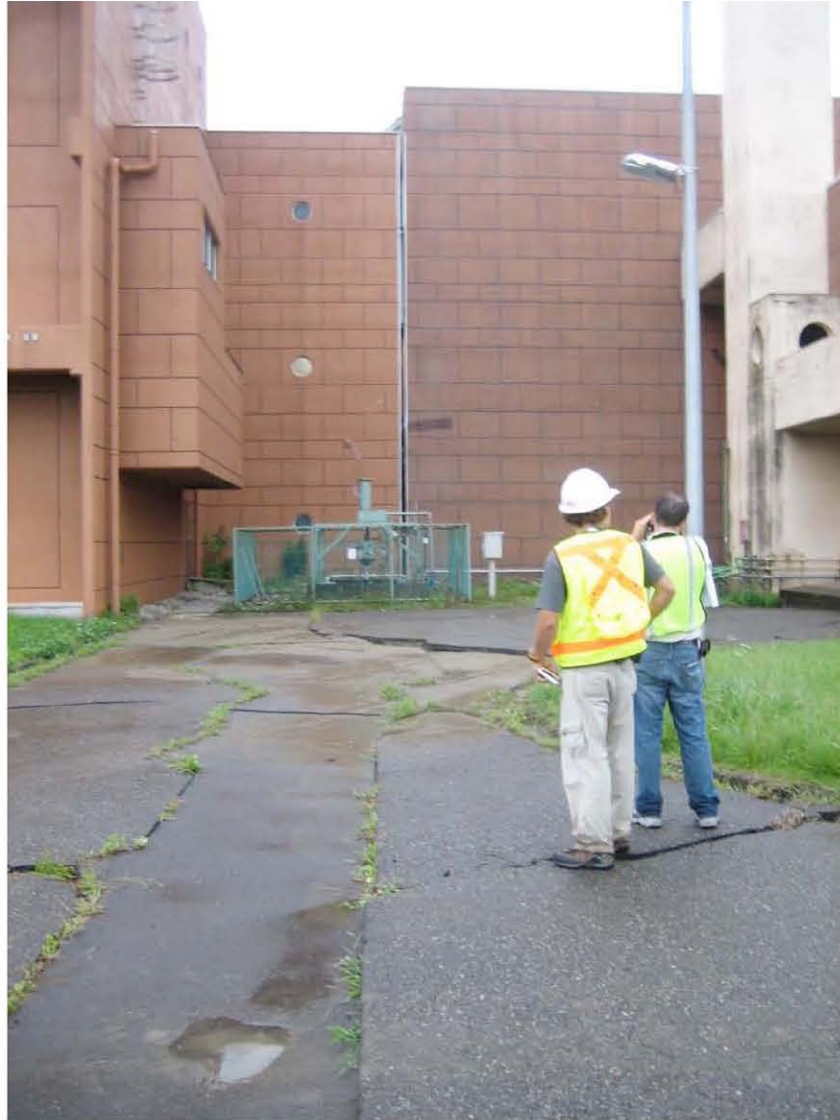
Figure 4.16a: Kashiwazaki Wastewater Treatment Plan on the south side of Sabaishi River near its outlet to the Sea of Japan (Site RK9 N37.38748° E138.56587°, 7/19/2007). Damage to the main building from liquefaction of ground resulted in the complete separation of two sections of the adjacent, yet integrated, three-story buildings with associated building and ground settlements.

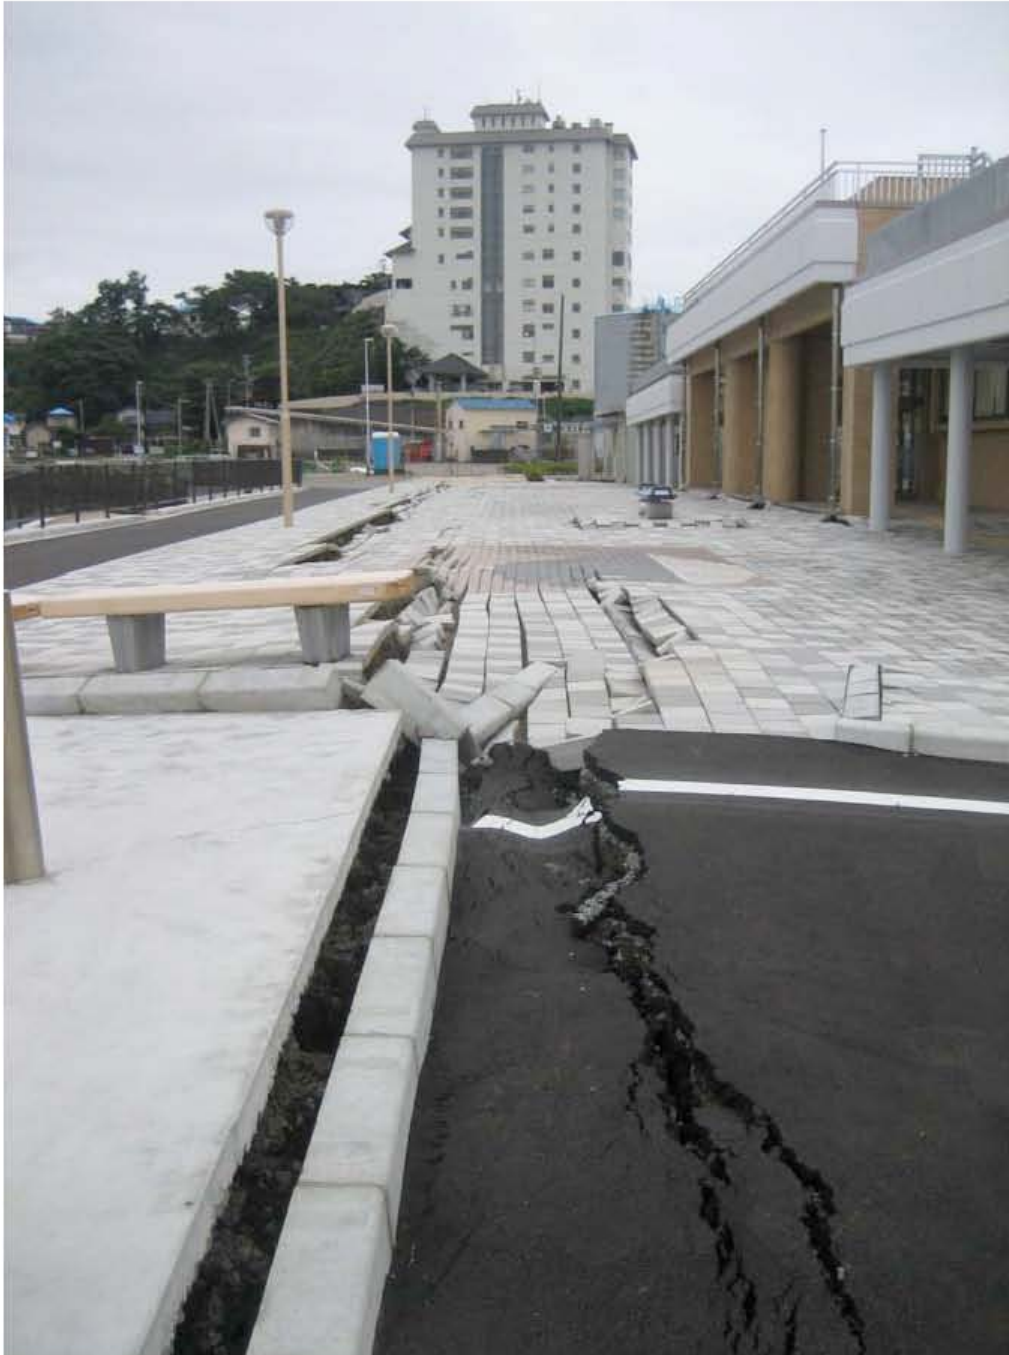
Figure 4.21: Kashiwazaki Harbor - The southern area experienced ground damage from liquefaction-induced lateral spreading and settlement. A harbor-front caisson rotated toward the harbor, to the left of the photo, initiating lateral displacement of the soil behind it, between the caisson and port building (Site RK25, N37.36713° E138.53210°, 7/20/2007).

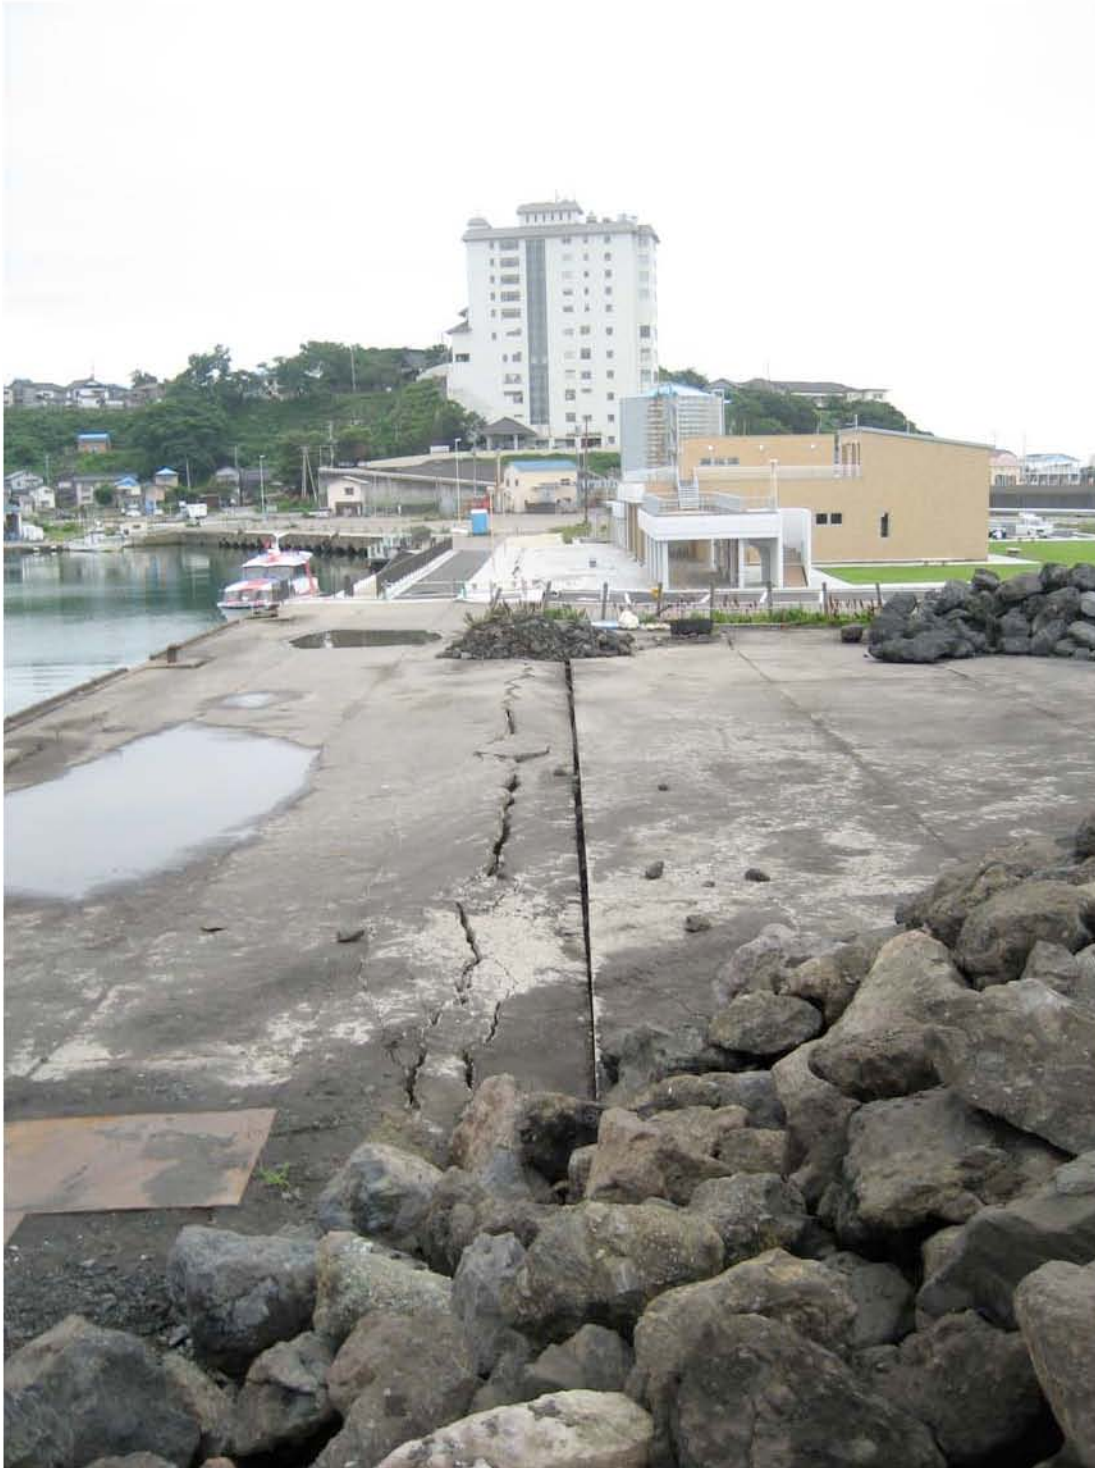
Figure 4.24: Kashiwazaki Harbor - South area experienced ground damage from liquefaction-induced lateral spreading and settlement, here seen from a mound of riprap (Site RK25, N37.36713° E138.53210°, 7/20/2007).

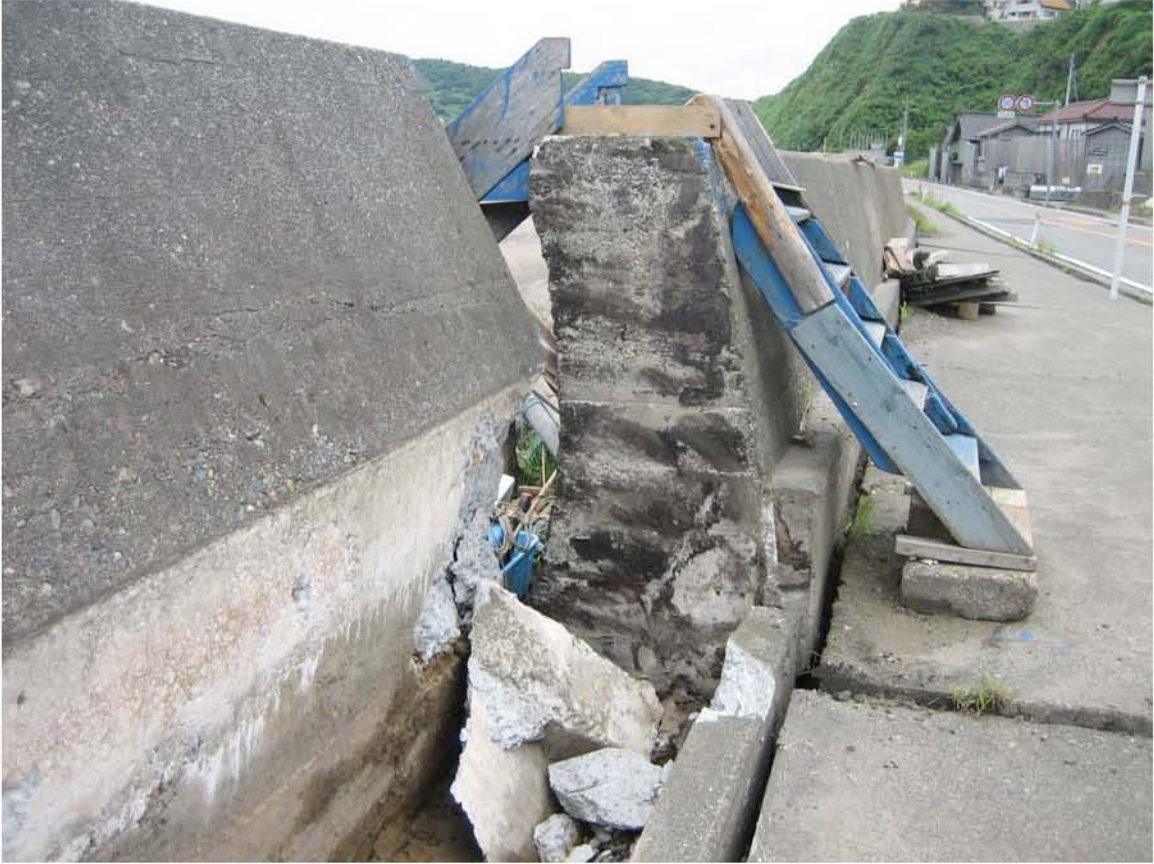
Figure 4.30: Concrete seawall deformations were on the order of 25 cm vertical (failed section up), and up to 64 cm horizontal, with a component of rotation as measured by 32 cm lateral deformation at the base of wall and 64 cm lateral deformation at 2 m height of wall. (Site RK35, N37.48497° E138.62645°, 7/22/2007).

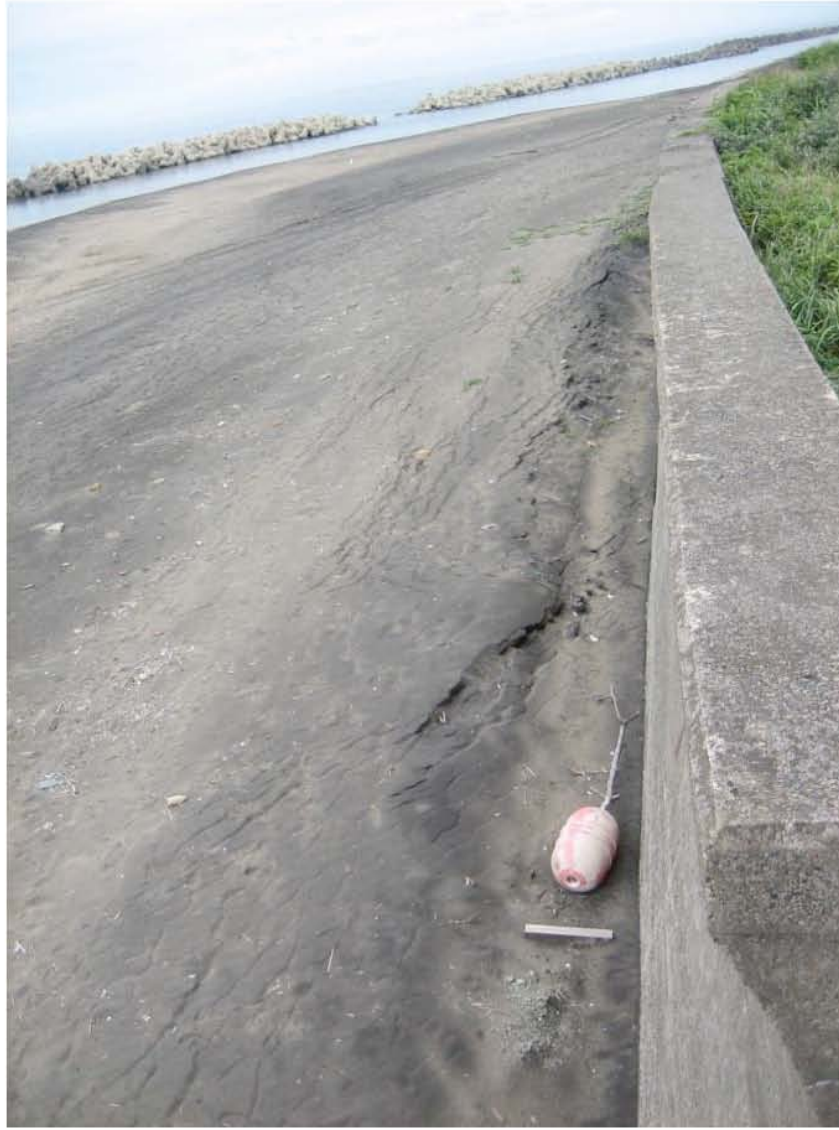
Figure 4.32: Lateral spreading related ground cracking in front of seawall. (Site RK37, N37.45478° E138.60927°, 7/22/2007).

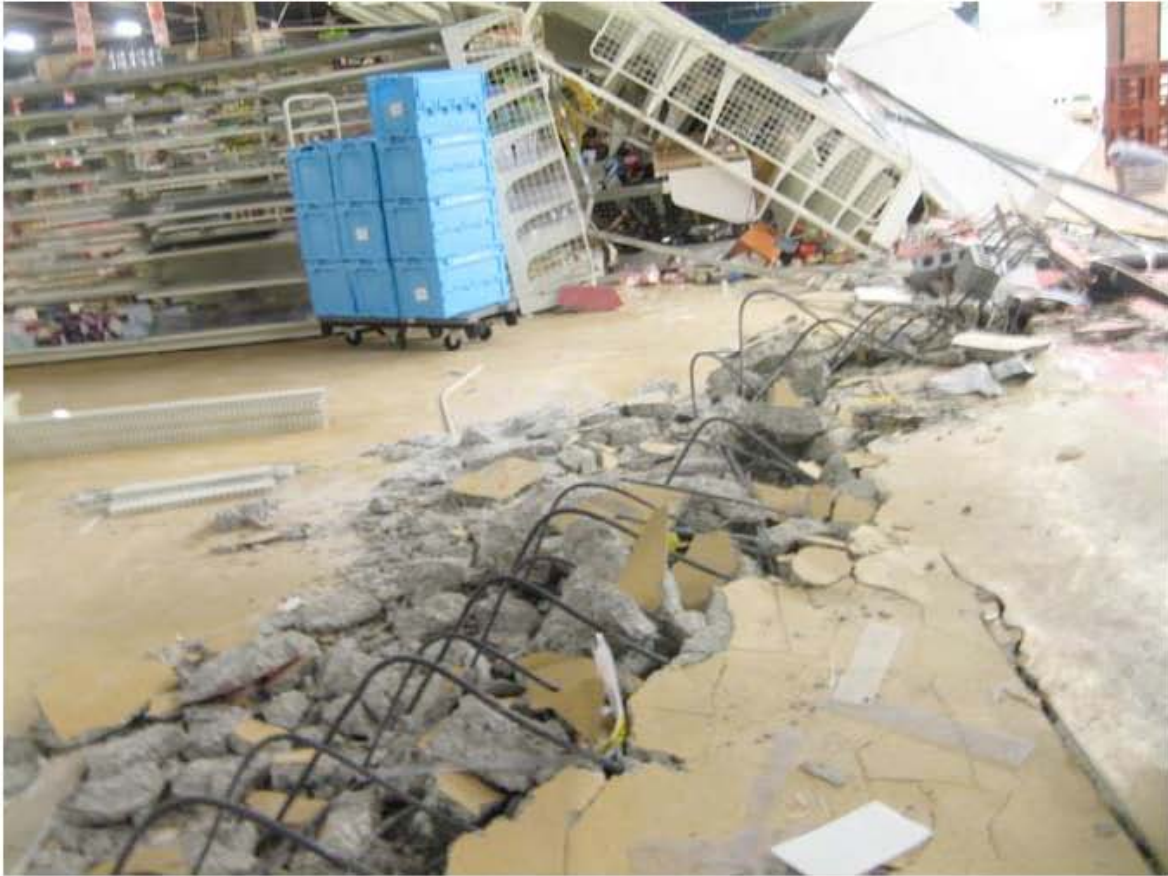
Figure 4.39: Plant 5 – Failure of slab on grade with buckled reinforcing bars. (Site RK41, N37.41468° E138.60840°, 7/22/2007).

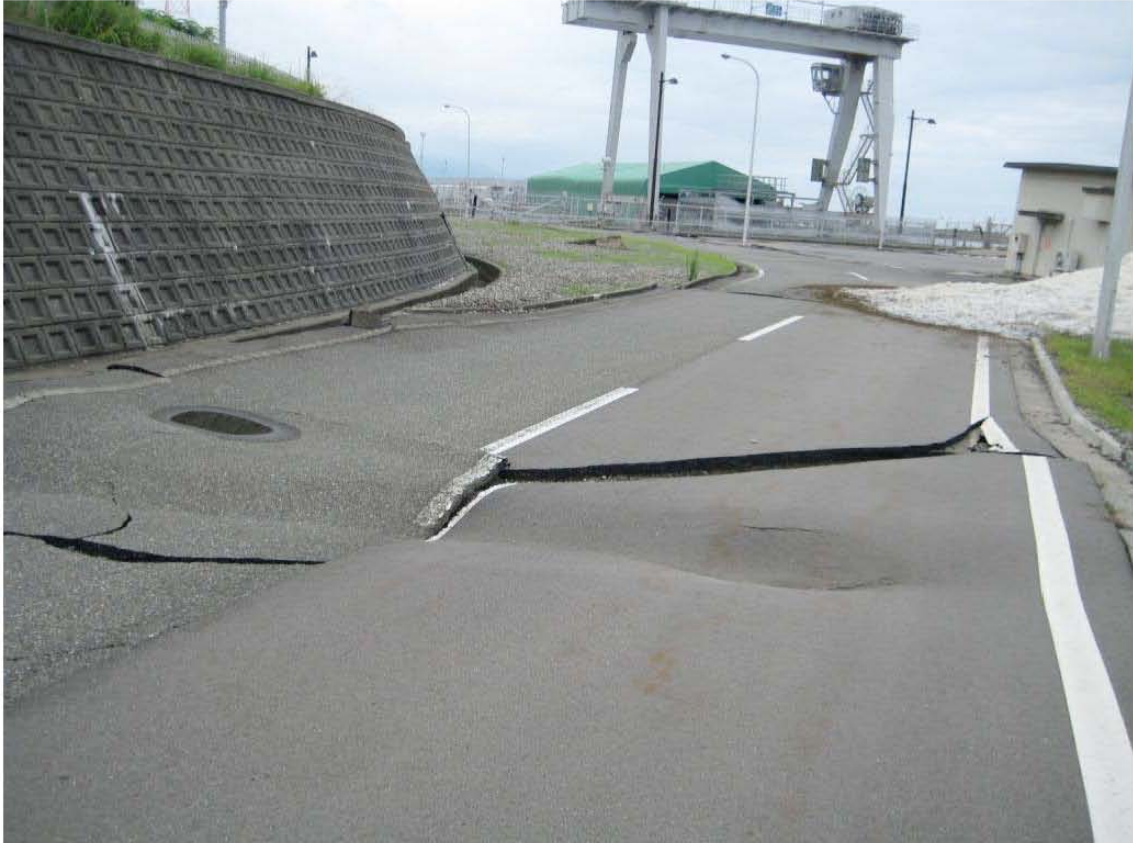
Figure 5.3: Damaged road at power plant.

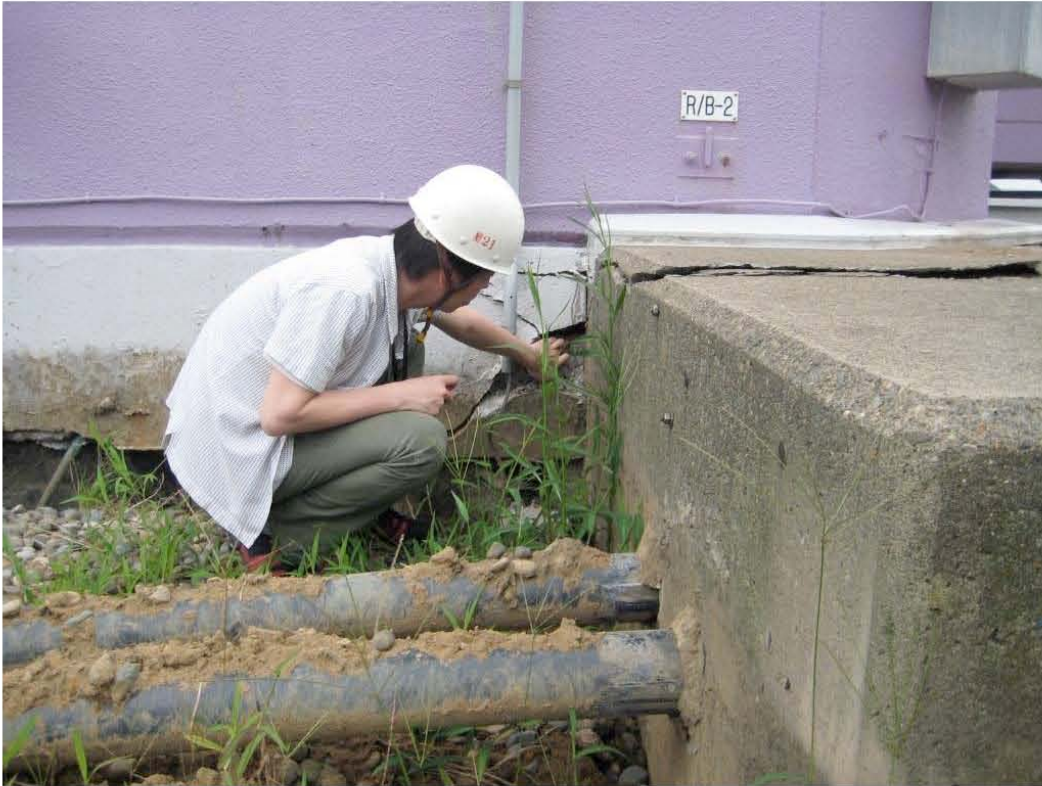
Figure 5.4: Cracks in reinforced concrete element at ground level.

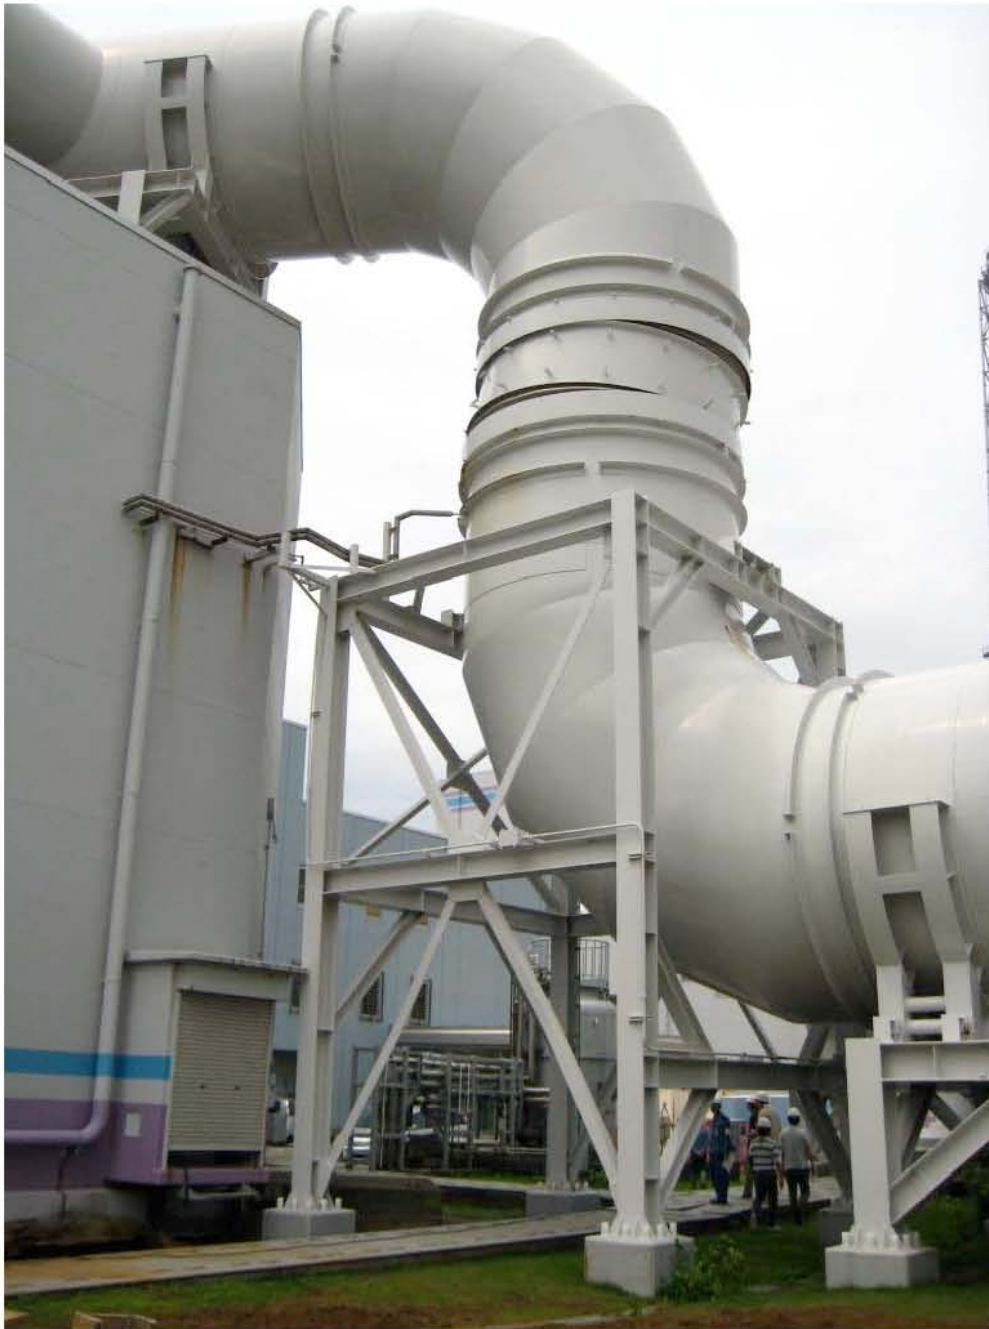
Figure 5.5: Failure of joint in exhaust pipe.

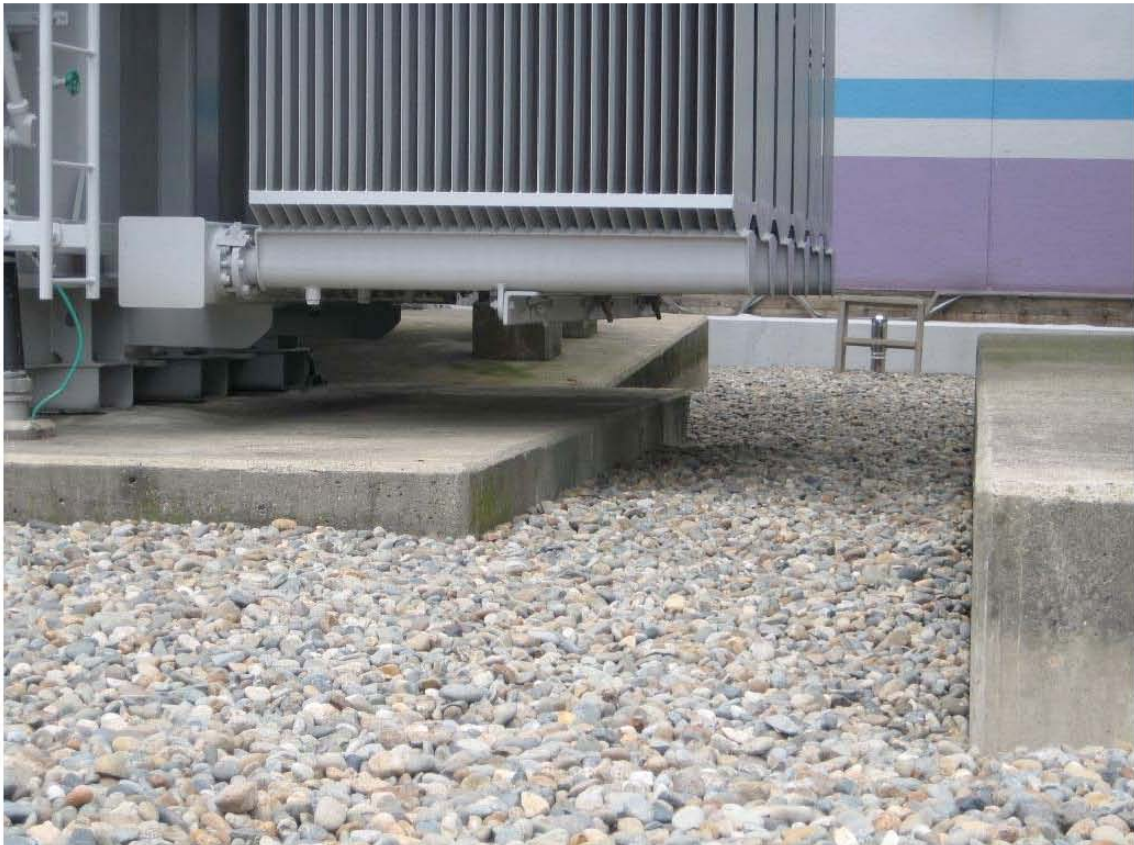
Figure 5.6: Rotation of isolated footings for equipment at nuclear power plant.

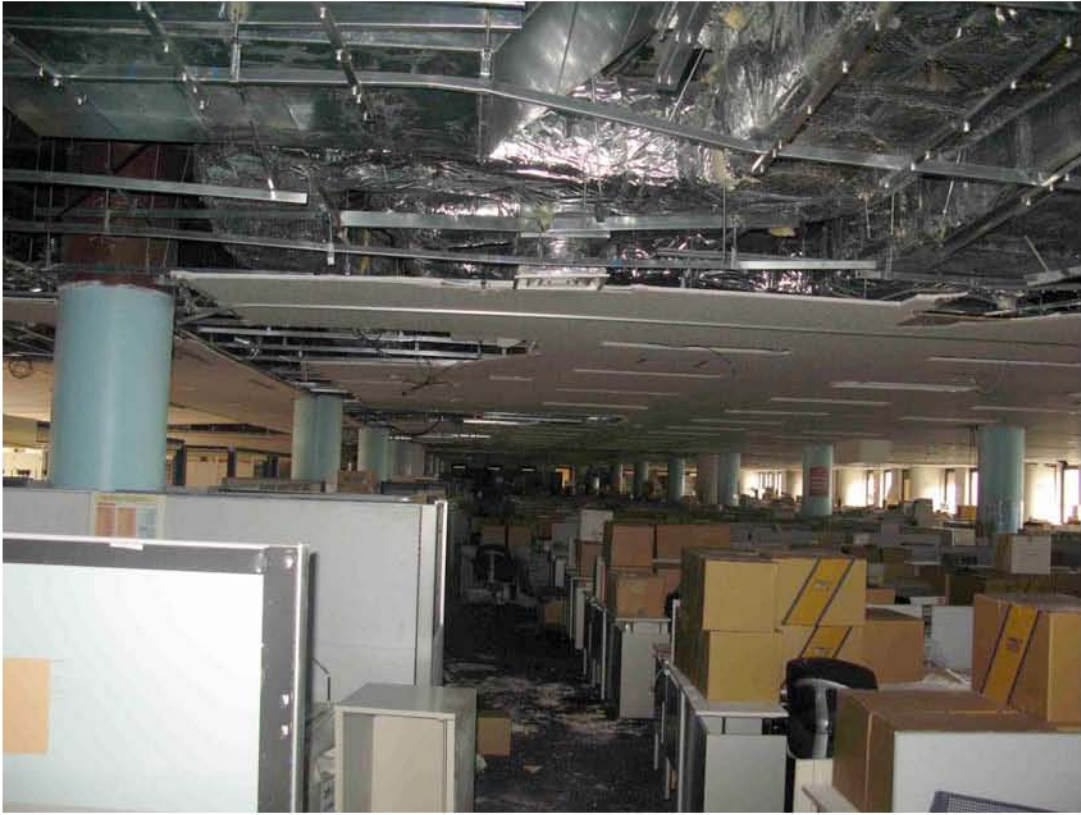
Figure 5.7: Ceiling damage in administration building of nuclear power plant.

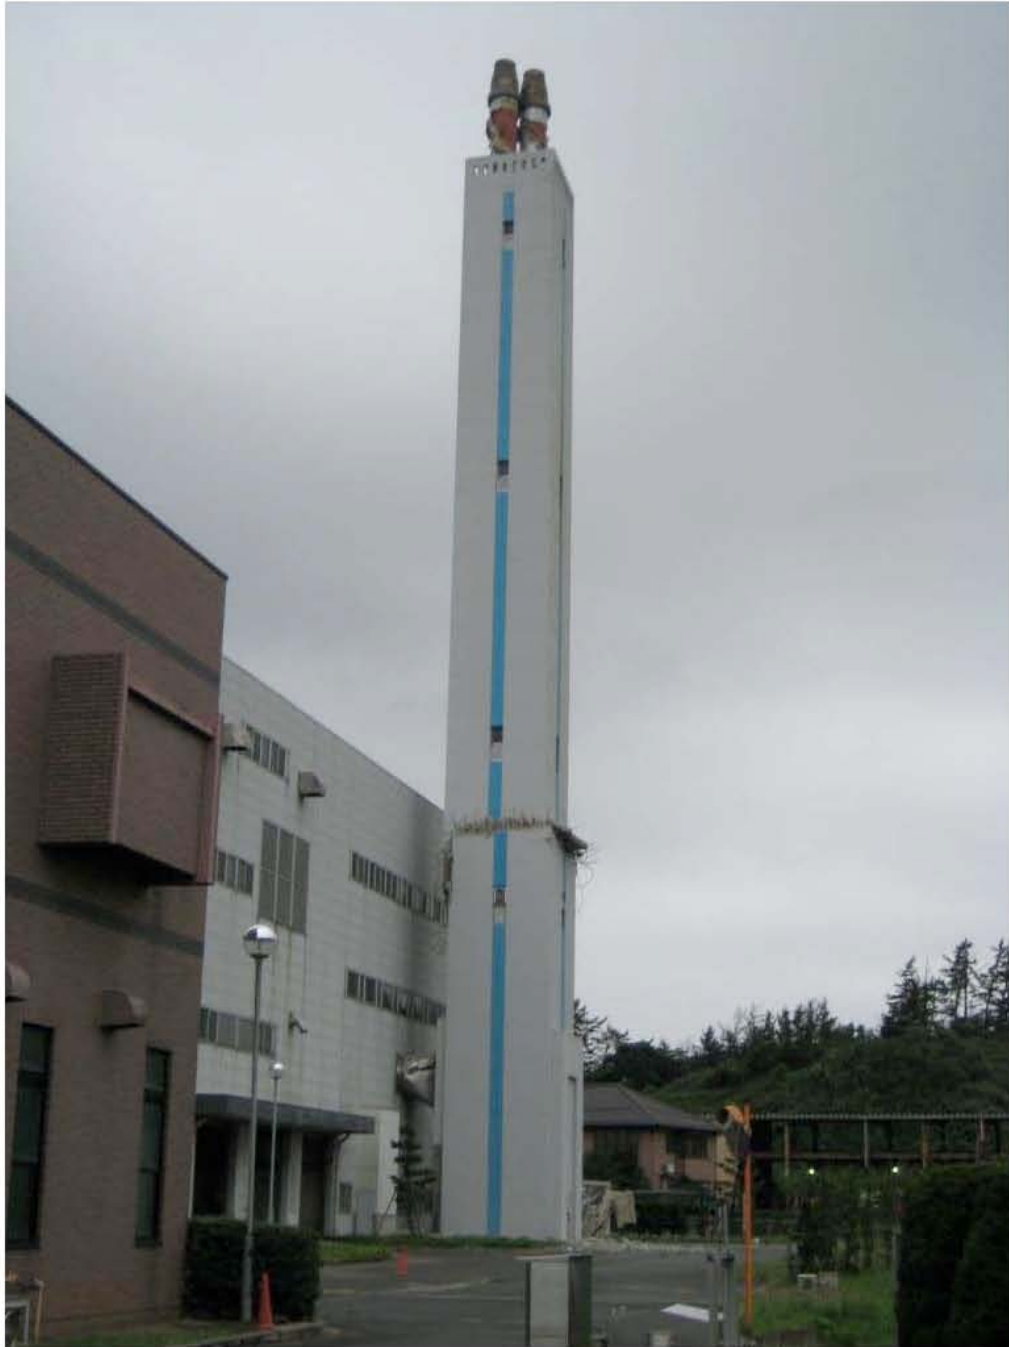
Figure 5.8: Failure of reinforced concrete stack (Site SP31, N37.3939° E138.5840°).

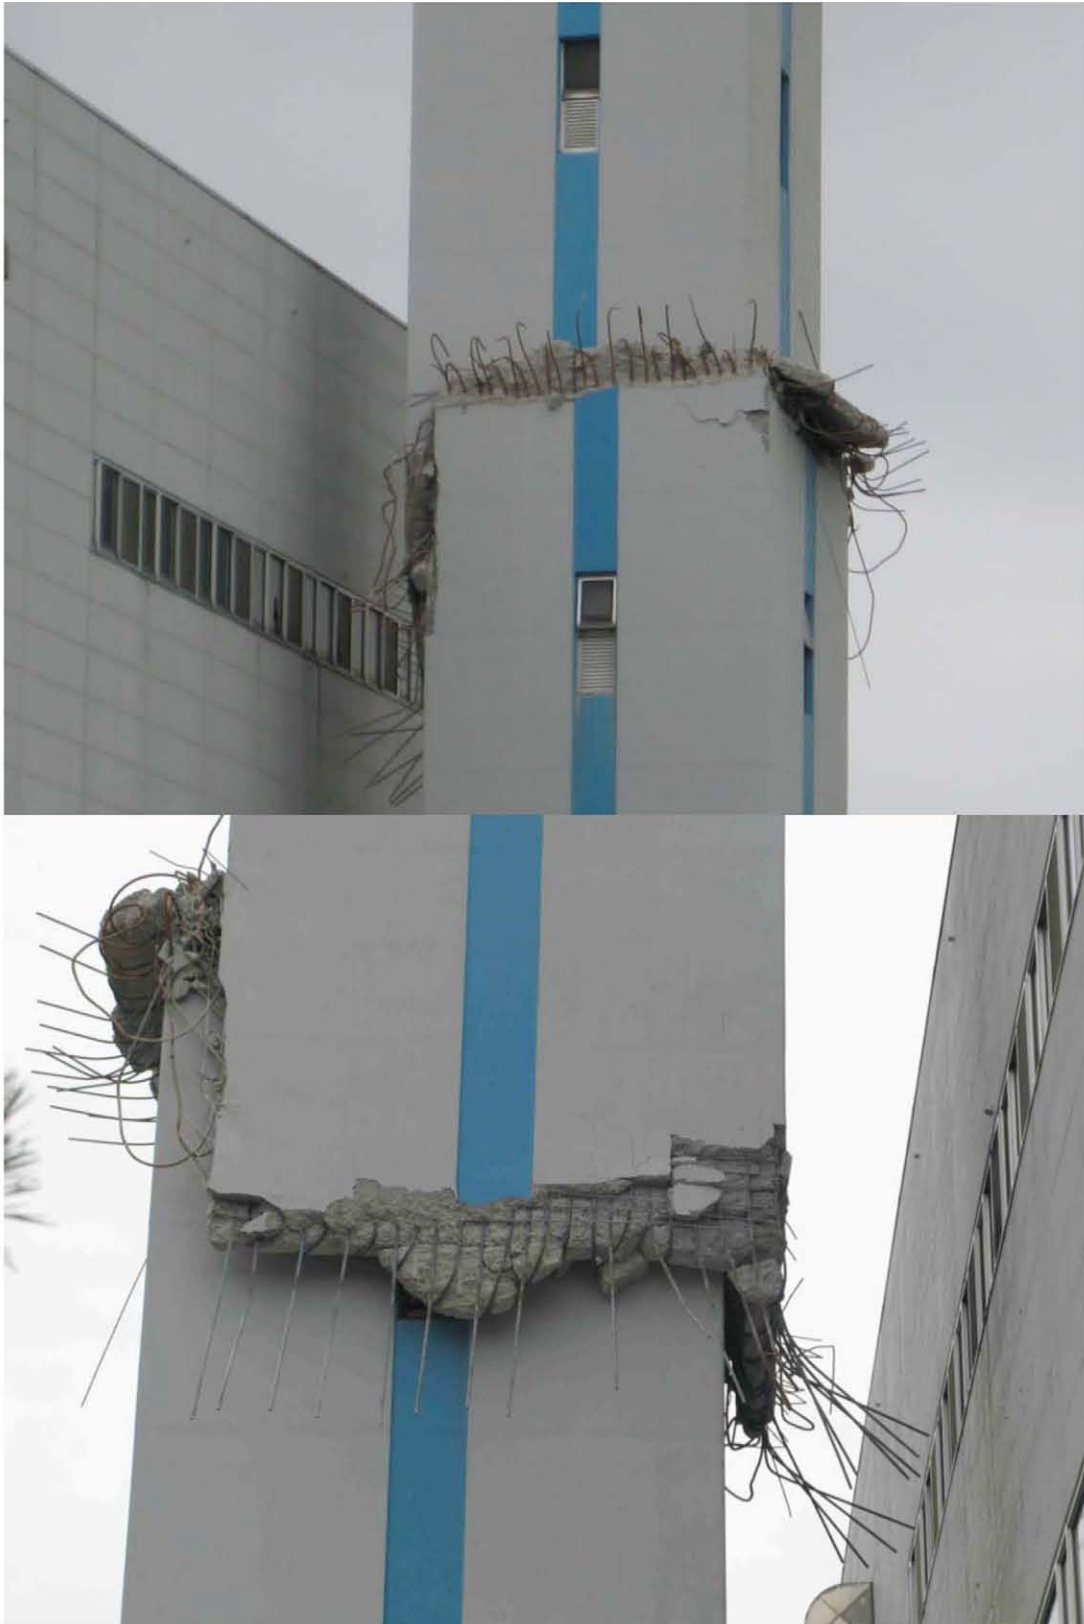
Figure 5.9: Details of failure of reinforced concrete stack (Site SP31, N37.3939° E138.5840°).

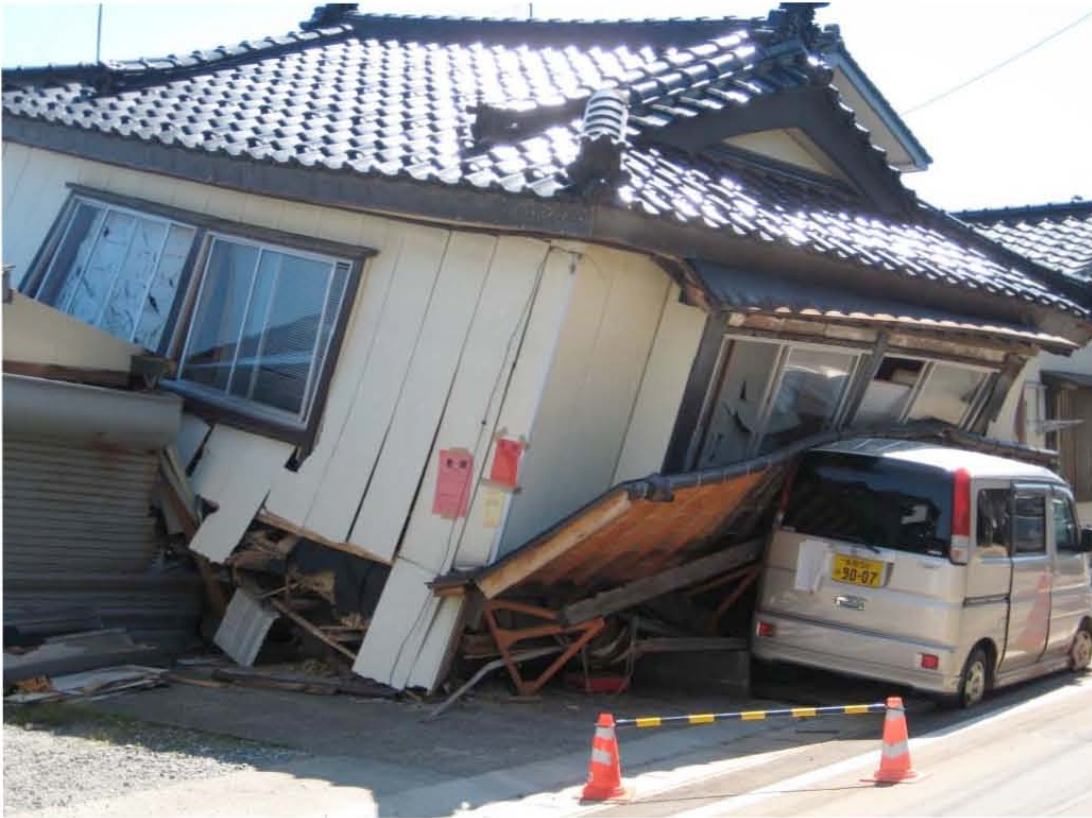
Figure 5.10: Collapse of house (N37.367°, E138.567°).

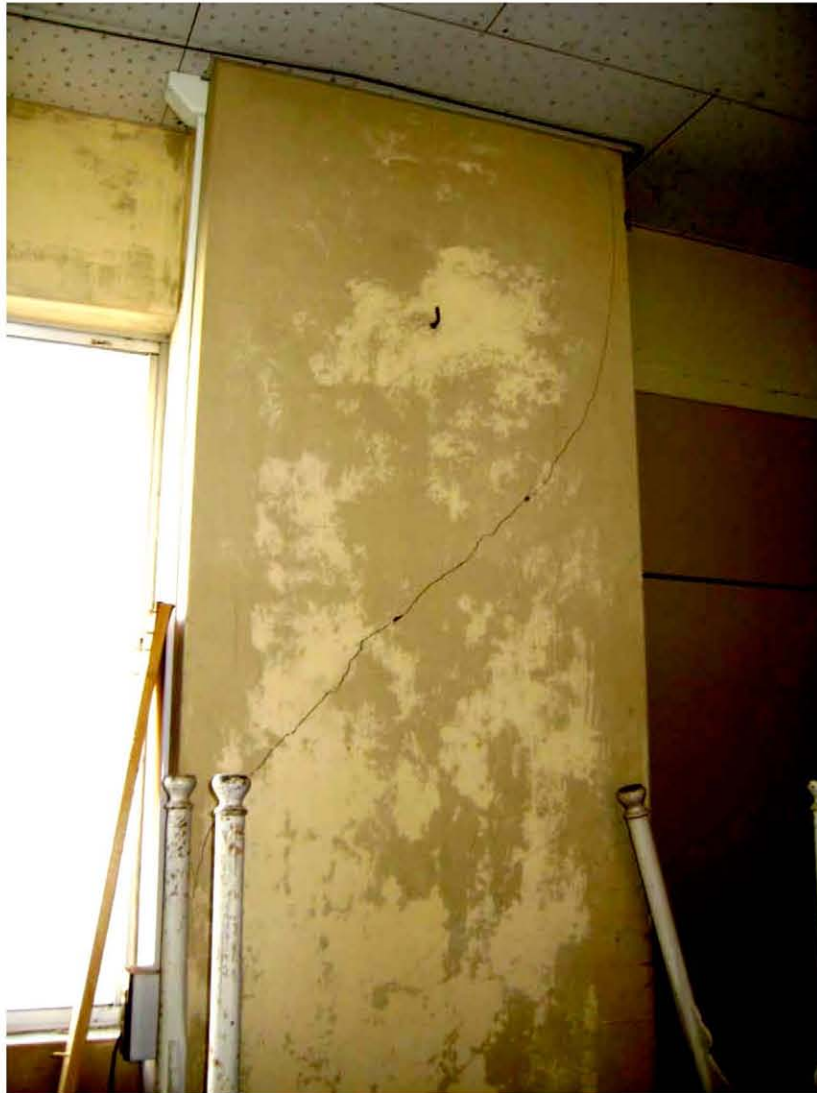
Figure 5.21: Column in first story of The Kashiwazaki High School, cross section and observed crack pattern (Site SP11, N37.3721°, E138.5569°).

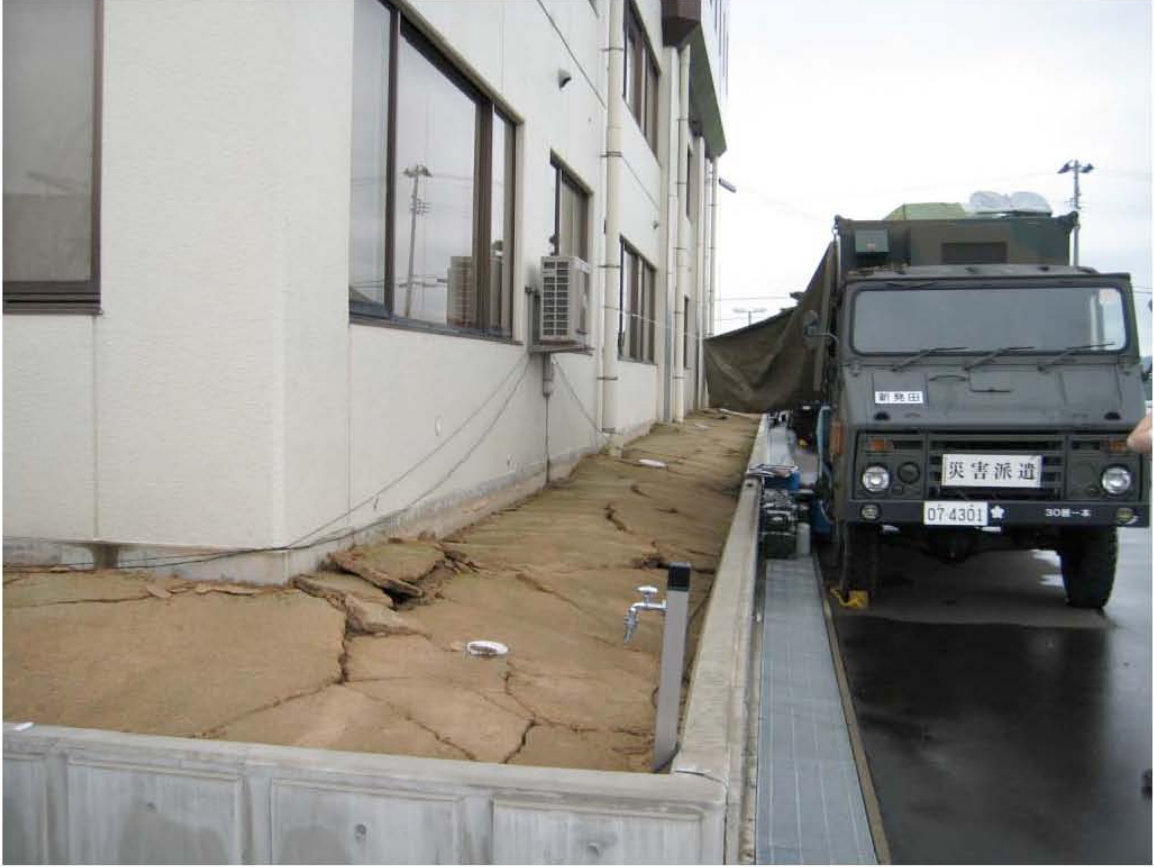
Figure 5.22: Disruption of soil surrounding a government building in Kariwa (Site SP33, N37.4223° E138.6222°).

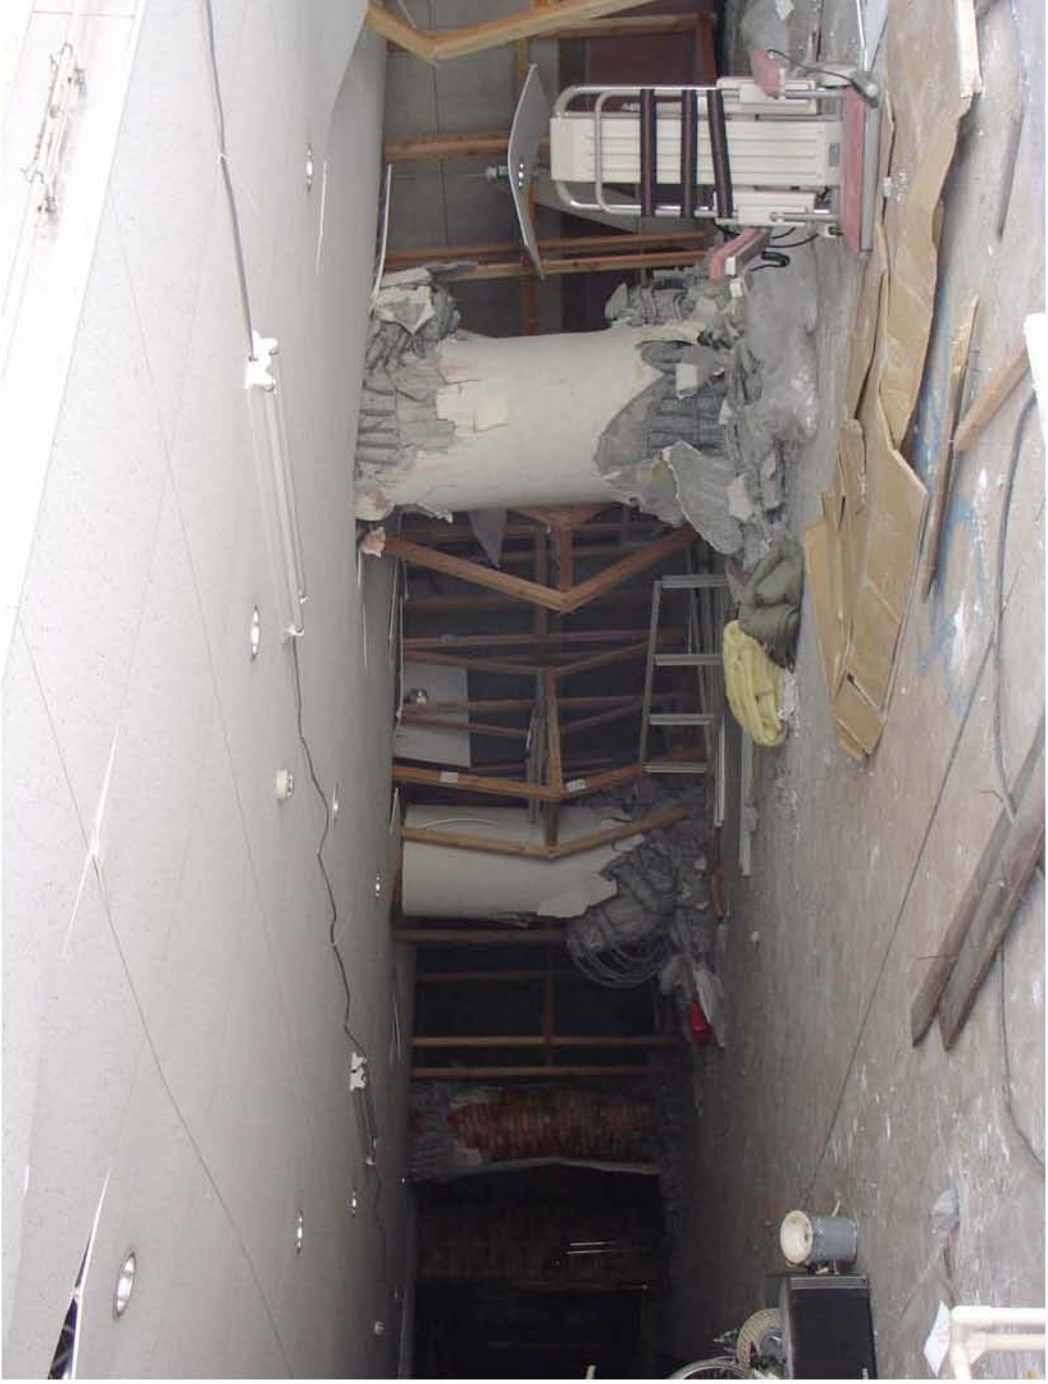
Figure 5.24: Shear failures of reinforced concrete columns (Site NIT-81, N37.37000° E13855825°, photo by Peter Yanev)
