Investigation of the M6.6 Niigata-Chuetsu Oki, Japan, Earthquake of July 16, 2007

Open File Report 2007–1365

U.S. Department of the Interior
U.S. Geological Survey

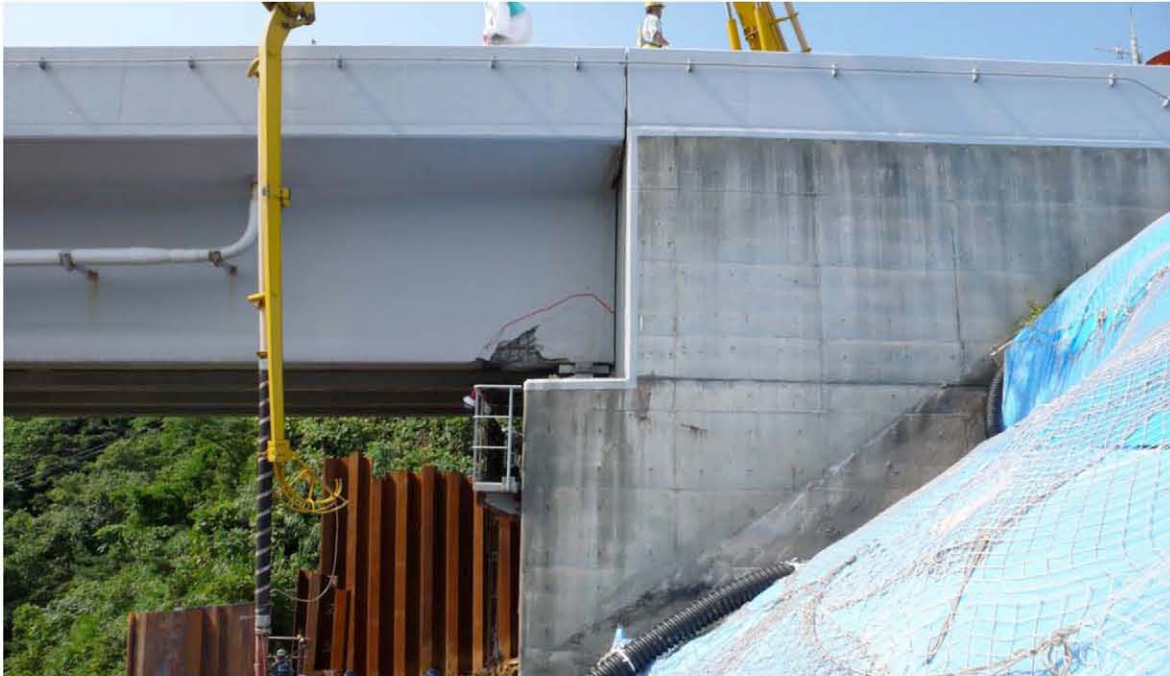
Fig. 6.3. Damage at north end of the west Hachisaki Bridge.

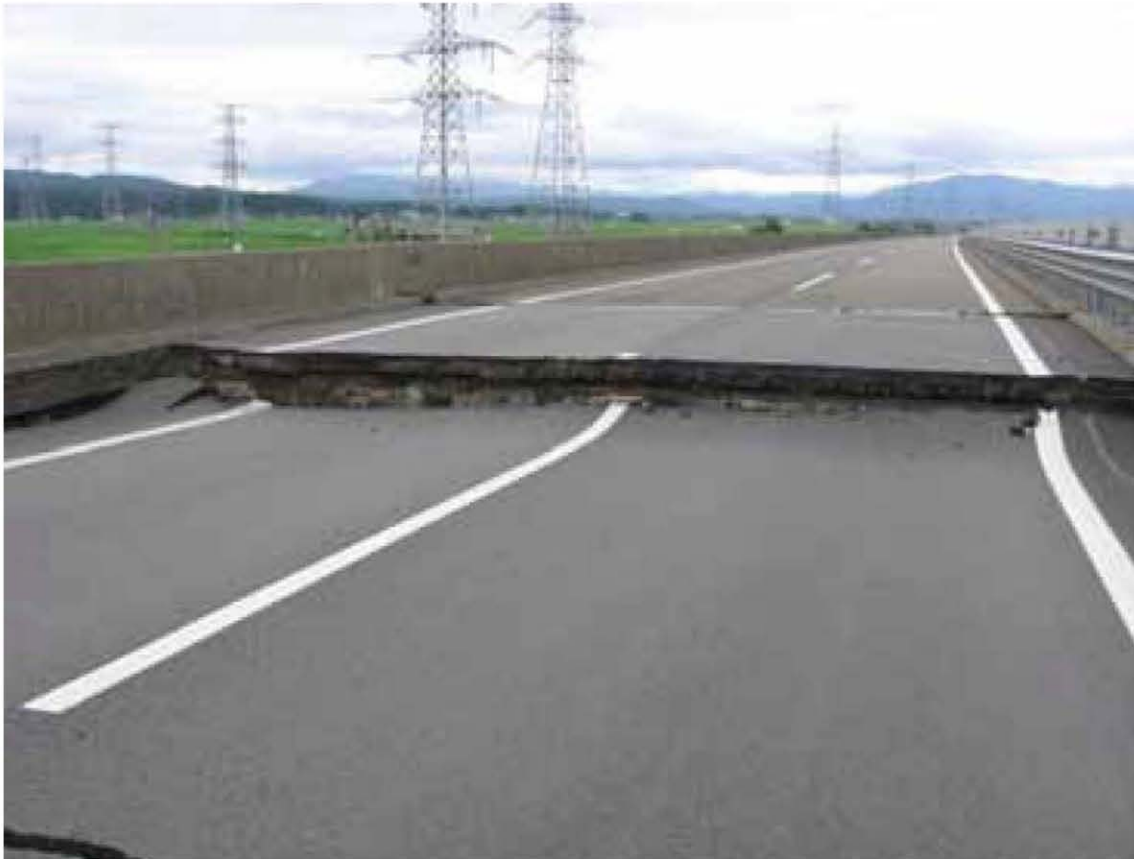
Fig. 6.8. Damage to approach slab and embankment at Yoshiigawa Bridges.

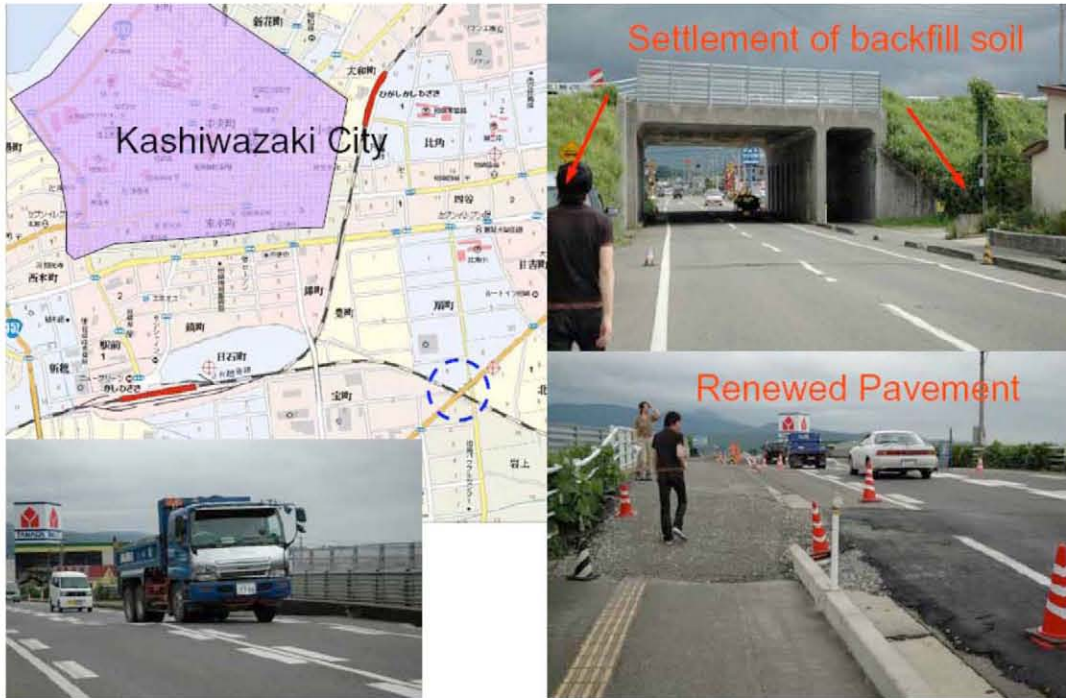
Fig. 6.16. Damage and repairs where Highway 8 crosses Route 522 Bridge (courtesy G. Watanabe, Tokyo Institute of Technology).

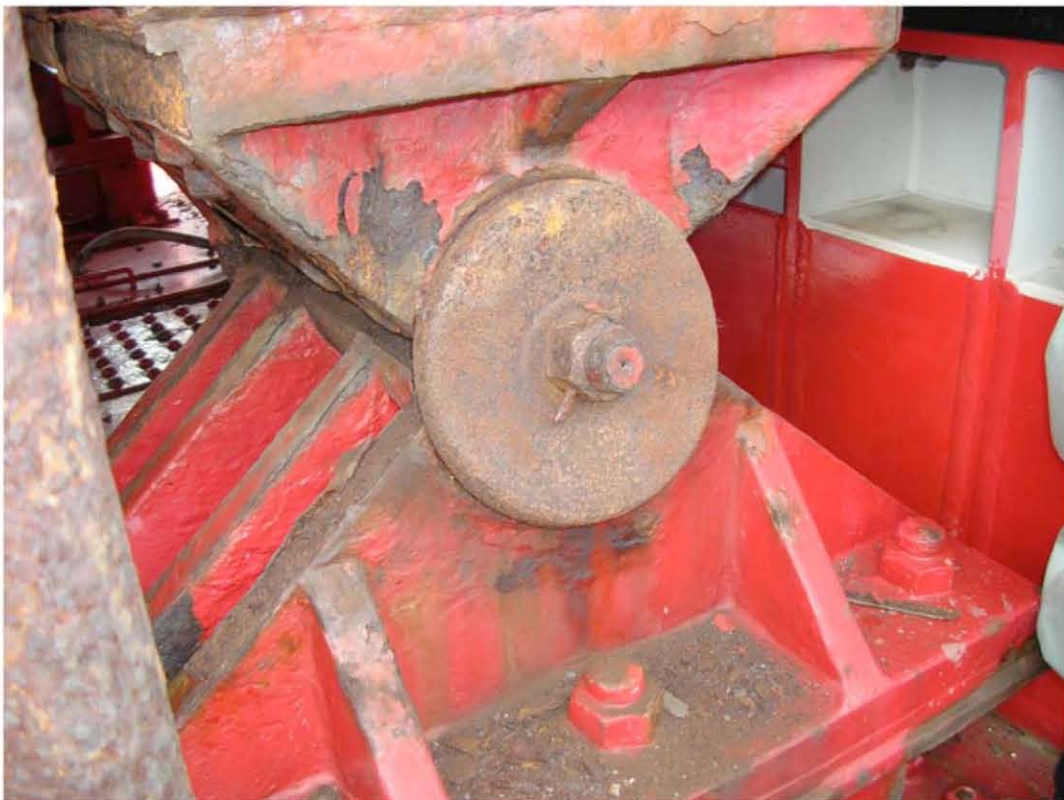
Fig. 6.23. Deformation of Bearing Pin-Cap caused by uplift force (courtesy of S. Unjoh, PWRI).

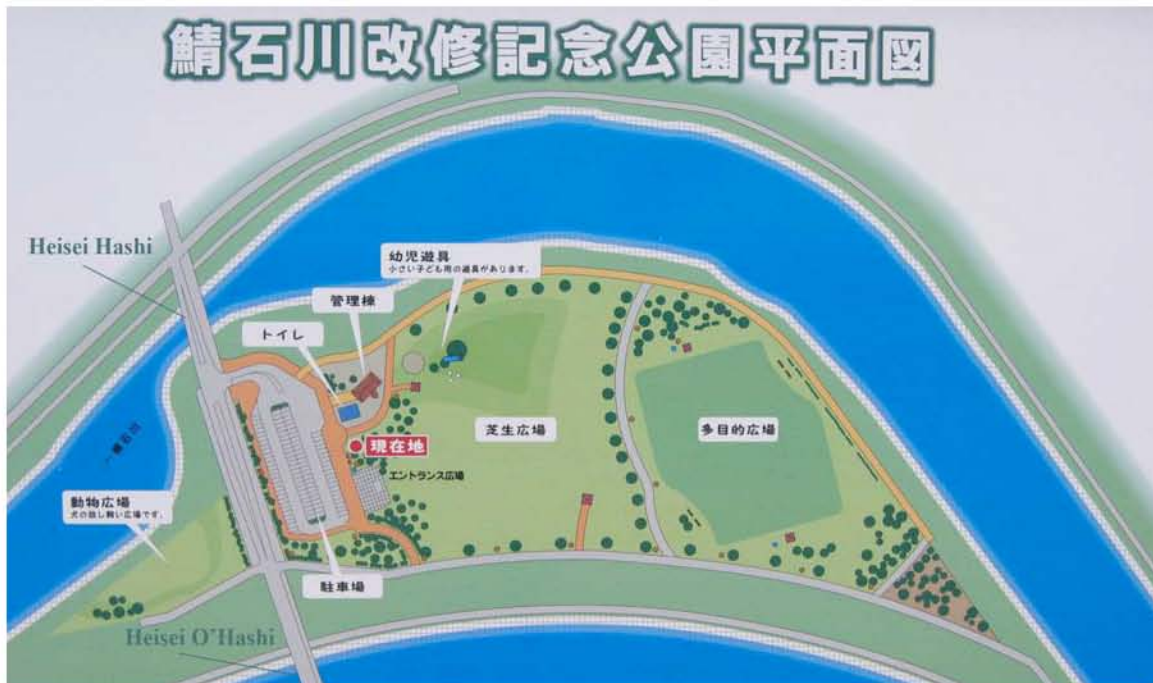
Fig. 6.30. An island in the meander of the Sabaishi River liquefied.

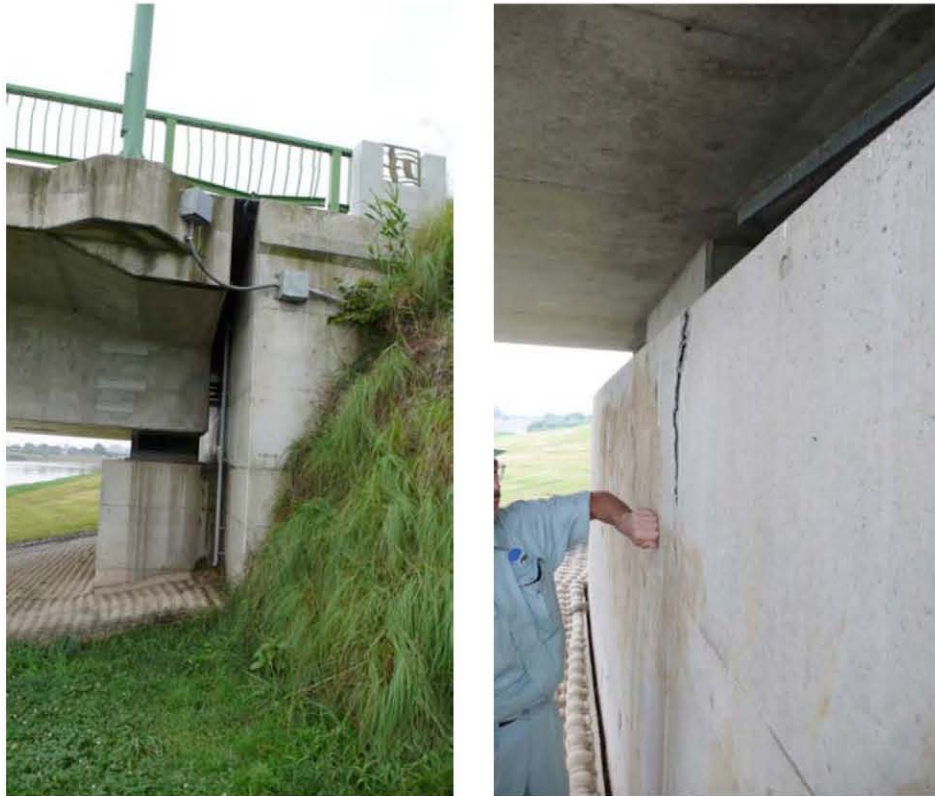
Fig. 6.36. The superstructure and bearings moved back and forth, cracking the abutment.

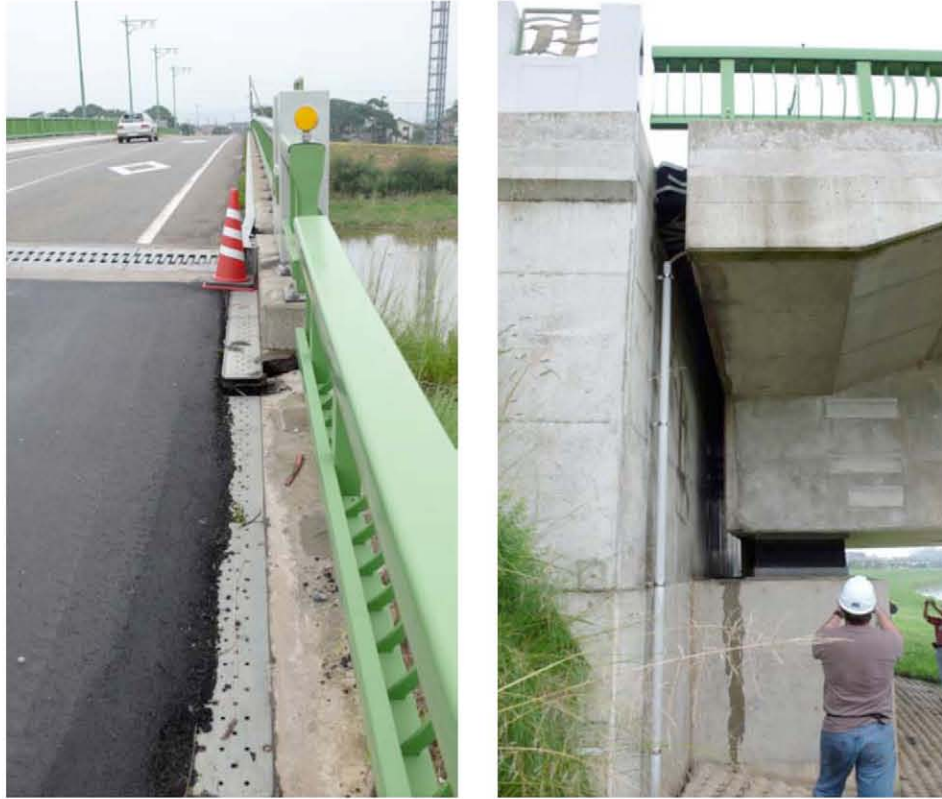
Fig. 6.37. Signs of movement of the abutments included distortion of bearings.

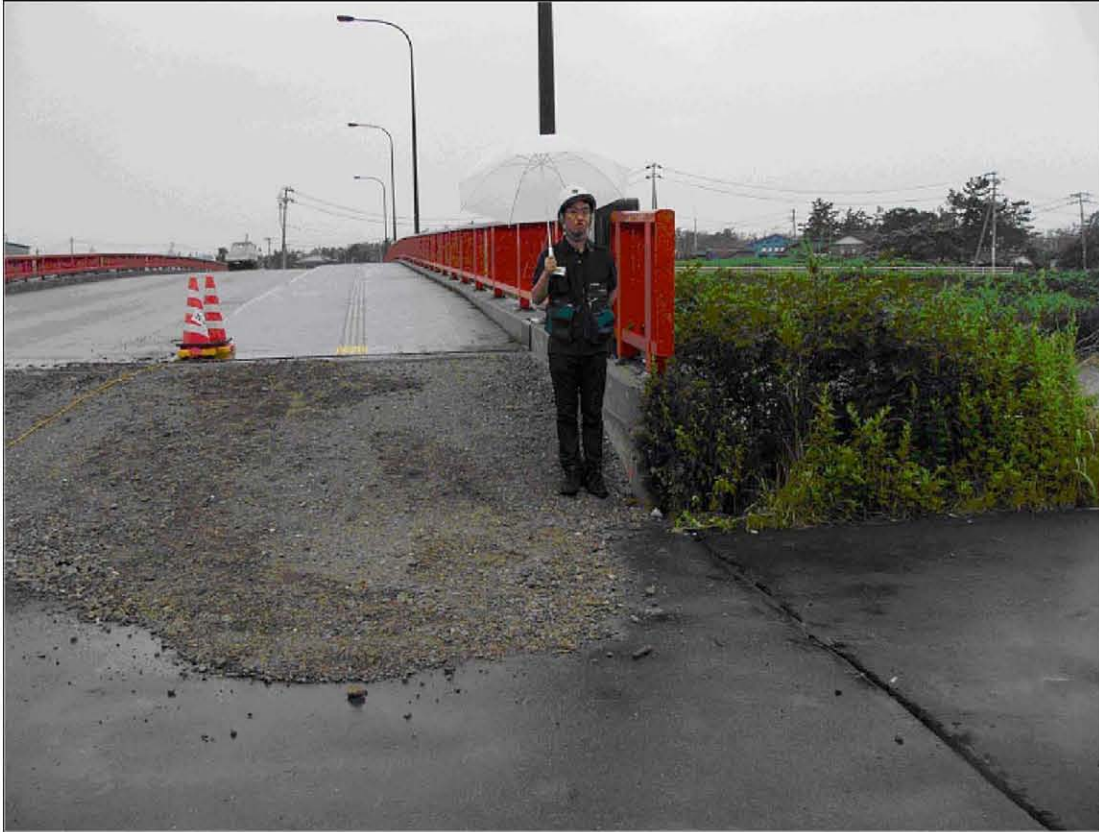
Fig. 6.41. About one meter settlement of south Kaiun bridge approach.

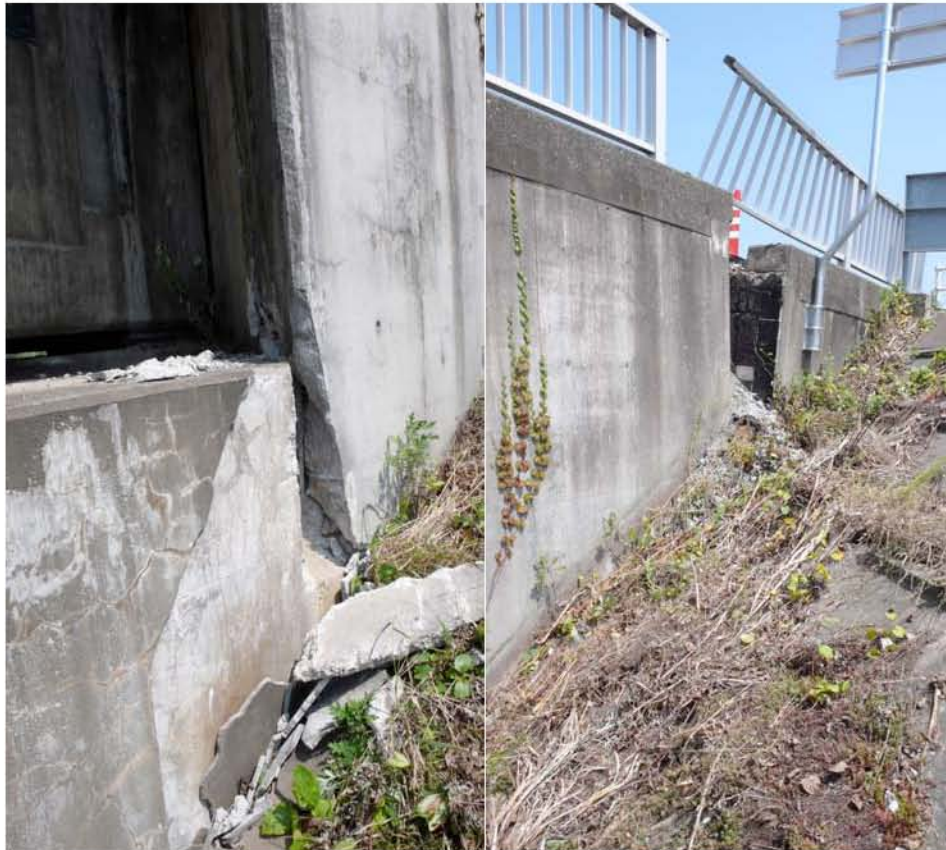
Fig. 6.51. Abutment and wingwall damage from the earthquake.

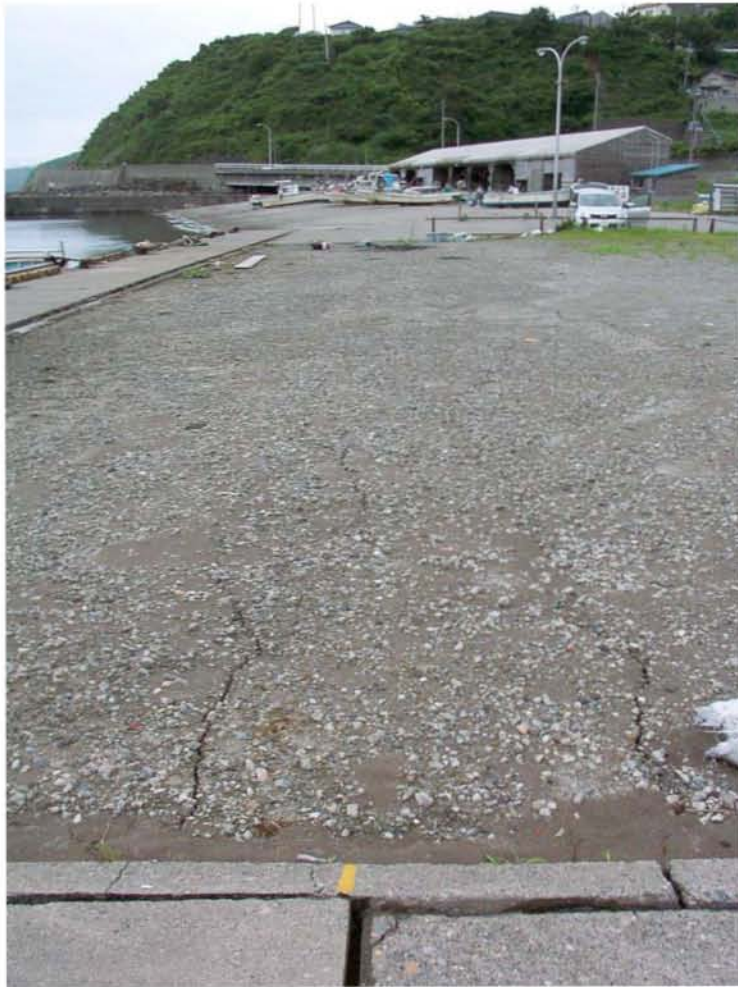
Figure 8.1: Minor ground failure along the waterfront at Kasashima (Site RK21, N37.33702° E138.46680°, photo taken 7/21/07 14:49). The limited extent of the ground cracking indicated incipient lateral movement.

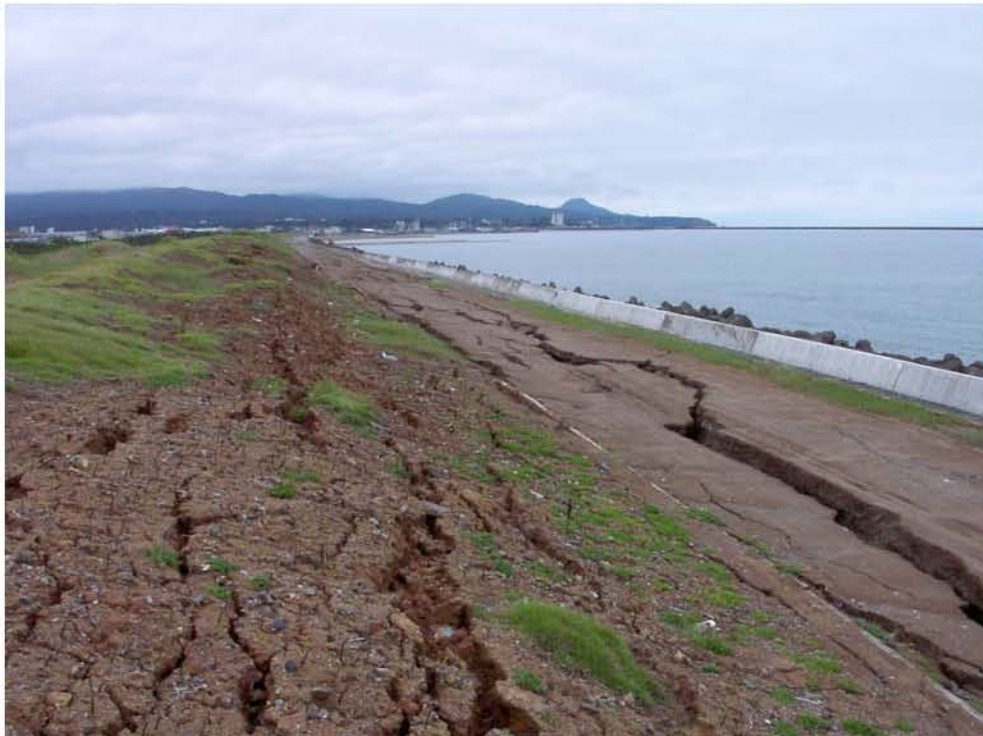
Figure 8.36: Representative cracking and lateral displacement of the clayey earth embankment adjacent to the seawall (Location is southwest of Site SD1, photo taken 7/22/07 11:35).

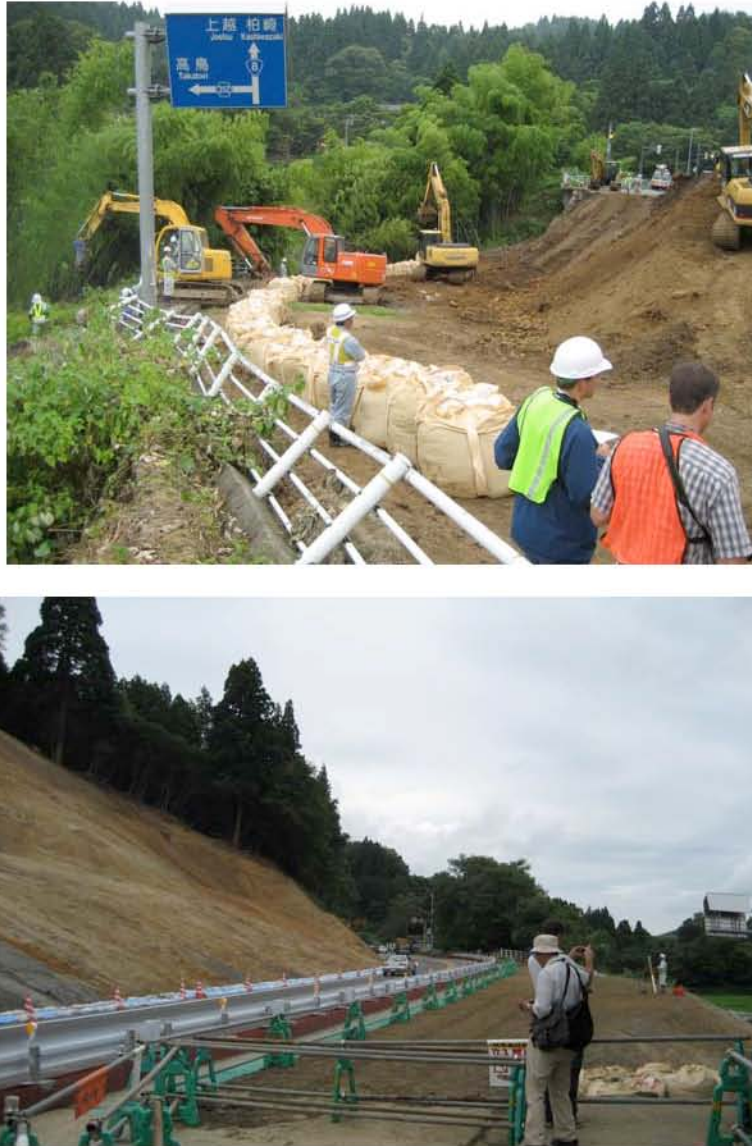
Figure 9.1: The Ozumi Senbon Landslide (Site RK1, N37.41422° E138.71347°), located along Highway 8 just north of the intersection with Route 252, closed both lanes of traffic. The upper photo, taken 7/20/07 at 11:30, four days after the earthquake, shows the displaced roadway which ran from the distance vehicles to the upper right of the photo to just in front of the investigation team members in the lower right. The bottom photo, taken 7/23/07 at 13:00, shows the nearly completed landslide and roadway repair, complete with guard rails, pavement, and center striping, just three days later.

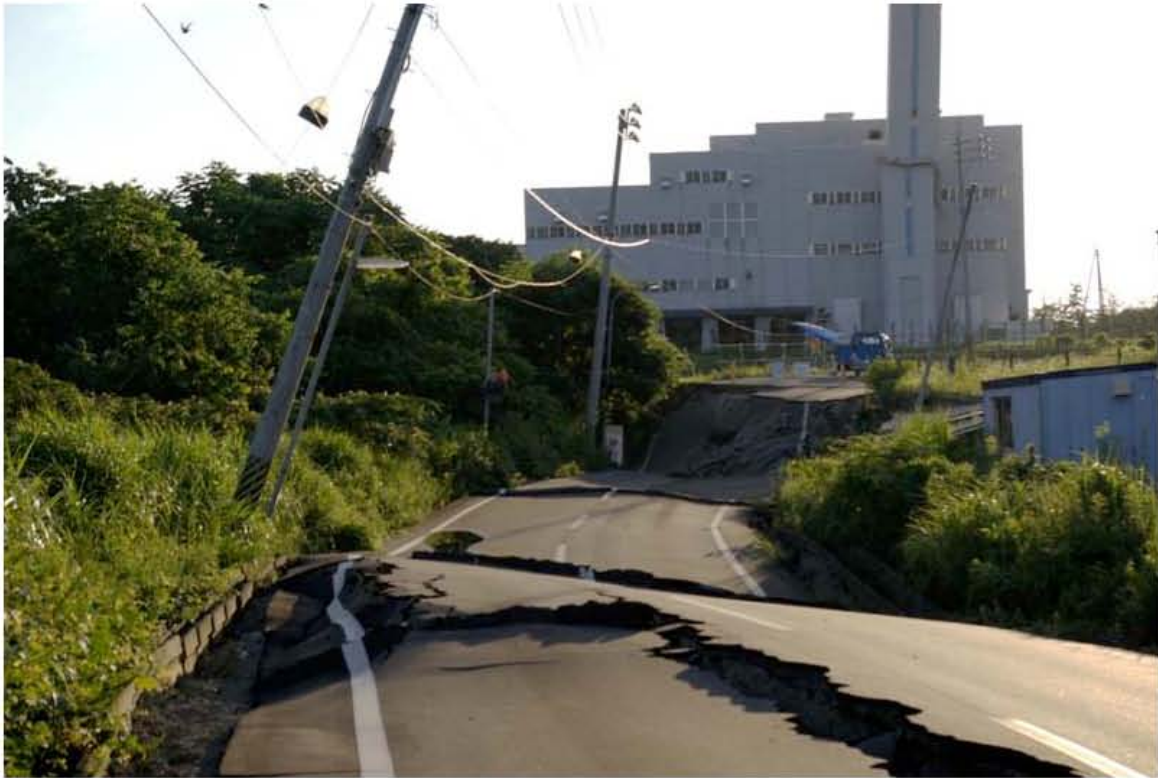
Figure 9.2: Road to Kashiwazaki municipal waste incinerator plant (Site RK6, N37.39343° E138.58555°, photo taken 7/24/07 18:06). Liquefaction-induced lateral spreading led caused the roadbed and associated slope to move southwards towards the Sabaishi River. Photos show formation of a 2.5 meter tall head scarp at the west end.

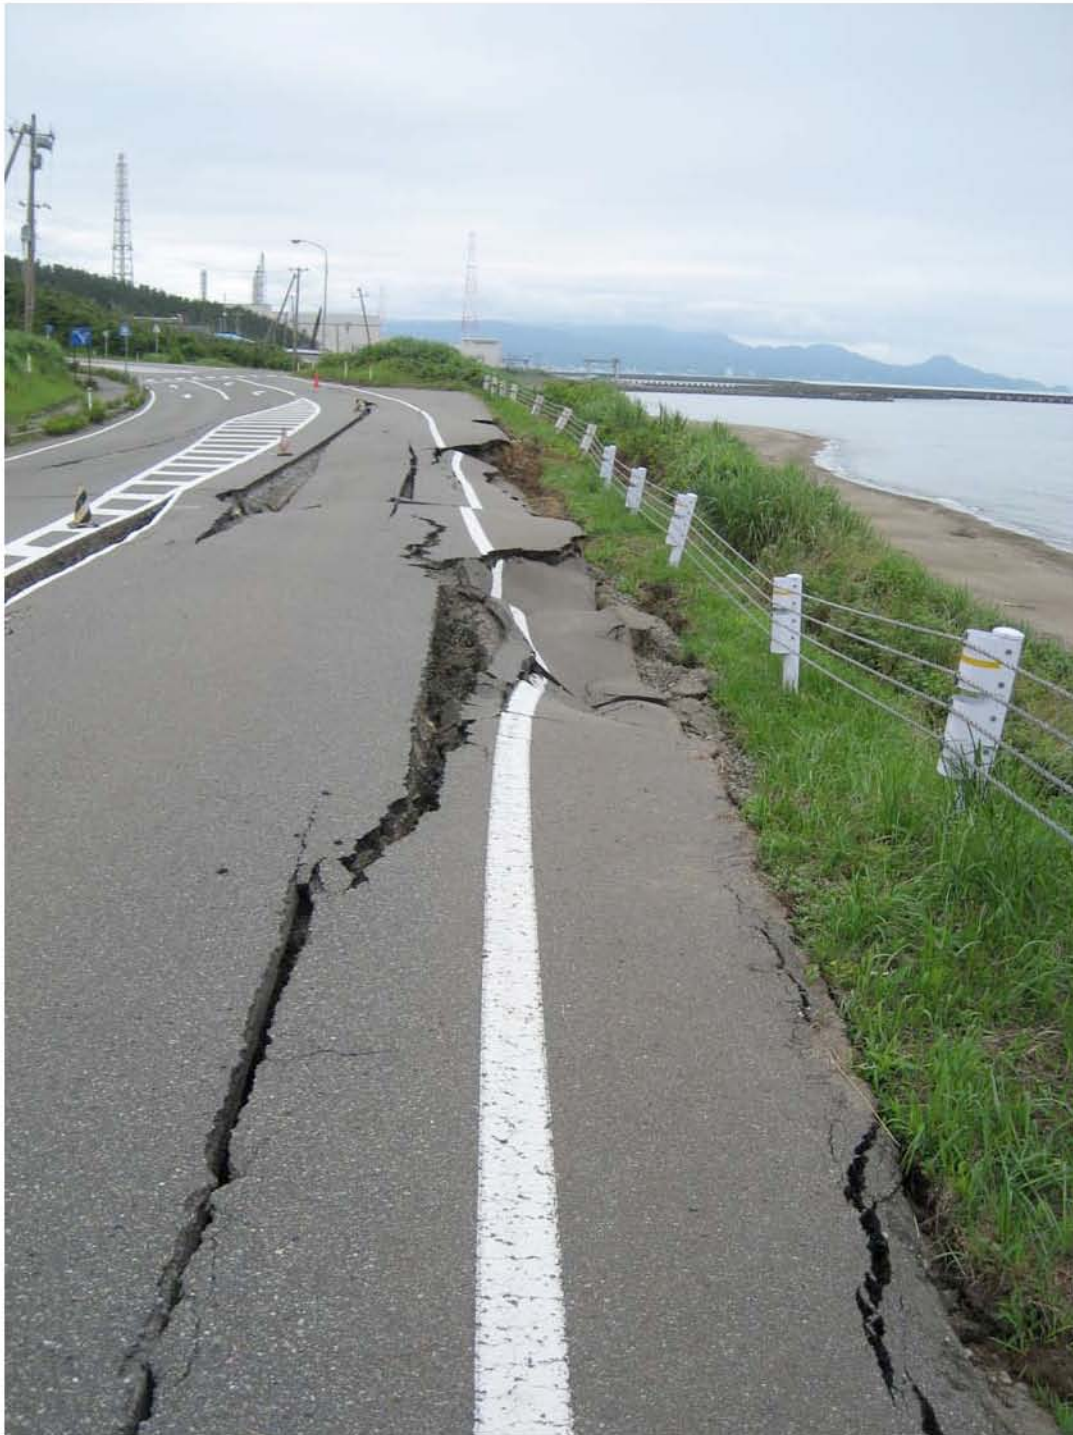
Figure 9.3: Road damage from fill embankment failure on coastal road north of Kashiwazaki Nuclear Power Station (Site RK38, N37.44927° E138.60572°, photo taken 7/22/07 13:04). Such damage tended to increase with distance toward the epicenter, often requiring traffic controls to guide cars across the one open lane.

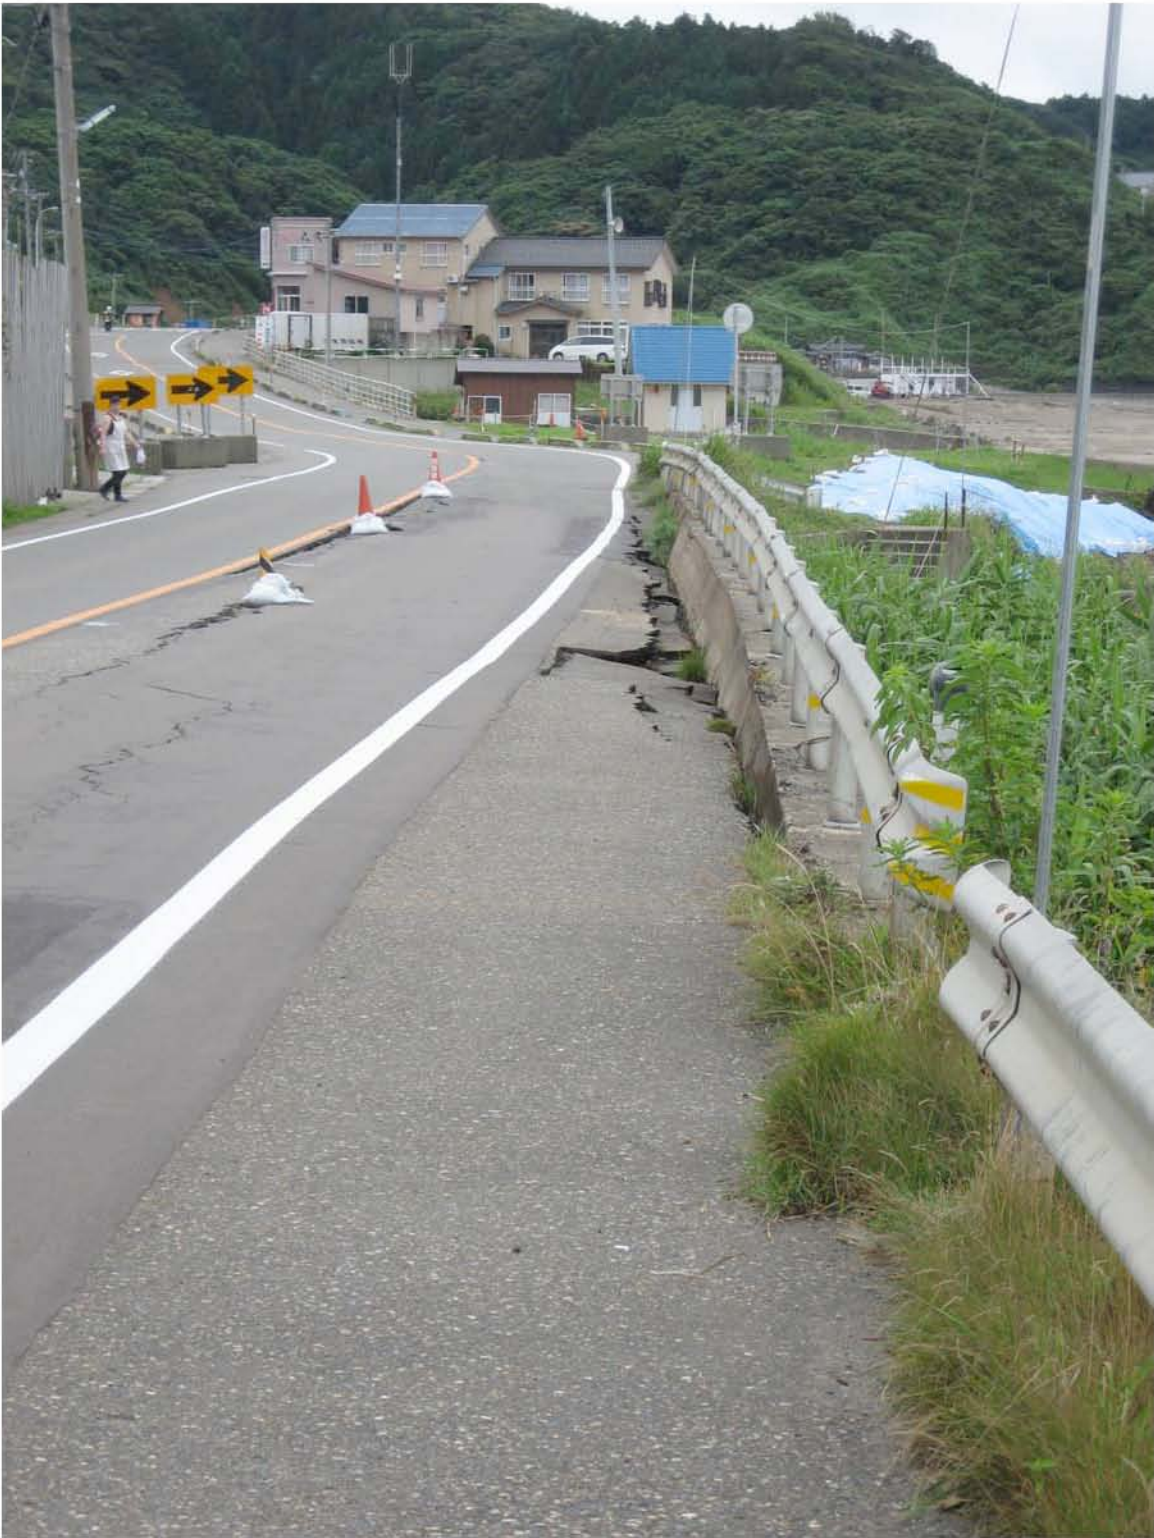
Figure 9.4: Site RK34 - Road damage from fill embankment failure on coastal road north of Kashiwazaki-Kariwa Nuclear Power Plant (Site RK34, N37.48455° E138.62435°, photo taken 7/22/07 09:56).

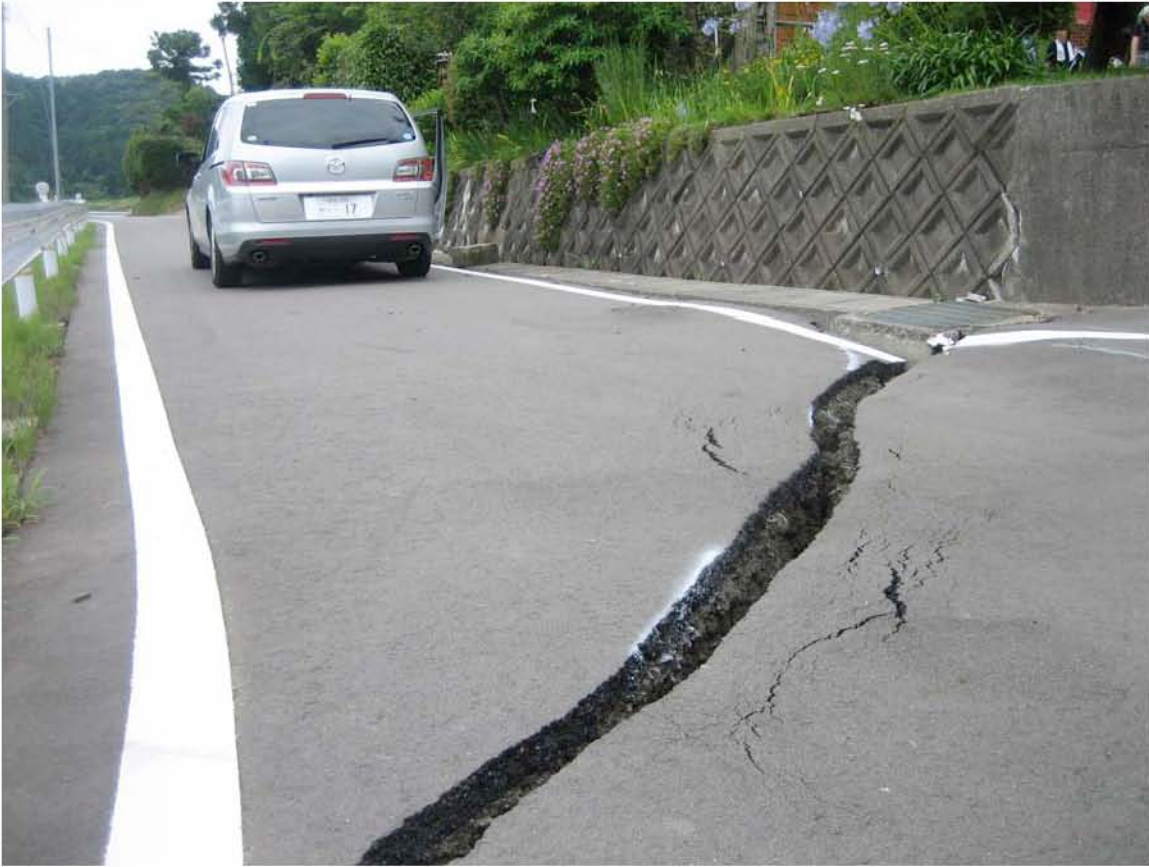
Figure 9.5: Typical road damage near epicentral region (Site RK30, N37.45727° E138.65328°, photo taken 7/22/07 09:46). Cracks of 5 to 10 cm were often quickly paved over in high-traffic areas, within one or two days of the earthquake. On local community roads with alternate traffic routes, this damage was not immediately repaired.

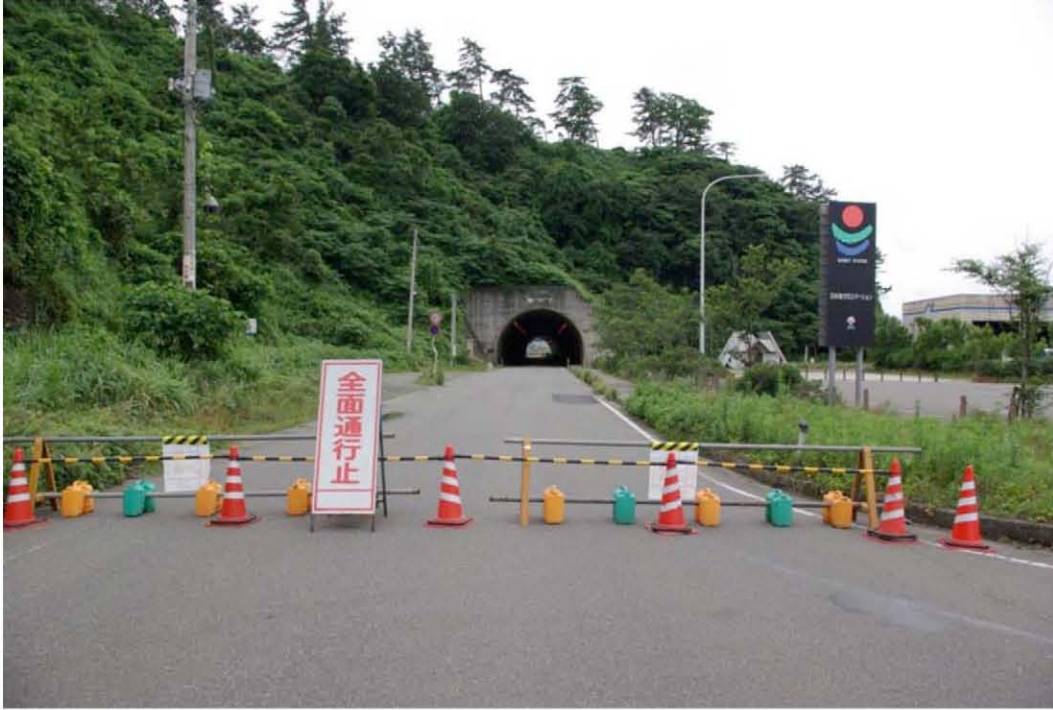
Figure 9.8: Tunnel was initially open to traffic following earthquake, but subsequently closed as of July 22nd (Site SD4, N37.38439° E138.60083°, photo taken 7/22/07 13:36). Damage to tunnel was not observed, but landsliding and toppled monuments on top of the tunnel was observed.

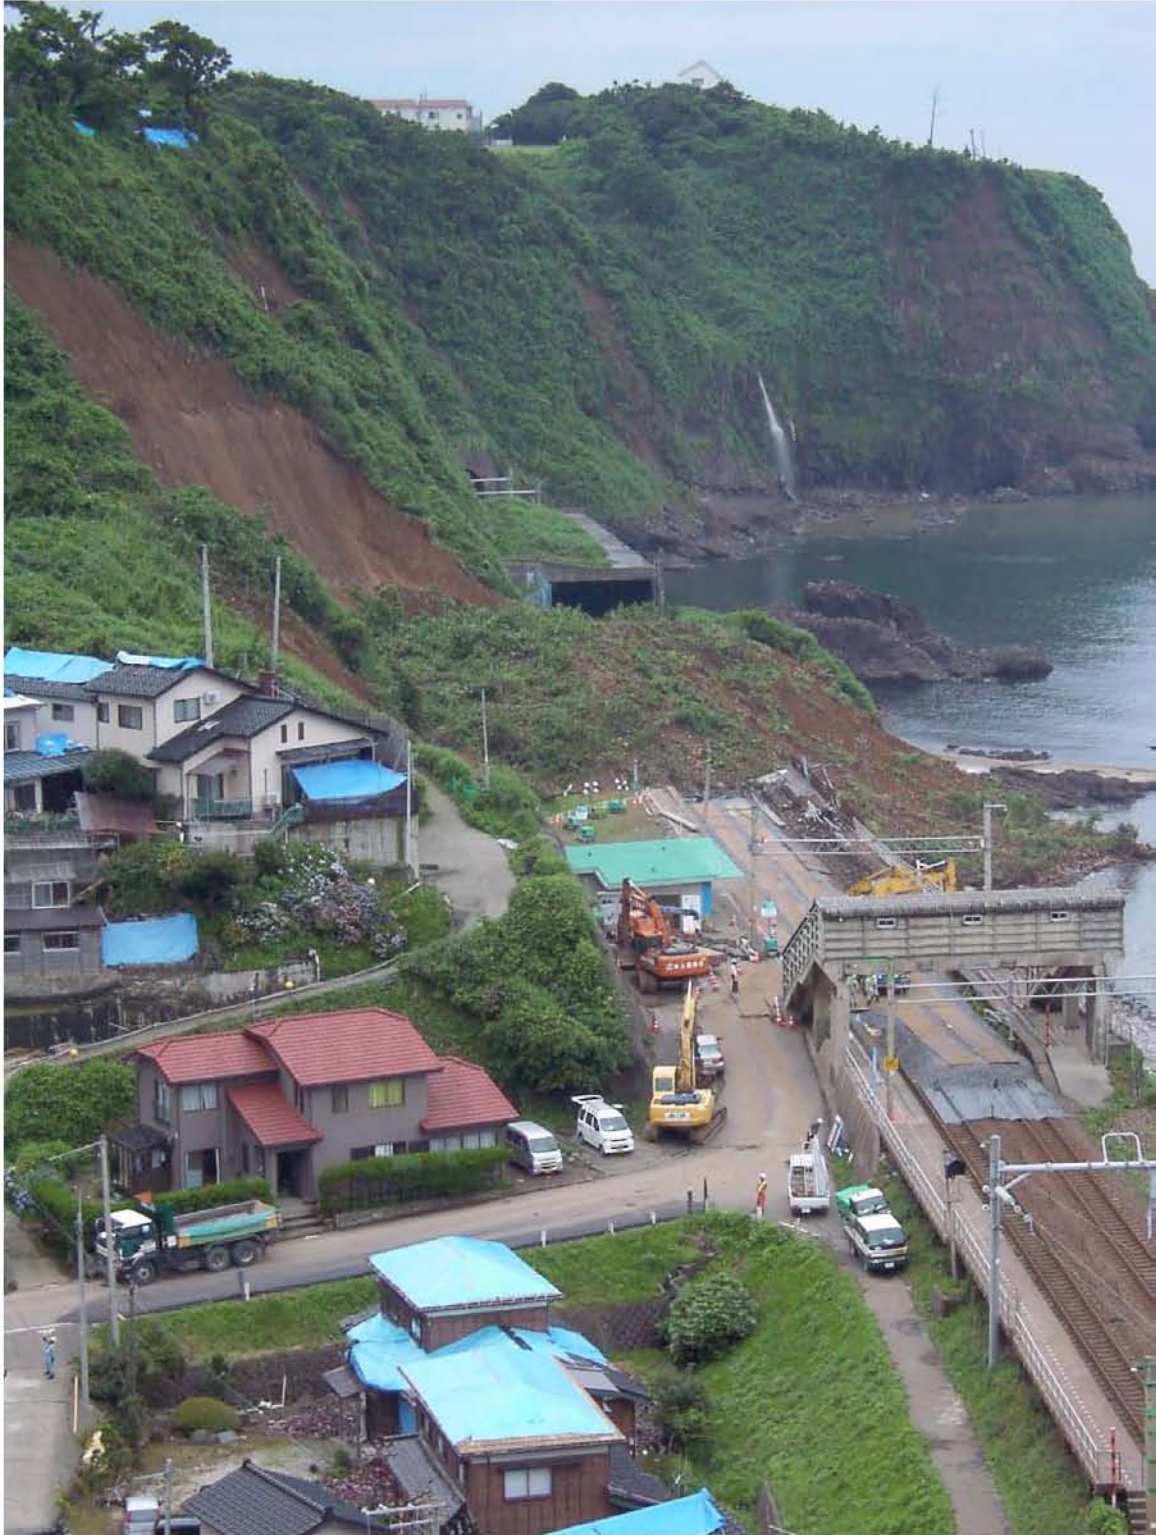
Figure 9.10: Landslide at Oumigawa Train Station impacted Shin-etsu line railway (Sites RK20/YT16/SA9, N37.34490° E138.48435°, 7/21/07 13:52).

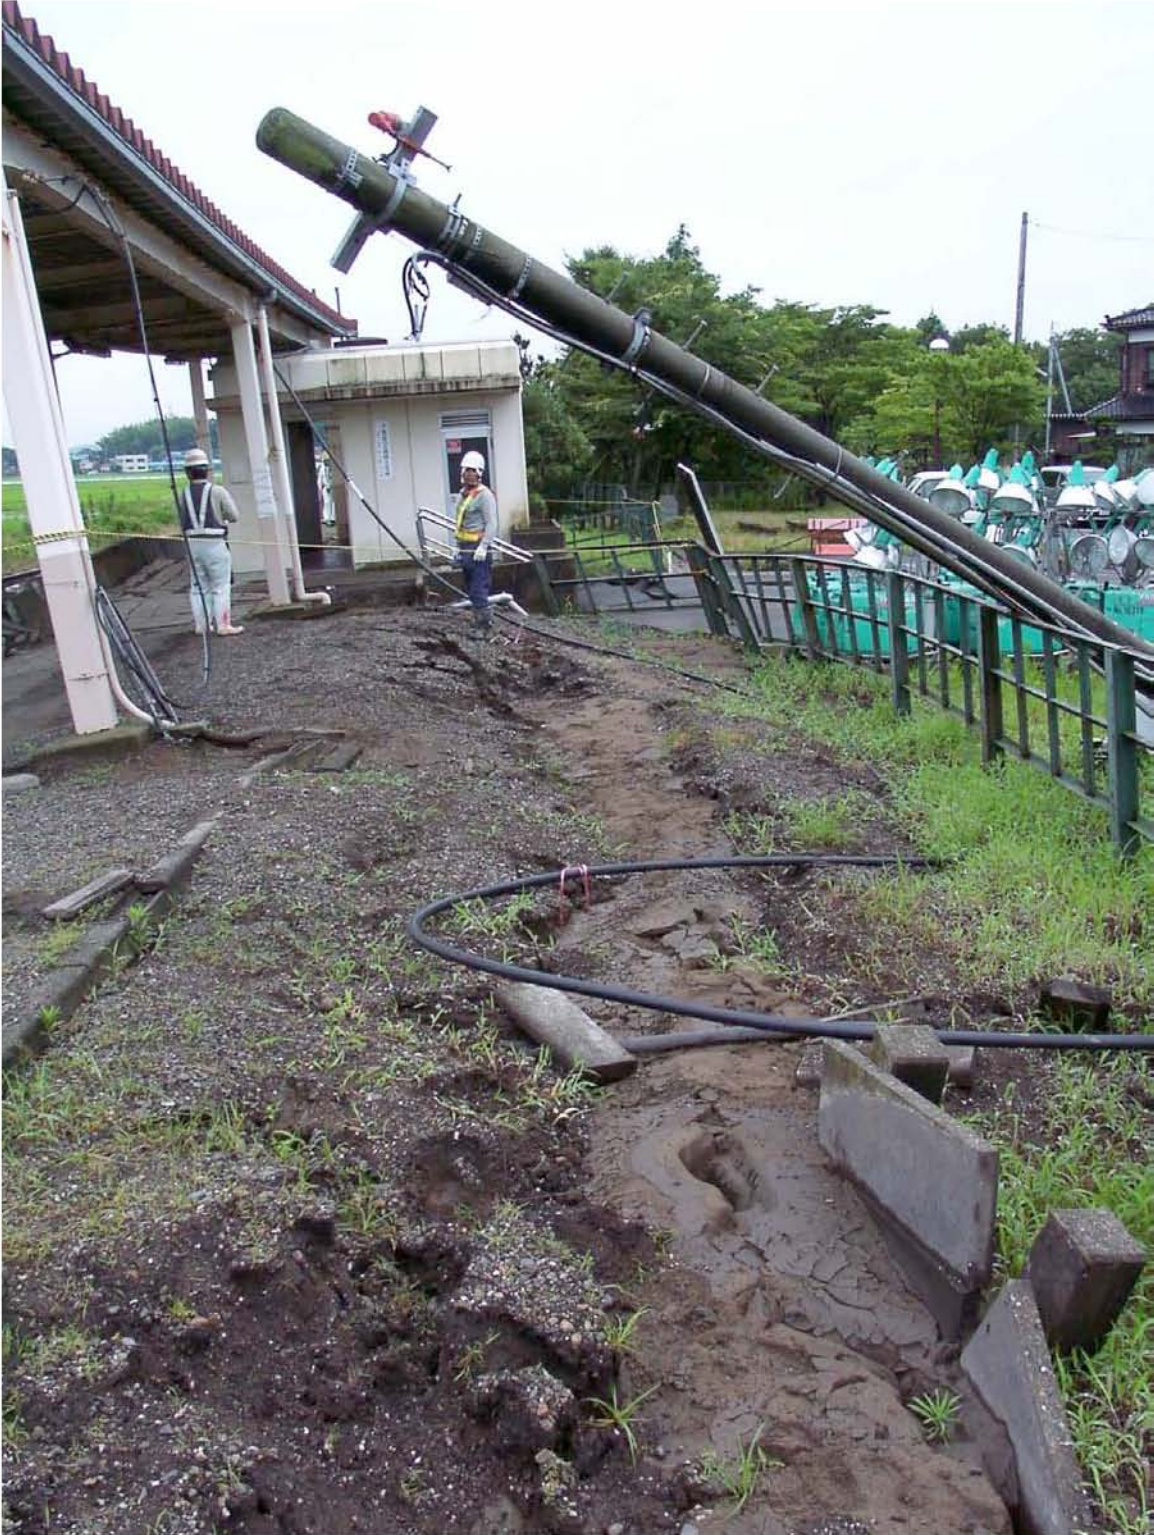
Figure 9.11: Liquefaction-induced damage at Arahama Station (Site RK13, N37.40555° E138.60197°, 7/21/07 09:42).

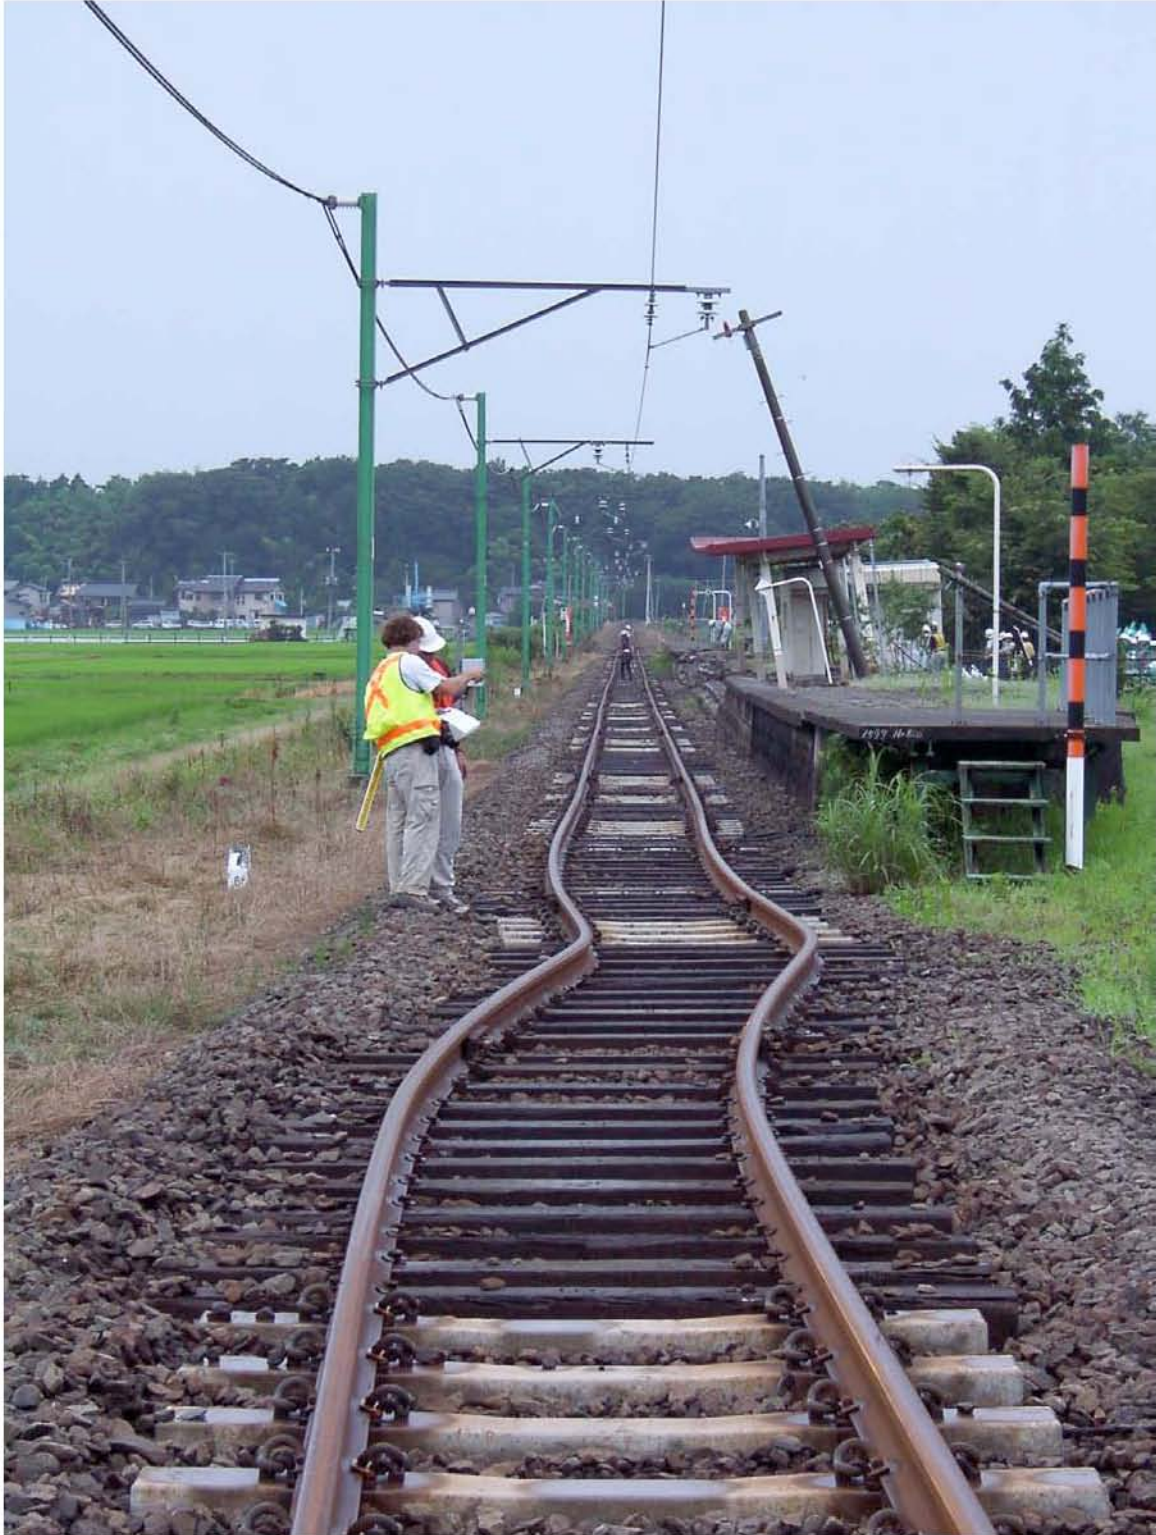
Figure 9.12: Lateral deformation of train tracks at Arahama Station (Site RK13, N37.40555° E138.60197°, 7/21/07 09:52).

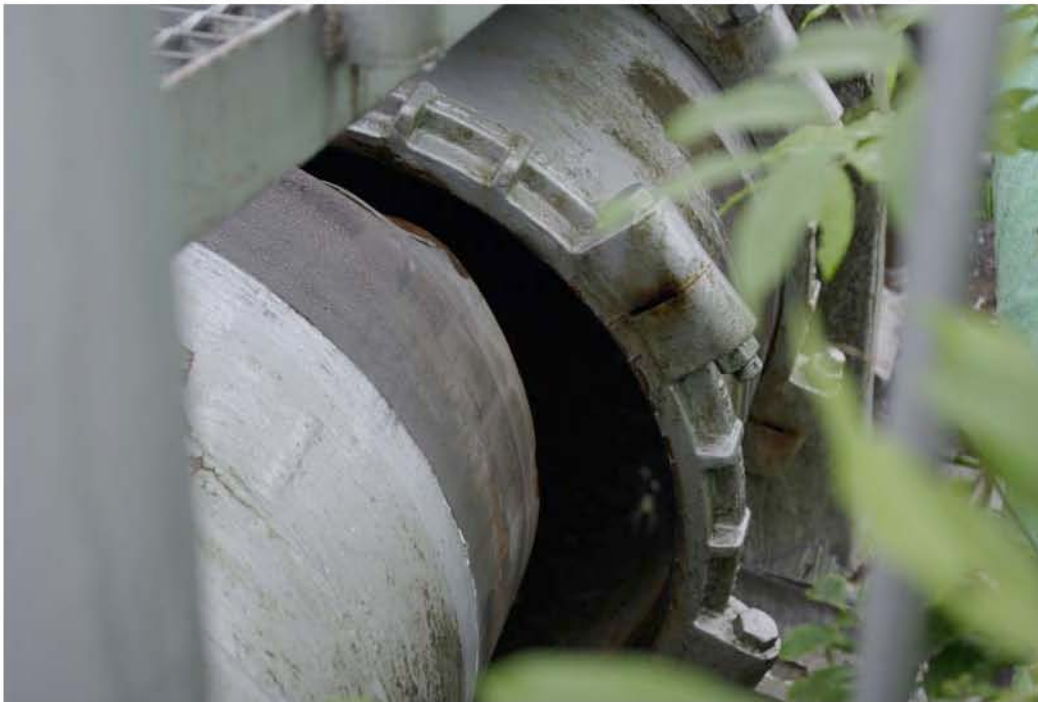
Figure 10.3: Damage to a water pipe at a stream crossing (Site RK4/YT3, N37.39233° E138.58063°, photo taken 7/20/07).
