Investigation of the M6.6 Niigata-Chuetsu Oki, Japan, Earthquake of July 16, 2007

Open File Report 2007–1365

U.S. Department of the Interior
U.S. Geological Survey

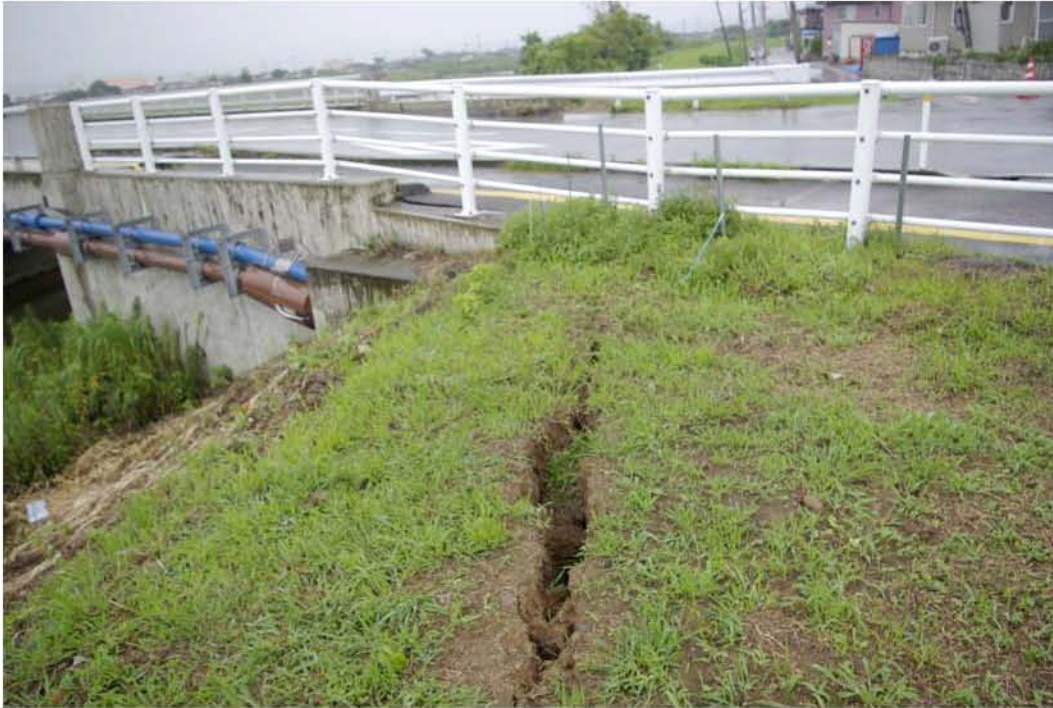
Figure 10.9: Evidence of moderate ground failure in an approach fill. Minor damage to the pipes was observed (Site RK7, N37.38940° E138.57393°, photo taken 7/21/07).
