REPORT

SL 2012/04

REPORT ON AIRCRAFT ACCIDENT ON
10 OCTOBER 2006 AT STORD AIRPORT,
SØRSTOKKEN (ENSO) NORWAY INVOLVING A
BAE 146-200, OY-CRG, OPERATED BY ATLANTIC
AIRWAYS

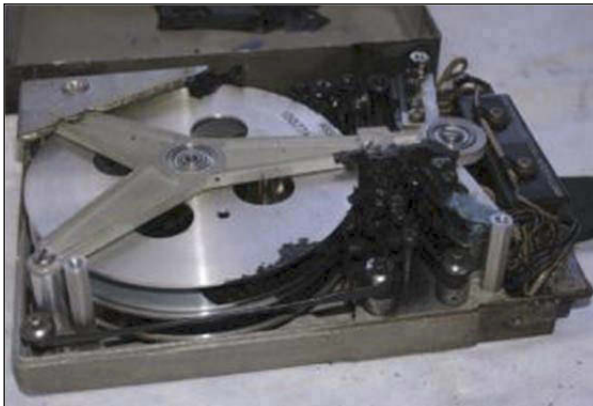
Figure 16: Heat-damaged storage unit in FDR.

- 1.11.2.3 The AIBN therefore brought the storage unit on to the manufacturer L3 Communications in Sarasota, Florida, USA, where they were able to repair the circuit board and recover the data stored on it.
- 1.11.2.4 The quality of the CVR recording was good. The recording was of the pilots' communication amongst themselves, their two-way communication with the various Air Traffic Control units and cockpit sounds. The recording was of 30 minutes duration as expected, and covered everything from starting the plane at Sola until the power supply failed as a result of the accident.

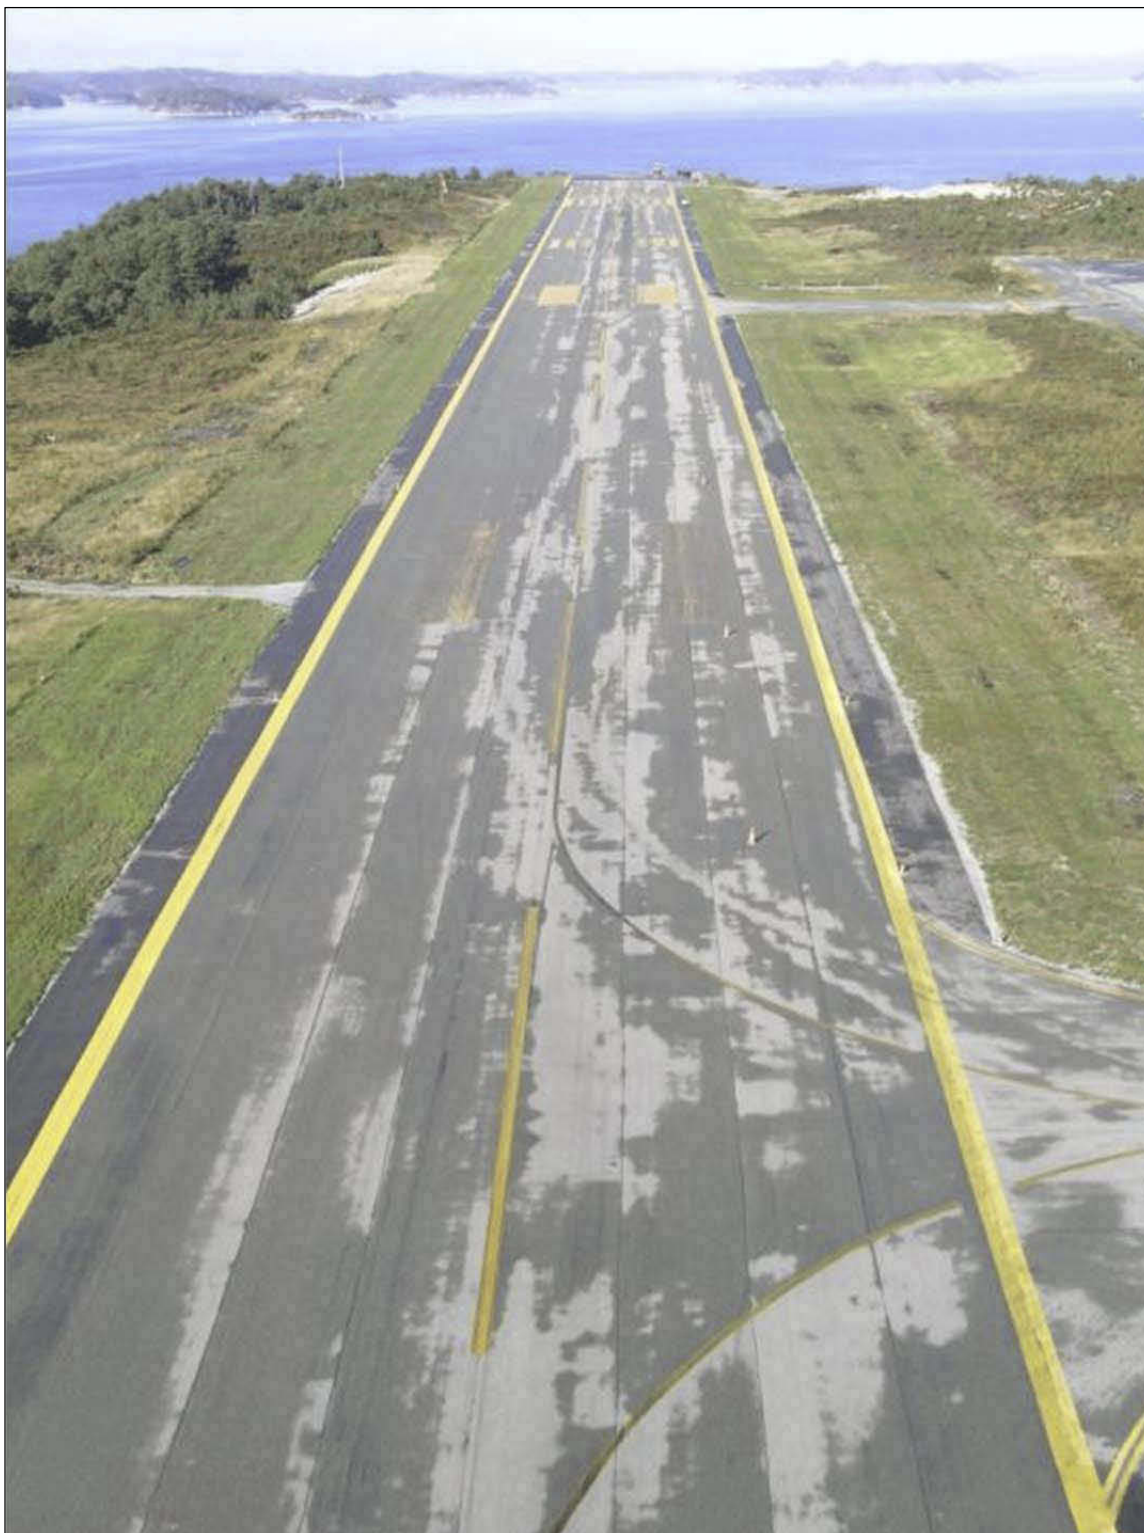
When the AIBN arrived at Stord airport by helicopter at 1308 hours, the runway still had dark patches of dampness (see Figure 19). From the air, it was also possible to glimpse the skid marks left behind by the aircraft. These skid marks were initially difficult to spot from the ground, but they became clearer as the runway dried out.

Figure 19: The runway photographed from the helicopter at 1308 hours.

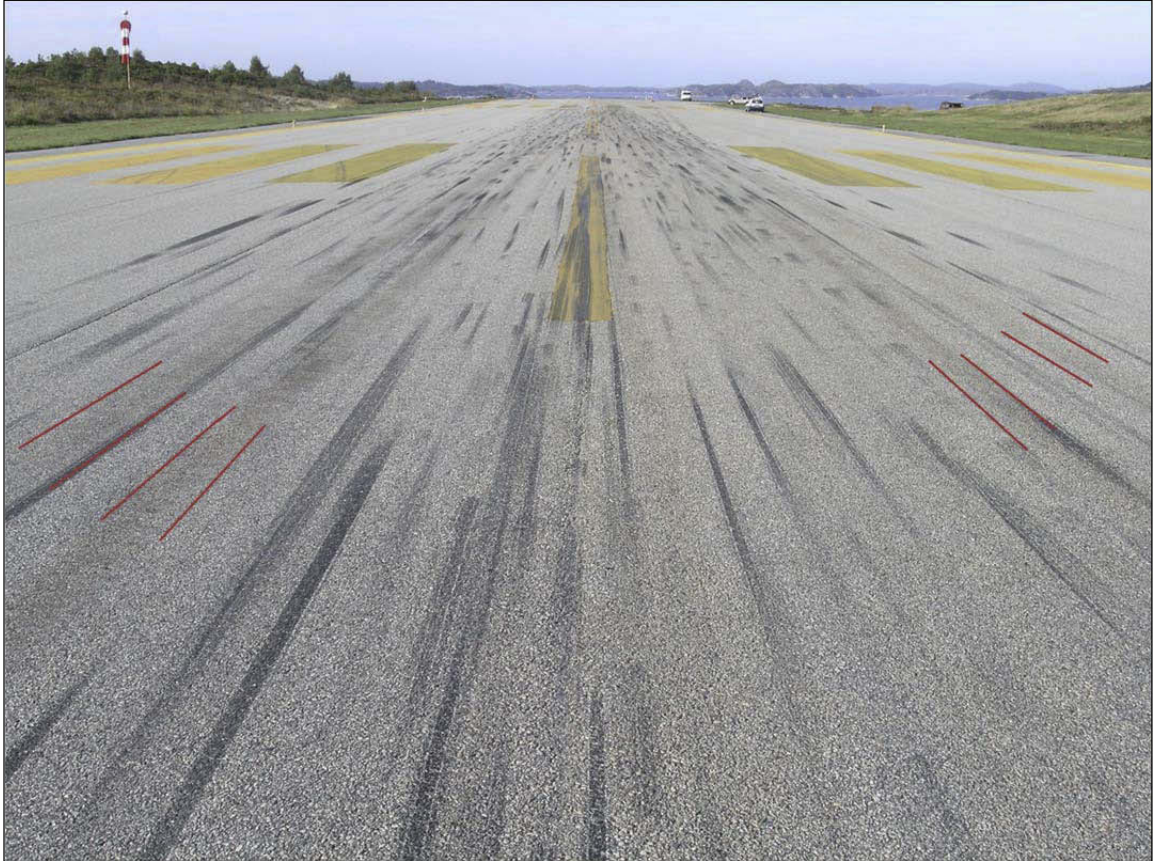
The skid marks left by OY-CRG were different from other skid marks left on the runway. There were no rubber deposits in the microstructure on the runway surface, which was typical of the black brake skid marks left by other aircraft (see Figure 20). The skid marks left by OY-CRG were lightly defined and partially unclear skid marks of a light brown colour. Many small bits of rubber were left outside the skid marks, most of them between one and eight millimetres wide (see Figure 22). Some bits of rubber were found several metres from the skid marks.

Figure 20: The skid marks left by OY-CRG on the runway. The red guiding lines show what route the main wheels took.

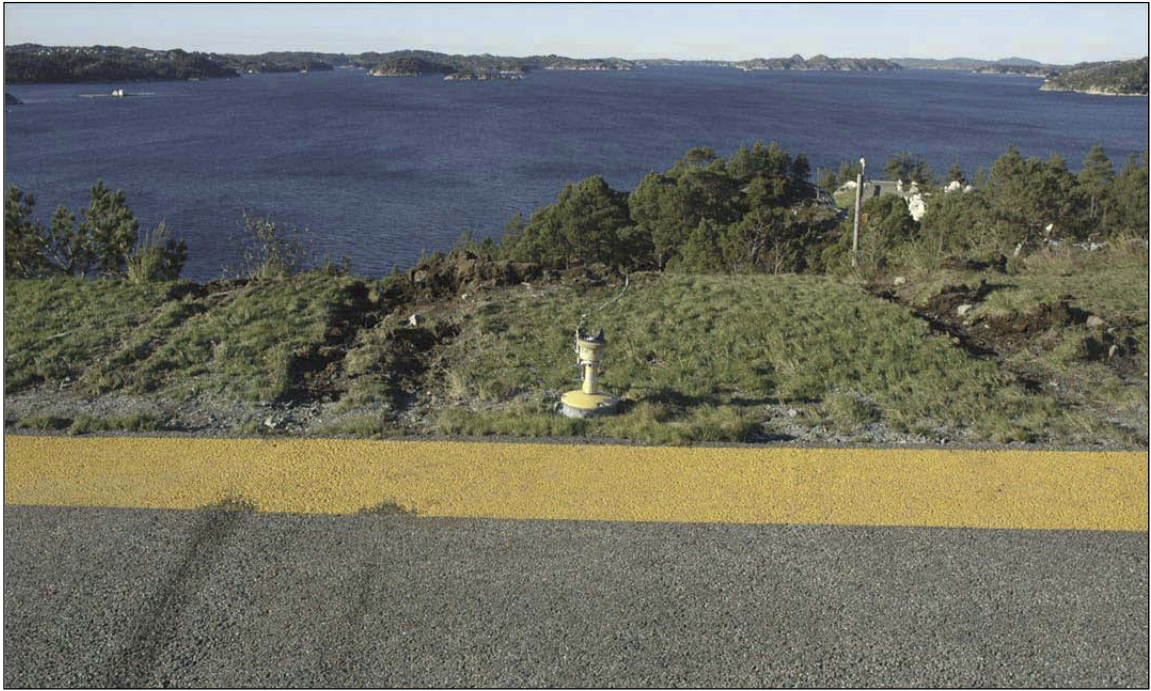
Figure 21: The end of the runway with skid marks left by the tyres. The nose landing gear on the left, followed by the left main landing gear, which left black stripes on the paved surface, and, to the far right at the edge of the photo, the skid mark left by the right main landing gear.

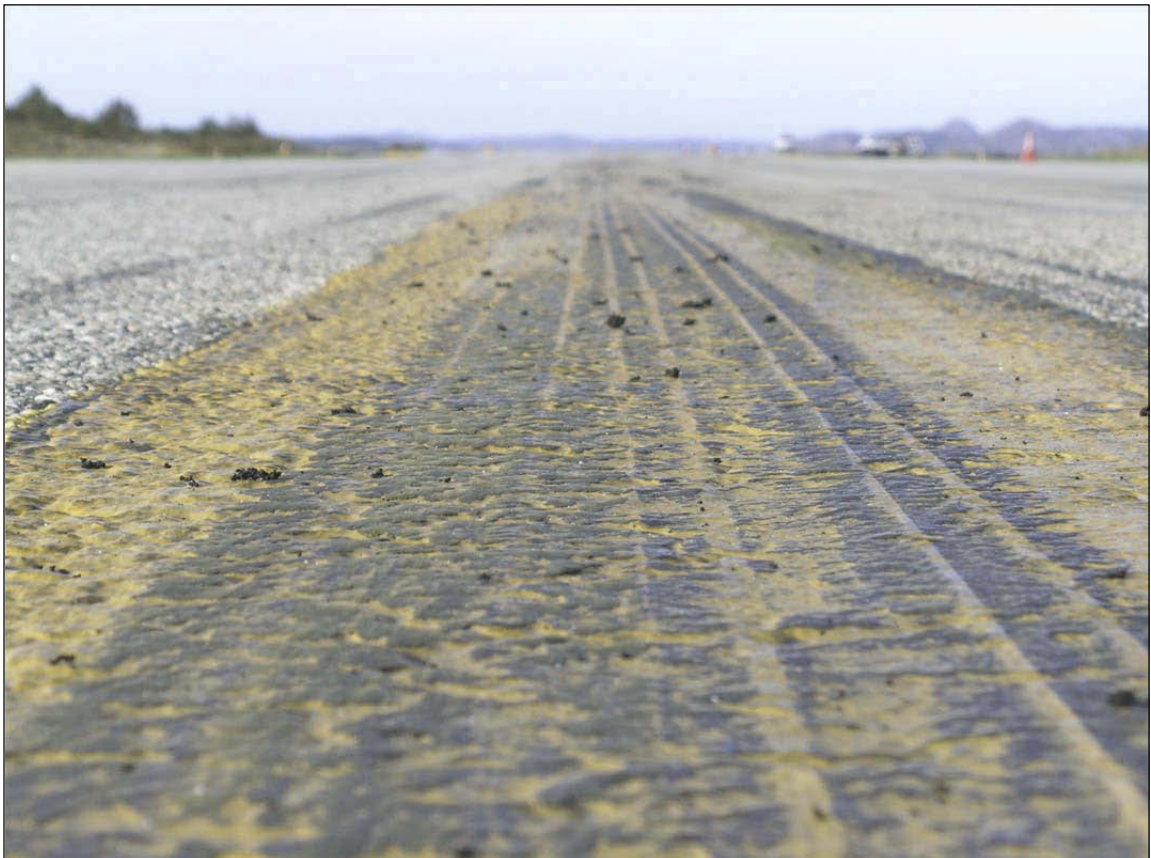
Figure 22: Close-up of small bits of rubber that were spread across the runway on both sides of the skid marks left by OY-CRG. (The black skid marks on the yellow runway markings are not from the aircraft involved in the accident).

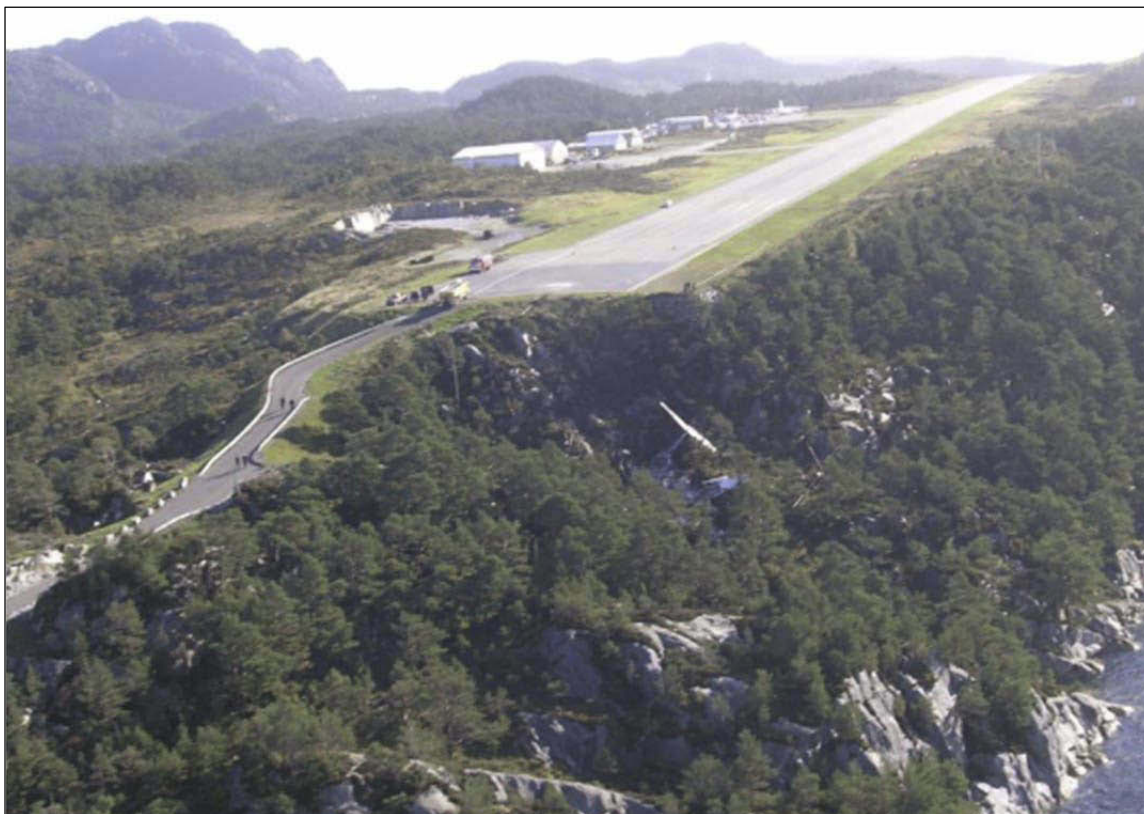
There was damage to the vegetation and scratches in the rock in several places along the slope.

Figure 23: The airport viewed towards the south-east with the aircraft wreckage, the slope and the northern end of the runway closest to the camera.

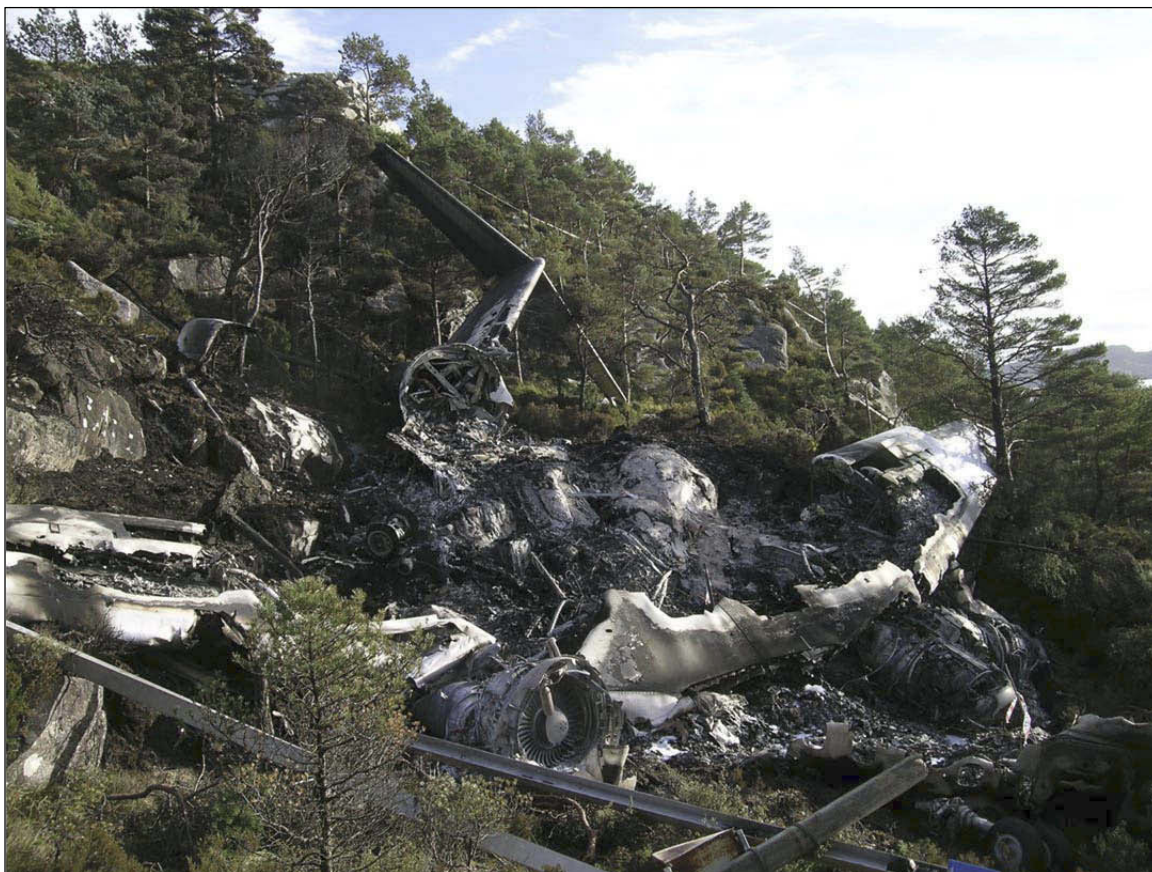
Virtually all the wreckage came to rest in one place 46 m from the end of the runway and approximately 55 m from the sea. The aircraft came to rest with its nose pointing down and banking a few degrees left. Of the major objects found between the runway and the wreckage, were both main landing gear doors, one engine cowling detached from the outer right engine (engine no 4) and engine no 4. The engine cowling lay approximately half-way between the end of the runway and the aircraft wreck. The engine was found 4.3 metres from the right wing tip. It had not been damaged by exposure to heat. The aircraft wreckage generally showed clear signs of exposure to fire and high temperatures. Large parts of the fuselage and wings had burnt up completely or melted.

Figure 24: The aircraft wreckage with parts of the approach lighting system in the foreground.

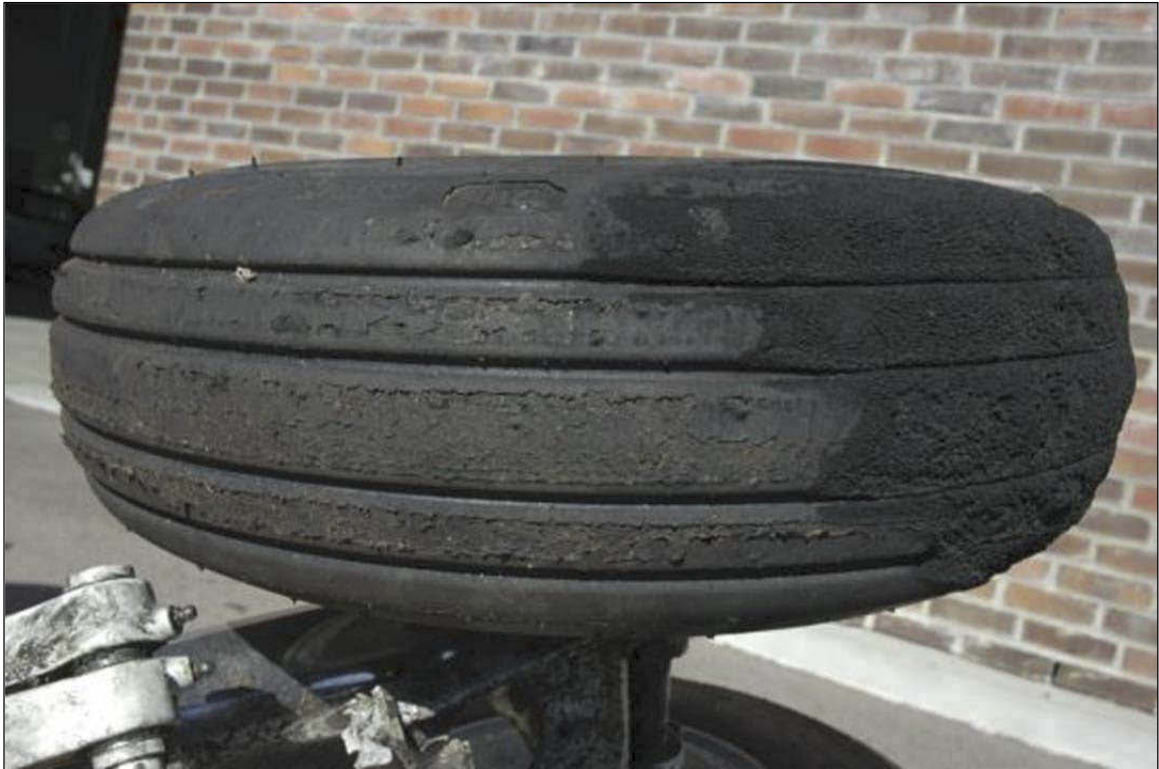
The whole nose landing gear had been ripped off and was lying to the right of the cockpit. Wear marks were clearly evident on the right nose wheel (see Figure 25). Similar wear marks were found to a lesser degree on the left nose wheel. Both wheels had sustained heat damage, but were otherwise intact.

Figure 25: Right nose wheel. Clear wear marks on the left and heat damage on the right.

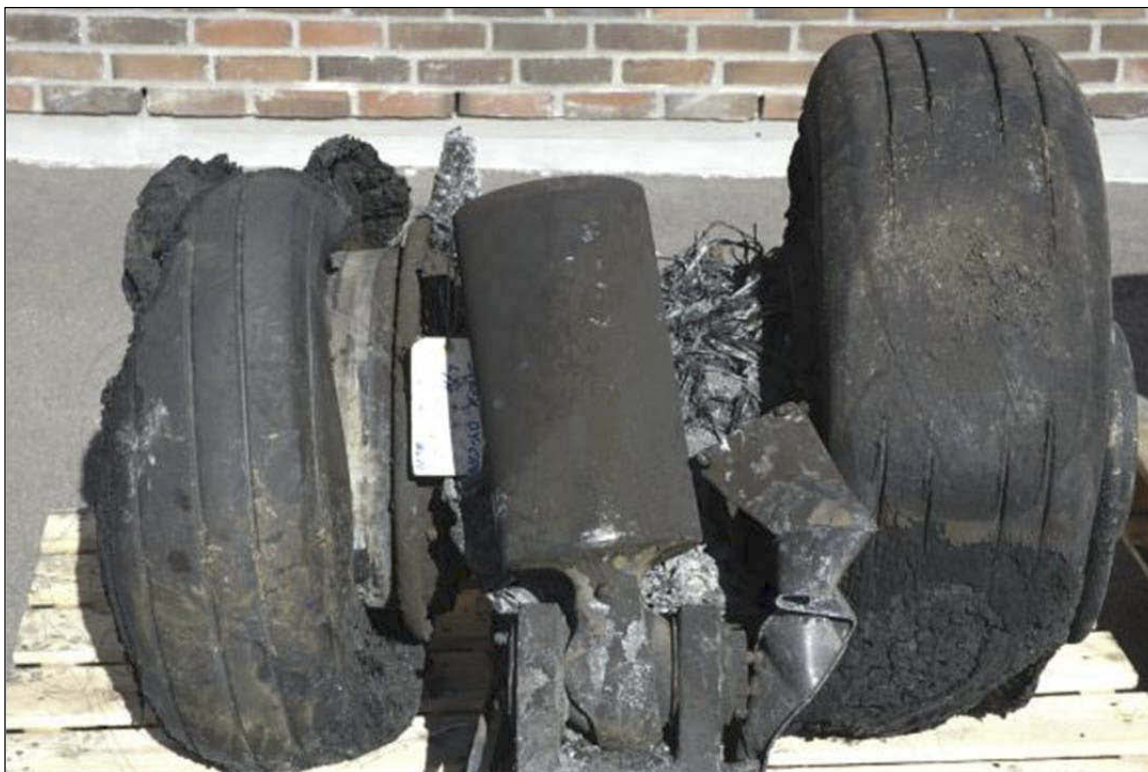
The left main landing gear was found to be partially submerged in a small bog, and this had protected some parts of the tyres (see the photo in Figure 26). That part of the left tyre which had skidded along the runway was completely undamaged by fire (see Figure 27). Corresponding wear marks were not found on the right tyre, but more than half the surface of that tyre had been burnt up.

Figure 26: The wheels on the left main landing gear. The left wheel is on the right in the photo.

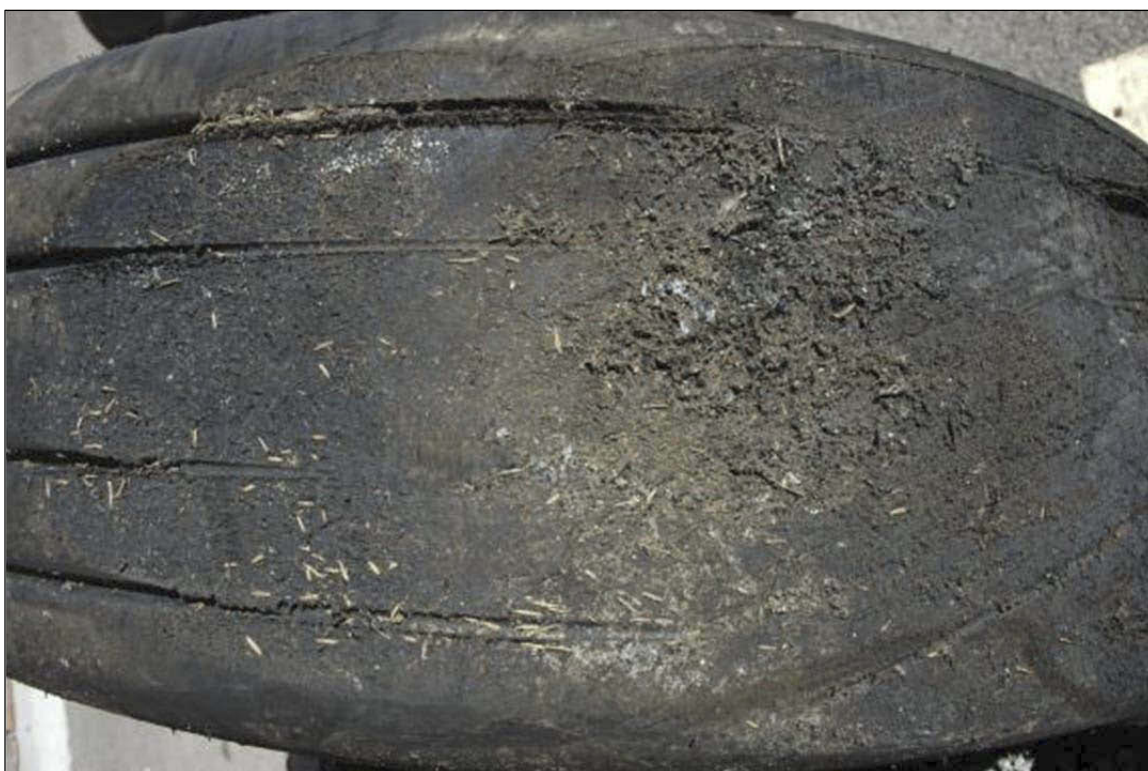
Figure 27: Wear marks on the left tyre of the left main landing gear. The tyre had moved from left to right at an angle of 27° in relation to the asphalt, for an unspecified period. Clumps of decomposed rubber on the right in the photo.

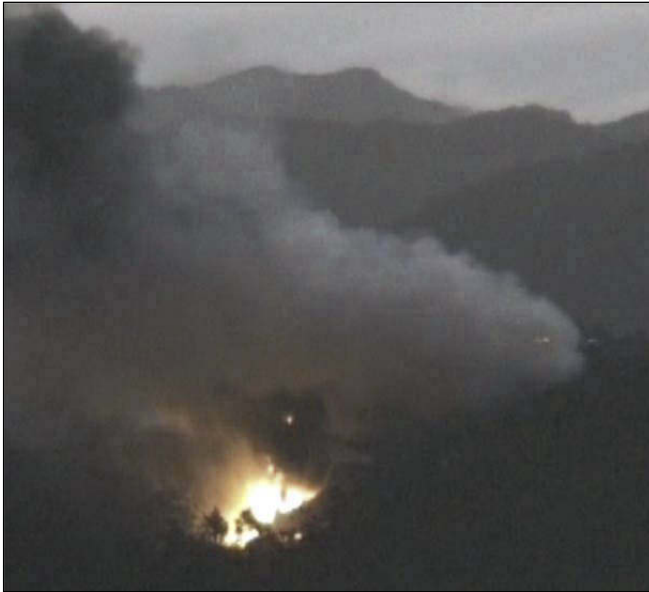
Figure 30: Fire development 1 minute and 45 seconds after the aircraft left the runway and when the fire crew had been trying to extinguish the fire for 1 minute.

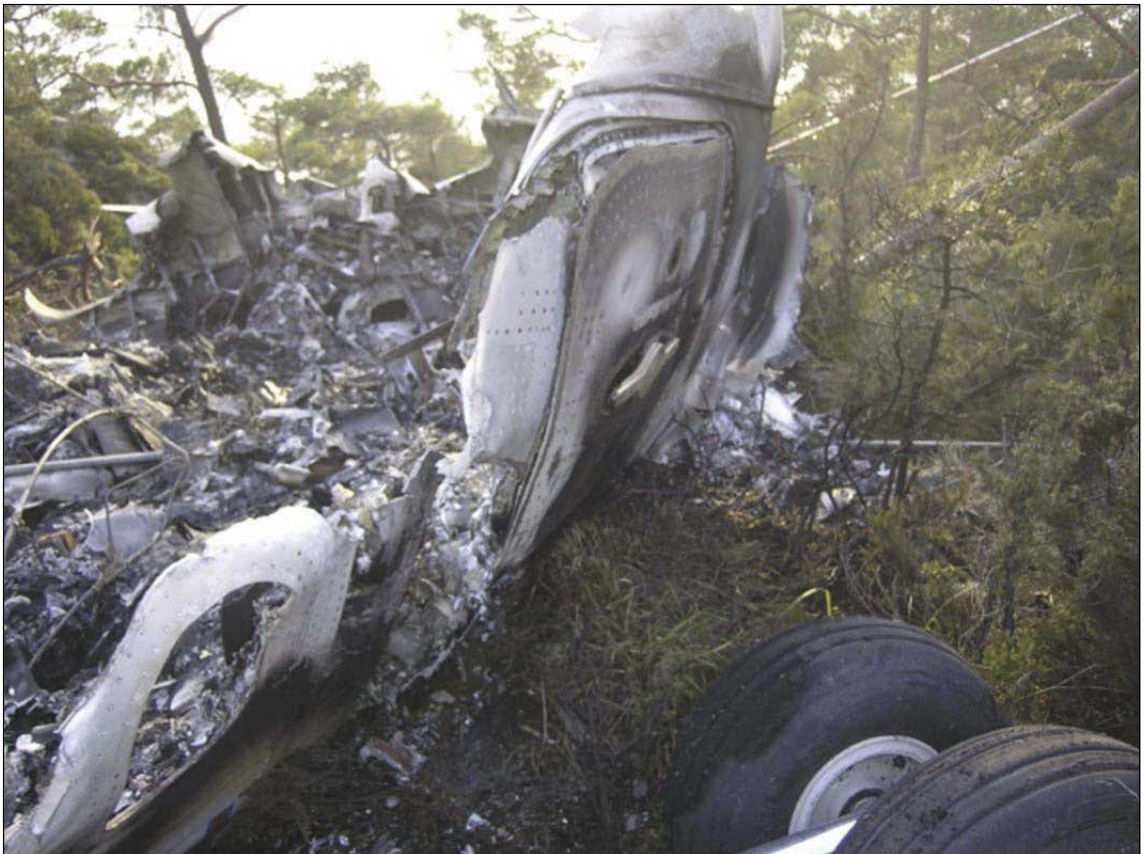
Trees and bushes outside the aircraft were swaying in the powerful jet blast from the engine. Most of the passengers thought that there was a drop of about three to four metres to ground level. One of the passengers looked under the arm of cabin crew member no 2 and observed a green patch just outside the aircraft. He was able to see this because the day was breaking and there was light from the flames. One of the passengers tried to open the rear right door. Because of the position of the aircraft, he was unable to get enough foothold or grip and hence apply enough force to open the door. He eventually managed to get the door slightly ajar and observed flames on the outside. He immediately closed the door and deemed the exit to be unsuitable.

Figure 33: The cockpit and the blocked front right emergency exit. The door handle has been pushed out (partially opened). The nose wheels can be seen in the foreground on the right.

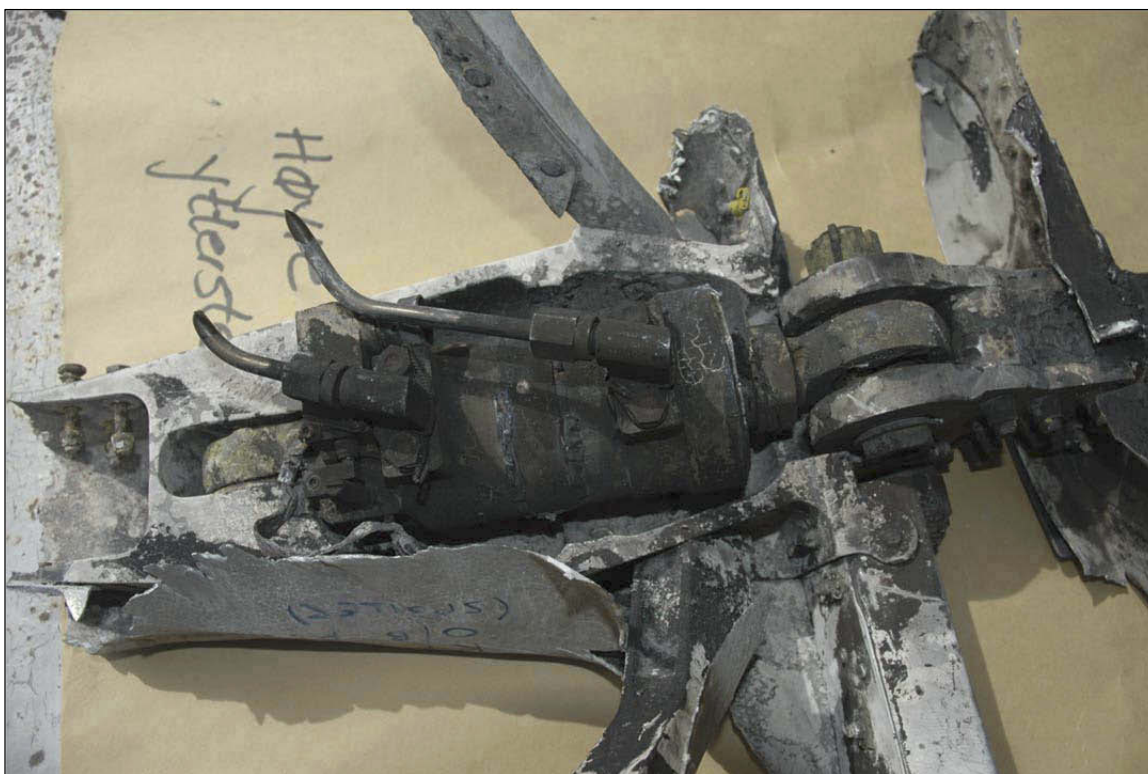
All lift spoiler actuators were found in a much burnt condition inside the aircraft wreck. They were sent to the Royal Norwegian Air Force's main maintenance depot at Kjeller (LHK) for radiographic examination. The radiographic images showed that all six actuators were in the closed and locked position. This was subsequently verified by the AIBN at the manufacturer Smiths Aerospace's facilities in Wolverhampton in the UK.

Figure 34: One of the six lift spoiler actuators.
