گزارش نهایی بررسی سانحه در فرودگاه بندر ماهشهر

Final Report

State File Number: A981107 EPCPZ

Aircraft Model: MD83

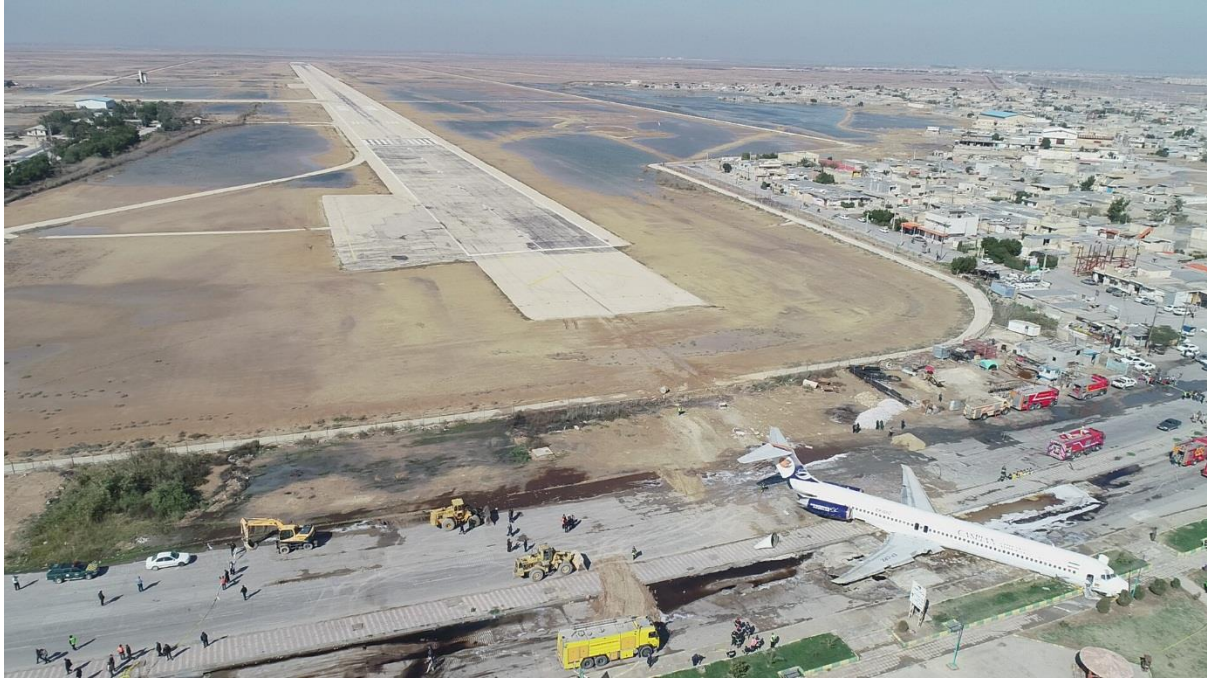
Figure 2- Accident site

Finally, at 04:06:11 UTC, the aircraft landed on RWY 13, passed two-thirds of RWY length and ran off the end of runway 13 after landing at Mahshahr Airport at 04:06 UTC, Khuzestan province.

The main door of the accident aircraft was opened in emergency condition, but the slide skid did not operate automatically. The cabin floor was just too close to the ground (grass surface) due to the impact of the nose and main landing gears strut which were broken after the runway overrun.

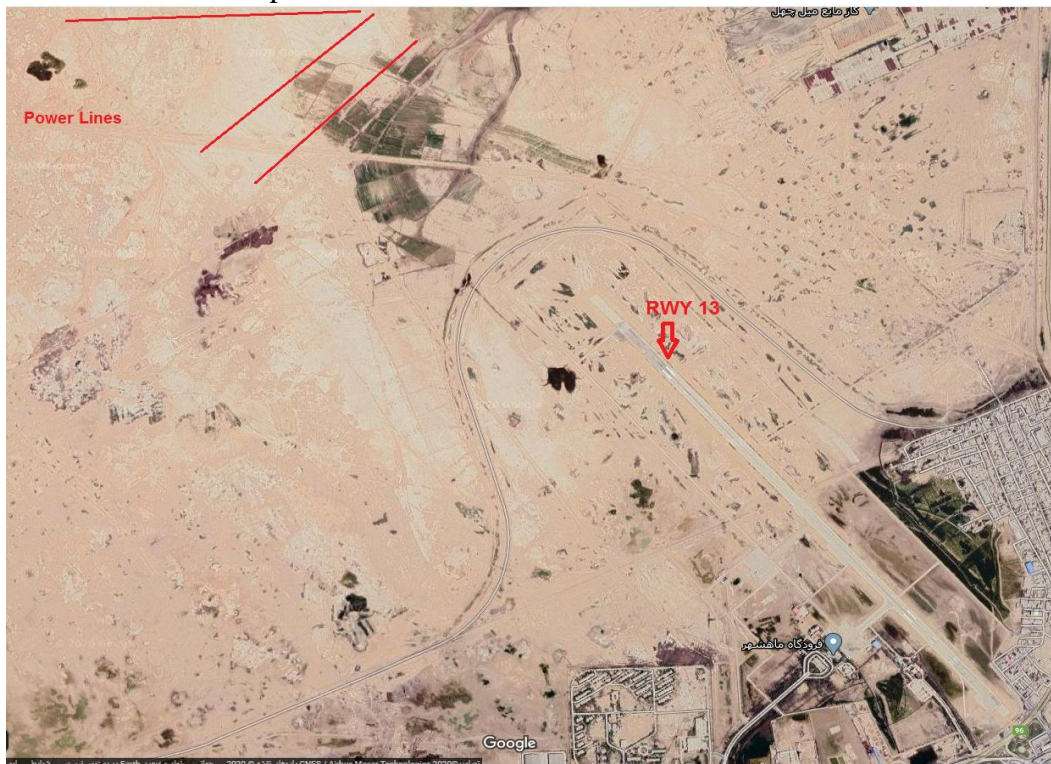
The runway is surrounded with a main road from RWY 31 and three rows of high-voltage power lines with a height of 35 to 45 meters. The maximum height of the power line was inserted in Iranian AIP, equal to 197 ft. AGL

According to the investigation carried out, the nearest power line from the RWY 13 threshold in this airport is 30 meters in height and is 1710 meters away from it. In accordance with Annex 14, the RWY strip shall be at least 60 meters away from the runway, and the Standard Arrival Chart Instrument (STAR) for RWY 13 for Mahshahr Airport was approved according to Annex 11 Standards. However, under Iran Aerodromes Bylaw, the standard strip is defined at 360 meters wherein the power line could be considered a non-standard obstacle.

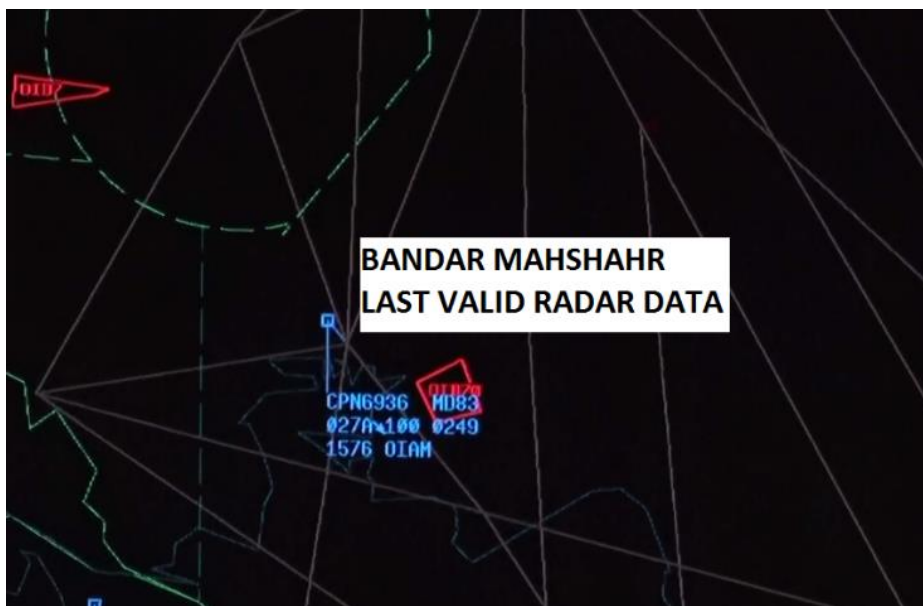
Figure 12- Last valid radar data

Last valid radar data indicates a high ground speed of 249 kt., while passing an altitude of 2700 ft. about 3 miles from threshold RWY 13.

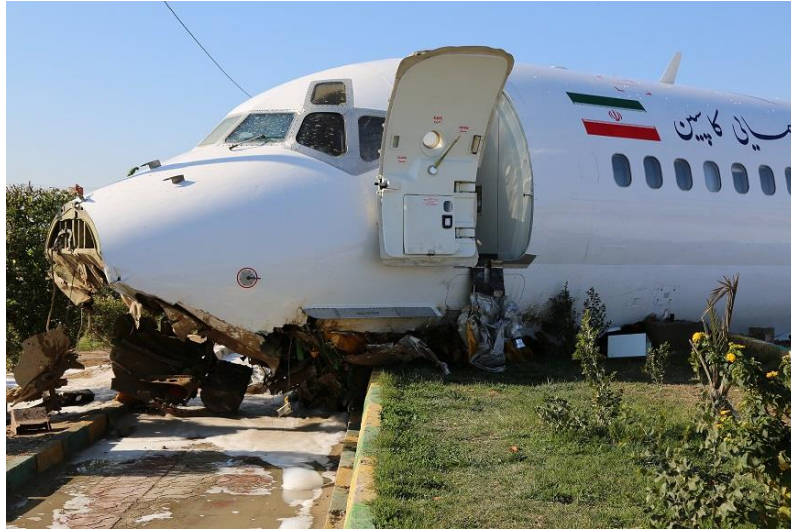
Figure 13- Damage to the fuselage nose

Some of the aircraft body like her tail cone, radome and landing gears broke apart, and the aircraft belly and wings and control surfaces deflected in a way that she sustained major irreparable damage.

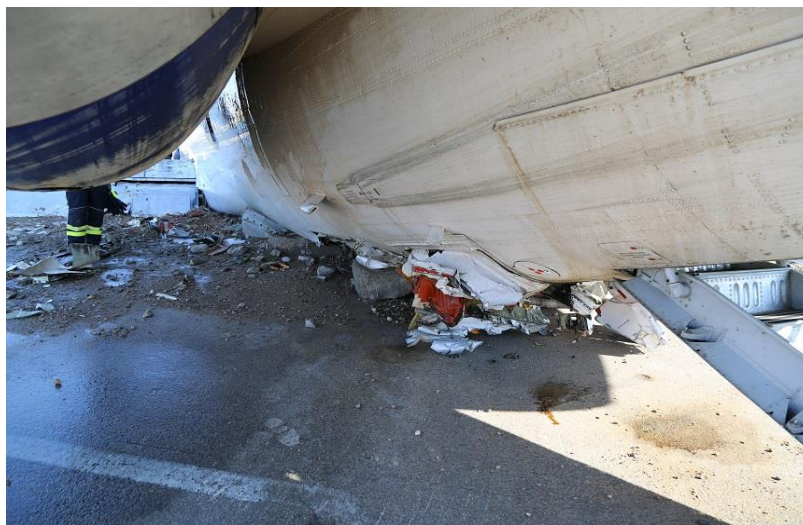
Figure 14- Damage to aft fuselage

Aircraft overran the end of the runway and after 67 meters beyond the end of RWY13 (stopway) rolled through a non-paved area and airport perimeter fence, passed a shallow canal then onto an adjacent roadway, where it struck a concrete median strip and a lamp post before coming to a stop, and came to rest on fuselage as a result of passing over the rough surface.

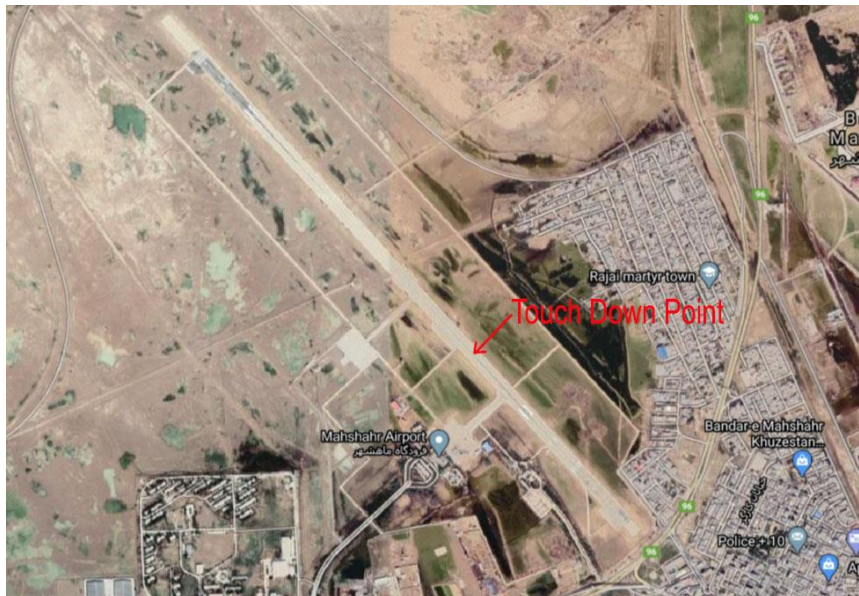
Figure 16-Touchdown point

The touchdown occurred about 1695 meters after the threshold of RWY13 with a remaining runway distance of 1000 meters.

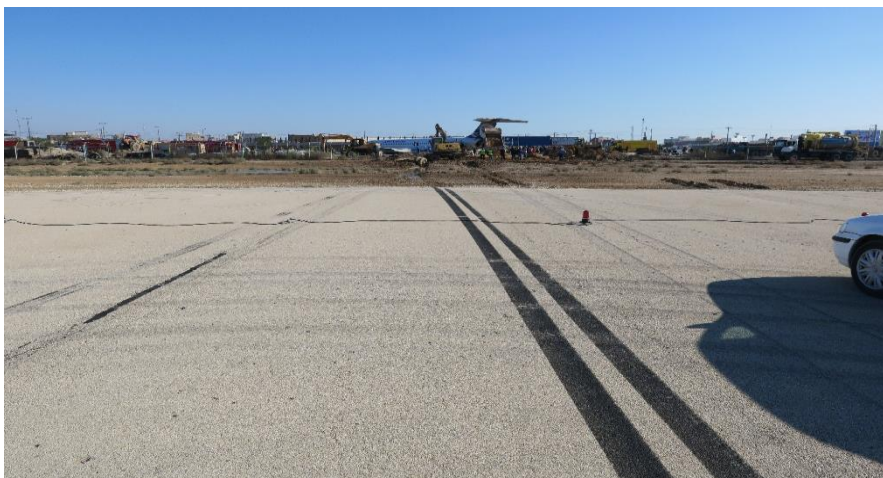
Figure 17- Braking sign

The sign of brake applying was seen on the asphalt surface on the ground at the end of RWY, which shows the pilot's attempt to stop the aircraft by using the brake system.

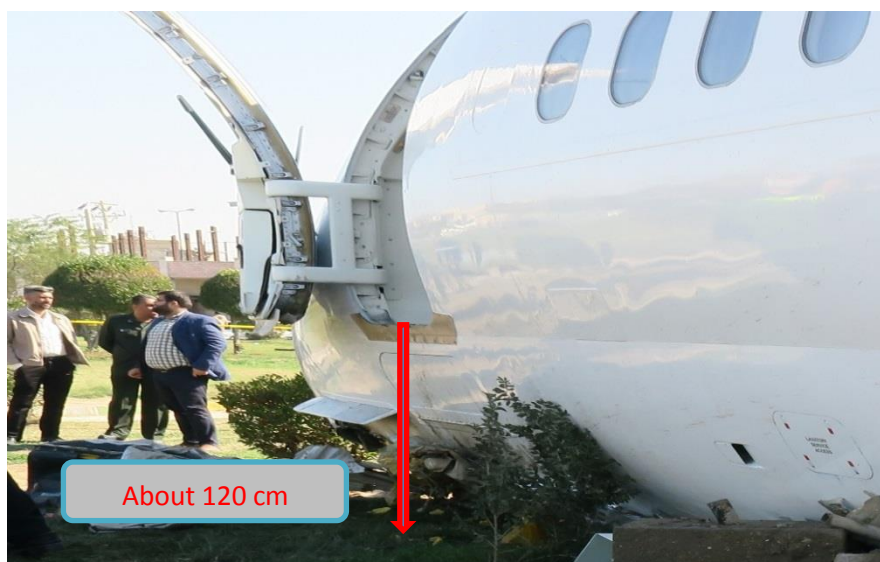
Figure 18- Disembarking door

The aft door and emergency windows were opened by the cabin crew, but the passengers were evacuated only via the main left door. The related slide skid of the main left door could not be activated.
