**COMANDO DA AERONÁUTICA**  
**CENTRO DE INVESTIGAÇÃO E PREVENÇÃO DE**  
**ACIDENTES AERONÁUTICOS**

**FINAL REPORT**  
**A - 121/CENIPA/2021**

<b>OCCURRENCE:</b>	<b>ACCIDENT</b>
<b>AIRCRAFT:</b>	<b>PT-ONJ</b>
<b>MODEL:</b>	<b>C90A</b>
<b>DATE:</b>	<b>05NOV2021</b>

During the approach phase, under Visual Meteorological Conditions (VMC), the aircraft collided against a lightning arrester cable of a power grid on the final approach to threshold 02 of Caratinga Aerodrome (SNCT), Uaporanga - MG, resulting in loss of control and the impact of the aircraft against the ground.

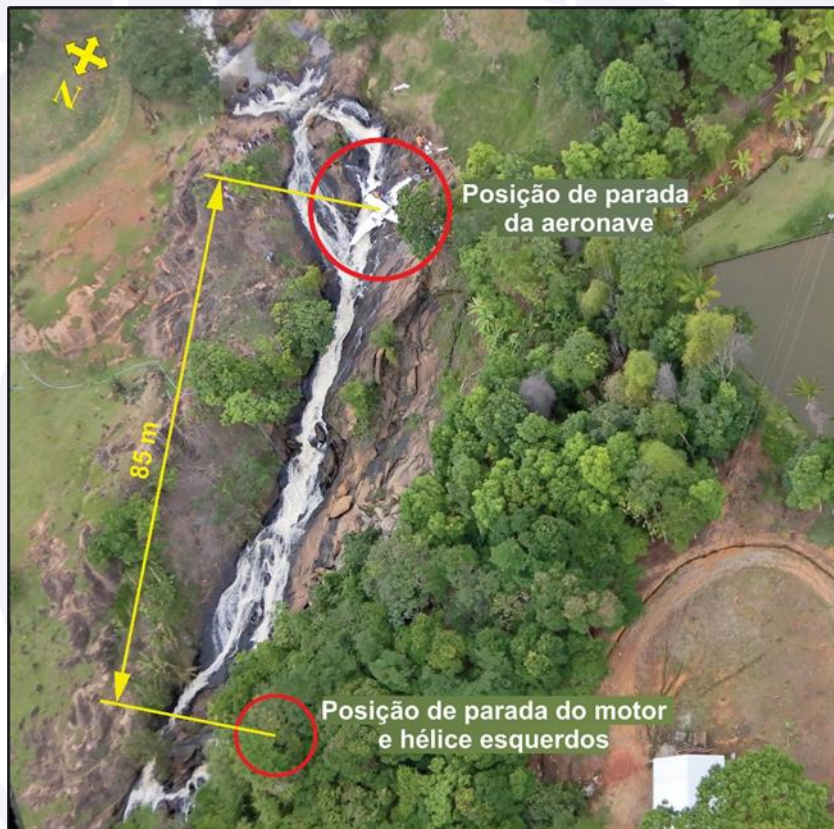
Figure 17 - Identification of the location of the fall and stop of the left engine/propeller.

The left engine detached from the wing still in flight due to inertial and impact forces, coming to rest at a distance of about 85 m ahead of the aircraft (Figure 17).

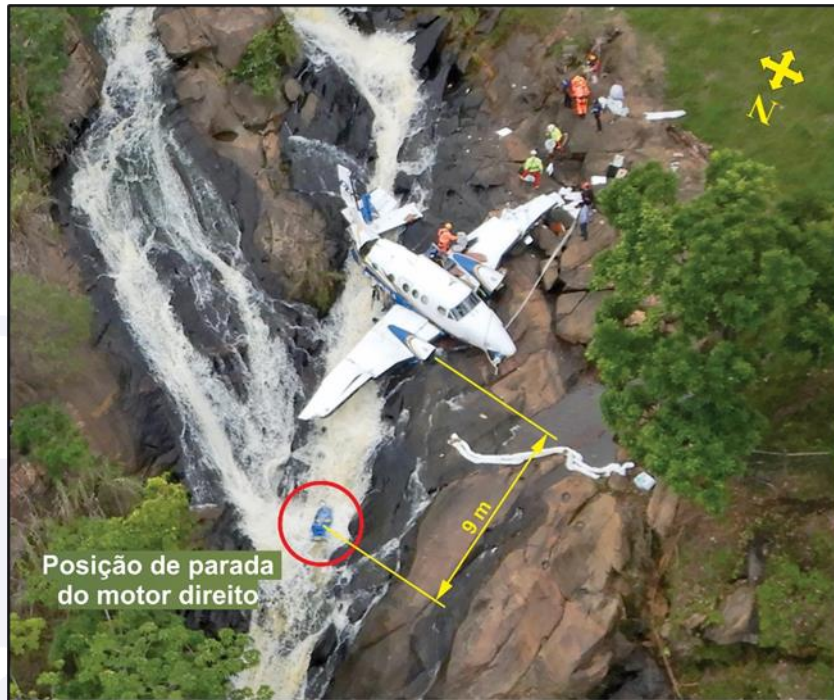
Figure 18 - Identification of the stop location for the right engine/propeller.

The right engine detached from the wing upon impact with the ground and stopped about 9 m ahead of its attachment point on the aircraft, being partially submerged in the waterfall (Figure 18).

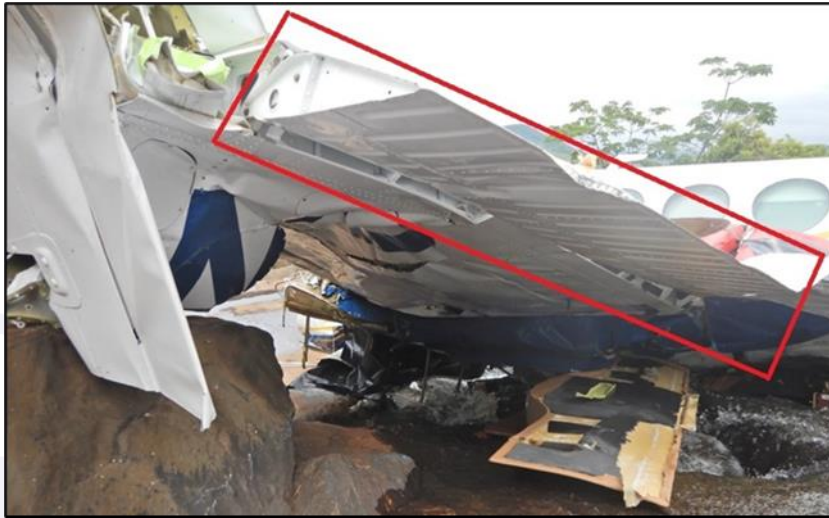
Figure 20 – Left-wing flap position after impact with the ground.

The angle of the flaps identified in the wreckage was compatible with the APPROACH position (Figure 20).

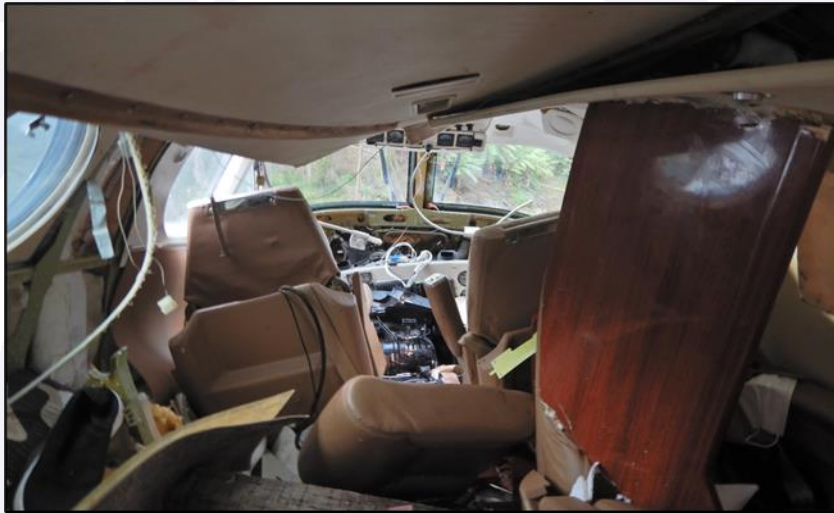
Figure 22 - Extent of damage inside the aircraft.

The aircraft's interior had an extensive detachment of its internal lining, the instrument panel, the floor, and all the seats (Figure 22).

It could not be determined whether the passengers were wearing their seatbelts. The force of the impact was much greater than the resistance and absorption capacity of both the fuselage and the seats.

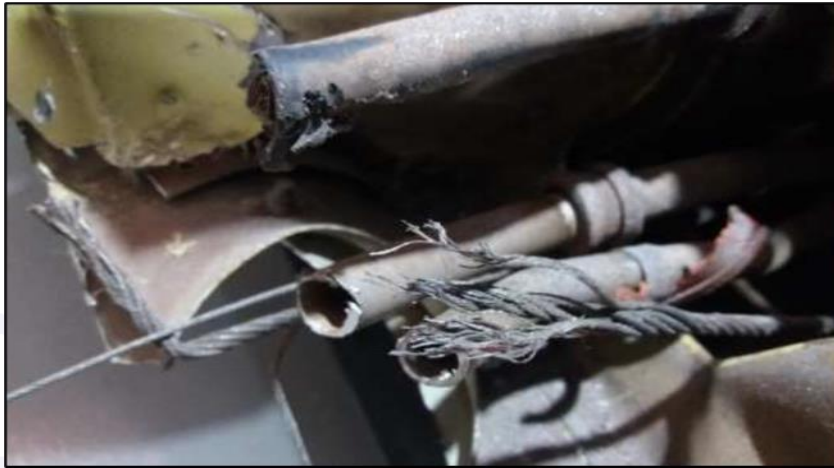
Figure 23 - Aircraft control cables with overload indicator.

From the examinations performed on the primary flight control cables, it was observed: the spreading of the wires that composed the cables, different heights of wire breakage, and stranding; were indicative of overloading due to the aircraft impact (Figure 23).

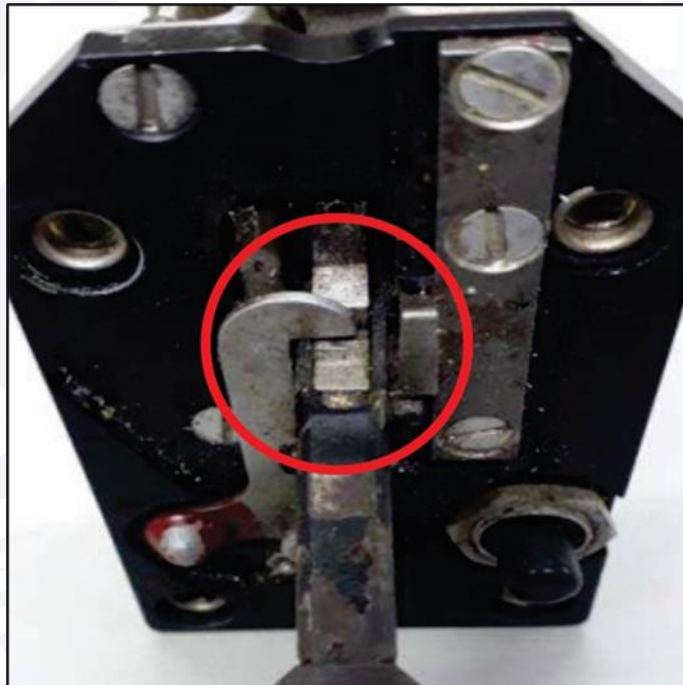
Figure 24 - Landing gear activation lever with protection lock activated.

In the visual examination carried out on the landing gear control lever, it was observed that it was in the “gear down” position and with the safety lock activated (Figure 24).

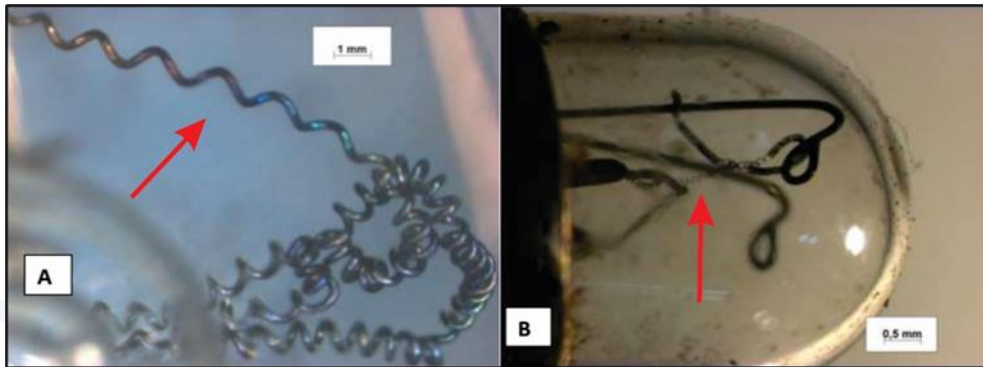
Figure 25 - Photo stereoscopy of the lamp filaments, landing gear headlight (A), and lock indication (B).

Examination of the lamps revealed that the filaments of the landing gear lock indicator and headlight had suffered hot plastic deformation, indicating that they had been lit at the moment of impact (Figure 25).

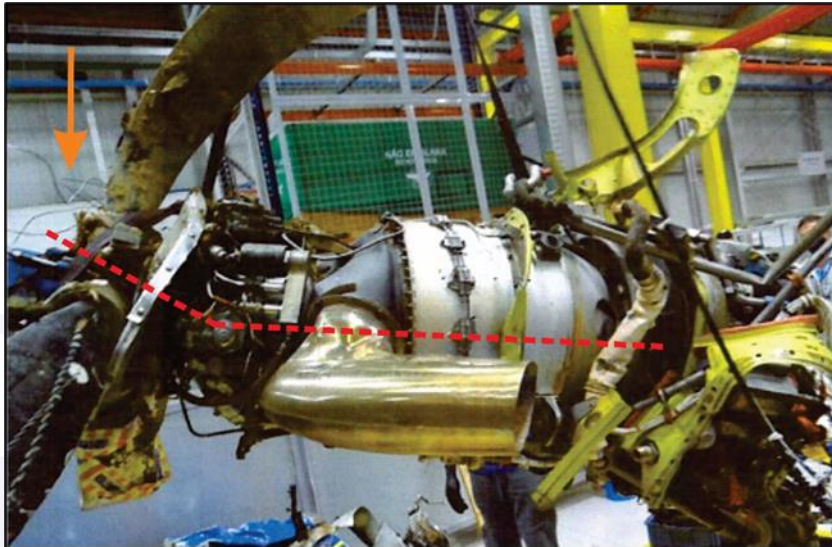
Figure 26 - View of the left side of the left engine without fairing. The dashed line projects the engine's longitudinal axis. The arrow indicates the cable wrapped around the propeller hub.

The exams of the left engine revealed that the external part was covered with dirt and organic debris, and that there was a piece of steel cable wrapped around the propeller hub. The front was deformed and twisted upwards, altering the engine shaft (Figure 26).

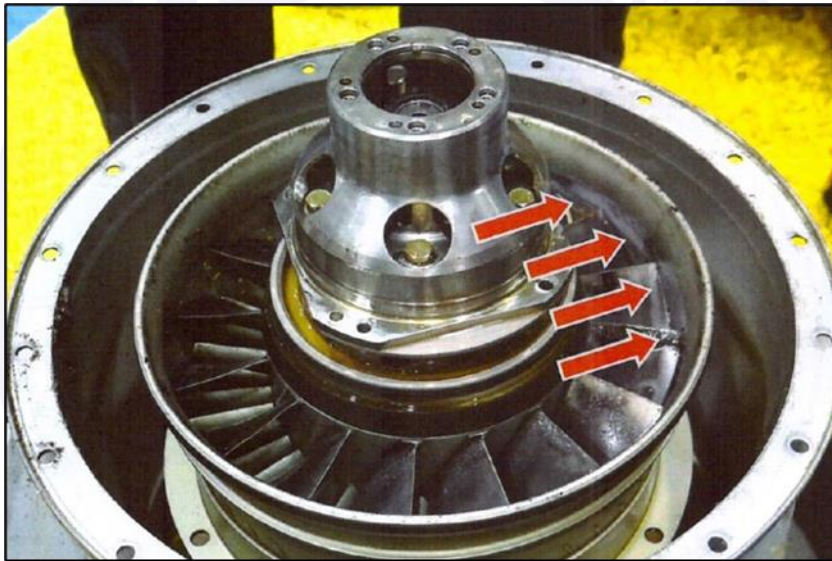
Figure 27 – View of the rotor of the first stage of the left engine compressor with rubbing marks observed on the housing.

The analysis of the compressor's rotating assembly revealed rubbing marks on the casing in the region of the compressor's first stage, compatible with the development of power at the moment of impact against the lightning arrester cable (Figure 27).

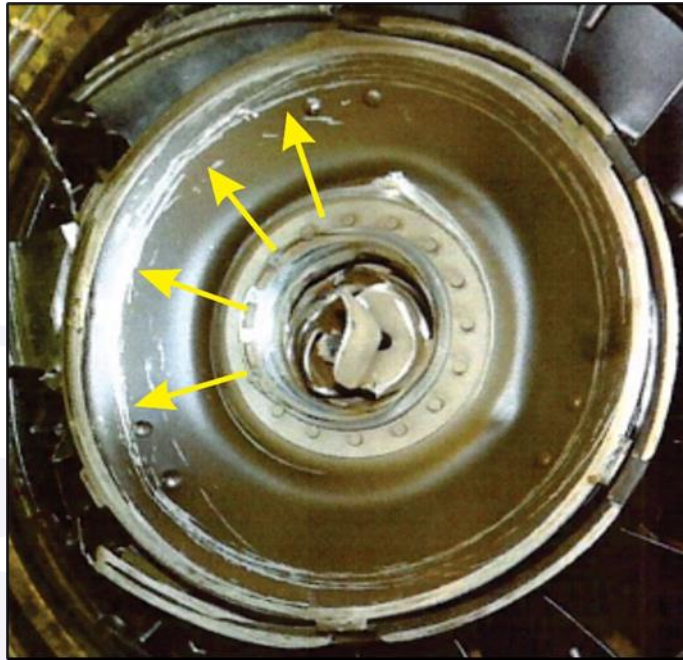
Figure 28 - Anterior view of the left-engine diaphragm with intense rubbing marks.

The hot section of the engine was examined in detail. Because this type of engine operates with independent turbines, heavy rubbing marks left by the compressor turbine rotor on the diaphragm were found (Figure 28).

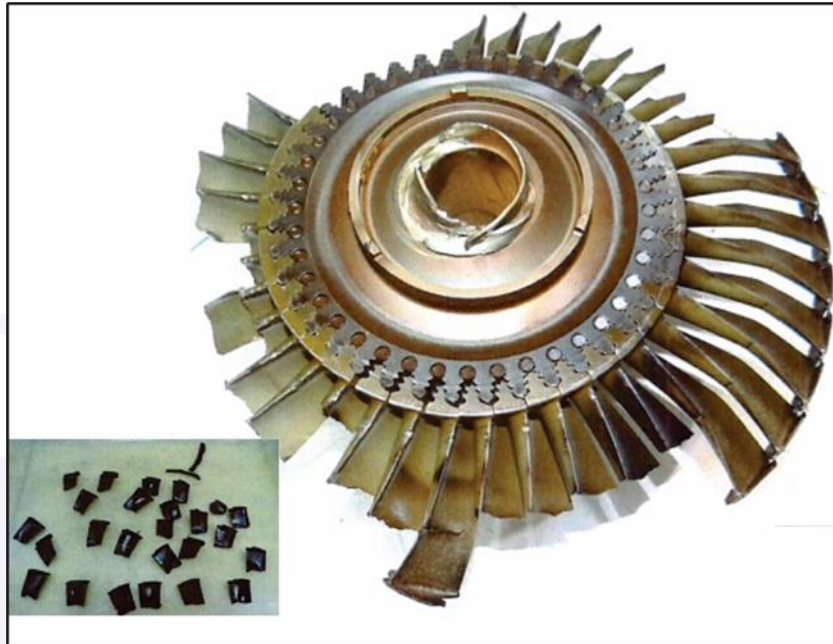
Figure 30 - Front view of the left engine power turbine rotor and part of the blades that were recovered.

The rupture of the blades of the power turbine rotor, at half the length, corroborates the absence of rotation in that engine section at the moment of the collision against the ground. This is explained by the fact that the left propeller collided with the lightning arrester cable and had its rotation abruptly interrupted (Figure 30).

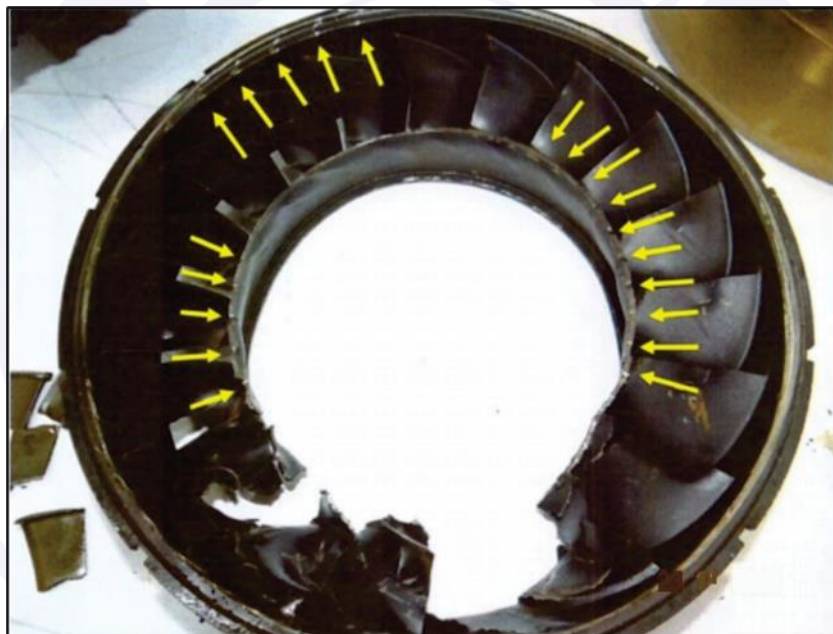
Figure 31 - Rear view of the left engine power turbine stator with stopped impact marks and damage to the fins.

Like the rotor, the power turbine stator also showed marks of stopped impact and damage to the fins (Figure 31).

The impact marks with the stopped power turbine rotor appeared due to the locking caused by the lightning rod cable on the propeller. This lock condition passed through the reduction box and reached the engine's power turbine.

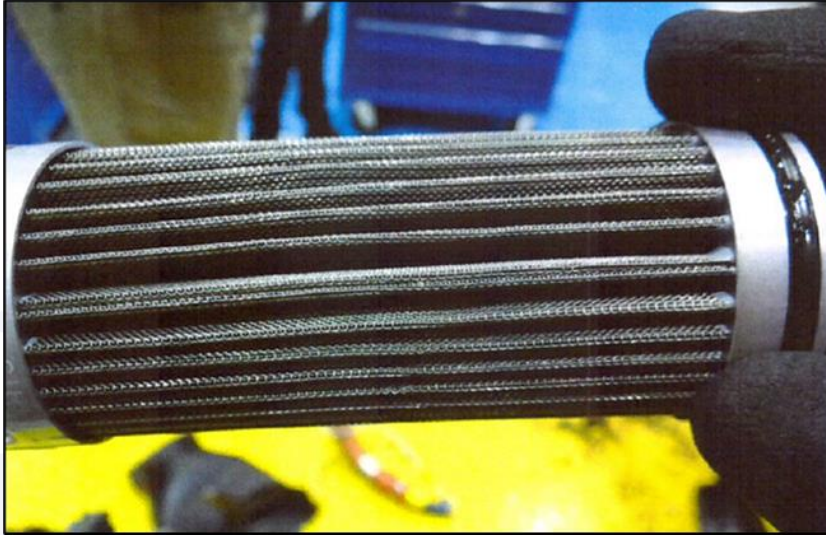
Figure 32 - Left engine oil filter without abnormalities.

In the engine lubrication system, no abnormality was detected that could compromise the engine operation. During disassembly, it was noticed that the internal components, which require lubrication, showed evidence that they worked lubricated all the time (Figure 32).

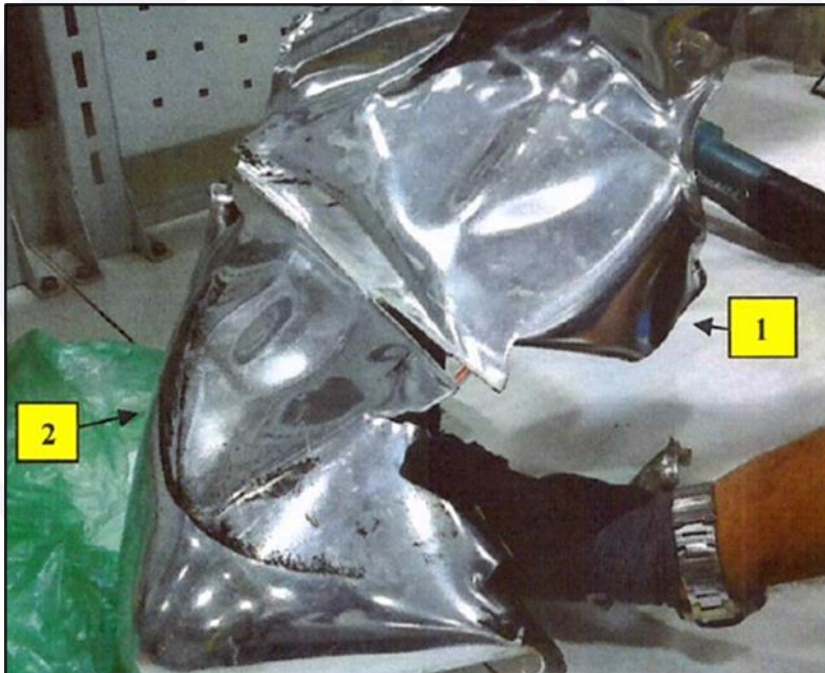
Figure 33 - Impact marks on the left engine spinner.

Analysis of the left engine propeller showed that initially, the lightning arrester cable hit the spinner and sectioned it. Then, the spinner was pulled from its attachment point to the propeller plate. The lightning arrester cable, when wrapped around the propeller, blocked the servo piston and the propeller blades in the position they were in at that moment of the flight (Figure 33).

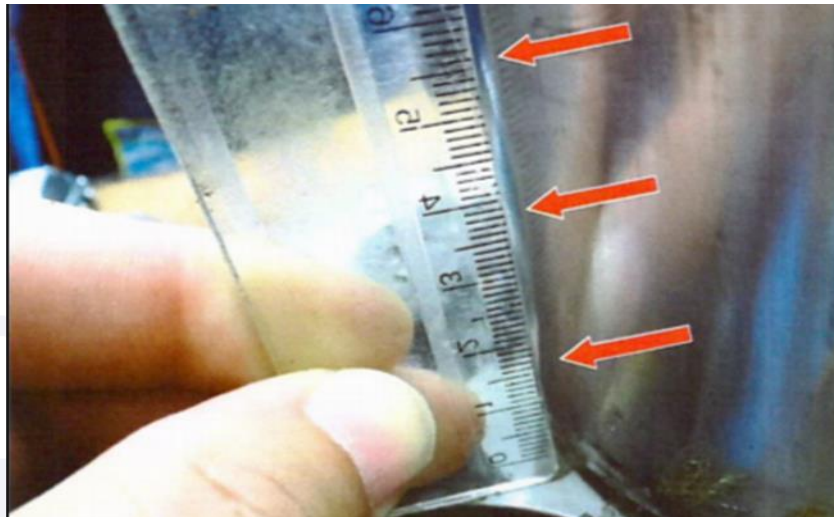
Figure 34 - Deformation observed at the base of the left engine propeller cylinder.

It was observed that the propeller cylinder presented a deformation of about 25 mm from its base (Figure 34).

This deformation indicates that the servo piston was displaced from its rest position and that hydraulic wedging occurred at the instant of the collision. The observed marks indicated that the servo piston and propeller blades were out of their rest (feather) position, therefore, in-flight pitch.

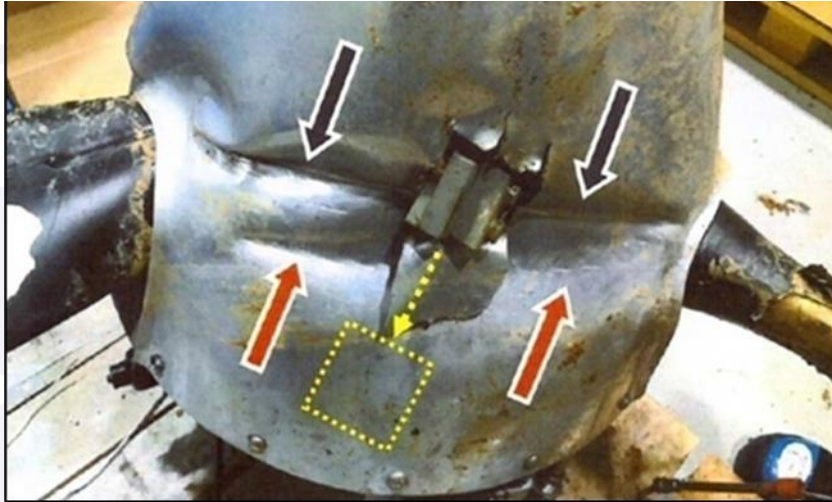
Figure 36 - Lightning arrester cable mark left on the right engine spinner.

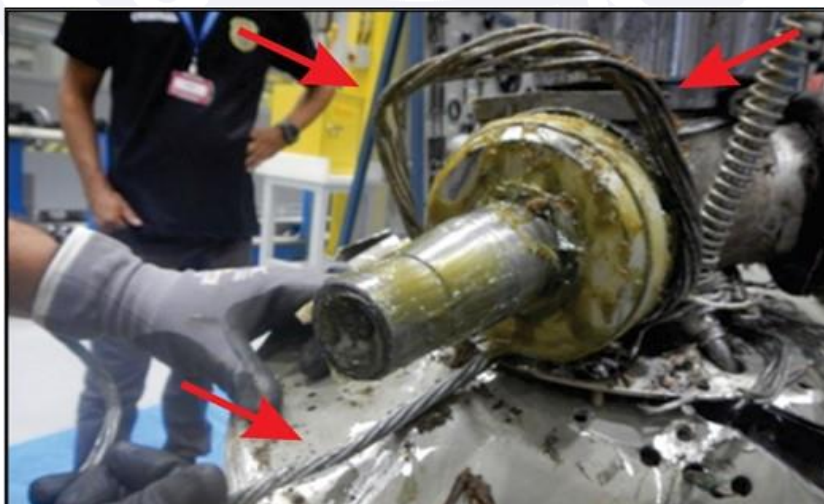
Figure 37 - Lightning arrester cable wrapped around the left engine propeller shaft, indicated by red arrows.

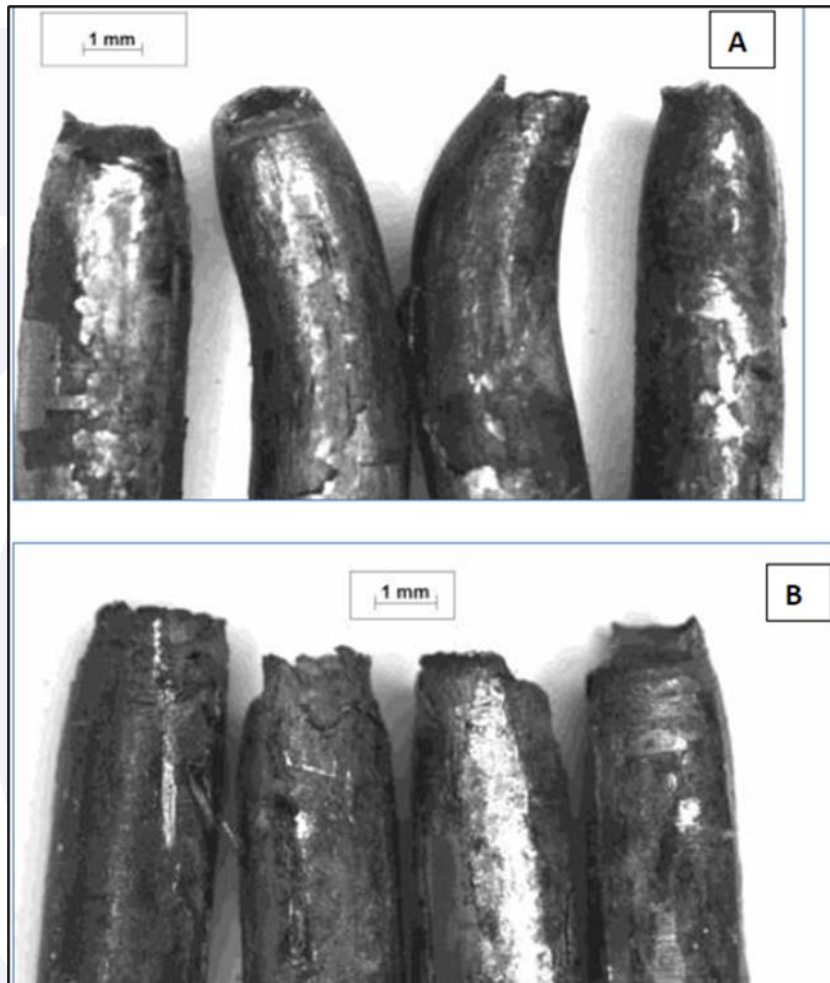
Figure 38 – Photo stereoscopies of the cable removed from the engine shaft (A) and cable submitted to the traction test (B).

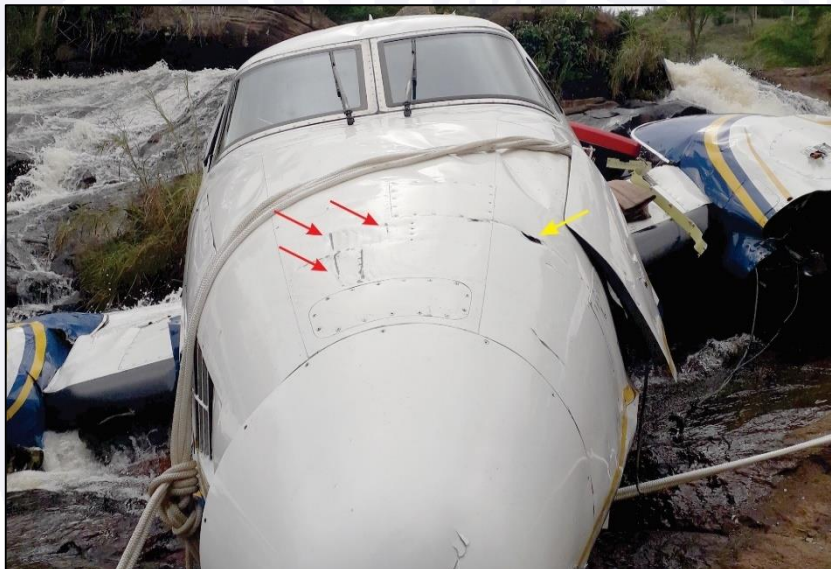
Figure 40 - Contact marks of the cable against the nose of the aircraft. The red arrows point to friction marks, and the yellow arrow shows one of the perforation points in the coating.

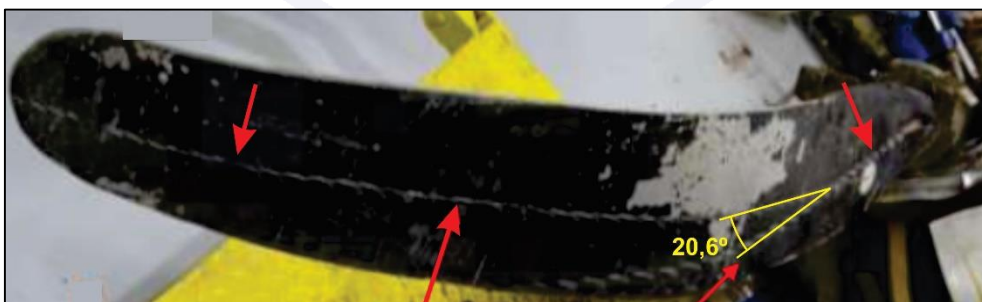
Figure 41 - Details of the impact marks of the cable against the left engine propeller blade.

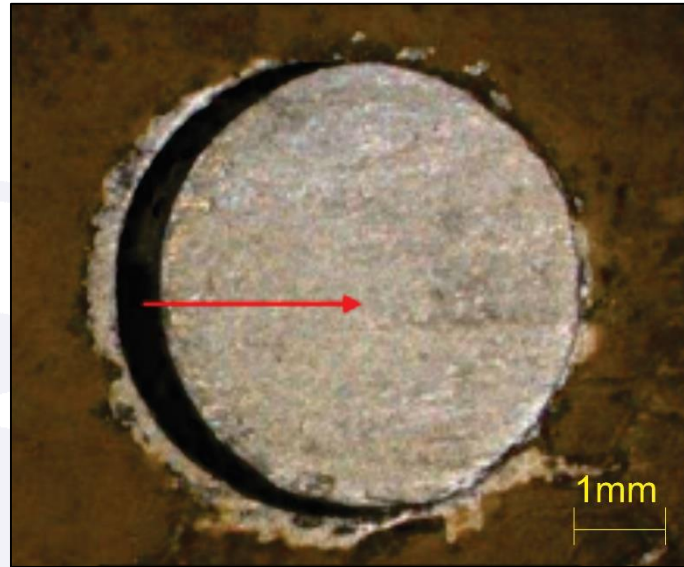
Figure 42 - Detail of the shear marks on the left engine support rivet. The arrow indicates the direction of the shear.
