ATSB TRANSPORT SAFETY REPORT
Occurrence Investigation Report AO-2007-001
Final

Microburst event
Sydney Airport, NSW
15 April 2007
VH-OJR
Boeing Company 747-438

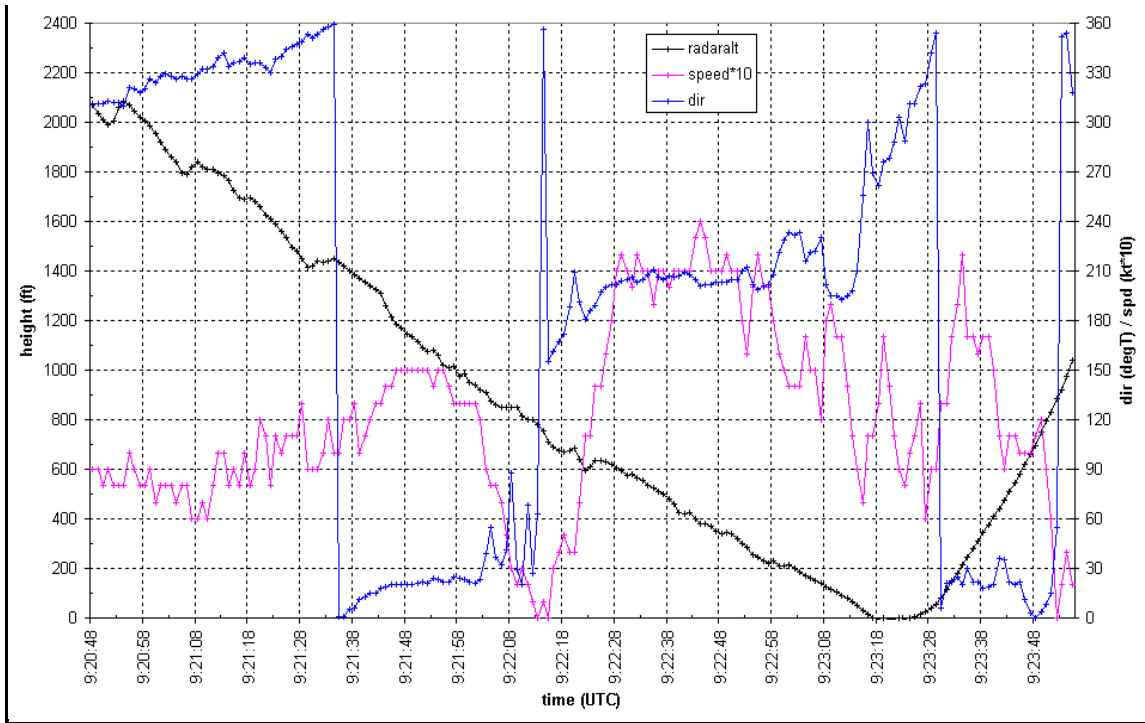
Figure 3: Recorded flight data showing aircraft altitude, wind speed and wind direction

As the aircraft descended through 2000 ft it experienced NW winds around 10 kt that shifted NE and increased to 15 kt. At around 092213 UTC when the aircraft was at 800 ft the wind shifted from NE to S and increased to around 20 kt. At this time the aircraft was around 4 km north of the threshold for Rwy 16R and the observed wind change is consistent with the aircraft descending through the upper boundary of the gust front that passed across the airport earlier. The observed winds are also consistent with those observed at the threshold of Rwy 16R at this time.

In the period 092311-092316 UTC when the aircraft was at less than 100 ft altitude the wind rapidly shifted from 190/18 kt to 280/12 kt. This is a significant wind change at such a critical stage of landing. The along-track wind component changed from an 18 kt headwind to a 5 kt tailwind with an airspeed loss of 23 kt and there was a rapid increase in the cross wind component. The observed wind change reported by the aircraft is again consistent with the wind observed at the threshold of Rwy 16R where the wind shifted from S to W in the period 092220-092250 UTC.

As the aircraft climbed the observed wind is reported as 020/18 kt consistent with the presence of the divergent outflow.

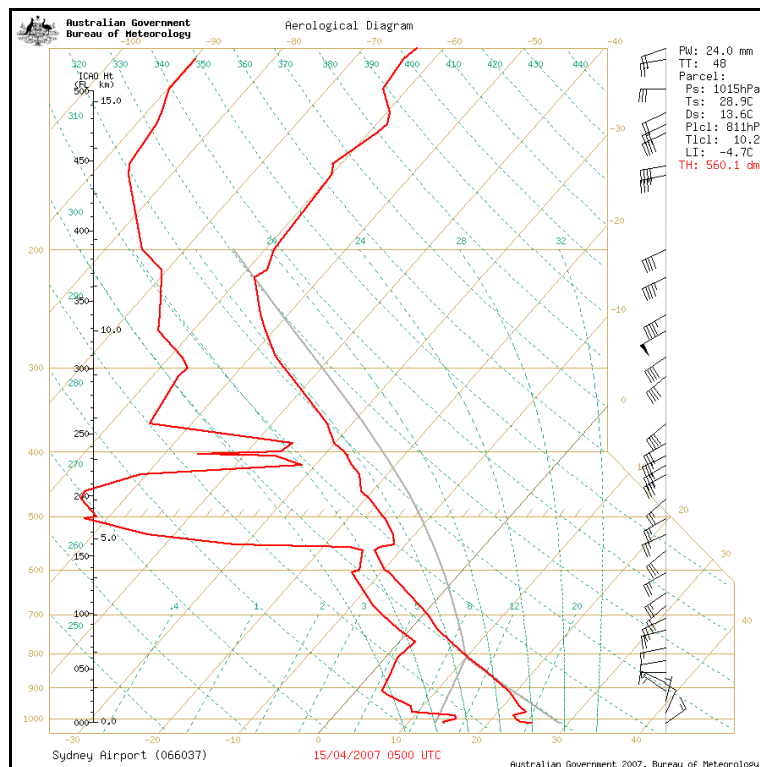
In the afternoon, before the incident occurred, the weather in Sydney started out fine with northeast winds around 15 knots and little, if any, significant cloud (see Aerodrome Weather Reports in Appendix 1). The vertical profile of the atmosphere (Figure 2.1) shows that it was potentially unstable at the time, with conditions suitable for high-based convective clouds to develop (if the necessary atmospheric forcing was present). The steep lapse rate in air temperature, especially in the lowest several thousand feet, shows an environment suitable for convective clouds to grow to a significant height. The moisture profile also shows that the air was relatively dry in the layers below about 8000 feet (apart from the relatively shallow and moist layer at the surface). Overall, the atmospheric profile shows conditions favourable for the development of moderately high-based convective clouds, with relatively dry air below the cloud base: i.e. conditions not unfavourable for the formation of a microburst.

Figure 2.1 Vertical profile of air temperature (right) and moisture (left) at Sydney Airport (05Z, 15 April 2007) shows a steep temperature lapse rate (between 1000ft-15000ft) and dry air (between 1000ft-8000ft). The vertical wind profile is shown on the far right.

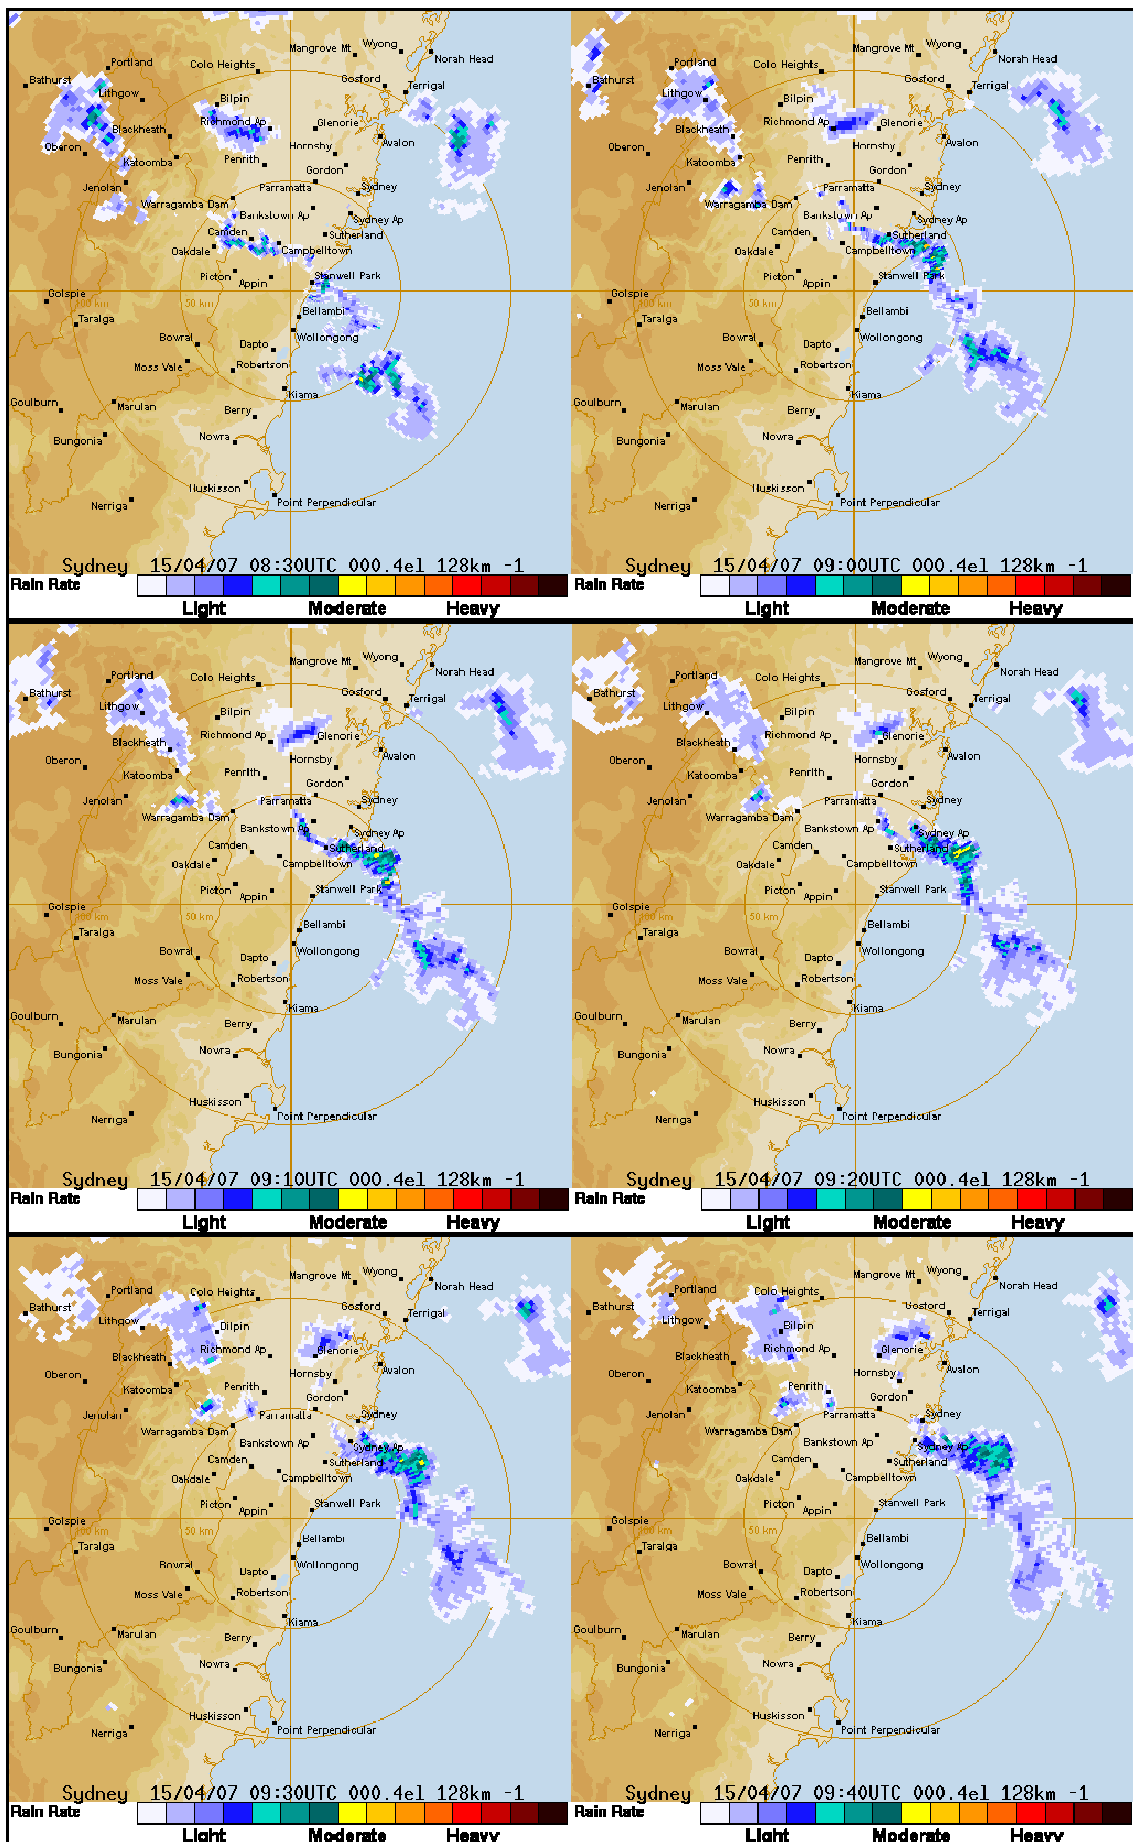
The cluster of showers and thunderstorms, which caused the thunderstorm and microburst at the Airport, first appeared on radar to the southwest of Sydney (before 0830Z), then moved over the Airport between 0920Z – 0930Z and cleared to the east by 1000Z (see Figure 2.4).

Figure 2.4 Radar images show storms moving over the Airport around 0920UTC.

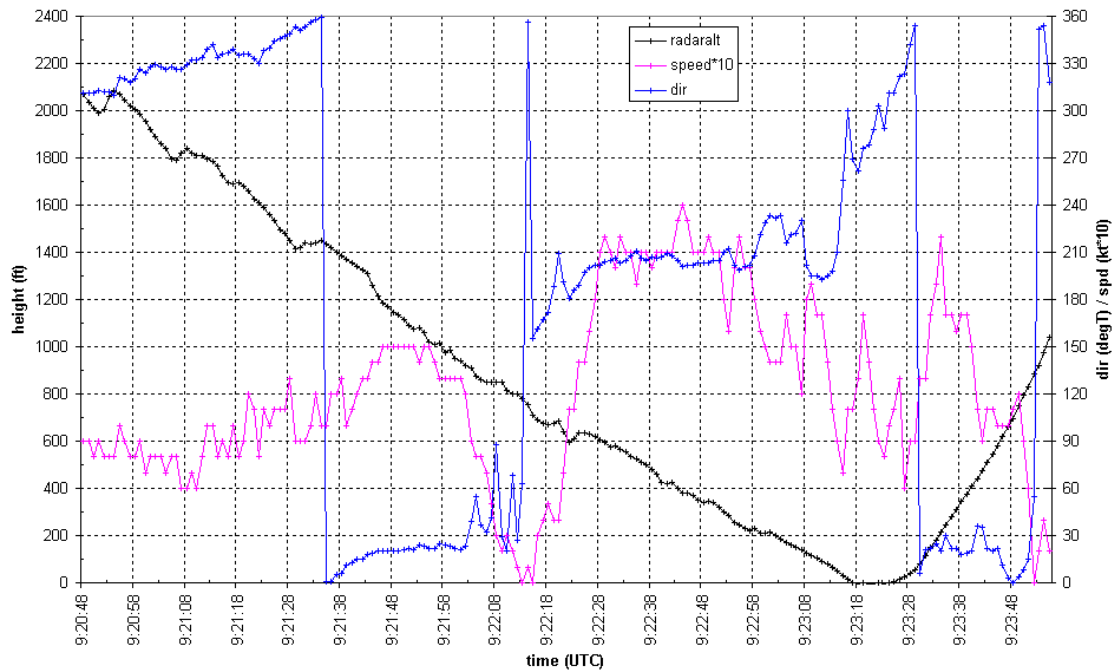
Figure 2. Flight recorder data for period 092048-092348 UTC.

Fig. 2 shows Flight Recorder Data from the aircraft concerned as it approached Rwy 16R, touched down at 092318 UTC and then climbed as it aborted the landing. This covers the 3 minute period 092048 – 092348 UTC and shows the radar altitude (ft), the wind direction (degT) and the wind speed (x 10 kt) as the aircraft approached.

As the aircraft descended through 2000 ft it experienced NW winds around 10 kt that shifted NE and increased to 15 kt. At around 092213 UTC when the aircraft was at 800

ft the wind shifted from NE to S and increased to around 20 kt. At this time the aircraft was around 4 km north of the threshold for Rwy 16R and the observed wind change is consistent with the aircraft descending through the upper boundary of the gust front that passed across the airport earlier. The observed winds are also consistent with those observed at the threshold of Rwy 16R at this time.

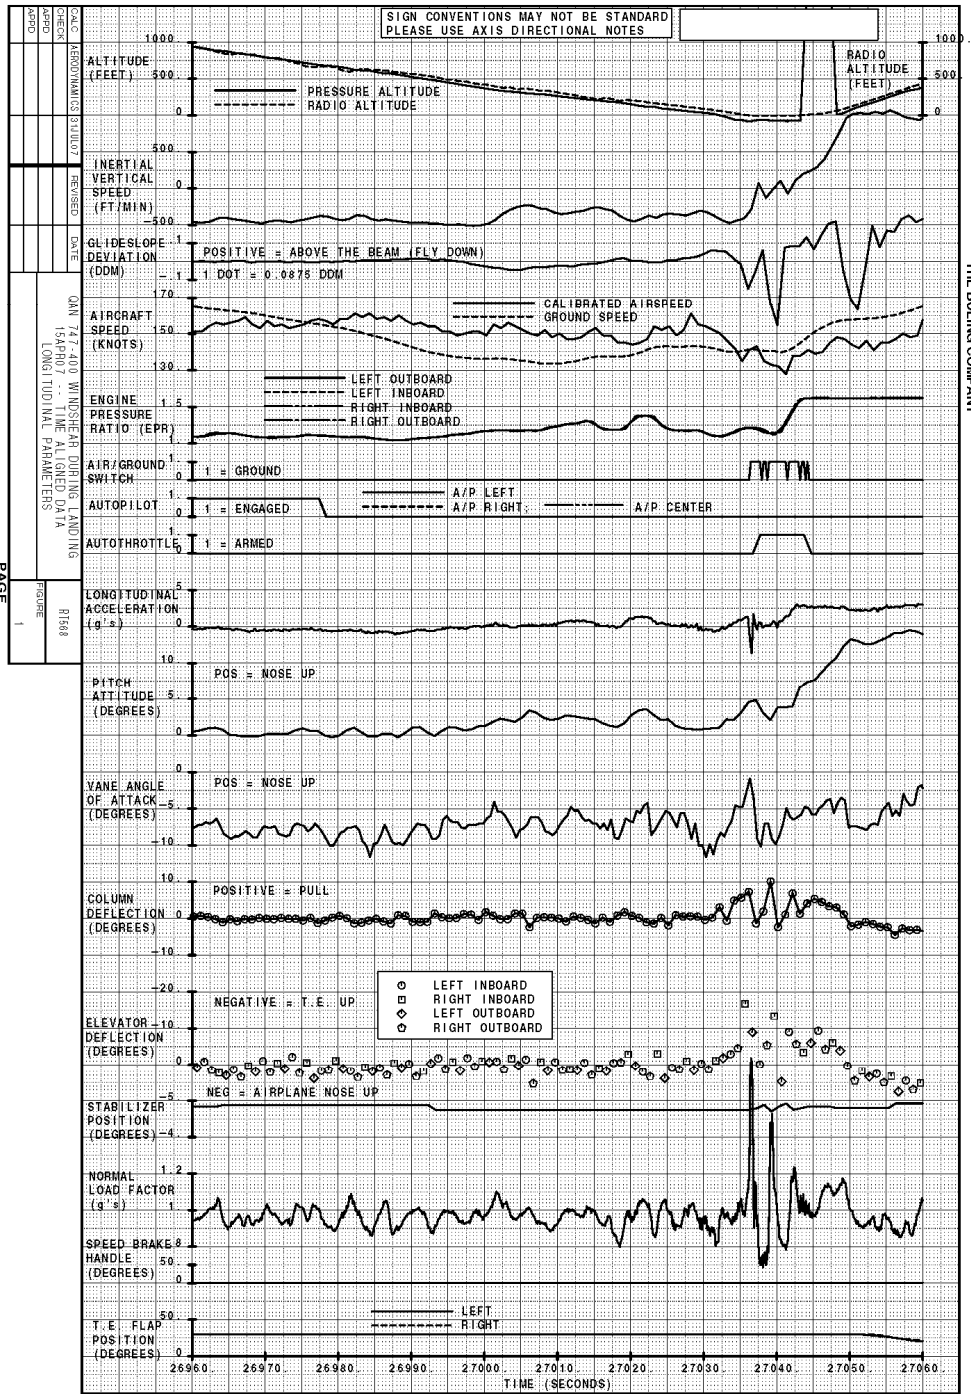
CHECKED: []
 DATE: []
 REVISIONS: []
 DATE: []
 LONGITUDINAL PARAMETERS
 QAN 747-400 W/ NOISEAR DURING LANDING
 15APR07 -- TIME ALIGNED DATA
 FIGURE 1
 R1808

QAN reported a windshear event on approach on a 747-400 (RT568) aircraft at the Sydney International Airport (SYD) on 15 April 2007. Analysis of the FDR data indicates that a headwind which shifted to a crosswind caused a loss in airspeed. This loss in airspeed (primary effect), combined with an 8 ft/sec downdraft and a large right wheel input (secondary effects), contributed to a high rate of sink just before touchdown. The flare and the commanded increase in thrust were unable to arrest the high sink rate and the aircraft touched down with a normal acceleration of 1.84 g's and a calculated sink rate of approximately 720 ft/min (12 ft/sec).

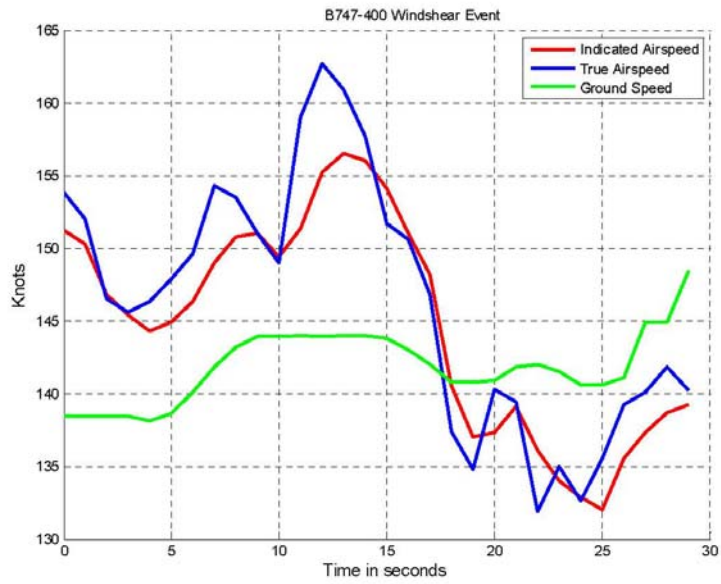
Figure 2 -

Figure #2 shows the recorded speeds. True Airspeed first increases from 150 knots to a maximum of 163 knots starting at time 10 seconds. Then True Airspeed rapidly decreases from the 163 knot maximum to a minimum of 135 knots (-28 knots) over the next 7 seconds. Ground speed is fairly steady during this time. This rapid decrease in True Airspeed (shear) started at a radio height of 111 feet. This is about 8 seconds before touchdown.
