## ***Report RL 2011:01e***

**Aircraft incident to SE-DSO  
over Sjöbo, Skåne County, Sweden  
on 13 October 2009**

Case L-16/09

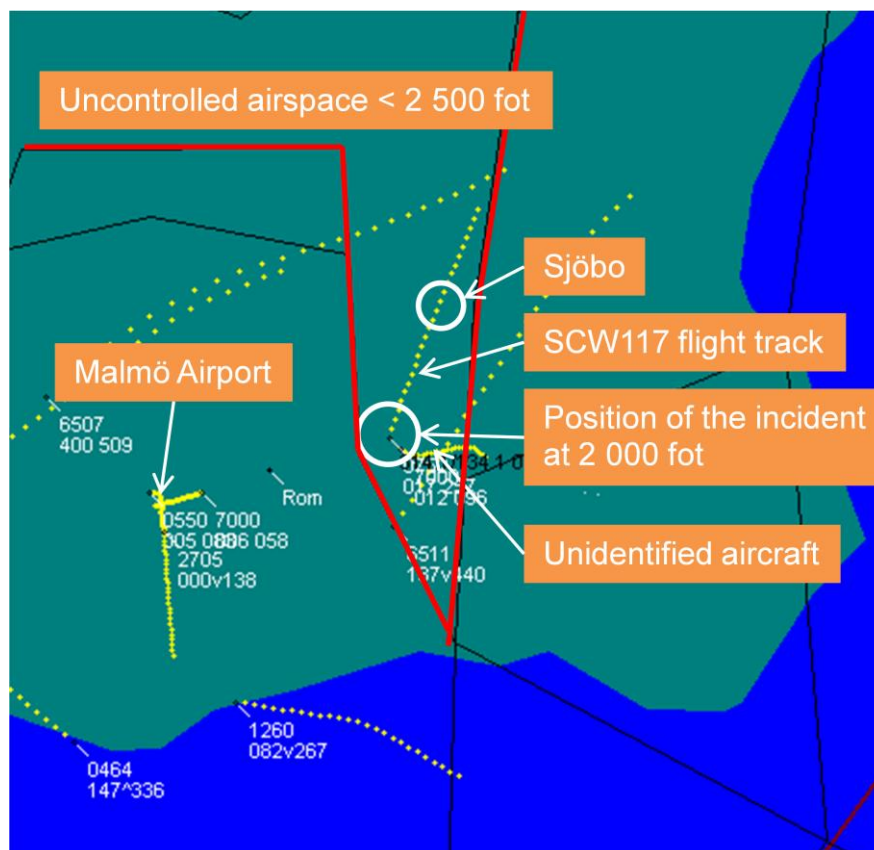
The incident occurred at approximately 610 m above sea level at position 55 35.9 N 13 40.6 E, approximately 4 km south-southwest of Sjöbo community in Skåne County, (Fig. 2). The red line in Fig. 2, marks the border between air-space with different altitude restrictions. In the area around Malmö Airport there are several small private airfields.

Fig. 2. Zoomed image of the LfV<sup>15</sup> ATC-radar image of the incident area. The text on amber background was added by SHK.

The radar images, Appendix 1, show that an aircraft passed below and near SCW117 at the incident. SCW117 was at 2 000 feet on a near southerly heading and the other aircraft at 1 200 feet on a near north-westerly heading. The minimum distance between the aircraft was about 1.5 km horizontally and approximately 245 m in height. SCW117 was in uncontrolled airspace during approximately one minute.

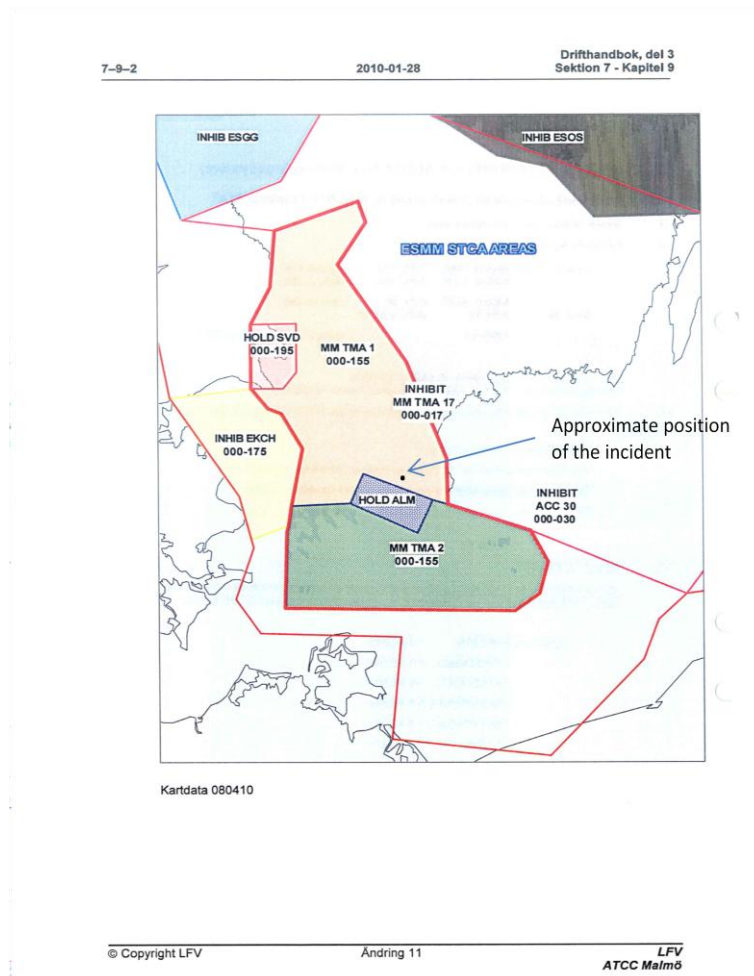
The air traffic management system, System 2000, incorporates an automatic conflict warning system, Short-Term Conflict Alert, STCA. The system is permanently inhibited in some areas and can be manually inhibited in some other areas, in the event of too many undesirable STCA alarm at low altitude. Manual inhibition may in such cases be performed by the supervisor at the air traffic control centre. In the area of the incident, STCA was permanently inhibited from ground level to 1 700 ft QNH, fig. 3. To trigger an STCA it is required that both aircraft are within the area for active STCA.

Fig.3. Chart over areas in Malmö TMA where STCA warnings are permanently inhibited.

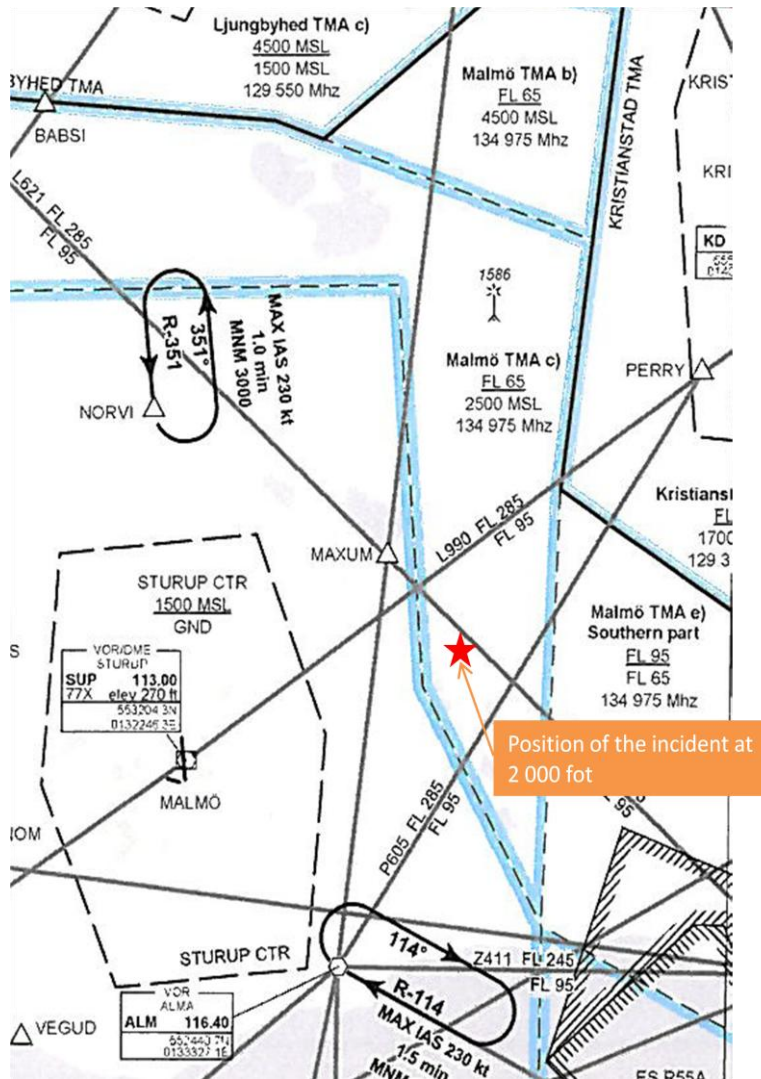
For Malmö terminal area LFV publishes an area chart that shows, among other things, airspace subdivision with altitude limits, restricted areas, airways, etc, see Appendix 3. Fig. 4 shows an excerpt from LFV area chart marking the site of the incident, which among other things, shows that Malmö TMA c) is established between 2 500 feet and flight level (FL) 65.

Fig. 4. Enlarged part of LFV AIP Sweden area map for Malmö TMA. The site of the incident has been marked by SHK.

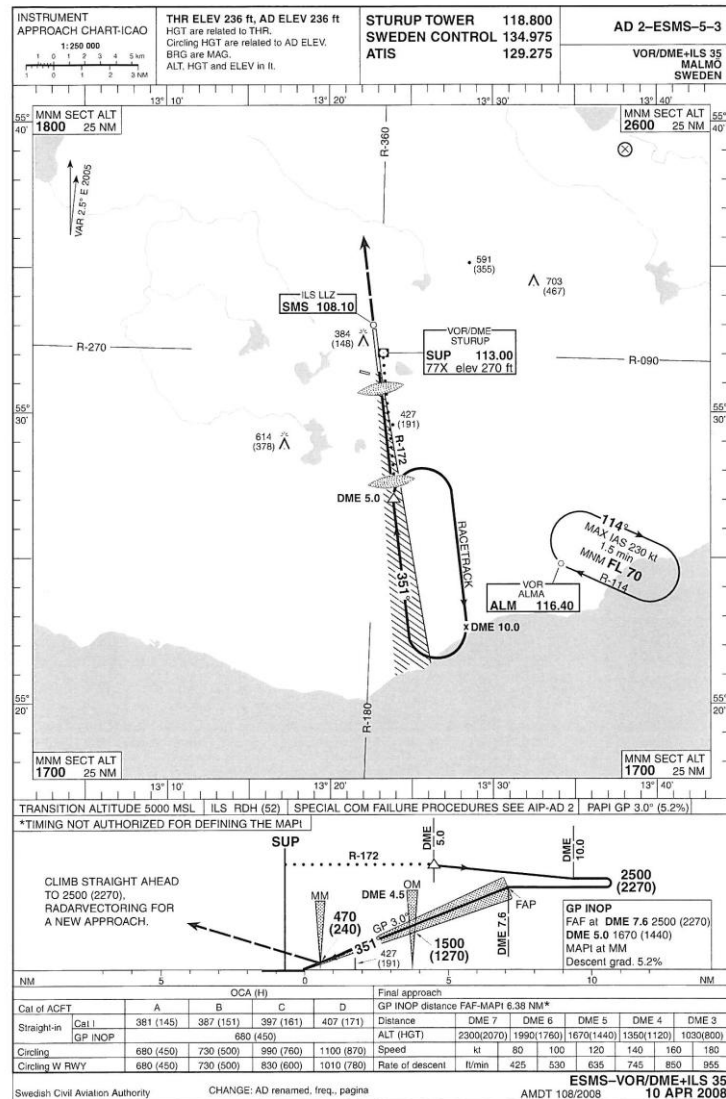
LFV AIP Sweden's map for ILS<sup>21</sup> approach to runway 35 at Malmö Airport is shown below in fig. 5. Neither airspace class nor its borders are shown in the map.

Fig. 5. Instrument approach chart to runway 35 at Malmö Airport. LFV AIP Sweden.

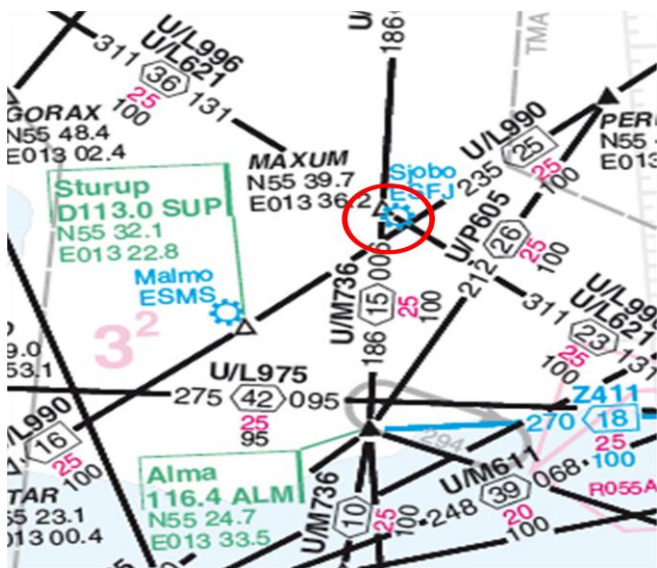
Fig. 6. Enlarged part of the enroute chart. The incident occurred at Sjöbo, ESFJ, marked with red circle. Black lines indicate routes for air traffic.

Both the surface and altitude limits for the controlled airspace are missing on the maps for IFR-flights.

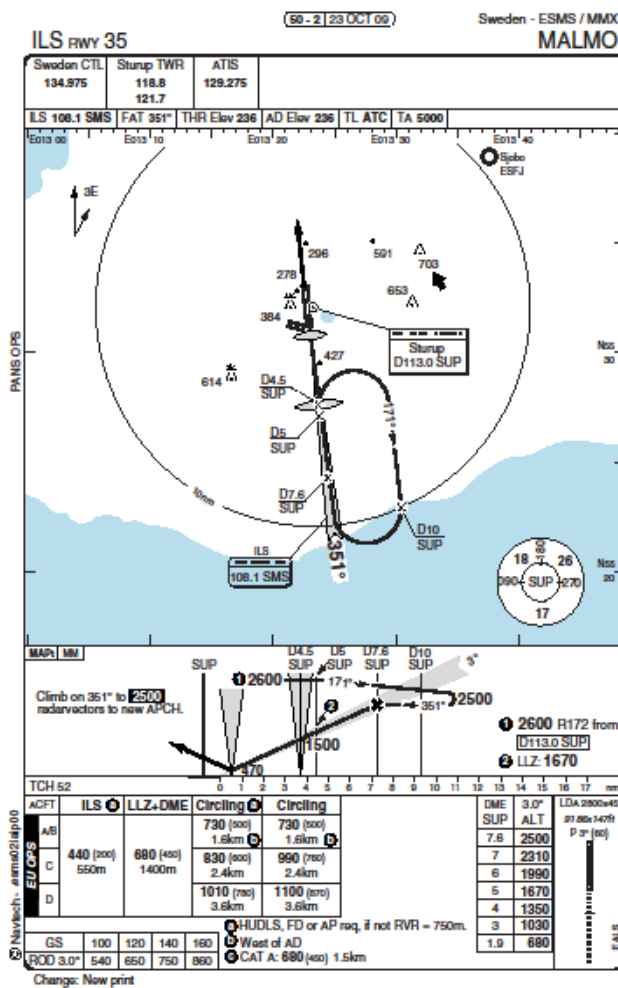
Fig. 7. Chart for ILS approach to runway 35 at Malmö Airport. Map by Navtech (Sweden) AB.

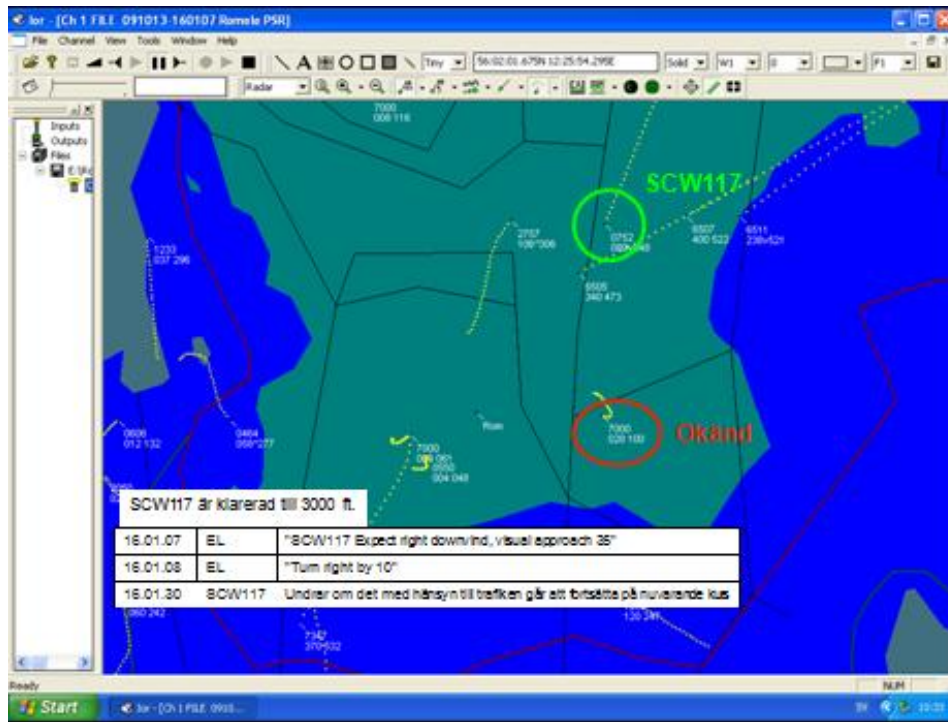
**Radar picture 1**

SCW117 is cleared to 3000 ft

16.01.30 SCW117 Wonder if, taking other traffic into account, it's possible to continue of the present course

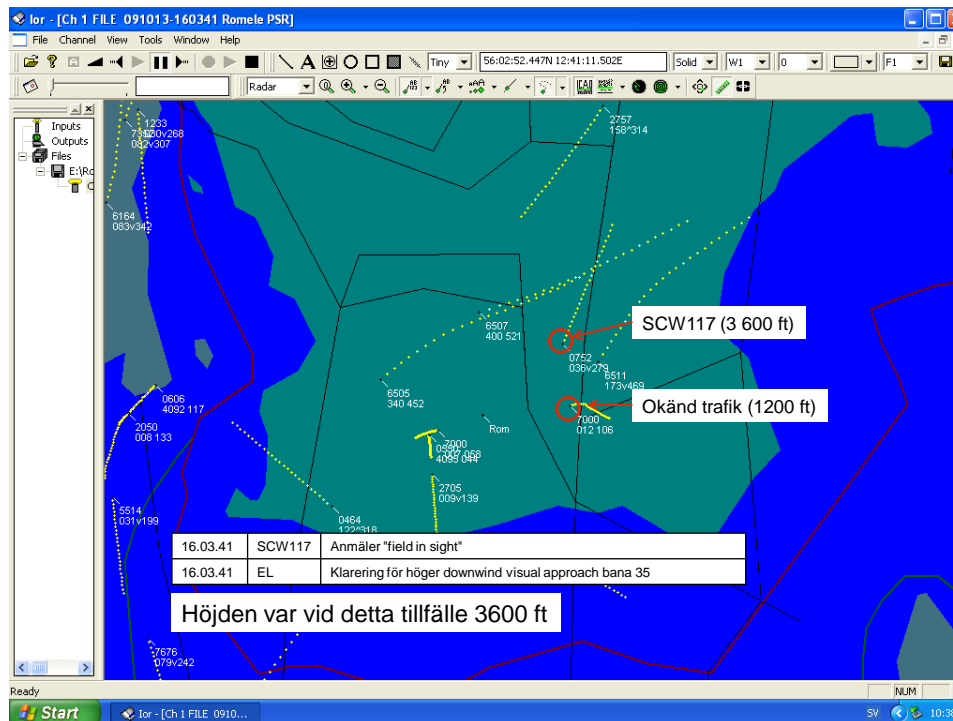
**Radar picture 2**

16.03.41 SCW117 Report "field in sight"

At this time the altitude was 3600 ft

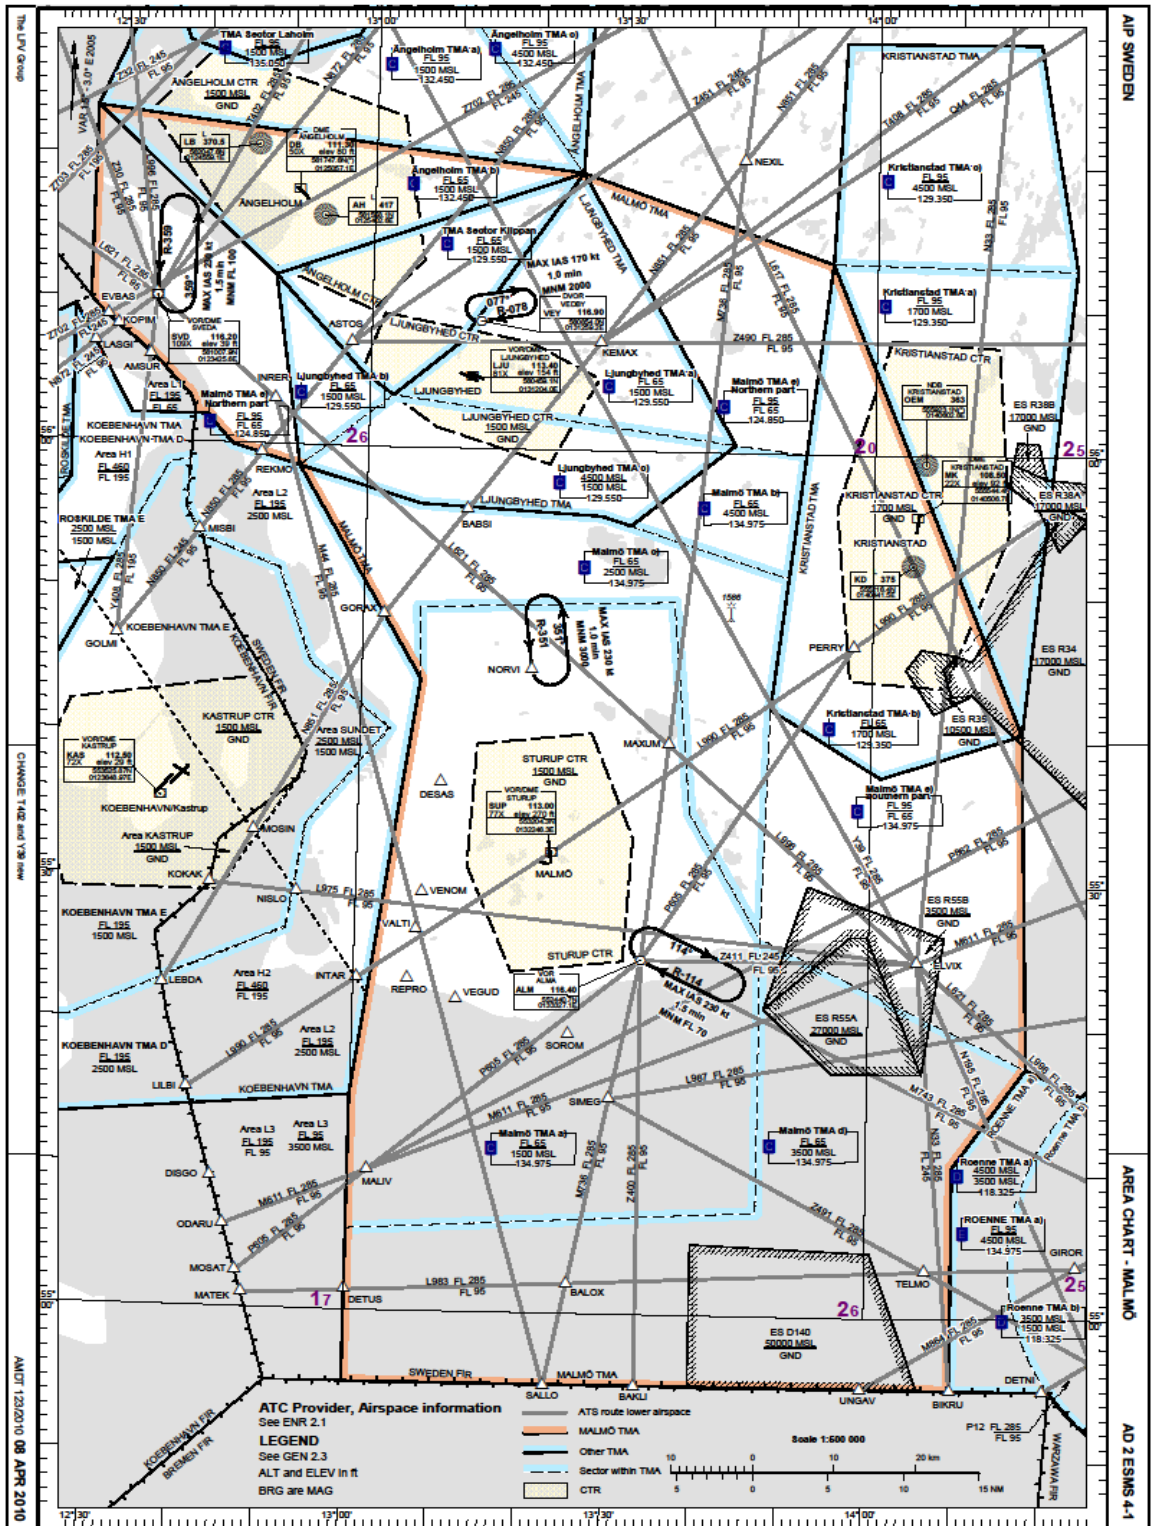
SCW117 was initially cleared to Alma VOR, which meant that the pilots' chart in this phase was the en route map, Appendix 4. Once clearance was obtained for the visual approach the instrument approach chart to runway 35 fig. 7, was the pilot's available navigation information.

En-route navigation chart Europe High/Low, Navtech (Sweden) AB. 20 % of natural size.
