**Ref. No. CZ-10-534**

**FINAL REPORT**  
**Investigation into the air accident of aircraft type Z-126,**  
**registration mark OK-JGL, at LKMO aerodrome**  
**on 20<sup>th</sup> October 2010**

Prague  
March 2011

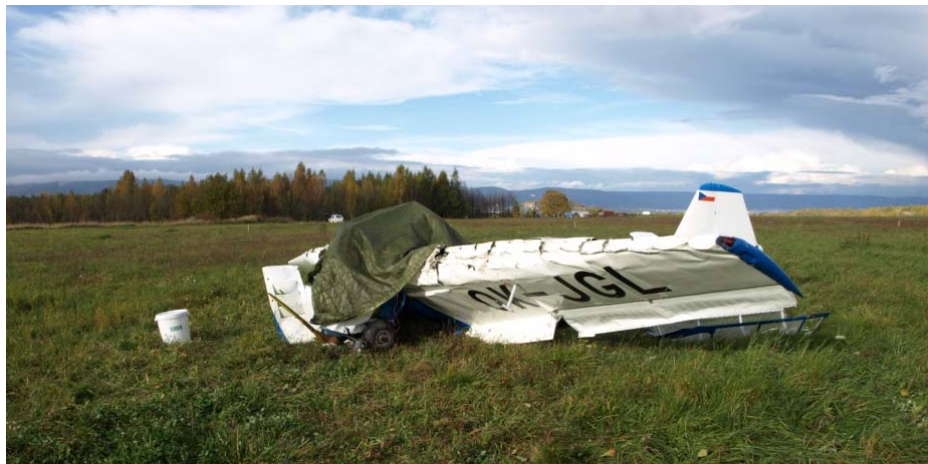
The aircraft was destroyed by forces due to impact onto the ground.

Position A/C after crash

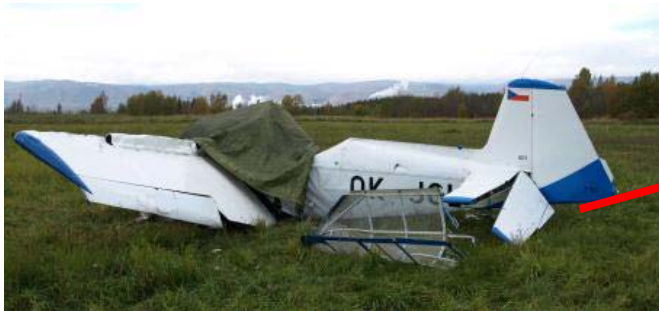
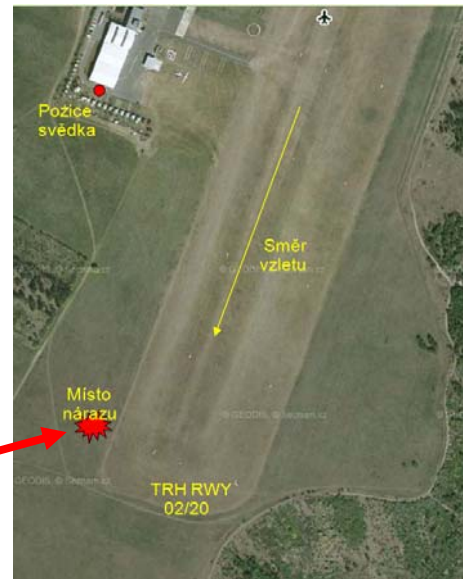
The site of the accident was on grass at the end of RWY 20R, 98 m to the right of the RWY 02L left threshold mark. The aircraft longitudinal axis / nose directed towards a heading of ca 230 deg. In its forward prolongation at a distance of 8.5 – 11.5 m was a print of the aircraft nose.

In the print there was a broken blade of the propeller. To the left there was an adjacent print of the left wing in which were pieces of white and blue paint. In the vicinity between right wing and tail were fragments of aircraft structure and parts of instrumentation. Behind the left wing lay the canopy in the upside down position.

The accident site

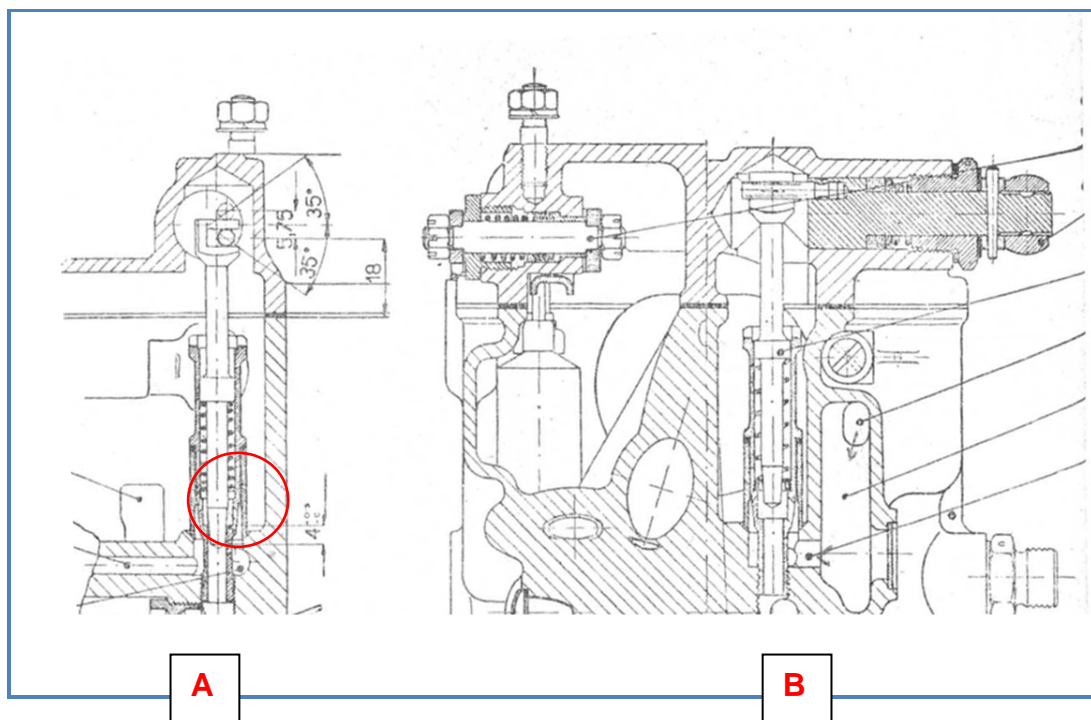
Judging on a print found on the correction needle it was found out that at a distant of 4.0 mm from the needle end, the needle was impressed on by the correction case. In addition, several prints were discovered on the needle surface coming from the spring coils with pitch 1.32 to 1.40 mm. This dimension corresponds to the spring compression and to the needle position “lean mixture”. The needle prints discovered occupy one row to witness that the resultant of inertial forces due the plane impact on the ground directed almost perpendicularly to the needle axis, which was set to position “lean mixture” during the impact.

Position of correction needle: A/ - full correction – “lean mixture”  
B/ - without correction – “rich mixture”

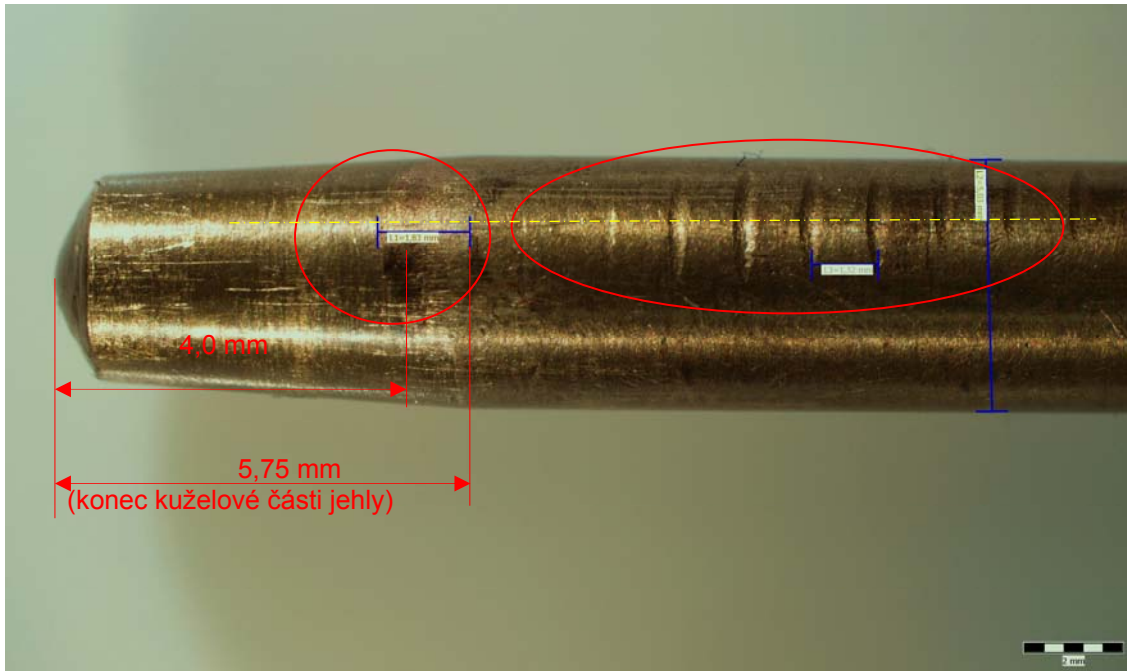
**On the correction needle it was found out that at a distant of 4.0 mm from the needle end, the needle was impressed on by the correction case**

The position of the altitude correction needle in the carburettor corresponded to “full correction” as well. It was found out experimentally that the position of altitude correction needle had no effect on engine run at transition to higher output. However, the correction lever could have a negative effect on engine maximum power, reducing aircraft performance in the climbing phase.

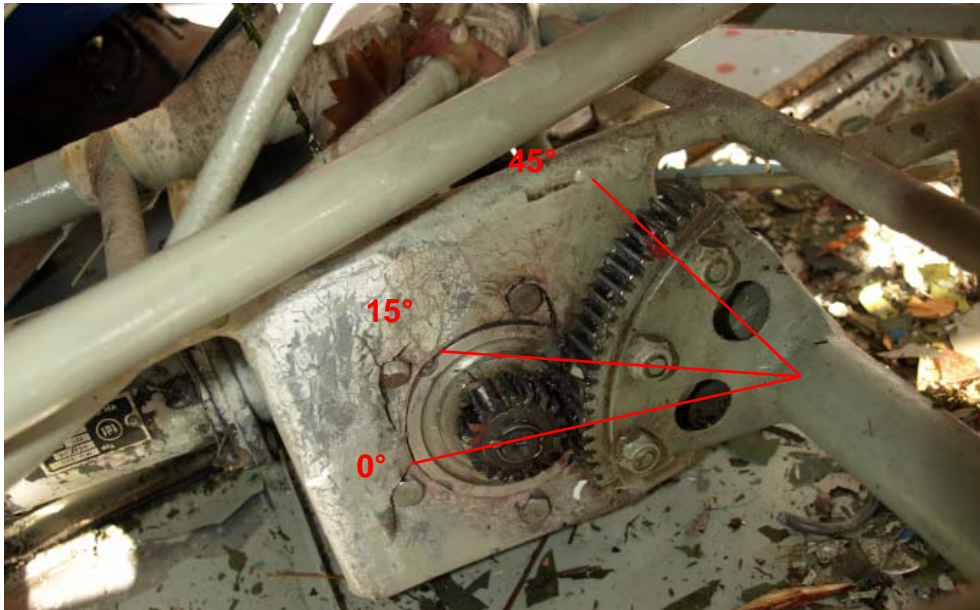
It follows from the position of the lift flaps mechanism and from the position of the driving gear (pinion) relative to the tooth segment that the lift flaps were retracted. The electric circuit of the flap mechanism is actuated by pressure on the electric switch dog. The flaps position is then shown in degrees on the dashboard. From the point of view of handling it means that the left hand keeps holding that switch all the time the flaps are being adjusted. Regarding the way the flaps influence aerodynamic characteristics at takeoff, the speed reserve, needed to carry out this manoeuvre safely, diminished. The time to move flaps from position “15°” to position “0°” is ca 8 – 10 sec. Most likely, the flaps were not extended or were already retracted too soon during taking off.

**Tooth segment – flaps adjusting**
