**AVIATION INVESTIGATION REPORT**  
**A08O0233**

**UNCONTROLLED DESCENT INTO TERRAIN**

**CESSNA 172P C-GHSQ**  
**SHELBURNE, ONTARIO, 7 nm W**  
**01 SEPTEMBER 2008**

Report Number A08O0233

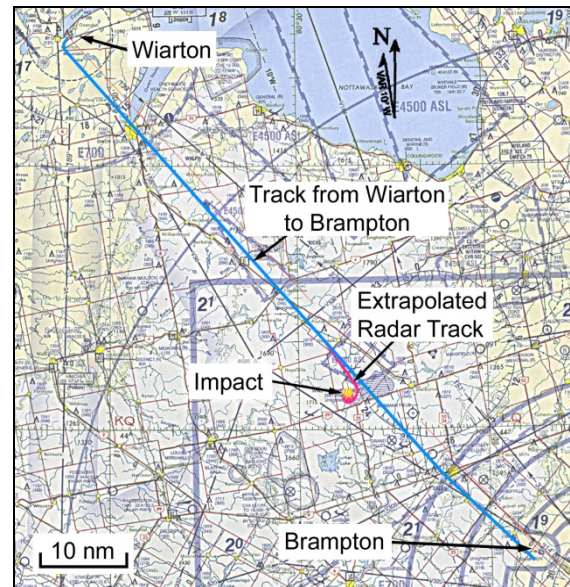
Figure 1. C-GHSQ track and crash site

C-GHSQ departed CNC3 at 2311 and proceeded to CYKZ, landing at 2341. The pilot and his passengers entered the Seneca College flight simulator facility at 2357 and used the flight simulators for about an hour. At 0127, C-GHSQ took off and flew to the Barrie-Orillia (Lake Simcoe Regional) Airport (CNB9), Ontario, where it landed and spent about 30 minutes on the ground. It then flew to Wiarton Airport (CYVV), Ontario, landed, and spent a short time on the ground. C-GHSQ departed CYVV at approximately 0350. The crash site was just past the half-way point along the track from CYVV to CNC3 (see Figure 1).

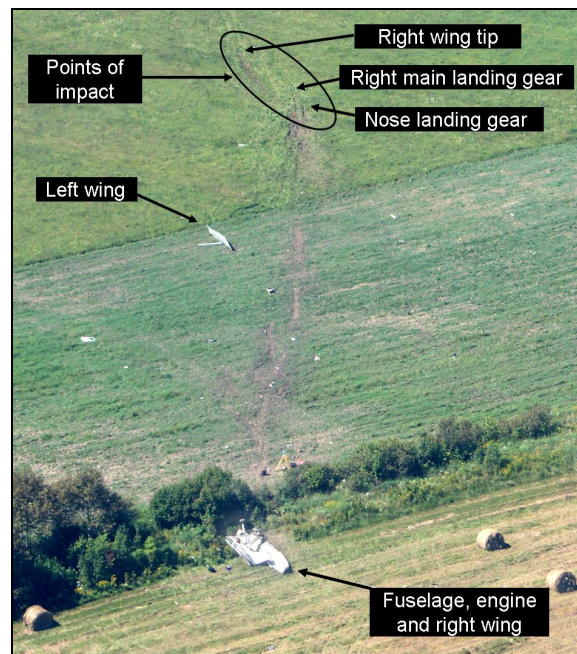
Photo 1. C-GHSQ crash site

The aeroplane struck the ground on an easterly heading, approximately 45° right bank, pitch angle 7° to 8° nose down, airspeed 140 knots. Ground scars indicate that the aircraft's right wing touched the ground first followed by the right main wheel and then the nose wheel. The aeroplane cartwheeled and began to break up. The left wing separated from the fuselage approximately 200 feet from the first point of contact. The main wreckage, consisting of the fuselage and right wing, was found about 430 feet from the initial point of contact. Various items from the cockpit, wing components, doors, and landing gear were found along the impact path. The aeroplane was destroyed (see Photo 1).

The wreckage indicated that flaps were up, and the engine was producing power at time of impact. Control continuity was established except for aileron controls, which were severed as a result of the left wing impact damage. A fuel odour existed at the crash site indicating fuel availability, but the amount of fuel remaining at the time of impact could not be determined due to post-impact leakage. The automatic direction finder was found tuned to 326 kHz. Other radio frequencies could not be determined. A TSB Laboratory examination of the dial faces and the mechanisms of cockpit instruments did not reveal any information as to their indications at the time of impact.

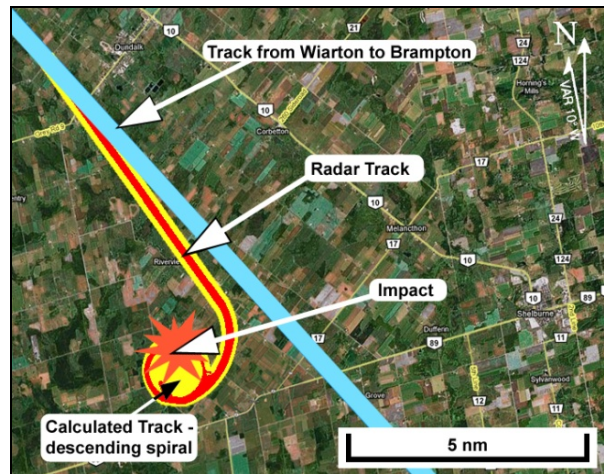
Figure 2. CGHSQ crash site

The flight path data from the radar recording showed that the aeroplane was in essentially straight and level flight between CYVV and CNC3 until 0424:30 when there was a distinct change in the flight path (see Figure 2). The remaining radar data showed a turn to the right and the beginning of a descent. The flight path from that point to impact was then reconstructed assuming no change to the aircraft trim condition (that is, no change of engine power and no change to control forces) and fine-tuning for wind and initial flight path angle. The resulting flight path is shown in Figure 3.

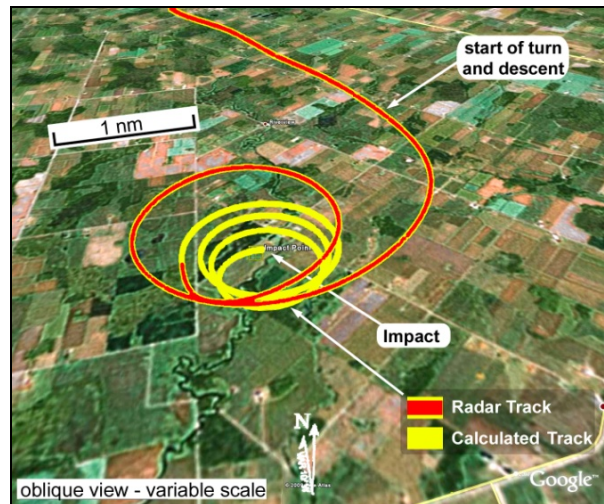
Figure 3. CGHSQ final flight path

The flight path change that was detected by analysis is consistent with the pilot ceasing to maintain the lateral-directional control input required to maintain the heading of the aeroplane. As the aeroplane deviated from its initial azimuth and bank condition, its natural stability would result in a rate of descent that increased as the bank increased, characteristic of spiral mode stability without pilot intervention. The flight path analysis determined that, without any pilot control input, the aeroplane would continue to fly a descending spiral flight path from last recorded position on radar to the point where it struck the ground. Furthermore, the analysis predicted accurately the location, heading, and attitude of the aeroplane at impact.
