Preliminary Observations on the Niigata-Chuetsu Oki, Japan, Earthquake of July 16, 2007

EERI-GEER Web Report 2007-1 v.8
October 9, 2007

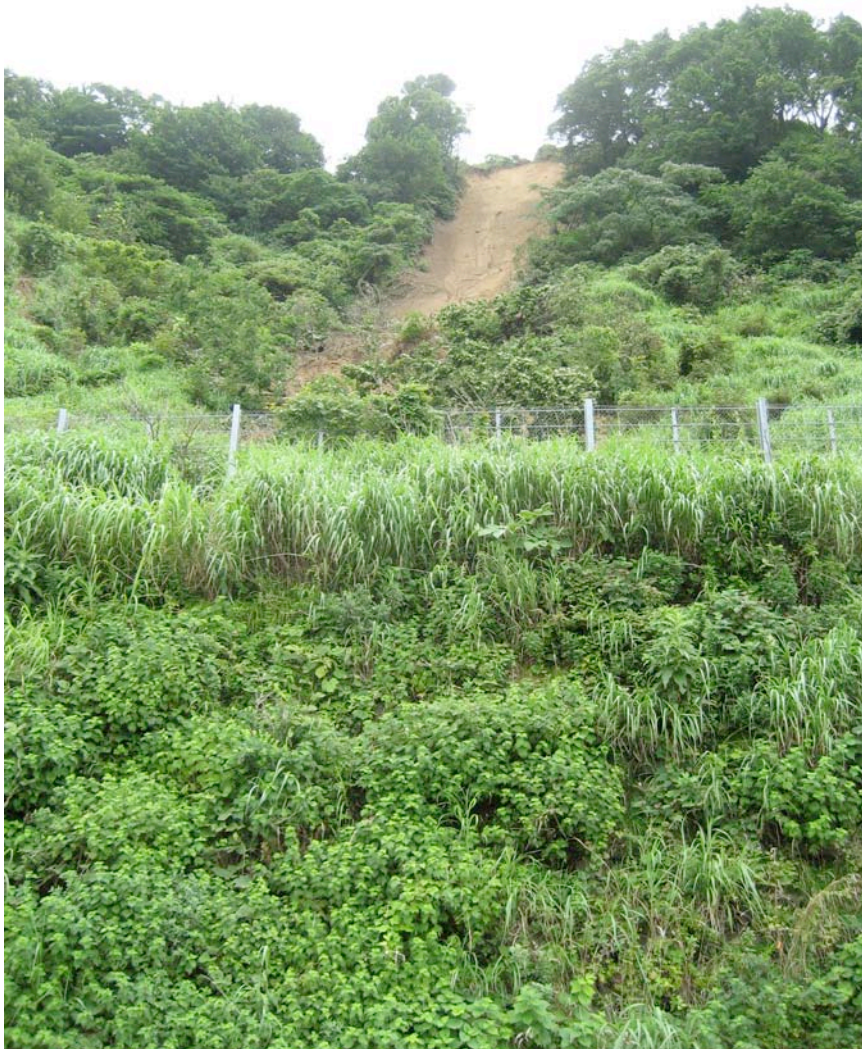
Figure 3.3: Coastal landslides on Highway 352 north of Kashiwazaki-Kariwa Nuclear Power Plant at road closure south of Route 373 (Site RK34-Slide 4; N37.48455° E138.62435°, photos taken 7/22/07 at approx. 10:45). This landslide is typical of many of those observed along the coast, and in this case did not damage transportation lines. Slide is approximately 10 m wide, 25 m long, and 0.5 m thick. Failure plane has approximate 50° inclination.

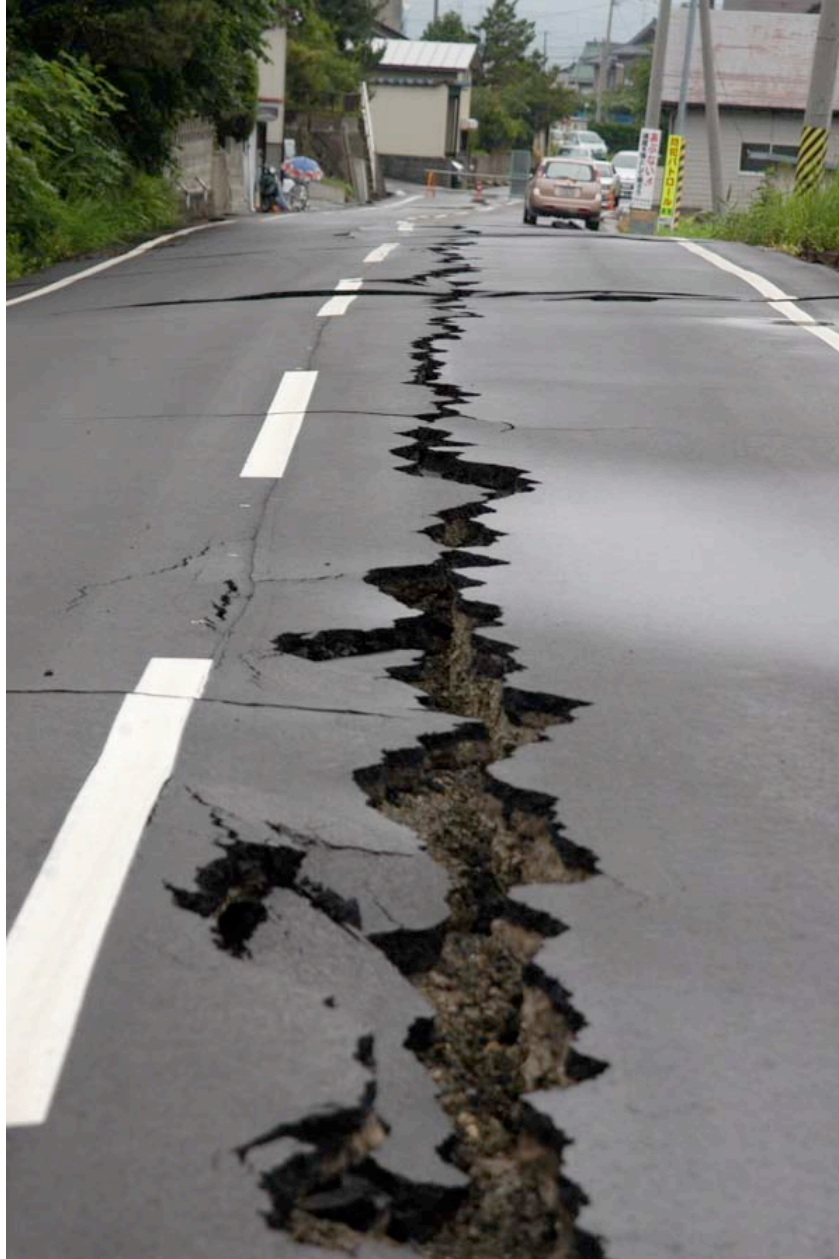
Figure 4.13: North side of Kai-Un Bridge area Sabaishi River - Lateral Spread on Road to Kashiwazaki Incinerator (Site RK6, N37.39343° E138.58555°, 7/19/2007). Lateral spreading on the north side of the river adjacent to the Kashiwazaki Municipal Incinerator damaged the access road of the facility.

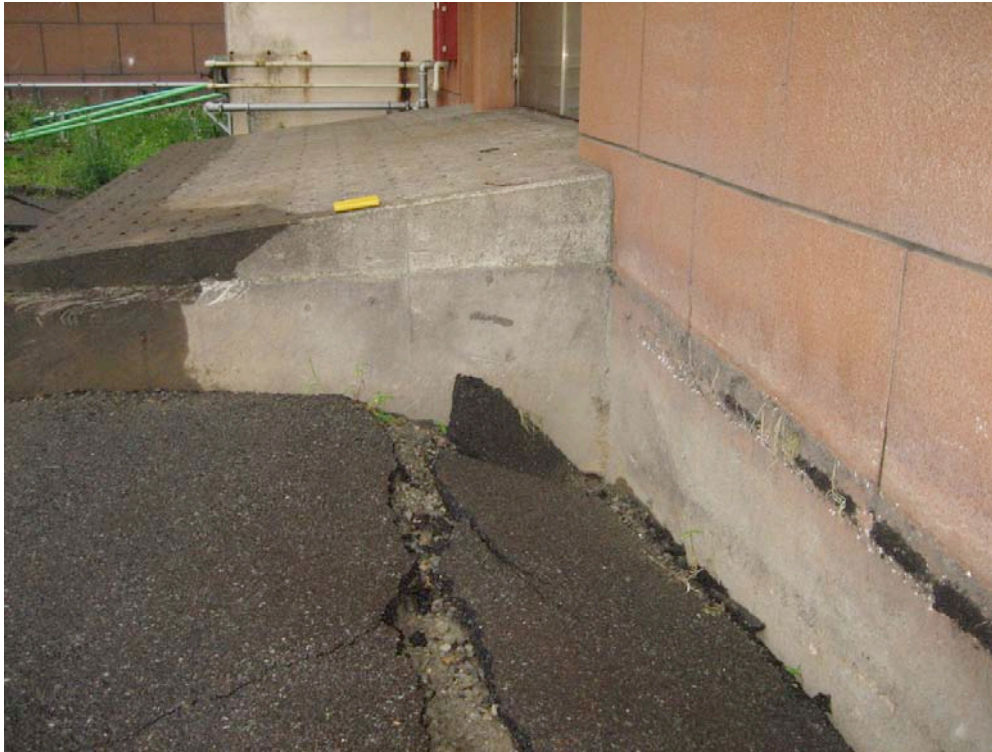
Figure 4.15: Kashiwazaki Wastewater Treatment Plant on the south side of Sabaishi River near the Sea of Japan (Site RK9 N37.38748° E138.56587°, 7/19/2007). Damage to the main building from liquefaction of ground resulted in meter-scale ground settlements.

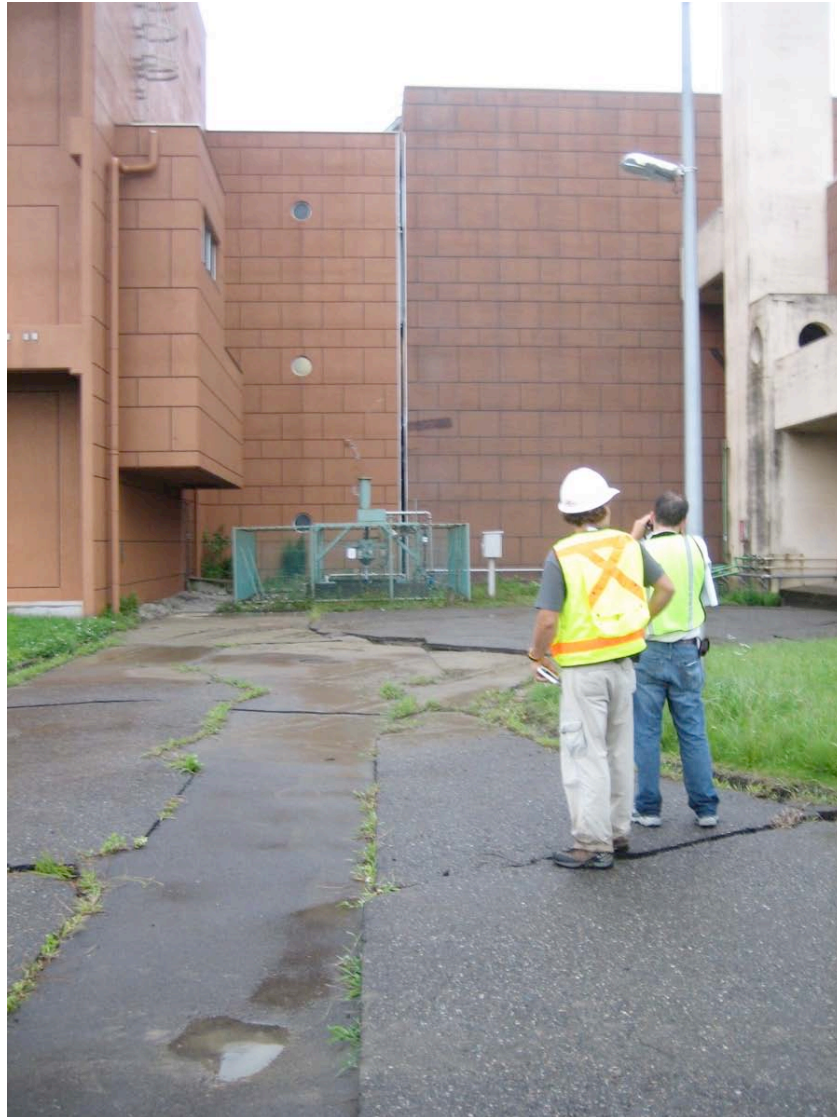
Figure 4.16a: Kashiwazaki Wastewater Treatment Plan on the south side of Sabaishi River near its outlet to the Sea of Japan (Site RK9 N37.38748° E138.56587°, 7/19/2007). Damage to the main building from liquefaction of ground resulted in the complete separation of two sections of the adjacent, yet integrated, three-story buildings with associated building and ground settlements.

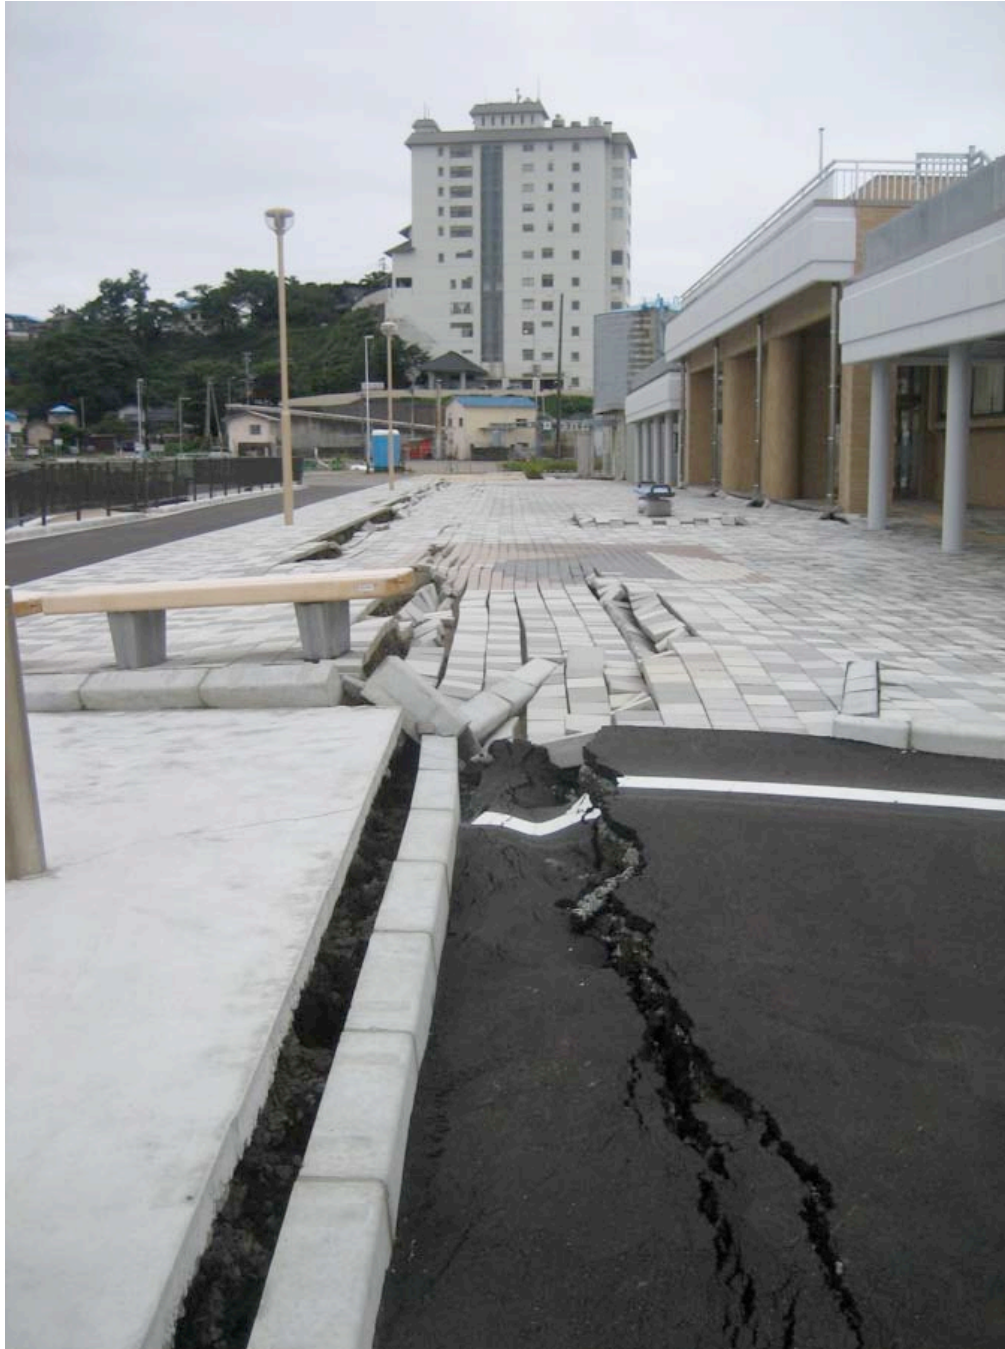
Figure 4.21: Kashiwazaki Harbor - The southern area experienced ground damage from liquefaction-induced lateral spreading and settlement. A harbor-front caisson rotated toward the harbor, to the left of the photo, initiating lateral displacement of the soil behind it, between the caisson and port building (Site RK25, N37.36713° E138.53210°, 7/20/2007).

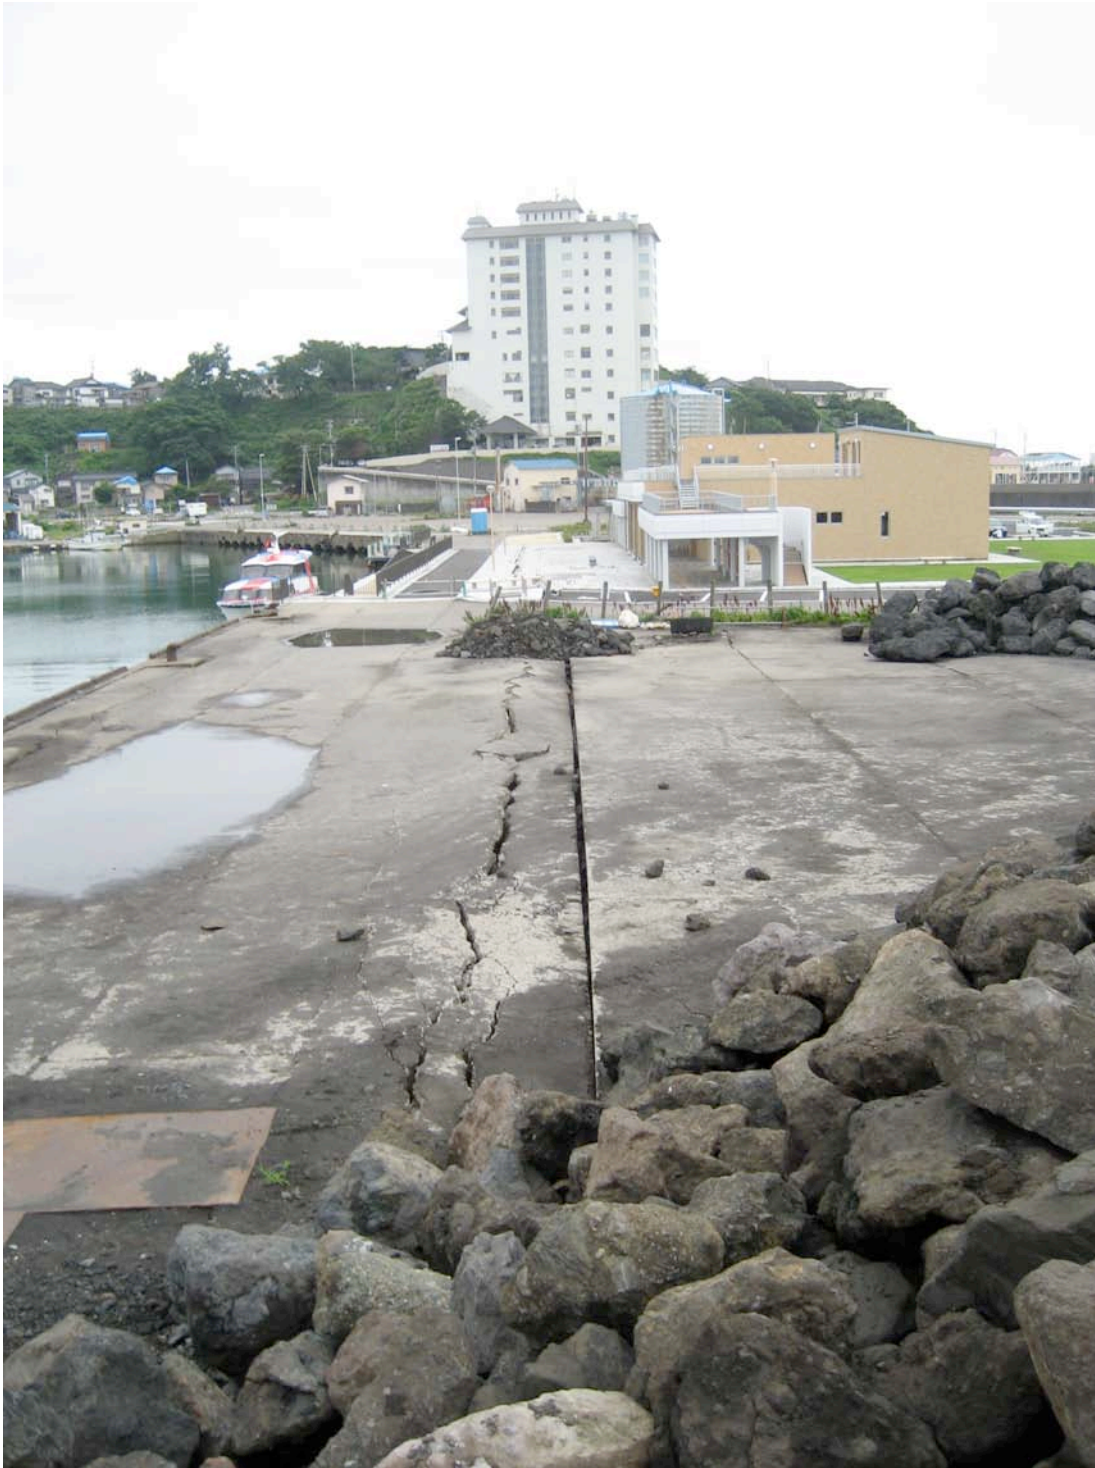
Figure 4.24: Kashiwazaki Harbor - South area experienced ground damage from liquefaction-induced lateral spreading and settlement, here seen from a mound of riprap (Site RK25, N37.36713° E138.53210°, 7/20/2007).

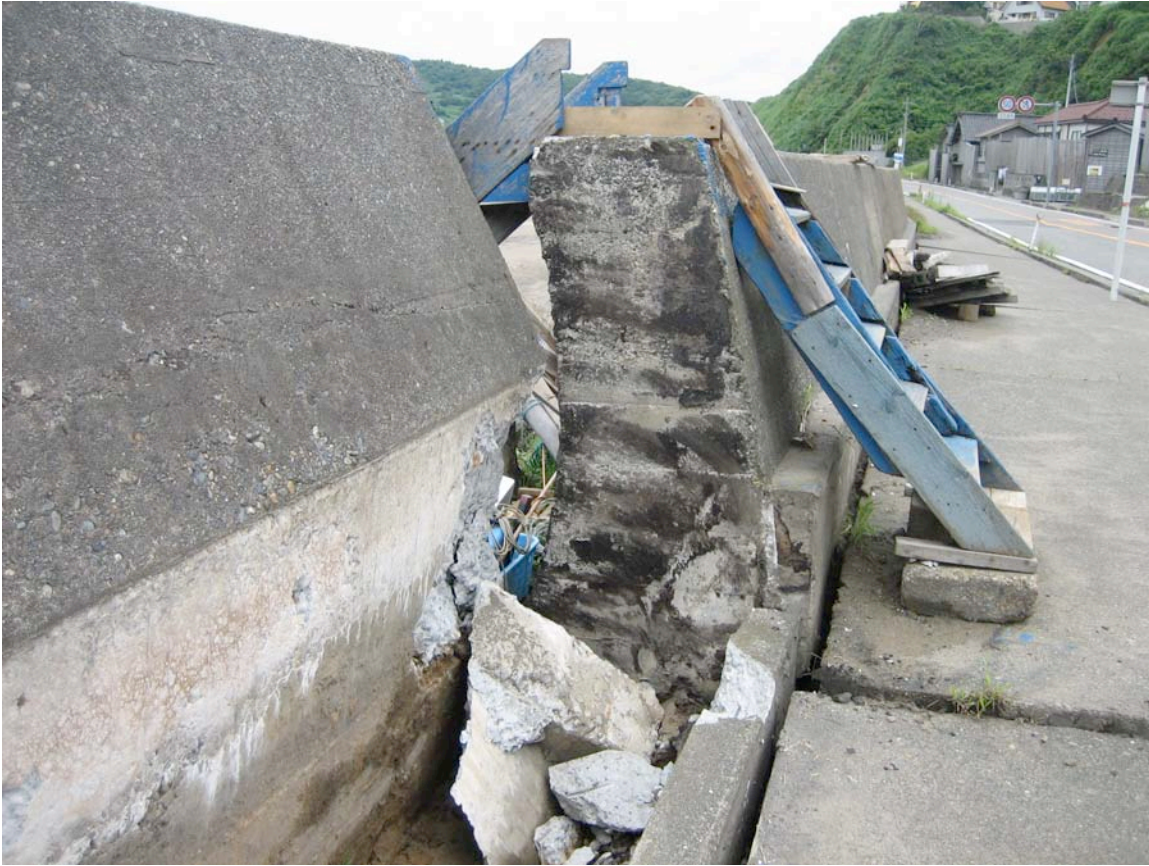
Figure 4.30: Concrete seawall deformations were on the order of 25 cm vertical (failed section up), and up to 64 cm horizontal, with a component of rotation as measured by 32 cm lateral deformation at the base of wall and 64 cm lateral deformation at 2 m height of wall. (Site RK35, N37.48497° E138.62645°, 7/22/2007).

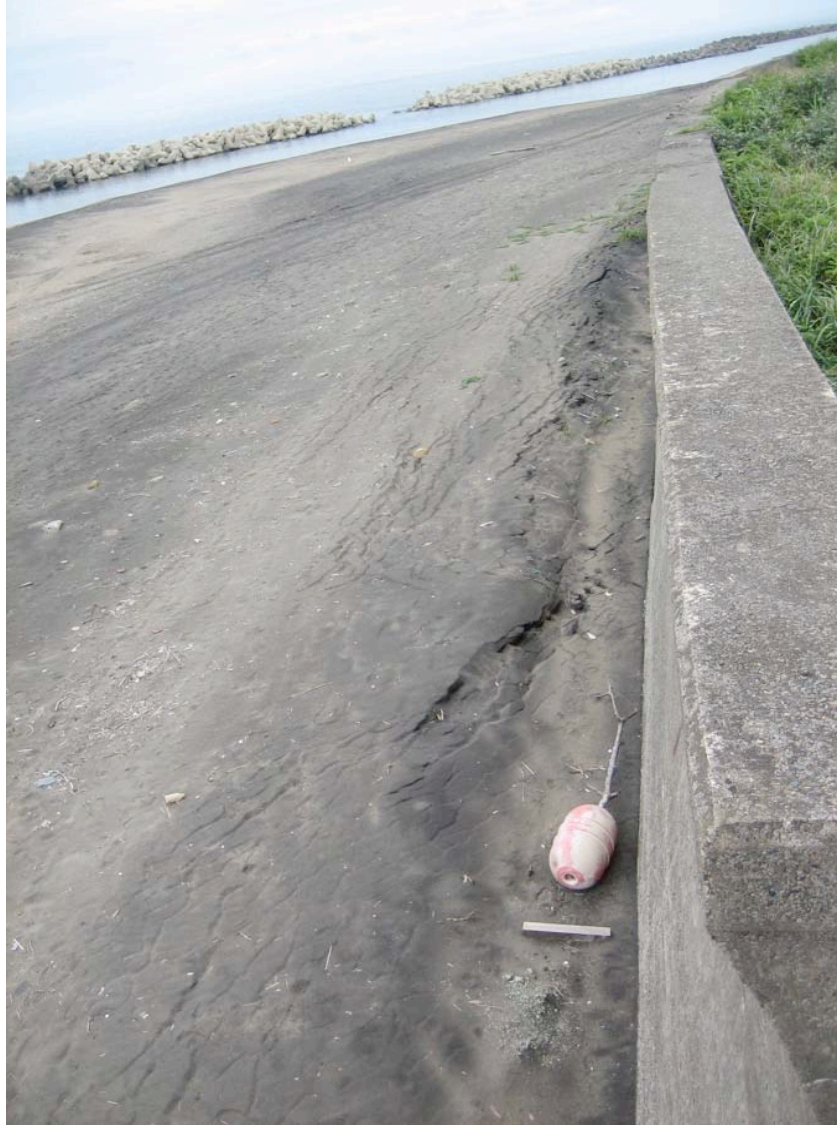
Figure 4.32: Lateral spreading related ground cracking in front of seawall. (Site RK37, N37.45478° E138.60927°, 7/22/2007).

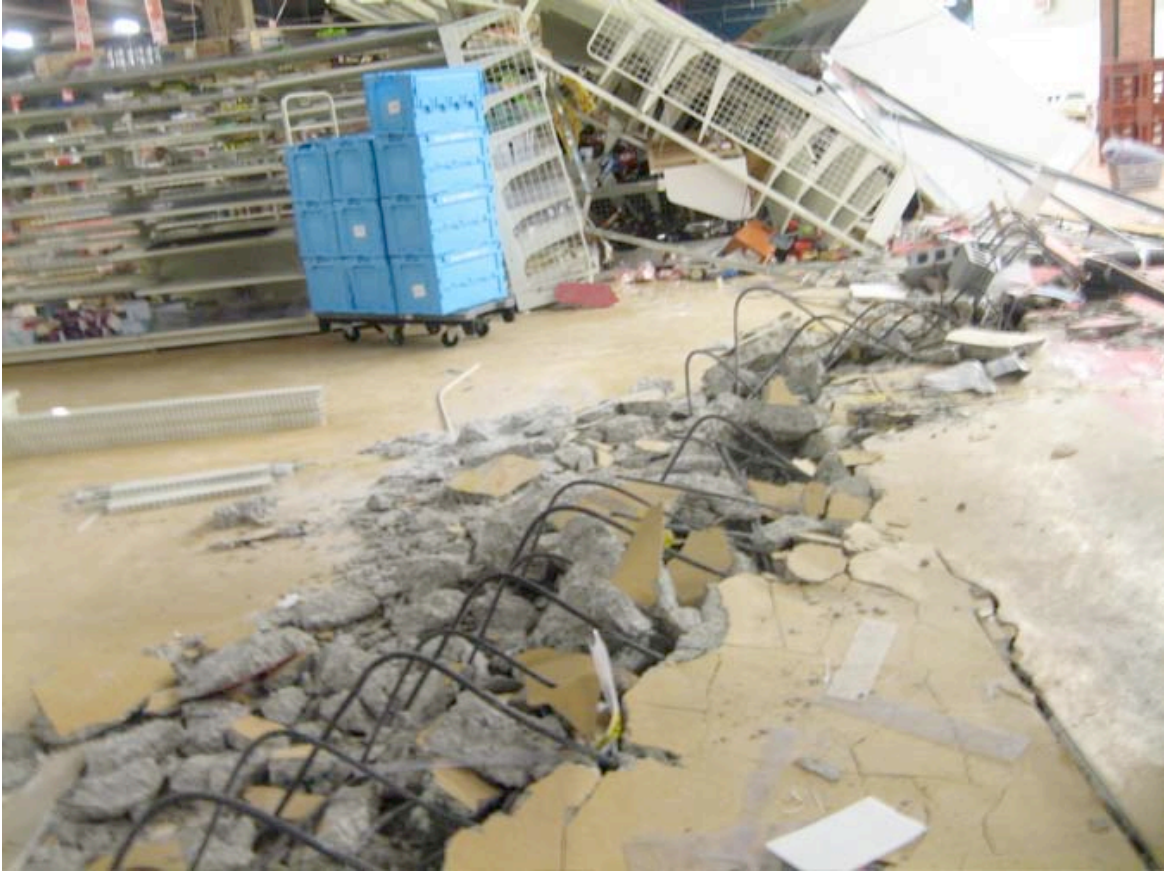
Figure 4.39: Plant 5 – Failure of slab on grade with buckled reinforcing bars. (Site RK41, N37.41468° E138.60840°, 7/22/2007).

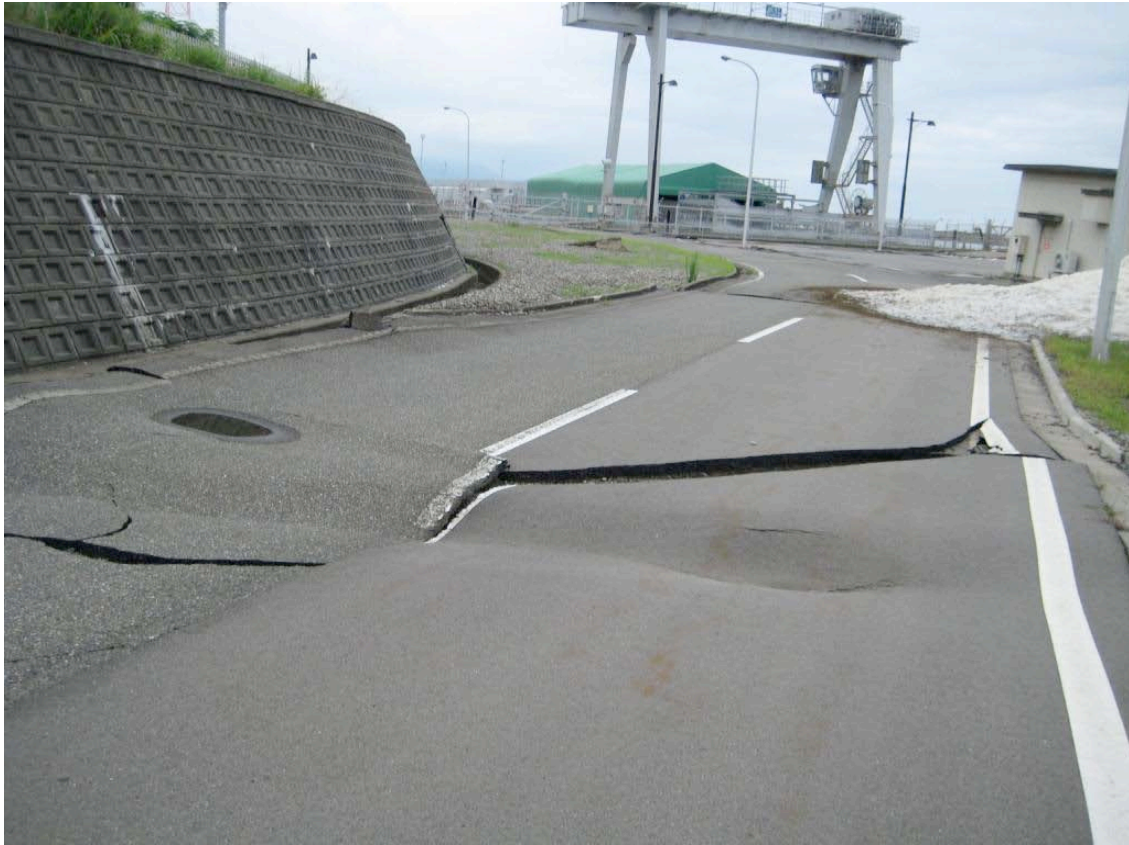
Figure 5.3: Damaged road at power plant.

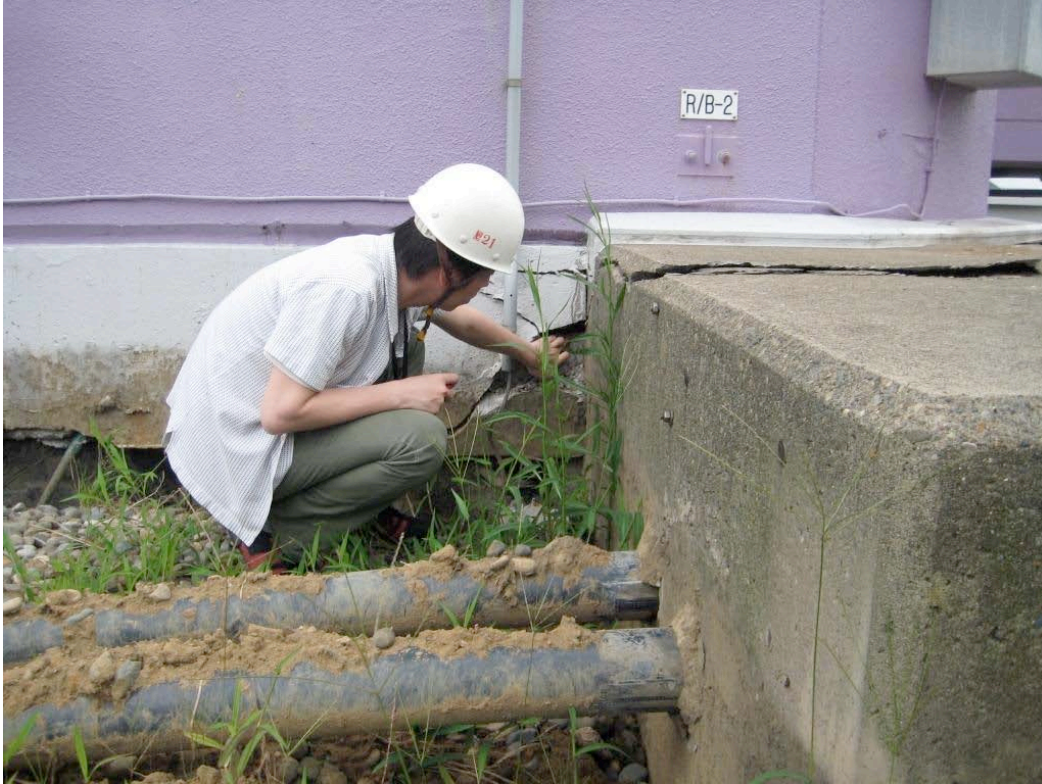
Figure 5.4: Cracks in reinforced concrete element at ground level.

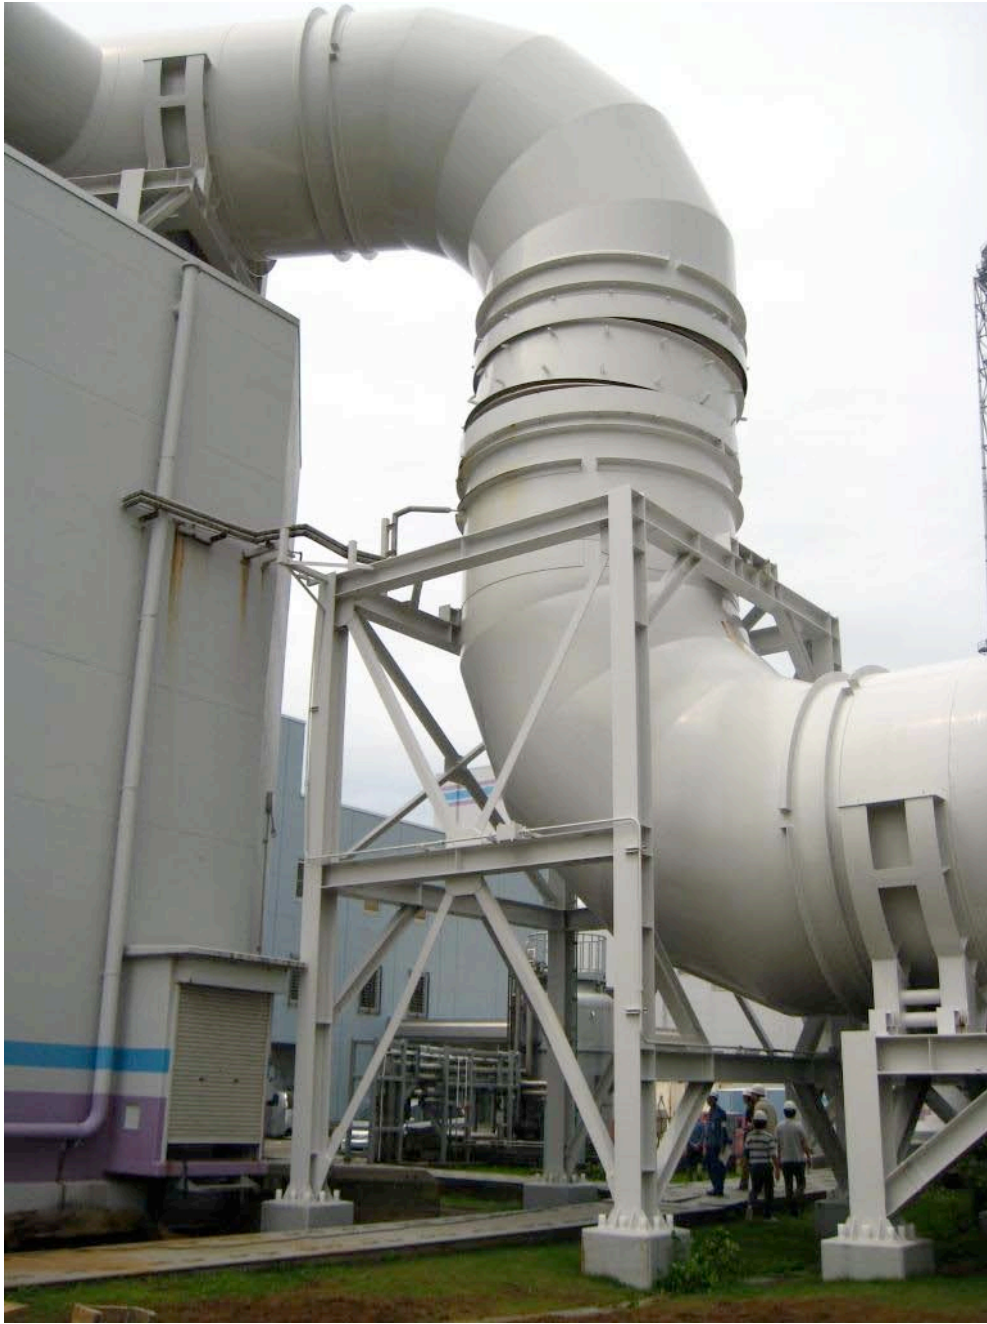
Figure 5.5: Failure of joint in exhaust pipe.

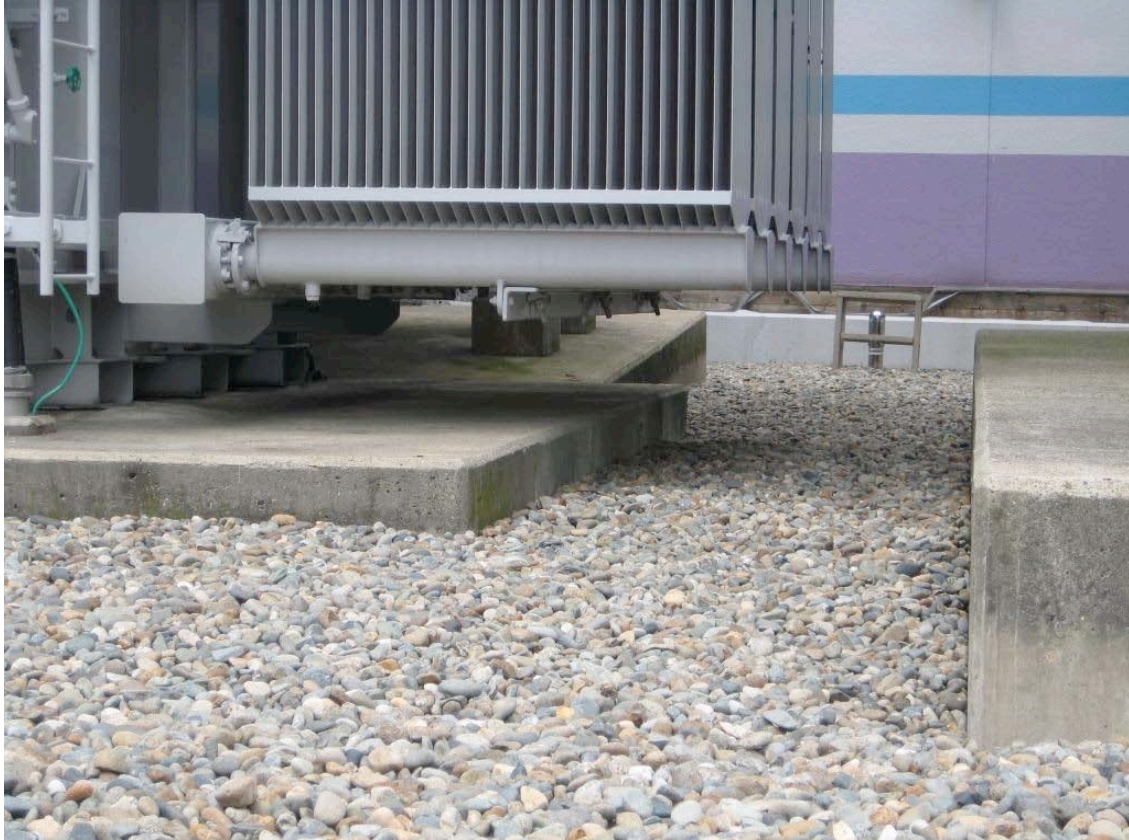
Figure 5.6: Rotation of isolated footings for equipment at nuclear power plant.

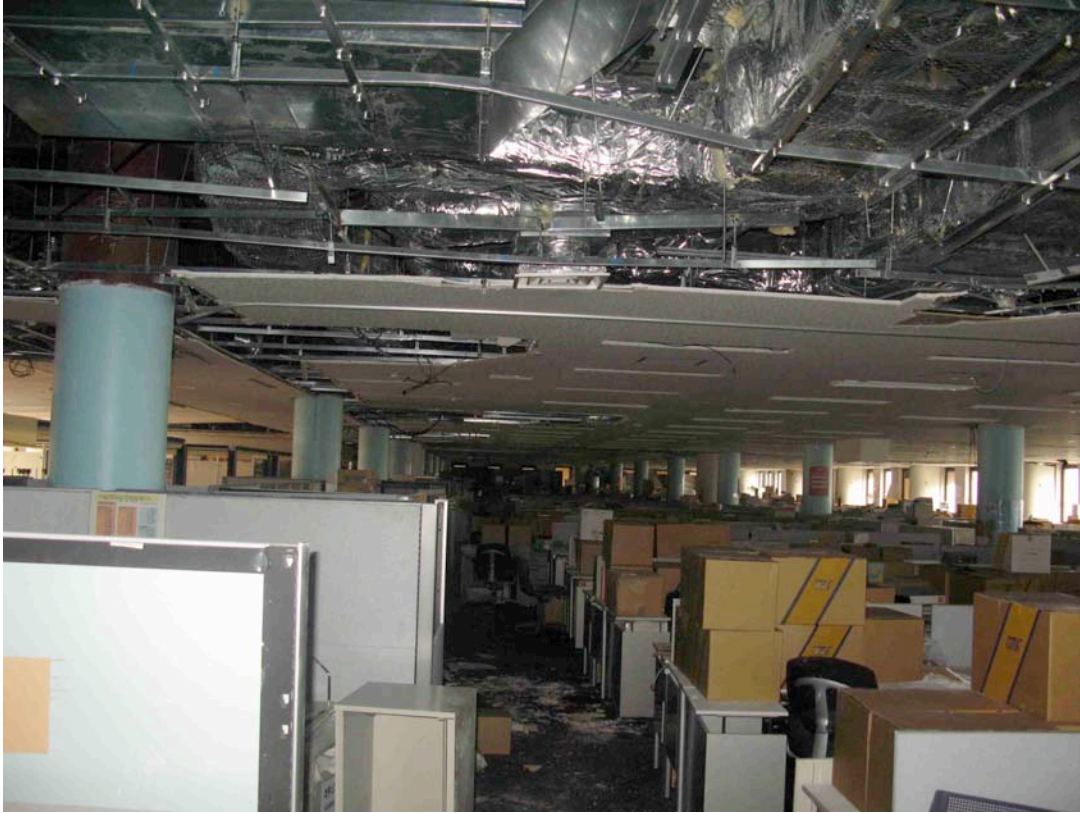
Figure 5.7: Ceiling damage in administration building of nuclear power plant.

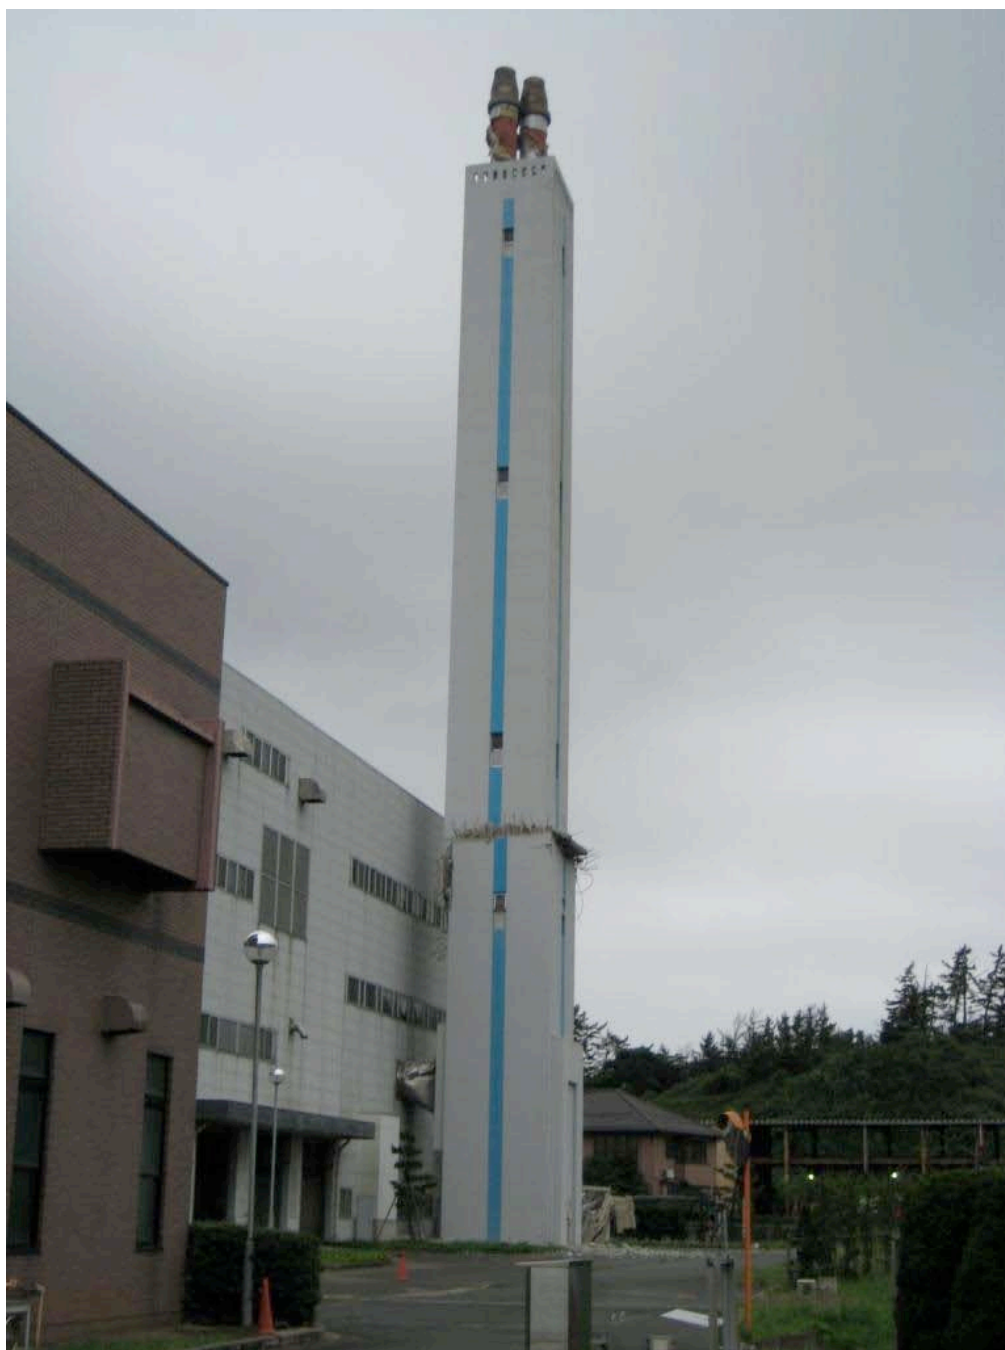
Figure 5.8: Failure of reinforced concrete stack (Site SP31, N37.3939° E138.5840°).

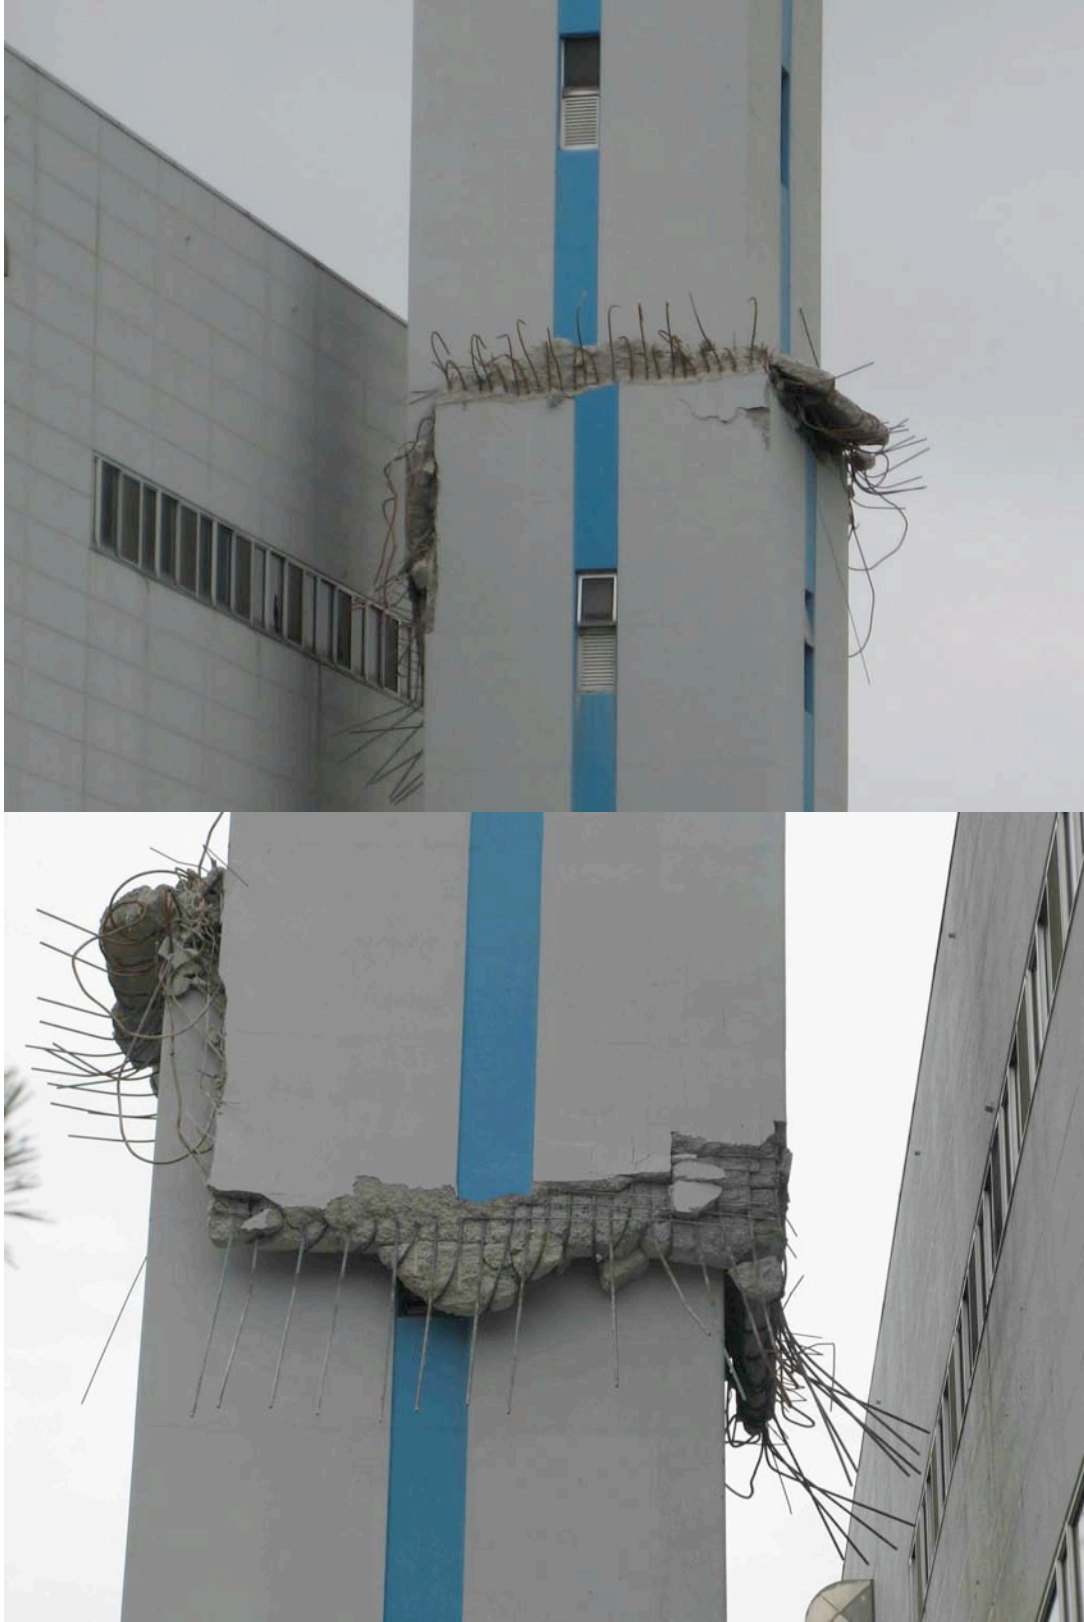
Figure 5.9: Details of failure of reinforced concrete stack (Site SP31, N37.3939° E138.5840°).

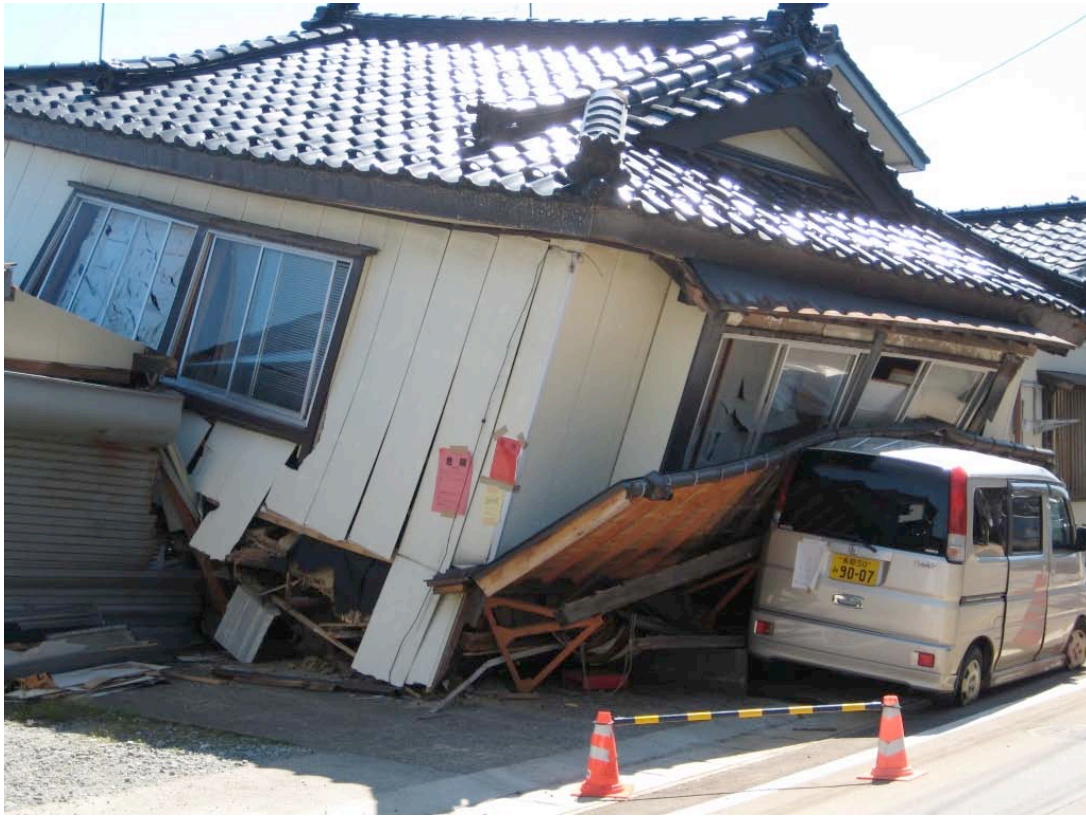
Figure 5.10: Collapse of house (N37.367°, E138.567°).

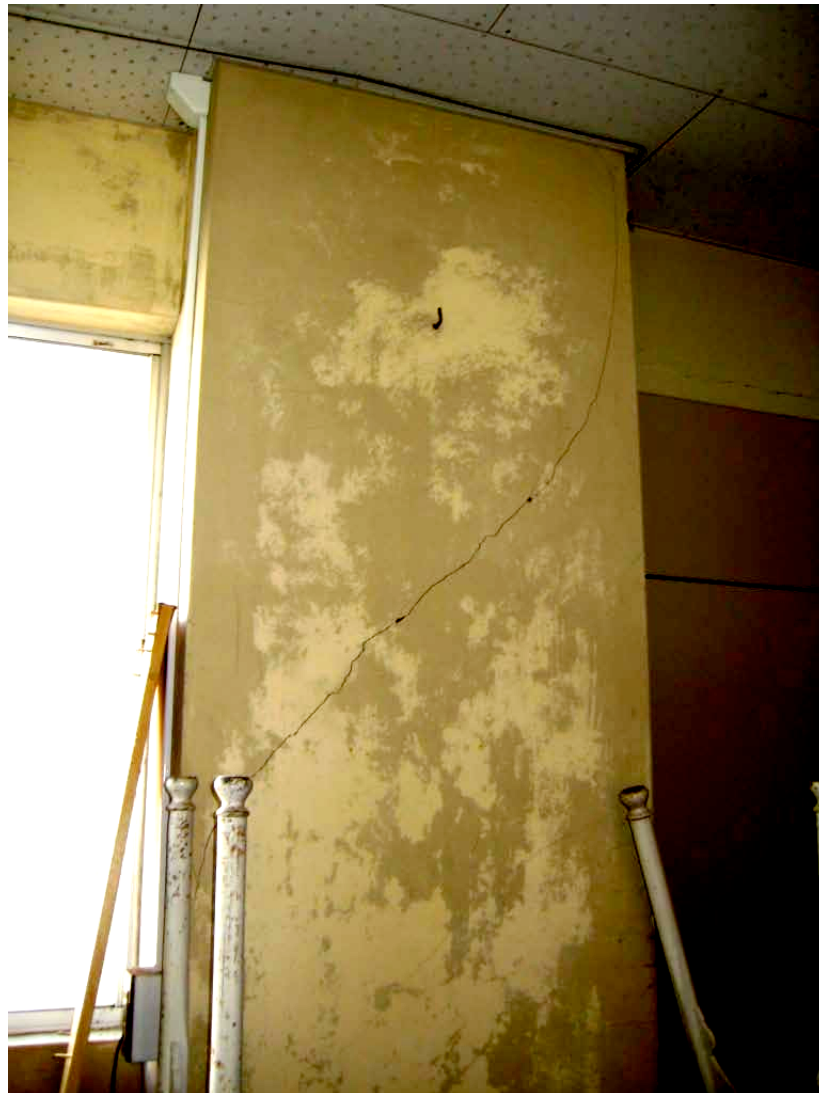
Figure 5.21: Column in first story of The Kashiwazaki High School, cross section and observed crack pattern (Site SP11, N37.3721°, E138.5569°).

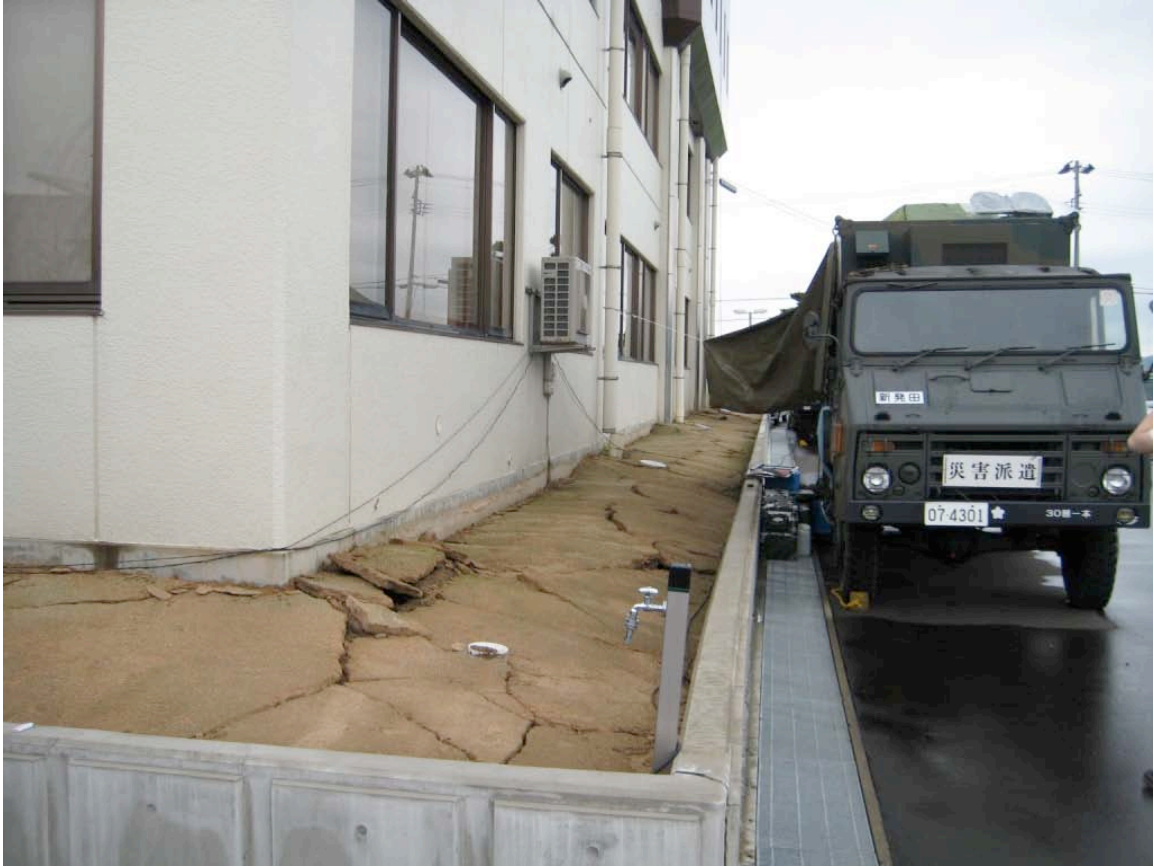
Figure 5.22: Disruption of soil surrounding a government building in Kariwa (Site SP33, N37.4223° E138.6222°).

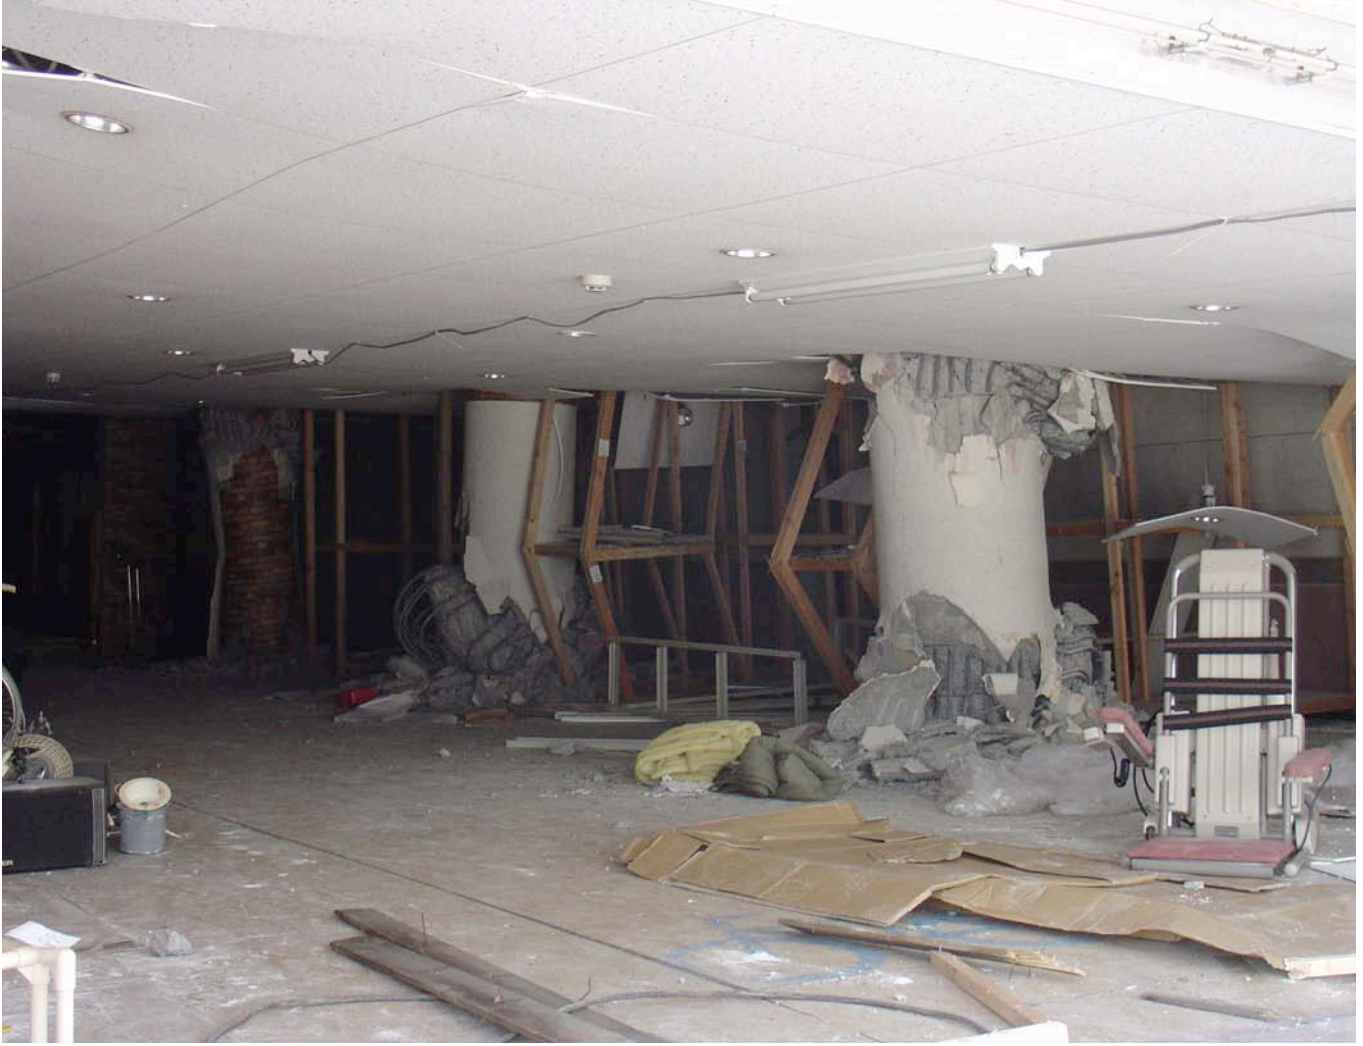
Figure 5.24: Shear failures of reinforced concrete columns (Site NIT-81, N37.37000° E13855825°, photo by Peter Yanev)
