Preliminary Observations on the Niigata-Chuetsu Oki, Japan, Earthquake of July 16, 2007

EERI-GEER Web Report 2007-1 v.8
October 9, 2007

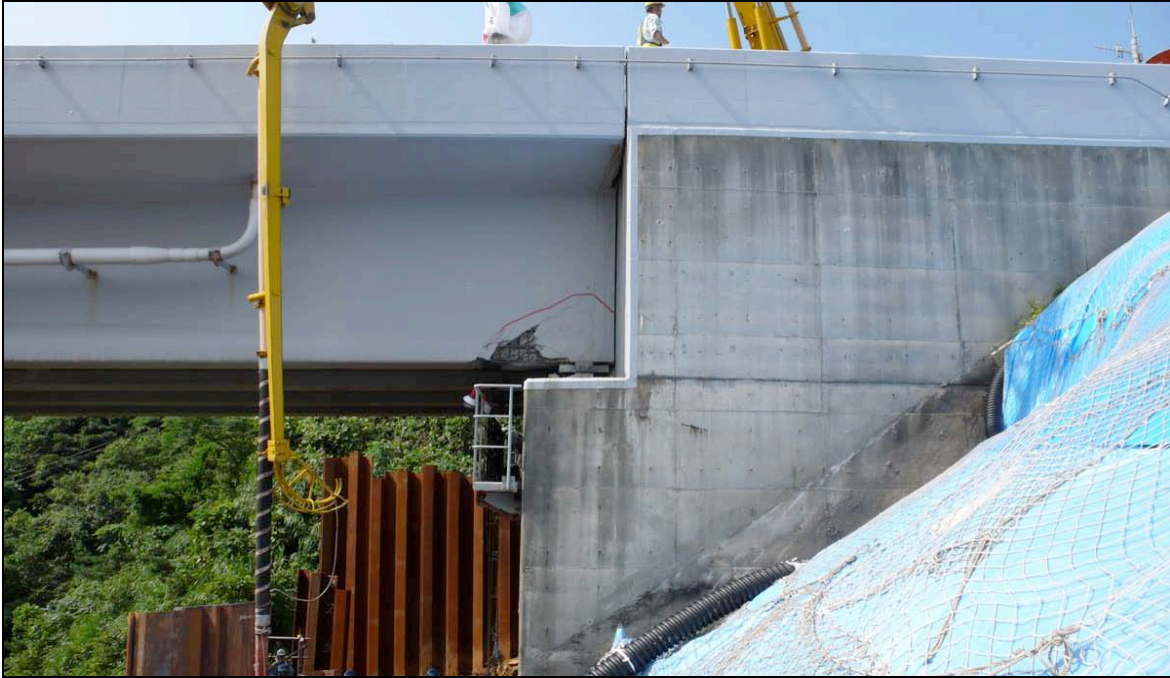
Fig. 6.3. Damage at north end of the west Hachisaki Bridge.

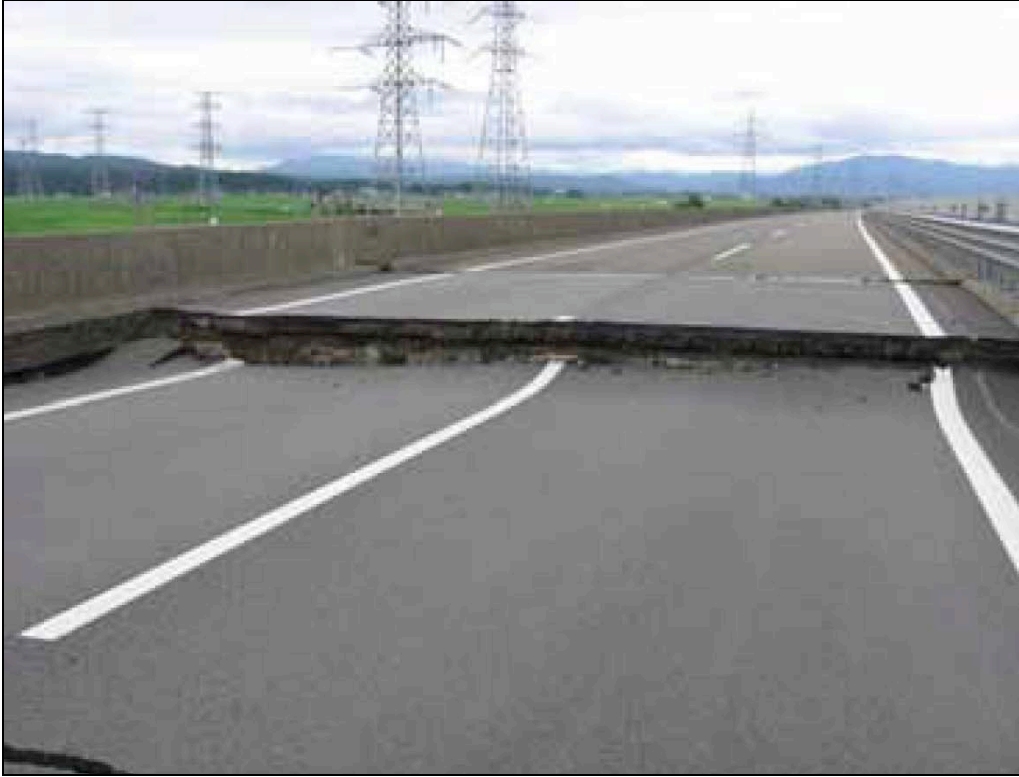
Fig. 6.8. Damage to approach slab and embankment at Yoshiigawa Bridges.

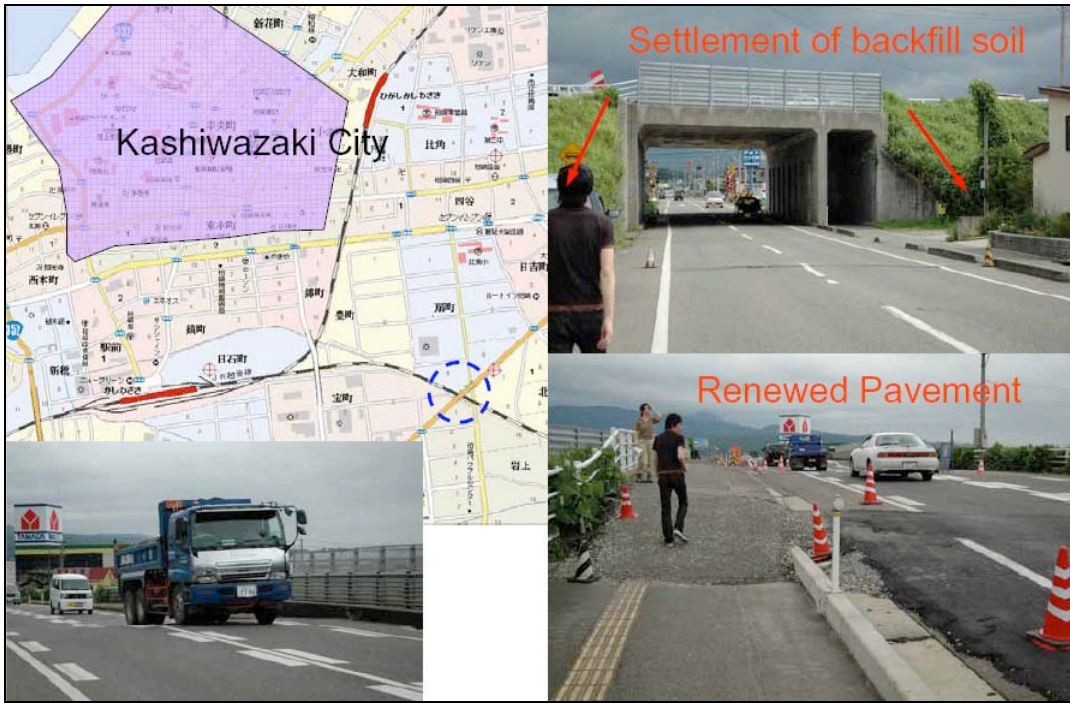
Fig. 6.16. Damage and repairs where Highway 8 crosses Route 522 Bridge (courtesy G. Watanabe, Tokyo Institute of Technology).

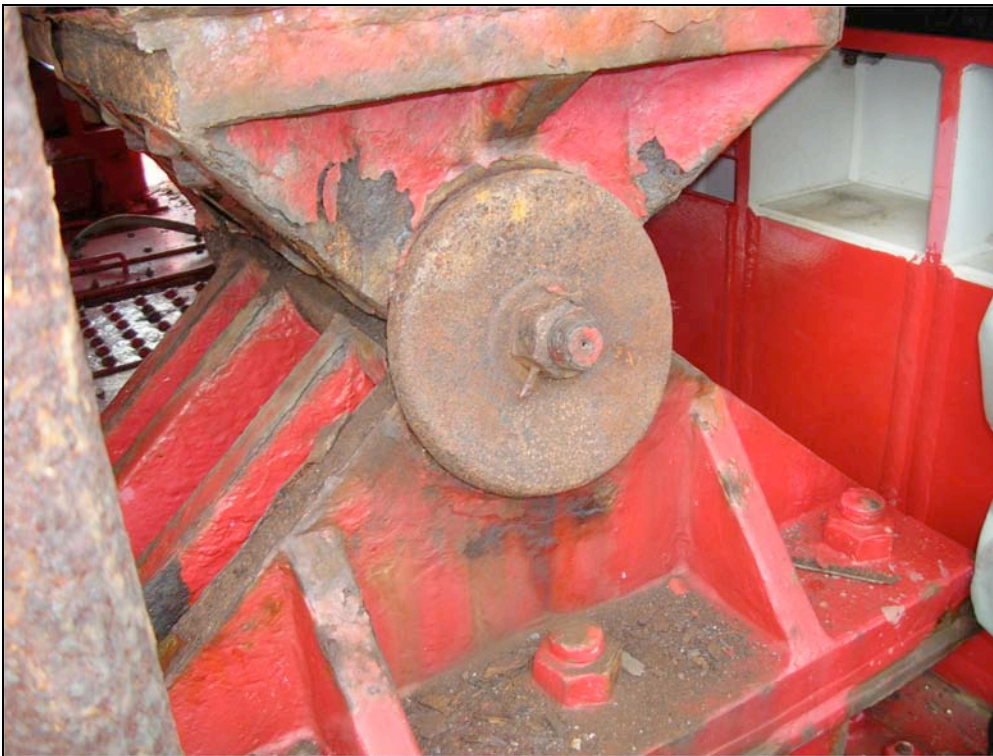
Fig. 6.23. Deformation of Bearing Pin-Cap caused by uplift force (courtesy of S. Unjoh, PWRI).

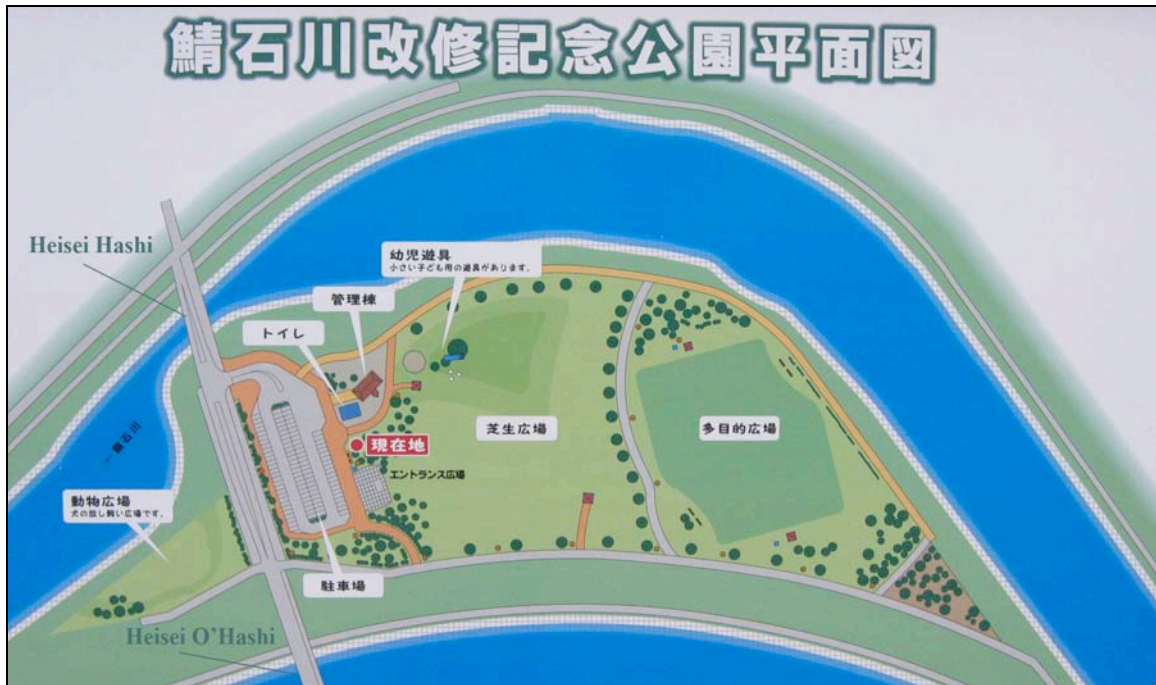
Fig. 6.30. An island in the meander of the Sabaishi River liquefied.

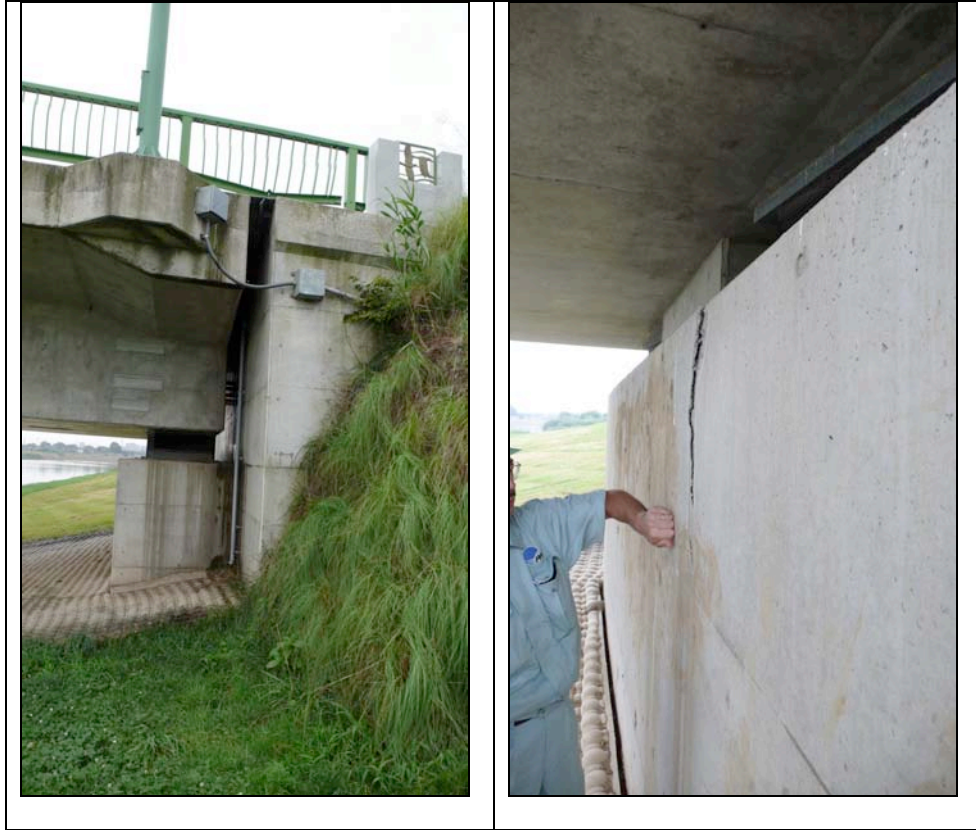
Fig. 6.36. The superstructure and bearings moved back and forth, cracking the abutment.

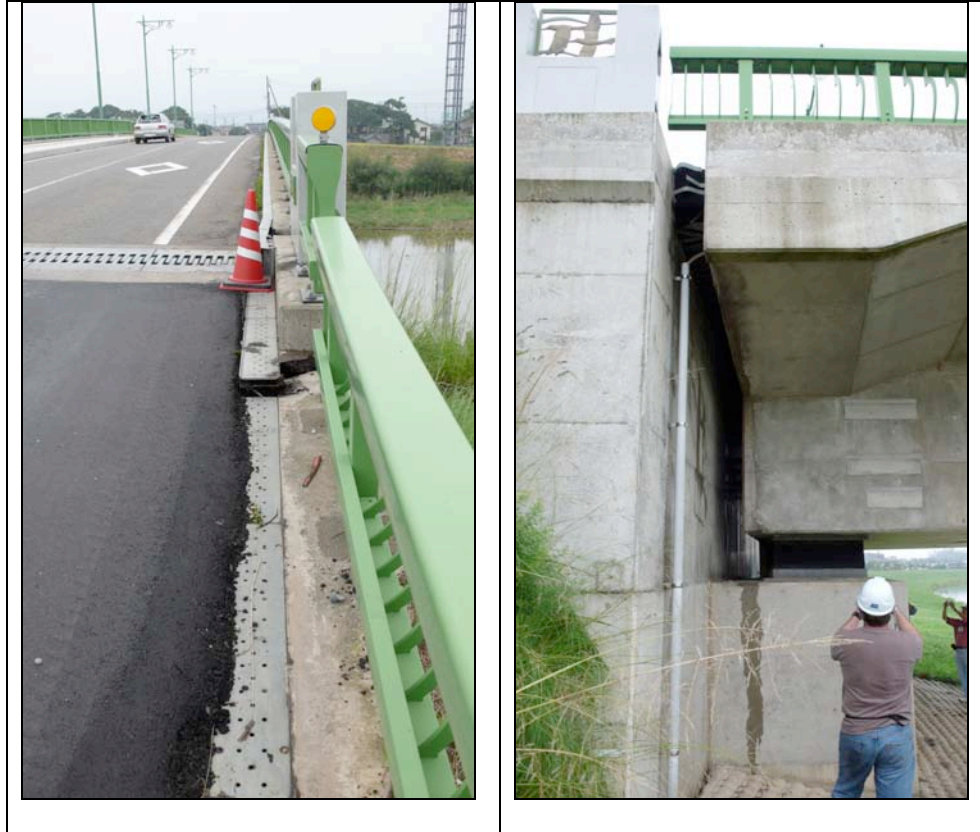
Fig. 6.37. Signs of movement of the abutments included distortion of bearings.

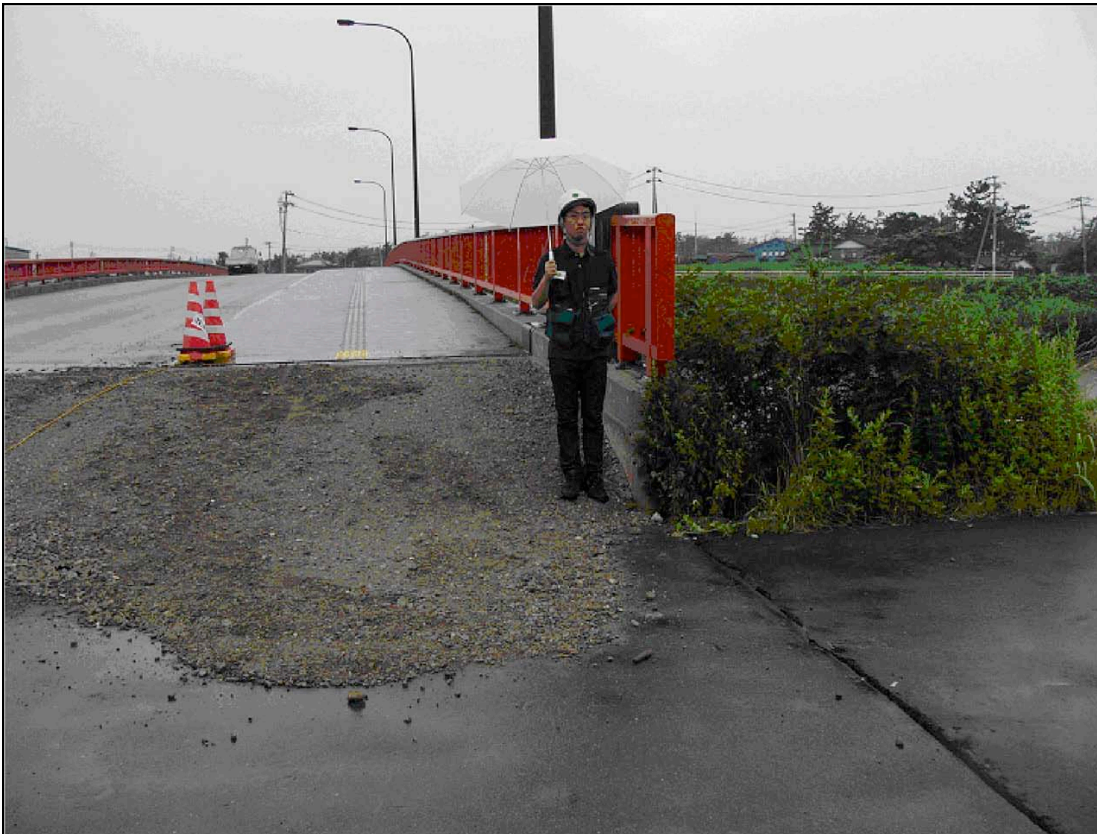
Fig. 6.41. About one meter settlement of south Kaiun bridge approach.

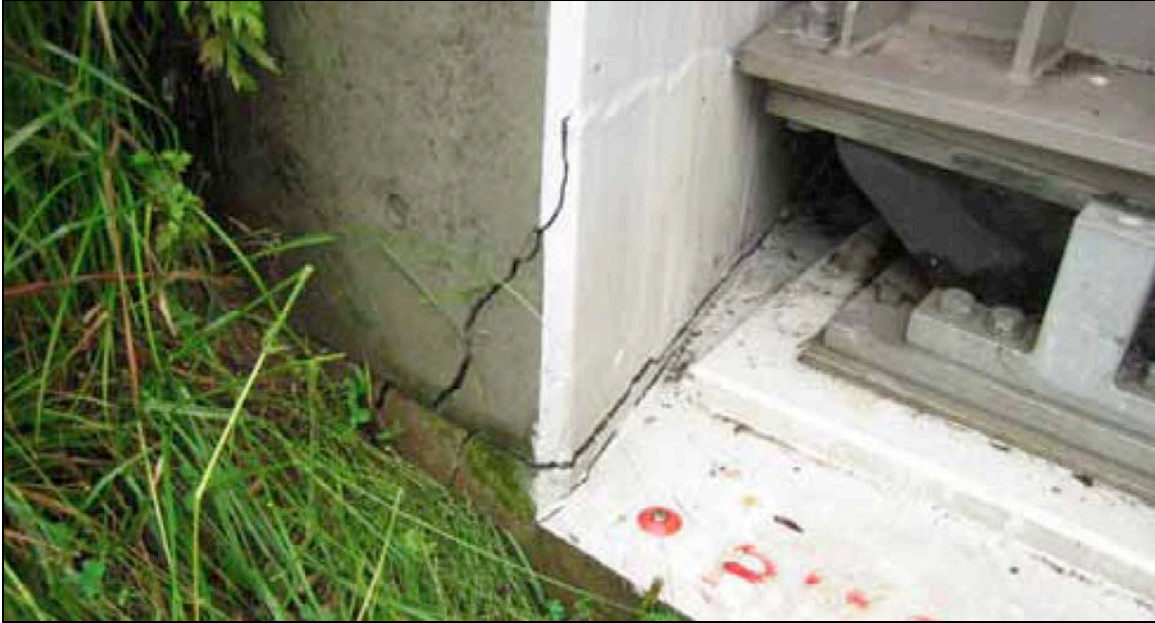
Fig. 6.46. Distorted bearing and cracked abutment backwall (photo courtesy of Scott Brandenburg).

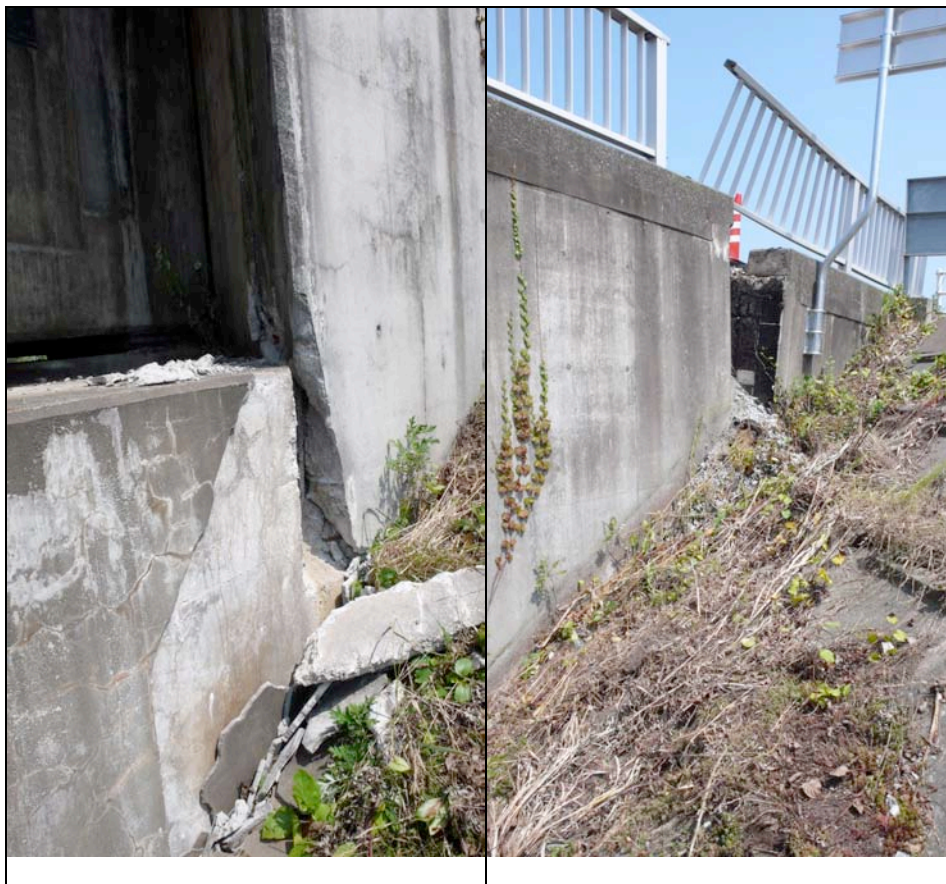
Fig. 6.51. Abutment and wingwall damage from the earthquake.

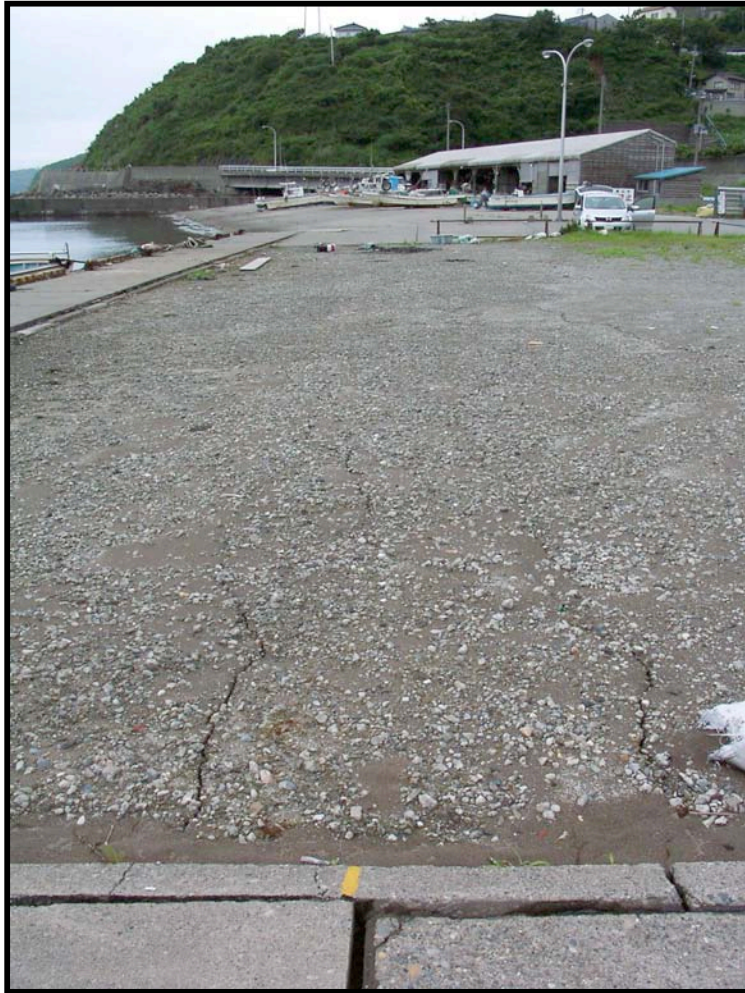
Figure 8.1: Minor ground failure along the waterfront at Kasashima (Site RK21, N37.33702° E138.46680°, photo taken 7/21/07 14:49). The limited extent of the ground cracking indicated incipient lateral movement.

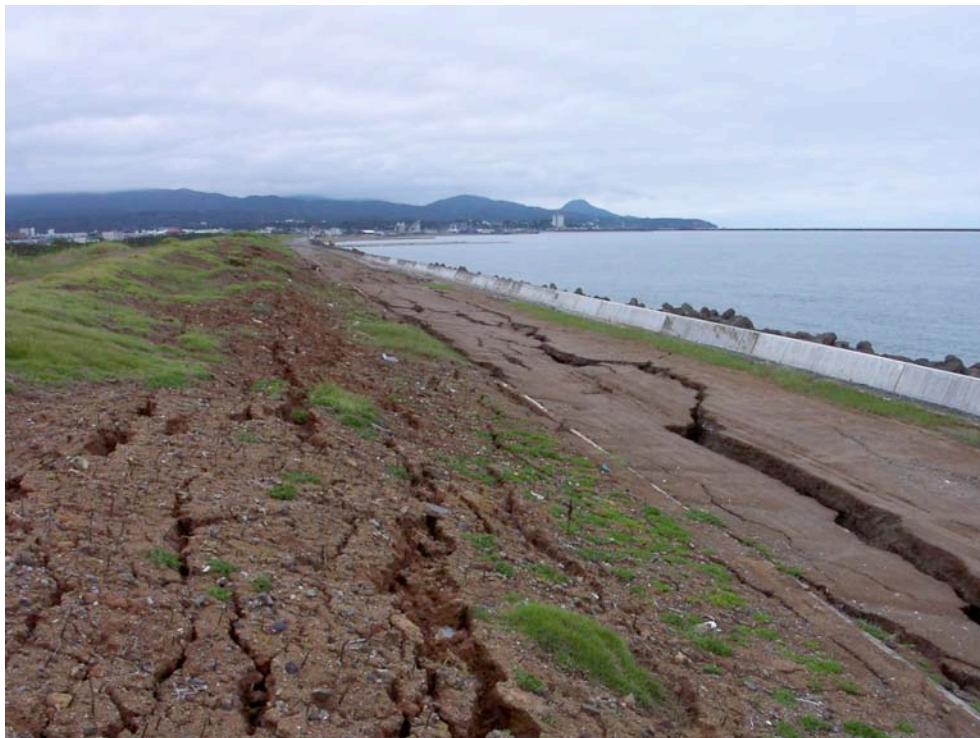
Figure 8.36: Representative cracking and lateral displacement of the clayey earth embankment adjacent to the seawall (Location is southwest of Site SD1, photo taken 7/22/07 11:35).

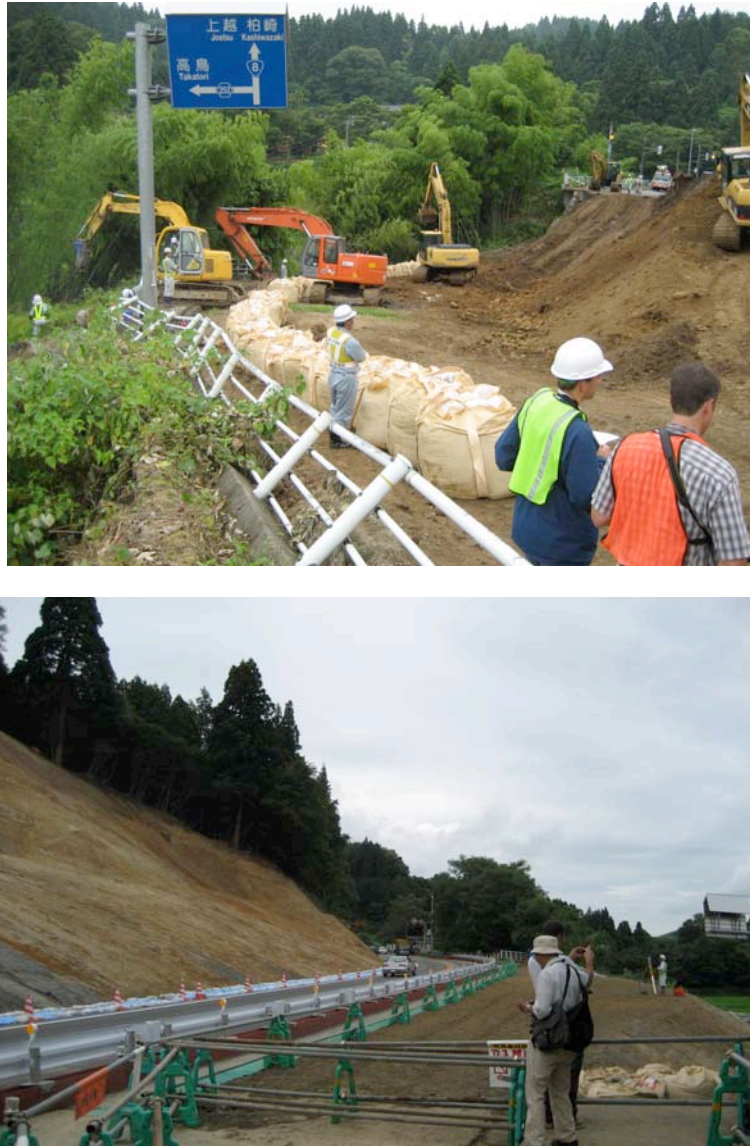
Figure 9.1: The Ozumi Senbon Landslide (Site RK1, N37.41422° E138.71347°), located along Highway 8 just north of the intersection with Route 252, closed both lanes of traffic. The upper photo, taken 7/20/07 at 11:30, four days after the earthquake, shows the displaced roadway which ran from the distance vehicles to the upper right of the photo to just in front of the investigation team members in the lower right. The bottom photo, taken 7/23/07 at 13:00, shows the nearly completed landslide and roadway repair, complete with guard rails, pavement, and center striping, just three days later.

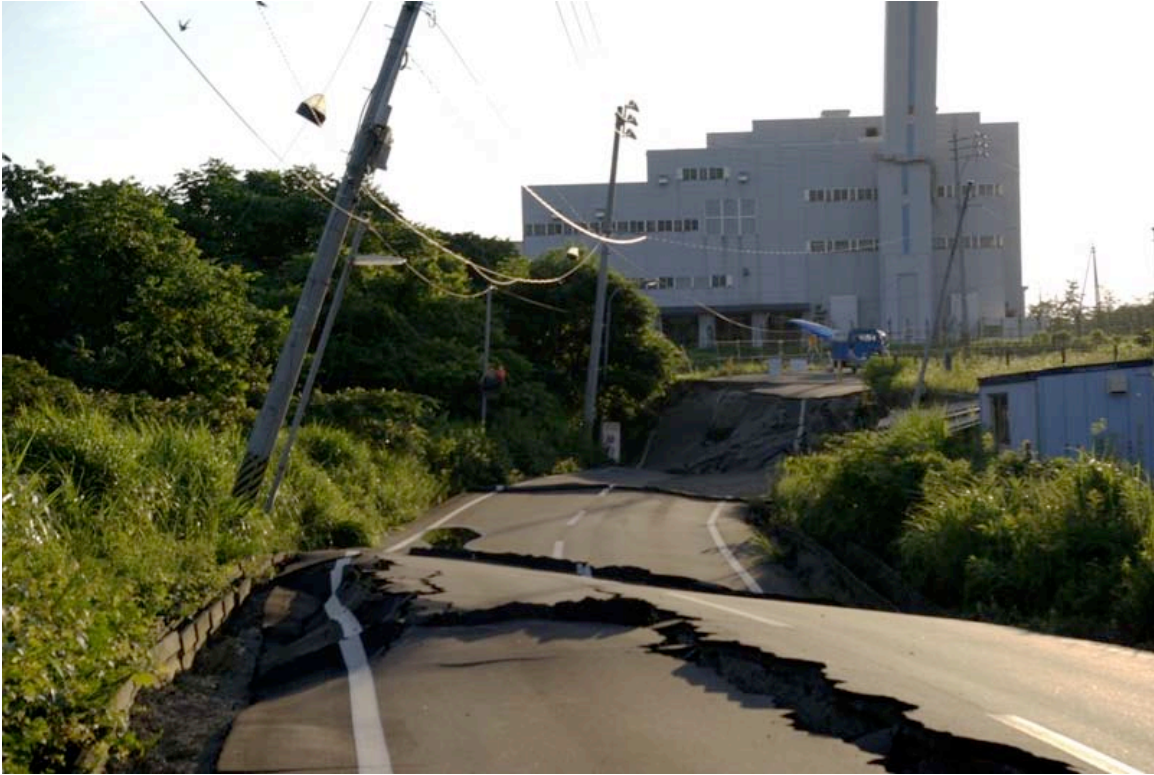
Figure 9.2: Road to Kashiwazaki municipal waste incinerator plant (Site RK6, N37.39343° E138.58555°, photo taken 7/24/07 18:06). Liquefaction-induced lateral spreading led caused the roadbed and associated slope to move southwards towards the Sabaishi River. Photos show formation of a 2.5 meter tall head scarp at the west end.

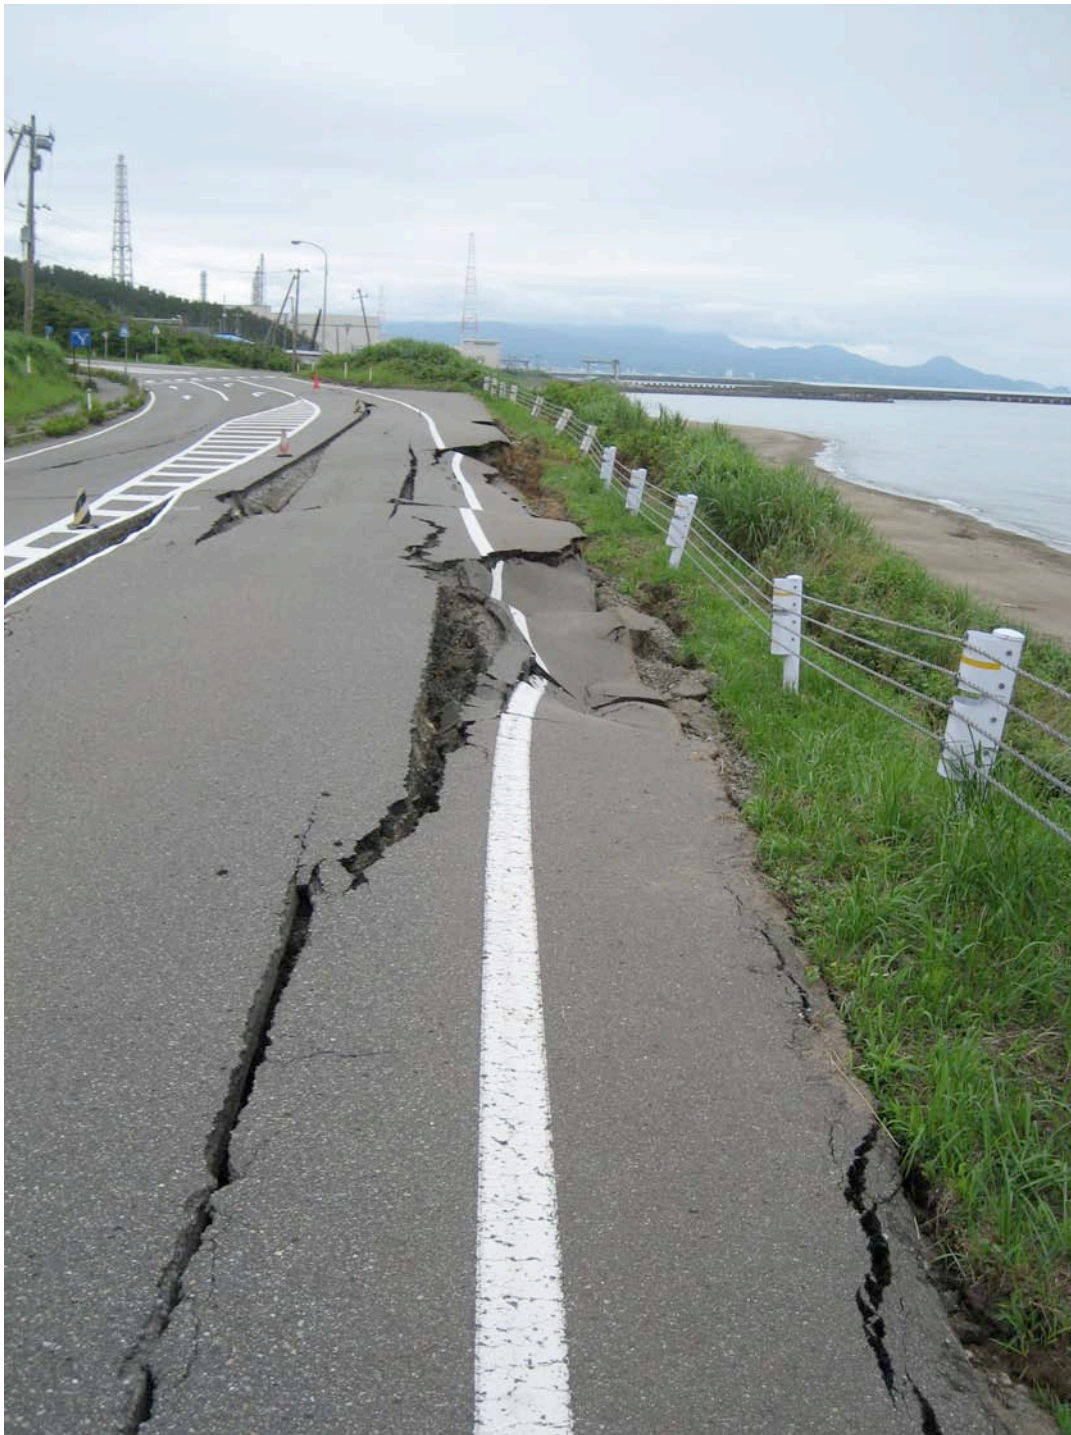
Figure 9.3: Road damage from fill embankment failure on coastal road north of Kashiwazaki Nuclear Power Station (Site RK38, N37.44927° E138.60572°, photo taken 7/22/07 13:04). Such damage tended to increase with distance toward the epicenter, often requiring traffic controls to guide cars across the one open lane.

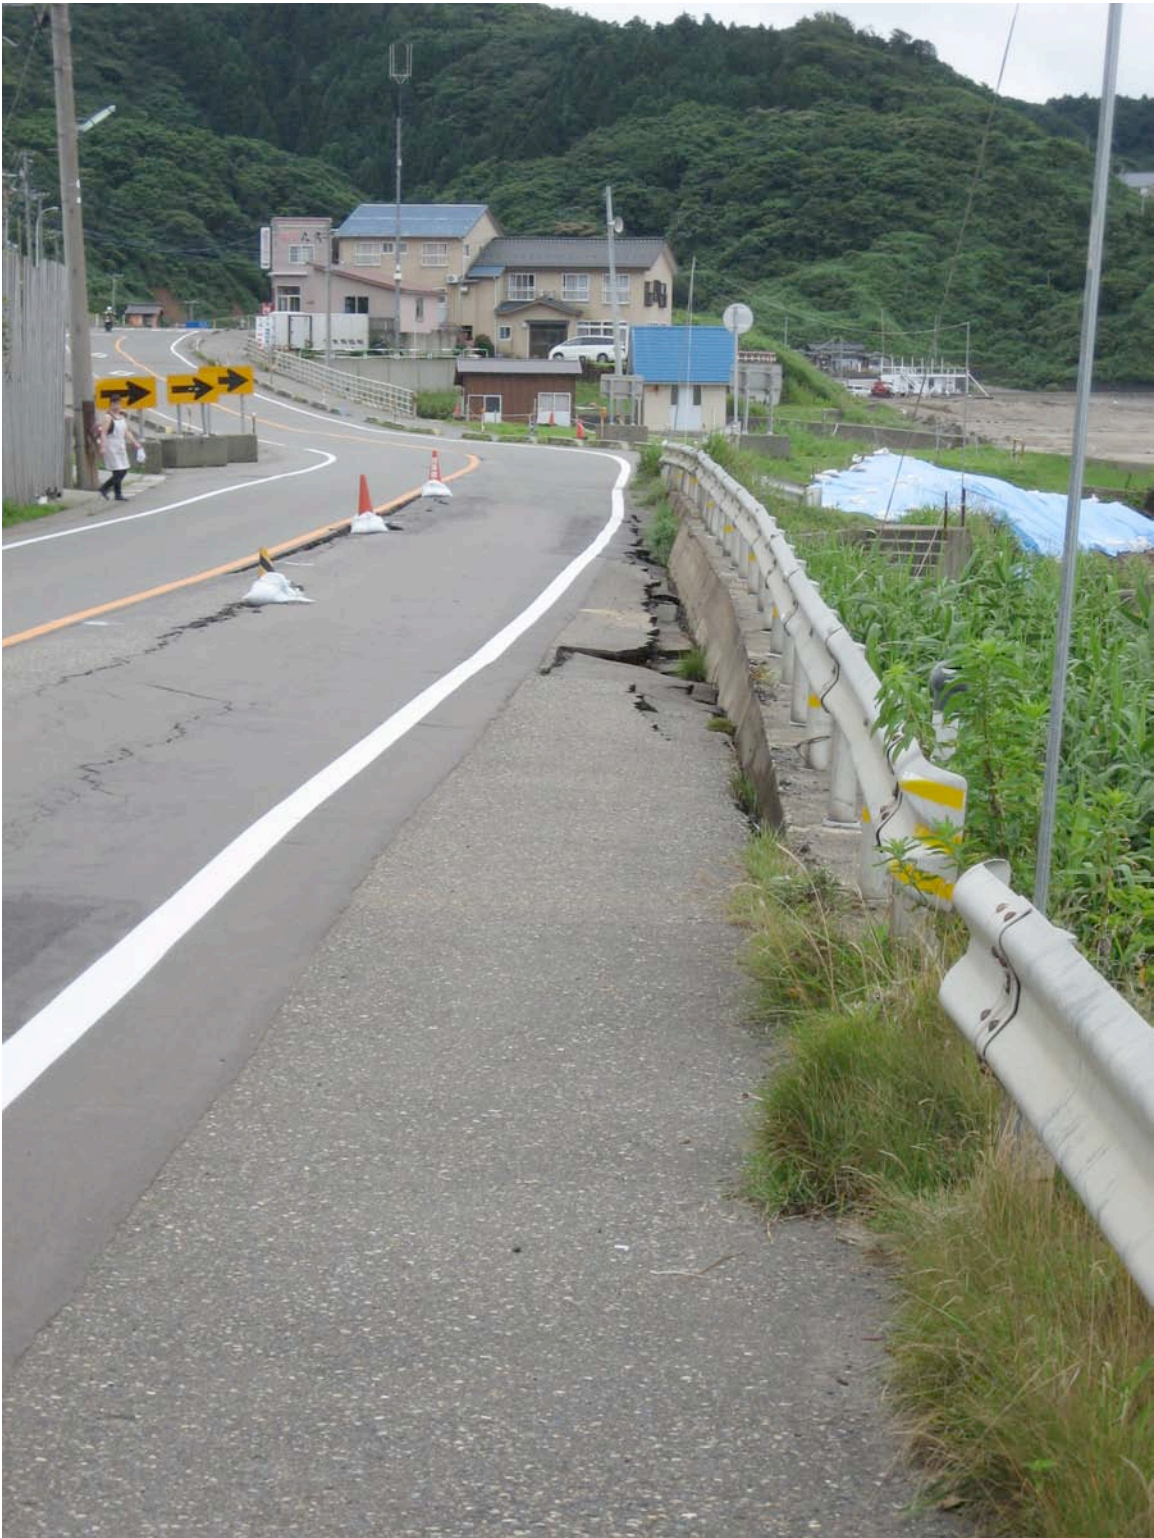
Figure 9.4: Site RK34 - Road damage from fill embankment failure on coastal road north of Kashiwazaki-Kariwa Nuclear Power Plant (Site RK34, N37.48455° E138.62435°, photo taken 7/22/07 09:56).

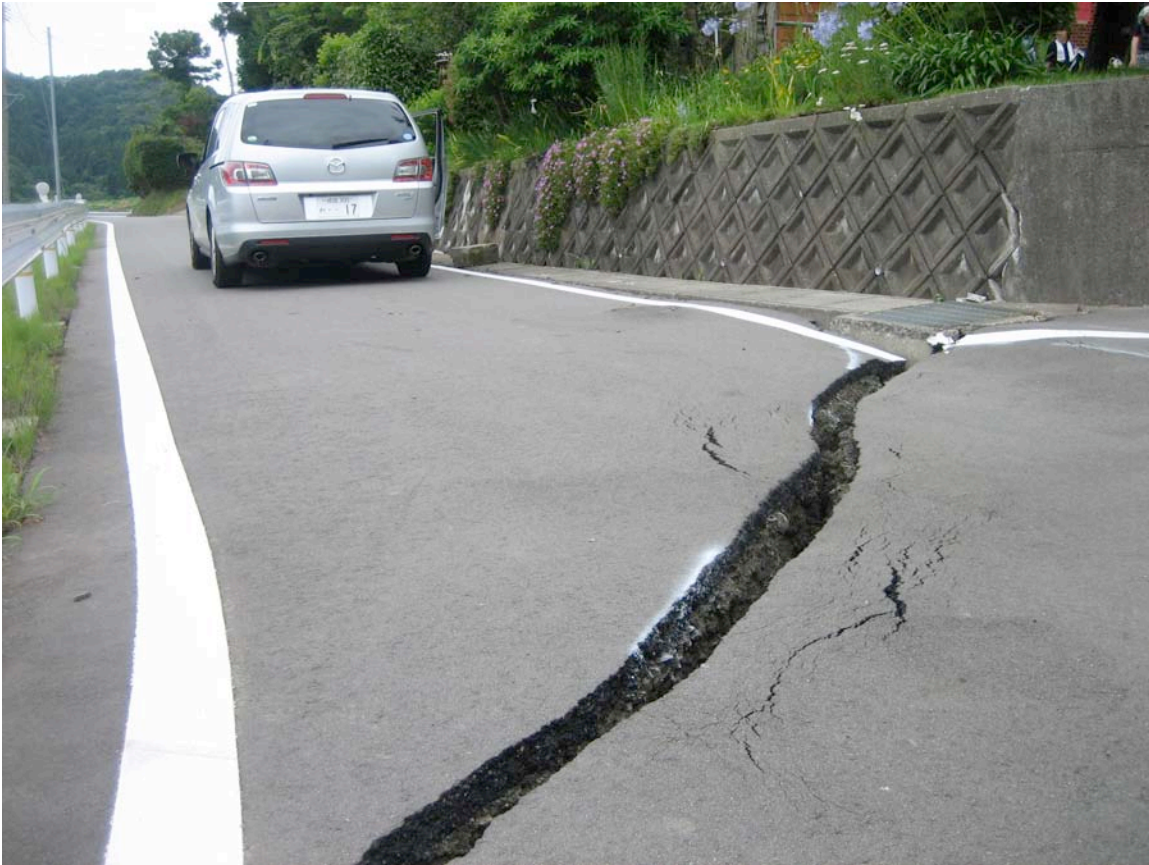
Figure 9.5: Typical road damage near epicentral region (Site RK30, N37.45727° E138.65328°, photo taken 7/22/07 09:46). Cracks of 5 to 10 cm were often quickly paved over in high-traffic areas, within one or two days of the earthquake. On local community roads with alternate traffic routes, this damage was not immediately repaired.

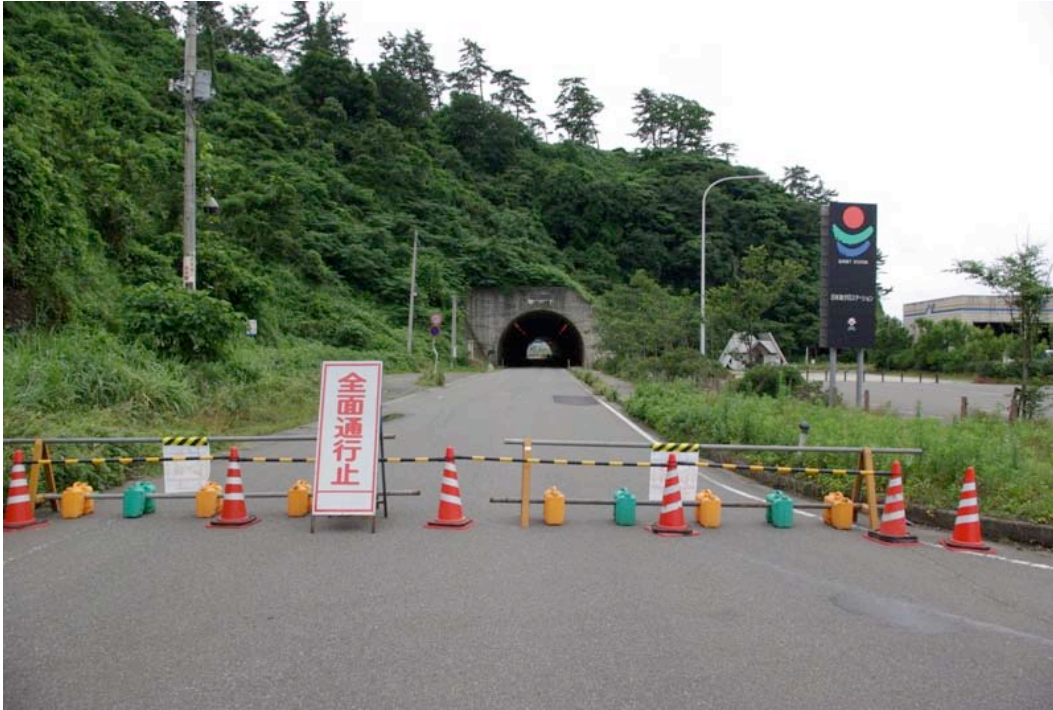
Figure 9.8: Tunnel was initially open to traffic following earthquake, but subsequently closed as of July 22nd (Site SD4, N37.38439° E138.60083°, photo taken 7/22/07 13:36). Damage to tunnel was not observed, but landsliding and toppled monuments on top of the tunnel was observed.

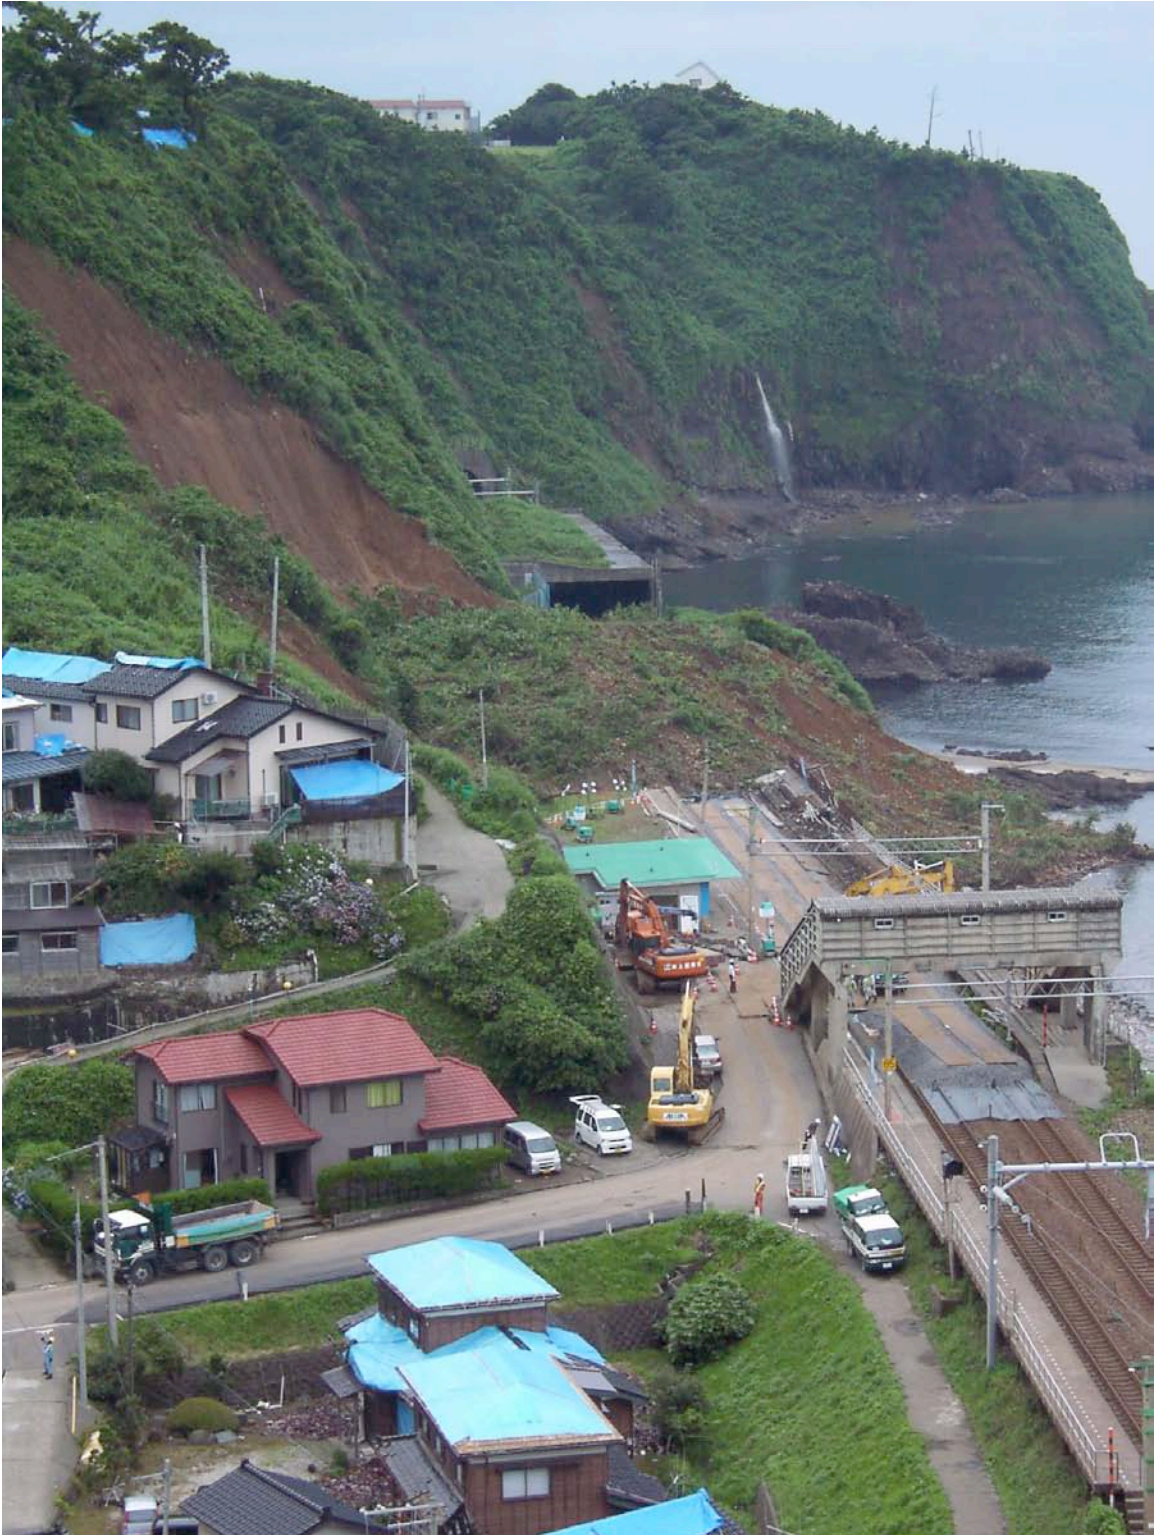
Figure 9.10: Landslide at Oumigawa Train Station impacted Shin-etsu line railway (Sites RK20/YT16/SA9, N37.34490° E138.48435°, 7/21/07 13:52).

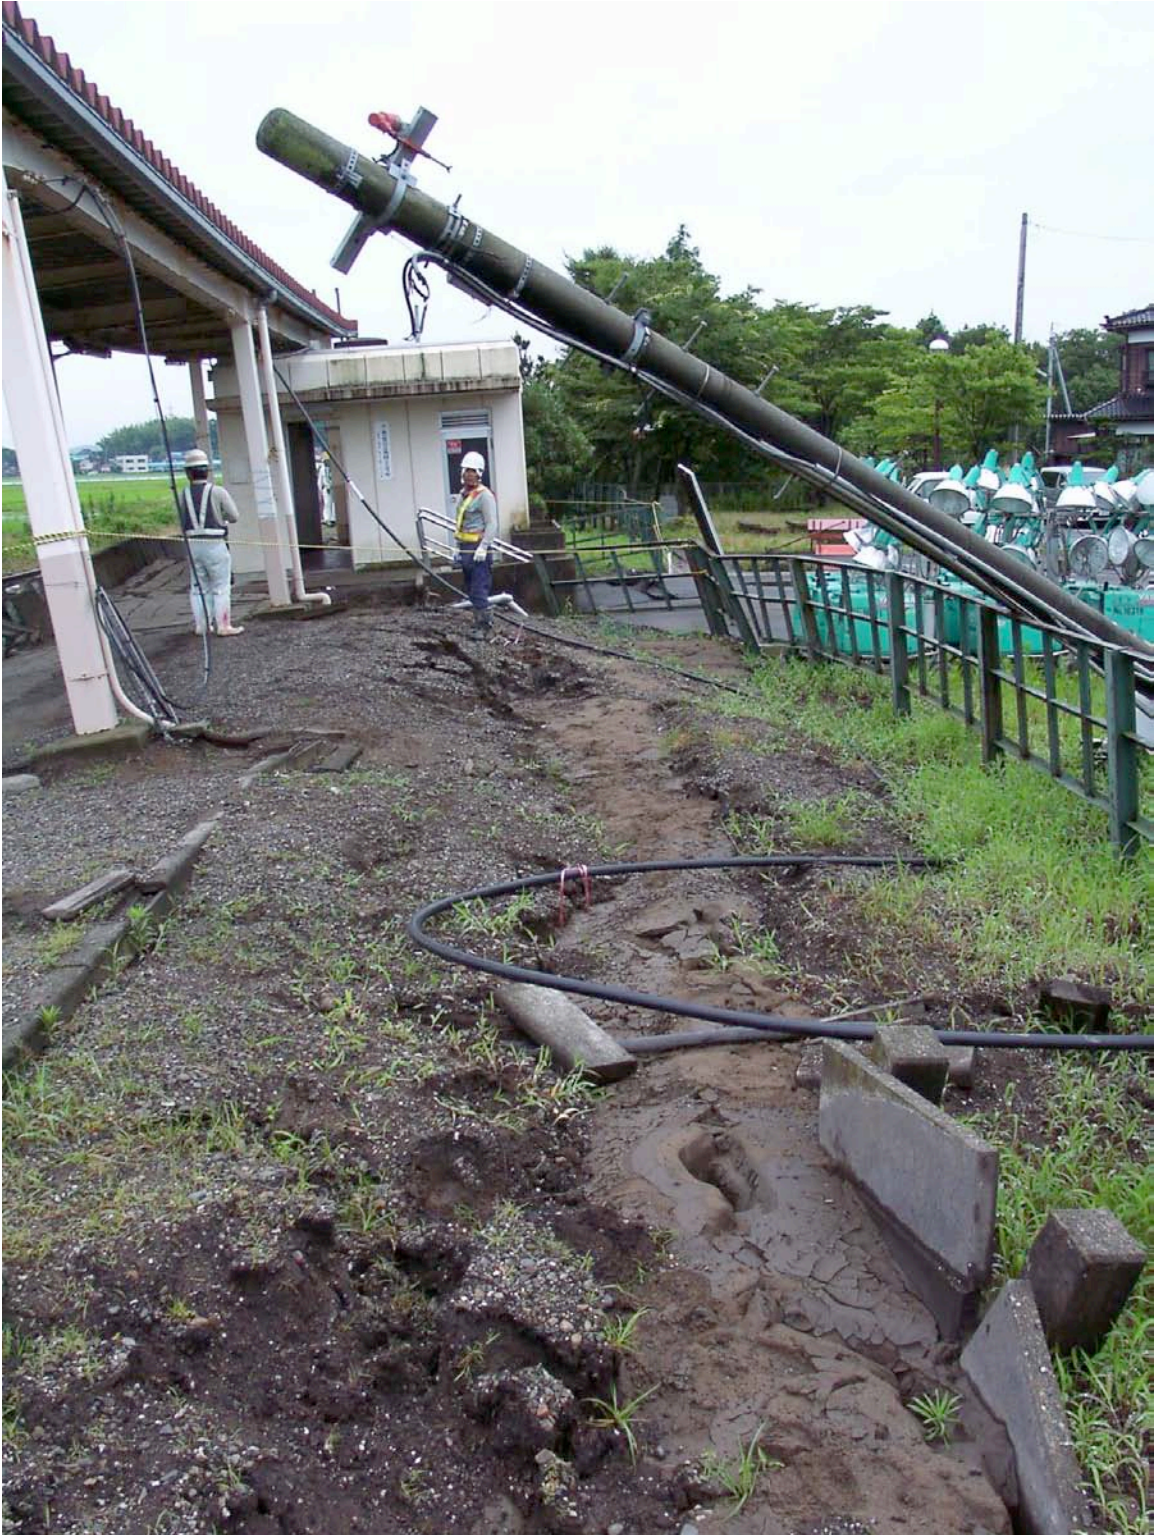
Figure 9.11: Liquefaction-induced damage at Arahama Station (Site RK13, N37.40555° E138.60197°, 7/21/07 09:42).

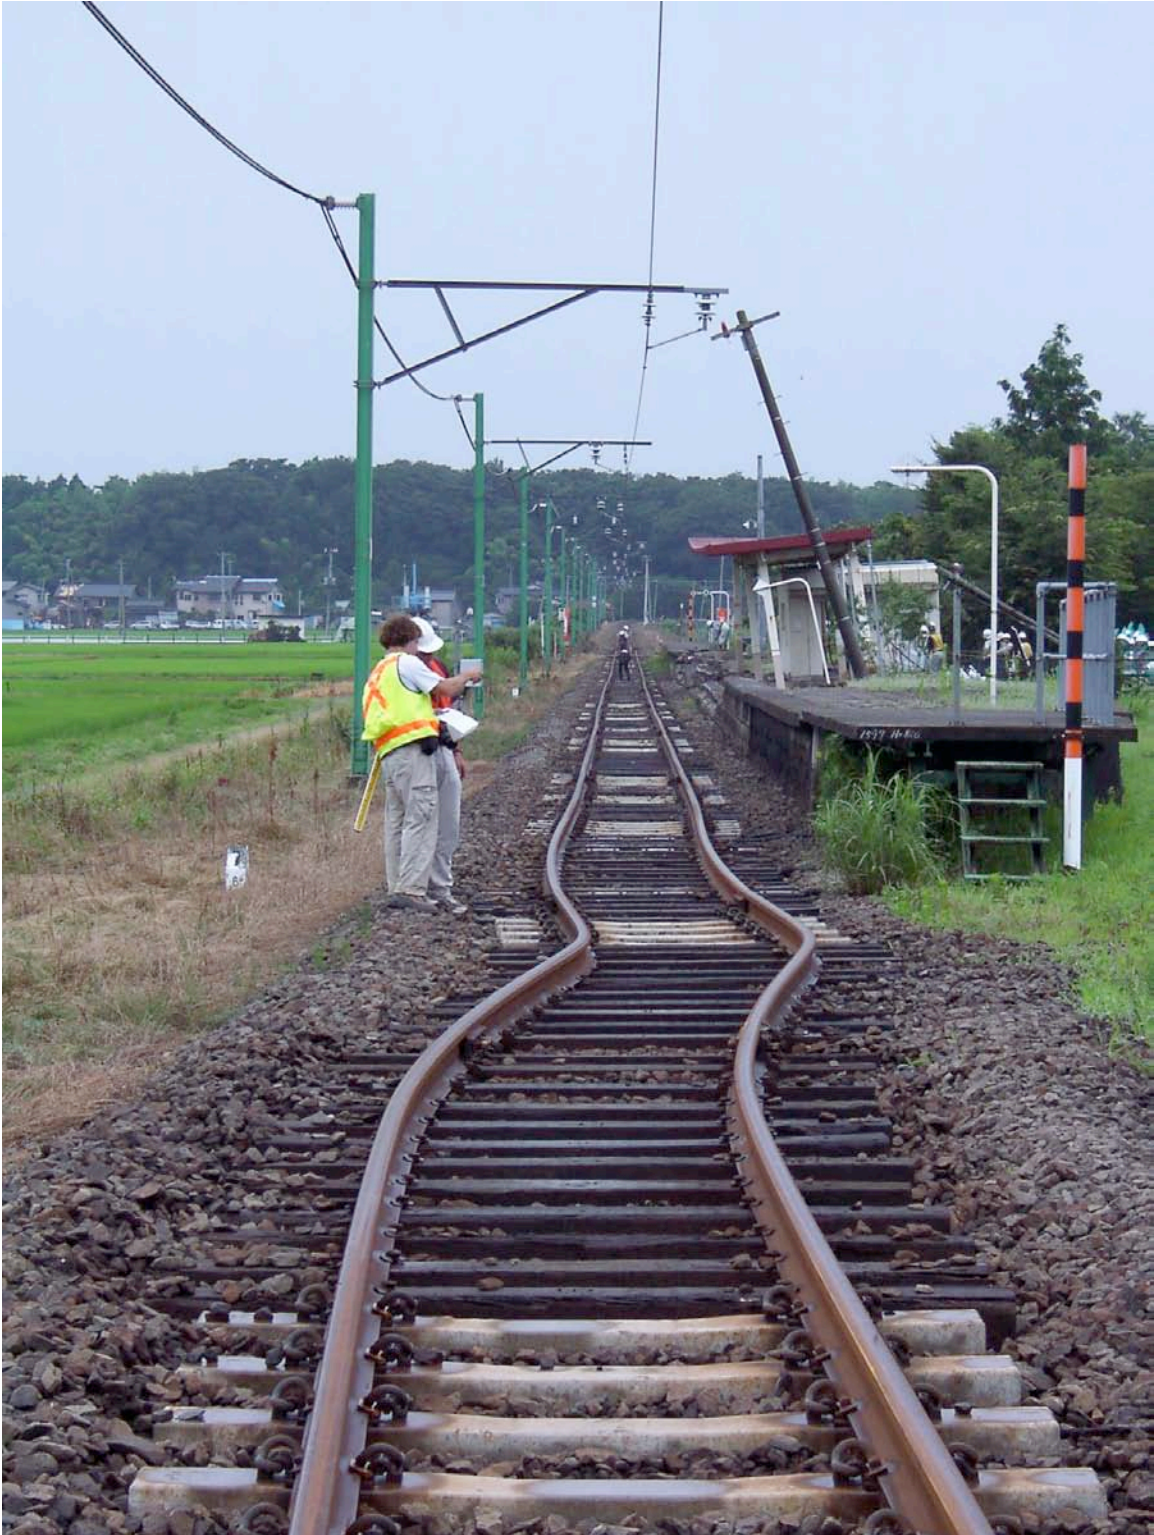
Figure 9.12: Lateral deformation of train tracks at Arahama Station (Site RK13, N37.40555° E138.60197°, 7/21/07 09:52).
