Preliminary Observations on the Niigata-Chuetsu Oki, Japan, Earthquake of July 16, 2007

EERI-GEER Web Report 2007-1 v.8
October 9, 2007

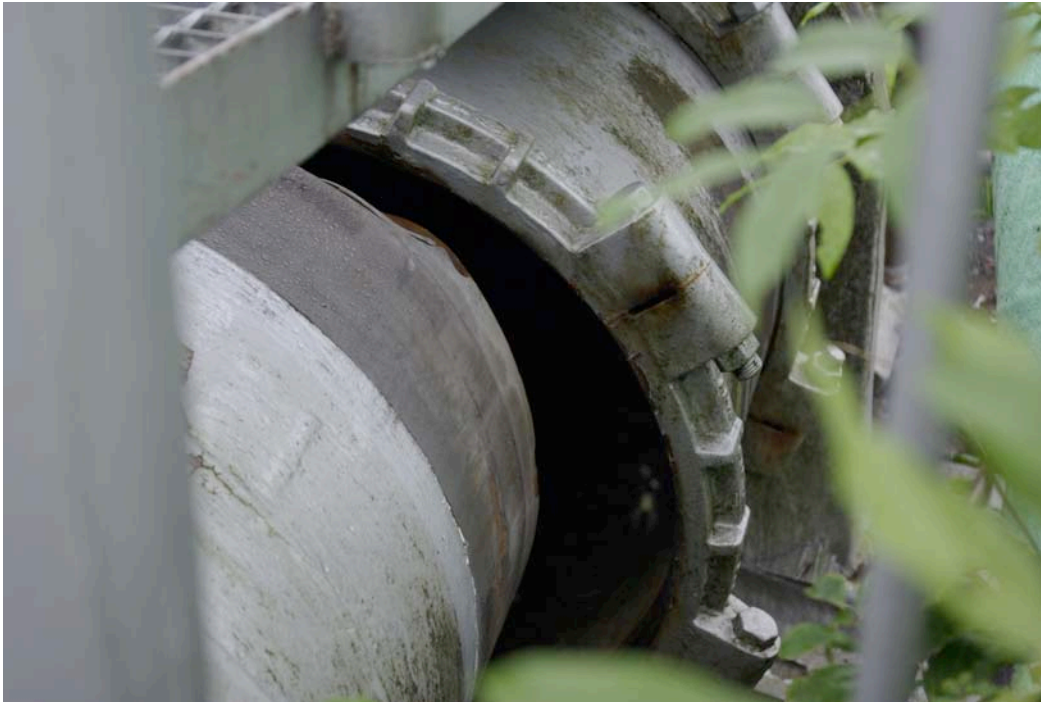
Figure 10.3: Damage to a water pipe at a stream crossing (Site RK4/YT3, N37.39233° E138.58063°, photo taken 7/20/07).

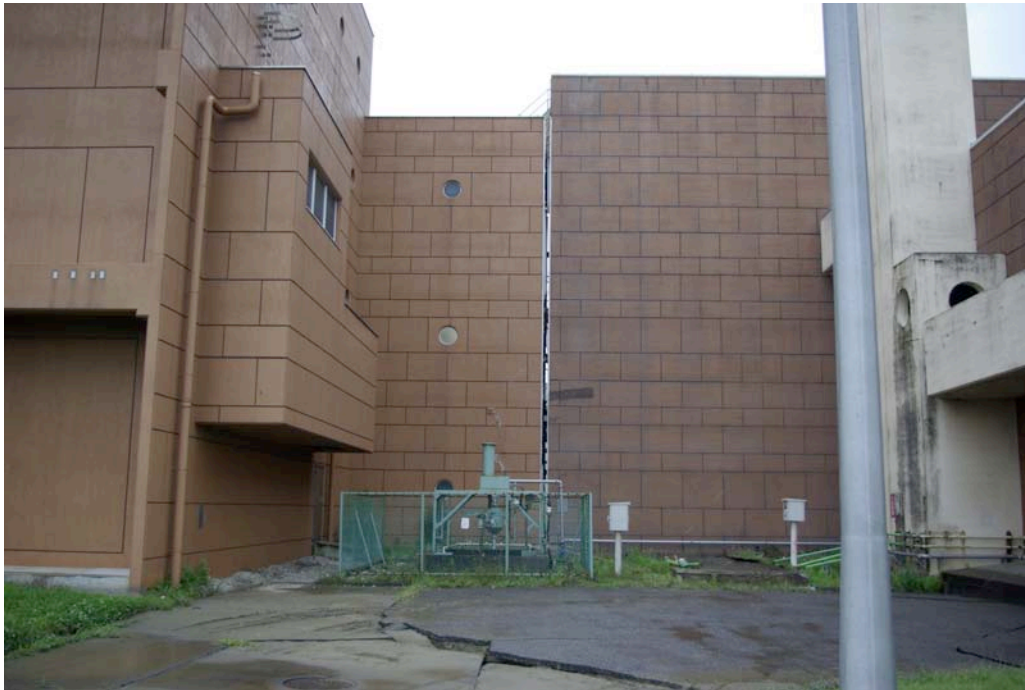
Figure 10.4: Ansui-Chou waste water treatment plant showing evidence of lateral spreading and extension of the structure (Site RK9, N37.38748° E138.56587°, photo taken 7/20/07).

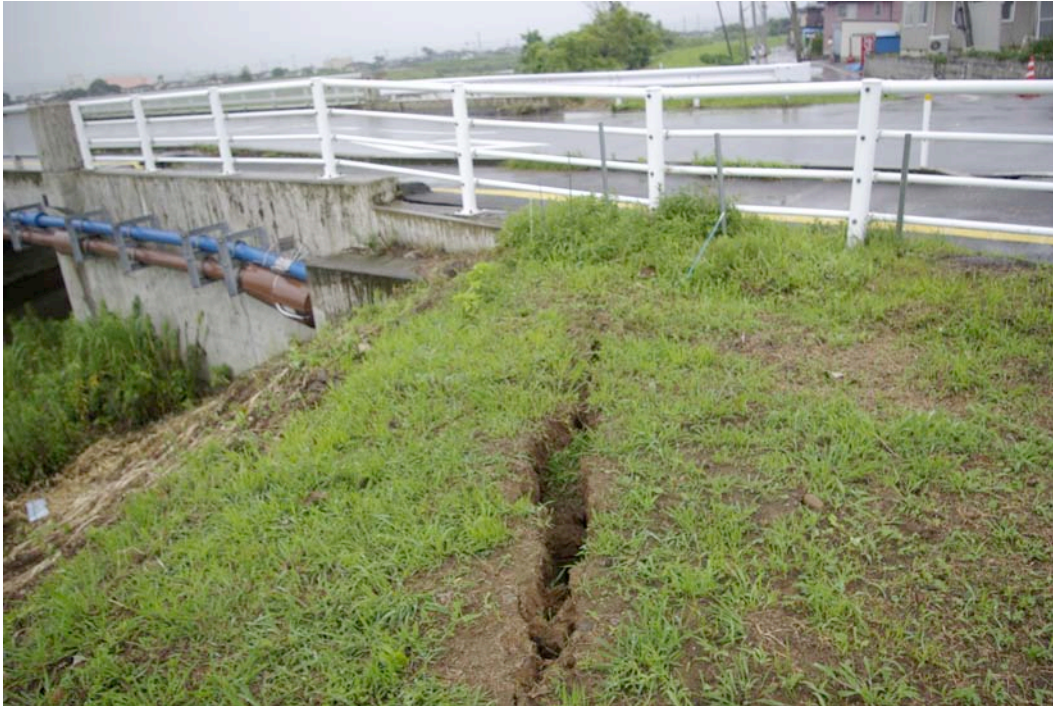
Figure 10.9: Evidence of moderate ground failure in an approach fill. Minor damage to the pipes was observed (Site RK7, N37.38940° E138.57393°, photo taken 7/21/07).

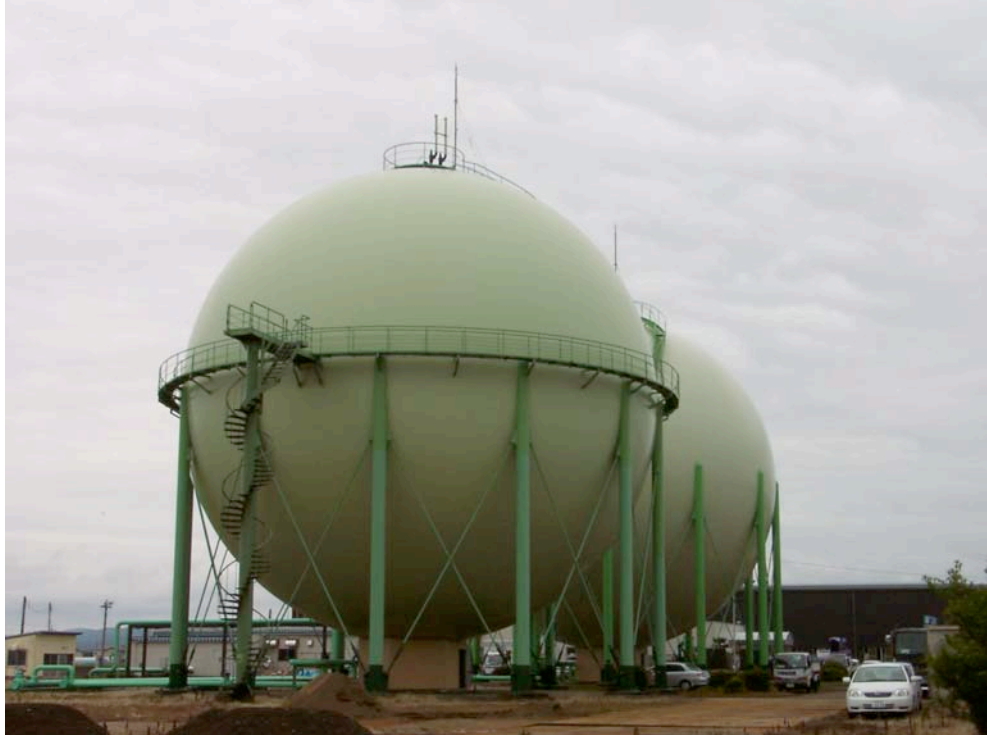
Figure 10.11: Natural gas tanks being inspected by local engineers (Site SD13/RK57, N37.37253° E138.59488°, photo taken 7/23/07). Very minor ground settlement and later movement near ditches was observed in the vicinity but the no damage was apparent to the tank foundations, appurtenant piping, or the tanks.
