# **Technical Report 096/2011**

**Accident that occurred on 18 May 2011**

**Aircraft Saab 340 A, LV-CEJ. Location: Caltrauna,  
between Los Menucos and Prahuaniyeu, province of Río  
Negro**

**Civil Aviation Accident  
Investigation Board (JIAAC)**

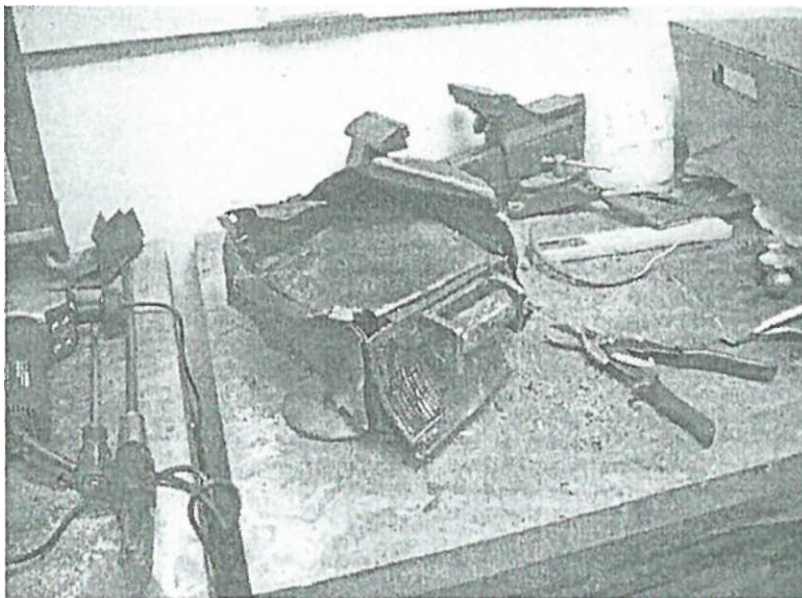
1.11.4.1.1 The CVR showed signs of severe impact shock and impact penetration, with the destruction of the external structure (impact and penetration) and the internal protection (resistant structure and thermal protection). There was evidence that the equipment had been on fire for a considerable period of time. The Underwater Locator Beacon (ULB) was found to be damaged; however, it withstood the impact and was still attached to the equipment.

1.11.4.1.2 The protective structure, along with the recording medium, were extracted with the use of manual tools, while the rest of the equipment was removed and preserved. Upon removing the subset and opening it up, the internal thermal protection was found to be damaged. When the last layer of mechanical protection was extracted, the recording medium was found to be fractured and damaged, as were the recording heads and other internal components.

*The state of the CVR equipment at the time of the retrieval.*

1.11.4.1.3 Upon the removal of the magnetic tape, it was found to be torn; one part was detached from the rest, but recovered. The damages to the tape ( "Mylar®" polymer tape coated with ferromagnetic material)

were found close to the recording heads, and the impact had left the tape entangled.

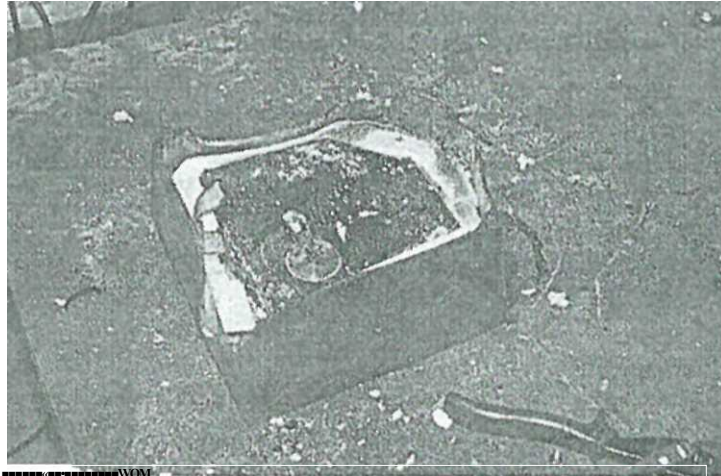
1.11.5.1.1 The FDR equipment was damaged by the impact and the fire; however, it was in better condition than the CVR. During the impact, the protective internal module - in which the tape was located - became detached. Despite becoming detached, the recording medium was protected.

1.11.5.1.2 When opening up the equipment, it was revealed that the tape around the recording heads was damaged and torn. This occurred due to the violence of the impact. It resulted in the tape tearing and stopping in the final recording position.

*The state of the FDR equipment at the time of the*

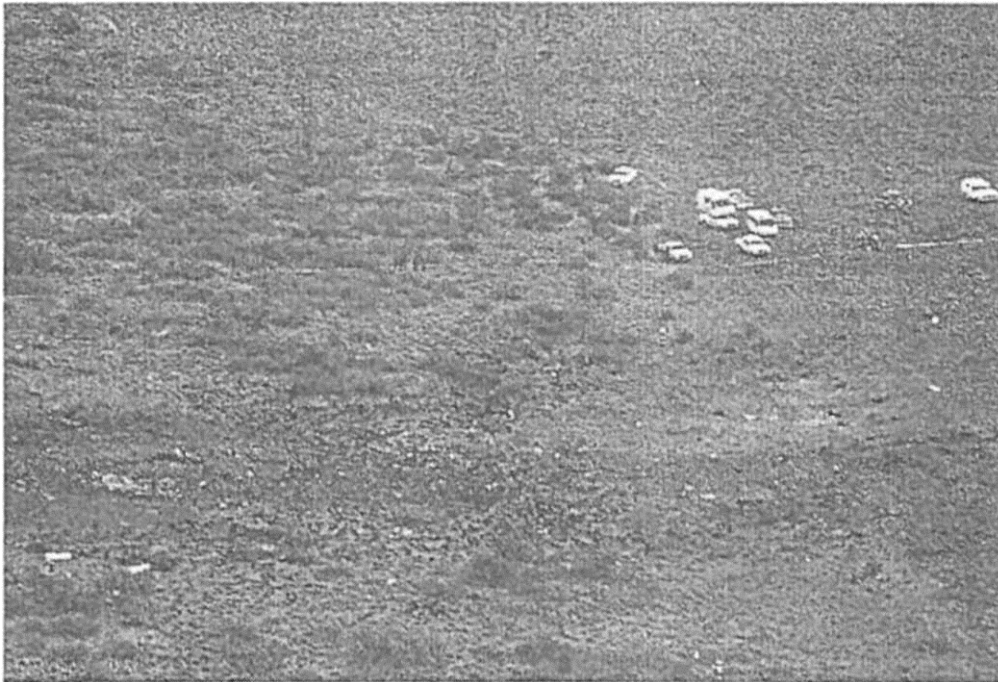
1.12.2 Most of the wreckage was spread out, starting at the site of the first impact, with a heading that formed a scattering angle, ranging from 300° to 350° with a minor amount of wreckage spread out in a radius of about 200 m around the main point of impact. There was no evidence of the aircraft components detaching before impact.

1.12.3 The components of the right engine and the propeller blades were scattered about 130 m from the main impact point with the same heading. The components of the left engine and propeller blades were 90 m from the impact and with a recovery degree (R°) of 350. The remaining propeller blades were found 70 m from the main impact and with R°350.

*Aerial view of the impacted area.*
