**UNITED REPUBLIC OF TANZANIA
MINISTRY OF WORKS AND TRANSPORT**

**AIRCRAFT ACCIDENT AND INCIDENT
INVESTIGATION BRANCH
TANZANIA**

PRELIMINARY REPORT

Accident No. CAV/ACC/6/22

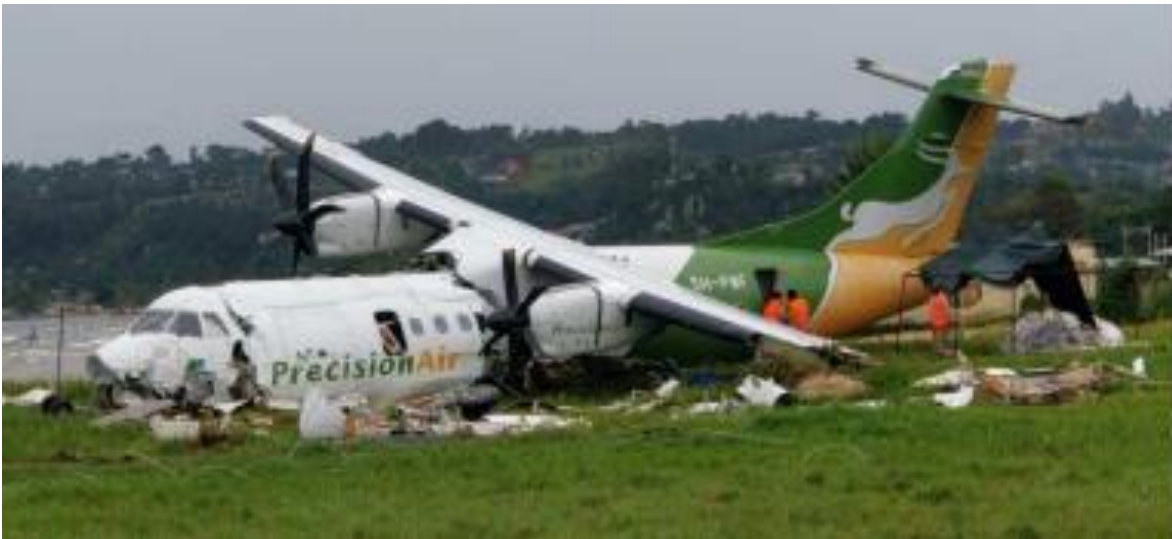
The aircraft was substantially damaged by impact with water and it sustained more damage during recovery to the shore. It has since been declared written off.

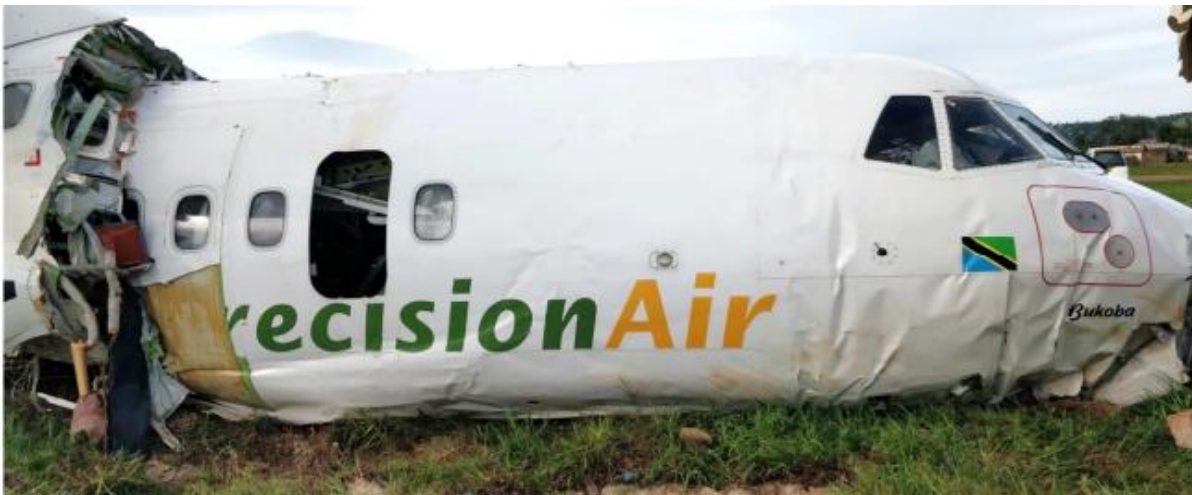
The nose and forward fuselage sections were significantly damaged whereas the aft section suffered minor damage. The radome was found completely separated from the fuselage.

The frame 1 bulkhead, the stiffeners and the Nose Landing Gear (NLG) bay were found severely deformed, buckled and fractured, consistent with heavy impact damage. The underneath section of the fuselage were significantly damaged, deformed, wrinkled frames and aircraft skin, detached with broken belly fairing panels.

The floor panels and associated structures were heavily damaged. The skin was completely torn and the fuselage was almost separated between frame number 13 and 23.

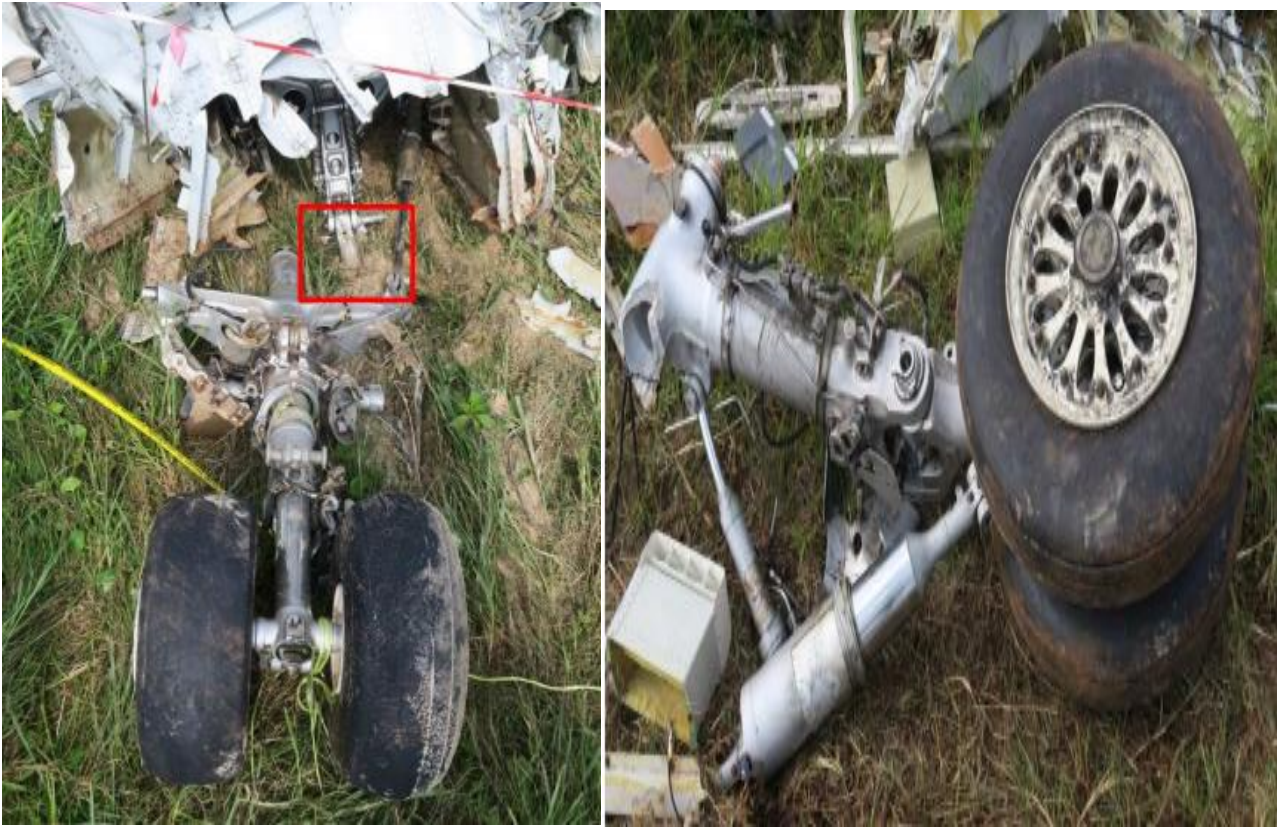
The right hand main landing gear was found in extended position and still attached to the aircraft structure. The left main landing gear was found separated from the aircraft, fractured at the middle of the upper leg and a deformed extension/retraction actuator.

The NLG assembly was separated from its main fittings but still attached to the actuator link. The connection with the drag brace was broken.

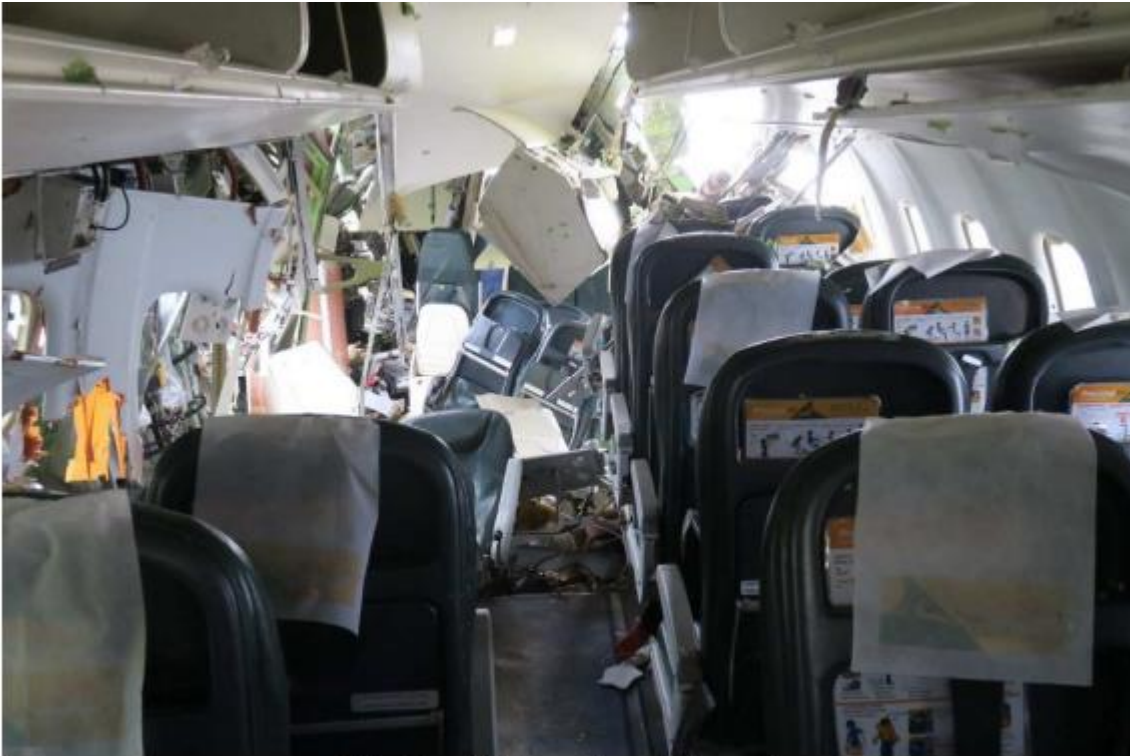
Cabin floor from seat row number 7 forward was significantly damaged, distorted and several passengers seats were partially or completely detached consistent with high energy impact with water sustained after the crash.

Forward cabin crew seat was in place but the aft seat was completely detached and was found outside the wreckage.
