**1970 LIGHTNING AND STATIC ELECTRICITY
CONFERENCE, 9-11 DECEMBER**

Sponsored Jointly By

AIR FORCE AVIONICS LABORATORY

SOCIETY OF AUTOMOTIVE ENGINEERS

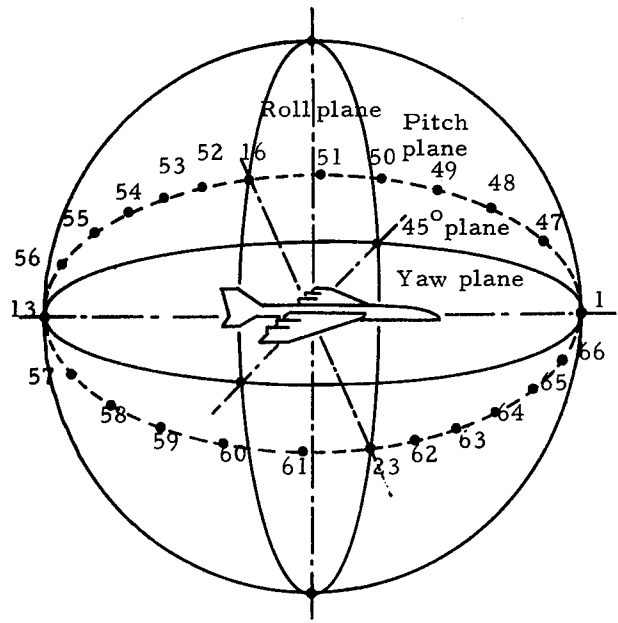
Figure 2. Sketch of 45° plane discharge probe positions at 15° increments.

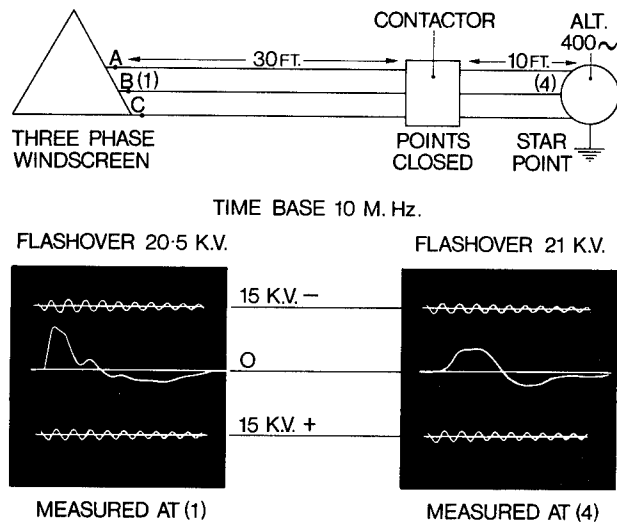
Fig. 5 - Typical power line voltage pulses; approximately 20 kV windscreen external surface flash.

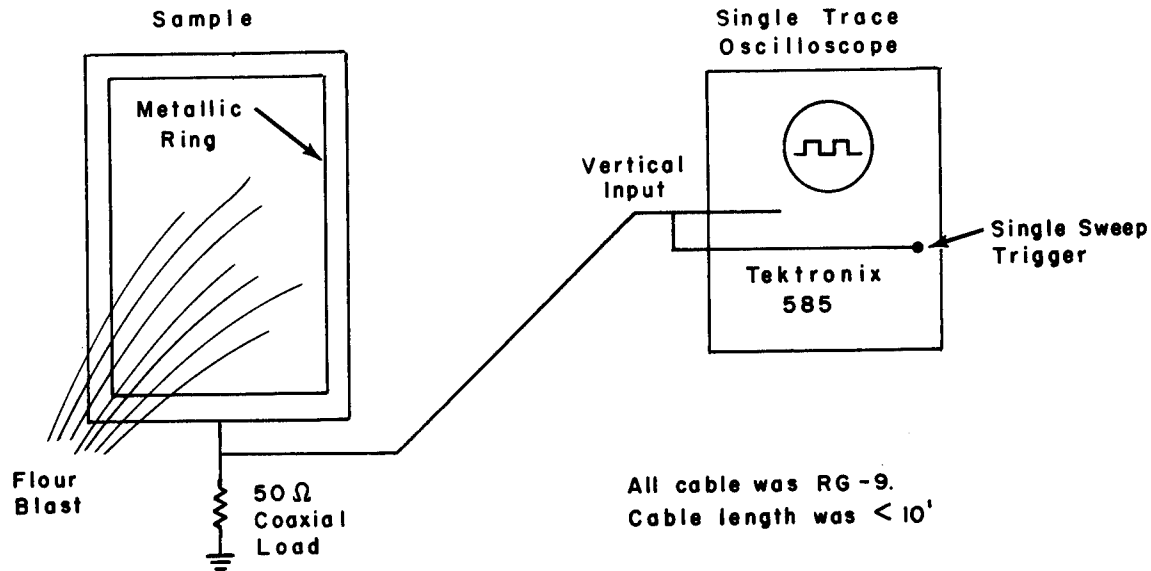
Fig. 8 - Pulse risetime measurement instrumentation

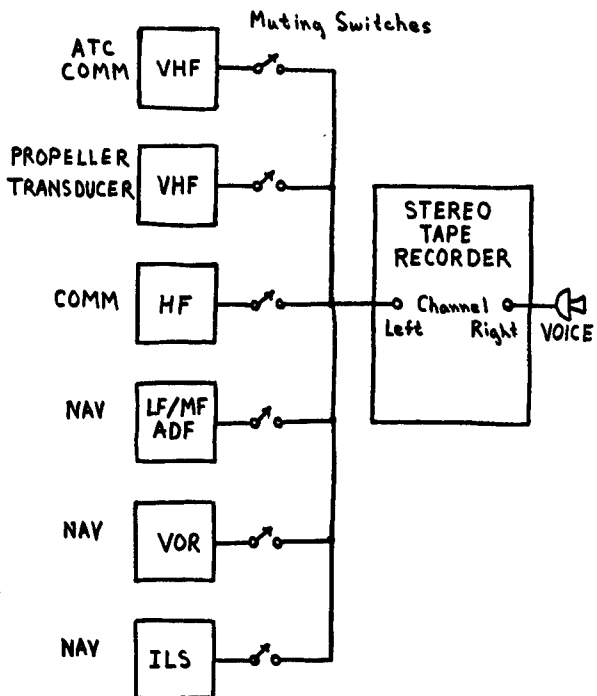
Figure 23 - Aural recording system.

A stereo tape recorder was also added to the instrumentation. One track was used to record voice notes, observations, etc. The other channel was used to record from the installed aircraft receivers. The intercom muting switches permitted selective recording from these receivers. With a common time base between the tape aural recorder and the strip chart discharger current recorders, and later field mill recorders, data could be gathered much more expeditiously for subsequent analysis.

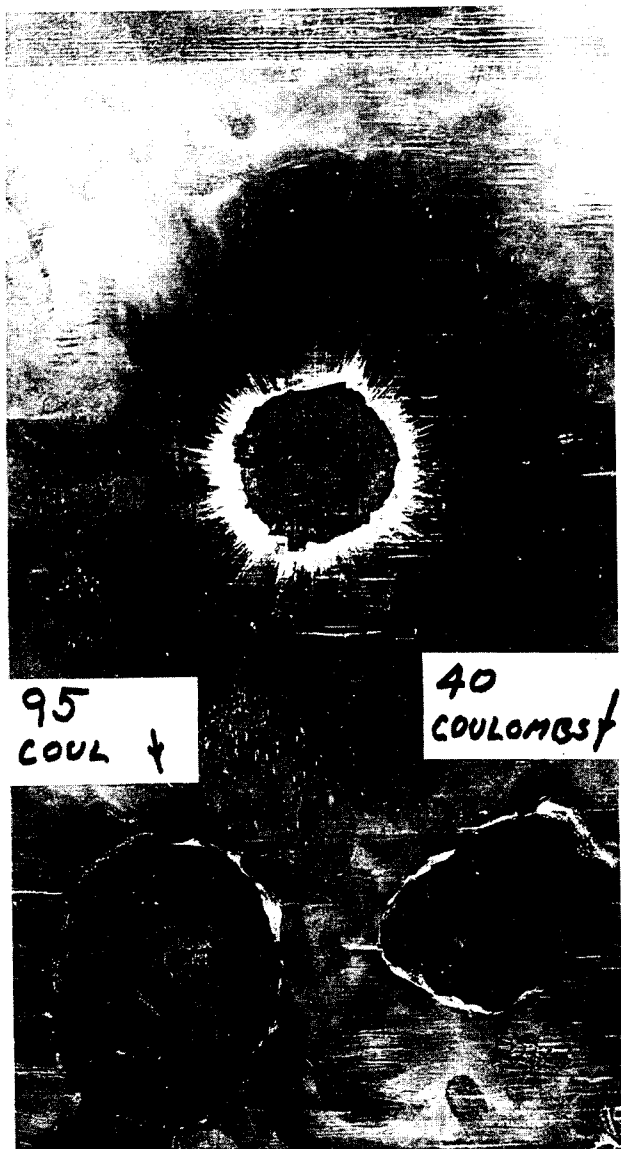
Fig. 3 - Panel B-3 (boron fiber epoxy) after exposure to 100 kiloamps (100 kiloamp discharge at top center - 95 coulomb and 40 coulomb discharges at bottom of panel were done later).

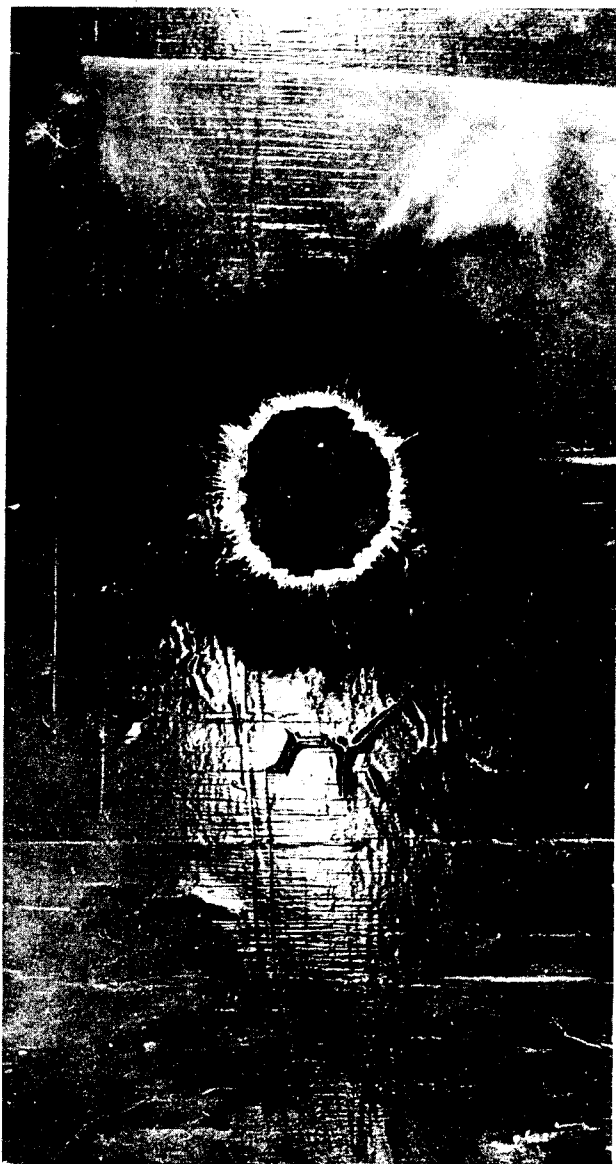
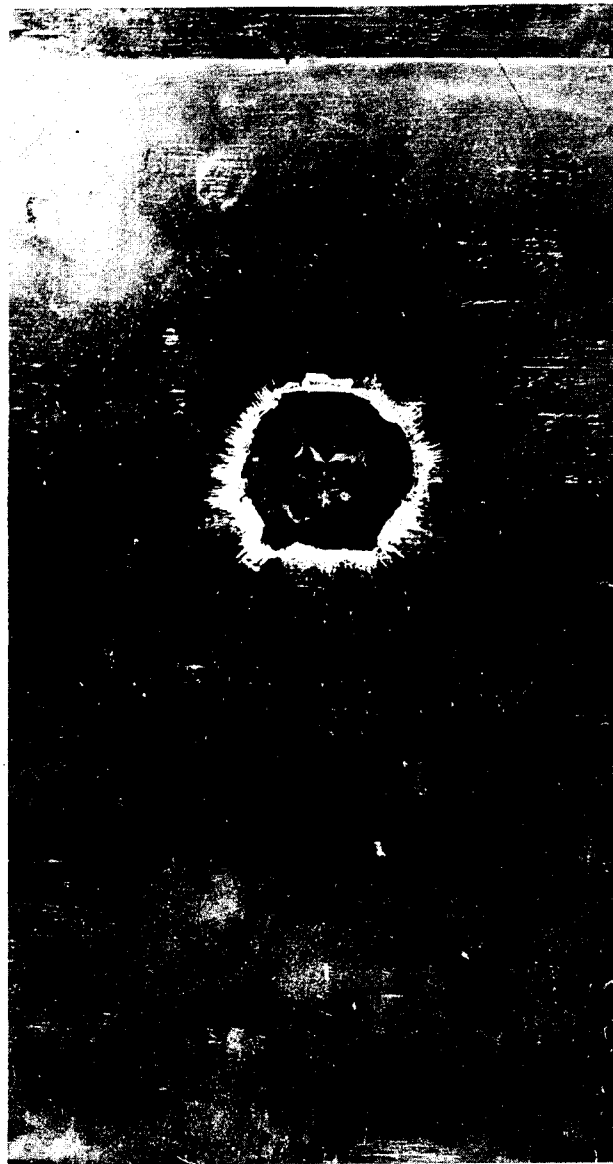
Fig. 4 - Boron fiber epoxy panels B-1 (left) and B-2 (right) after exposure to 100 kiloamps. B-1 had a 3 mil thick polyester film interlayer and B-2 had a 1 mil thick polyimide film interlayer.

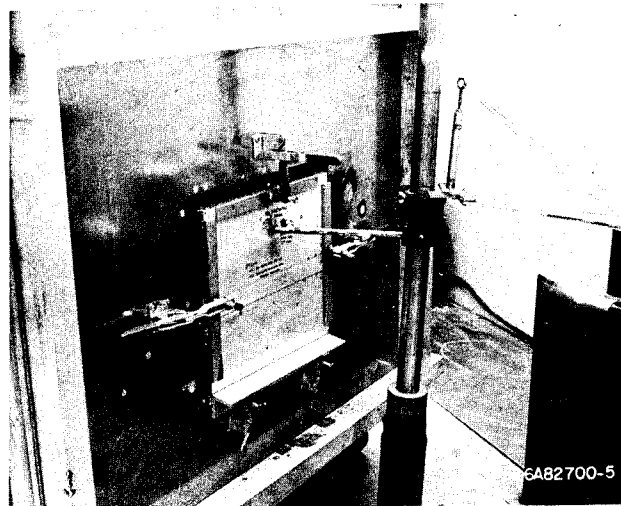
Fig. 16 - Laboratory setup for exposing test panels to simulated lightning strikes.

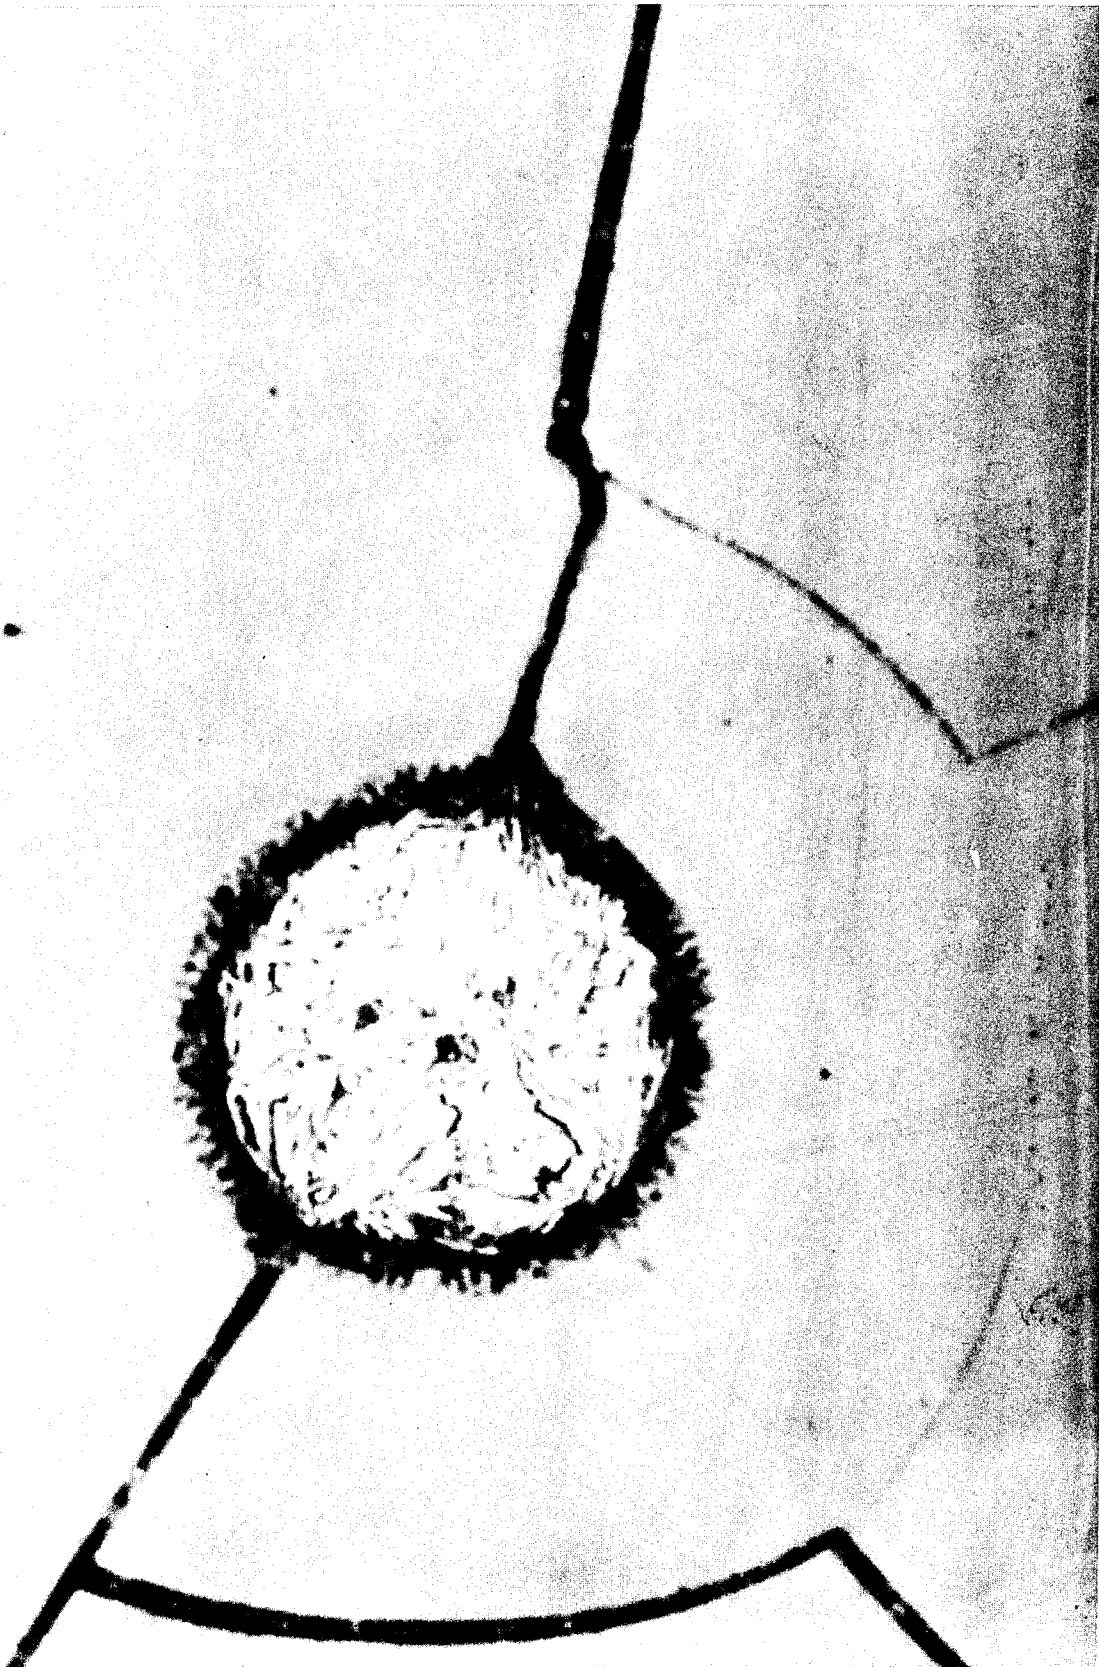
Fig. 22 - (2000X) View of core of damaged boron filament (BU #26)
that has been etched to show evidence of melting

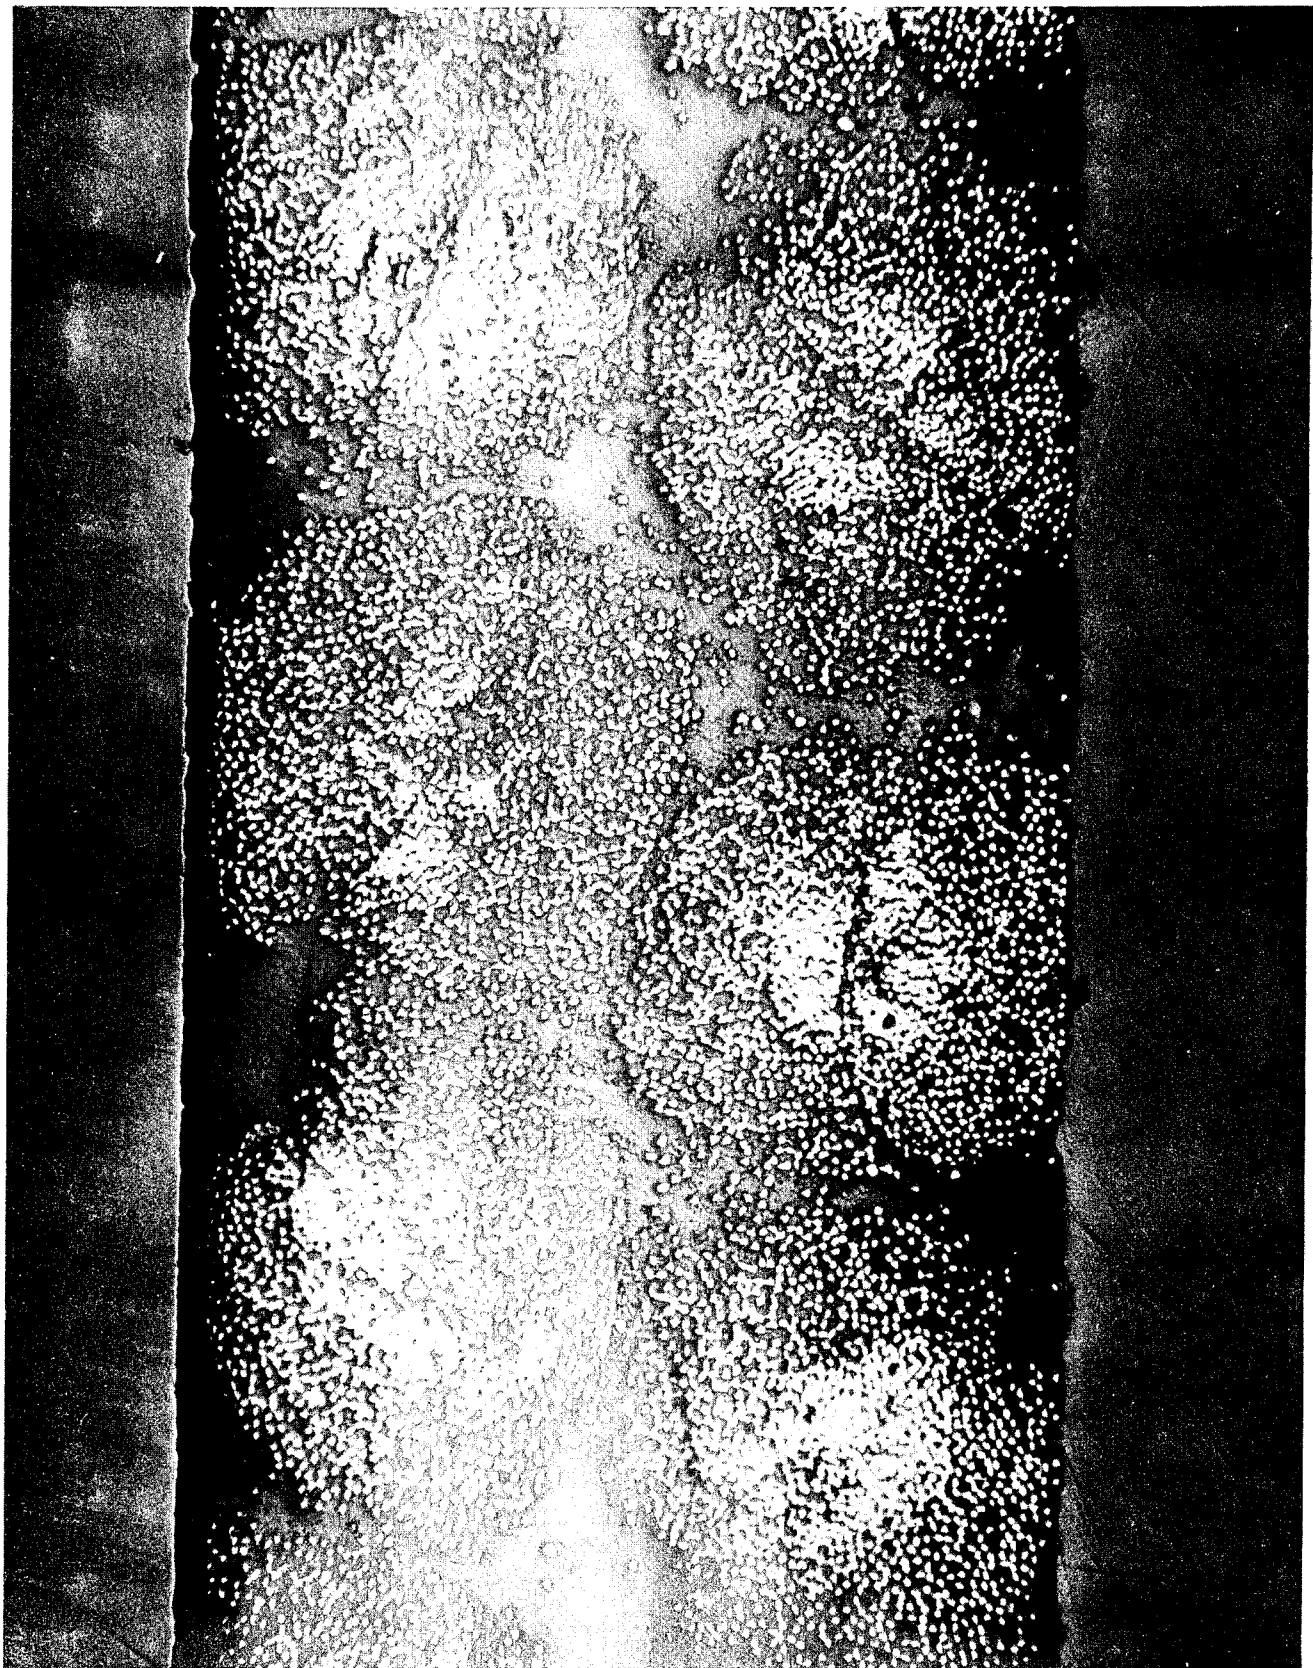
Fig. 30 - (100X) HMG-50/epoxy specimen after 13.04×10^4 amperes per cm^2 of filament crest current injection--no damage

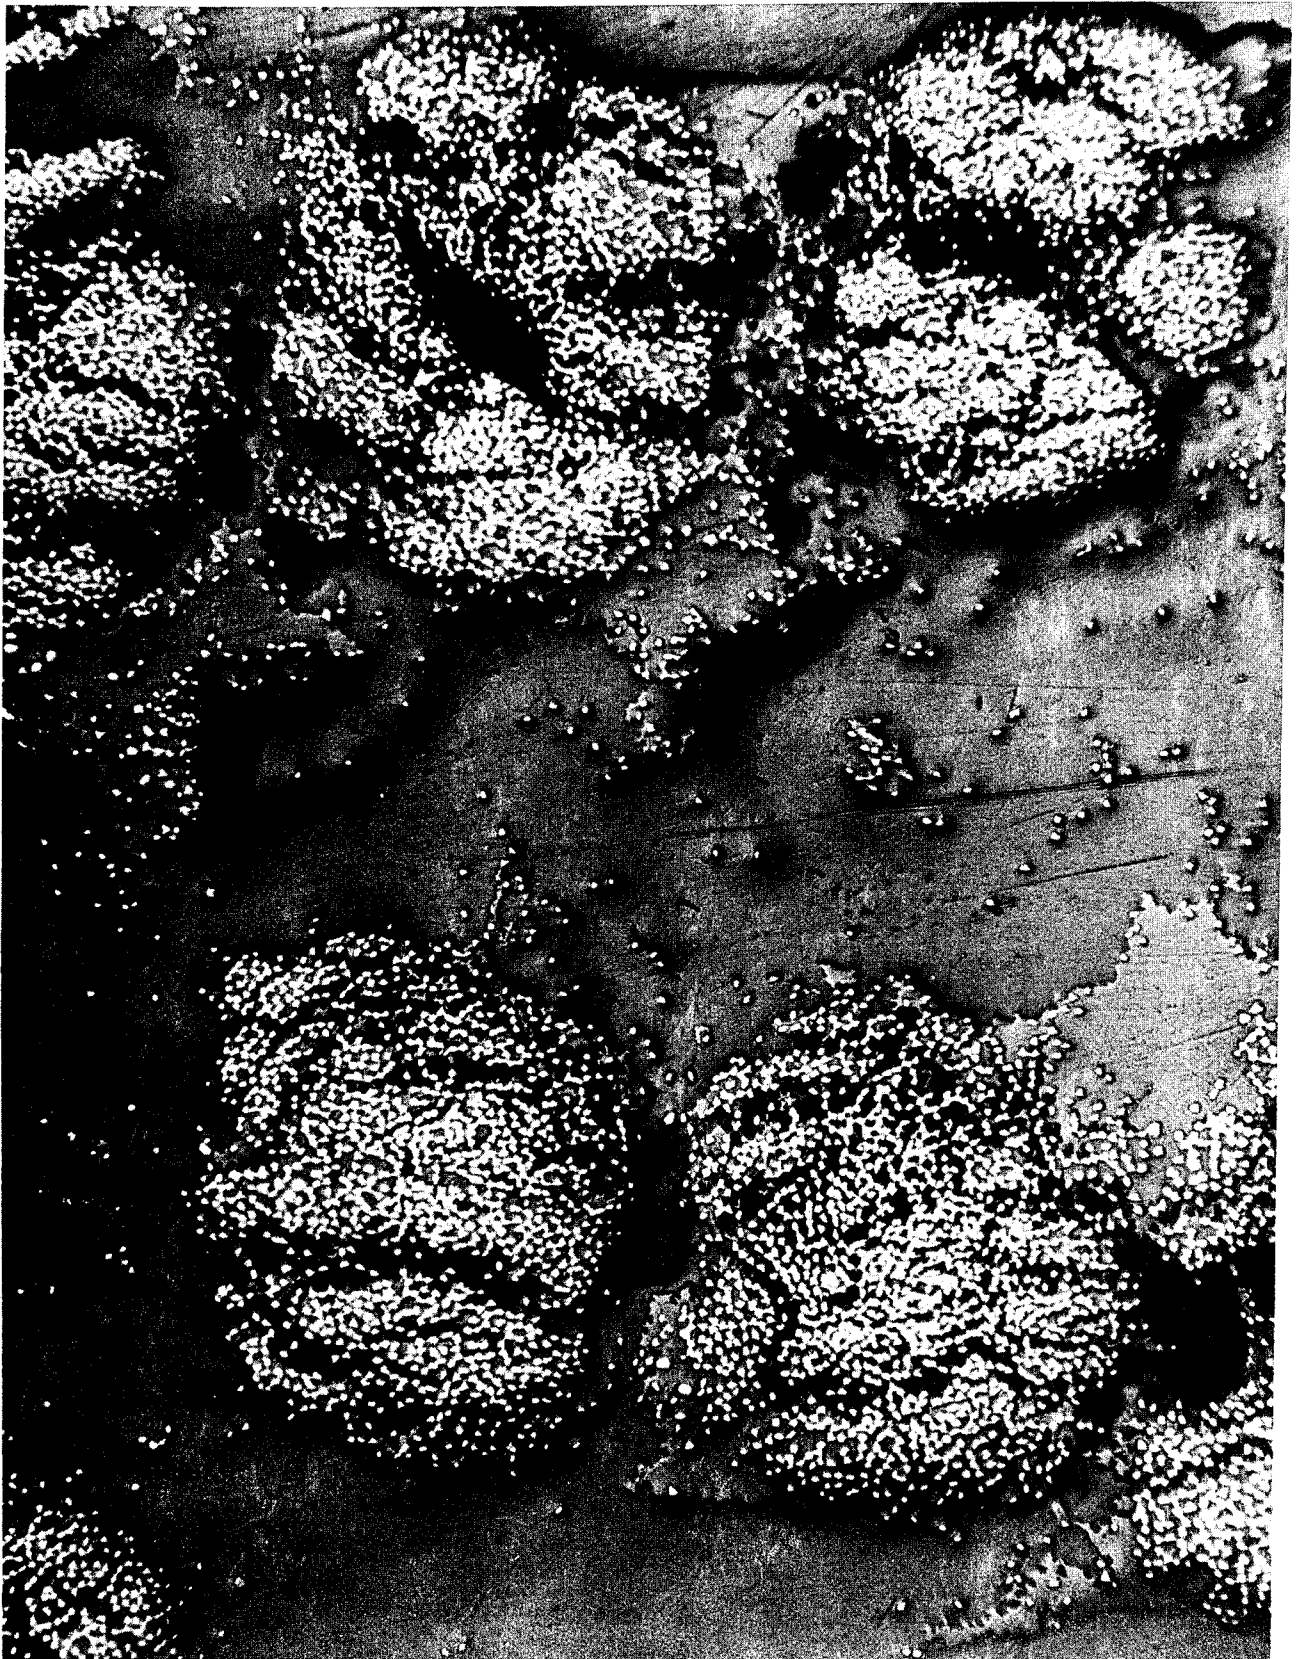
Fig. 33 - (100X) HMG-50/epoxy specimen after 55.8×10^4 amperes per cm^2 of filament crest current injection--severely burned and delaminated

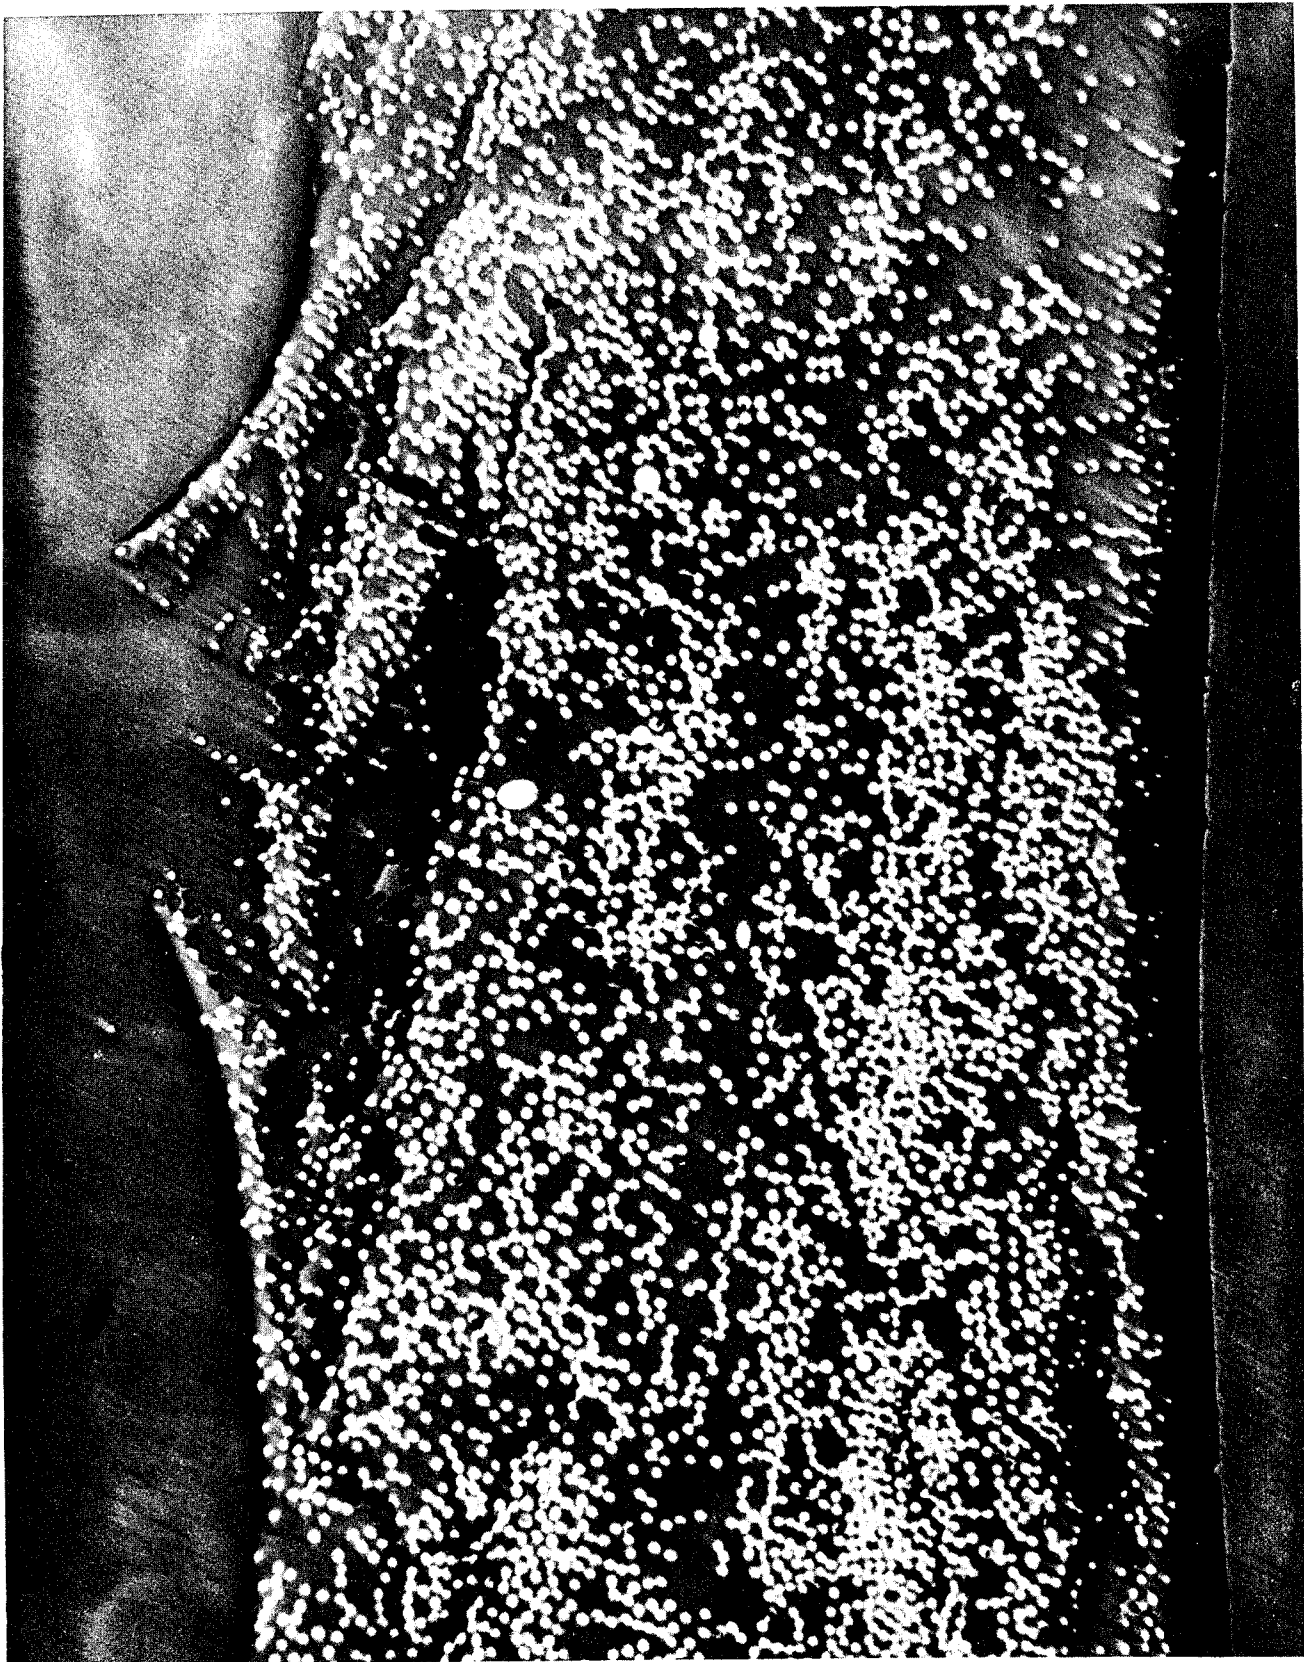
Fig. 37 - (100X) HM-S/epoxy specimen after 25×10^4 amperes per cm^2 of filament crest current injection--some burning and delamination
