**FINAL REPORT OF SERIOUS INCIDENT OF MYANMAR NATIONAL
AIRLINES CESSNA GRAND CARAVAN (Reg: XY-AMC) AT MANAUNG
DOMESTIC AIRPORT ON the 16th of NOVEMBER 2016**

SYNOPSIS

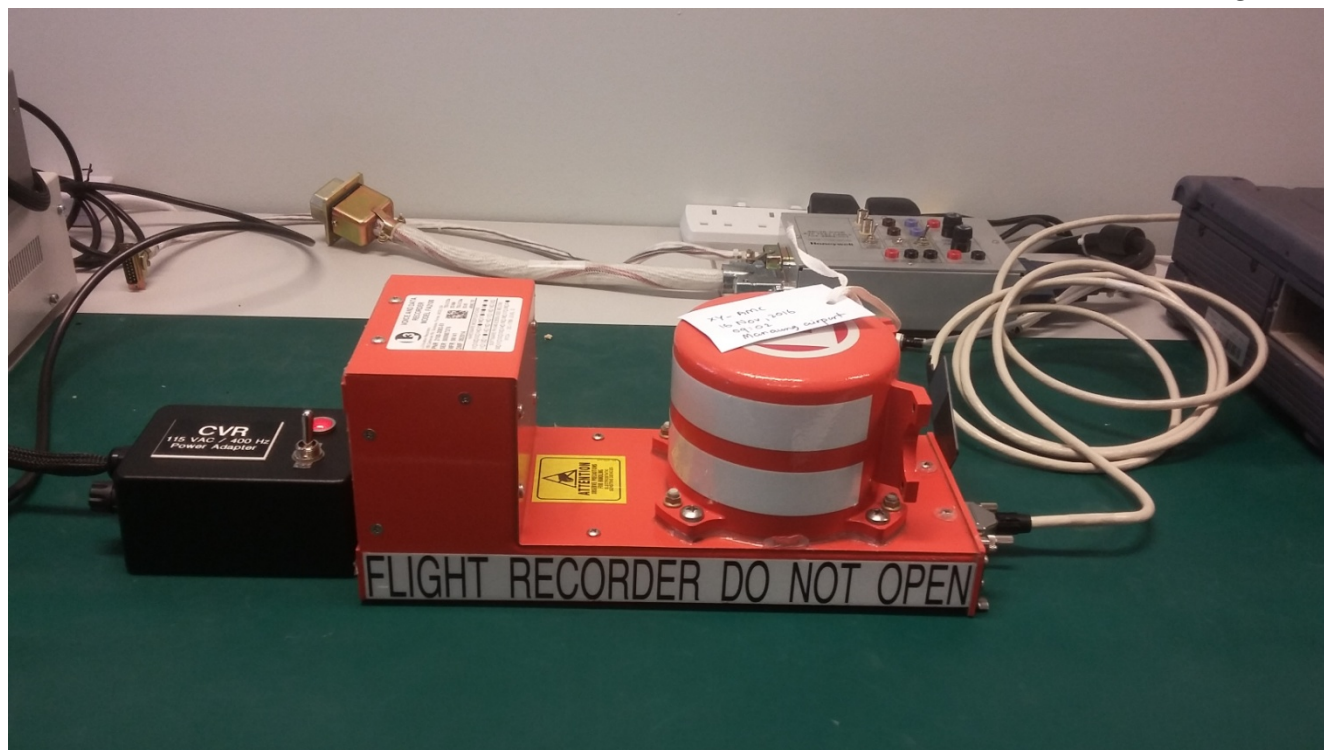
Figure: 13 Cockpit Voice Data Recorder (CVDR)

There was limited recorded data in the CVDR and it did not contain any parameters related to the condition of the tyres. As such, the investigation team was unable to determine if the right tyre was deflated before the aircraft landed.

No aircraft system defect or anomaly was observed in the recorded flight data parameters.

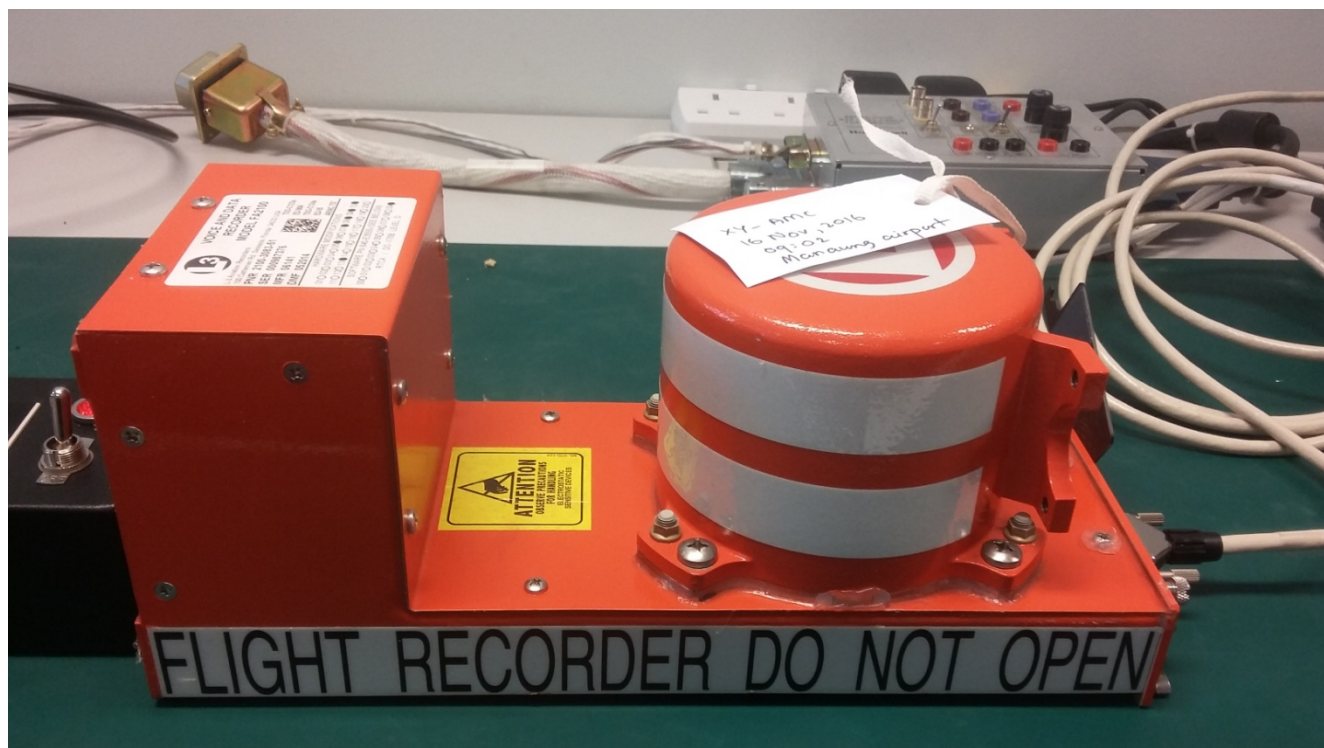
Figure: 14 Cockpit Voice Data Recorder(CVDR)

There was no damage observed to the flight recorders. The interface pins for both recorders were checked and they appeared to be in good condition.

The data downloaded from the CVDR was of good quality and comprised flight 16 data parameters and cockpit voice information recorded during the occurrence. No aircraft system defect or anomaly was observed in the recorded flight data parameters.
