DEPARTMENT OF THE AIR FORCE
HEADQUARTERS OGDEN AIR LOGISTICS CENTER (AFMC)
HILL AIR FORCE BASE, UTAH

February 14, 1995

Mr. Floyd Baham
Davis and Weber Counties Canal Company
138 West 1300 North
Sunset, UT 84015

The scope of work of this IPA was to investigate the possibility of over-irrigation on the golf course at Hill Air Force Base (HAFB), and its effect on degradation of the Davis-Weber Canal through seepage down the steep slope upon which the canal is located. A related issue dealt with the hydraulic consequences of a sudden (hypothetical) canal blockage due to a landslide, possibly caused by seepage and sloughing, and possible impact on an elementary school located 1,400 ft downhill from the canal.

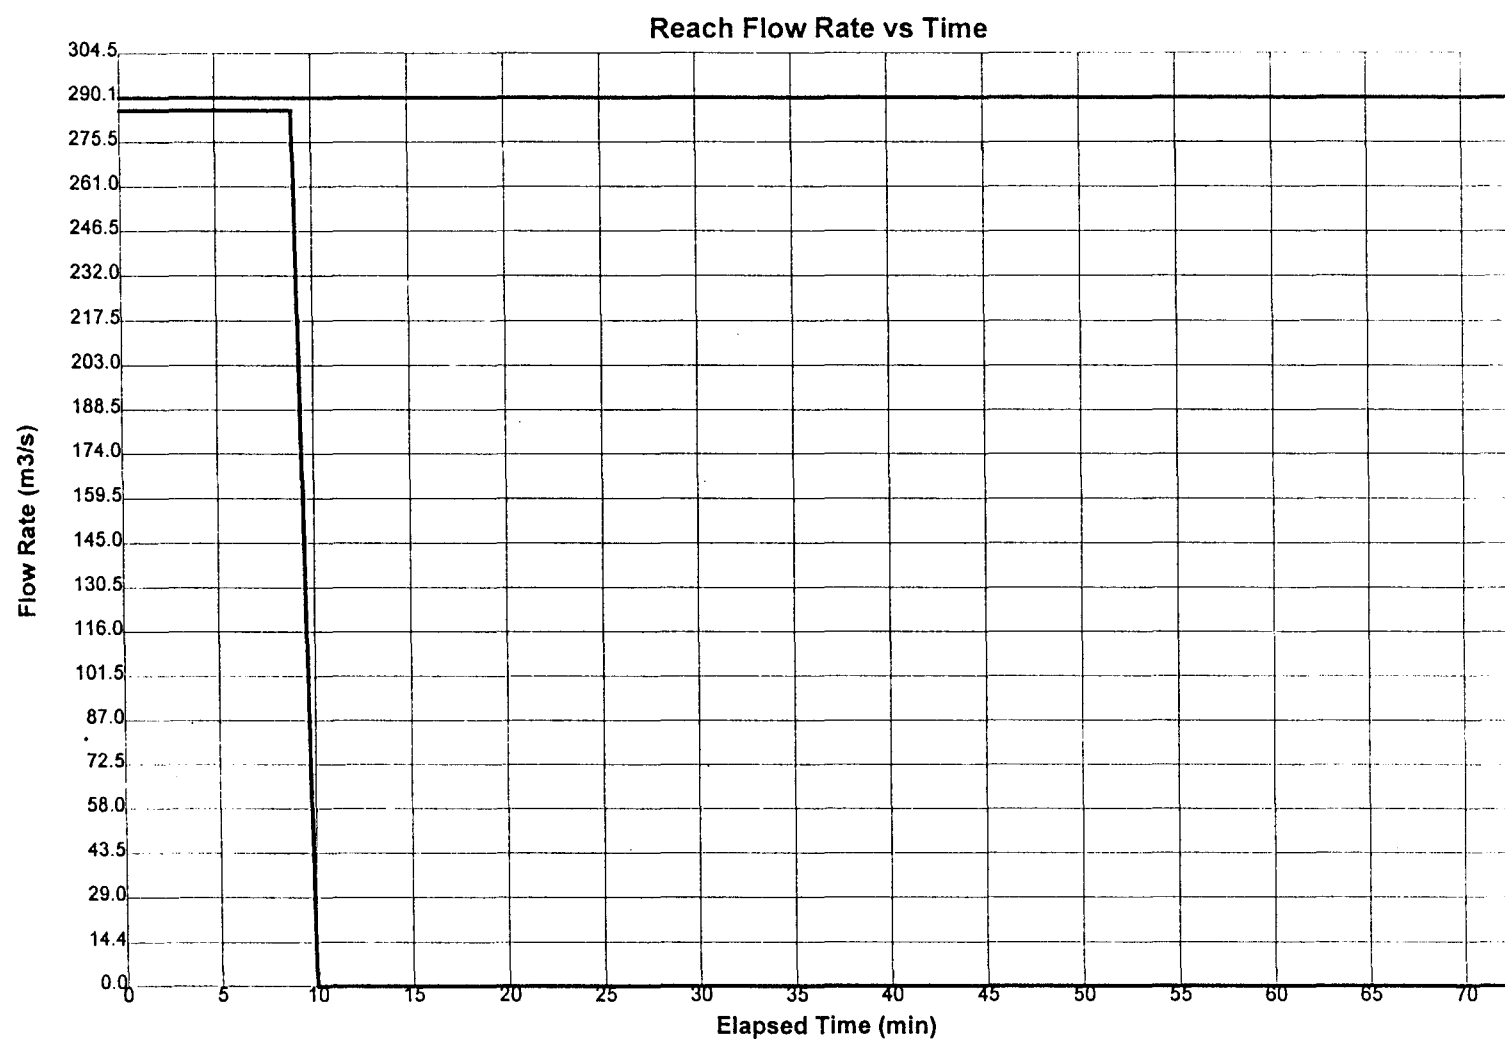
Figure 4. Reach Flow Rate vs. Time in the Simulated Davis-Weber Canal.

Simulation results from the **CanalMan** hydraulic model (Merkley 1994) are given in Table 4 and Figures 4, 5 and 6 (the spike in the curve at about 11 minutes elapsed time in Figure 5 is due to a temporary numerical instability in the simulation, and would not be expected to occur in the real canal). The simulation began with a steady-state condition and 290 cfs inflow. The steady-state outflow

The spill from the canal at the point of blockage would, of course, move downhill. Some of the water would be intercepted by the Bambrough canal, and some would flow along drainage ditches between the irrigated fields below. Nevertheless, the full-flow capacity of the Davis-Weber Canal would also cause some flooding of the fields and beyond. The velocity of the flow would slow down considerably as it spreads out over the relatively flat irrigated areas. Also, some of the flow would initially infiltrate into the soil, but for the following calculations it is assumed that the full 286 cfs continues over the fields.

Using a conservative (small) flow width of 50 ft, and assuming a 2% slope towards the school, the flow depth would be in the neighborhood of 1.2 ft. This can be determined by applying the Manning equation (Henderson 1966) with a roughness value of 0.050. This depth would decrease in the downstream direction as the flow spreads out and more water infiltrates into the soil. However, the flow velocity at 50 ft wide, 1.2 ft depth, and 286 cfs would be 4.8 ft/s, arriving at the school no sooner than $1400 \text{ ft} \div (4.8 \text{ ft/s} \times 60 \text{ s/min}) = 4.9 \text{ min}$. Thus, the full flow of the canal breach would not arrive at the school before about $25 + 4.9 \approx 30 \text{ min}$, and the depth of water at the school would be less than 1.2 ft. Being worst-case conditions (full canal flow and complete blockage), the time to arrive at the school would likely be more than 30 min.

Taking a more realistic flow width of 500 ft over the fields, the depth would be approximately 0.30 ft (3.6 inches). Due to soil infiltration and some interception of the flow by the Bambrough Canal and other open ditches in the fields, the actual depth may be closer to 1 inch when arriving at the school. Also, at the assumed flow width of 500 ft, not all of the school grounds would be affected.

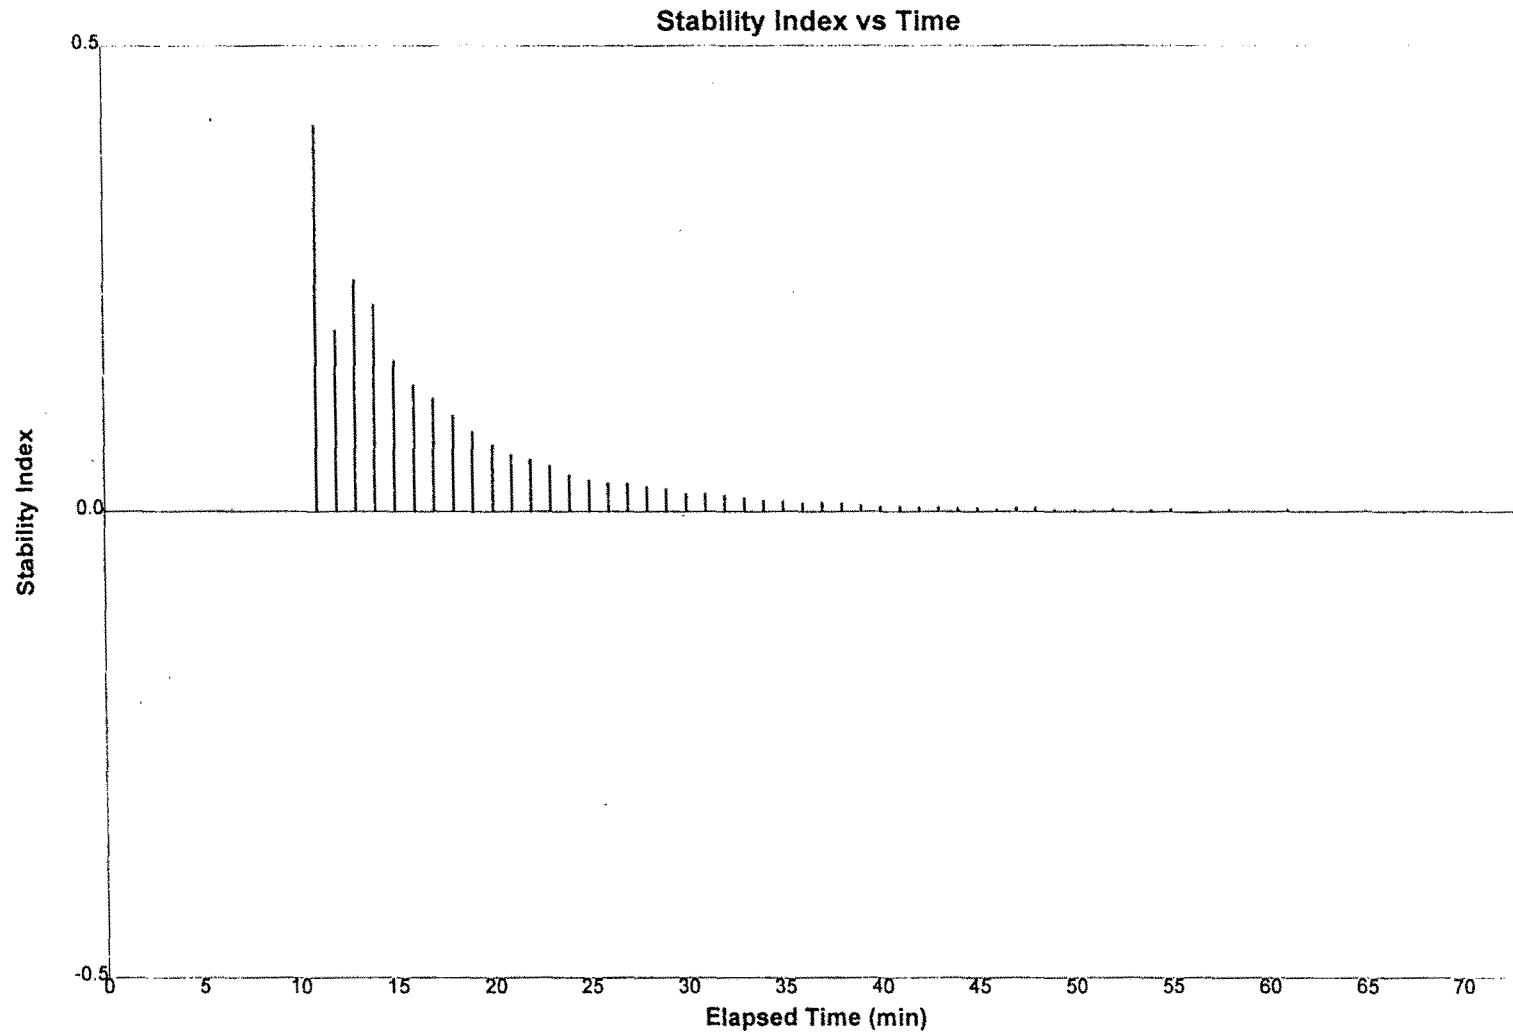
Figure 6. Hydraulic Stability in the Simulated Davis-Weber Canal.

Note: The "Stability Index" is the ratio defined as $(Q_{in} - Q_{out}) / (Q_{in} + Q_{out})$, where Q_{in} is the total inflow and Q_{out} is the total outflow (including seepage loss).

From the hydraulic modeling results on the Davis-Weber Canal for complete blockage under full-flow conditions, it can be argued that flooding from a canal breach would not be a threat to human life. Property damage would be expected due to erosion, especially in the steep slope below the canal, and in some of the fields beyond. However, the flow depth at the elementary school, some 1400 ft from the canal, would probably be less than 3 inches. The flood waters may not even cross the school grounds at all, especially if the breach were to occur in the canal at a location further east or further west from the school's position. As far as the school is concerned, flooding from a canal breach would be nothing more than an inconvenience, but possibly with minor property damage. In any case, a more detailed study would be required to provide a more accurate description of the flooding from a canal breach.
