Investigation of the M6.6 Niigata-Chuetsu Oki, Japan, Earthquake of July 16, 2007

Open File Report 2007–1365

U.S. Department of the Interior
U.S. Geological Survey

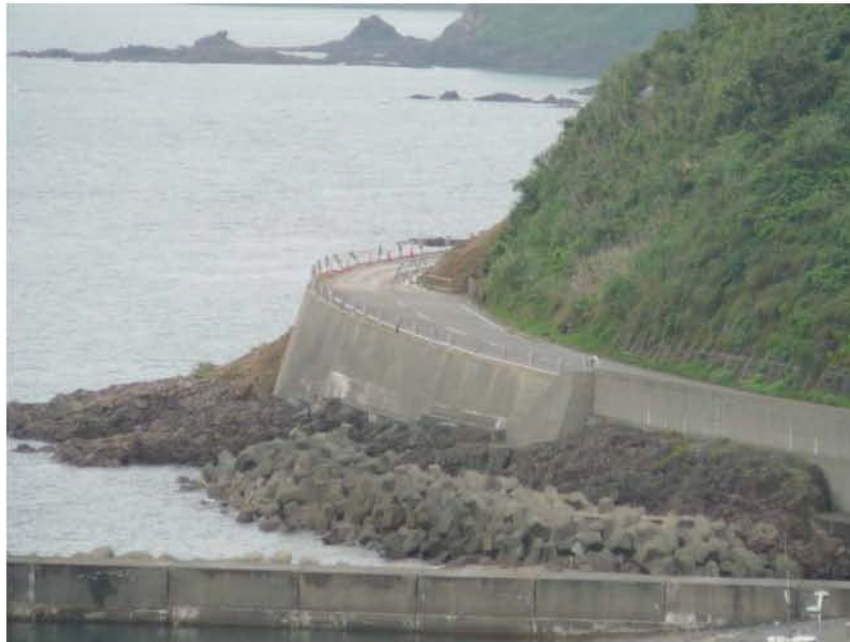
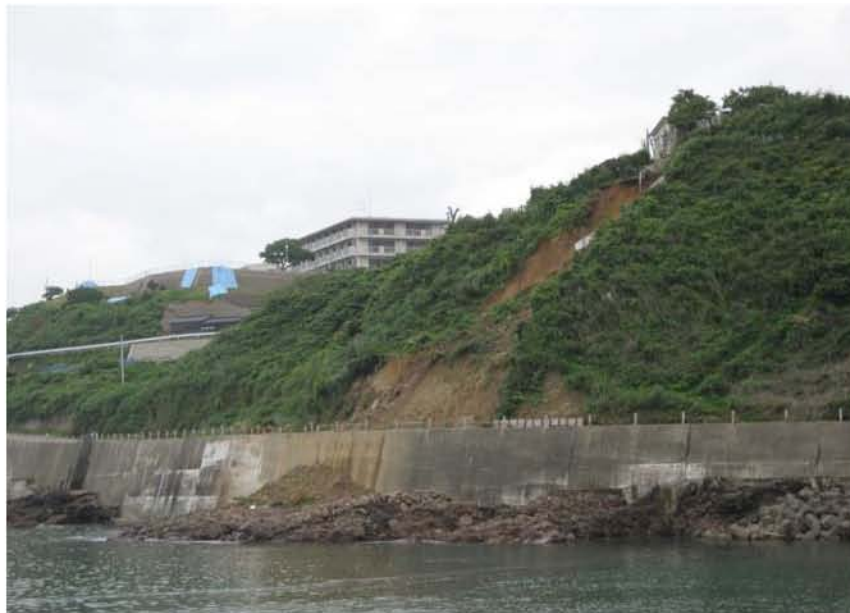
Figure 3.1: Shallow colluvial landslide located just north of the Kasashima Fishing Village, Site RK22/SA10; N37.33802° E138.46995°, photos taken 7/20/07 15:57 (top) and 7/21/07 13:35 (bottom). Dimensions are approximately 36 m wide, 24 m tall, 2 m thick. The lithology is composed of 24 m of weak mudstone overlying 6 m of more indurated, brecciated mudstone, which outcrops at the road. A 10 m tall concrete seawall leads down to the brecciated mudstone shore platform. The slide occurred in weak mudstone/colluvium, sliding over the brecciated mudstone, onto the road, and over the edge of the concrete seawall, spilling debris onto the shore platform at ocean's edge.

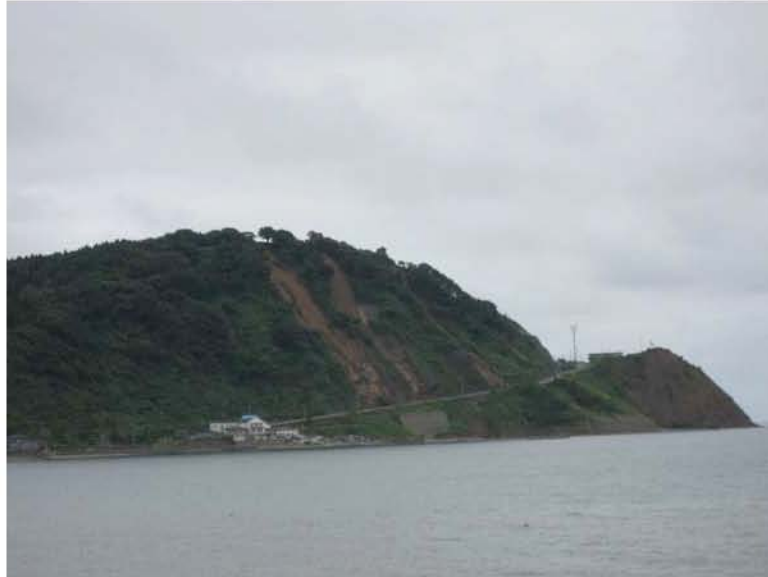
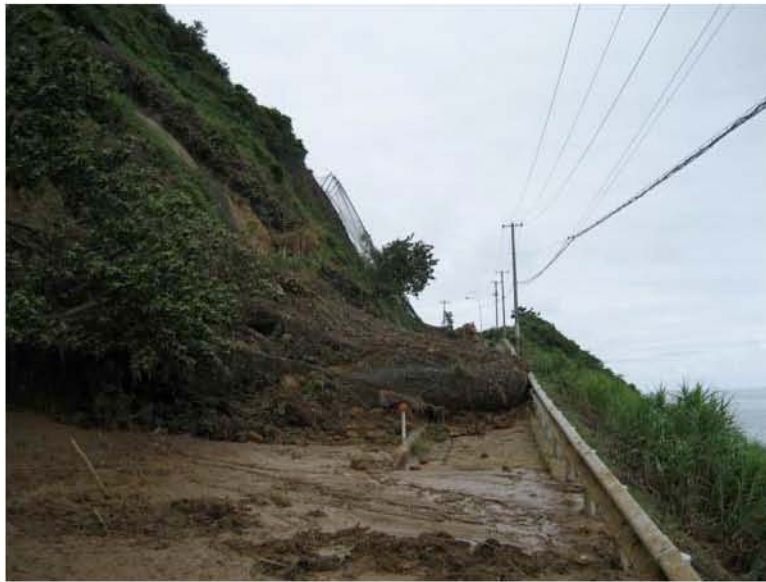
Figure 3.2: Coastal landslides on Highway 352 north of Kashiwazaki-Kariwa Nuclear Power Plant at road closure south of Route 373 (Site RK34; N37.48455° E138.62435°, photos taken 7/22/07 at approx. 10:45). This area consisted of at least eight individual slides. The landslide shown in the bottom photo consists of a slide in an area of previous instability - a shotcrete stabilization system is in effect for the bottom 50 m of this slope (total slope height is ~115 m), and overlain with a wire-mesh rock deflection system. The slide is approximately 50 to 60 m wide, 65 m long, and less than 1 meter thick. The landslide initiated above the shotcrete slope, moved into the wire-mesh and caused failure of the meshing and pull-out of the steel supports. The wire-mesh restrained most of debris, depositing the majority on the road, with only a slight quantity of the debris sliding over the road edge. The failure plane inclination is approximately 60°.

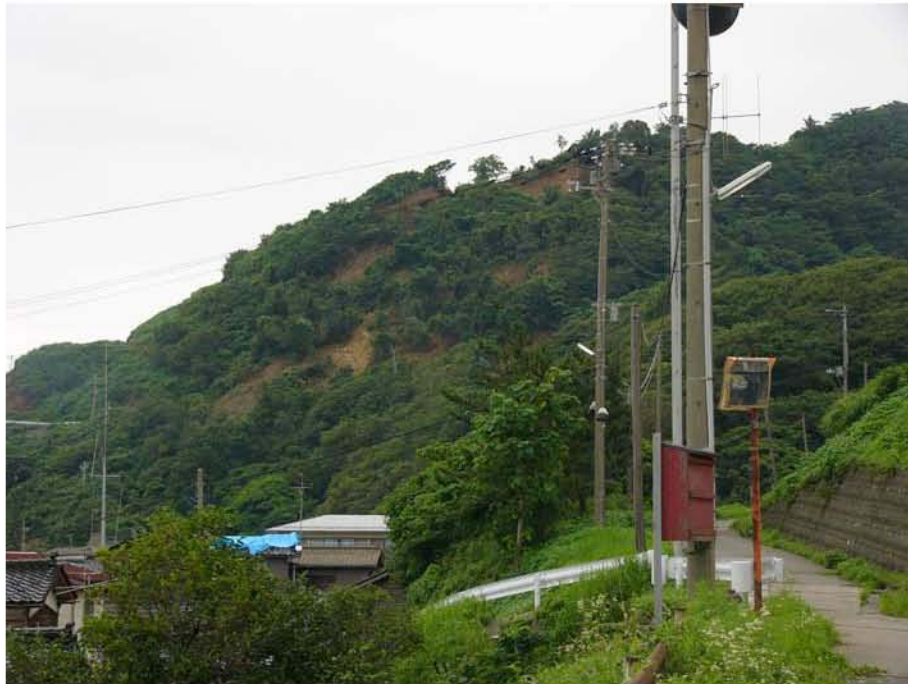
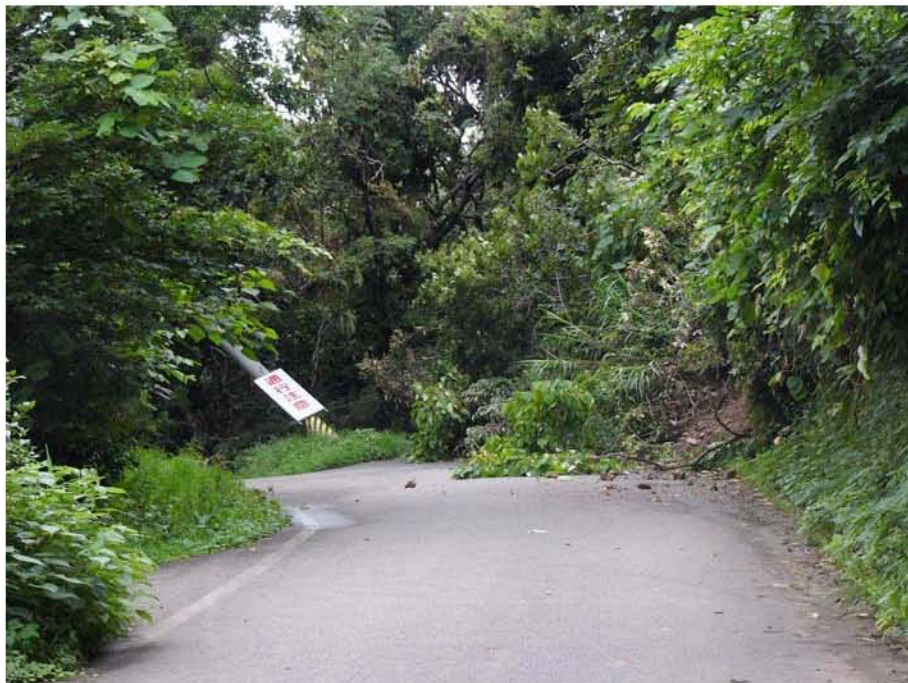
Figure 3.4: Yoneyama Landslide, located south of Kashiwazaki (Site YT17; N37.32223° E138.43828°, photos taken 7/21/07 at approximately 15:20). This slide marked the southwest-most limit of observed landslides along the Sea of Japan coast. The slide extended to the full height of the slope and blocked a paved coastal access road.

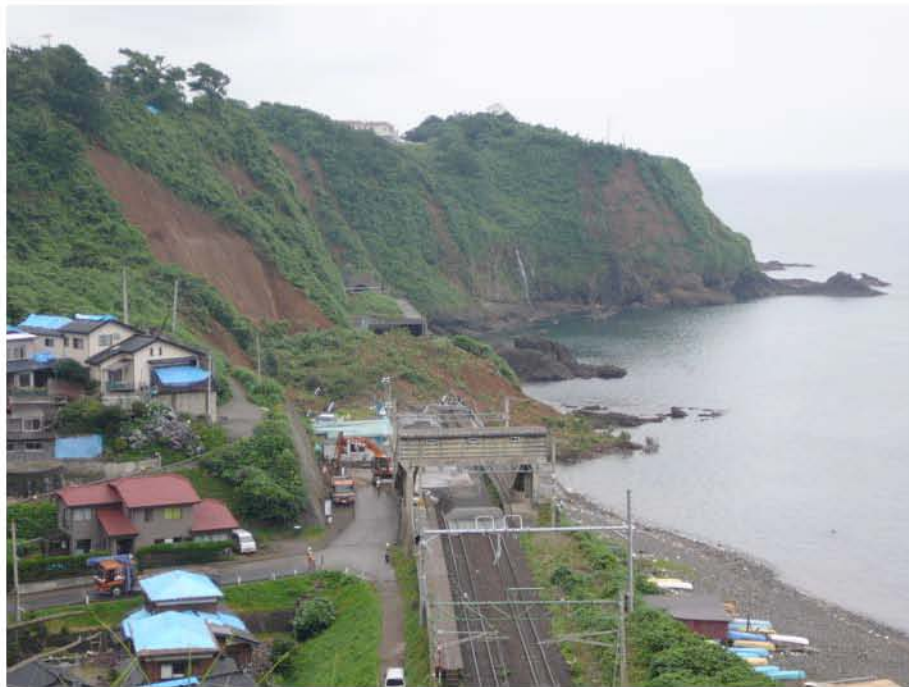
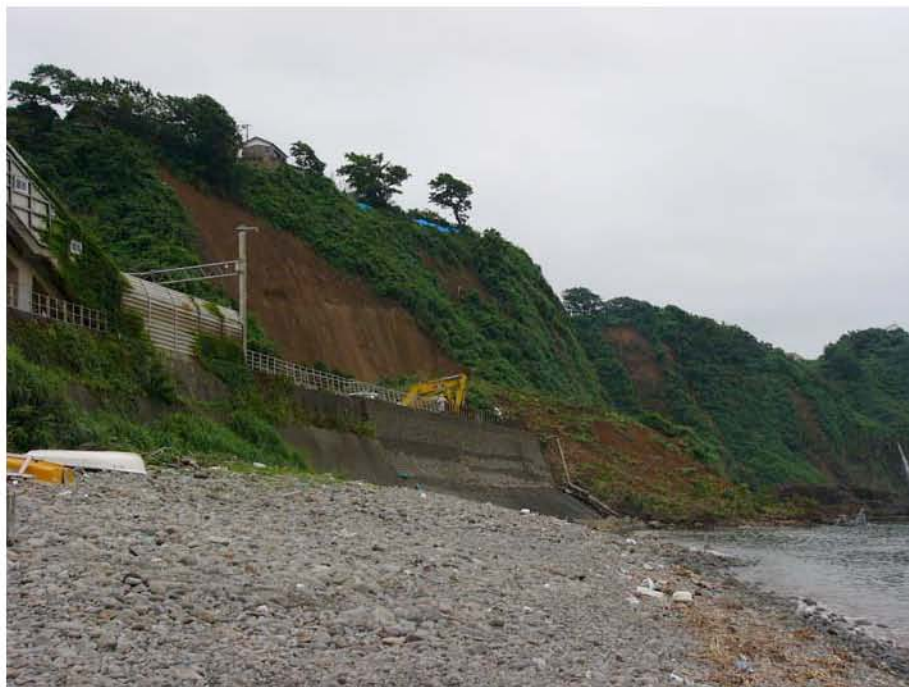
Figure 3.5: Landslide at the Oumigawa Train Station on the Shin-etsu Line (Site RK20/SA9/YT16; N37.34200° E138.48888°, photos taken 7/21/07 12:48 (top) and 7/24/07 15:00 (bottom)). This was among the largest of the coastal landslides to the south of Kashiwazaki. Site access was not possible due to construction repairs. Note that slope stability in this area has been a problem, as seen by the railway tunnel protection structure immediately behind (to the south) of this landslide. Many more smaller landslides were observed to the north and south of this location.

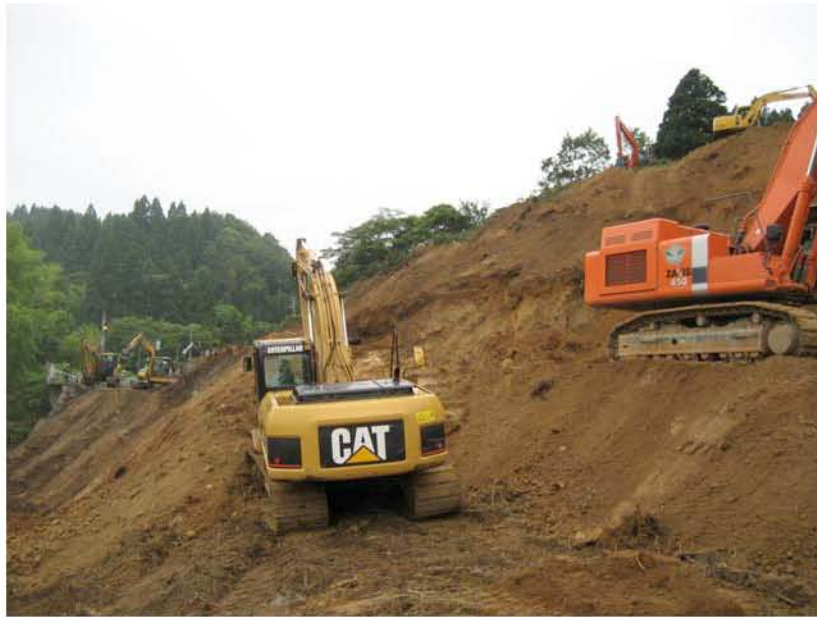
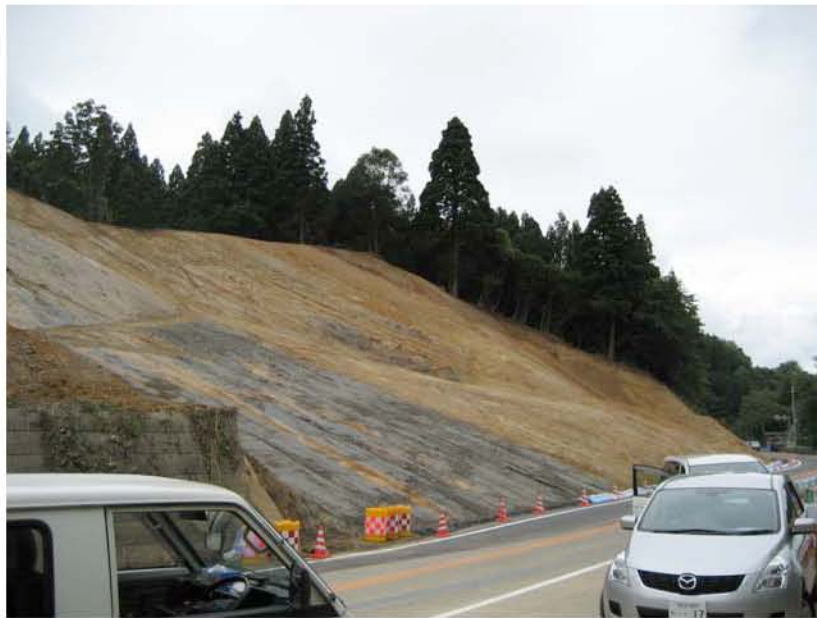
A large, deep, rotational slide occurred in weak mudstones and colluvial materials fairly far (~10 km) inland from the coast. The Ozumi Senbon landslide (Fig. 3.6) consisted of approximately $150,000 \text{ m}^3$ of total displaced material and led to destruction of a large road section on Route 8. According to on-site construction personnel, the slide plane was located at a depth ranging between 6 and 11 meters. Nearby to this site, several debris slumps/colluvial slides were also observed, however these required only

Figure 3.6: Ozumi Senbon Landslide at Highway 8 north of intersection with Route 252 (Site RK1/YT1; N37.41422° E138.71347°, photos taken 7/20/07 10:24 (top) and 7/23/07 13:04 (bottom)). This slide is approximately 150 meter wide, 100 meters long and 10 meters deep. According to construction personnel at the site during the reconnaissance, the slide plane occurred near the colluvial/bedrock interface, at a depth of between 6 and 11 meters. Signs of rotational movement were noted from back-rotated guardrails at the toe of the slide. This landslide forced closure of both lanes of traffic along Highway 8, just north of the intersection with Route 252, however both lanes had been reopened as early as 8 days following of the earthquake when reconnaissance team members revisited the site. Bottom photo shows excavated slide and subsurface bedrock lithology and structure.

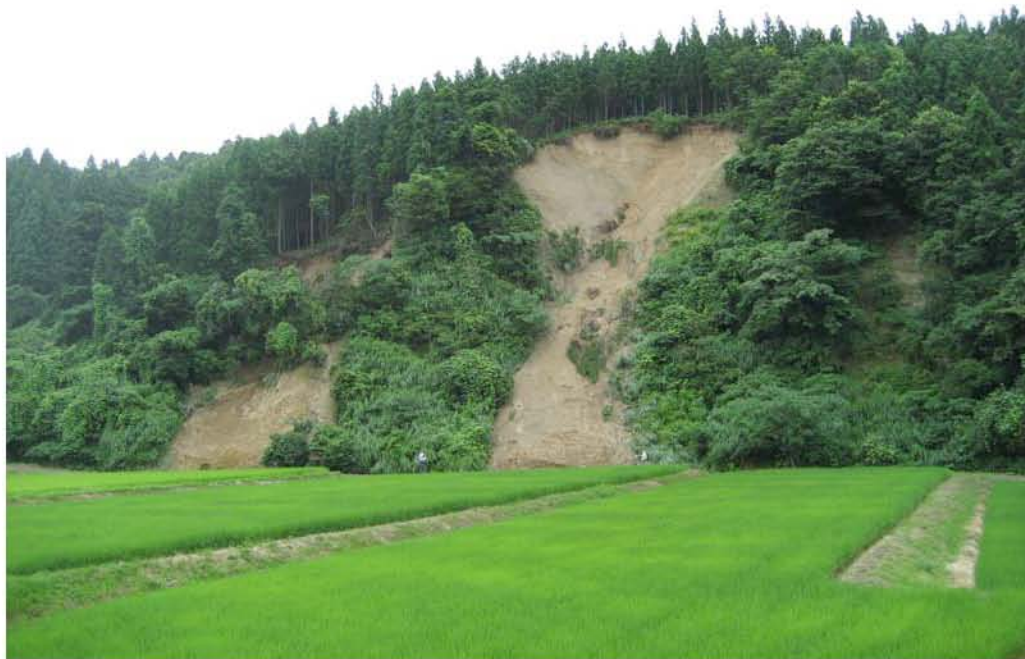
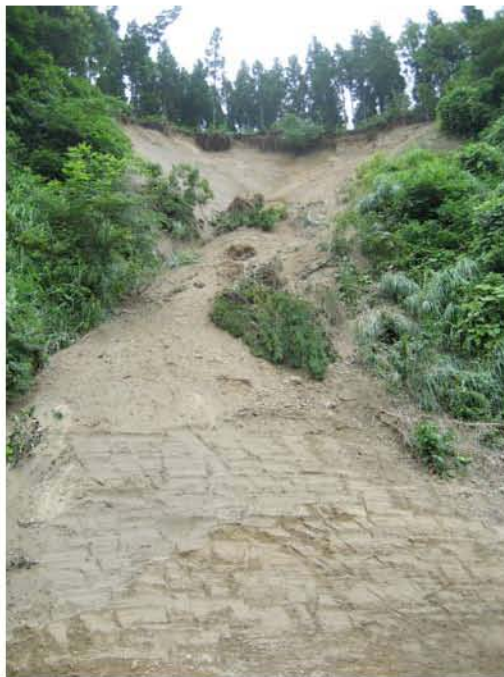
Figure 3.7: Ozumi-Mishimayamachi Landslides (Site RK2/YT2; N37.44057° E138.70467°, photos taken 7/20/07 at approximately 11:30). These slides occurred on a native hill slope and consisted of debris slumps in mudstone/siltstones and colluvium materials. High-resolution, topographic data was collected of these landslides using the terrestrial LiDAR scanning method.

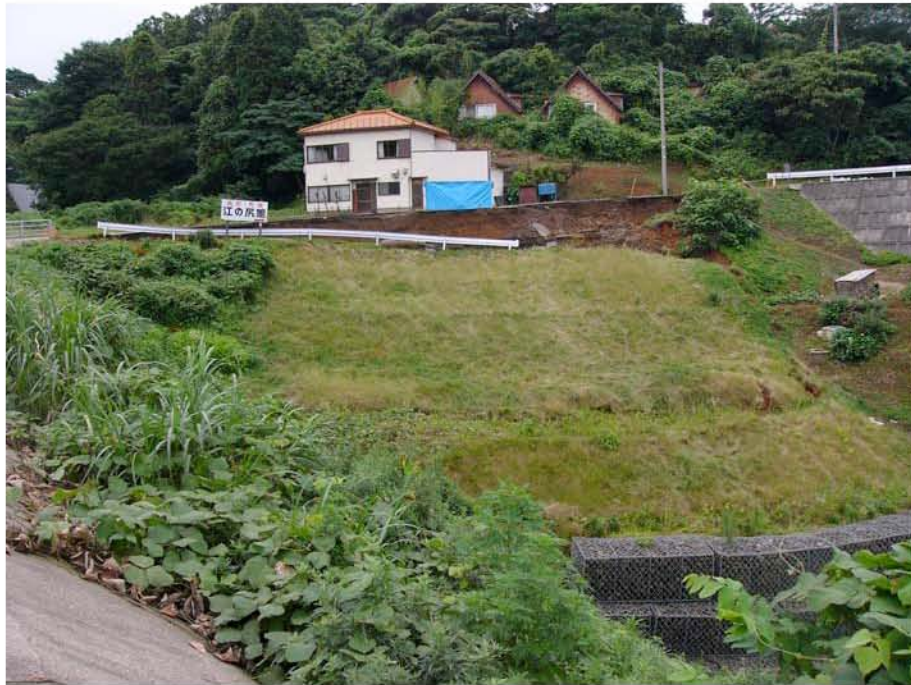
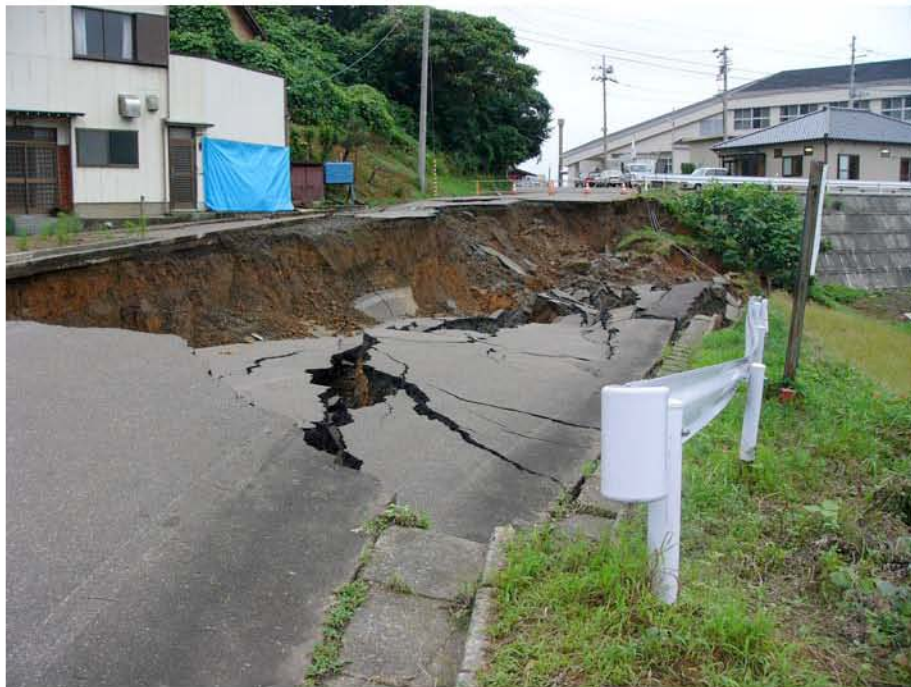
Embankment failures were typical in road fills along the coast (Fig. 3.8), and were also observed at three sites located further inland (e.g. Figs. 3.9 - 3.10). Embankments underwent from 10 cm up to one meter of vertical displacement (Fig. 3.8), extending between 10 and to 60 meters in length. Three embankment failures required full closures of roads, and/or protection with tarps to reduce rainfall infiltration and the associated potential for additional movement. Among these was a 15-meter high, 97.5-meter wide, earth-fill dam located to the east of the region (Fig. 3.9), where cracking through the midpoint of the crest was observed. However, the dam was not storing water at the time of our visit and the reservoir had not been filled recently. Further, from on-site design documents, it appears that the normal water level is typically 8 meters below the crest of the dam. At a water supply dam located southwest of the city of Kashiwazaki (Fig. 3.10), cracking of the crest was also observed along with minor concrete cracking and spalling on the upstream side. Here, the reservoir water level was within several meters of the dam crest at the time of observation.

Figure 3.8: Road embankment failure off Route 8 on the way to Kasashima (Site YT18; N 37.33325 ° E 138.46500°, photos taken 7/21/07 at approximately 15:40). The slope appears to have undergone previous stabilization using slope grading and gabion baskets to support the toe.

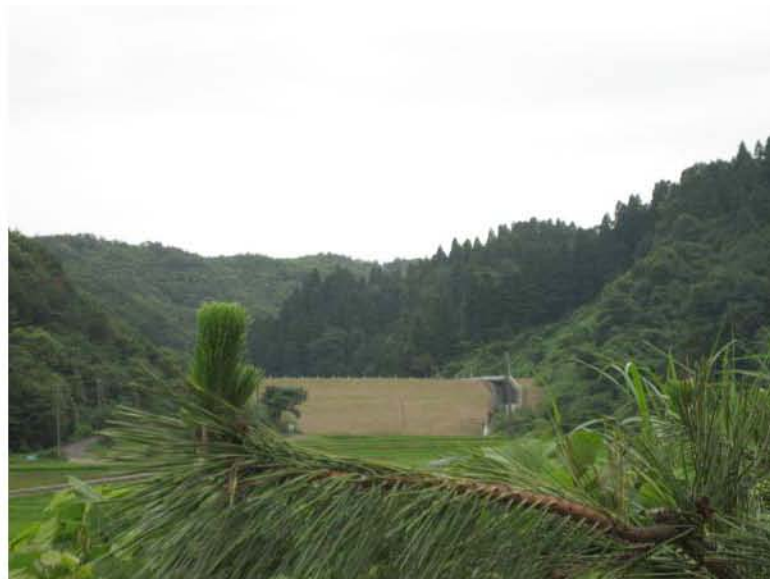
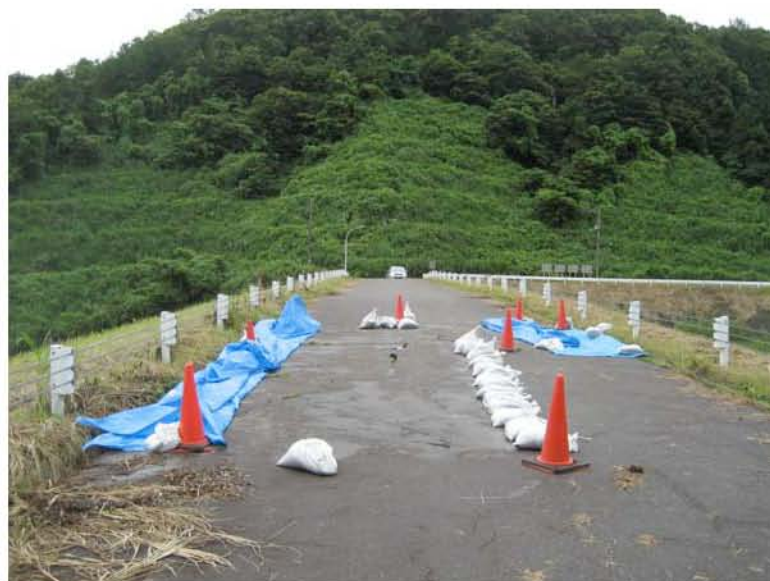
Figure 3.9: Embankment cracking and settlement of South Dam near Miyamo Parking Area along Highway 8, Nagaoka-Shi region (Site RK50; N37.43267° E138.73674°, photos taken 7/23/07 at approximately 11:15). The dam is a 15-meter tall, 97.5-meter wide earth fill structure with 3(H):1(V) downstream and 3.5(H):1(V) upstream benched slopes. Crest elevation is 63 meters and normal pool elevation is 55 meters. Observations were made of an embankment slope failure along the crest of this dam, through half the crest width (~4 m). Settlement and deformation occurred along a 10 m long section with up to 4 cm each of lateral and vertical deformation in the down slope direction. Contour-parallel ground cracking (2-4 cm wide, 1-2 m long) along the ground-spillway interface were also observed, two-thirds of the way down the dam face. The reservoir was empty and appeared to not have been filled in some time judging by the height of vegetation growing in the reservoir area.

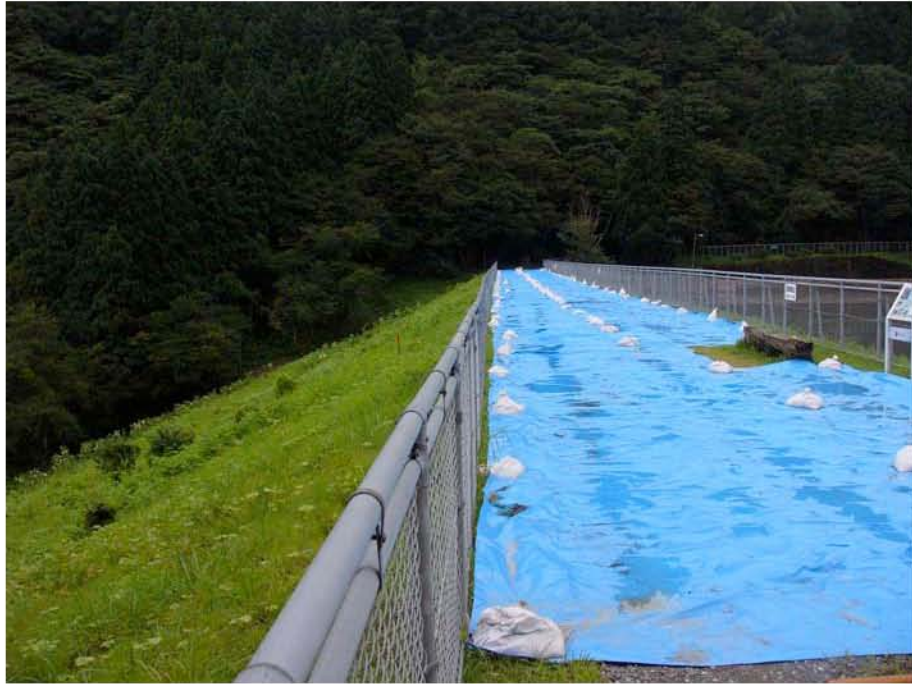
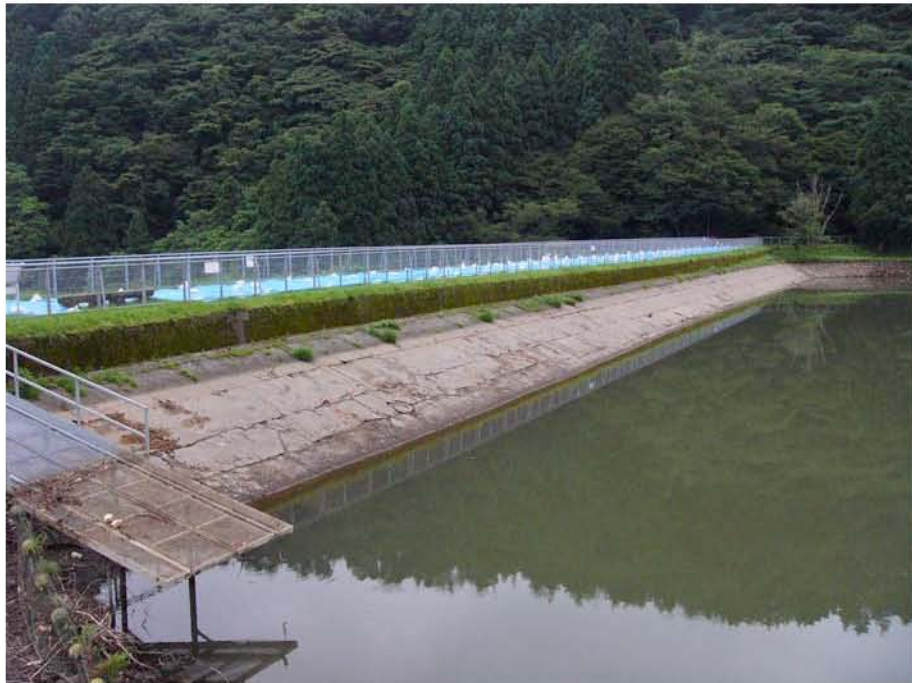
Figure 3.10: Embankment cracking at the crest of Kawauchi Dam, constructed in 1938. (Site YT19; N37.33635° E138.52410°, photos taken 7/21/07 at approximately 16:20).

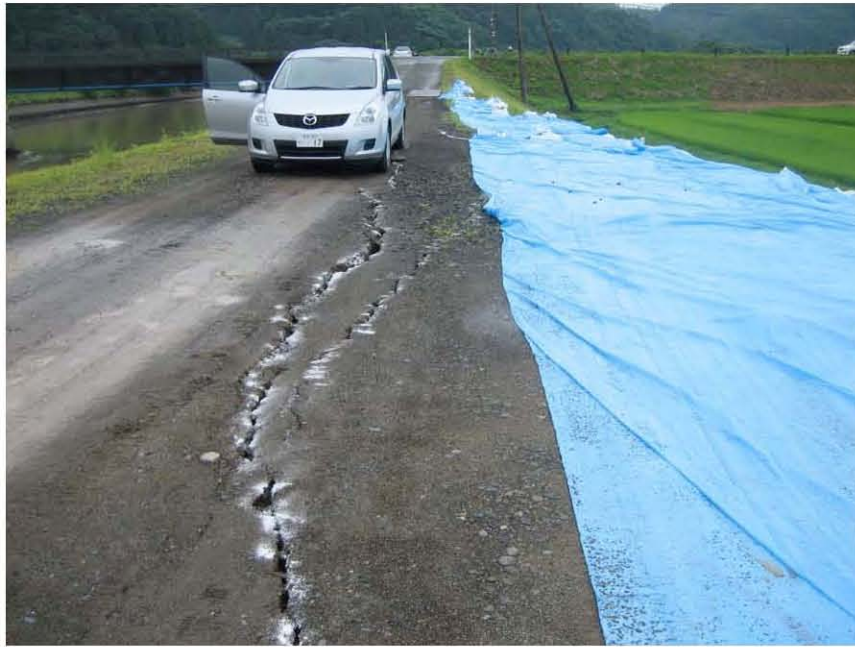
Extensive cracking of levee embankment. Repairs were taking place to the levee/weir intersection with sand bags to support an embankment failure. We observed good performance of the weir, with no signs of damage. The control building suffered damage to the foundation with settlement of fill beneath the structure: 15 cm on downstream side of building at the retaining wall, 30 cm at the building, and 30 cm at the upstream side retaining wall that formed contributory channel. Three to four sets of transverse cracks parallel to the river ran through the embankment fill that the structure was built upon. Liquefaction and lateral spreading with ground cracks were observed upstream of the operations building and the contributory channel to the south.

Figure 4.1: Fujii Weir downstream from Tashiou Bridge crossing of river. (Site RK16; N 37.34875° E 138.61670° , visited 7/21/2007 11:28 am UTZ+8). Extensive cracking of levee embankment.

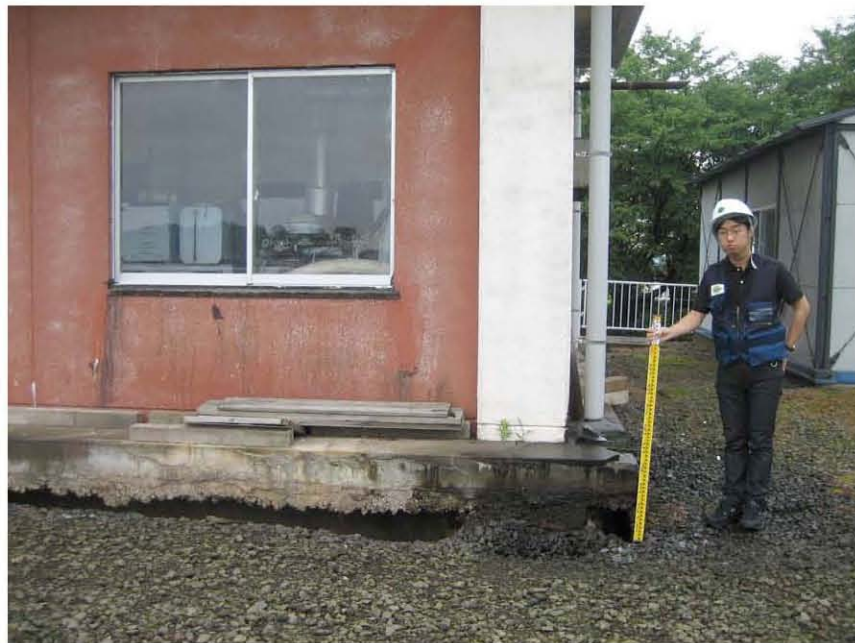
Figure 4.2: Fujii Weir downstream from Tashiou Bridge crossing of river. (Site RK16; N 37.34875° E 138.61670° , visited 7/21/2007 11:28 am UTZ+8). The control building exhibited damage to the foundation with settlement of fill beneath the structure.

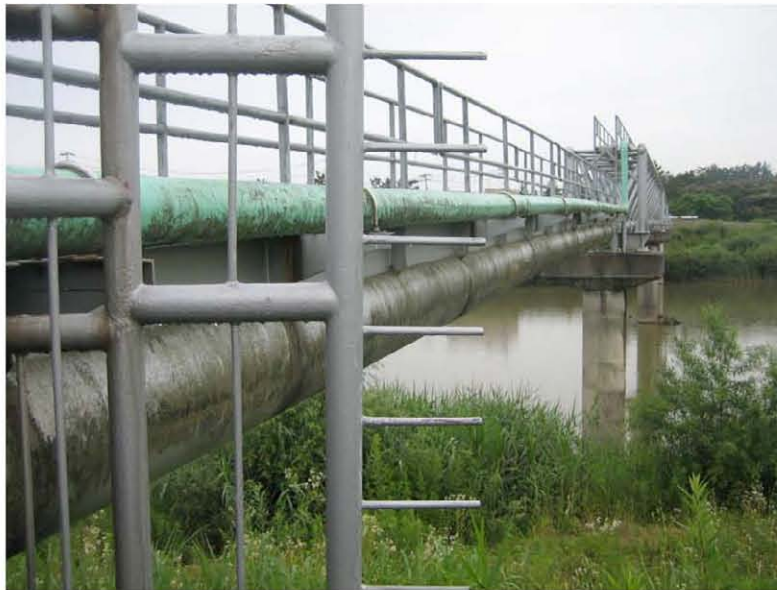
This area experienced liquefaction, lateral spreading, bridge-ground differential settlement, pavement cracking, structural damage, and embankment failure. We observed approximately one meter of ground extension consisting of several 10-20 cm wide cracks (covered by tarps) in a river levee embankment over a distance of 45 meters associated with lateral spreading. Near an adjacent bridge, we measured pipeline rupture and pipe offsets of 13 cm in the horizontal direction, 10 cm in the vertical direction, and with 40 cm of associated nearby settlement between the pipeline and the ground. In a nearby house to the south, extensive signs of liquefaction were observed with sand boils, uplifted manholes, and large-scale ground cracking. A nearby home had been red-tagged due to distortions that appeared to line up with ground cracks.

Figure 4.3: Kai-Un Bridge over Sabaishi River (Site RK4 N37.39233°, E 138.58063°, 7/19/2007, 1:40 p.m.). A water pipeline rupture was found with pipe offsets of 13 cm in the horizontal direction, 10 cm in the vertical direction, and with 40 cm of associated nearby settlement between the pipeline and the ground.

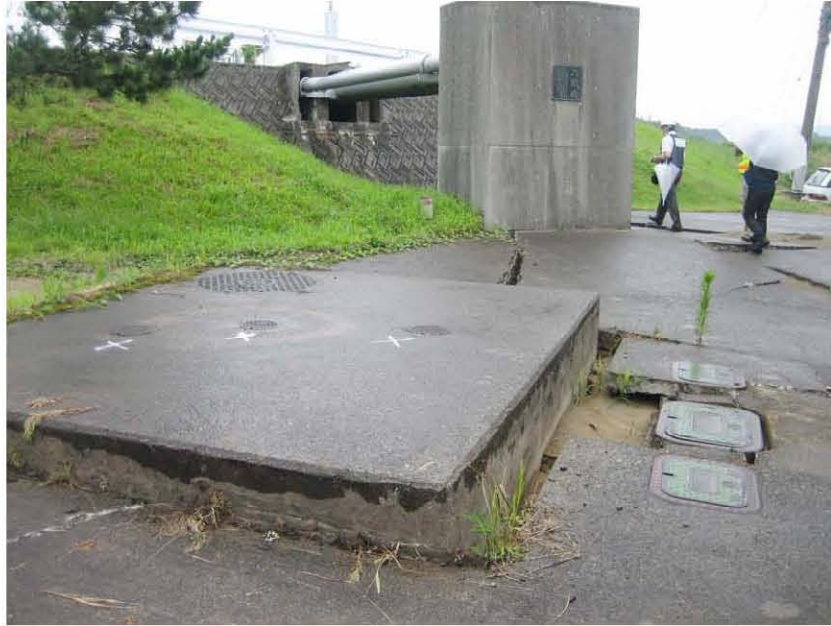
Figure 4.4: Kai-Un Bridge over Sabaishi River (Site N37.39233°, E138.58063°, 7/19/2007, 1:40 p.m.). A water cistern near the pipeline rupture uplifted in liquefied ground.

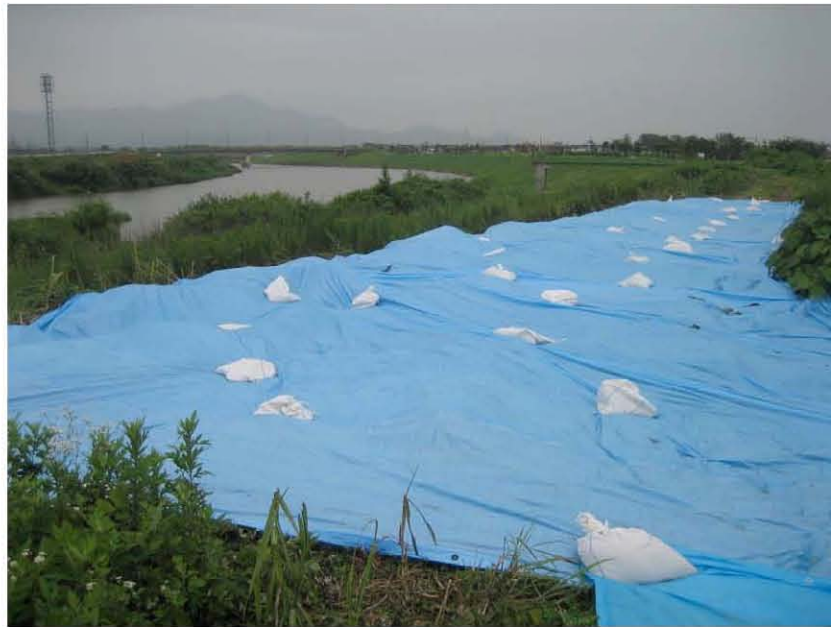
Figure 4.5: Kai-Un Bridge over Sabaishi River (Site RK4 N37.39233° E 138.58063°, 7/19/2007, 1:40 p.m.). Liquefaction induced crest cracking on the levee embankment near the northwest side of the bridge.

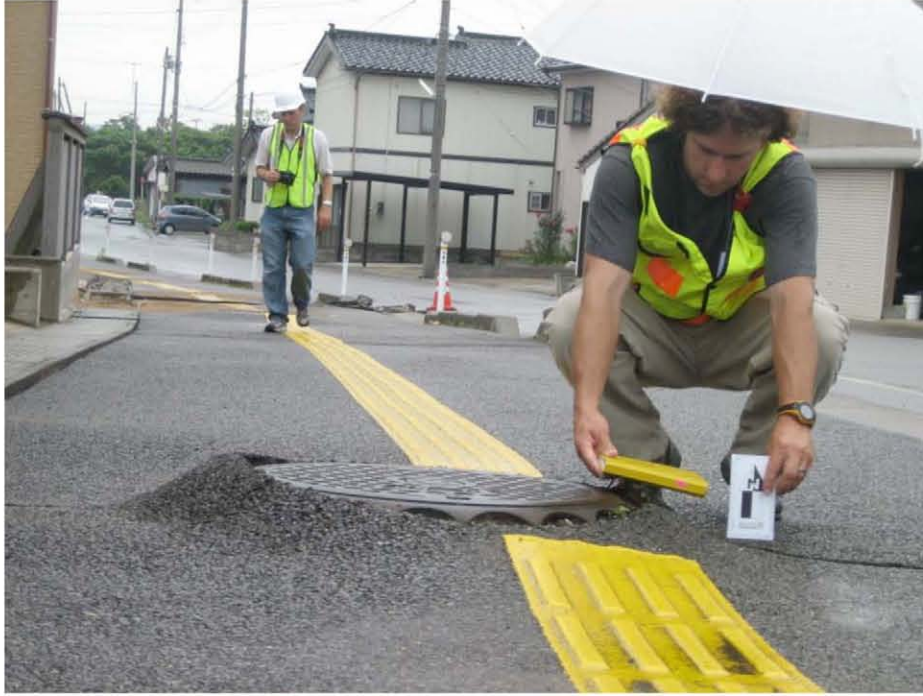
Figure 4.6: Kai-Un Bridge area Sabaishi River (Site RK4 N37.39233° E138.58063°, 7/19/2007, 1:40 p.m.). Numerous manholes on the southeast bank near the Sabaishi River uplifted in liquefied ground.

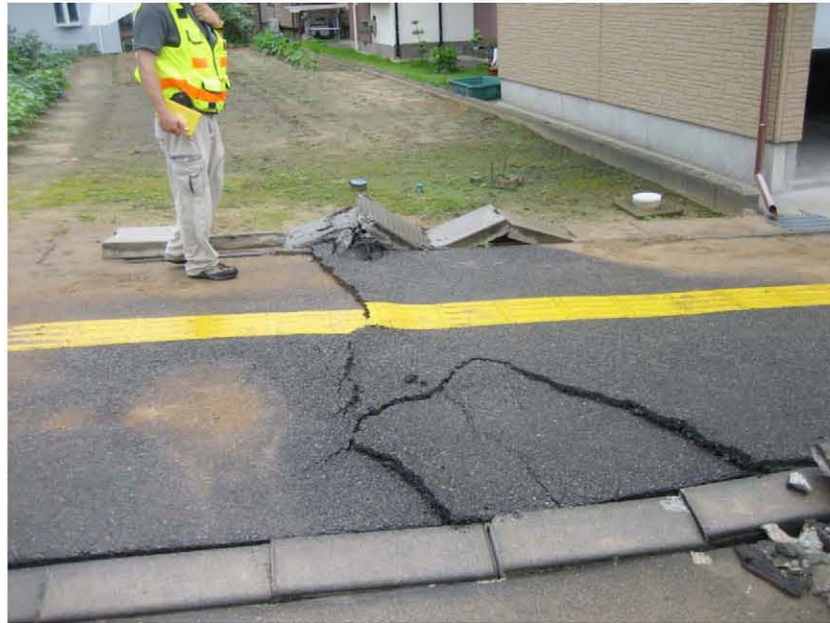
Figure 4.7: Kai-Un Bridge area Sabaishi River (Site RK4 N37.39233° E138.58063°, 7/19/2007, 1:40 p.m.). A sub-linear zone of lateral spreading, sand boils and settlement that may be associated with a buried shoestring sand deposit from the former channel of the Sabaishi River resulted in damage in the neighborhood immediately south of the Kai-Un Bridge.

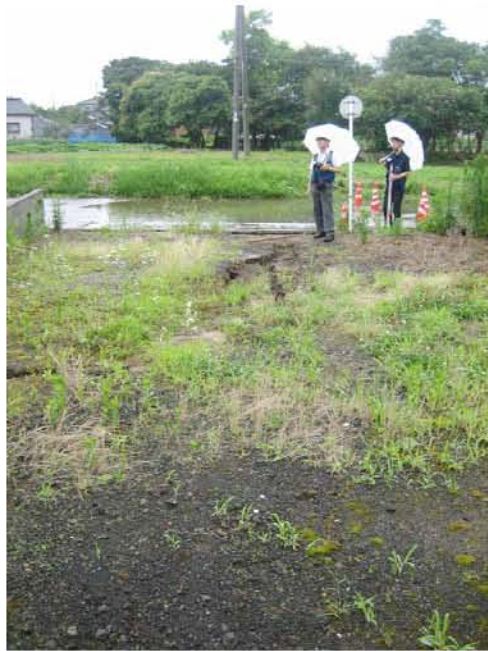
Figure 4.8: Kai-Un Bridge area Sabaishi River (Site RK4 N37.39233° E138.58063°, 7/19/2007, 1:40 p.m.). A sub-linear zone of lateral spreading, sand boils and settlement that may be associated with a buried shoestring sand deposit from the former channel of the Sabaishi River resulted in damage in the neighborhood immediately south of the Kai-Un Bridge.

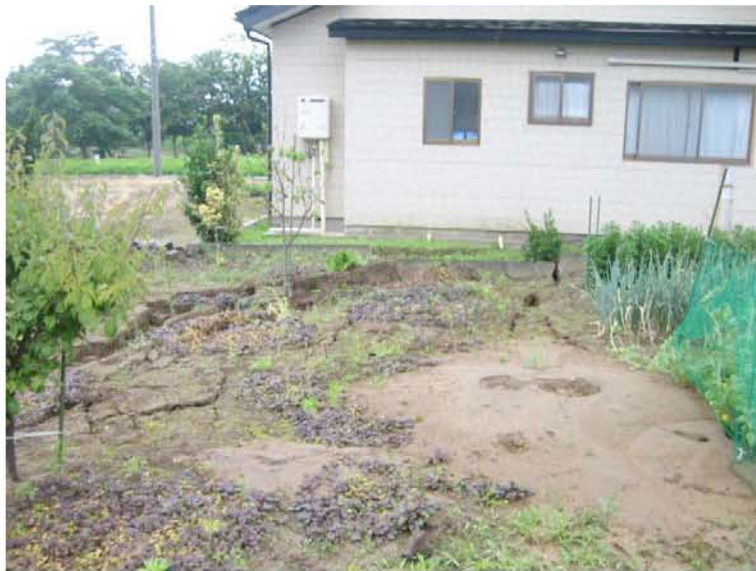
Figure 4.9: Kai-Un Bridge area Sabaishi River (Site RK4 N37.39233° E138.58063°, 7/19/2007, 1:40 p.m.). A sub-linear zone of lateral spreading, sand boils and settlement that may be associated with a buried shoestring sand deposit from the former channel of the Sabaishi River resulted in damage in the neighborhood immediately south of the Kai-Un Bridge. Here, settlement caused damage to a residential structure.

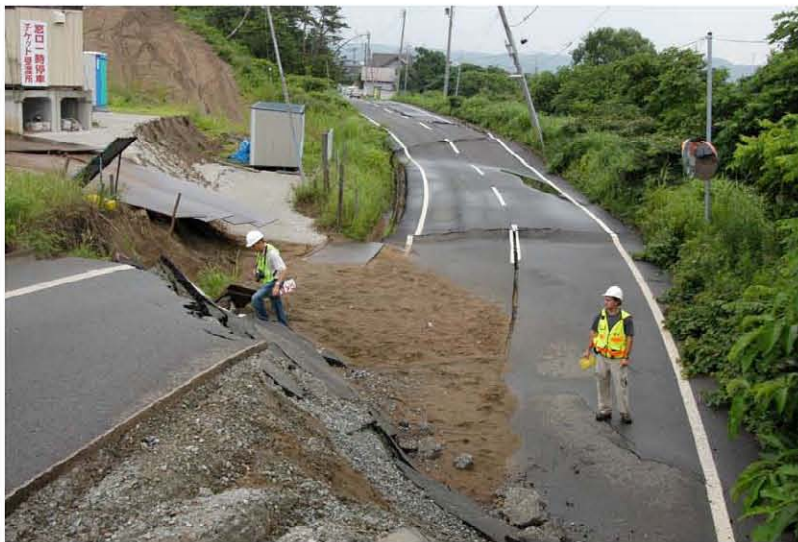
We observed lateral spreading, liquefaction, slope failures, and associated retaining wall failures at this site. This site was scanned with terrestrial LiDAR for documentation purposes and for further analysis. A massive embankment failure was observed to have occurred from liquefaction and lateral spread slope movement in aeolian sands. Movement was from north to south, from sand quarry area towards river. Vertical displacement of head scarp was a maximum of 2.8 m and diminished in height moving away from road crossing of head scarp. Measurements were made of total lateral displacement along a representative track-line through the failure representing the maximum likely displacement of the failure ~10 m over 55 m distance between head scarp and river edge (approximately 18% strain). The inclination of slope from road to river was measured to be approximately 14°. Nearby, a slope lateral spread caused failure of a 2.6-meter-tall, concrete block, gravity retaining wall, that resulted in the red-tagging of an otherwise undamaged home. The damaged retaining wall section was 25 meters in length and constructed of 40 cm by 30 cm by 100 cm sized concrete blocks. No backfill, drainage, or tieback reinforcement were observed.

Figure 4.11: North side of Kai-Un Bridge area of the Sabaishi River - Lateral Spread on road to Kashiwazaki Municipal Incinerator (Site RK6, N37.39343° E138.58555°, 7/19/2007). A zone of lateral spreading, sand boils and settlement crossing the present-day Sabaishi River, and that may be associated with a buried shoestring sand deposit of a former channel, resulted in failure of a road on the north side of the river adjacent to the Kashiwazaki Municipal Incinerator.

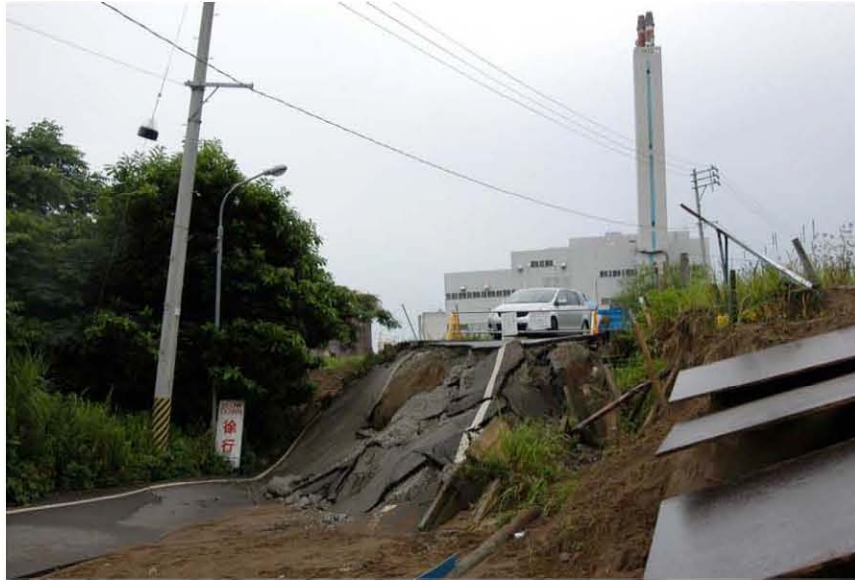
Figure 4.12: North side of Kai-Un Bridge area of the Sabaishi River - Lateral Spread on Road to Kashiwazaki Incinerator (Site RK6, N37.39343° E138.58555°, 7/19/2007). A zone of lateral spreading, sand boils and settlement crossing the present-day Sabaishi River, and that may be associated with a buried shoestring sand deposit of a former channel, resulted in failure of a road on the north side of the river adjacent to the Kashiwazaki Municipal Incinerator.

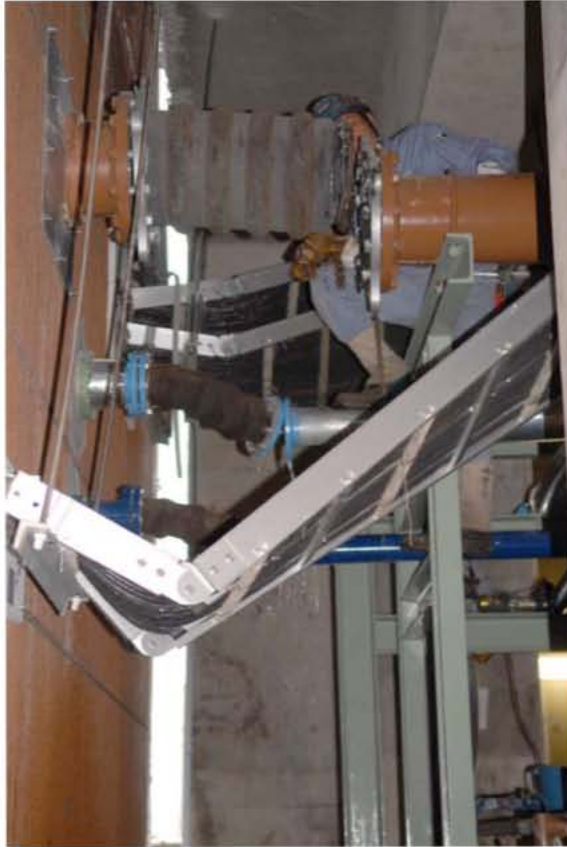
Figure 4.16b: Kashiwazaki Wastewater Treatment Plan on the south side of Sabaishi River near its outlet to the Sea of Japan (Site RK9 N37.38748° E138.56587°) Pipe breaks are due to separation of two adjacent building sections (Photo taken at 7/21/07 9:15)

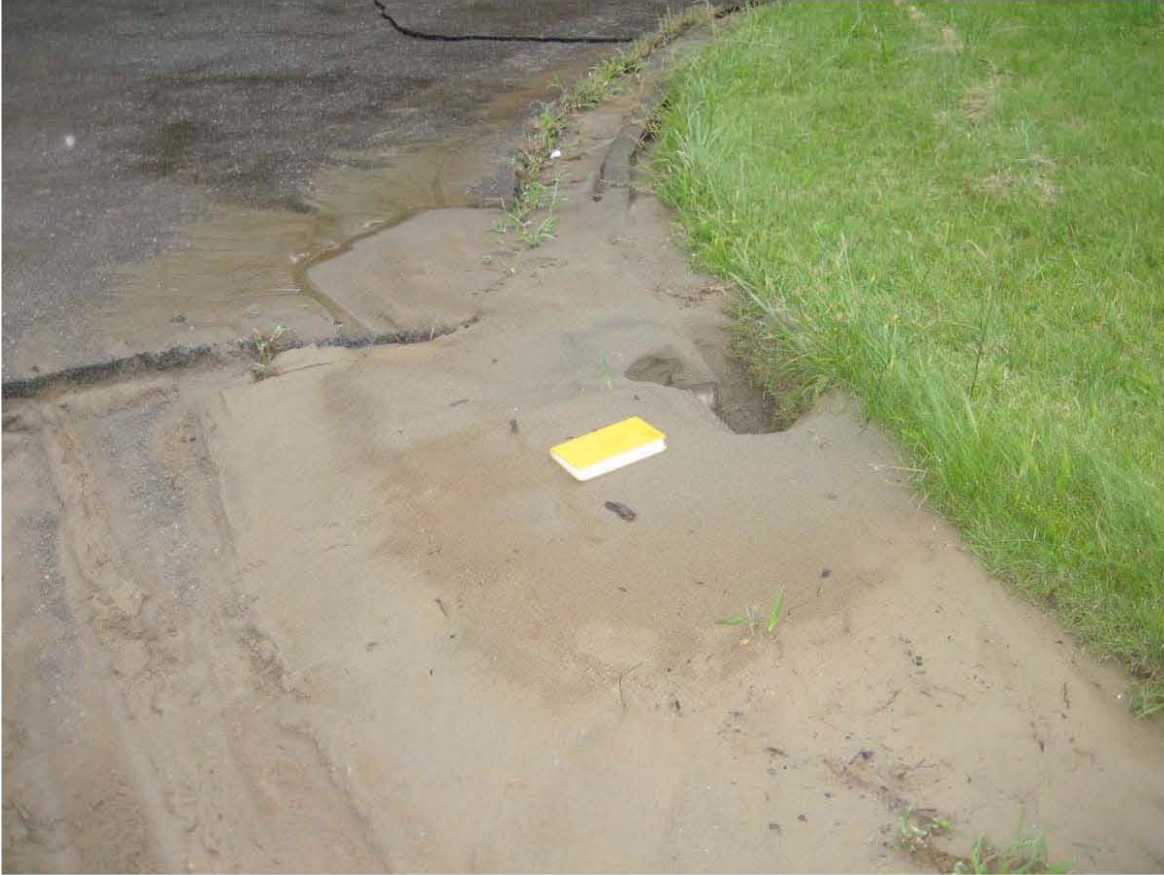
Figure 4.17: Kashiwazaki Wastewater Treatment Plant on the south side of Sabaishi River near its outlet to the Sea of Japan (Site RK9 N37.38748° E138.56587°, 7/19/2007). Liquefaction features were abundant near the wastewater treatment facility.

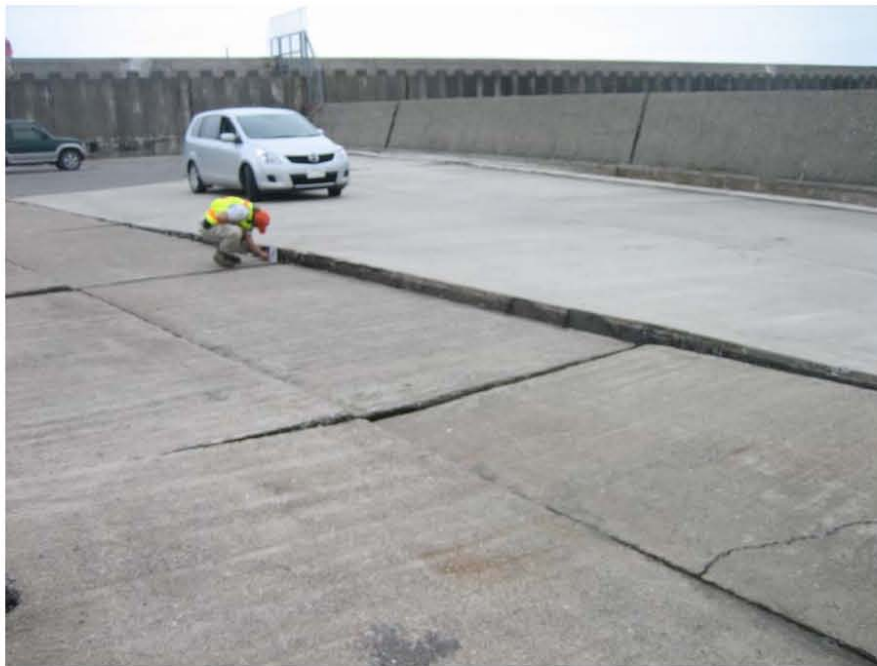
This area experienced ground damage from liquefaction induced lateral spreading. We observed sand boils in the grassy area behind the port office building and on the west end of the pier between separated pier slab sections. Some areas of concrete had 15 cm of vertical and 20 cm of lateral displacement. A track-line measurement was performed with a cloth tape. Measurements indicate that 0.7 m of lateral displacement occurred over 79 meters resulting in 0.9% strain, as measured between the seawall on the west to the edge of the pier to the east. The displacement direction was inland to the east. Terrestrial LiDAR scanning was performed at this site.

Figure 4.18: Kashiwazaki Harbor - South area experienced ground damage from liquefaction induced lateral spreading and settlement of separated pier slab sections (Site RK25, N37.36713° E138.53210°, 7/20/2007).

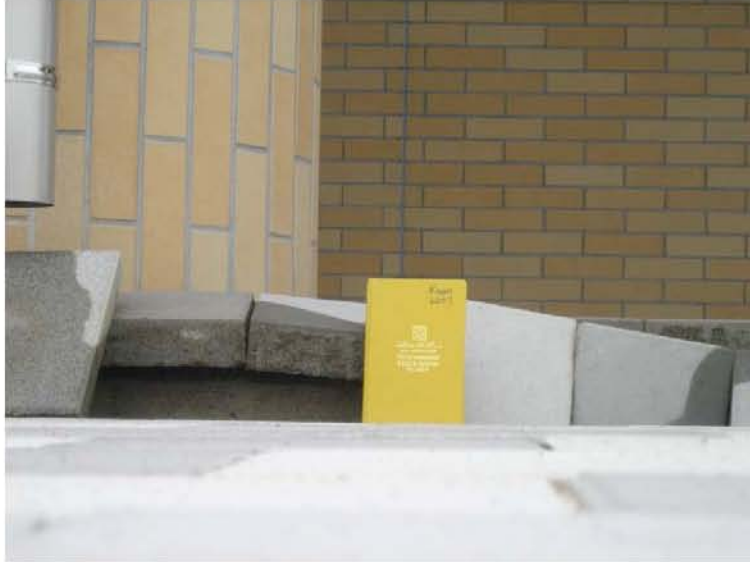
Figure 4.19: Kashiwazaki Harbor - South area experienced ground damage from liquefaction-induced lateral spreading and settlement immediately adjacent to the pile-supported port office building. (Site RK25, N37.36713° E138.53210°, 7/20/2007).

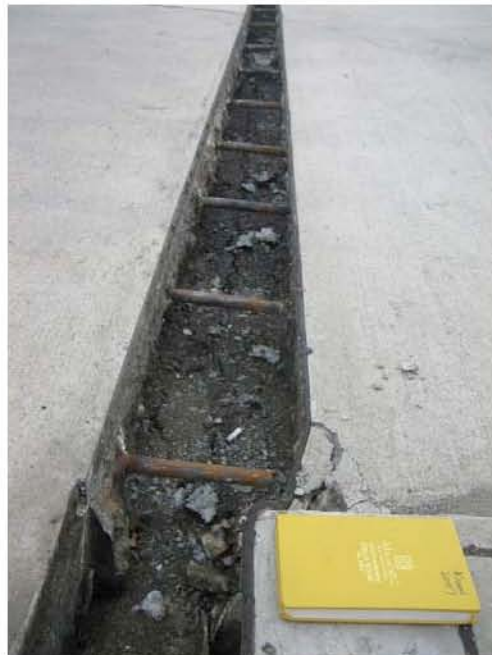
Figure 4.20: Kashiwazaki Harbor - South area experienced ground damage from liquefaction-induced lateral spreading resulting in separated pier slab sections (Site RK25, N37.36713° E138.53210°, 7/20/2007).

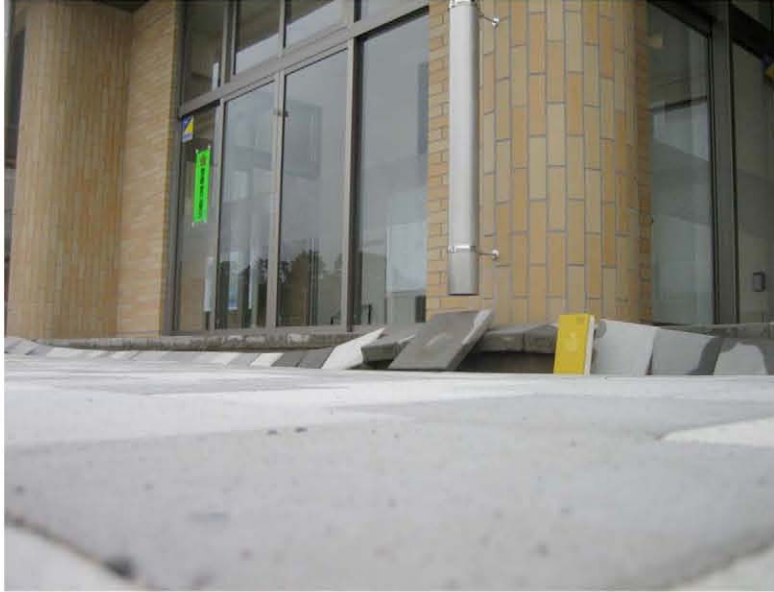
Figure 4.22: Kashiwazaki Harbor - The southern area experienced ground damage from liquefaction-induced lateral spreading and settlement. We observed settlement immediately adjacent to the pile supported port office building. (Site RK25, N37.36713° E138.53210°, 7/20/2007).
