Investigation of the M6.6 Niigata-Chuetsu Oki, Japan, Earthquake of July 16, 2007

Open File Report 2007–1365

U.S. Department of the Interior
U.S. Geological Survey

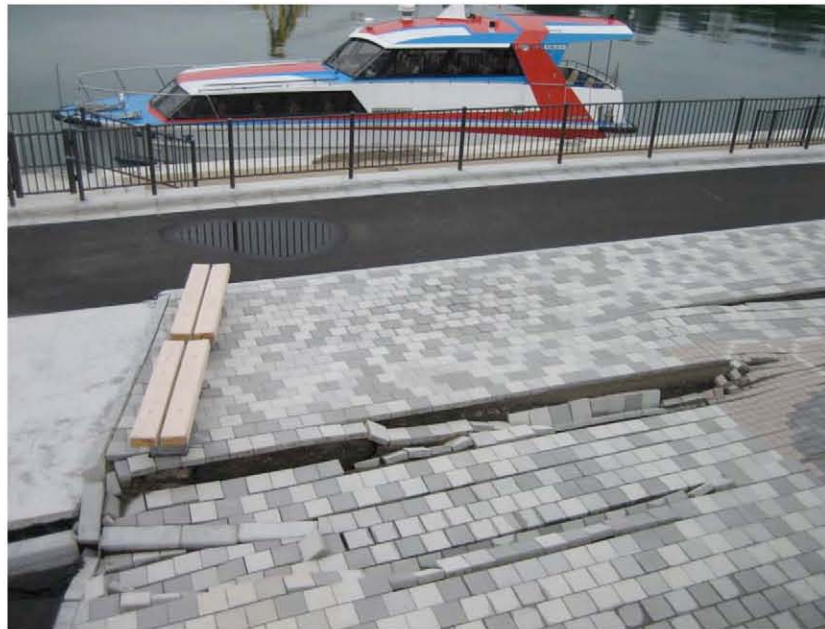
Figure 4.23: Kashiwazaki Harbor - The southern area experienced ground damage from liquefaction-induced lateral spreading and settlement. A harbor-front caisson rotated toward the harbor, uplifting the asphalt and tiled section shown here and initiating lateral displacement of the soil behind it, between the caisson and port building (Site RK25, N37.36713° E138.53210°, 7/20/2007).

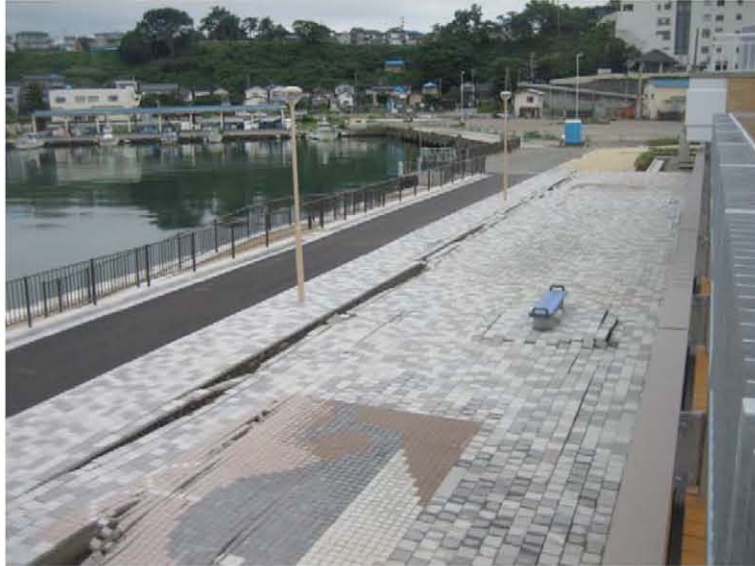
Figure 4.25: Kashiwazaki Harbor - South area experienced ground damage from liquefaction-induced lateral spreading and settlement. A harbor front caisson rotated toward the harbor, to the left of the photo, initiating lateral displacement of the soil behind it, between the caisson and port building. Settlements can also be seen in this photo. (Site RK25, N37.36713° E138.53210°, 7/20/2007)

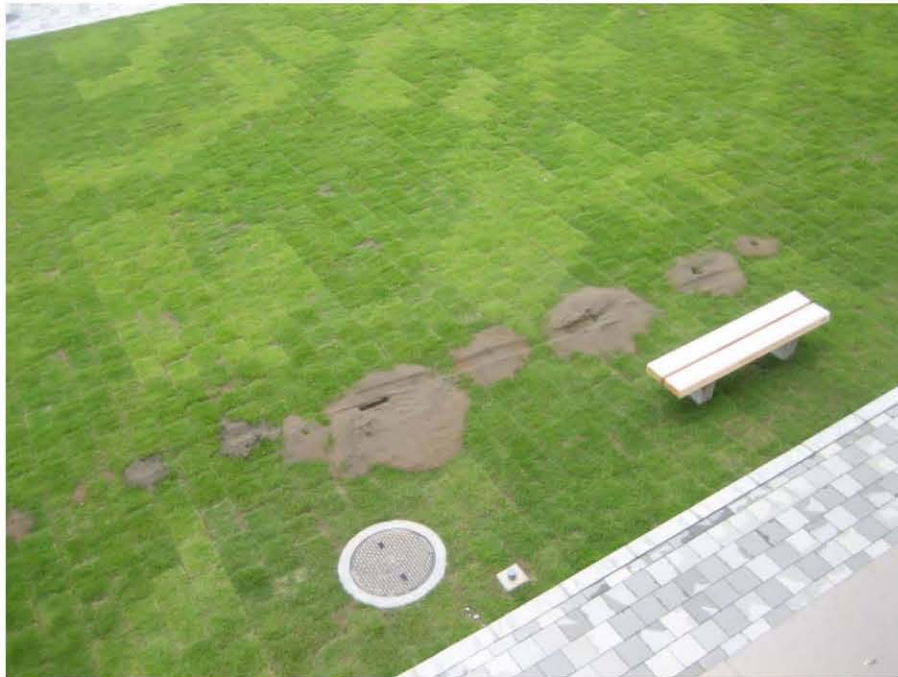
Figure 4.26: Kashiwazaki Harbor - South area exhibited surficial features of liquefaction on all sides of the port building. (Site RK25, N37.36713° E138.53210°, 7/20/2007).

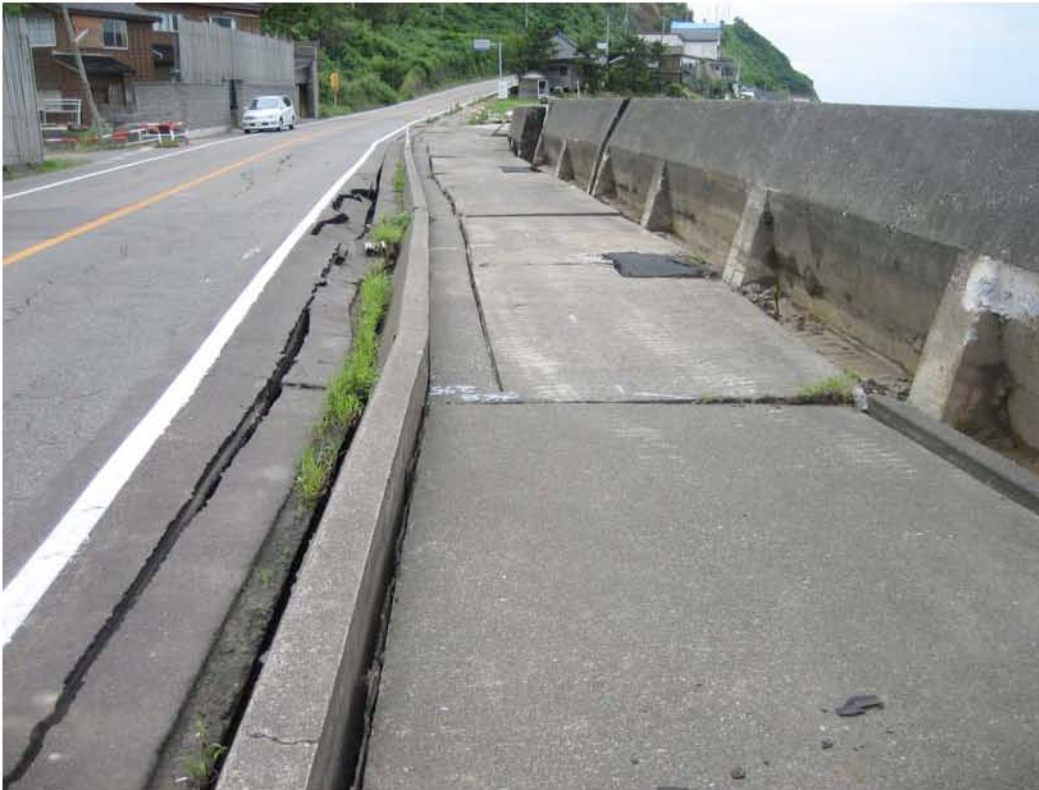
Liquefaction of beach sand led to lateral spreading of a road embankment and both rotation and translation of a 30-meter-long segment of concrete seawall. Deformations were on the order of 25 cm vertical, and up to 64 cm horizontal, with a component of rotation as measured by 32 cm lateral deformation at the base of wall and 64 cm lateral deformation at 2m height of wall.

Figure 4.27: Liquefaction of beach sand led to lateral spreading of a road embankment and both rotation and translation of a 30-meter-long segment of concrete seawall. (Site RK35, N37.48497° E138.62645°, 7/22/2007).

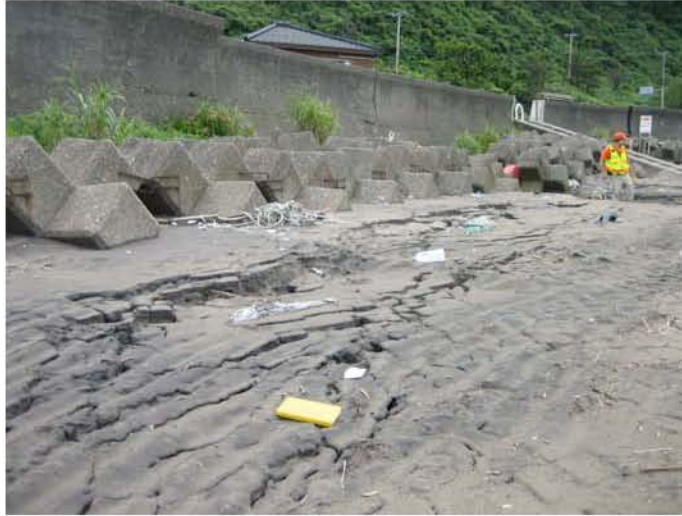
Figure 4.28: Liquefaction of beach sand resulted in lateral spreading, above, in front of a 30-meter-long segment of concrete seawall. (Site RK35, N37.48497° E138.626°, 7/22/2007)

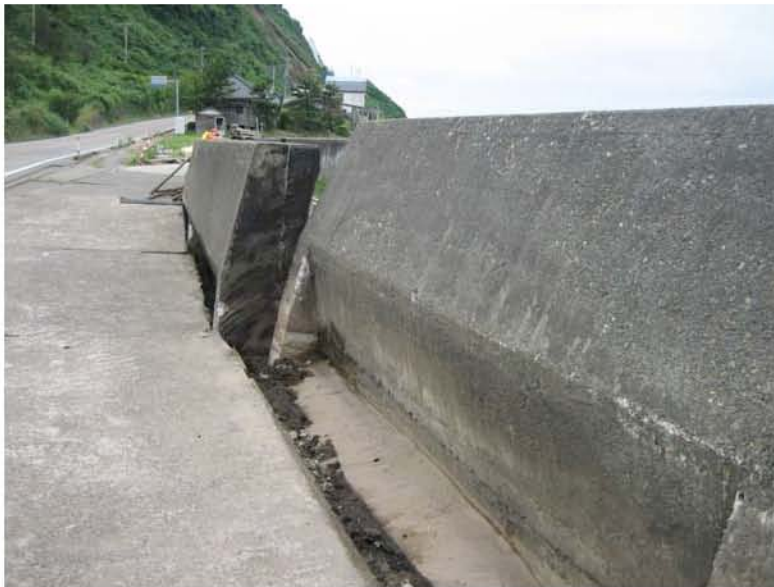
Figure 4.29: Liquefaction of beach sand led to lateral spreading of a road embankment and both rotation and translation of a 30-meter-long segment of concrete seawall. (Site RK35, N37.48497° E138.62645°, 7/22/2007). Deformations were on the order of 25 cm vertical, and up to 64 cm horizontal, with a component of rotation as measured by 32 cm lateral deformation at the base of wall and 64 cm lateral deformation at 2 m height of wall.

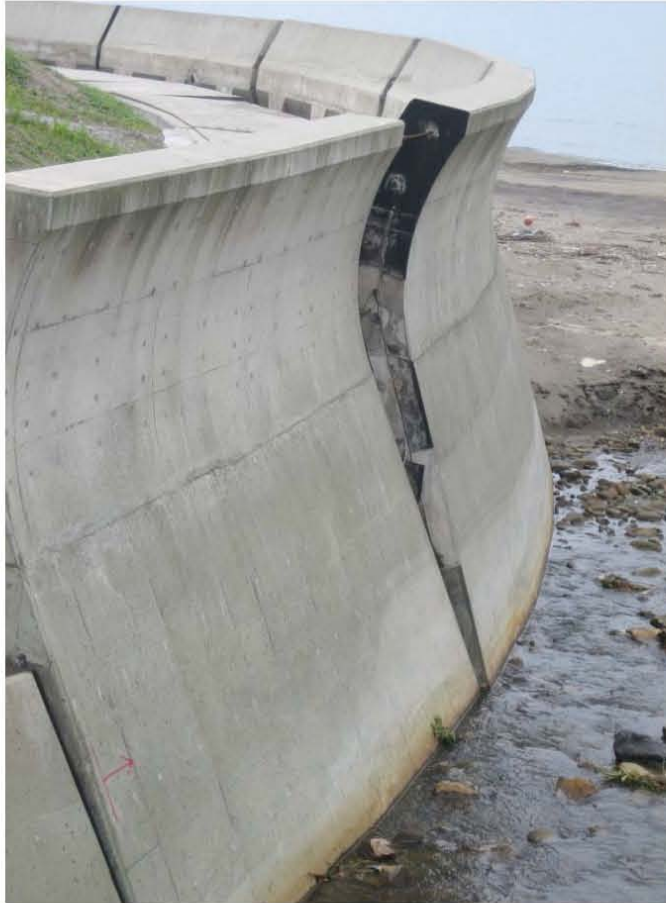
Embankment failure and lateral spread from liquefaction of beach sands at toe of seawall. We measured 21 cm of vertical displacement and 55 cm of horizontal displacement of a wall section from an adjacent non-failed wall section. The total length of failed sections was 40 m.

Figure 4.31: Seawall Failure as a result of embankment movement into a seawall founded on top of liquefied beach sands. (Site RK37, N37.45478° E138.60927°, 7/22/2007).

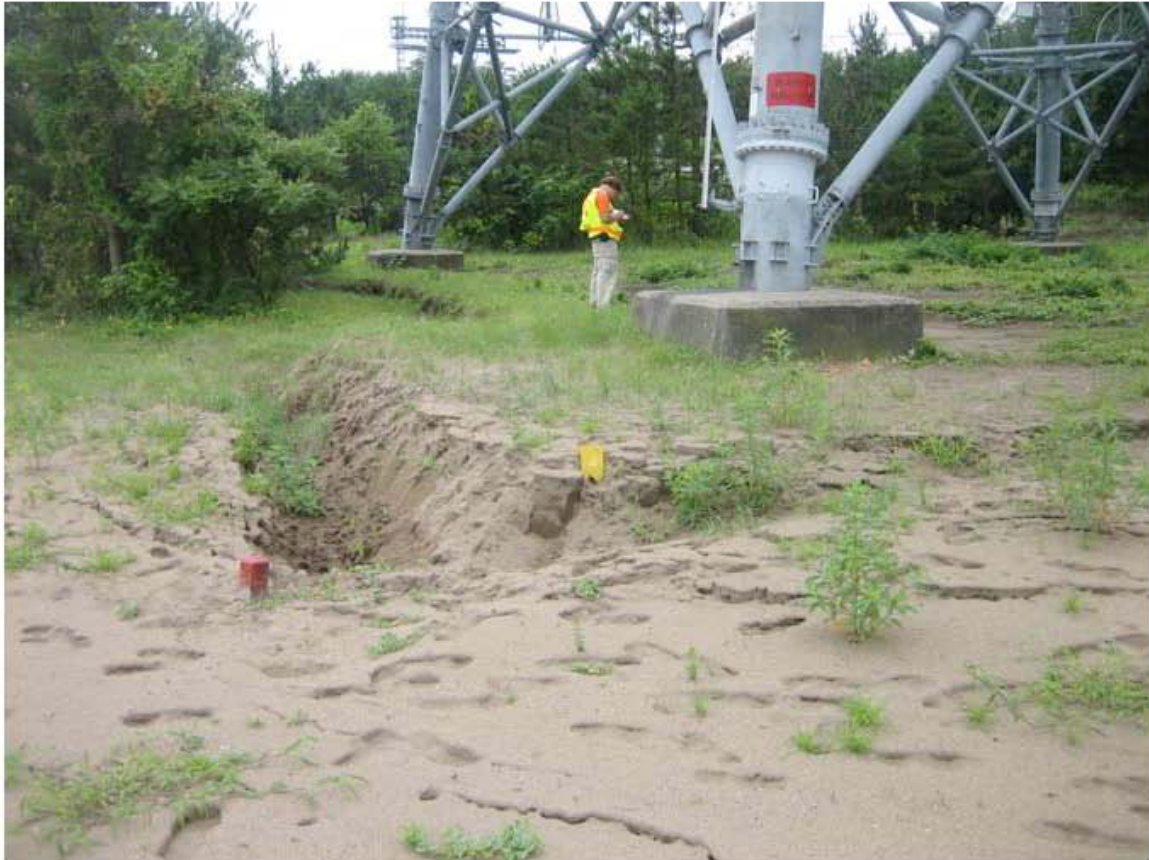
Liquefaction and lateral spread of dune sand adjacent to tower footings. We measured 40 cm of vertical displacement and 12 cm of horizontal displacement over a 20-meter track-line moving away from the footing for 0.6% of measured ground strain.

Figure 4.33: Liquefaction and lateral spread of ground adjacent to High Voltage Transmission Line Tower (Site RK40, N37.41633° E138.60792°, 7/22/2007).

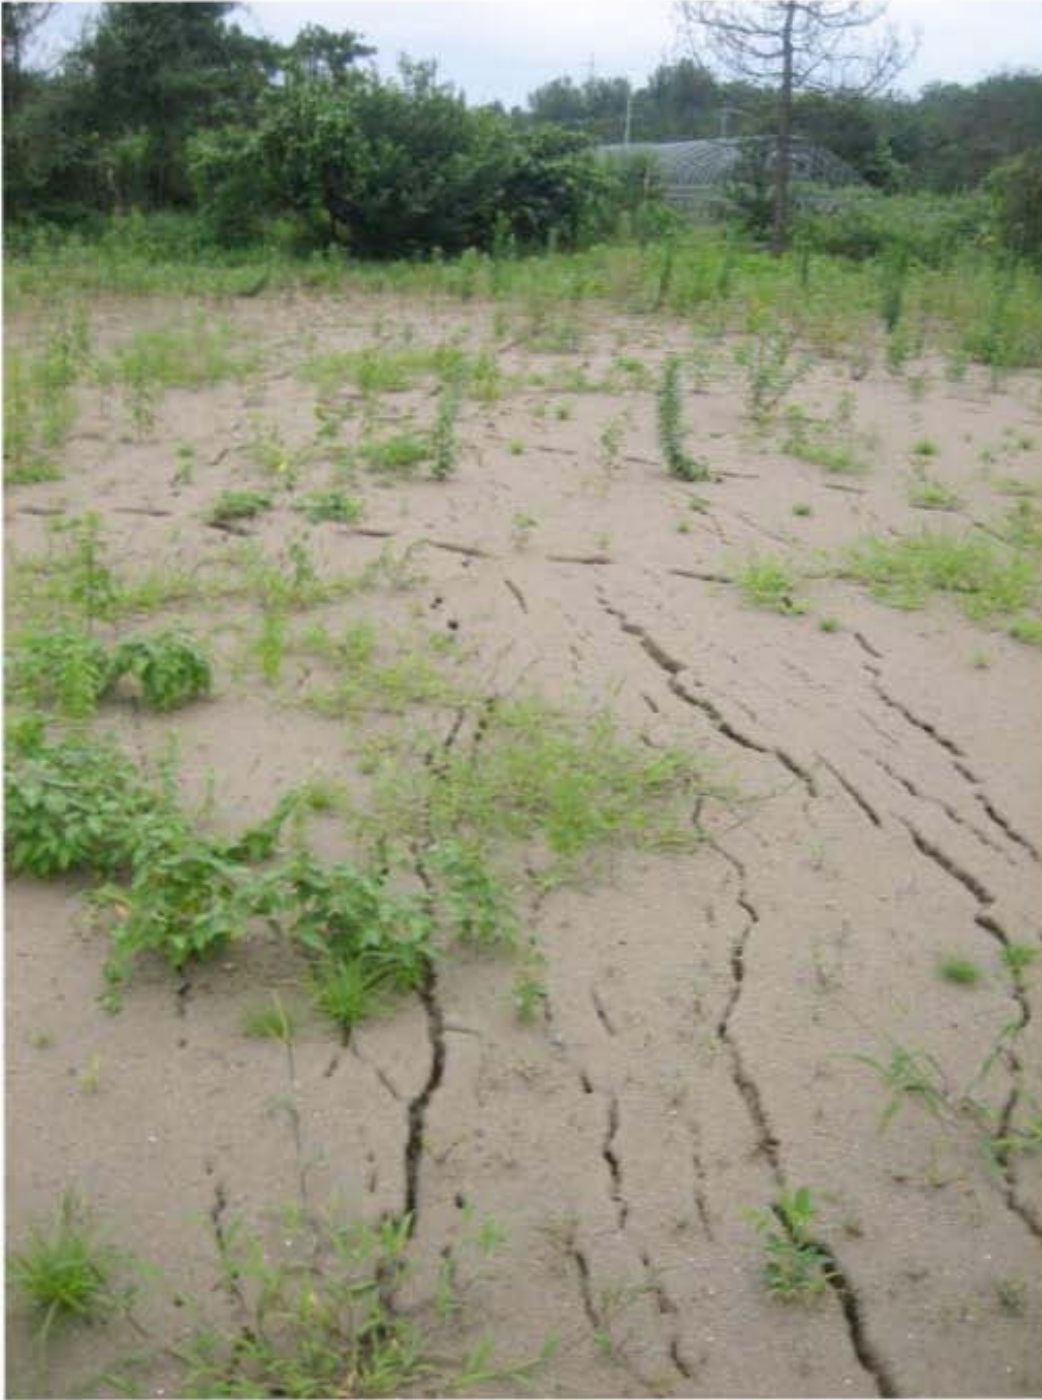
Figure 4.34: Lateral spreading in dune sand down slope of high voltage power transmission tower. We measured 0.6% of ground strain at the site. (Site RK40, N37.41633° E138.60792°, 7/22/2007).

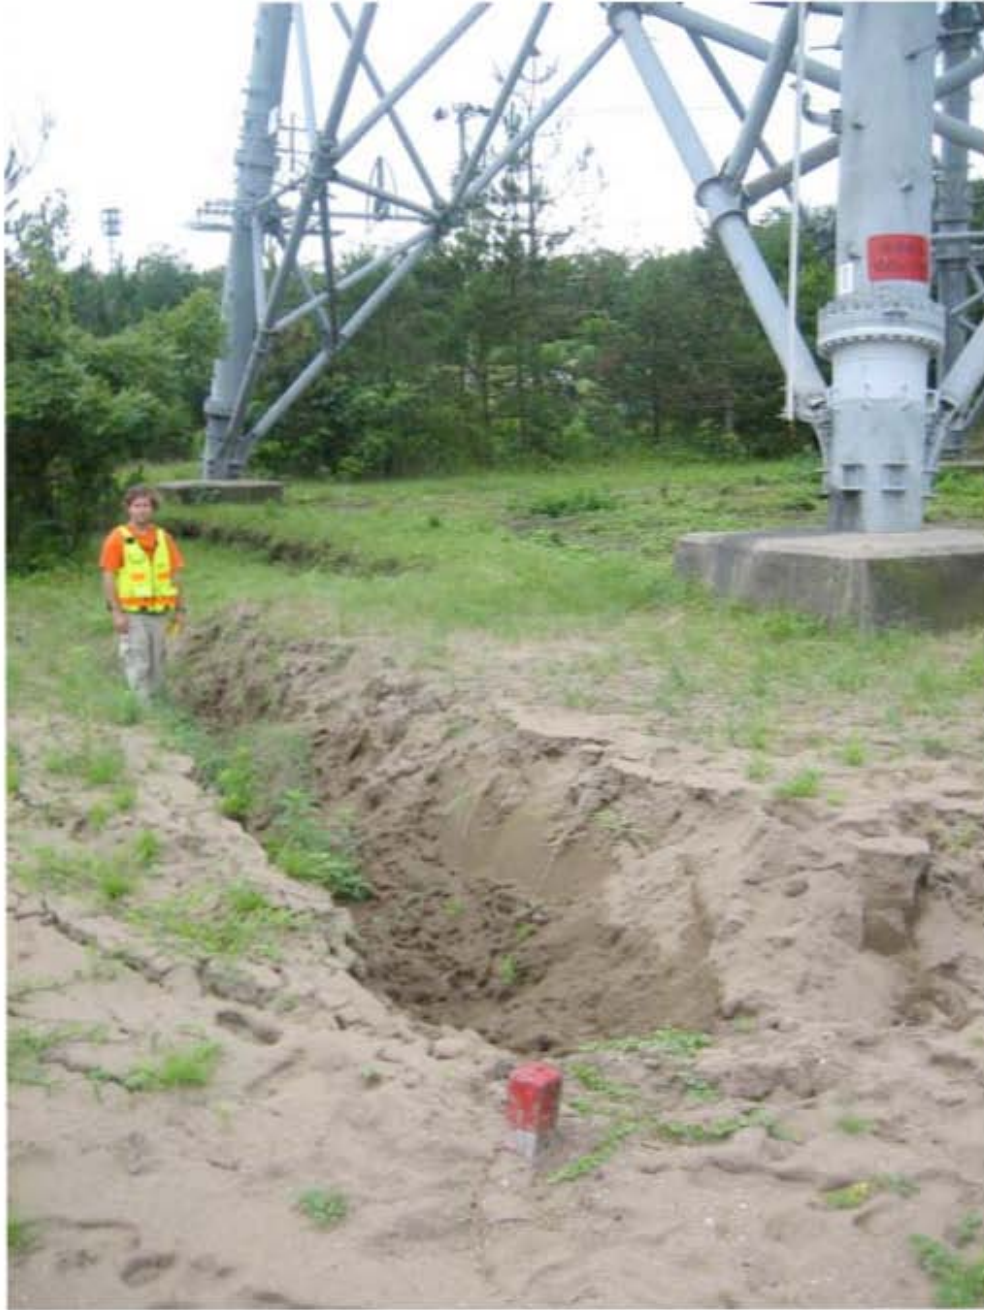
Figure 4.35: Settlement of ground adjacent to grade beam between footings of a high voltage transmission line tower (Site RK40, N37.41633° E138.60792°, 7/22/2007).

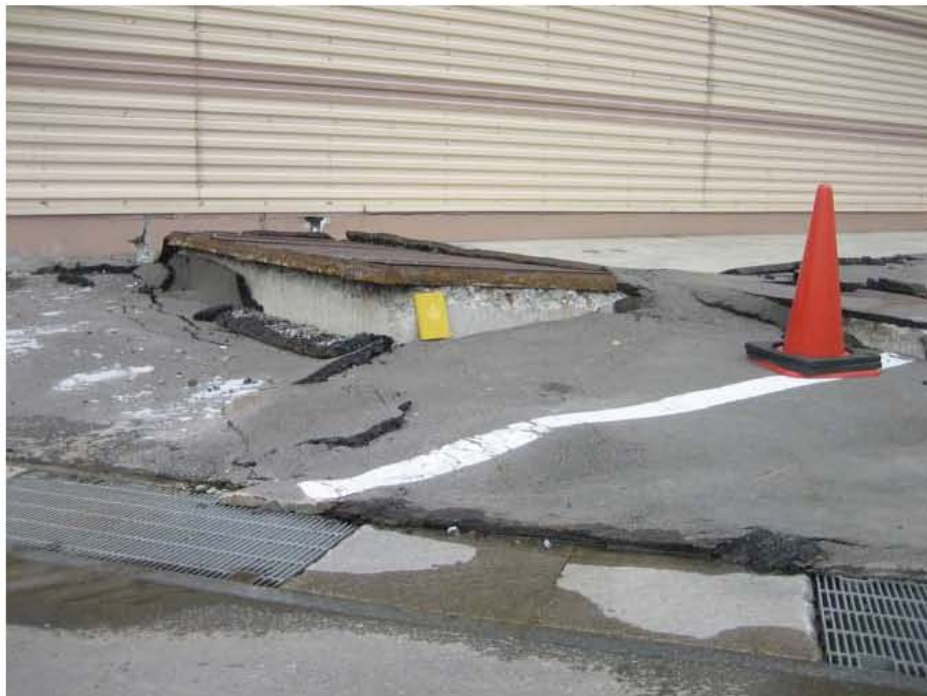
We observed structural damage and ground settlement of a large warehouse-type department store. The interior columns were deformed and leaning, and the interior floor slab reinforcing bars had buckled and were exposed. Reinforcing bars and concrete also failed at a corner of the building. Ground settlement was observed around the building and an underground storage tank had been uplifted (this was the only obvious sign of liquefaction).

Figure 4.36: Plant 5 Store - Ground settlement in dune sand was observed around the building and an underground storage tank had been uplifted (Site RK41, N37.41468° E138.6084°, 7/22/2007).

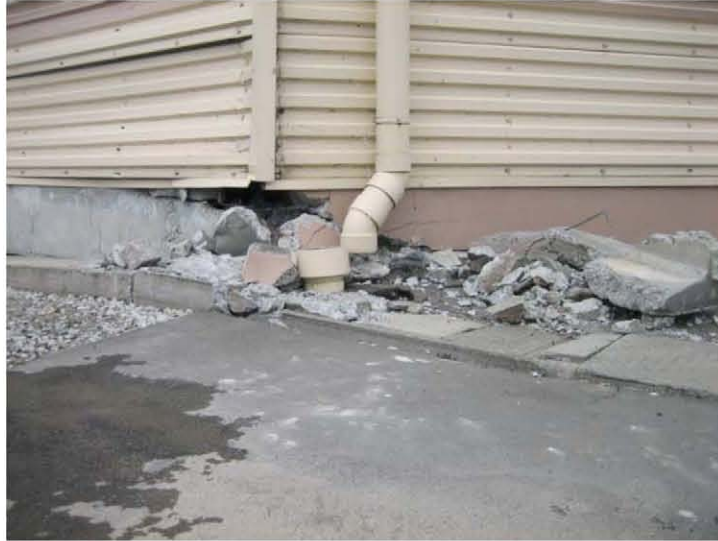
Figure 4.37: Plant 5 Store showing foundation corner area of failed reinforced concrete. (Site RK41, N37.41468° E138.60840°, 7/22/2007).

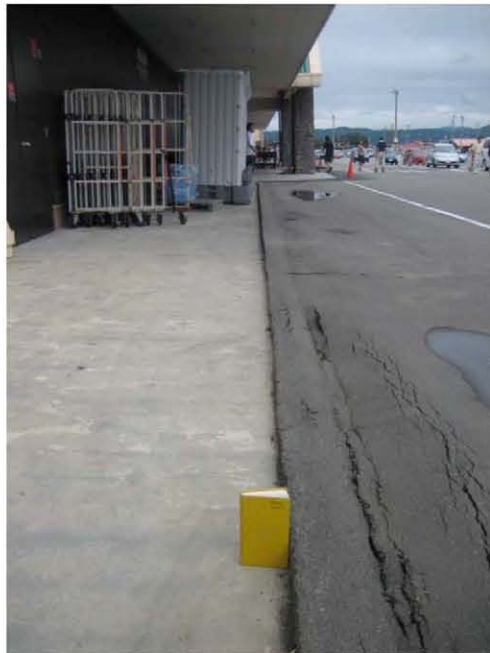
Figure 4.38: Plant 5 Store - Ground settlement in dune sand was observed around the building and an underground storage tank had been uplifted (Site RK41, N37.41468° E138.60840°, 7/22/2007).

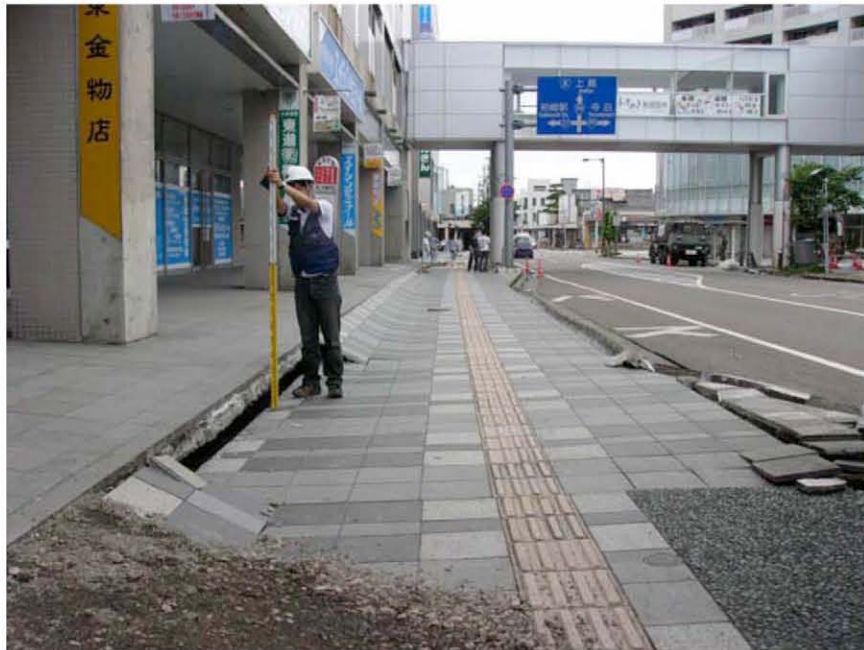
Damage to old wooden houses were concentrated in the downtown area of Kashiwazaki City where the old sand dune deposit is thought to cover the most of the area. Because of strong shaking in these sand deposits with water level at some depth below the surface, a deep seated lateral flow of ground appears to have occurred, resulting in various surface ground distortions in the Nishi-Honmachi area. This hypothesis was first presented by Prof. Konagai of Univ. of Tokyo who conducted a reconnaissance of the area immediately after the quake (July 17, 2007). Yellow markers in Fig. 4.40 show the locations where EERI & GEER team identified signs of ground lateral flow. Photos of each of these areas can be viewed in the Google Earth database available through the USGS website. The ground movement occurred typically from areas of higher elevation to lower elevation, and we observed open tension cracks at higher ground and compressive heaves in lower ground. Fig.4.41 (SiteYT24_YT_19 as shown in Fig. 4.40) shows the ground distortion near a department store building that seems to be supported by deep foundation and shows no major structural damage. The road on the hill side (northern side) settled and moved downwards to result in the large opening and distortion at the road side.

Fig. 4.41: Downtown Kashiwazaki Lateral Spread (SiteYT24, N37.36949°, E138.5541°, photo taken 7/22/07, SiteYT24_YT_19 as shown in Fig. 4.40).

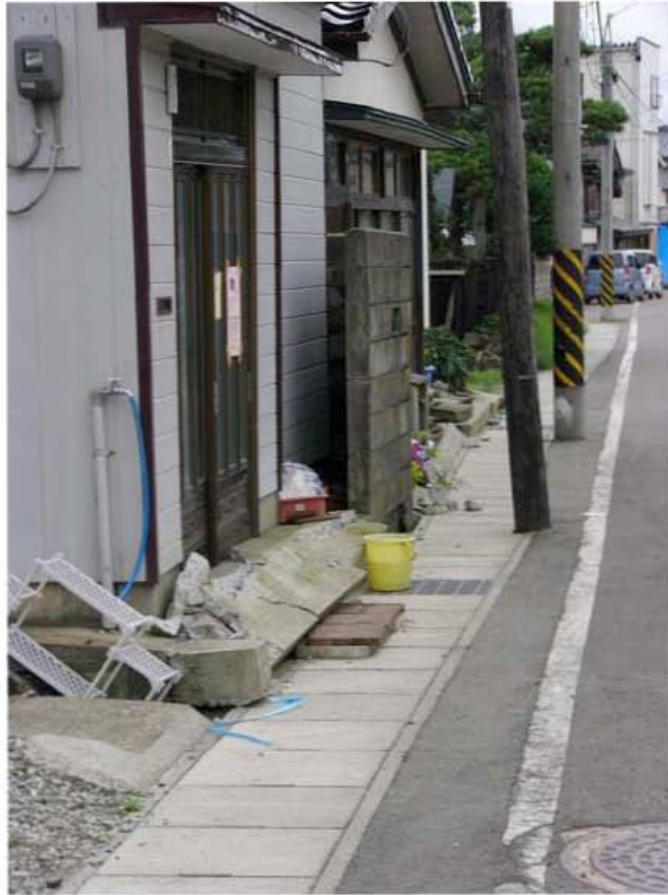
The reconnaissance was made to define the extent of such a deep-seated lateral flow from ground surface distortions. Fig. 4.42 (Site YT24-YT_03 in Fig. 4.40) shows damage at the north-western limit, whereas Fig. 4.43 (Site YT24-YT_14 in Fig. 4.40) shows damage at the south-eastern limit. Thus, the area covered between Fig. 4.42 and Fig. 4.43 may have suffered deep seated lateral flow from higher ground to lower ground. The damages due to such lateral flow extend to the north-eastern direction of downtown. The arcaded street next to (east) Fig. 4.43 (Site YT24-YT_14 in Fig. 4.40) was closed because of heavy structural damages of shops along the street.

Fig. 4.42: Downtown Kashiwazaki Lateral Spread (SiteYT24, N37.36963°, E138.5486°, photo taken 7/22/07, SiteYT24_YT_03 as shown in Fig. 4.40).

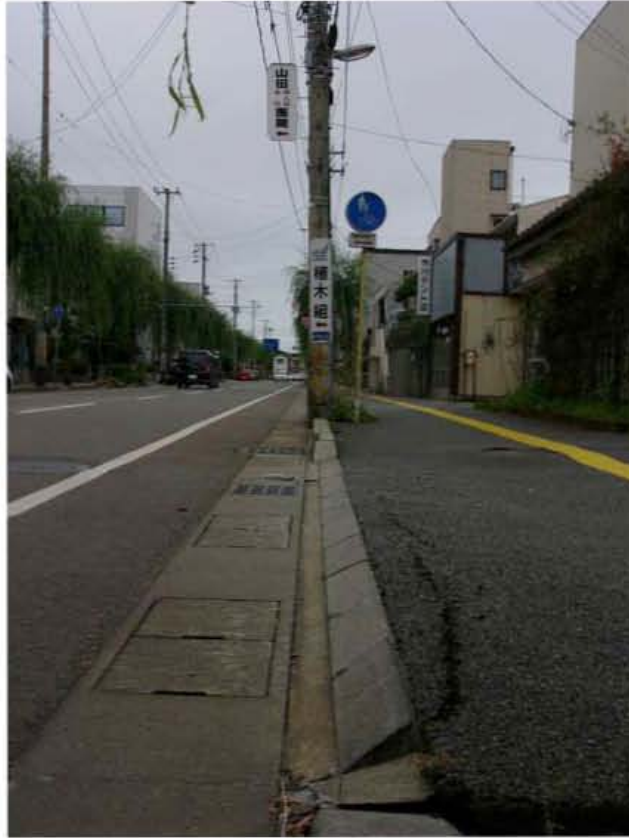
Fig. 4.43: Downtown Kashiwazaki Lateral Spread (SiteYT24, N37.36731°, E138.5522°, photo taken 7/22/07, SiteYT24_YT_14 as shown in Fig. 4.40).

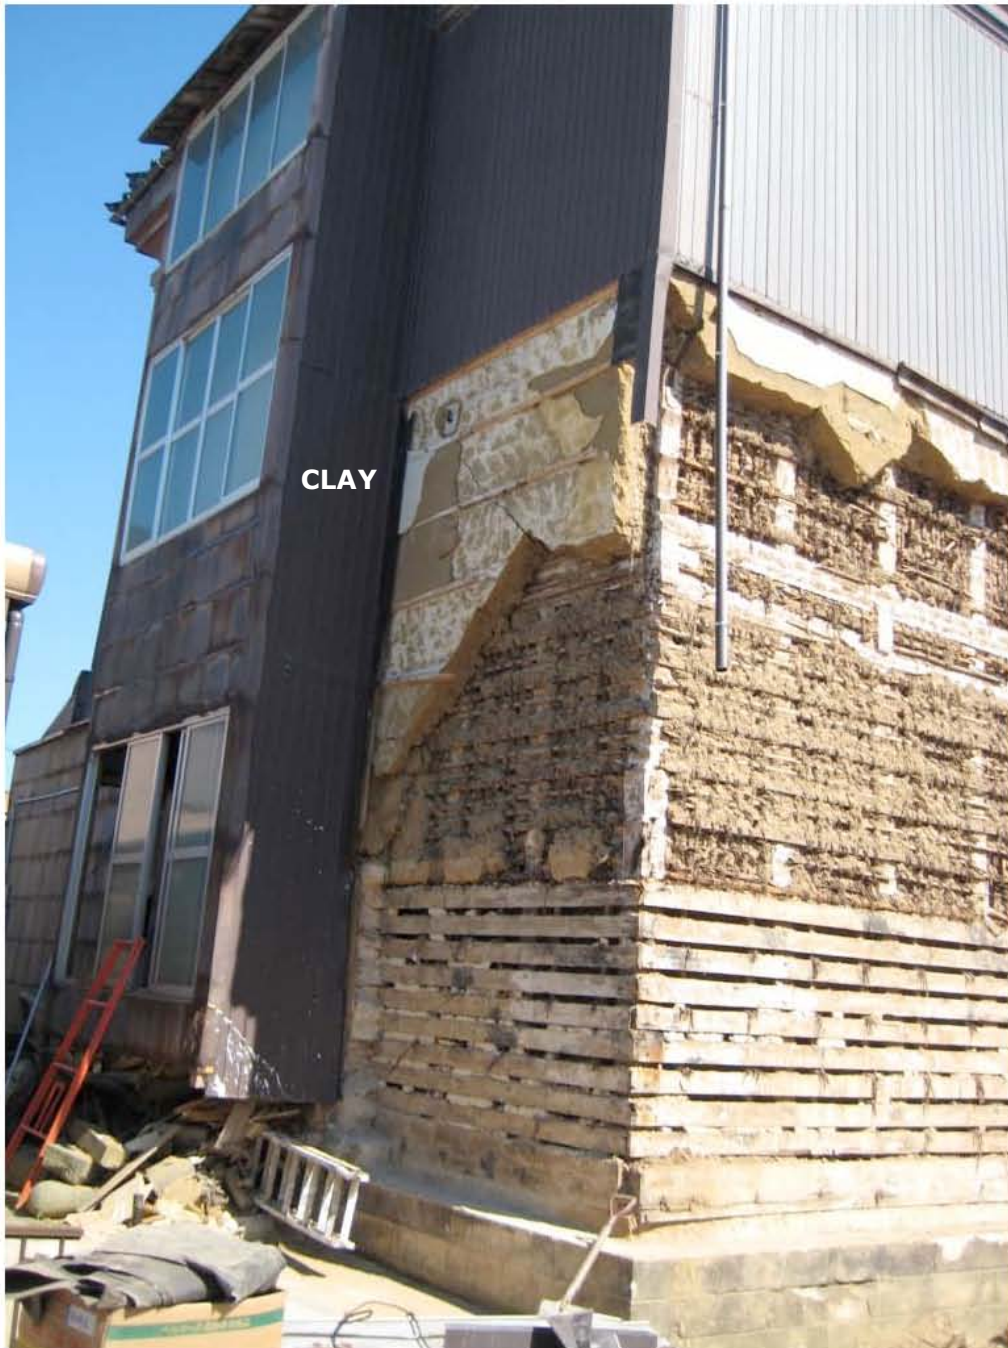
A large fraction of the houses affected were of old-style heavy clay-tile kawara roofs with walls constructed of wood, and walls of soil and bamboo-lathe known in Japanese as *tsuchi-kabe* or “soil wall” (Fig. 5.11). The clay-wood combination can be used effectively if provided with braces for lateral strength and stiffness, however in general, results in heavy and brittle building components. Soft story collapses were observed in buildings with open businesses on the ground floor. The business arcade of Higashi-Honcho Dori was particularly hard hit, accompanied by ground movement/settlement on the south side of the street that was located on the shoulder of sand dunes.

Figure 5.11: Traditional Japanese tsumi-kabe (“soil wall”) construction technique (Site SP13, N37.37056°, E138.55694°).

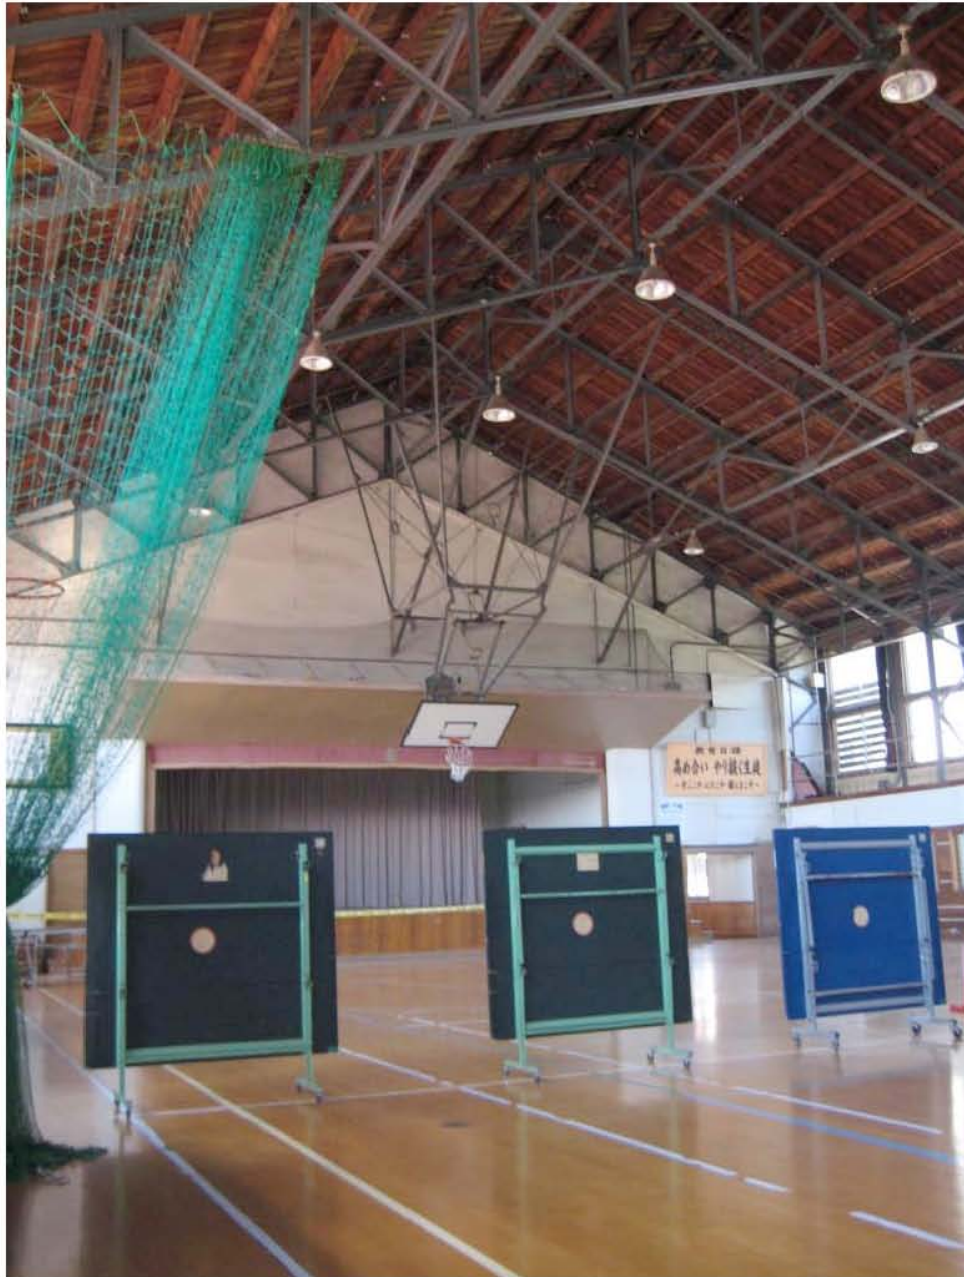
In Kashiwazaki, steel structures were not as common as concrete structures at the time of our visit. None of the few steel structures we saw collapsed. One of these structures was a gymnasium built in the 1950's (Site SP2), located 1.1 km away from the K-NET NIG018 station. The structure was composed of a series of 2D trusses running in the EW direction. Trusses running NS connected the EW trusses at the roof (Fig. 5.12). Finishes did not allow viewing of additional structural elements. But windows along the NS direction made it evident that, at least in this direction, the structure was provided with no braces. The structure survived the earthquake with an estimated permanent drift ratio of 2.5% to the north.

Figure 5.12: Gymnasium at Jr. High School No. 2, Kashiwazaki (Site SP2, N37.3728° E138.5709°).

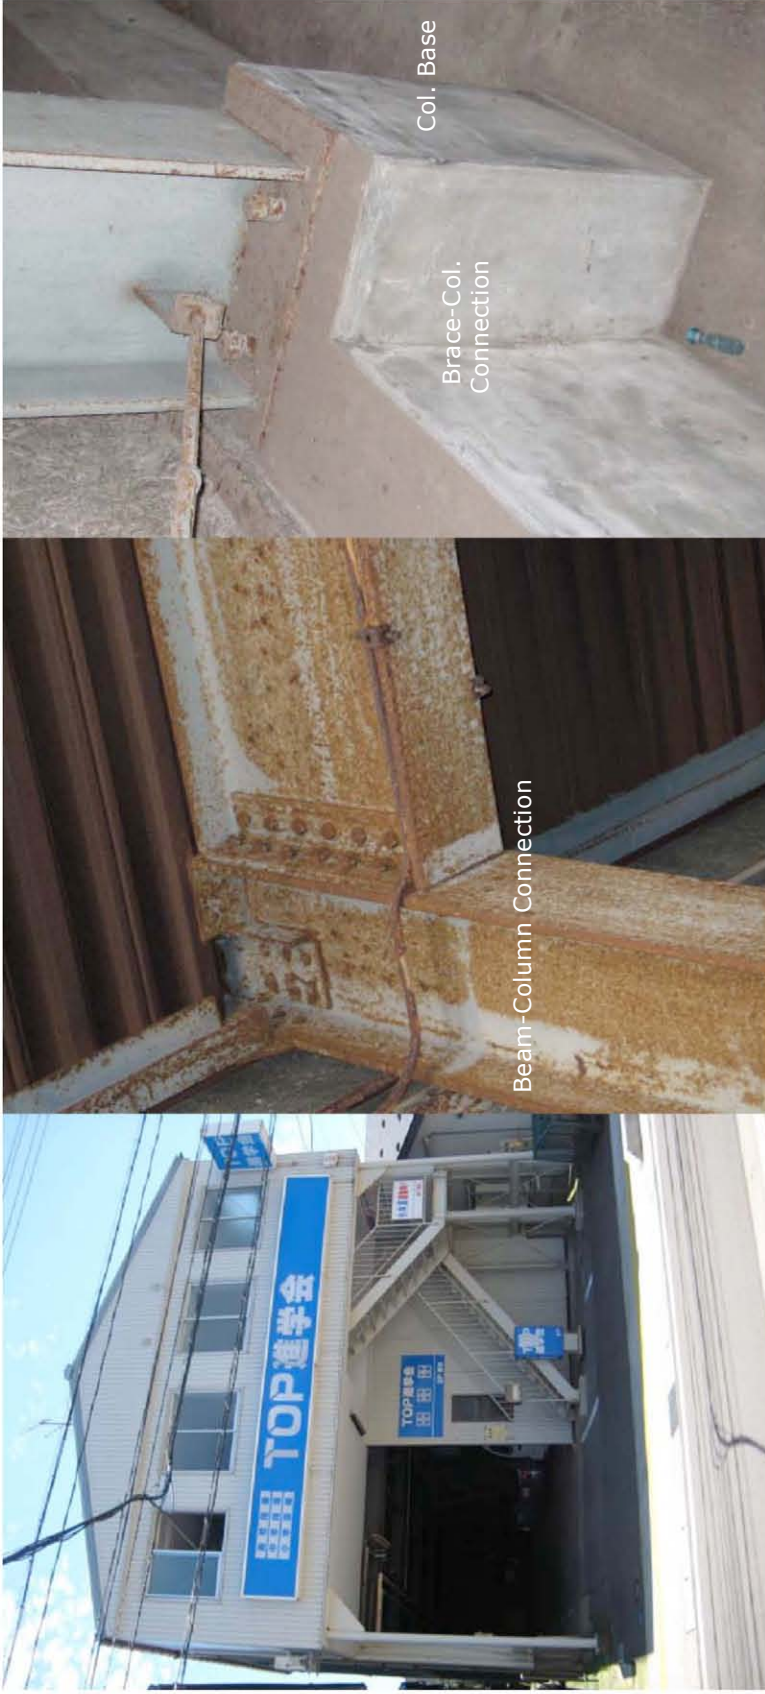
Another example of a surviving steel structure is illustrated in Fig. 5.13 (Site SP29). This structure was located at approximately 270 m from the K-NET NIG018 station, which measured PGV=100m/s. The two-story structure included nine, one-bay

frames parallel to the EW direction. The five frames closer to the front of the structure had no moment connections. The four frames closer to the back did have moment connections. The frames were connected to one another by a concrete slab cast on a steel deck at the second level and presumably by the roof. The slab had a step in the span that connects the moment resisting frames in the back and the gravity frames in the front. Braces were visible along the NS walls of the structure. The braces were connected to the webs of columns in the front frames through brackets as shown in Figure 5.13.

Figure 5.13: Parking structure in Kashiwazaki (Site SP29, N37.3707° E138.5566°).

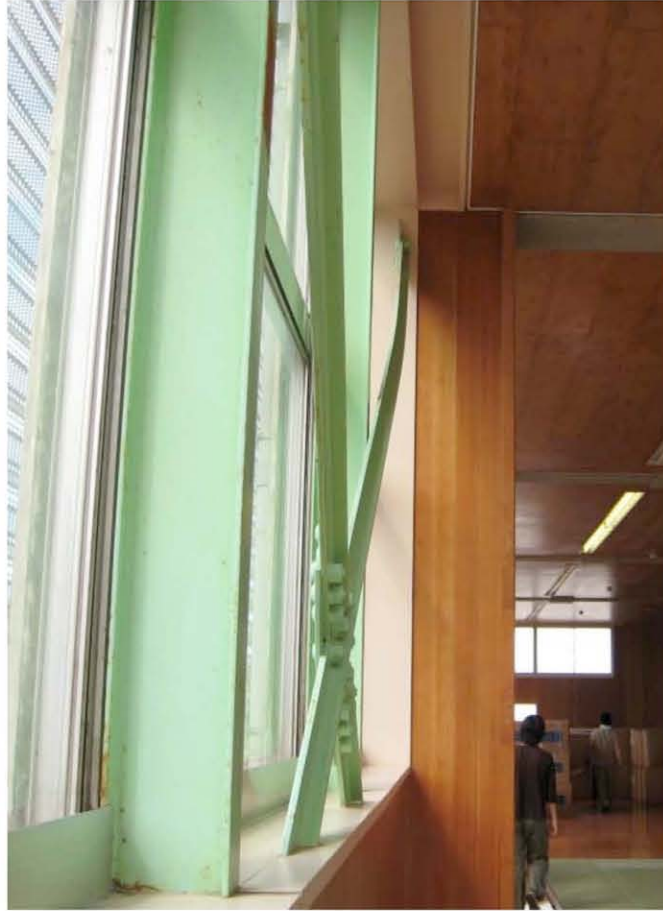
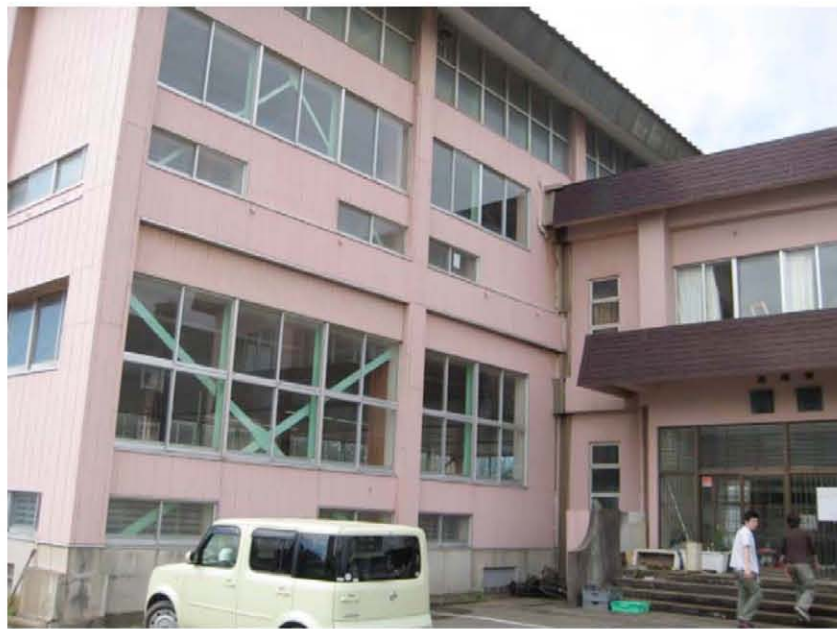
We inspected another gymnasium (Fig. 5.14 - Site SP7) with a steel structure. In this structure, located 430 m from the K-NET station, we observed buckling of steel braces in the lower of the two stories in the structure. The braces had T-shape cross sections with a thickness of 12 mm. The flange measured 150 mm, and the stem 45 mm. The braces had a slope of 2/3 with respect to the horizontal. Four pairs of braces reinforced each story in the NS direction. The floor plan was approximately 20 m in the EW direction and 33 m in the NS direction.

Figure 5.14: Buckling of braces in gymnasium in Kashiwazaki (Site SP7, N37.3755° E138.5541°).

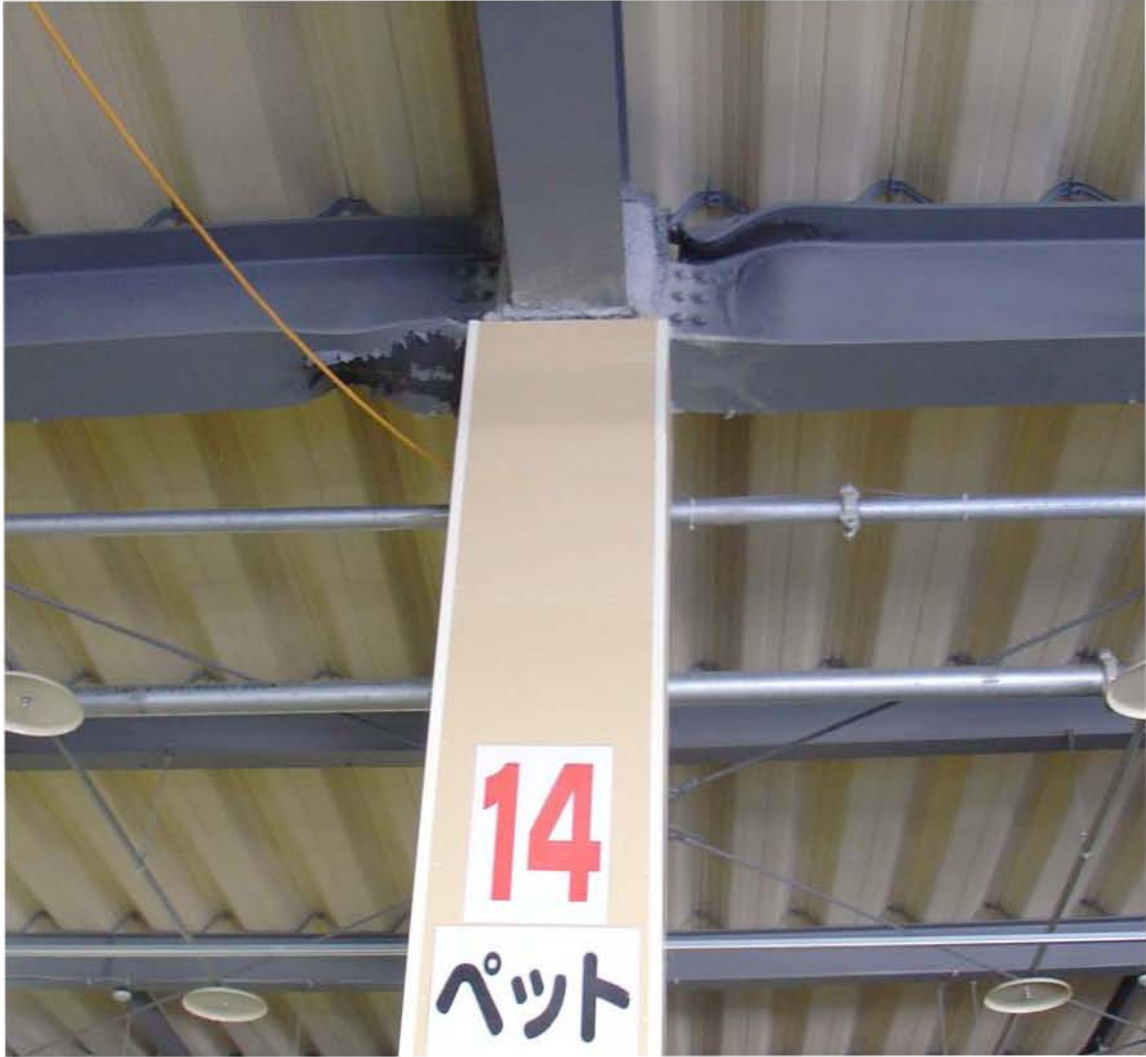
The storage at site RK41 was affected by large ground distortion (see Section 4). At this site, we observed buckling of flanges of beams at bolted connections (Fig. 5.15).

Figure 5.15: Buckling of beam flanges (Site RK41, N37.41472° E138.60833°, photo by Peter Yanev).

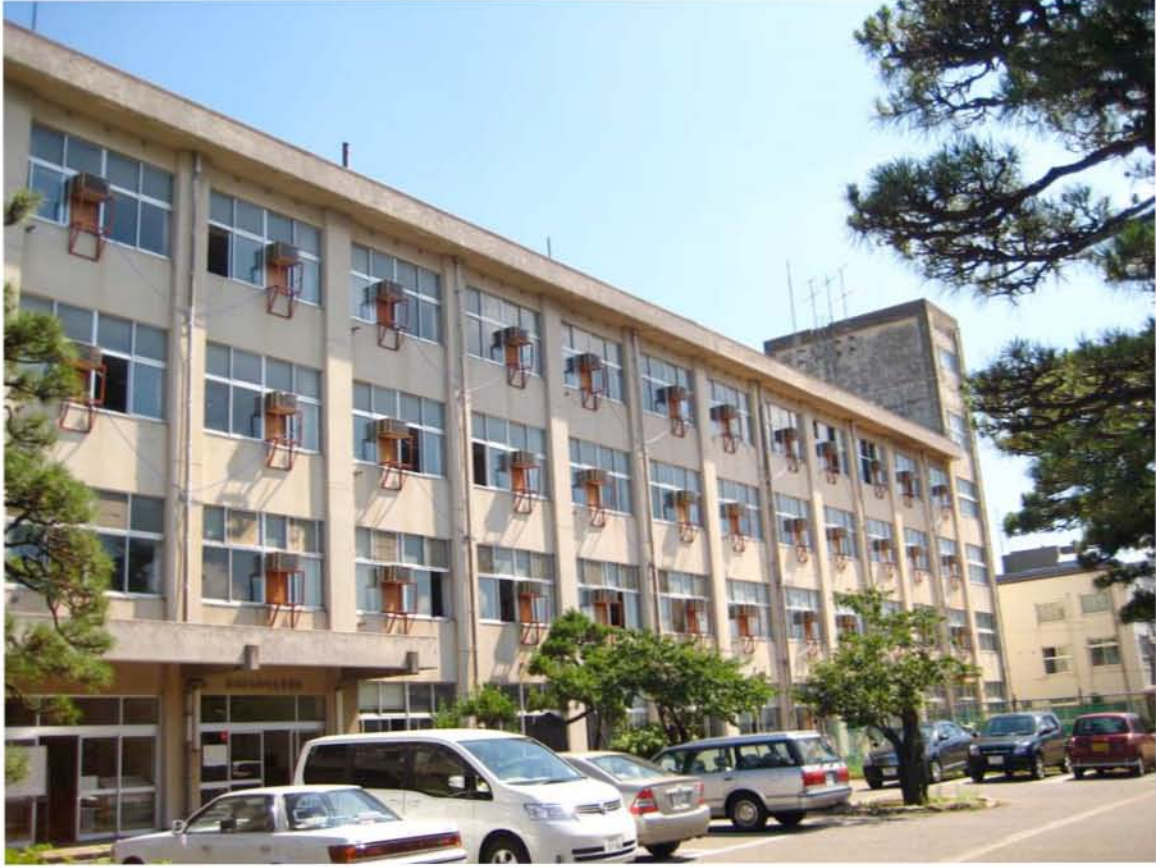
We observed 1-mm thick inclined cracks in a column and 1 to 2.5-mm-thick inclined cracks in reinforced concrete walls in the Kashiwazaki High School (Site SP11), located at 100 m from the K-NET NIG018 station. The high school facilities included two reinforced concrete buildings (Figs. 5.16 to 5.20). We observed the south building to be a four-story building with shear walls in the NS direction and moment-resisting frames in the EW direction. The walls with cracks filled bays in one of the frames parallel to the EW direction in the south building and had a thickness of 12 cm. These walls were reinforced with bars with a diameter of 10 mm, spaced at 20 cm in the vertical and

horizontal directions. The inclined cracks described had the same orientation in the column and the walls, and indicated movement of the second level towards the west. The wall with the largest cracks had a door opening (bay 3-4). Refer to the Google Earth map accompanying this report for additional information.

Figure 5.16: Kashiwazaki High School, south building (Site SP11, N37.3721° E138.5569°).

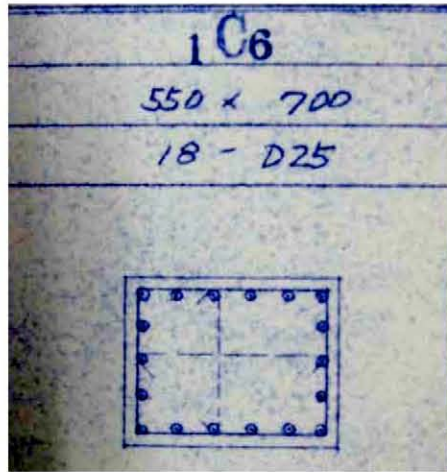
Figure 5.21: Column in first story of The Kashiwazaki High School, cross section and observed crack pattern (Site SP11, N37.3721°, E138.5569°).

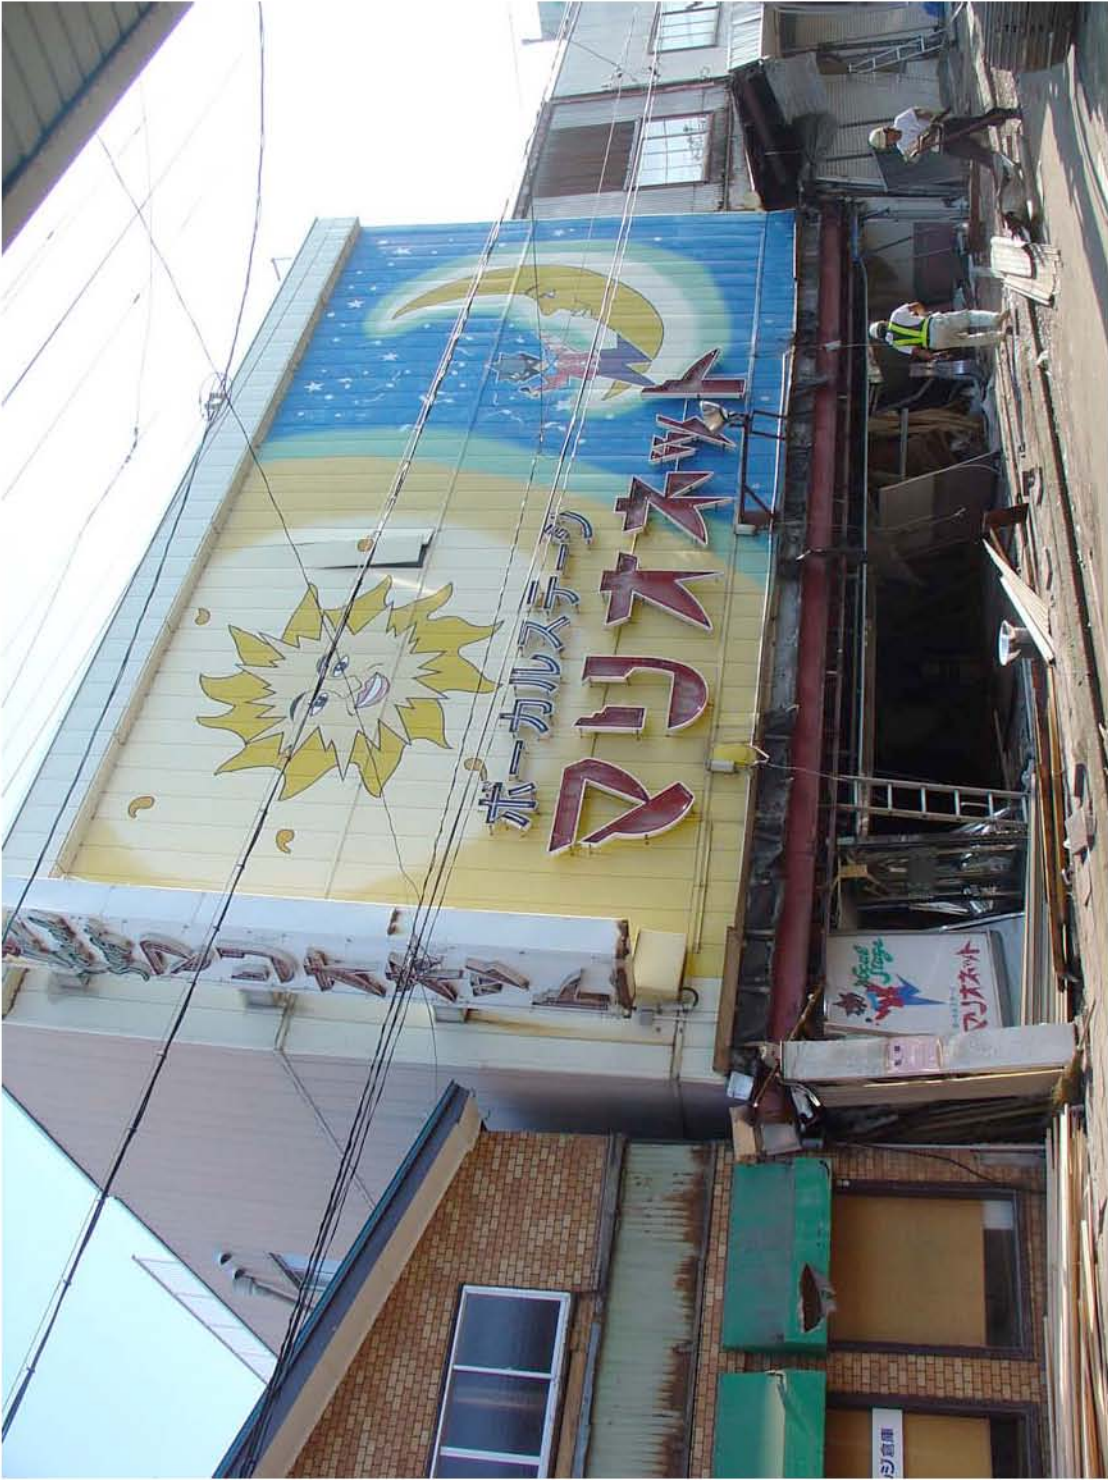
Figure 5.23: Karaoke parlor (Site NIT-81, N37.37000° E138.55825°, photo by Peter Yanev)
