Investigation of the M6.6 Niigata-Chuetsu Oki, Japan, Earthquake of July 16, 2007

Open File Report 2007–1365

U.S. Department of the Interior
U.S. Geological Survey

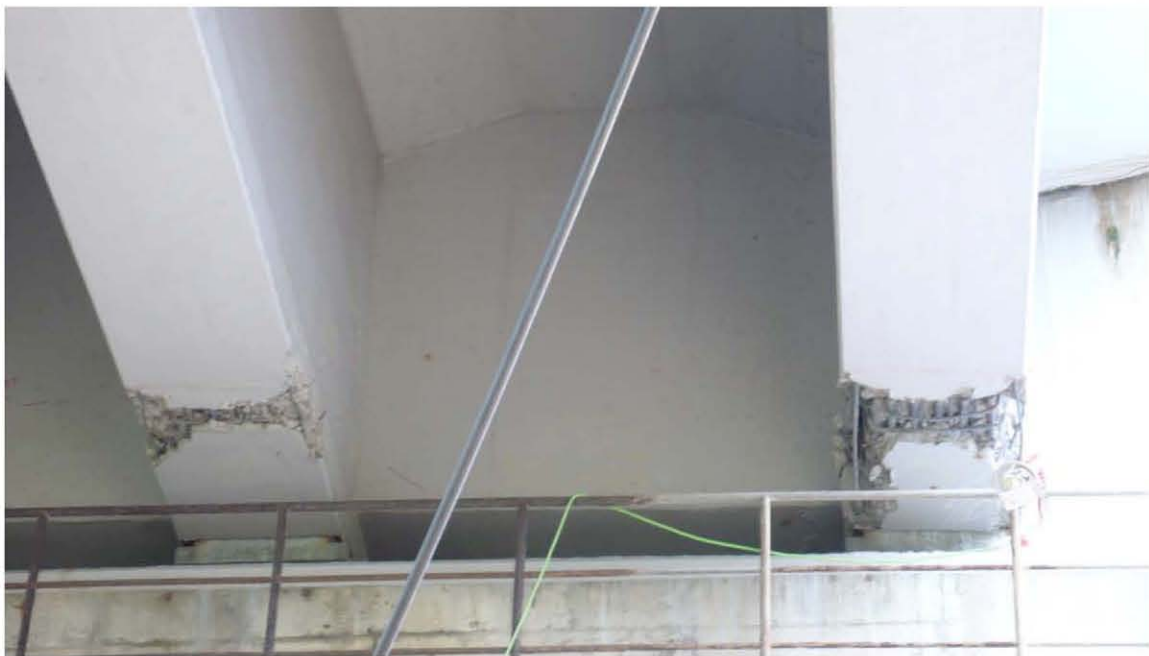
shear force exceeded the shear strength of girder at the bearing connection. There was a spall at the bottom of the girders about 0.6m from the abutment backwall and on the other side of the bearing. Perhaps, as the abutment moved downward, large shear forces in the girders caused them to spall (Fig. 6.4). The damage occurred at the north end of the west bridge (small cracks were observed on the east bridge).

Fig. 6.4. Closer view of girders on the west Hachisaki Bridge.

When we arrived at the scene (on August 5th), both directions of traffic had been diverted to the east bridge, they had finished driving sheet piles around the abutment to stabilize the soil, and were casting a large pad at the west bridge so that they could jack up the southern three spans and repair the girders and bearings.

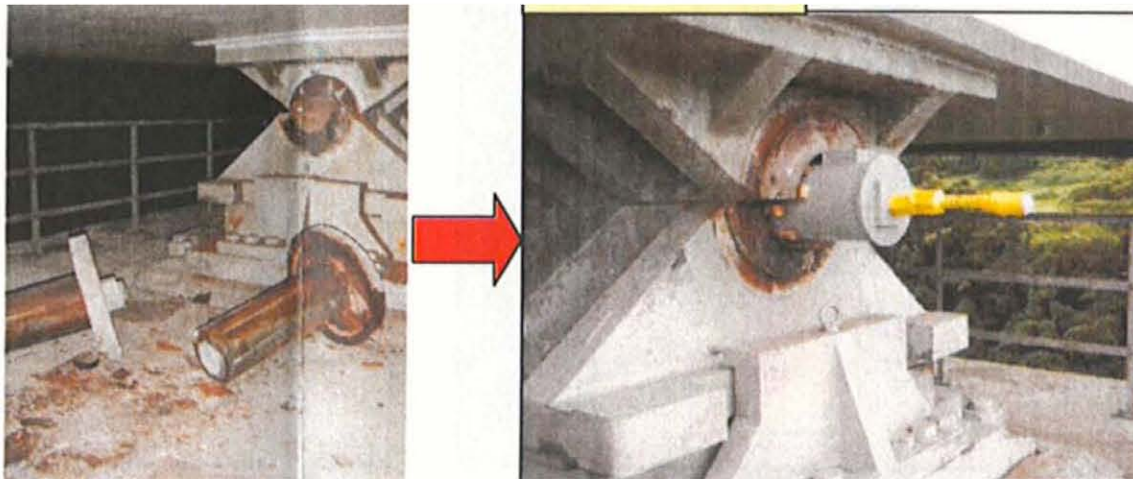
These are two haunched, three-span, segmentally-constructed cast-in-place, concrete box girder bridges on very tall hollow, reinforced concrete piers (Fig. 6.5). Like several other bridges in the same area, the superstructures moved enough during the earthquake to break the fixed steel bearings (Fig. 6.6). Perhaps the weakest member, in this case the

steel bearings, acted as fuses to protect the structure from more catastrophic damage. Jacking up these long, continuous superstructures is no easy task, and jacking them back transversely is also a lot of work, but it's also one of the most common types of bridge damage that occurs during earthquakes.

Fig. 6.6. Damage and Repair to Omigawa Bridge (photo courtesy of the Nippon Expressway Company.).

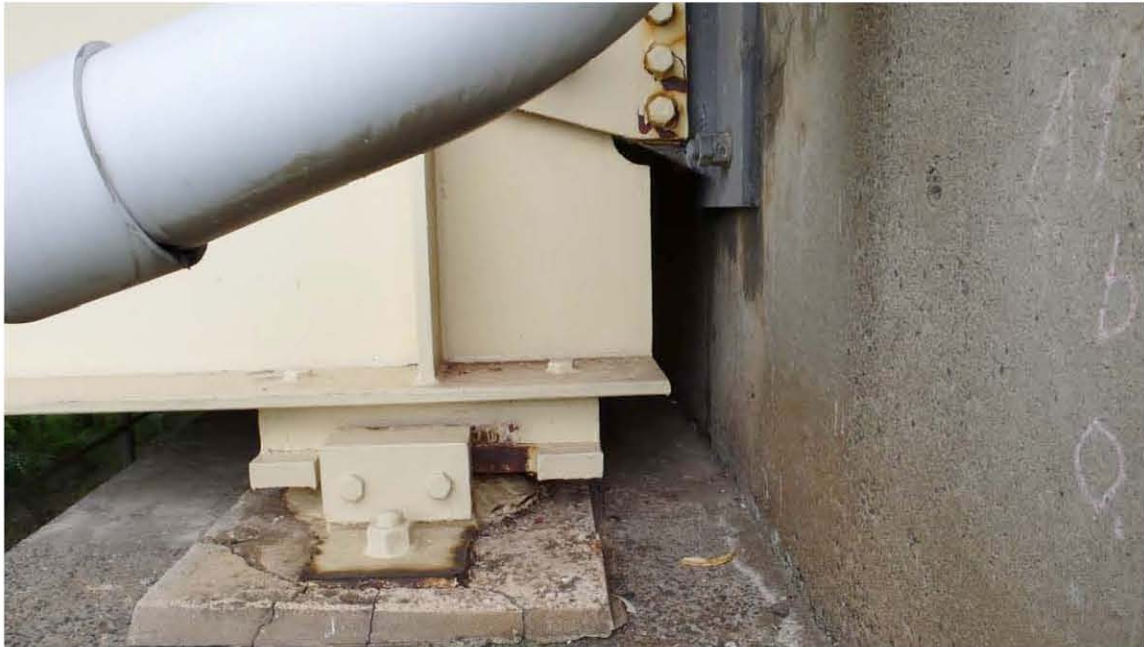
the steel abutment bearing was seated on had shattered as the steel girders banged against the steel longitudinal keys that were to limit movement (Fig 9).

Fig. 6.9. Bearing at south abutment of Yoshiigawa Bridges.

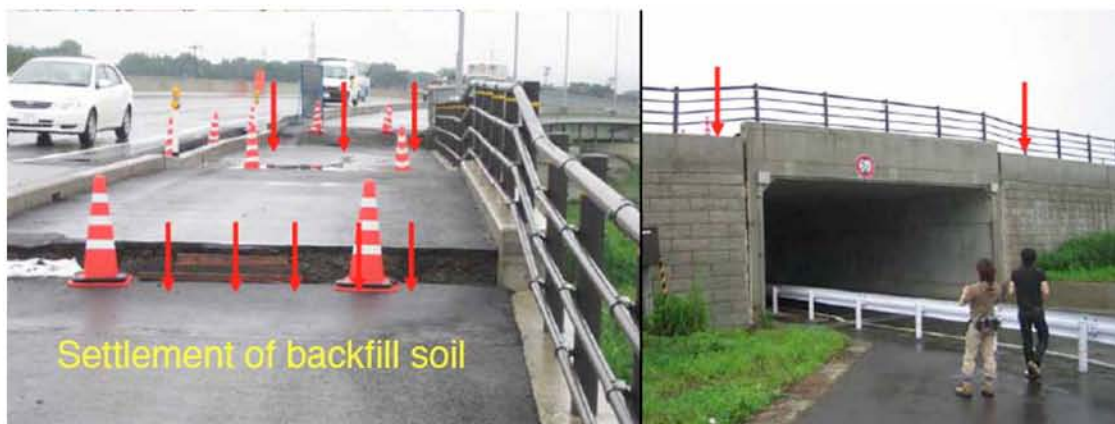
Fig. 6.13. Settlement of west embankment (courtesy G. Watanabe, Tokyo Institute of Technology).

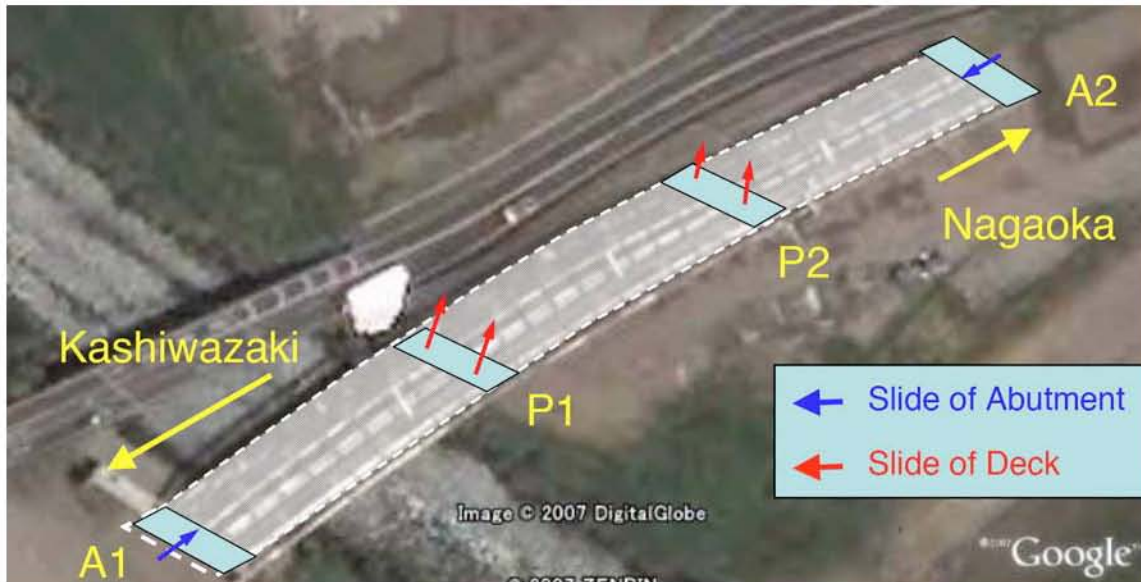
Fig. 6.14. Movement of Toyota Bridge (courtesy G. Watanabe, Tokyo Institute of Technology).

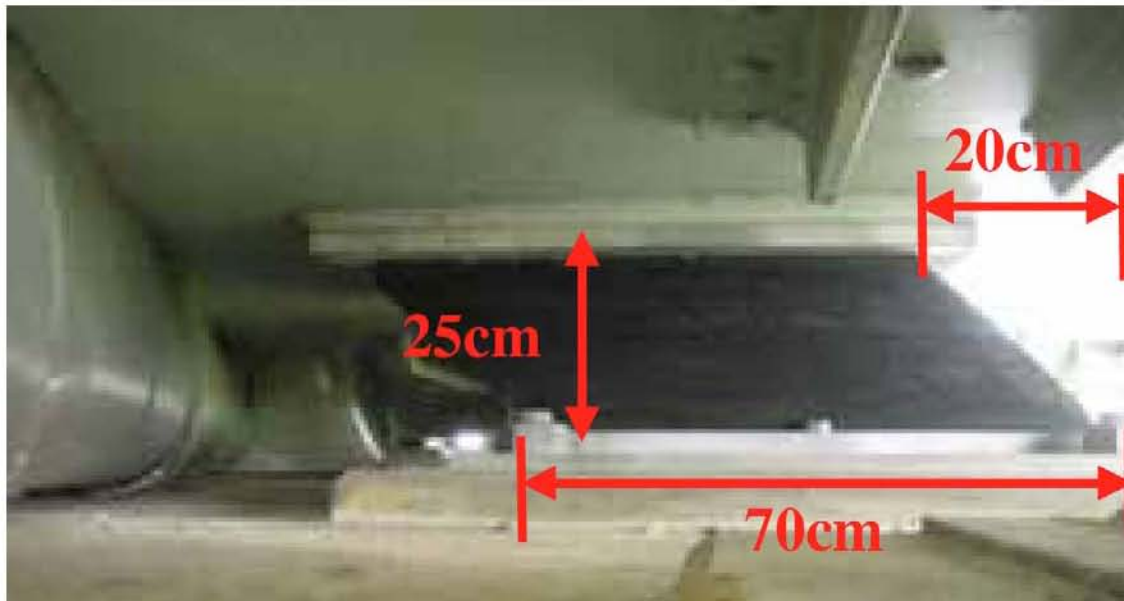
Fig. 6.15. Displacement of Bearing Bridge (courtesy G. Watanabe, Tokyo Institute of Technology).

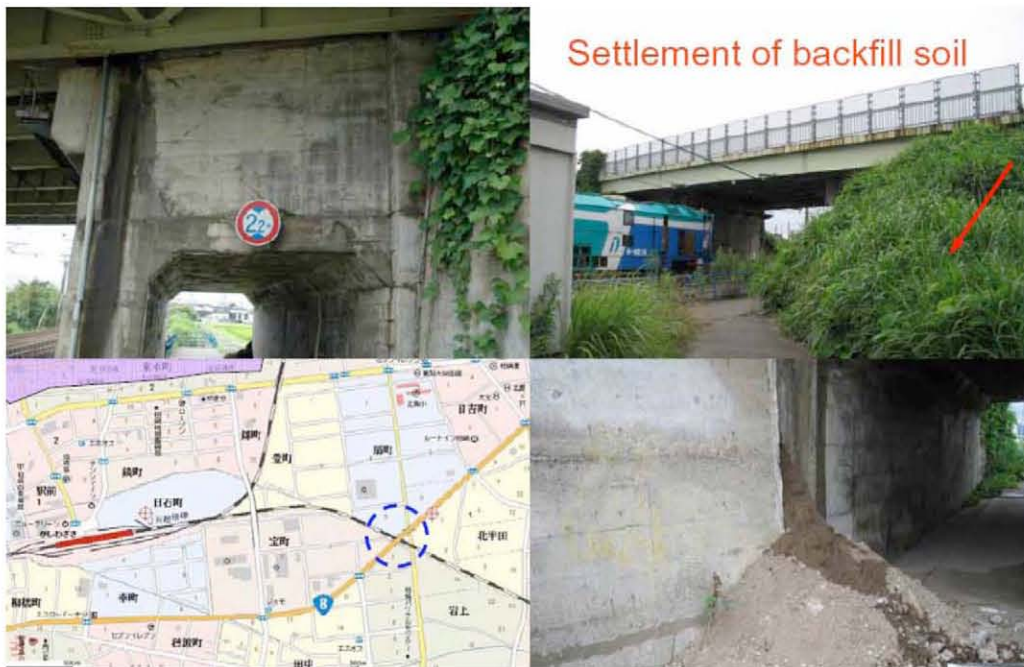
In downtown Kashiwazaki, on Highway 8 there are a couple of older bridges that are beginning to be maintenance problems. However, the only noticeable damage from the earthquake was some embankment damage behind the abutments on the Route 522 and the Japan Rail Bridges (Fig 6.16 and 6.17).

Fig. 6.17. Damage and repairs where railway crosses Highway 8 Bridge (courtesy G. Watanabe, Tokyo Institute of Technology).

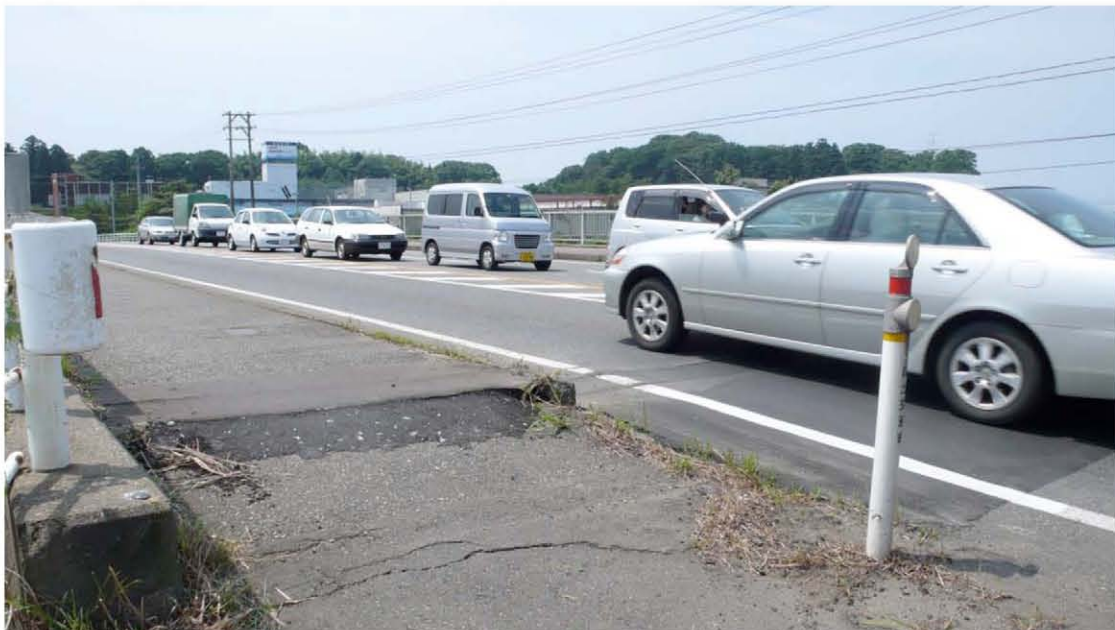
settlement that was quickly repaired (Fig. 6.19). Just north of the bridge were several manholes raised above another roadway's surface and a nearby stonecutter's shop had toppled statuary suggesting a $PGA > 0.25g$, and that liquefaction was a problem at this site. However, the embankment settlement was only about 10cm and continued to decrease upstream, suggesting better soil and/or weaker accelerations.

Fig. 6.19. Slight (10cm) settlement at bridge approaches.

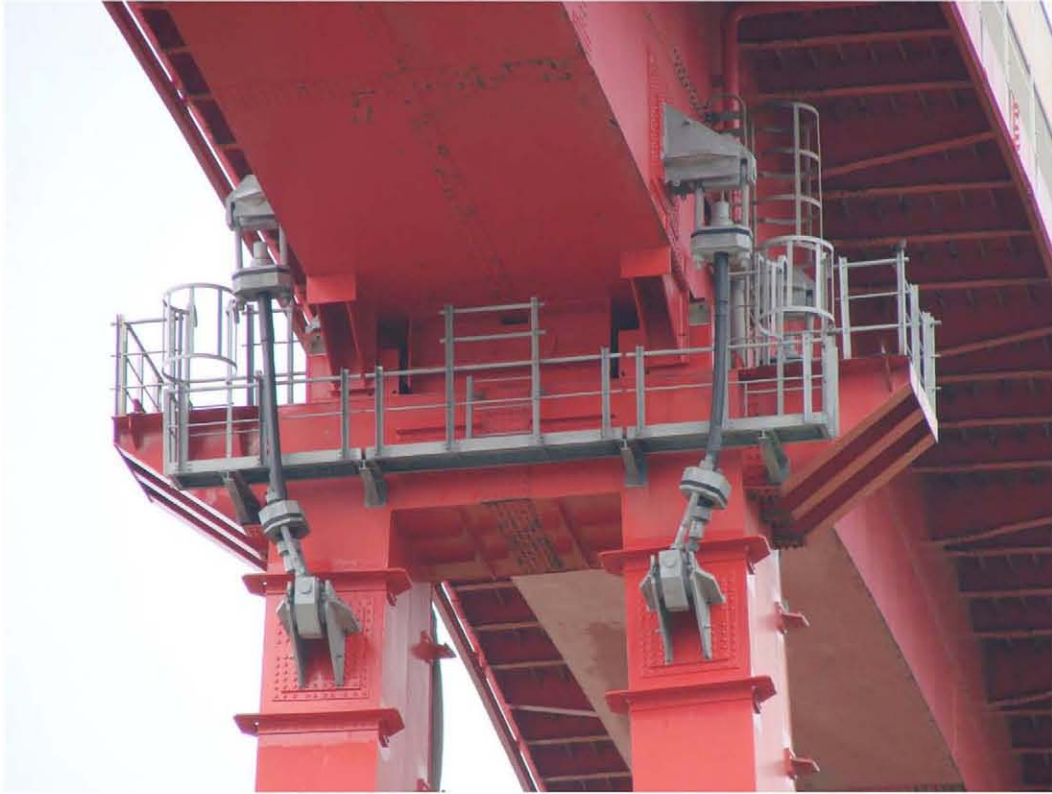
The bridge had been retrofit before the earthquake, which may have helped reduce the amount of damage that occurred. Lateral and vertical restrainers and stoppers were added at the superstructure (Fig. 6.22). The steel towers had been filled with concrete and stiffeners and doubler plates had been added to make the towers very stiff and strong. The bearing damage was very slight. It was just the failure of the stopper key element and deformation of the pin-cap, which did not affect the bearing function (Fig. 6.23). Other damage occurred as a result of the superstructure pounding against the abutment backwall.

Fig. 6.22. Retrofitted bent cap at Yoneyama Bridge (courtesy of S. Unjoh, PWRI).

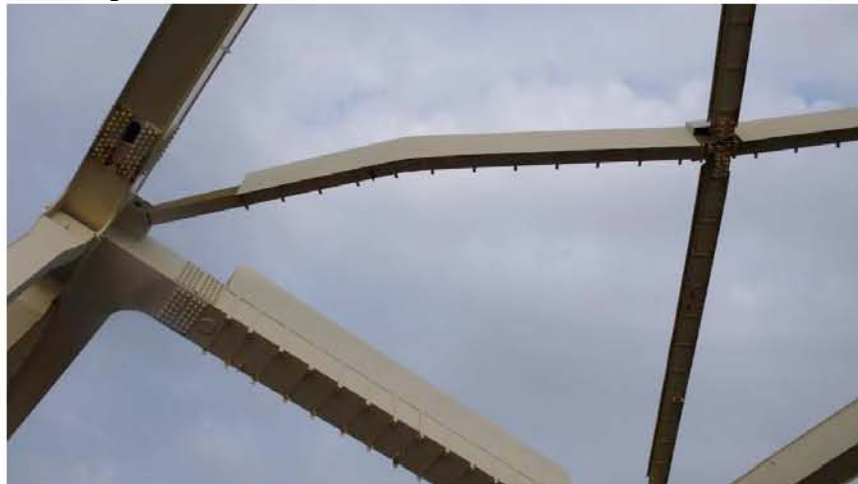
When we visited the bridge (on Aug. 4th) we saw many of its members had buckled (Fig. 6.25) and some of its connections were damaged (Fig 6.26) along with its bearings (Fig. 6.27). Still, the bridge remained in service. Metal boxes were placed around the bearings to support the bridge in case a strong aftershock occurs. This is a very common bridge type. However, the struts and bracings need to be designed against lateral wind force and lateral earthquake force. It appears that the earthquake force during this earthquake exceeded the design force. A deck arch bridge, the Agewa Bridge immediately to the north was undamaged by the earthquake (Fig. 6.28). It might be possible to retrofit the Yonahime bridge for large earthquakes, possibly by supporting it on isolation bearings. Certainly, these fixed bearings, which we saw damaged on several of the longer span bridges, are a lot of trouble to replace.

Fig. 6.25. Buckled cross bracing on Yonahime Bridge.

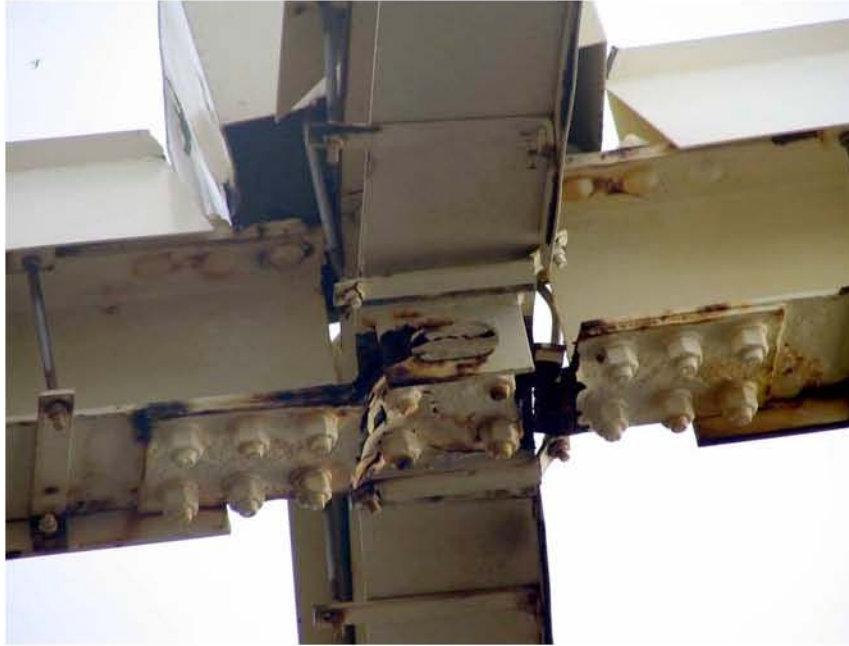
Fig. 6.26. Torn cross bracing connection on Yonahime Bridge.

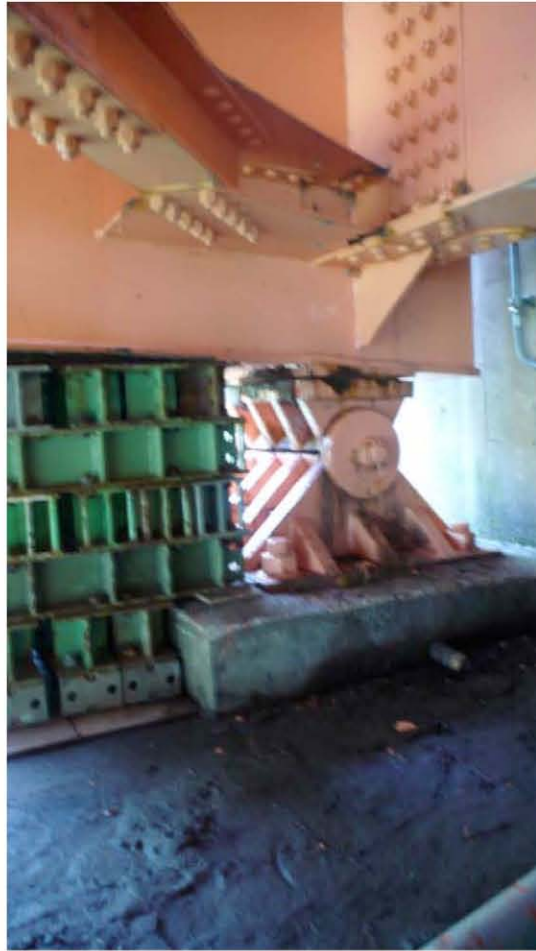
Fig. 6.27. Damage of set bolts and the additional steel box support to prepare the aftershocks)

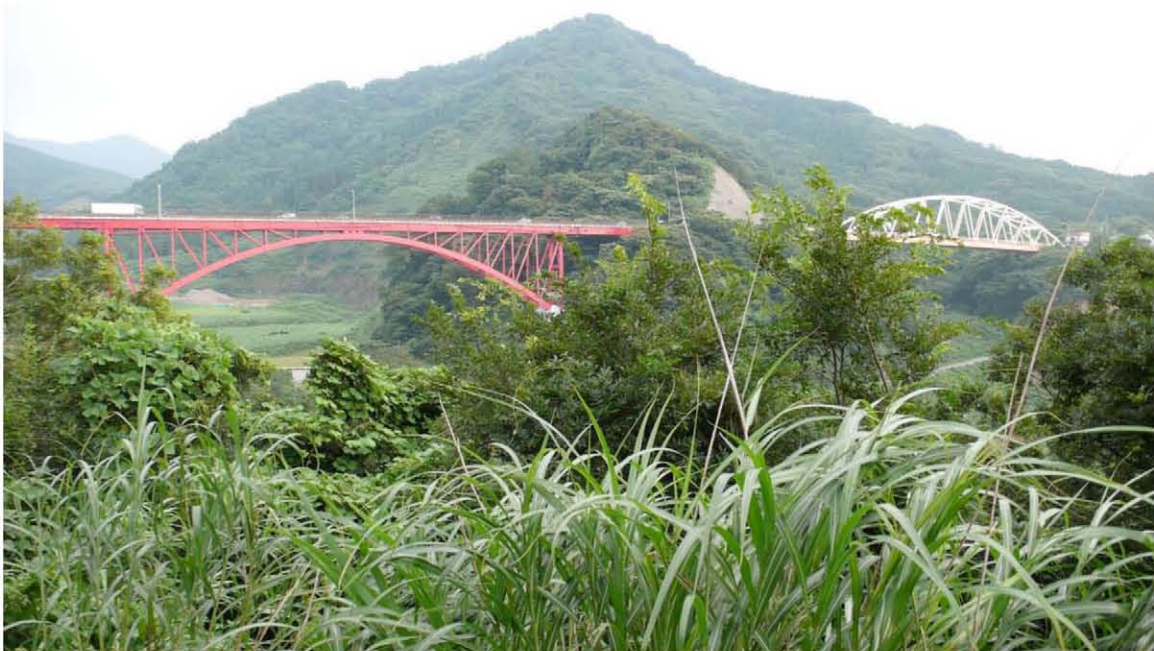
Fig. 6.28. Undamaged Agewa (Deck Arch) Bridge just north of damaged Yonahime Bridge.

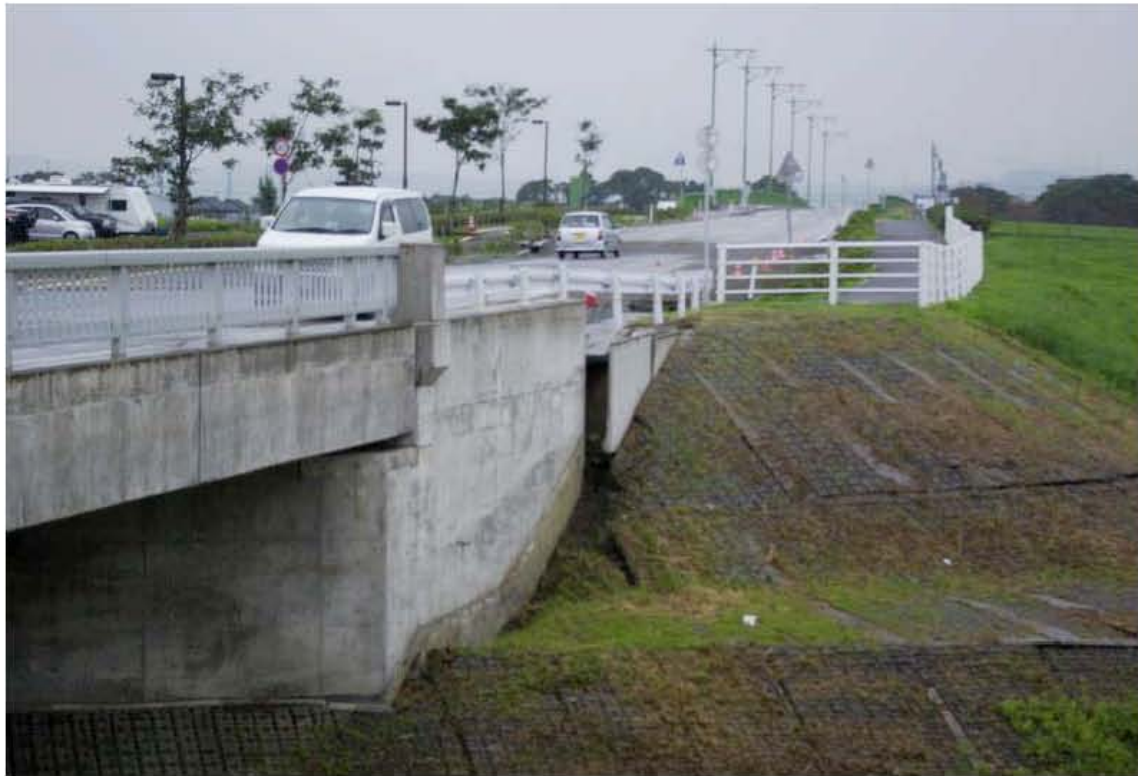
During the earthquake, the south bridge embankment settled as the bank spread into the river. The wingwalls weren't attached to the abutment (which was on piles) and moved with the embankment (Fig. 6.31). The lateral spread was the result of liquefaction of the island (Fig. 6.32). Figure 33 shows about 400 cm settlement of the south embankment.

Fig 6.31. Looking southeast at Heisei bridge abutment, settled embankment, and the island.

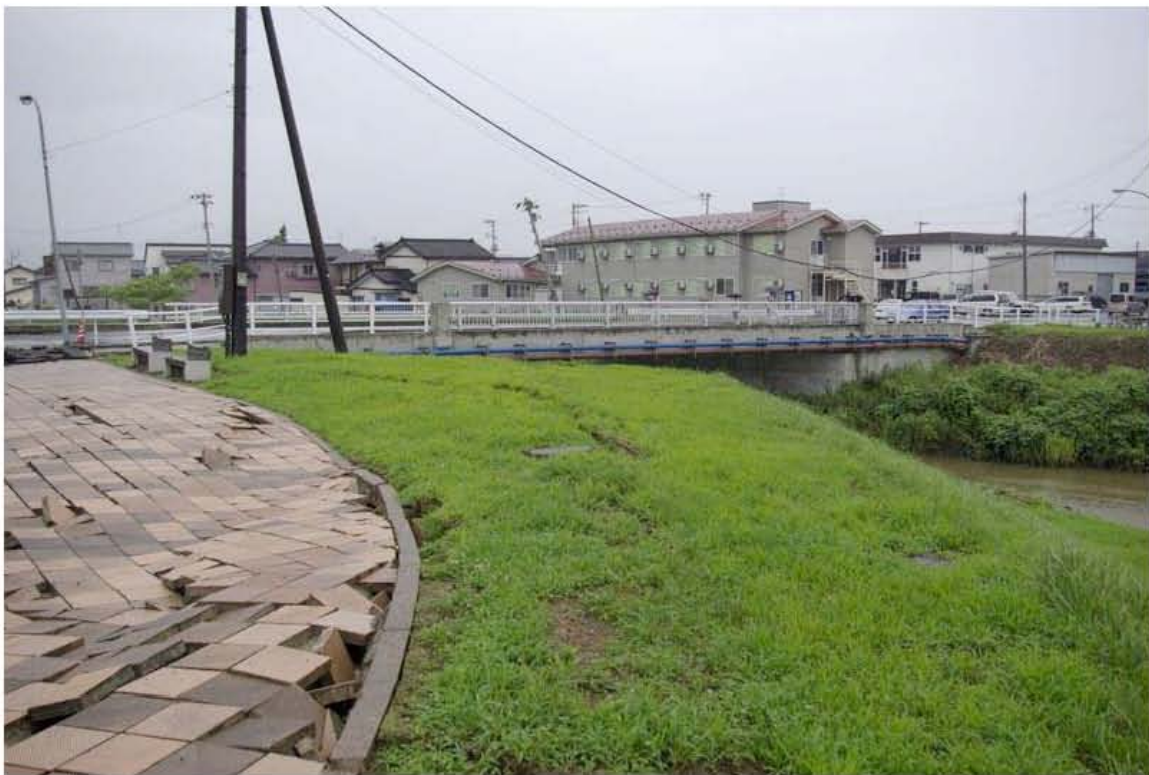
Fig. 6.32. Looking northwest at liquefaction of island and the Heisei Bridge.

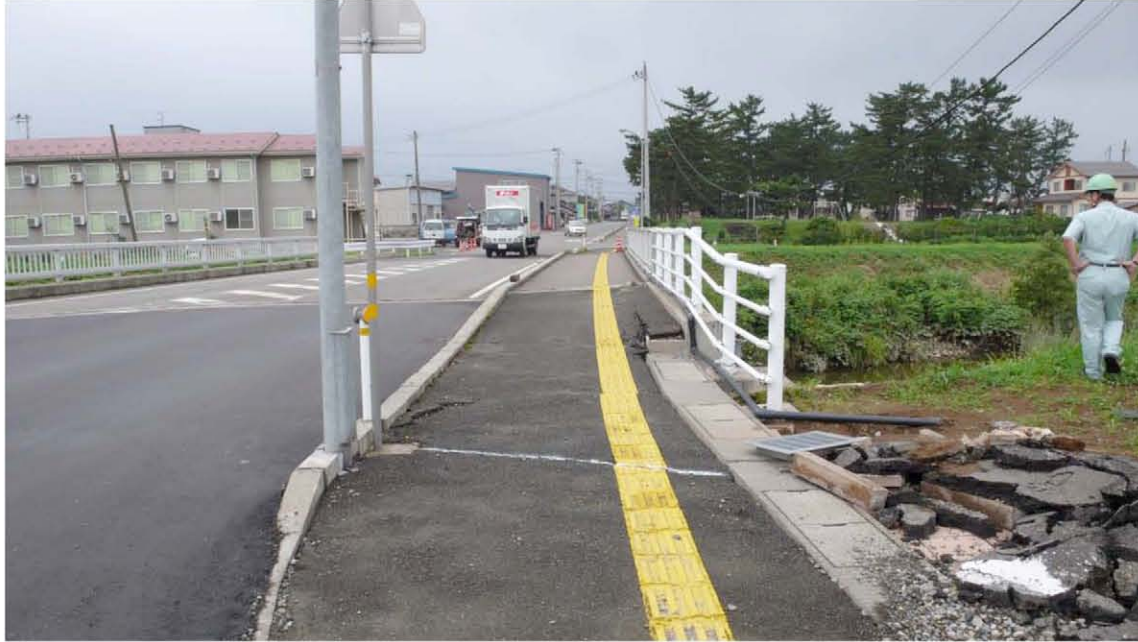
Fig. 6.33. Looking north from island at Hashi bridge deck.

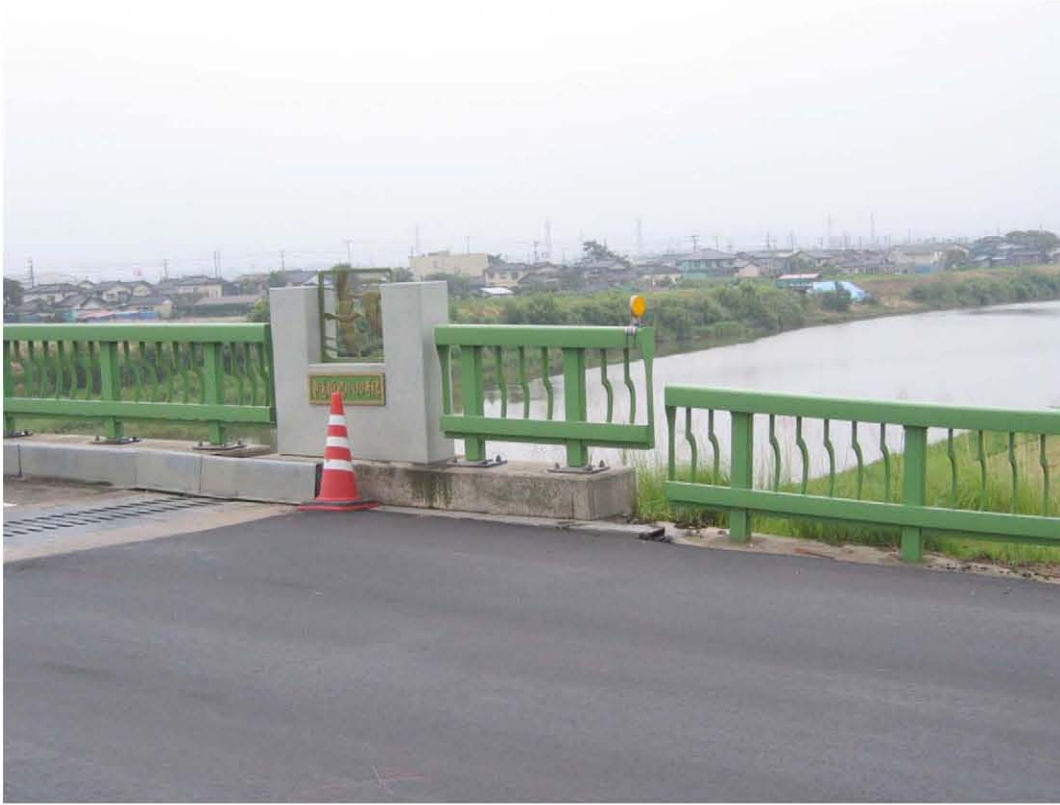
This is a continuous, two-span, concrete box girder bridge supported on seat abutments and a pier wall (Fig. 6.34). During the earthquake, the north bridge embankment settled about 40 cm (Fig 6.35). There were also signs that the bridge underwent shaking and pounding (Fig. 6.36). Although the abutments were on piles, the bearings were distorted, indicating that the abutments had been pushed toward the river (Fig. 6.37).

Fig. 6.35. Settlement of north bridge approach.

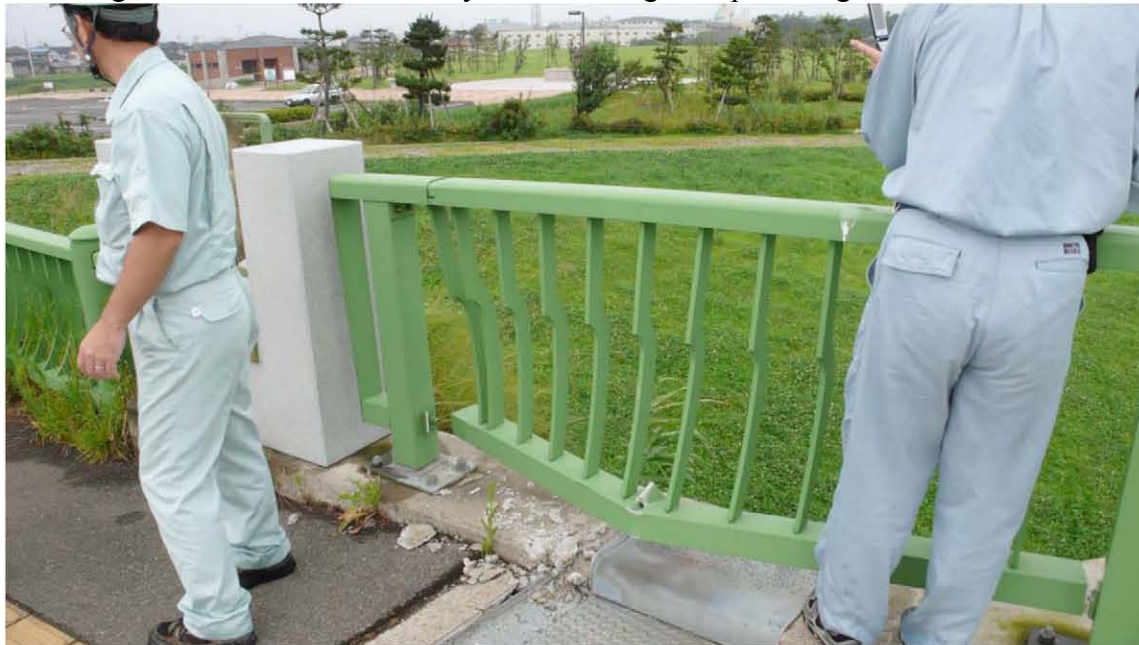
Note that unlike the north Heisei Bridge, there are apparently piles under the short wingwalls on the south Heisei Bridge. Figures 6.38 and 6.39 show the wingwalls at the same height as the abutment and they also show signs of pounding between them.

Fig. 6.38. Pounding between abutment and wingwall.

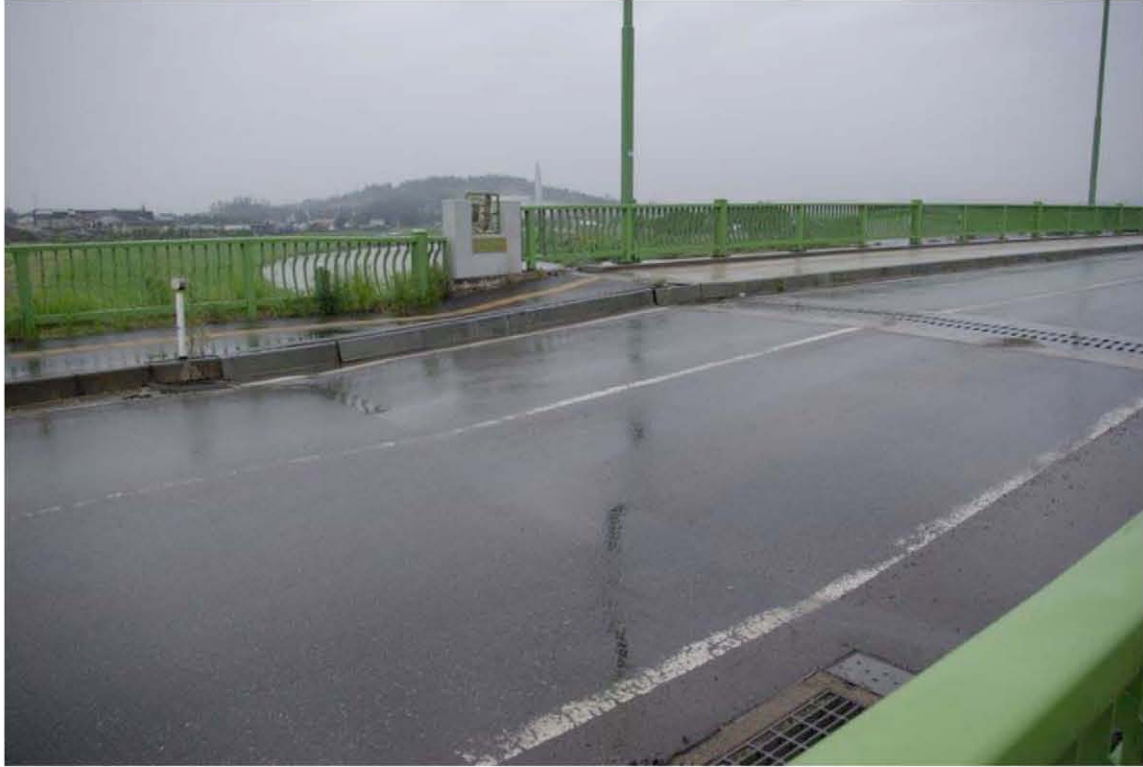
Fig. 6.39. Settlement of north bridge abutment.

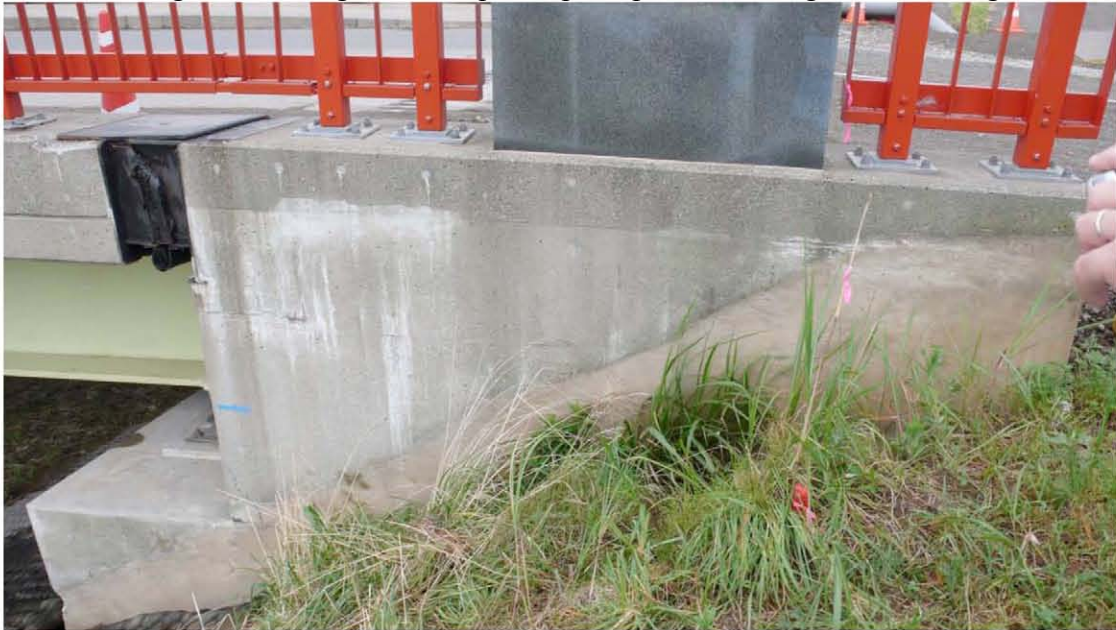
Like the other Sabaishi bridges, this settlement was caused by the riverbank spreading toward the river (Fig. 6.42). Although the expansion joint, the abutment, and the bearings should have been isolated from this movement by the pile supports, they were distorted as shown in Fig. 6.43 during the earthquake, perhaps due to the ground shaking.

Fig. 6.42 The soil around the south abutment moved towards the river during the earthquake.

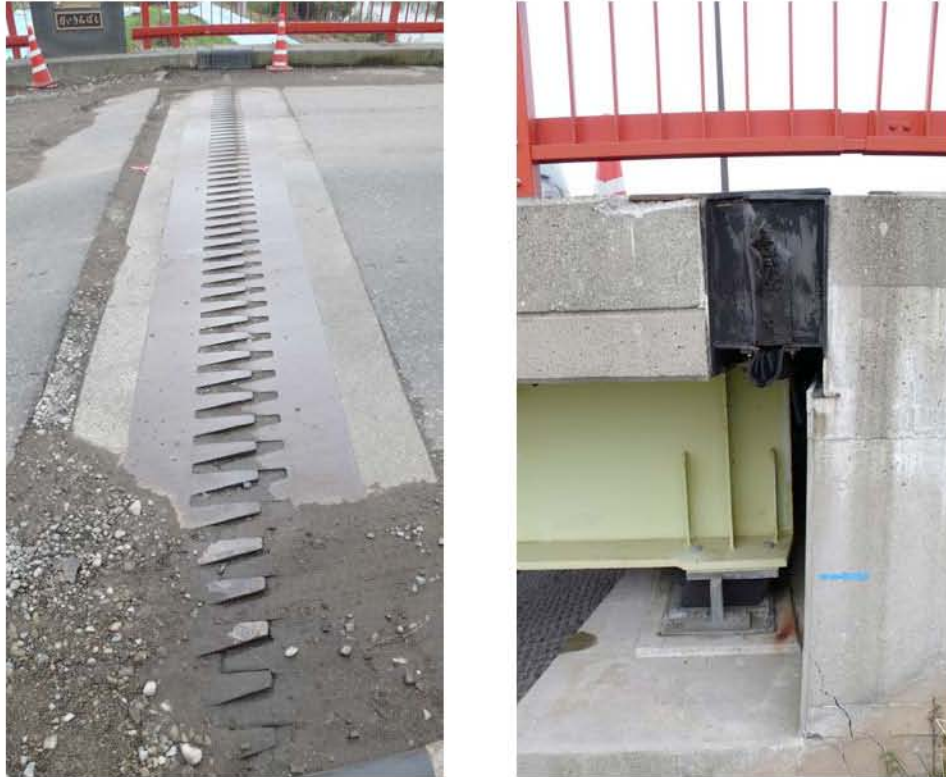
Fig. 6.43. Distortion of expansion joint, bearings, and abutment on Kaiun Bridge.

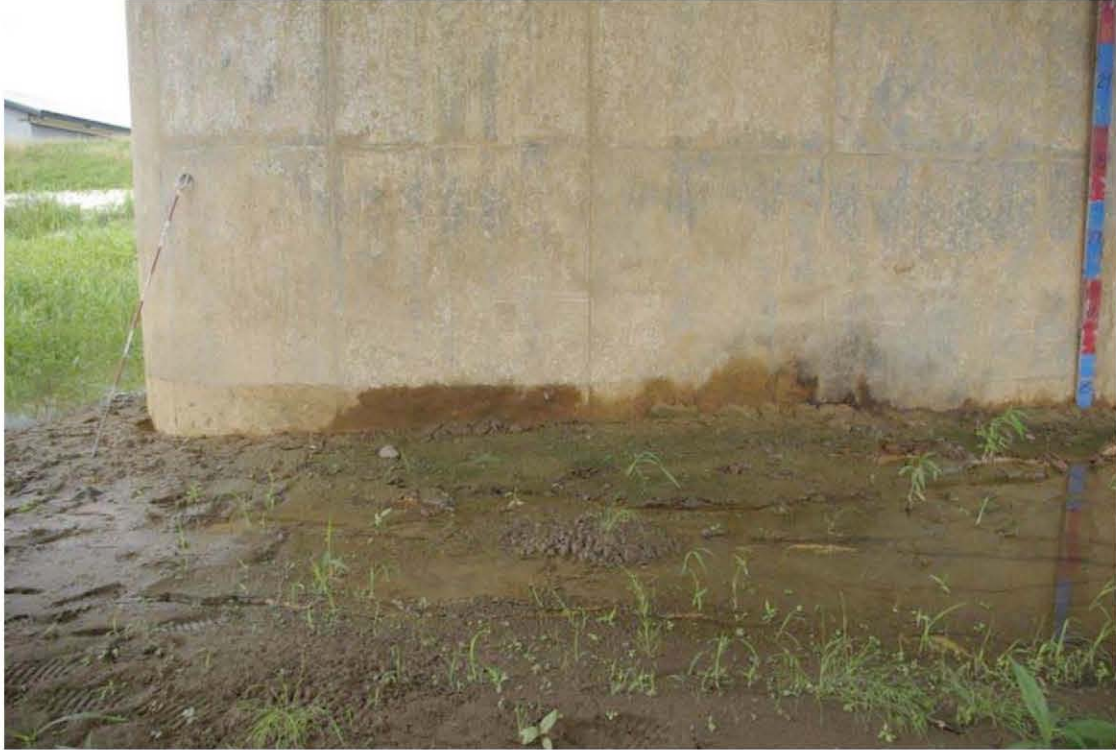
This is a three span steel girder bridge on pier walls and seat-type abutments (Fig. 6.44). There was evidence of fine grain soil being ejected at depth to the ground surface (along with settlement) at the saturated riverbanks (Fig. 6.45). There was damage to the abutment backwall (Fig. 6.46) and to the bridge approaches (Fig. 6.47).

Fig. 6.45. Soil settled around pier in riverbank (photo courtesy of Scott Brandenburg).

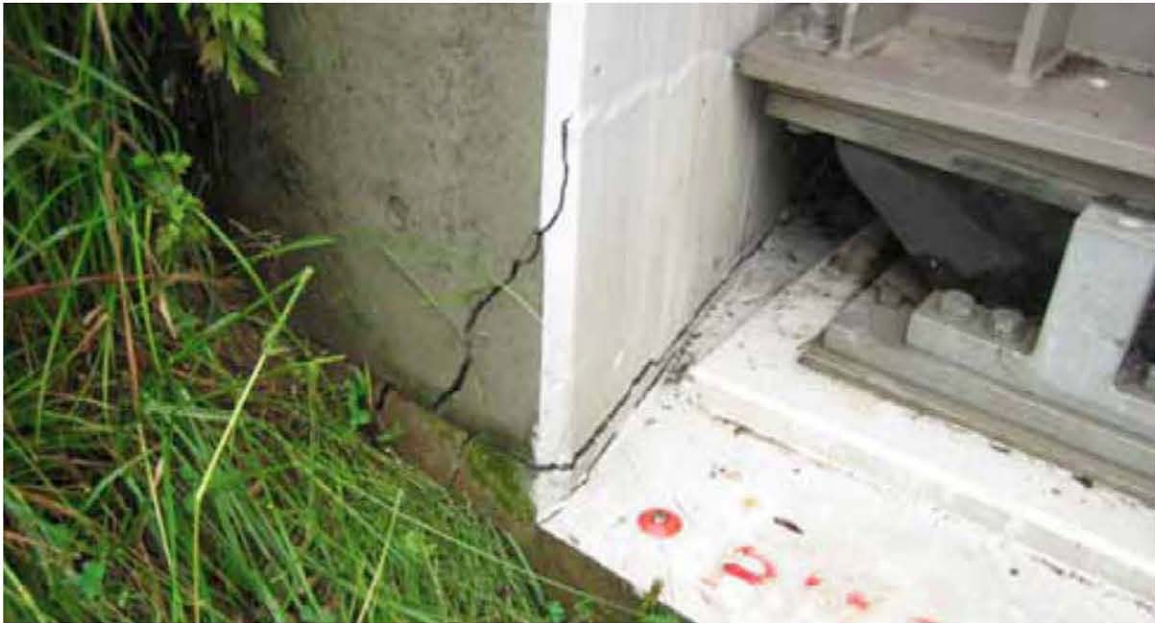
Fig. 6.46. Distorted bearing and cracked abutment backwall (photo courtesy of Scott Brandenburg).

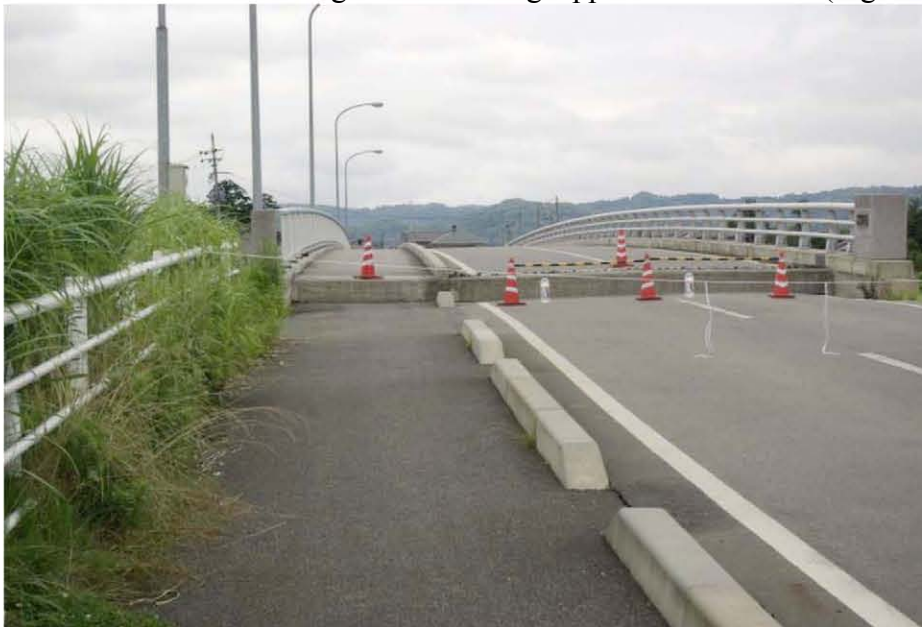
This is the last Sabaishi River bridge that had a big approach settlement (Fig. 6.48).

Fig 6.48 Genji Bridge (photo courtesy of Scott Brandenburg).

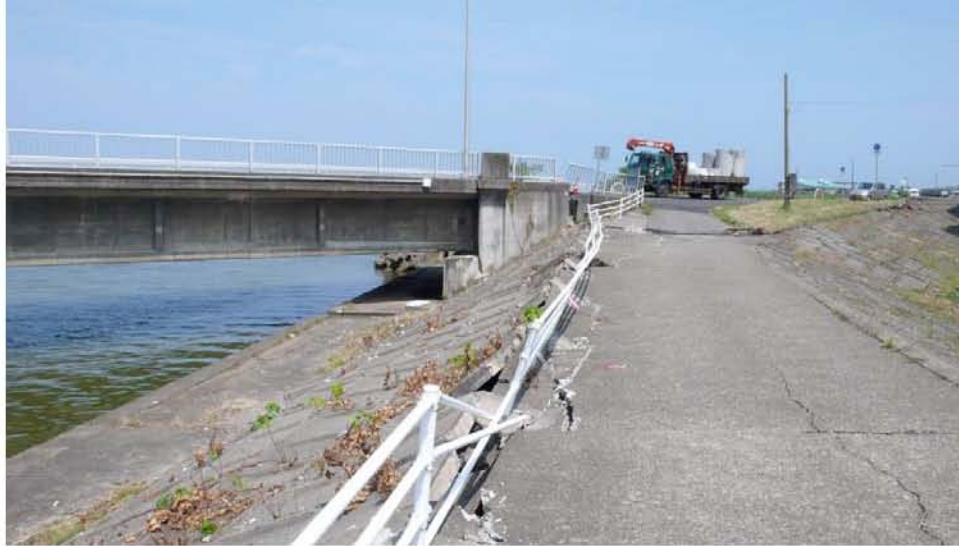
This is a two span concrete I girder bridge on seat abutments and a single column bent with a hammerhead cap at the mouth of the Ugawa. This location had the most lateral spreading on the Ugawa. The entire levee was dragged toward the river (Fig. 6.50) and the abutment was damaged and separated from the wingwall (Fig. 6.51).

Fig 6.50. Rinko Yasaka Bridge at the mouth of the Ugawa.

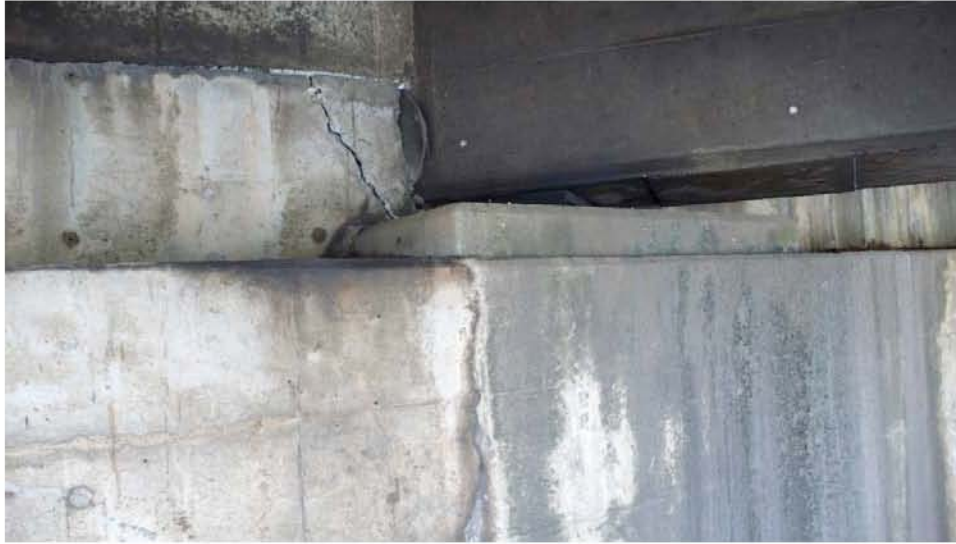
The concrete I girders broke the abutment backwall (Fig. 6.52), the bridge approaches were damaged but quickly repaired (Fig. 6.53), and it appeared that repair work was going on at the center pier (Fig. 6.54).

Fig. 6.52. Backwall-Diaphragm damaged by earthquake.

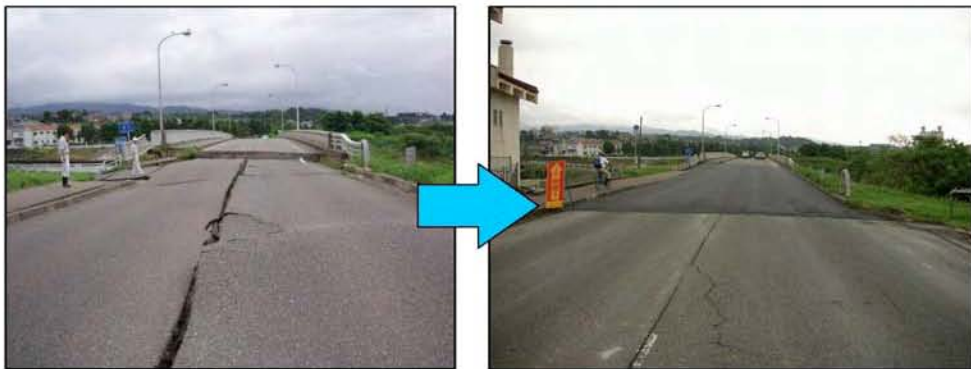
Fig. 6.53. Before and after views of approach and bridge deck.

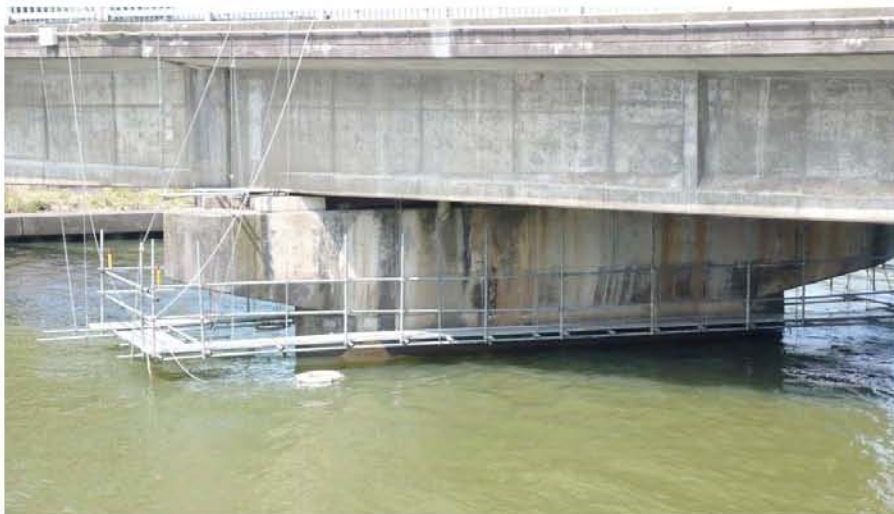
Fig. 6.54. Pier supporting Rinko Yasaka Bridge.

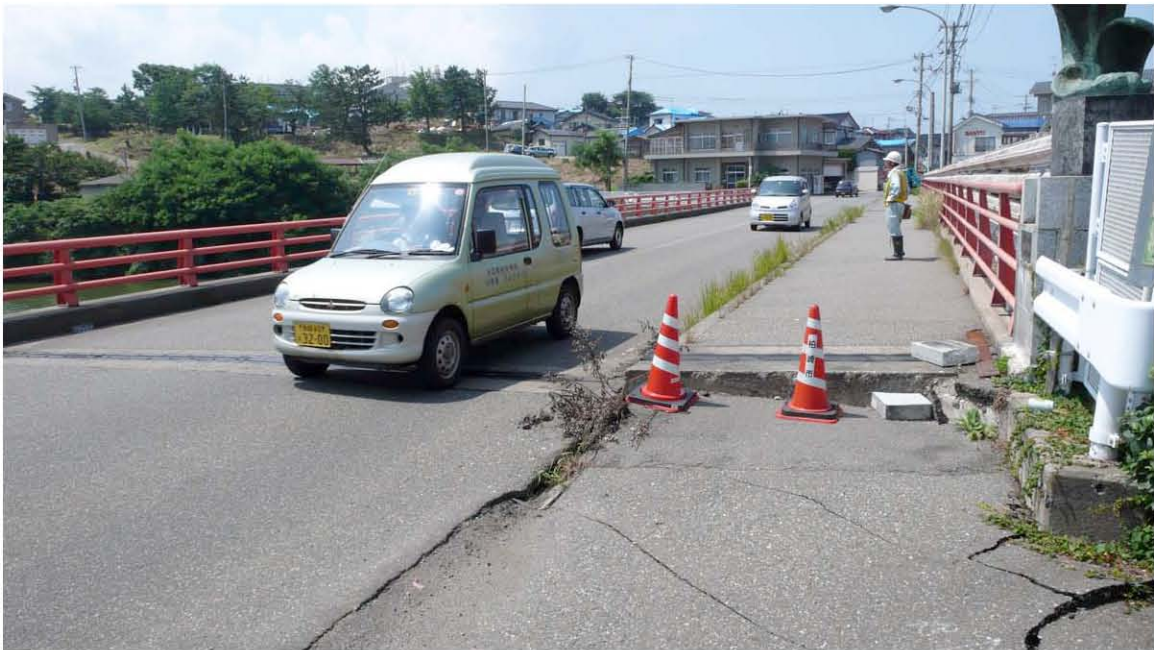
Like most of the bridges over the Ugawa, this is a two span, simply-supported river crossing, but with steel girders, and supported on a pier wall and seat-type abutments (Fig. 6.55). It is about 200 meters from the more heavily damaged Rinko Yasaka Bridge, but the soil was much firmer at this site, there was less than 100 cm of settlement at the approaches, and no damage to the abutments or wingwalls (Fig. 6.56).

Fig. 6.56. Approach and deck of Yasaka Bridge.

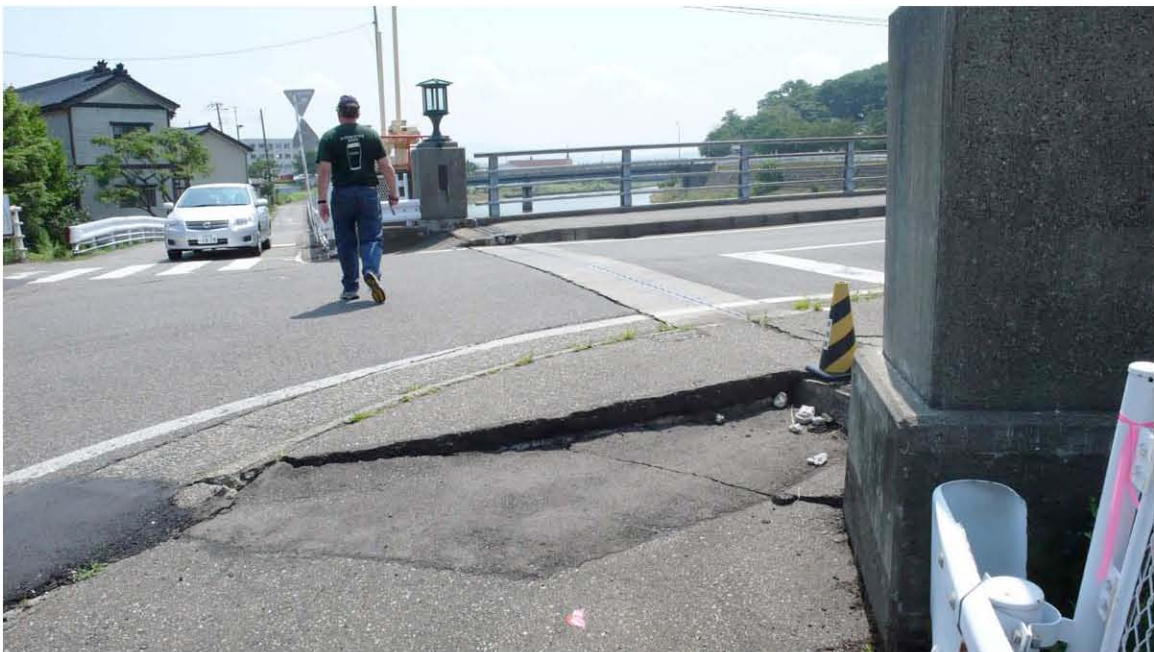
Continuing to walk upstream another 300 meters, we came to the third bridge crossing the Ugawa. The Ukawa bridge is a two (simple) span 'I' girder bridge supported by a pier wall and seat-type abutments (Fig. 6.57). All of these bridges are about 60 meters long. As seen in Figure 6.58 the only damage was some settlement of the sidewalk on the south end of the bridge.

Fig. 6.58. Approach to Ukawa Bridge.
