Investigation of the M6.6 Niigata-Chuetsu Oki, Japan, Earthquake of July 16, 2007

Open File Report 2007–1365

U.S. Department of the Interior
U.S. Geological Survey

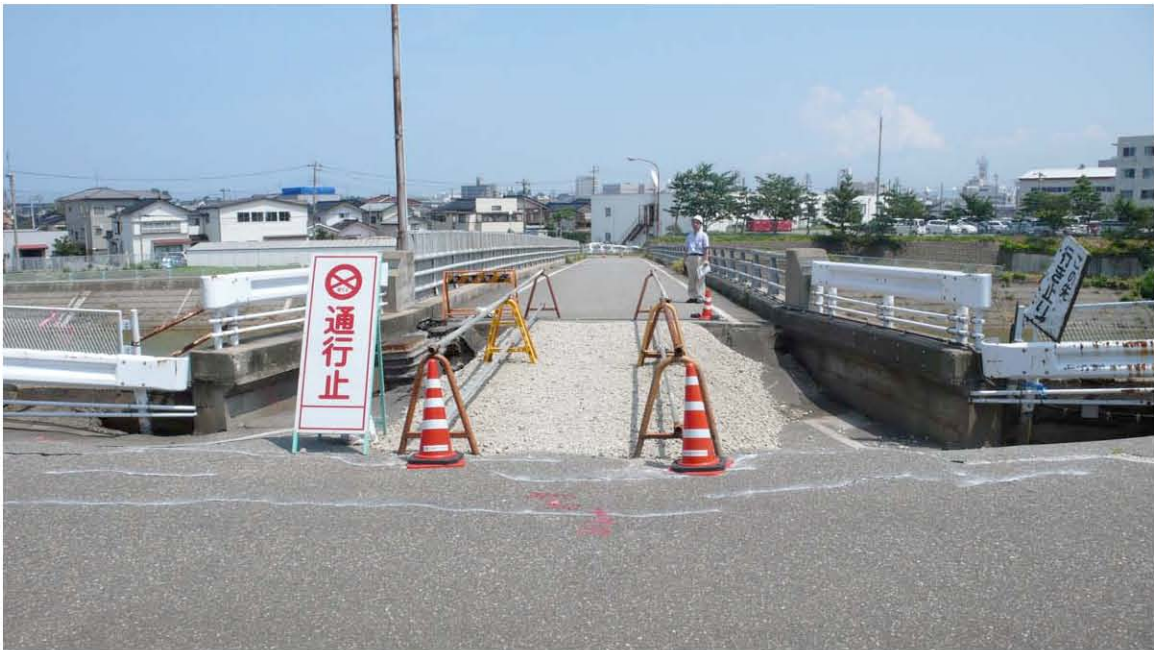
The fourth crossing, a narrow (6 m wide) two-span concrete box girder bridge on a single-column bent and tall and short abutments (Fig. 6.59) had more damage. Although the south levee moved very little, the embankment between the levee and the bridge settled a meter (Fig. 6.60) and there was damage to the abutment including a leaking waterline (Fig. 6.61). Figure 6.62 provides a closer view of the settled embankment.

Fig. 6.60. Looking north at the south approach to Osu Bashi.

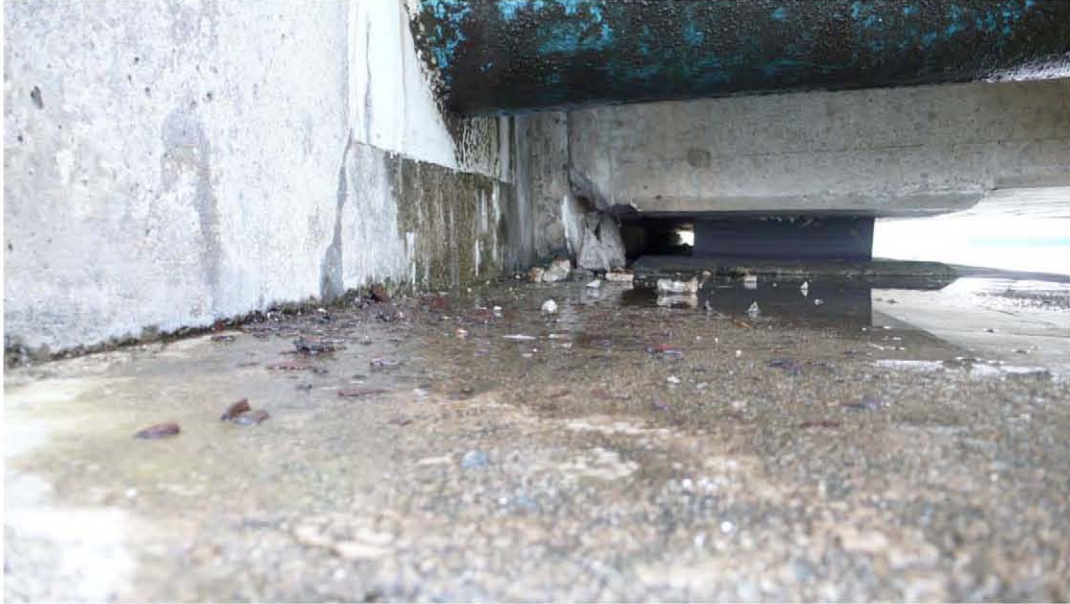
Fig. 6.61. The superstructure is supported on a single bearing (note waterline).

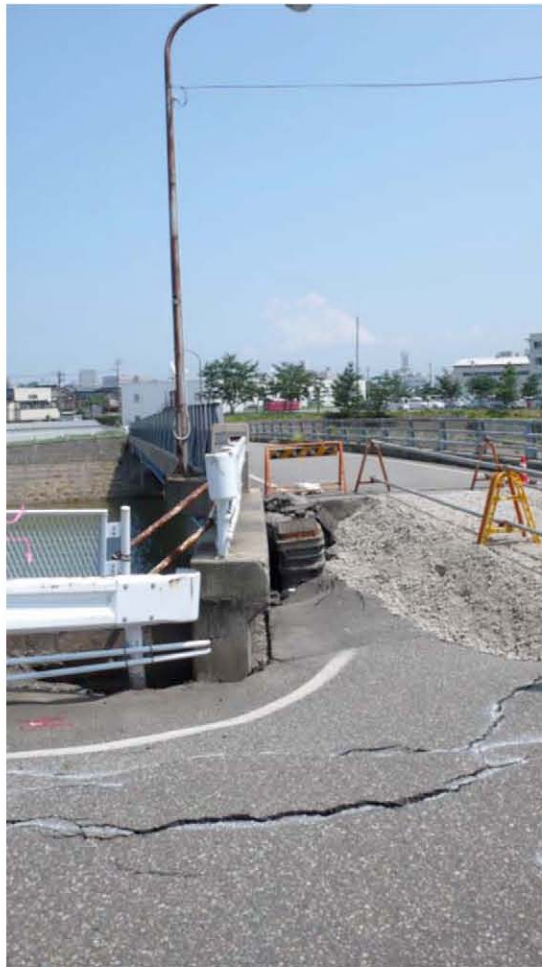
Fig. 6.62. Closer view of settlement at south abutment.

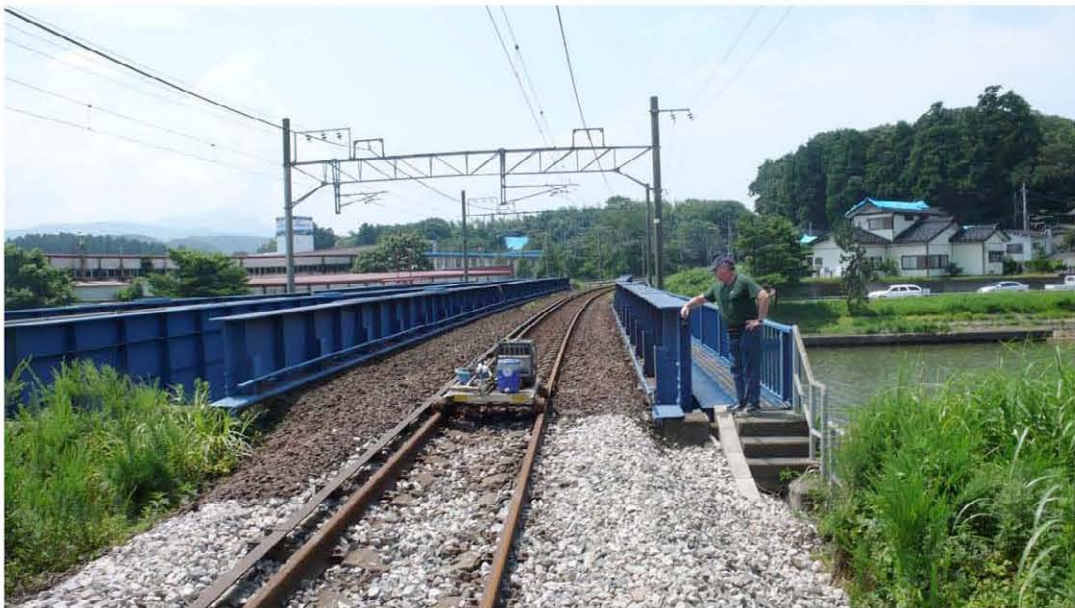
These are two through girder bridges on steel rocker bearings, seat-type abutments, and a pier wall 200 meters upstream from Osu Bashi (Figures 63 and 64). They are much beefier than the road bridges we had previously studied. When we arrived on August 6th, rail crew were re-attaching the rails and there was new ballast on the approaches. However, they went off to lunch before we could ask them if they were repairing earthquake damage. The rails were rusty, suggesting they hadn't been used in awhile, but its possible that the railway was closed due to damage down south at Omigawa Station. The bridge was built in 1997.

Fig. 6.64. Looking at rails on the west bridge where rail crew had left their tools.

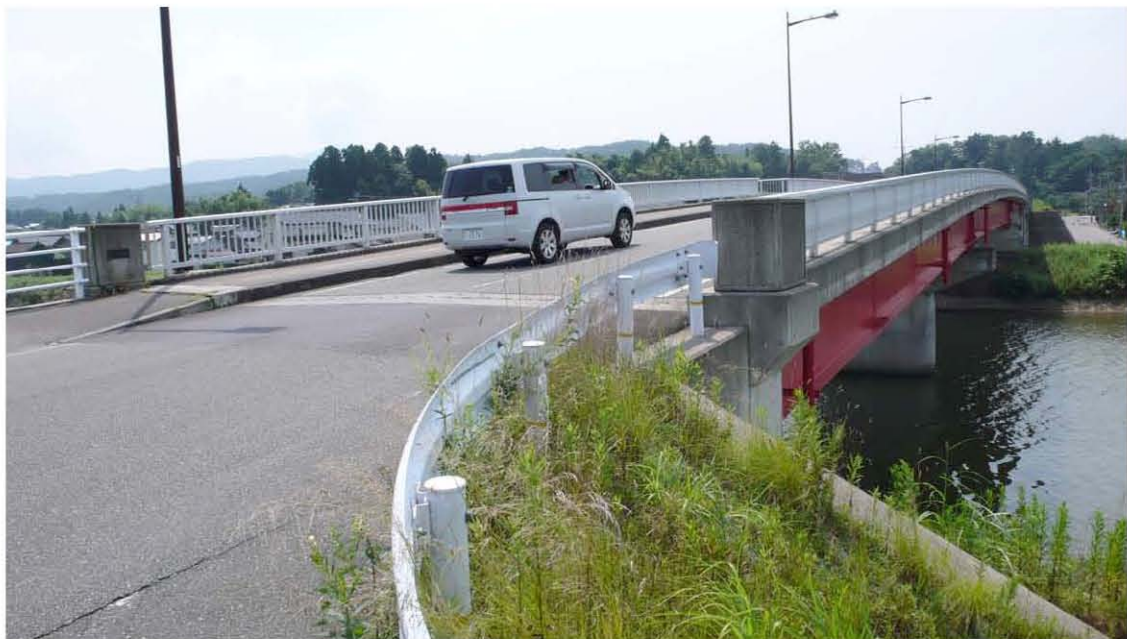
This was the last bridge across the Ugawa where we saw any sign of approach settlement. It's a four-simple span steel 'I' girder bridge that crosses over the river, the levees, and a river road. We walked past a lot of flood control facilities along the river including the flood gate seen in Figure 6.65. This bridge has a long embankment on the south side. Figure 6.66 shows a very slight settlement at the north approach.

Fig. 6.66. Looking at the north approach.

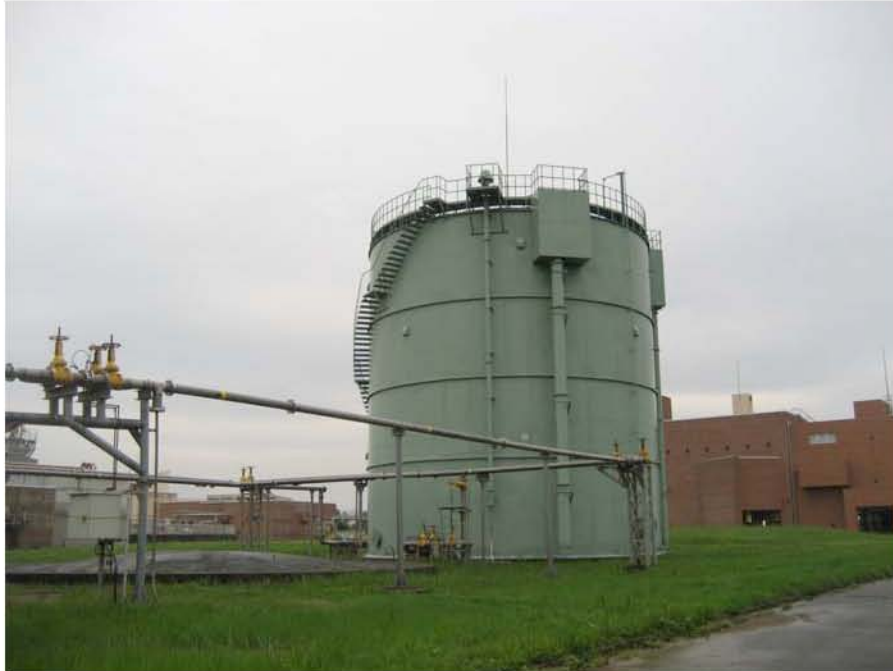
- Wastewater tanks at a site of extensive liquefaction. Both concrete and steel tanks were observed at the Ansei-Chou waste water treatment plant adjacent to the Sabaishi River (Figure 7.1). Sand boils and ground settlement adjacent to the tanks were observed, however the concrete tanks appeared undamaged. A large steel tank exhibited a section with very minor ripples along the wall that may have been due to the earthquake (Figure 7.2). Overall it appeared to be in good condition and maintained full operation.

Figure 7.1: Steel tank at the Ansei-Chou waste water treatment plant (Site RK9, N37.38748°, E138.56587°, photo taken 7/20/07 16:40). Sand boils and slight overturning of the support member to the far-most right of the photograph were observed, as was extensive lateral spreading and road damage. Indications of minor distress of the tank was identified but for the most part appeared in good service.

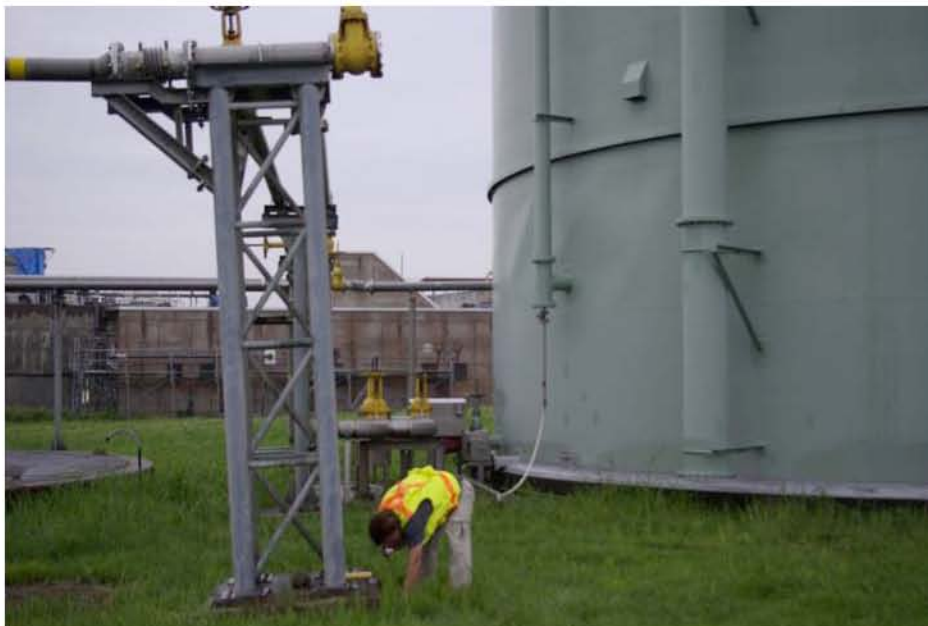
Figure 7.2: Steel tank at the Ansei-Chou waste water treatment plant (Site RK9, N37.38748°, E138.56587°, photo taken 7/20/07 16:40). Minor distress to the wall was observed roughly 3 m above the base of the tank.

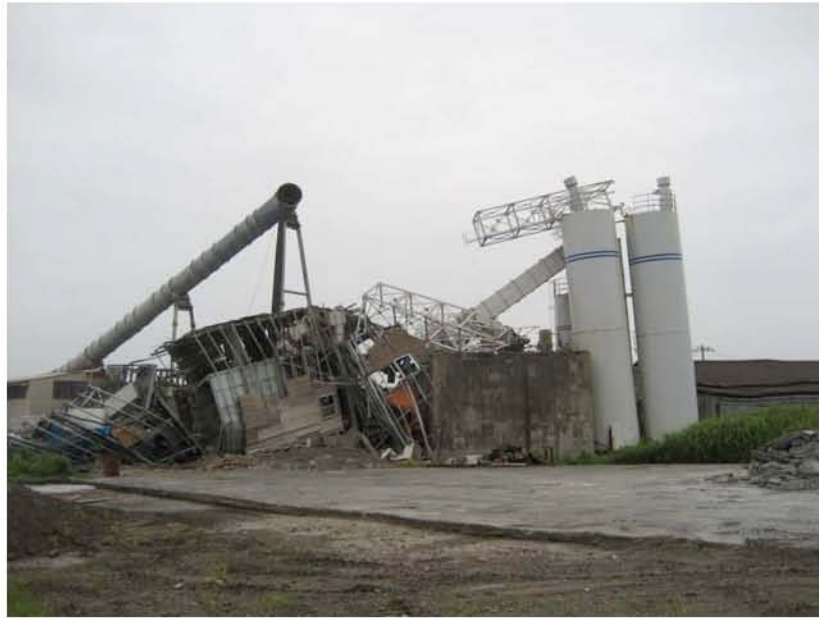
- Failure of two cement-plant storage tanks. Buckling failure of the tank bases was observed in an area of extensive liquefaction damage (Figures 7.3 and 7.4). Mast-structures perched above the tanks also failed at the mast-tank connection. The tanks, although recently painted and appearing to be operational, were also empty at the time of investigation, possibly indicating that the tanks were not currently in use or maintained.

Figure 7.3: Damage to steel tanks at the cement plant located adjacent to the mouth of the Sabaishi River (Site RK10, N37.38795°, E138.56508°, photo taken 7/20/07 17:10). Tank damage likely caused by the cumulative effects of inertial loading, ground failures, and lateral loads due to the failure of appurtenant structures.

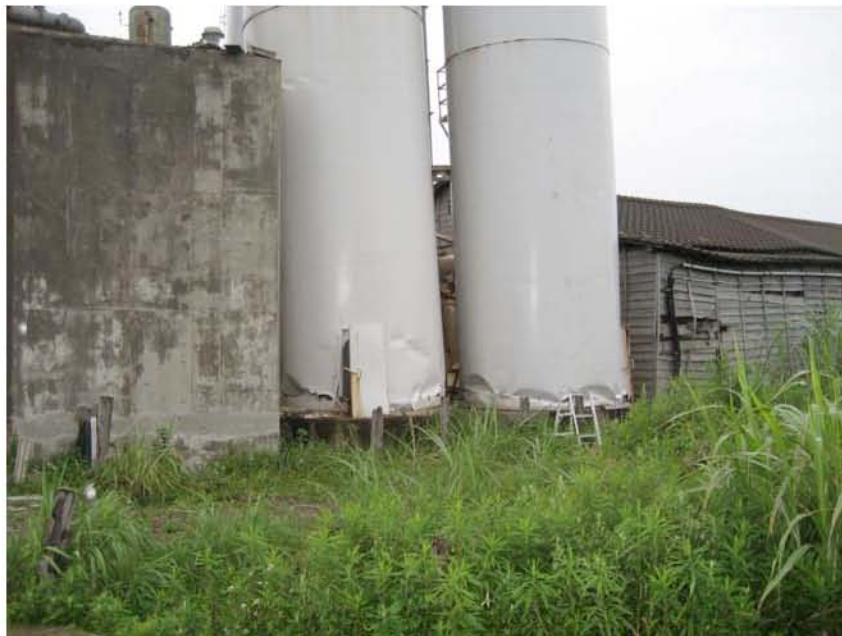
Figure 7.4: Close-up of damage to steel tanks at the cement plant located adjacent to the mouth of the Sabaishi River (Site RK10, N37.38795°, E138.56508°, photo taken 7/20/07 17:20). Buckling at the base of the tanks is evident.

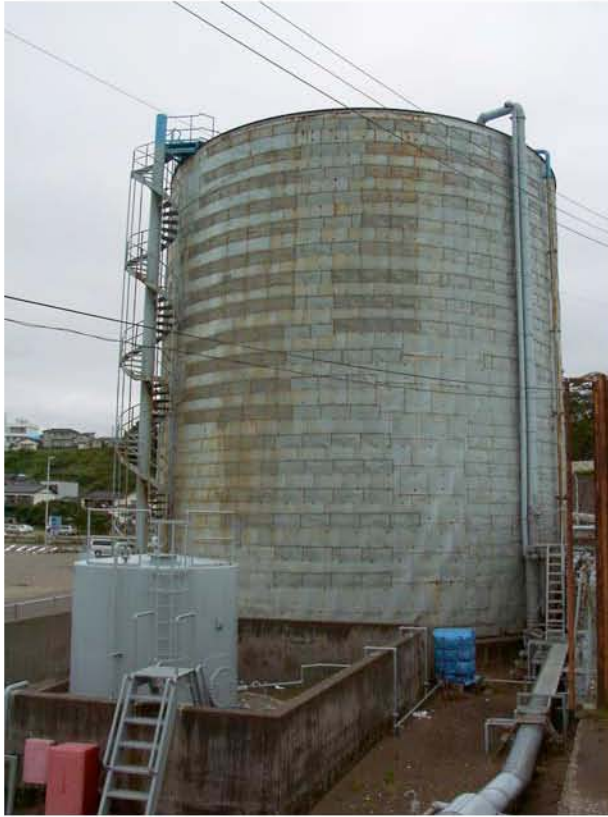
- Asphalt storage tank located in the western portion of the Port of Kashiwazaki (Take Naka Facility). The facility was in operation at the time of the reconnaissance and the inspection focused on the performance of a large, insulated asphalt holding tank (Figure 7.5). The tank is secured at its base by a bolt and flange detail (Figure 7.6). Many of the flanges were bent, however none of the bolts appeared to have failed. No “elephant’s foot” bulking of the tank was noted, although the exterior of the tank is covered with a layer of insulation which prohibited a more thorough inspection (Figure 7.7). The tank structure and appurtenant pipes appeared to be undamaged except for minor failures of the tank anchor system. This structure is also addressed in the section on Port and Harbors.

Figure 7.5: Kashiwazaki Port - Asphalt storage and transport facility located in the western portion of the port (Located near Site RK25, N37.36713° E138.53210°, photo taken 7/21/07 15:58).

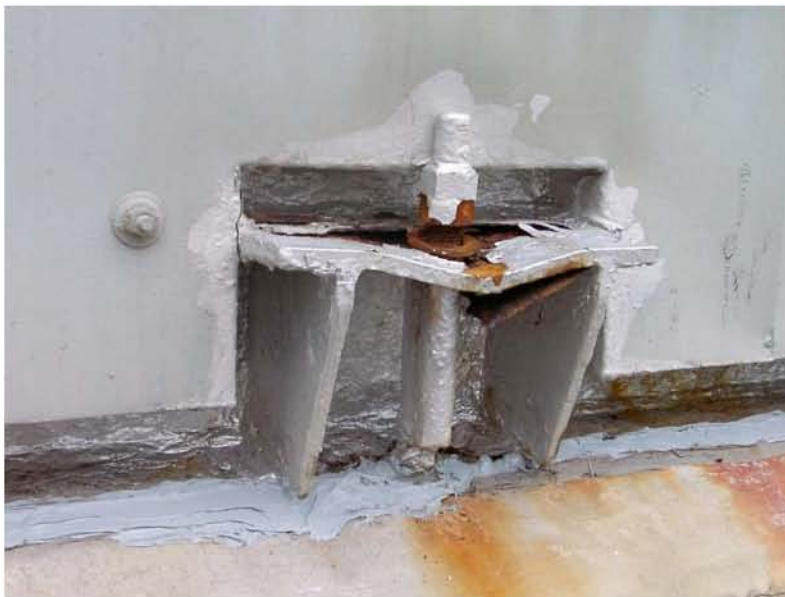
Figure 7.6: Kashiwazaki Port - Anchorage of asphalt storage tank (Located near Site RK25, N37.36713° E138.53210°, photo taken 7/22/07 12:37).

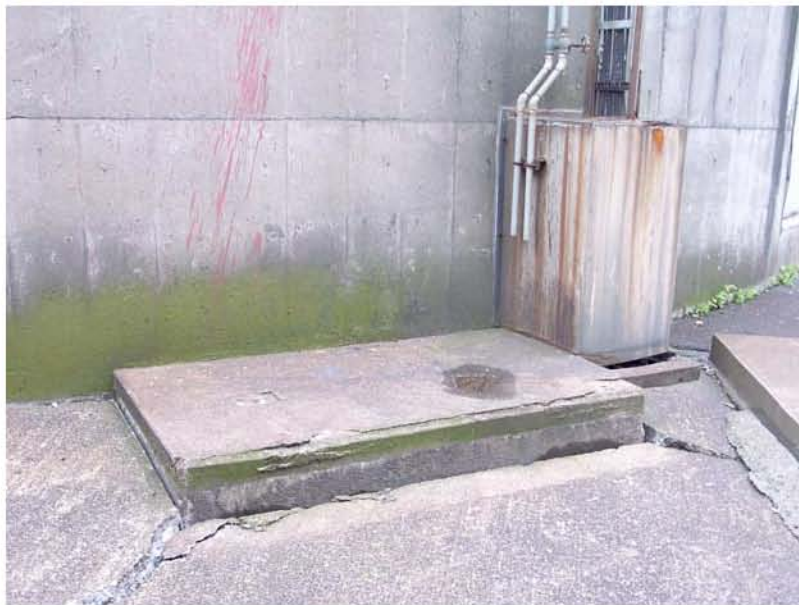
Figure 7.7: Kashiwazaki Port - Anchorage of asphalt storage tank (Located near Site RK25, N37.36713° E138.53210°, photo taken 7/22/07 12:37).

Taiheiyo Cement Tanks – This facility is located in the backland portion of the terminal and it is the site of two large cement tanks. Inspection of the tank foundations revealed minor ground settlement of 5 cm to 12 cm adjacent to the tank foundations (Figures 8.29 and 8.30). Liquefaction effects are negligible in this area. The tanks and appurtenant piping appeared to be in good shape with negligible damage.

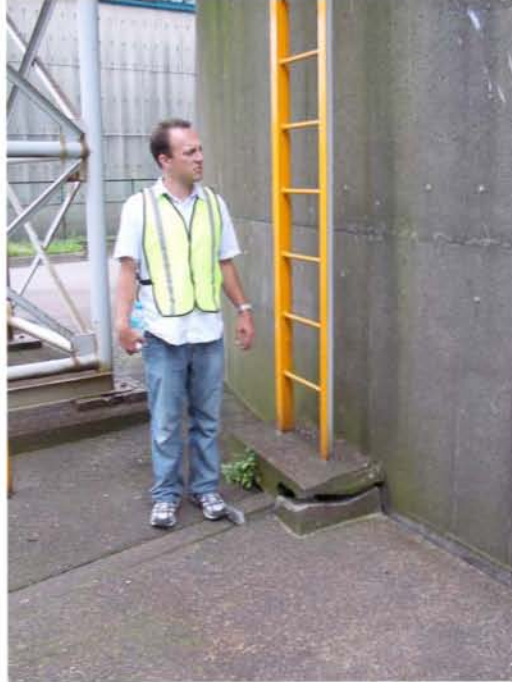
Figure 7.8: Kashiwazaki Port (Taiheiyo Cement Facility) - Evidence of minor to moderate settlement of sandy fill adjacent to one of the large diameter tanks (Site SD 9, approximately N37.36665° E138.53983°, photo taken 7/22/07 15:48).

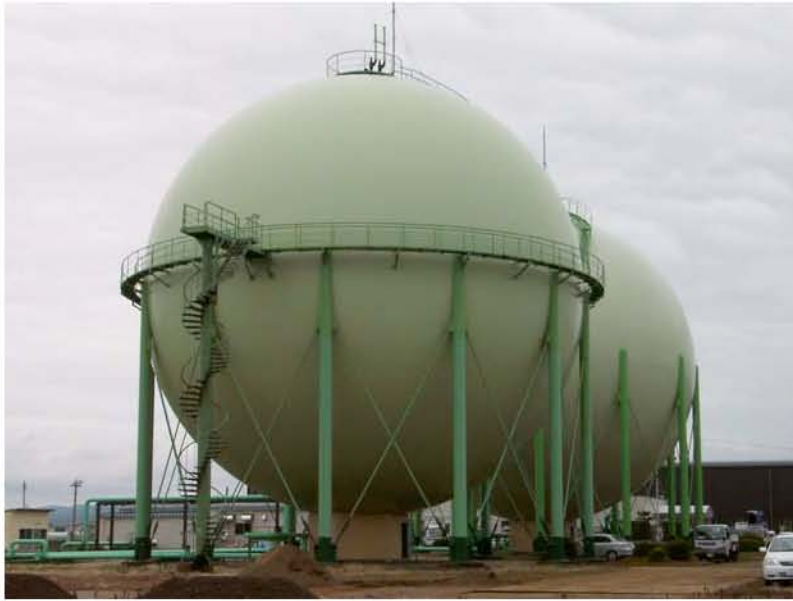
Figure 7.9: Kashiwazaki Port (Taiheiyo Cement Facility) - Evidence of minor to moderate settlement of sandy fill adjacent to one of the large diameter tanks (Site SD 9, approximately N37.36665° E138.53983°, photo taken 7/22/07 15:48).

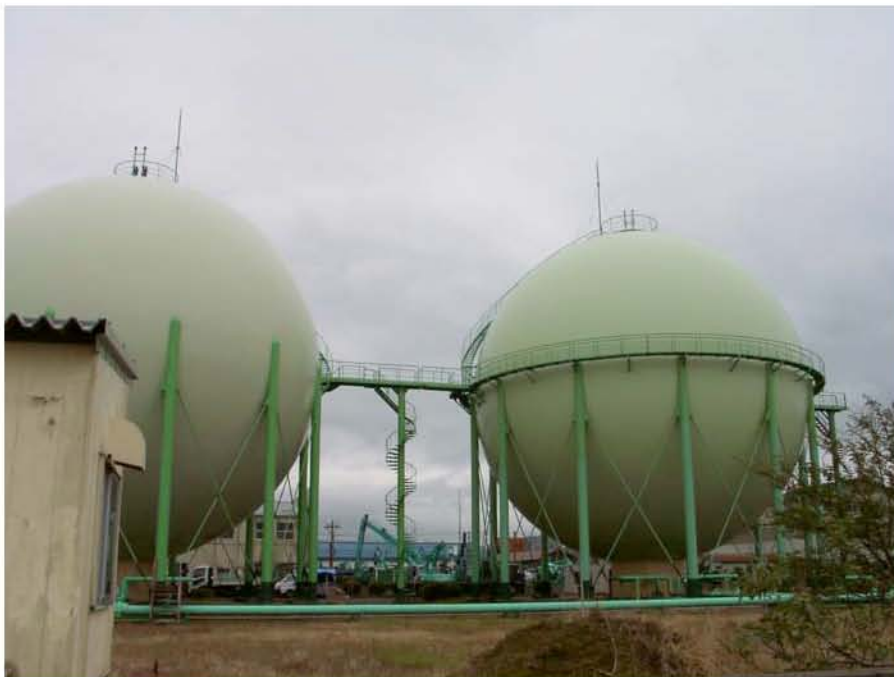
Figure 7.10: Steel natural gas tanks undergoing inspection by the operator and engineering consultants (Site SD13/RK57, N37.37253°, E138.59488°, photo taken 7/23/07 12:37). Trenching and below grade inspections had already taken place prior to the field investigation. No damage was observed to the tanks, pipe connections, or mains, however observations were made from the perimeter of the facility, a short distance from the structures.

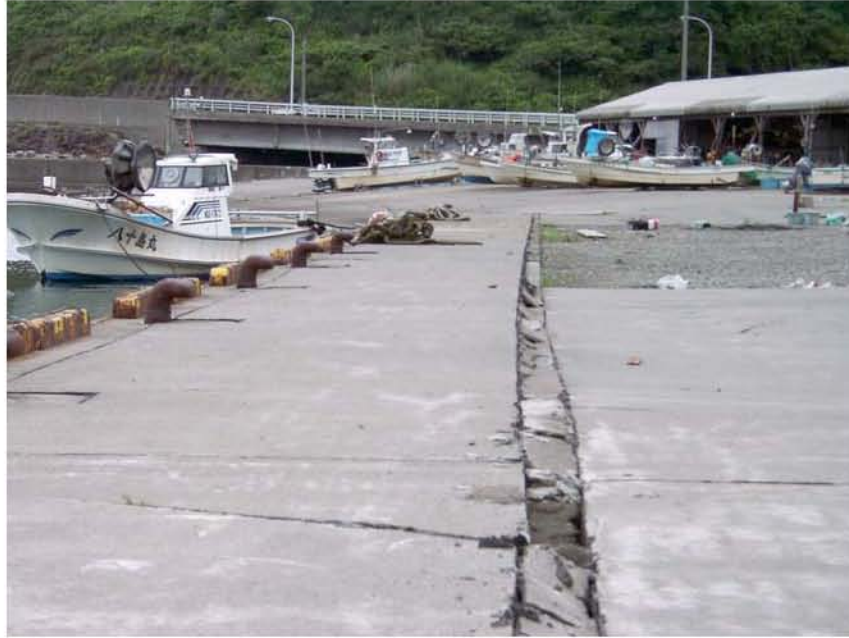
The Kasashima harbor exhibited negligible to very minor evidence of ground deformation and seismic effects to coastal infrastructure (e.g. quay walls, seawalls, breakwaters). Trace remnants of very small, localized ground deformations were observed, and it appears that the ground motions in this area were just strong enough for incipient lateral deformation of the ground and waterfront earth retention structures (Figure 8.1). This site is useful for investigating the regional extent of liquefaction-induced ground failure at ports located southwest of the meiseismic region. Lateral spreading of 7 cm to 12 cm was observed in beach deposits with lateral deformation of short concrete quay walls of 1 cm to 2 cm. No movement of larger caisson-type quay walls or breakwaters was observed. Settlement of paved aprons of roughly 10 cm to 12 cm was noted behind the short quay wall (Figures 8.2 and 8.3). The investigation team did not inspect coastal facilities located southwest of Kasashima harbor. It is possible that very minor evidence of liquefaction occurred to the west, however in the absence of significantly different site effects, the impact on coastal infrastructure is likely minimal. The investigation team did not receive reports of significant damage to coastal facilities west of Kasashima, despite the occurrence of several moderate to large landslides in cut slopes for highways and rail routes in this area.

Figure 8.1: Minor ground failure along the waterfront at Kasashima (Site RK21, N37.33702° E138.46680°, photo taken 7/21/07 14:49). The limited extent of the ground cracking indicated incipient lateral movement.

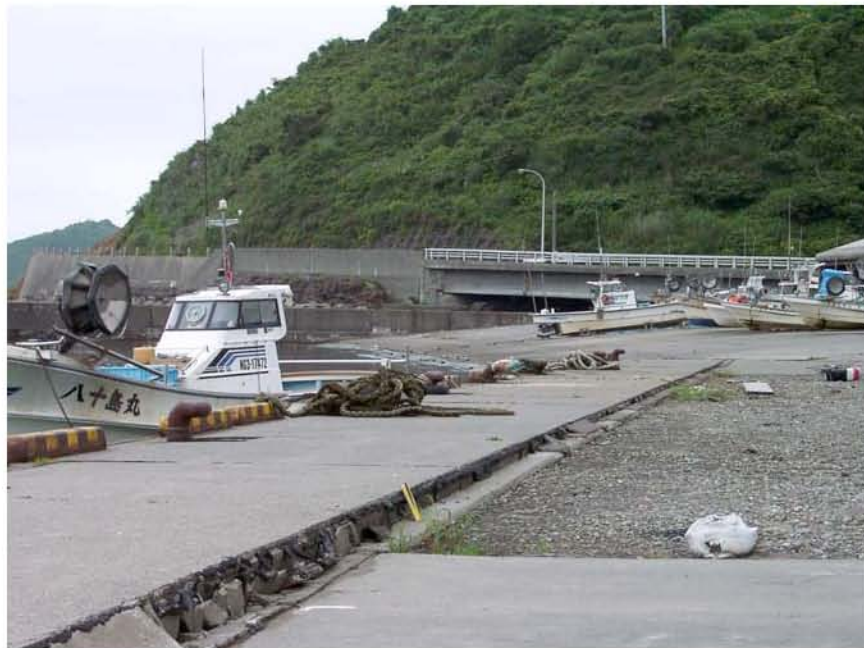
Figure 8.2: Kasashima Harbor - Ground settlement and minor lateral deformation adjacent to quay walls (Site RK21, N37.33702° E138.46680°, photo taken 7/21/07 14:40).

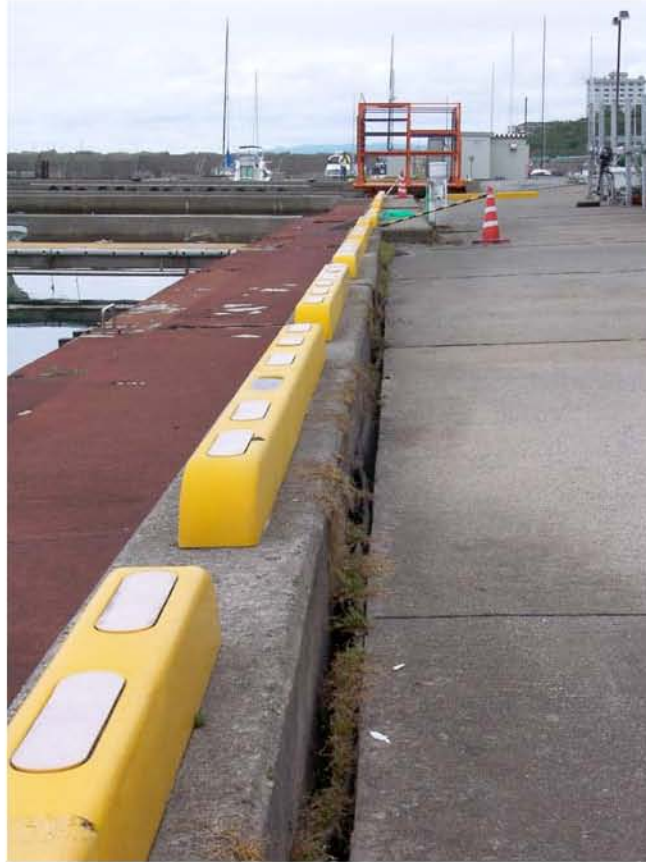
Figure 8.3: Kasashima Harbor - Settlement of fill behind quay walls (Site RK21, N37.33702° E138.46680°, photo taken 7/21/07 14:48).

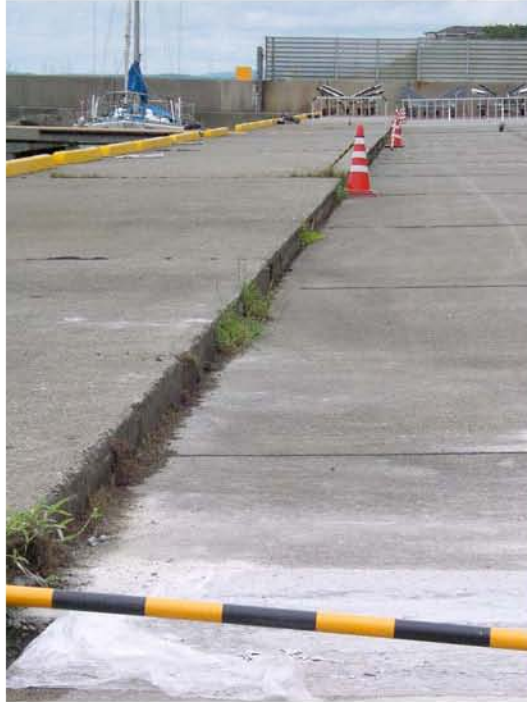
From Kasashima the reconnaissance moved eastward toward the epicentral region. The Kashiwazaki Marina was inspected and considered a site of minor damage. Evidence of ground deformation was observed in the form of minor lateral movement (generally 2 cm to 7 cm) of short quay walls and maximum ground settlements adjacent to quay walls of roughly 7 cm to 15 cm (Figures 8.4 and 8.5). Small sand boils were observed in isolated portions of the boat storage yard. The alignment of the quay walls was very good indicating fairly uniform, minor lateral movement. Estimates of maximum lateral wall movement are 6 cm to 10 cm. Minor ground cracking and lateral deformation was observed around the perimeter of the marina property. Paved and unpaved parking areas located in filled areas adjacent to the facility exhibited very minor cracks with cumulative displacements on the order of 3 cm to 5 cm. A park with a multi-story observation structure is located immediately to the west of the marina property (Onodachi Seaside Park). The structure appears to be located on fill, although the foundation type is not currently known to the team. The sloping, grass-covered fill at this site exhibited very minor cracking indicating incipient ground failure.

Figure 8.4: Kashiwazaki Marina - Evidence of minor lateral movement of quay walls and associated settlement of the paved apron (Site SD3, N37.36093° E138.52027°, photo taken 7/22/07 12:59).

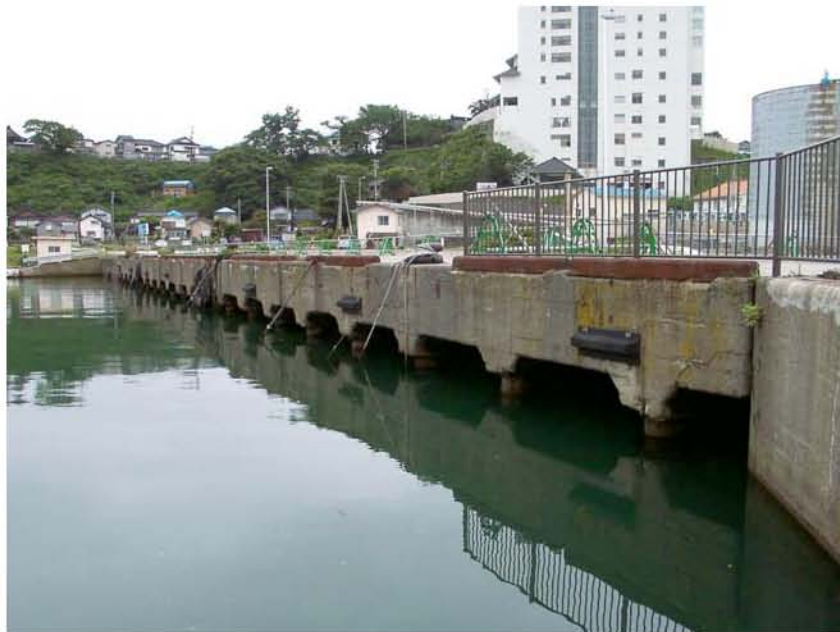
Figure 8.5: Kashiwazaki Marina - Evidence of minor settlement behind quay walls (Site SD3, N37.36093° E138.52027°, photo taken 7/22/07 13:12).

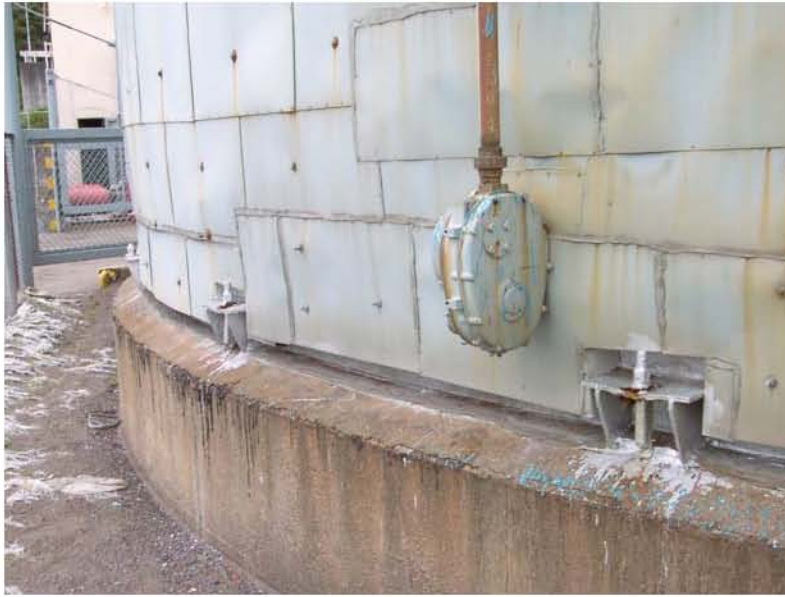
Figure 8.8: Kashiwazaki Port - Anchorage of asphalt storage tank (Located near Site RK25, N37.36713° E138.53210°, photo taken 7/22/07 12:37).

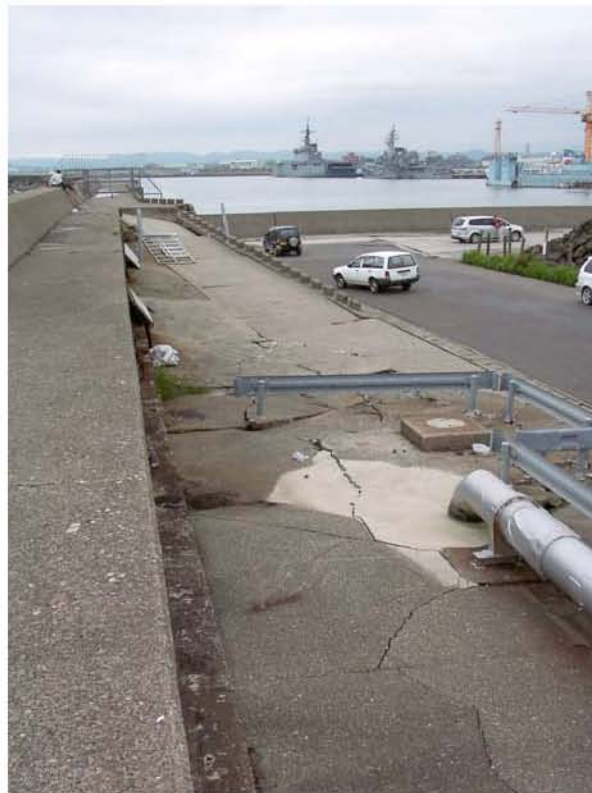
Figure 8.9: Kashiwazaki Port - Anchorage of asphalt storage tank (Located near Site RK25, N37.36713° E138.53210°, photo taken 7/22/07 12:37).

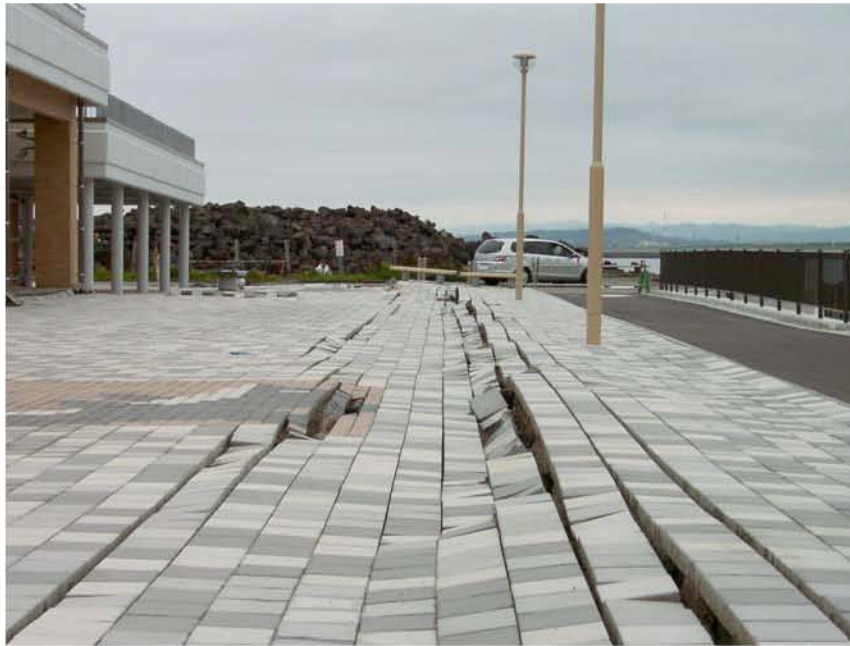
Westernmost section – From the landward portion of this section of the port to the outer harbor this area includes; (a) an older portion of the berth that appears to be relatively unused, (b) an asphalt heating and pumping facility, (c) a new facility that includes sightseeing boat mooring and a single-story office building, (d) an outer harbor-front quay wall, and (e) the major seawall and breakwater that extends from the beach into the harbor a total length of approximately 2.4 km. The landward portion of the berth (a) appears to include both concrete caissons and a wharf deck supported by vertical concrete piles (Figure 8.6). No lateral movement of this portion of the wharf was noted and no damage to the piles was noted, although only the waterfront row of piles was visible during the investigation. The Take Naka asphalt facility (b) exhibited very little damage (Figures 8.7 - 8.9). The facility was in operation at the time of the reconnaissance and the inspection focused on the performance of the large, insulated asphalt holding tank. The tank is secured at its base by a bolt and flange detail. Many of the flanges were bent, however none of the bolts appeared to have failed. No “elephant’s foot” bulking of the tank was noted, although the exterior of the tank is covered with a layer of insulation prohibiting a more thorough inspection. The asphalt distribution pipe, which is slightly elevated above the ground, did not exhibit signs of distress despite extensive ground failure along the adjacent area near the sightseeing facility (Figure 8.10).

Figure 8.10: Kashiwazaki Port - Seawall and exposed end of the elevated asphalt pipe (Located near Site RK25, N37.36713° E138.53210°, photo taken 7/21/07 15:51).

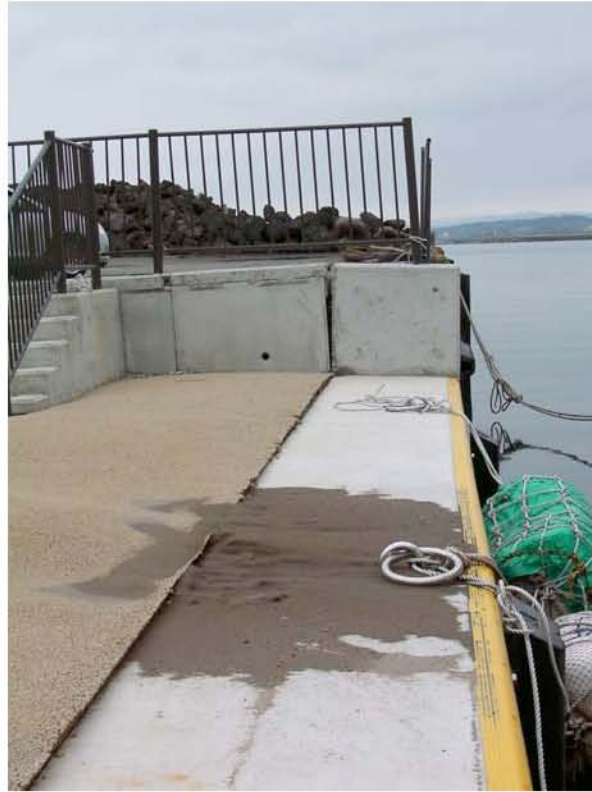
The new sightseeing facility (c), including a new single-story structure, associated pedestrian areas, and wharf, were subjected to the effects of widespread liquefaction, lateral spreading and settlement. The structure performed very well, but did exhibit minor distress along two pedestrian-accessible roof areas on either side of the main structure. It is believed that the distress is due to adjacent lateral spreading and differential settlement between the ground and structure. The paved areas and walkways surrounding the building were extensively damaged (Figure 8.11). Settlements exceeded 30 cm in many areas and a pronounced graben formed between the building and the waterfront quay wall. The quay wall has moved laterally and tilted a minor amount (Figure 8.12). This area was extensively investigated by the team and it was the focus of a ground-based LiDAR survey.

Figure 8.11: Kashiwazaki Port - Liquefaction-induced damage to the sightseeing wharf (Site RK25/SA25/YT4, N37.36713° E138.53210°, photo taken 7/21/07 16:03).

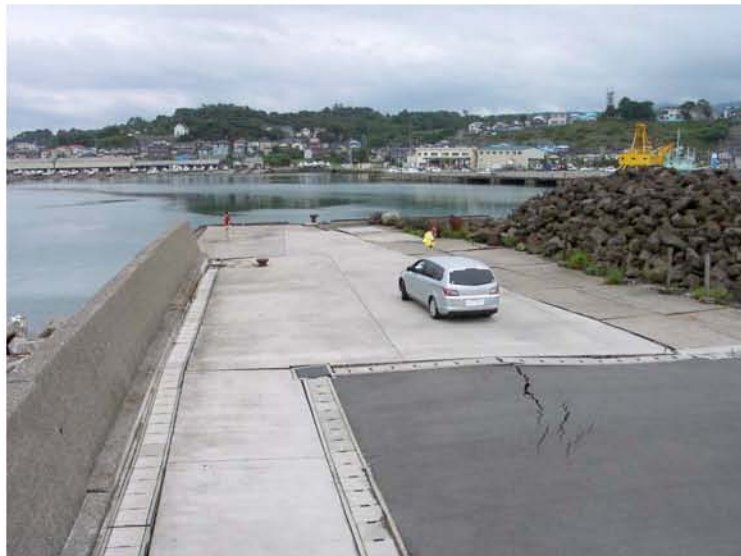
Figure 8.12: Kashiwazaki Port - Liquefaction-induced damage to the sightseeing wharf with minor displacement of the caisson quay wall (Site RK25/SA25/YT4, N37.36713° E138.53210°, photo taken 7/21/07 16:09).

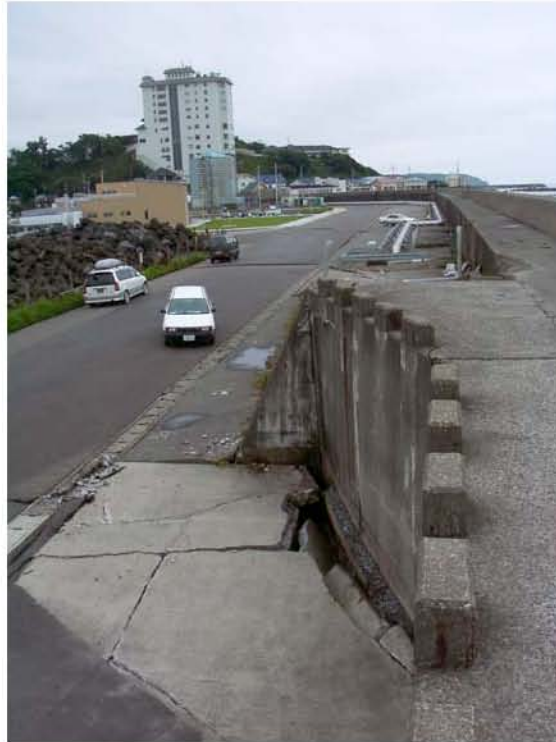
The outer quay wall area has been subjected to large lateral ground deformation and settlement due to liquefaction (Figures 8.13 and 8.14). The seawall/breakwater was inspected landward from the beach adjacent to the asphalt handling facility to the outer quay area. The breakwater exhibited negligible to very minor displacement adjacent to the beach. The waterfront side of the seawall is armored with concrete tetrapods. The tetrapods appear to be unreinforced and numerous units showed damage due to rocking during the earthquake (Figure 8.15). This type of damage to tetrapods and other wave armor units was noted throughout the Kashiwazaki Port and long seawall located northeast of the Sabaishi River.

Figure 8.13: Kashiwazaki Port - Evidence of lateral ground deformation adjacent to the outer quay wall (Located near site RK25/SA25/YT4, N37.36713° E138.53210°, photo taken 7/21/07 15:49).

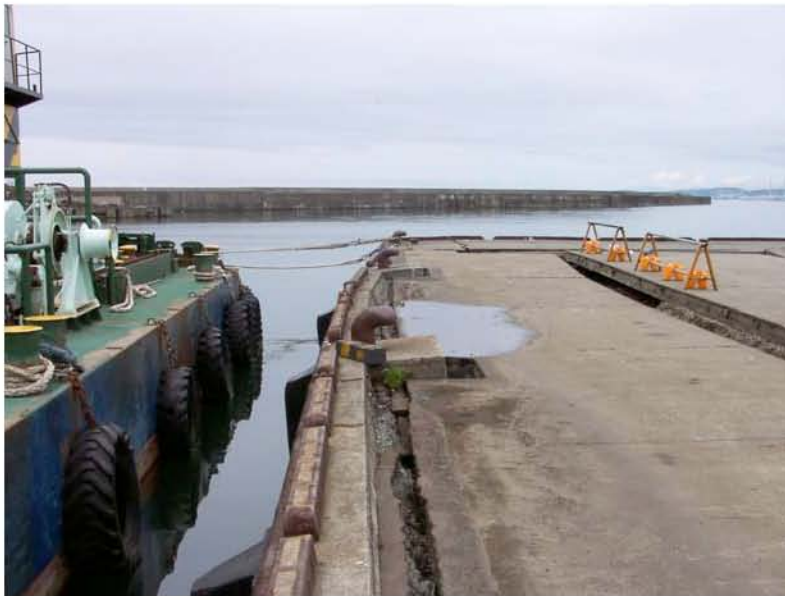
Southwestern pier – The portion of the Port of Kashiwazaki referred to herein as the “southwestern pier,” appears to be a shallow water terminal used along one berth as a staging area for a dredging barge and on the opposite side of the terminal as a fishing and/or light cargo handling area. This berth exhibited extensive liquefaction-induced damage. Lateral movement of the quay wall (anchored sheetpile wall) along the western face was approximately one meter with settlements of roughly 0.5 m to 0.6 m (Figures 8.16 and 8.17). The quay wall tilted roughly 5°. The lateral deformation along the eastern face was much less pronounced (roughly 0.3 m), although the settlement of the backfill was equally severe (0.6 m) (Figure 8.18). It appears that the eastern portion of the terminal has been constructed of concrete caissons. It is believed that a portion of the difference in the observed lateral quay wall movement is due to the use of different structures during construction of the terminal. The heights of the sheetpile walls and caissons could not be discerned during the reconnaissance.

Figure 8.16: Kashiwazaki Port - West facing portion of the “Southwestern Pier” showing displacement of the sheet pile wall and ground settlement due to liquefaction of sandy backfill (Site SD5, N37.36532° E138.53213°, photo taken 7/22/07 13:57).

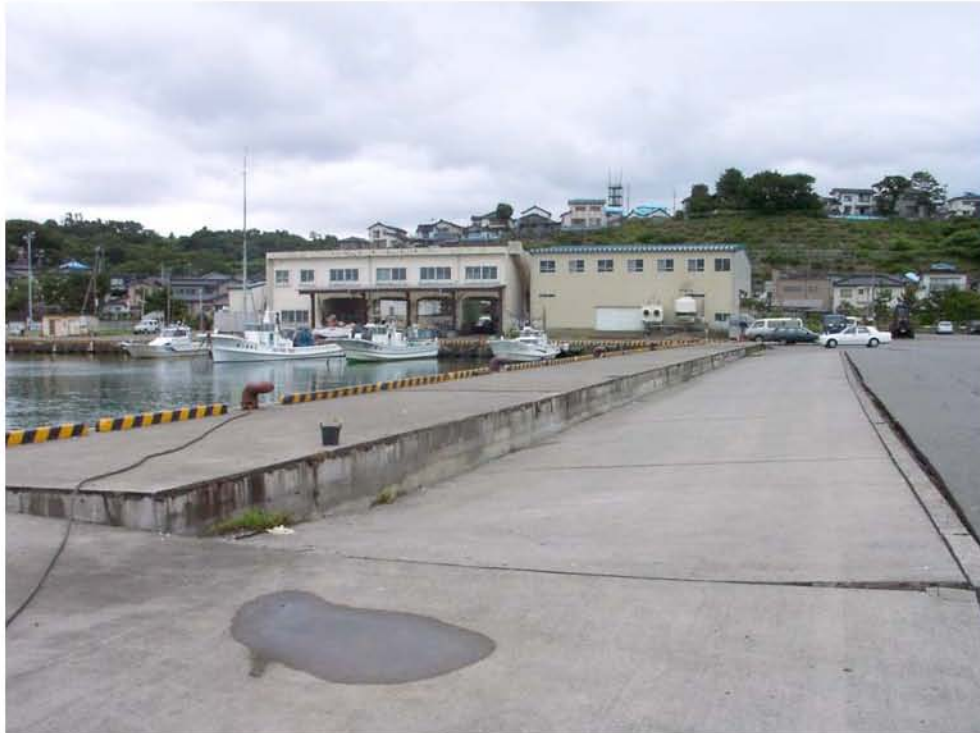
Figure 8.17: Kashiwazaki Port - West facing portion of the “Southwestern Pier” showing displacement of the sheetpile wall and ground settlement due to liquefaction of sandy backfill (Site SD5, N37.36532° E138.53213°, photo taken 7/22/07 13:58).

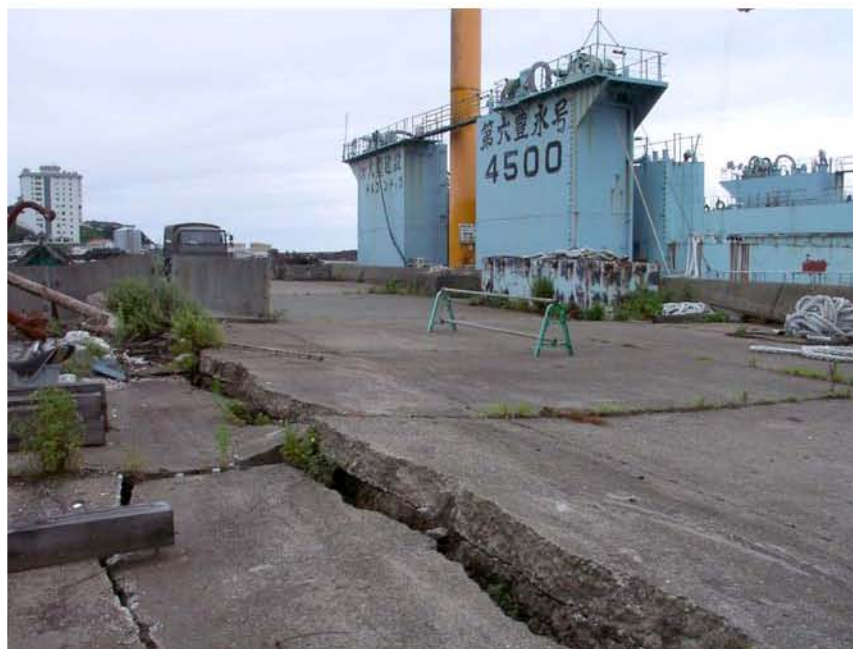
Figure 8.18: Kashiwazaki Port - East facing portion of the “Southwestern Pier” showing pronounced ground settlement (Site SD5, N37.36532° E138.53213°, photo taken 7/22/07 14:05).

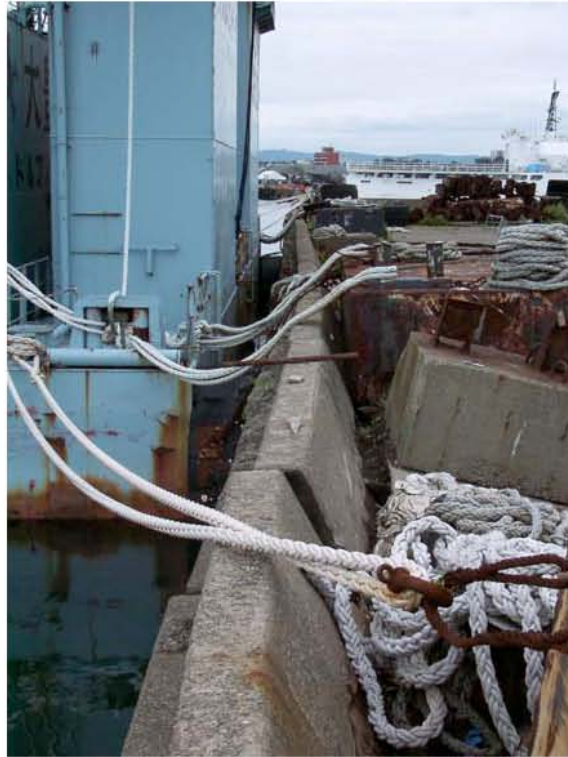
Steel Scrap Handling Facility – Moving eastward along the port complex the next major industrial facility is a steel scrap handling and transport wharf. Sand boils, ground cracks and liquefaction-induced settlement were pervasive throughout this facility, particularly around the waterfront perimeter. Waterfront settlements up to approximately 35 cm were noted and lateral wall movements varied between 2 cm and 30 cm depending on the orientation of the quay wall (Figures 8.19 and 8.20). Pronounced pavement disruption and ground cracks in the landward section of the facility indicated lateral deformation of the anchor system for the sheetpile walls (Figure 8.19). Lateral movement and rotation of near-shore concrete blocks with bollards and damage to wave armor units were also observed.

Figure 8.19: Kashiwazaki Port - Steel Scrap Transport Facility showing evidence of ground failure due to liquefaction of sand fill and damage to concrete aprons (Site SD6, N37.36668° E138.53565°, photo taken 7/22/07 14:46).

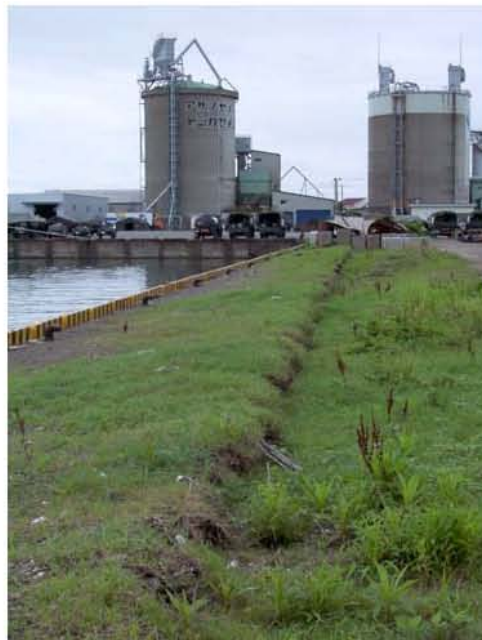
Figure 8.20: Kashiwazaki Port - Steel Scrap Transport Facility showing caisson displacement (Site SD6, N37.36668° E138.53565°, photo taken 7/22/07 14:56).

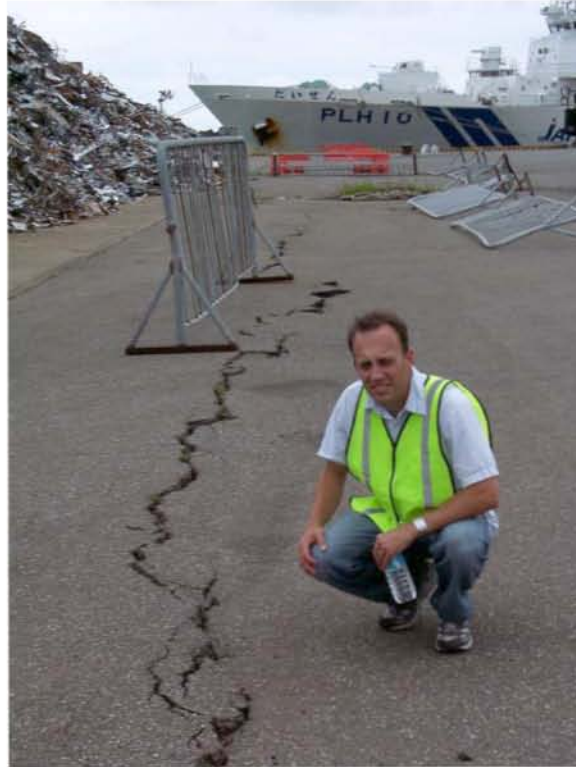
Figure 8.21: Kashiwazaki Port - North facing, landward quay wall exhibiting lateral movement and rotation of caissons (Site SD7, N37.36593° E138.53692°, photo taken 7/22/07 15:12). The Taiheiyo Cement Tanks are in the background.

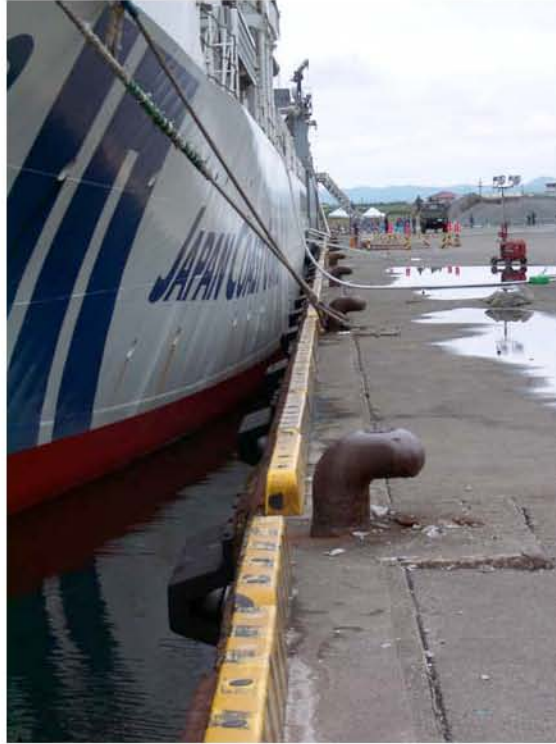
Figure 8.22: Kashiwazaki Port - Minor ground cracks located parallel to the western quay wall used as the berth for the Japan Coast Guard (Site SD8, N37.36680° E138.53825°, photo taken 7/22/07 15:17).

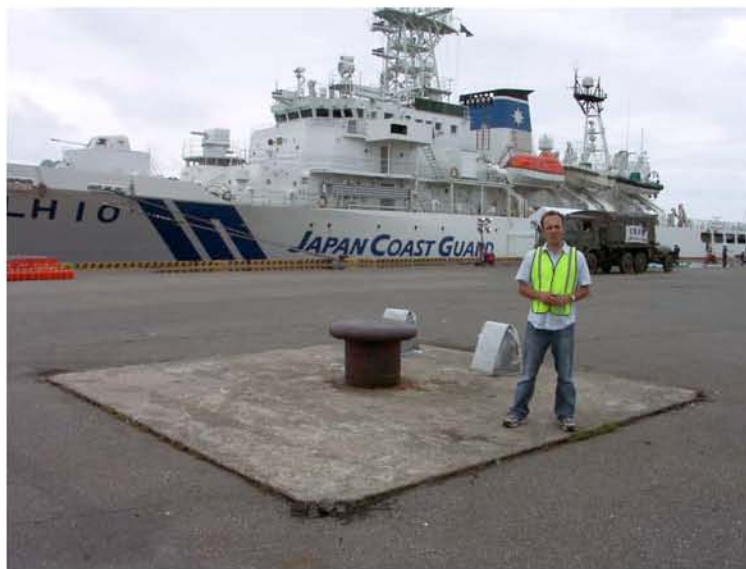
The west end of the north facing quay was also utilized by the Japan Coast Guard. This portion of the quay exhibited negligible lateral displacement (≤ 4 cm) and minor settlement (Figures 8.23 and 8.24). Overall, the seismic performance of this portion of the terminal was very good. The middle to eastern end of the quay was being used to berth a ship of the Japan Self Defense Forces at the time of the survey. The effects of liquefaction were similarly minor with localized apron cracking and minor lateral displacement along much of the berth (Figure 8.25). It is interesting to note however that the evidence of liquefaction-related ground failure and quay wall displacement increased along the berth to the east (i.e. closer to the eastern boundary of the berth at the mouth of the U River, Figure 8.26). Within roughly 100 m of the U River the effects of liquefaction became pronounced. Significant damage was observed to the quay wall with lateral displacement and failure of the upper portion of the wall (Figures 8.27 and 8.28).

Figure 8.23: Kashiwazaki Port - Evidence of very minor lateral movement of quay walls and minor settlement located along the northern face of the terminal used as the berth for the Japan Coast Guard (Site SD8, N37.36680° E138.53825°, photo taken 7/22/07 15:22).
