Investigation of the M6.6 Niigata-Chuetsu Oki, Japan, Earthquake of July 16, 2007

Open File Report 2007–1365

U.S. Department of the Interior
U.S. Geological Survey

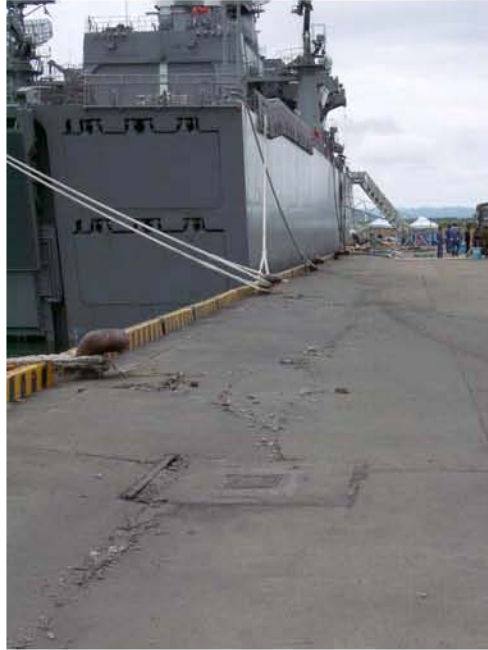
The west end of the north facing quay was also utilized by the Japan Coast Guard. This portion of the quay exhibited negligible lateral displacement (≤ 4 cm) and minor settlement (Figures 8.23 and 8.24). Overall, the seismic performance of this portion of the terminal was very good. The middle to eastern end of the quay was being used to berth a ship of the Japan Self Defense Forces at the time of the survey. The effects of liquefaction were similarly minor with localized apron cracking and minor lateral displacement along much of the berth (Figure 8.25). It is interesting to note however that the evidence of liquefaction-related ground failure and quay wall displacement increased along the berth to the east (i.e. closer to the eastern boundary of the berth at the mouth of the U River, Figure 8.26). Within roughly 100 m of the U River the effects of liquefaction became pronounced. Significant damage was observed to the quay wall with lateral displacement and failure of the upper portion of the wall (Figures 8.27 and 8.28).

Photo 8.24: Kashiwazaki Port - Evidence of minor settlement adjacent to a pile-supported (?) bollard anchorage located along the northern face of the terminal used as the berth for the Japan Coast Guard (Site SD8, N37.36680° E138.53825°, photo taken 7/22/07 15:21).

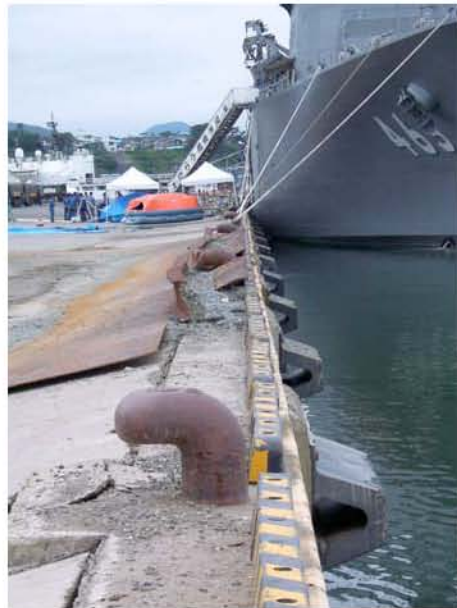
Figure 8.25: Kashiwazaki Port - Evidence of very minor lateral movement of quay walls and minor settlement located along the northern face of the terminal used as the berth for the Japan Self Defense Force (Site SD8, approximately N37.36680° E138.53825°, photo taken 7/22/07 15:24).

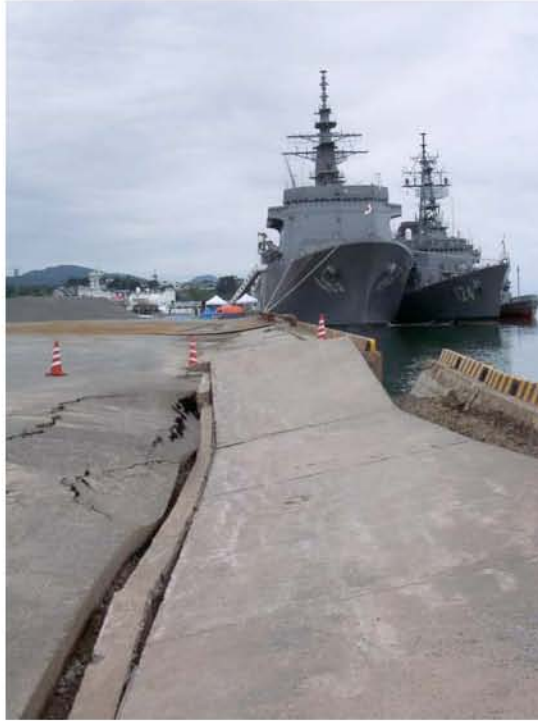
Figure 8.26: Kashiwazaki Port - Evidence of more extensive lateral caisson displacement and ground settlement adjacent to the quay wall located along the eastern end of the north face of the terminal (Site SD8, approximately N37.36680° E138.53825°, photo taken 7/22/07 15:36).

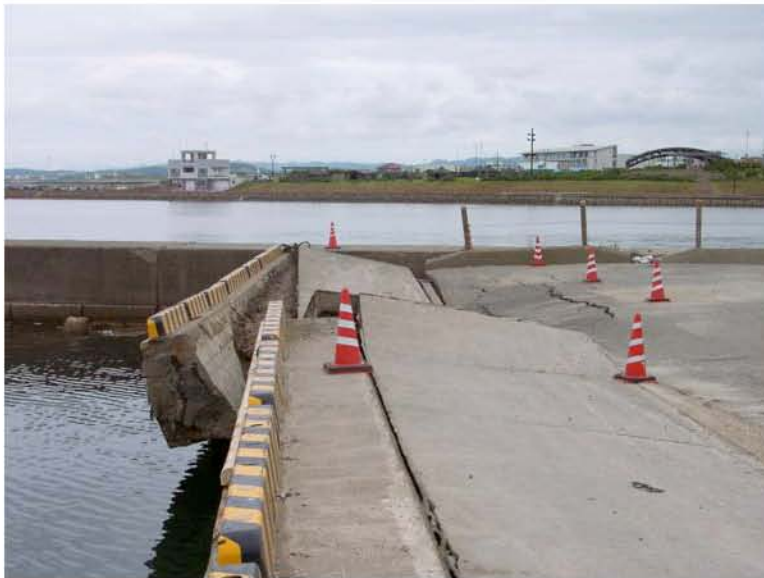
Figure 8.27: Kashiwazaki Port - Significant liquefaction-related damage to the quay walls located at the eastern edge of the terminal adjacent to the mouth of the U River (Site SD8, approximately N37.36680° E138.53825°, photo taken 7/22/07 15:32).

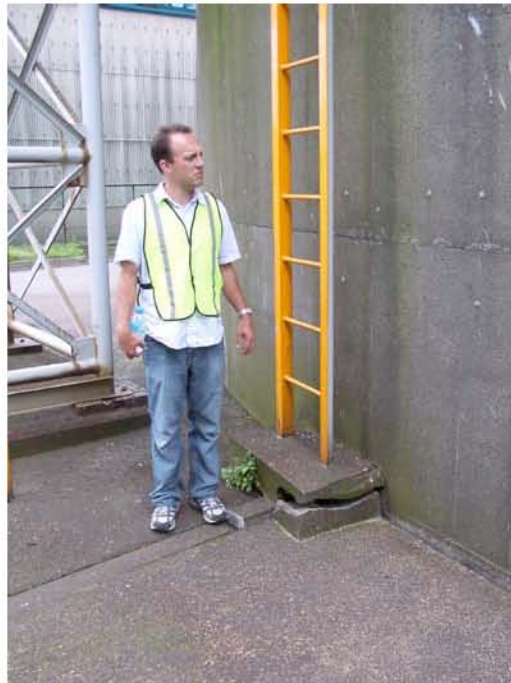
Taiheiyo Cement Tanks – This facility is located in the backland portion of the terminal and it is the site of two large cement tanks. Inspection of the tank foundations revealed minor ground settlement of 5 cm to 12 cm adjacent to the tank foundations (Figures 8.29 and 8.30). Liquefaction effects are negligible in this area. The tanks and appurtenant piping appeared to be in good shape with negligible damage.

Figure 8.29: Kashiwazaki Port (Taiheiyo Cement Facility) - Evidence of minor to moderate settlement of sandy fill adjacent to one of the large diameter tanks (Site SD9, approximately N37.36665° E138.53983°, photo taken 7/22/07 15:48).

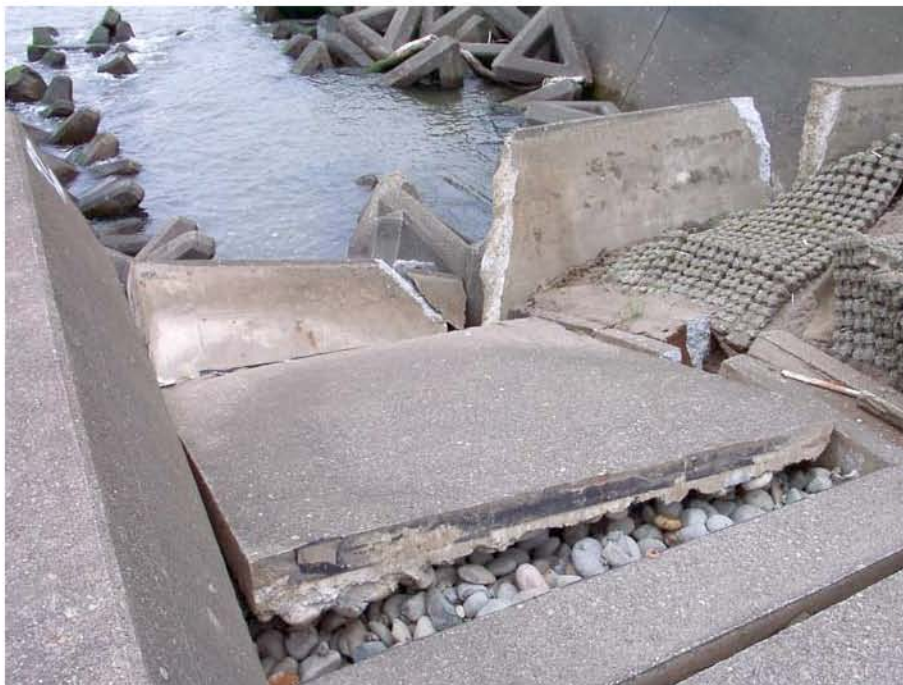
There is a seaward step in the seawall located immediately southwest of the cement plant site. This point was the location of a seawall failure that included a collapsed section of wall, significant settlement and cracking of the backfill, and settlement of the concrete panels located behind the seawall (Figure 8.33). The backfill adjacent to the seawall is composed of clean, rounded cobbles (diameter > 15 cm) (Figure 8.34). The lateral wall movement in this area was roughly 0.6 m.

Figure 8.33: Partial collapse of a portion of the seawall located at the lateral, seaward step in alignment just west of the damaged cement plant (Site SD1, N37.38868° E138.56413°, photo taken 7/22/07 11:18).

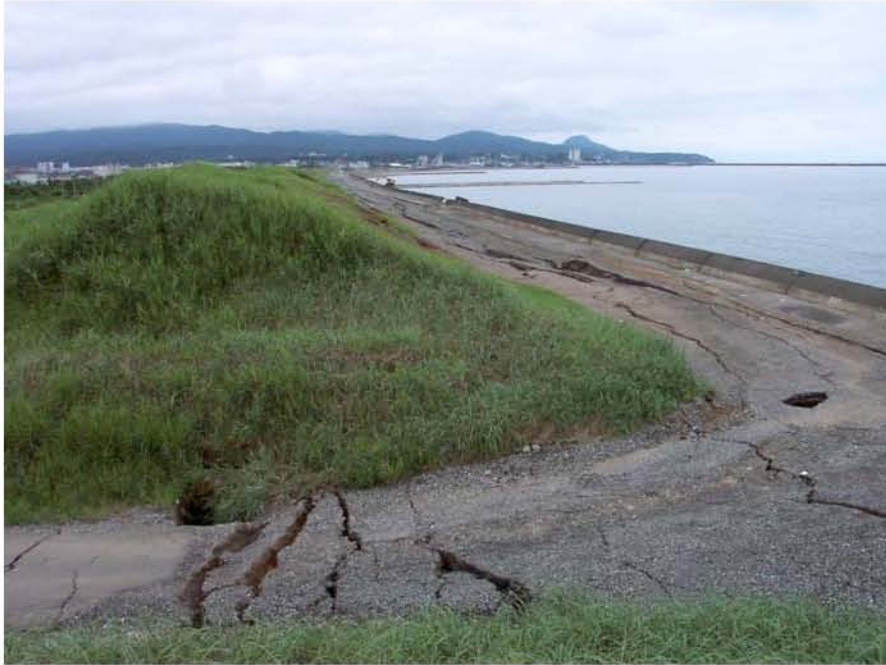
The area located behind the seawall has been developed with a benched, earth embankment composed of sandy clay and clayey sand that extends almost the entire distance to the beaches near the Minatomachi Seaside Park. The seawall exhibited an increased seaward tilt as the investigation moved to the southwest (Figure 8.35). The lateral deformation was crudely estimated to be approximately 1.5 m to 2.0 m. The actual lateral movement is very difficult to estimate in the field due to the contributions of lateral spreading, levee slumping, and foundation failure. The embankment exhibited pervasive longitudinal cracks along the crest and side slopes, and a less well-developed set of transverse cracks. The longitudinal cracks were noted on both sides of the embankment however the deformations in the seaward direction were much more pronounced (Figure 8.36). The embankment is discontinuous and is bisected by several unpaved access roads. At these sections it is clear that the embankment has experienced significant differential settlement, transverse cracking, and longitudinal cracking extending through the entire earth structure (Figure 8.37). The radial pattern of longitudinal cracks observed at the base of one of the embankment sections clearly demonstrated the extent of foundation failure and differential settlement of the embankment. No liquefaction features (e.g., sand boils, vented sand) were observed in the embankment fill or in tension cracks. Several large voids (> 1 m³) were exposed near the toes of failed portions of the embankment.

Figure 8.36: Representative cracking and lateral displacement of the clayey earth embankment adjacent to the seawall (Location is southwest of Site SD1, photo taken 7/22/07 11:35).

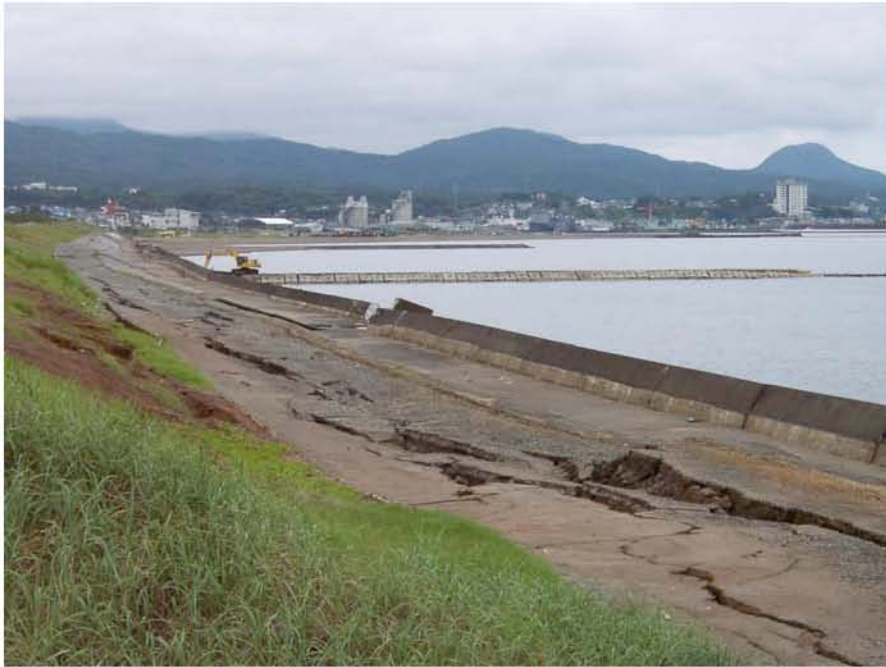
Figure 8.38: Ground deformations adjacent to the embankment and seawall (Location is southwest of Site SD1, photo taken 7/22/07 11:42).

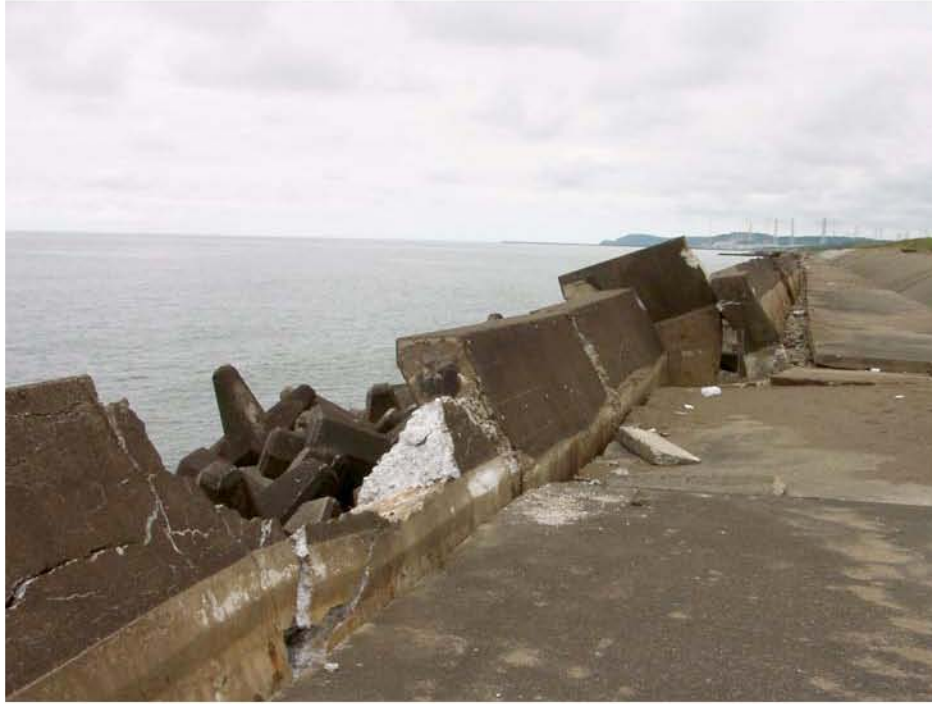
Figure 8.39: Lateral displacement, rotation, and structural damage to the seawall (Location is southwest of Site SD1, photo taken 7/22/07 11:45).

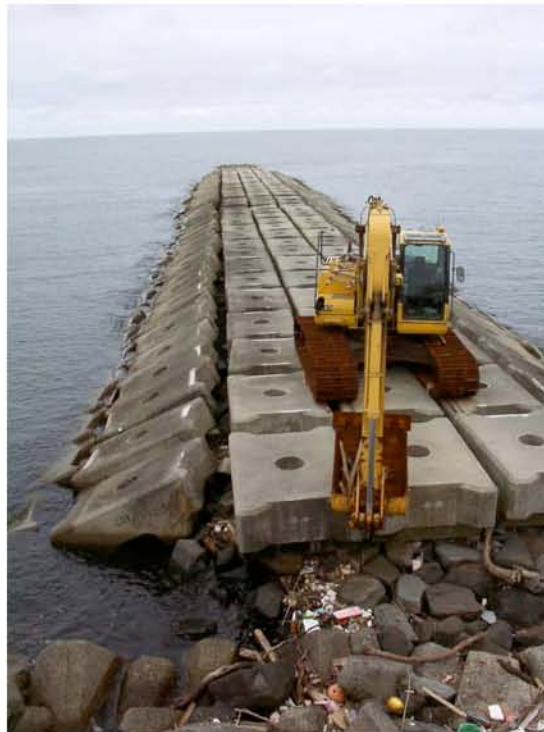
Figure 8.40: Repair of an armored, rockfill breakwater (possibly an outfall structure). (Location is southwest of Site SD1, photo taken 7/22/07 11:49).

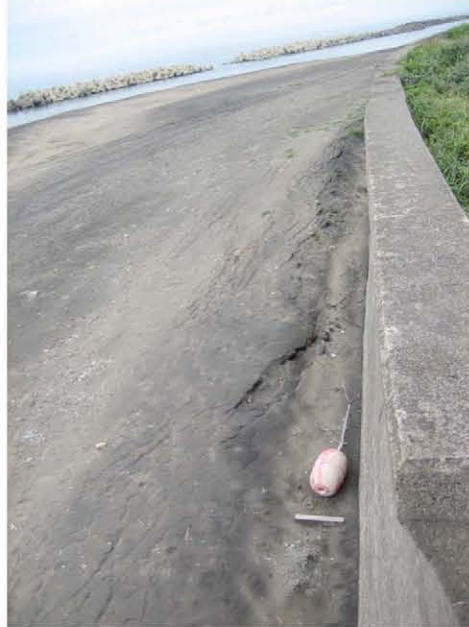
Figure 8.41: Evidence of minor liquefaction and lateral spreading in sandy beach deposits adjacent to the seawall (Site RK37, N37.45478°, E138.60927°, photo taken 7/23/07).

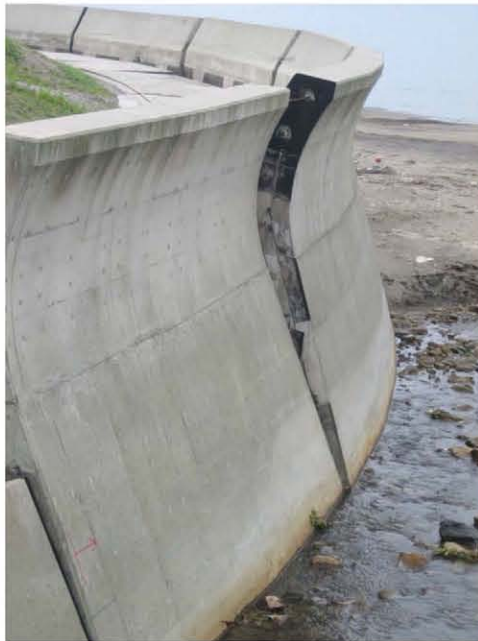
Figure 8.42: Rotation and lateral displacement of the concrete seawall (Site RK37, N37.45478°, E138.60927°, photo taken 7/23/07).

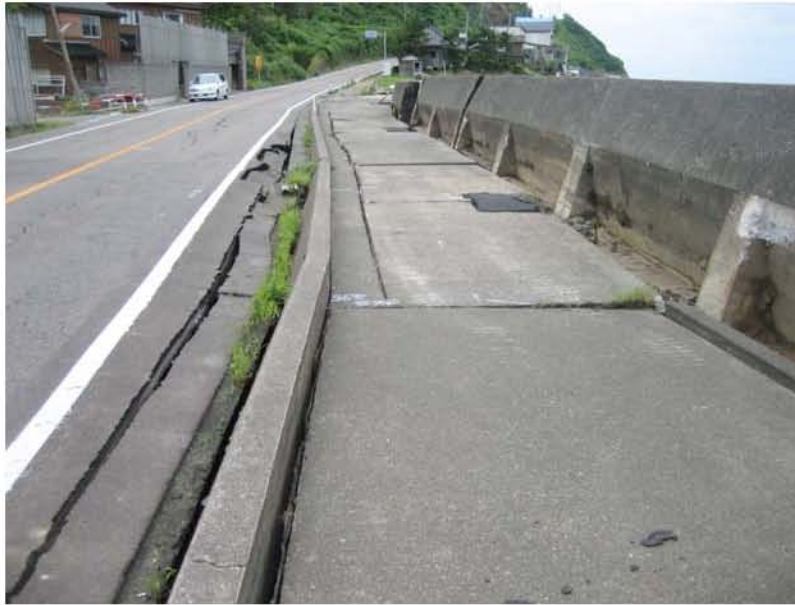
Figure 8.43: Liquefaction-induced damage to the seawall and adjacent roadway (Site RK35, N37.48497°, E138.62645°, photo taken 7/23/07).

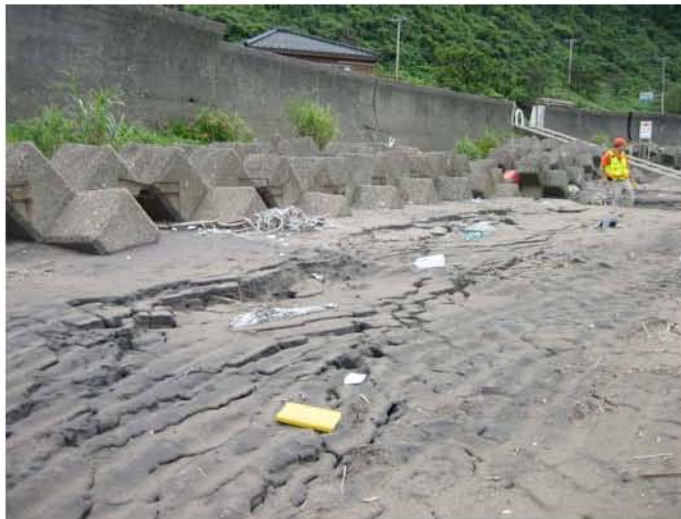
Figure 8.44: Lateral spreading associated with liquefaction of beach sand (Site RK35, N37.48497°, E138.62645°, photo taken 7/23/07).

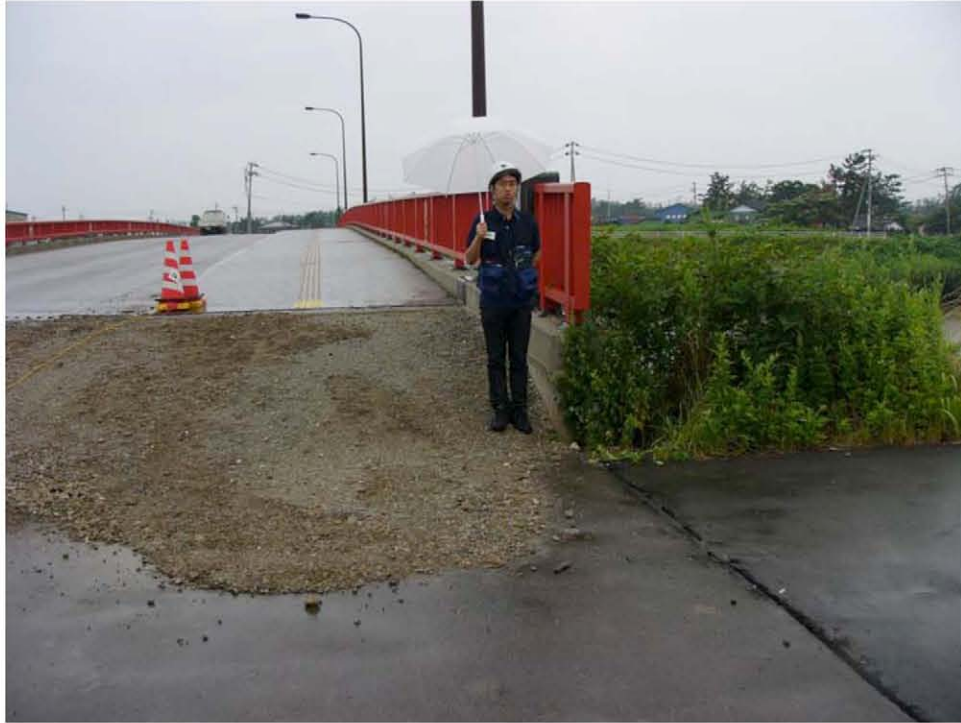
Settlement of soils at bridge approach fills caused vertical offsets at many bridges by as much as one meter (Figs 9.6 and 9.7, additional details are provided in the “Bridges Section”). The offsets required placement of gravel or asphalt pavement to maintain a smooth transition for traffic flow onto the bridges. At the beginning of the reconnaissance mission during July 20-24, 2007, fill had been placed at nearly all of the bridges requiring such repair and only two bridges remained closed. It is not clear how the bridge offsets affected traffic during the first three days following the earthquake.

Figure 9.6: Vertical offset at the approach of Kai-Un Bridge that has been temporarily repaired with gravel fill to permit access (Site YT3, N37.39232° E138.58063°, photo taken 7/20/07 12:42). A vertical offset of 33 cm was measured at the adjacent abutment (left of this photo).

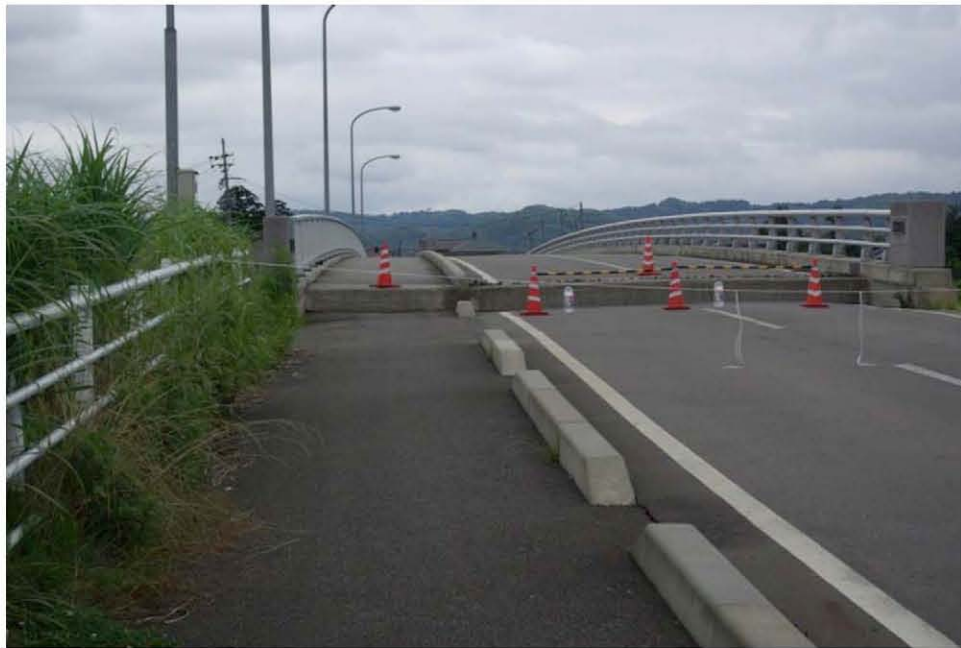
Figure 9.7: Vertical offset at approach of rural bridge that has not yet been repaired (Site SA22 N37.38439° E138.60083°, photo taken 7/21/07 15:00).

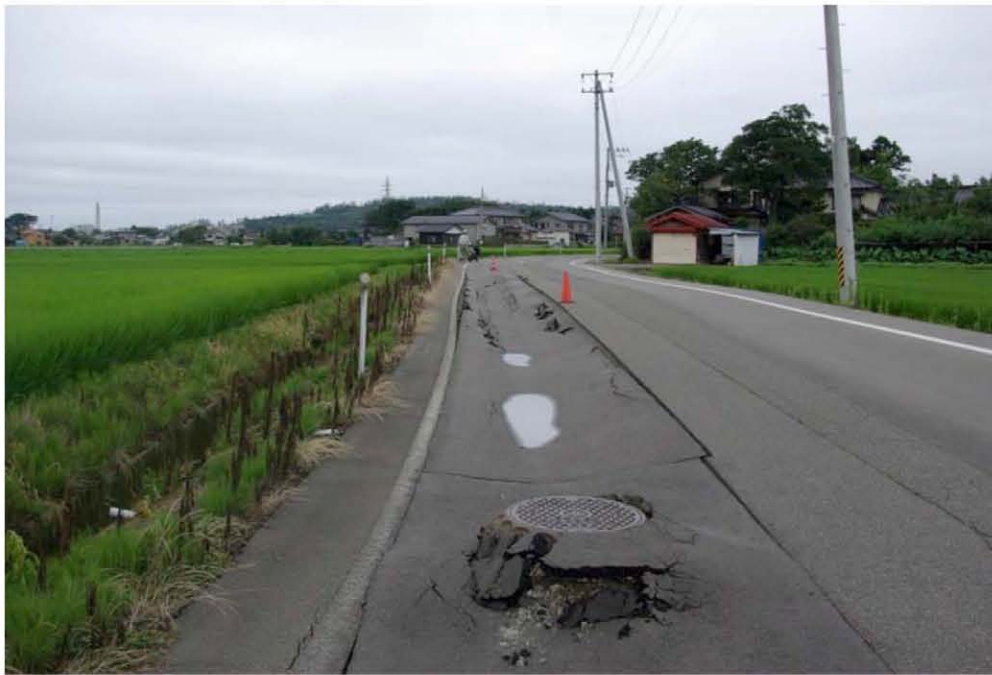
A common cause of pavement damage was liquefaction of utility trench fills, and/or uplift of buried utilities due to buoyancy in liquefied ground. Fig. 9.9 is an example of this widespread pavement damage mechanism. Such damage typically caused closure of one lane of traffic, and in only a few cases were closure of entire roadways necessary due to utility trench fill liquefaction failures.

Figure 9.9: Pavement damage caused by utility trench liquefaction (Site SA21, N37.38950° E138.59662°, photo taken 7/21/07 14:57).

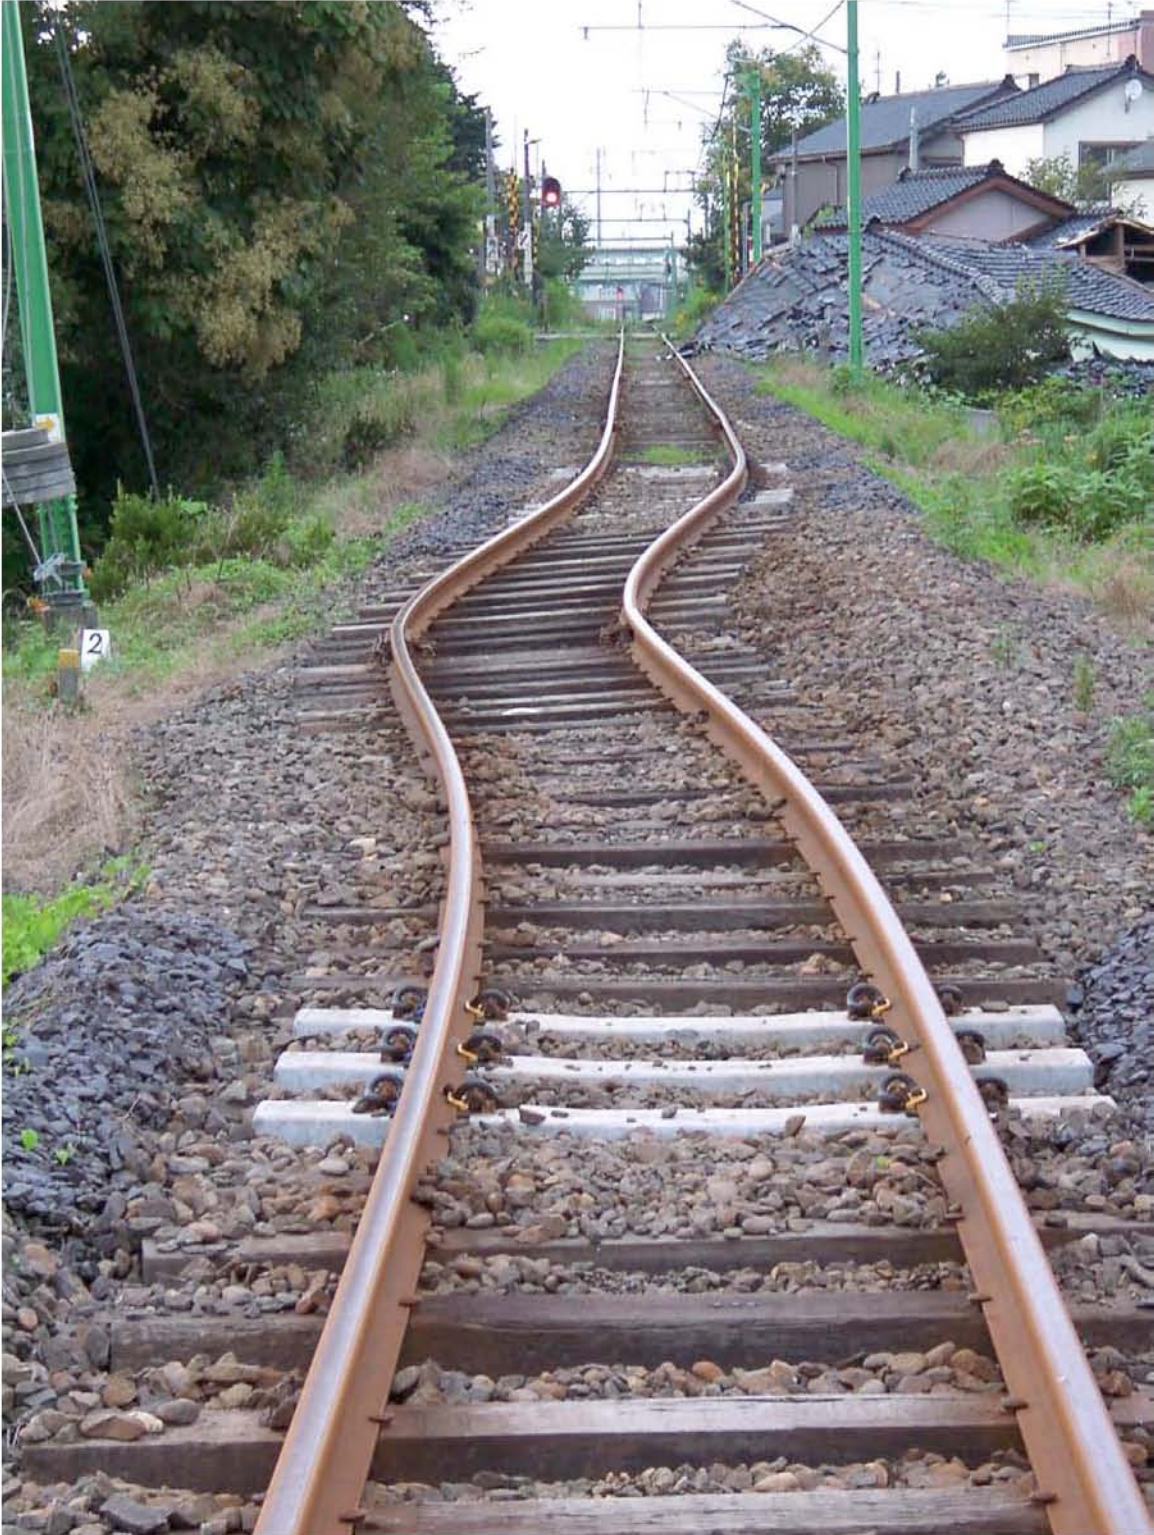
Figure 9.13: Lateral railway buckling (Site RK28, N37.37037° E138.56475°, 7/21/07 18:01).

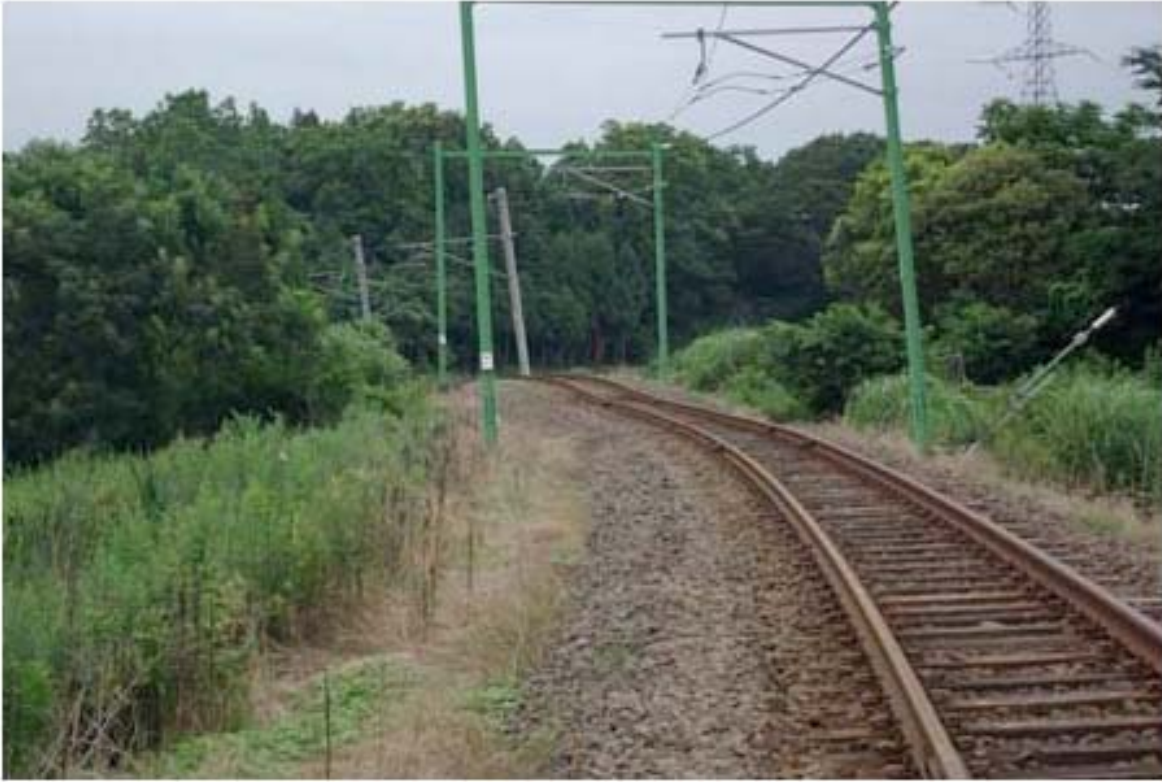
observed in the railway (Fig. 9.14). Numerous other rail disruptions due to foundation settlement and permanent ground deformations were observed by the reconnaissance team. In most cases the deformations were minor, yet significant enough to preclude rail traffic during the period of the reconnaissance. During this time, rail crews were observed making inspections of several rail lines in order to place them back into service.

Figure 9.14: Vertical deformation in train tracks (Site SA24, N37.39323° E138.59520°, 7/21/07 15:44).

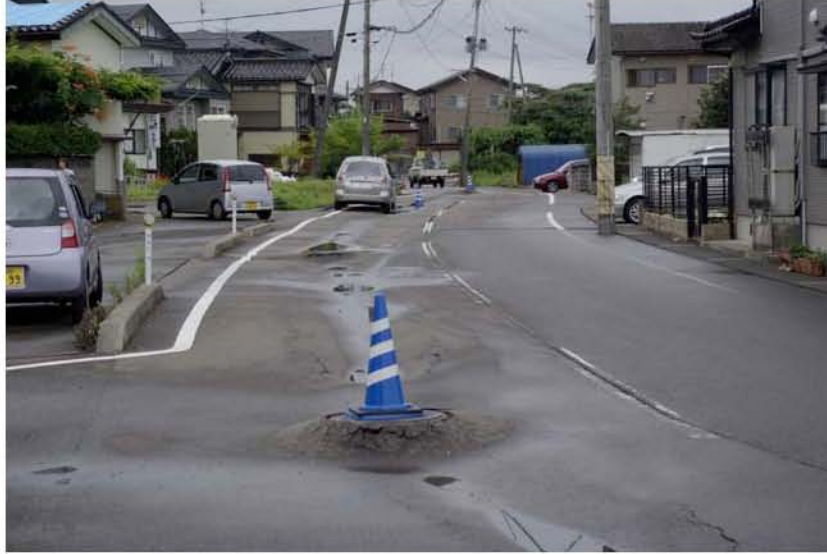
Figure 10.1: Example of an elevated manhole caused by settlement of road fill. The depression caused by densification of lightly compacted trench backfill during cyclic loading was evident along extensive sections of the roadway. This area was conspicuous for pipe breaks associated with ground deformation (Site SD11, N37.36650° E138.58868°, photo taken 7/23/07).

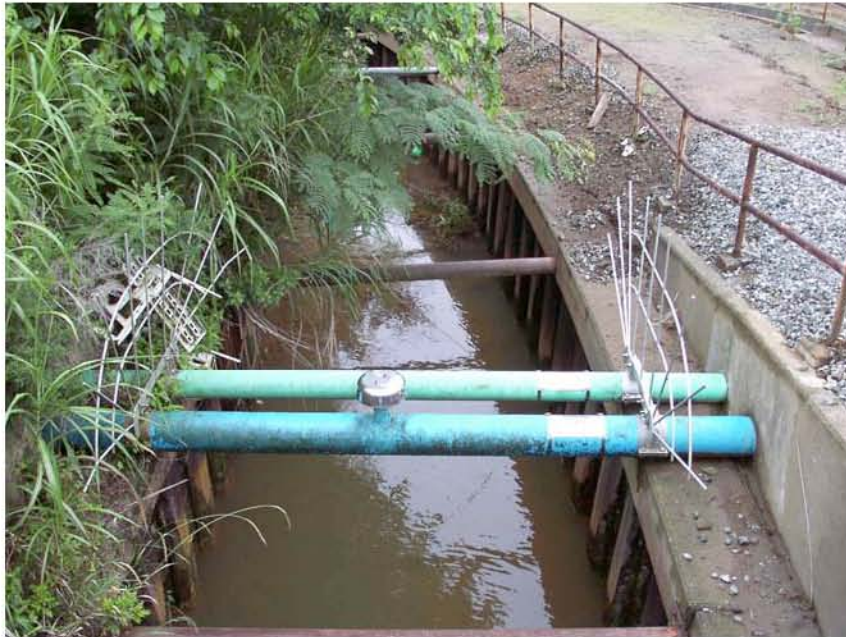
- Numerous water and gas pipes were observed at stream crossings. Many unsupported pipes were observed spanning small, channelized streams. No pipe breaks were observed at the small to moderate stream crossings despite evidence of minor lateral and vertical ground deformations (Fig. 10.2).

Figure 10.2: Example of short span pipes (water and gas) across a channelized stream exhibiting very minor ground deformation. No damage to the pipes was observed (Site SD12, N37.36663° E138.59223°, photo taken 7/23/07).

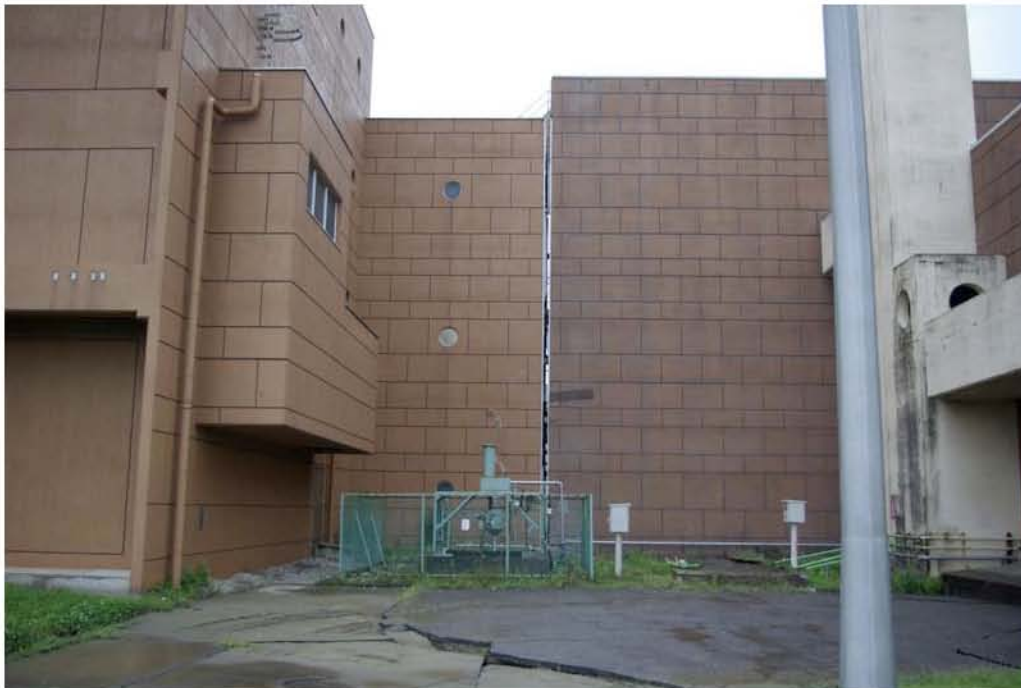
- The site of the Ansui-Chou waste water treatment plant (Site RK9) located adjacent to the Sabaishi River exhibited widespread liquefaction-induced ground deformation. The facility was out of operation at the time of the field survey due to extensive structural damage to the facility. Lateral spreading resulted in separation of one building (Fig. 10.4). Despite this level of ground deformation (vertical and lateral) the initial inspection revealed no rupture of pipes located at grade or in elevated pipe racks. No trenching had been performed at the time of the investigation therefore the performance of buried pipes could not be assessed. No surface evidence of buried pipe breaks was noted. This is an important location for subsequent investigation.

Figure 10.4: Ansui-Chou waste water treatment plant showing evidence of lateral spreading and extension of the structure (Site RK9, N37.38748° E138.56587°, photo taken 7/20/07).

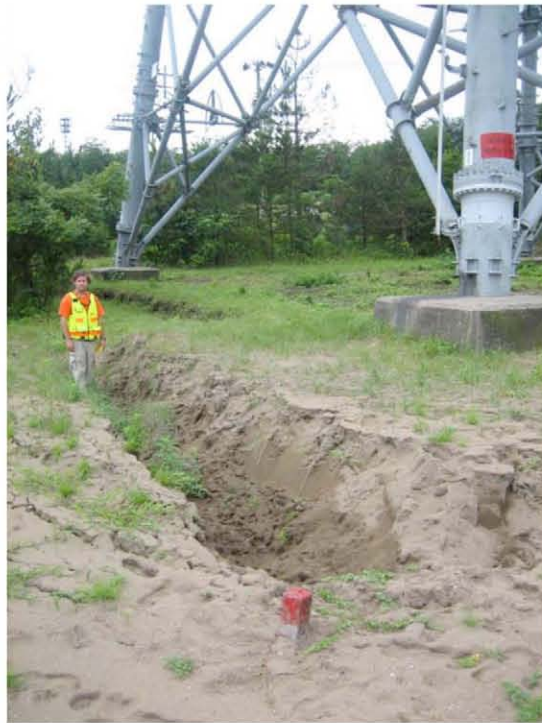
Figure 10.5: Ground failures at the site of a high voltage tower (Site RK40, N37.41633° E138.60792°, photo taken 7/24/07). No evidence of structural damage to the towers was observed.

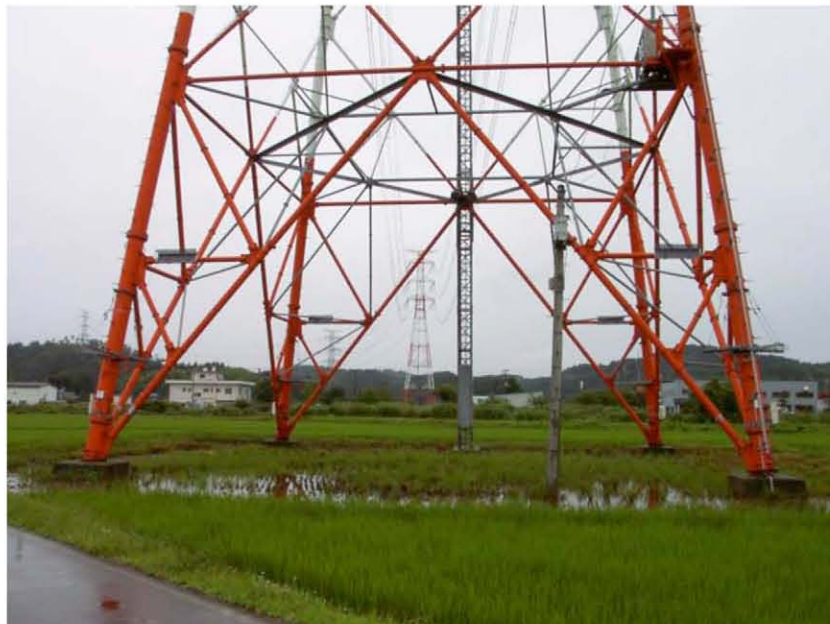
Figure 10.6: High voltage power line towers located in the Kashiwazaki area (Site RK12, N37.44113° E138.63390°, photo taken 7/21/07). No evidence of structural damage to the towers was observed.

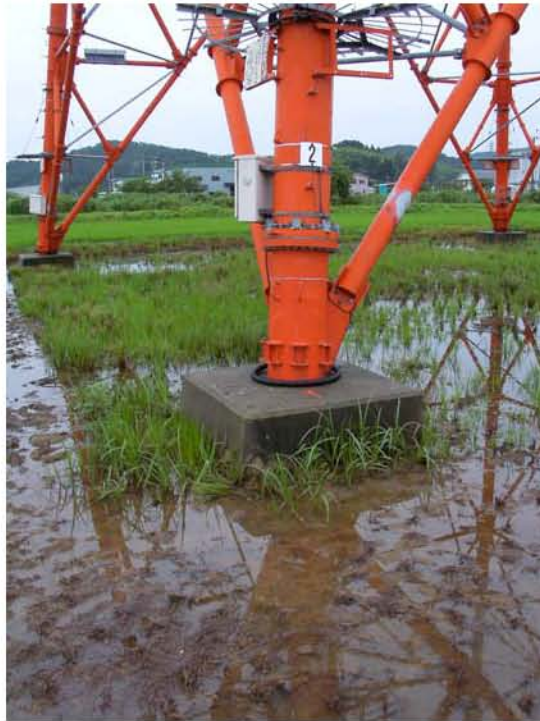
Figure 10.7: High voltage power line towers located in an area of soft ground (Site RK12, N37.44113° E138.63390°, photo taken 7/21/07). No evidence of ground failure, settlement, or structural damage to the towers was observed.

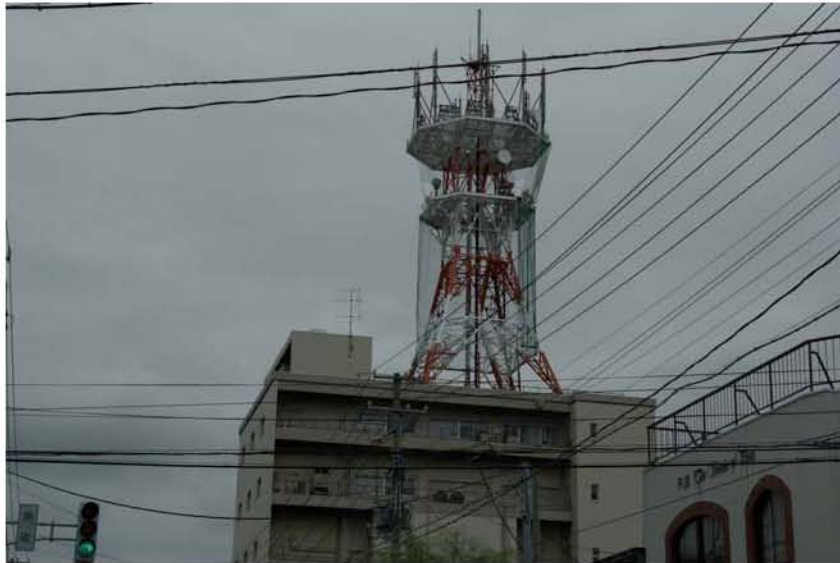
Figure 10.8: NTT communications building in downtown Kashiwazaki (Site SD20, N37.36847° E138.55813°, photo taken 7/23/07). No evidence of major structural damage to the tower was observed however no information on the performance of the electronics was available at the time of the investigation.

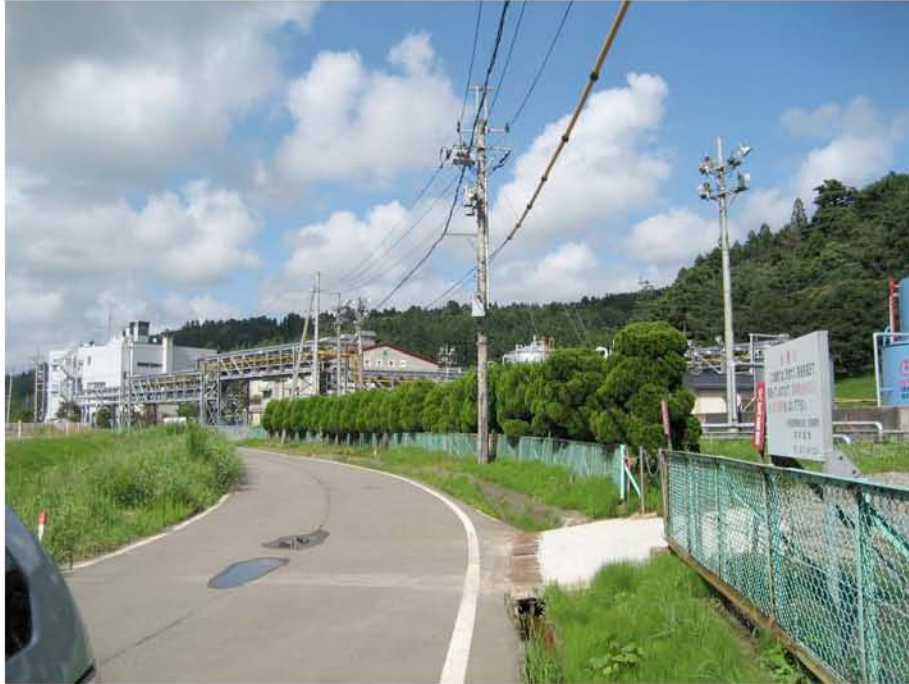
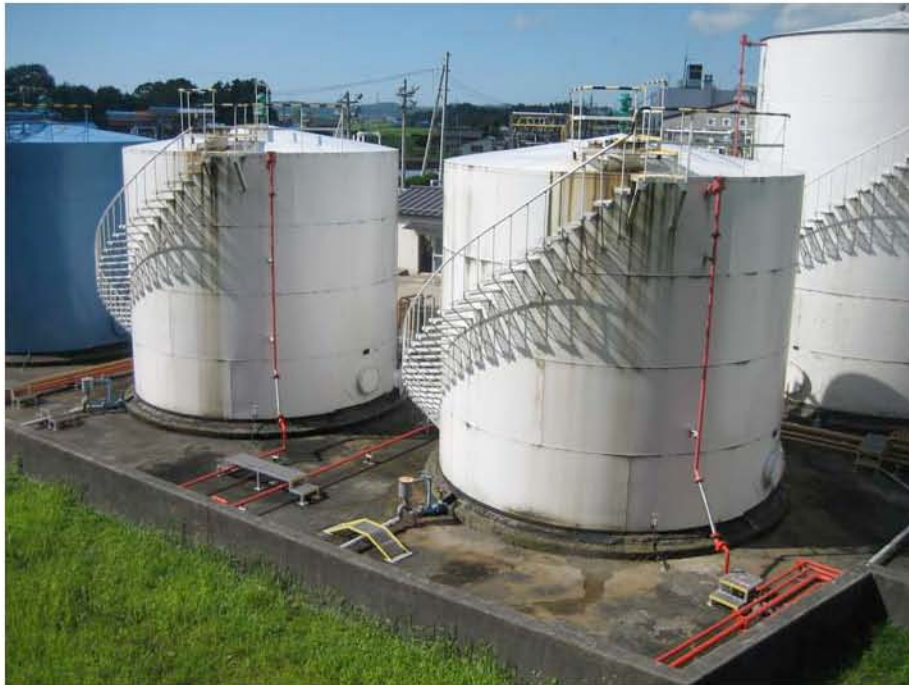
Figure 10.10: Oil storage and distribution facility (Site RK55, N37.38917° E138.63377°, photos taken 7/23/07 12:30). No damage was observed at this site.

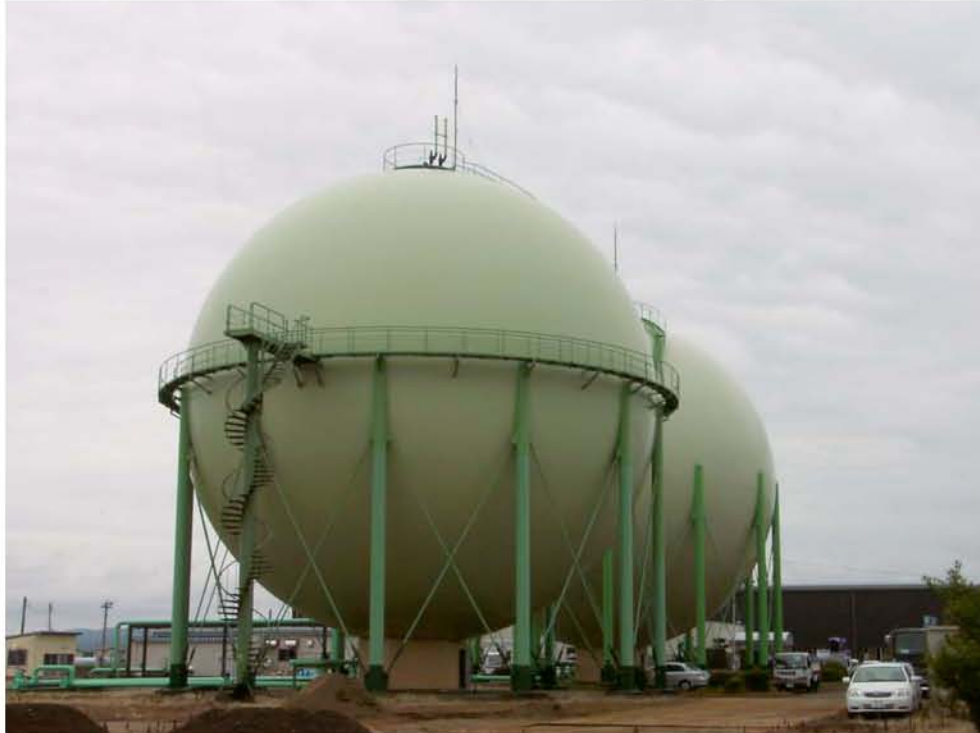
Figure 10.11: Natural gas tanks being inspected by local engineers (Site SD13/RK57, N37.37253° E138.59488°, photo taken 7/23/07). Very minor ground settlement and later movement near ditches was observed in the vicinity but the no damage was apparent to the tank foundations, appurtenant piping, or the tanks.

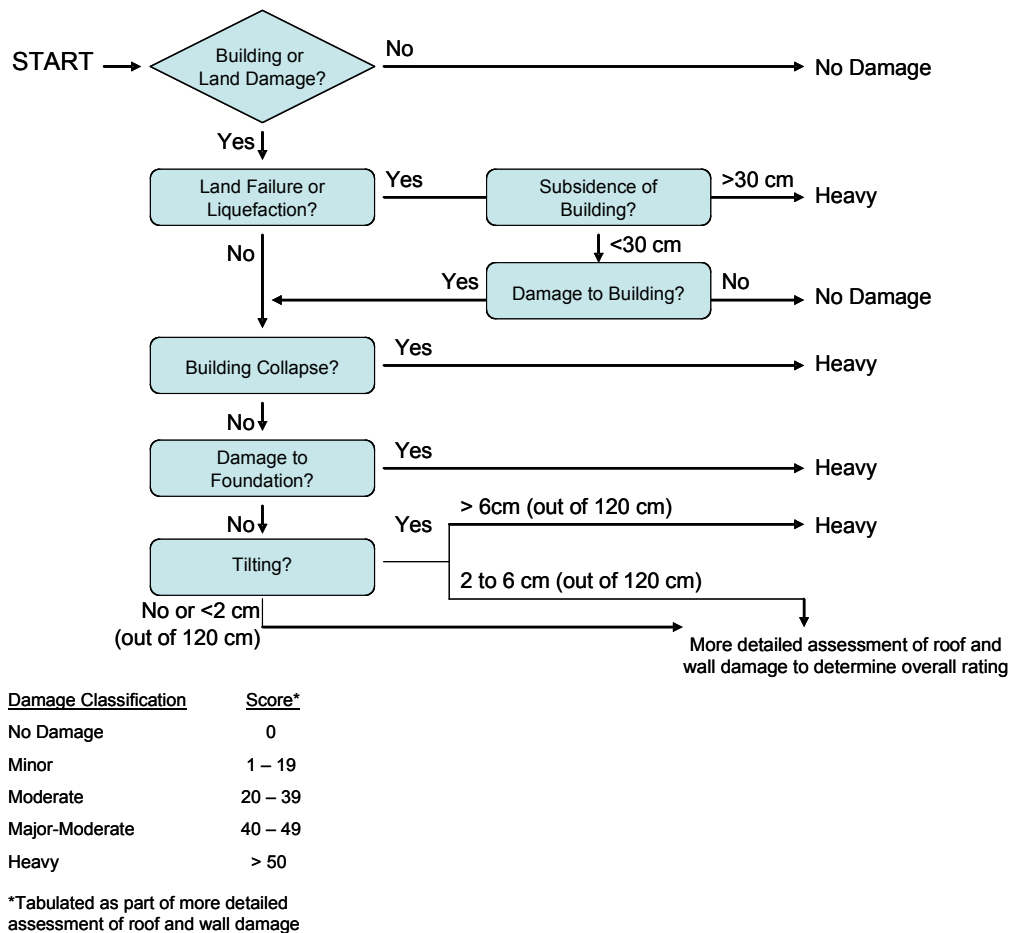
In 1996, the national government attempted to standardize the local damage certification procedures, developing a very detailed set of guidelines for assessing damage. The guidelines define 5 classes of damage which are determined by a scoring system. Structures that have 50 or more points are classified as ‘heavy damage.’ Figure 11.6 is a translation of a portion of the 1-page form and 5 damage classifications that are being used in the survey of damaged wooden houses in Kashiwazaki city.

Figure 11.7: Translated portions of the 1-page form for surveying damage to wooden houses in Kashiwazaki city.

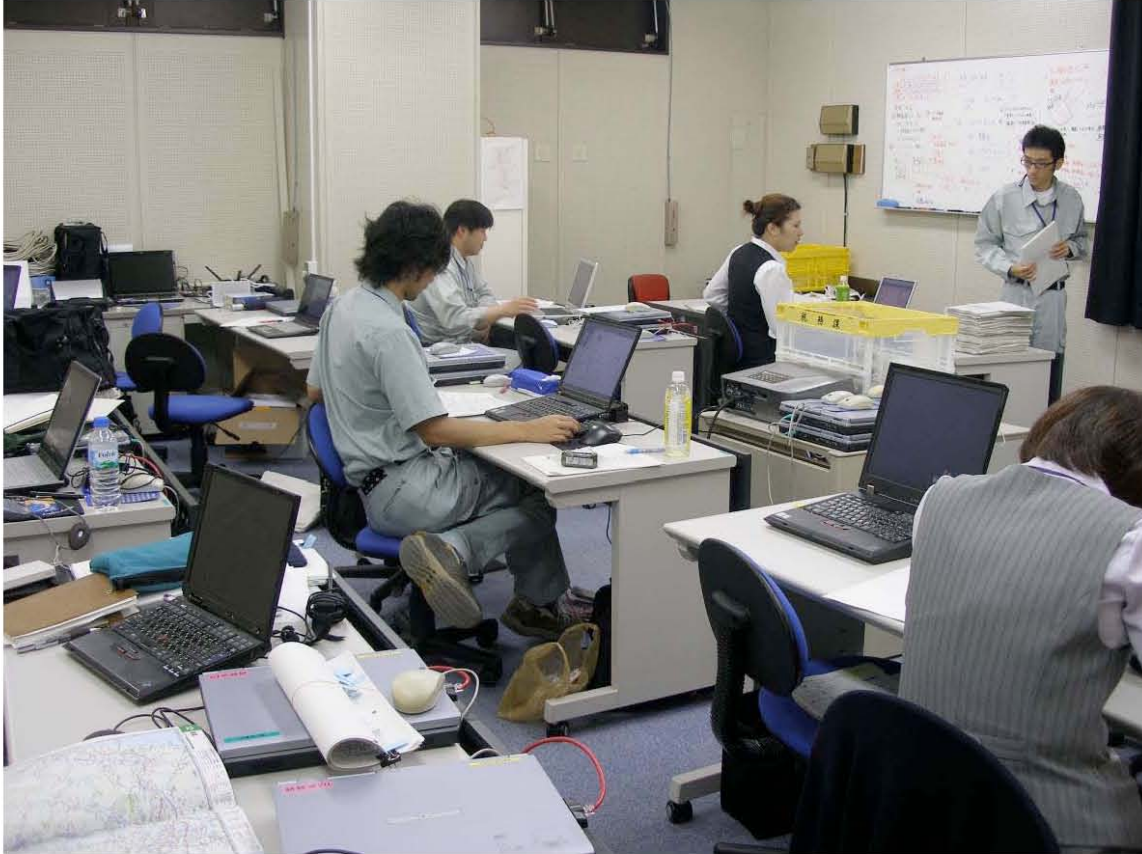
Figure 11.8: Data entry center for the damage certification survey underway in Kashiwazaki city.

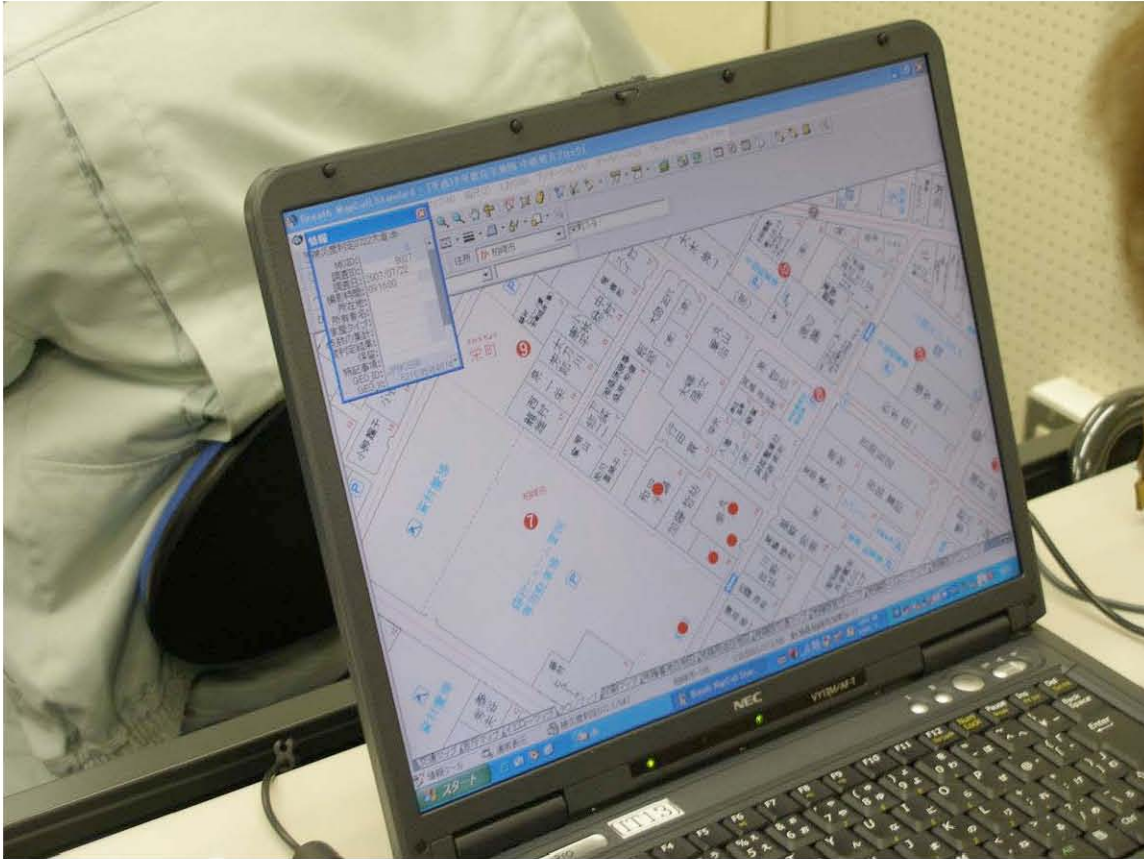
Figure 11.9: Close-up view of the GIS-based data entry program developed by Kyoto University that is being used in Kashiwazaki city.
