REPORT

SL 2012/04

REPORT ON AIRCRAFT ACCIDENT ON
10 OCTOBER 2006 AT STORD AIRPORT,
SØRSTOKKEN (ENSO) NORWAY INVOLVING A
BAE 146-200, OY-CRG, OPERATED BY ATLANTIC
AIRWAYS

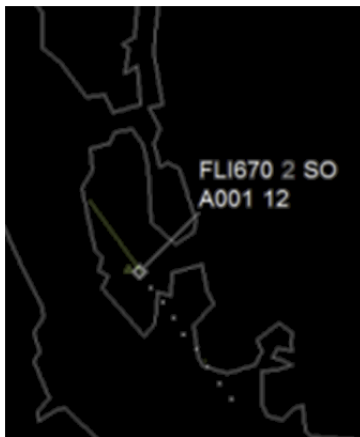
- 1.10.5.3 As shown in Figure 14 and Figure 15 respectively, FLI670 had a ground speed of 120 kt (indicated by the 12) while FLI610 had a ground speed of 110 kt. The difference in ground speed of 10 kt could be explained by the 5 kt tailwind as opposed to the corresponding headwind.

- 1.10.5.4 As described in section 1.1.7, FLI670 (OY-CRG) had been stabilised in accordance with the planned speed (V_{ref} bug speed) before landing. Given that FLI610 (OY-RCW) was holding the correct landing speed, a comparison of the radar images for the two planes will show that OY-CRG also had the expected speed on passing the threshold.

Figure 14: Shows FLI670 (OY-CRG) as it passed the threshold for runway 33. Ground speed: 120 kt.

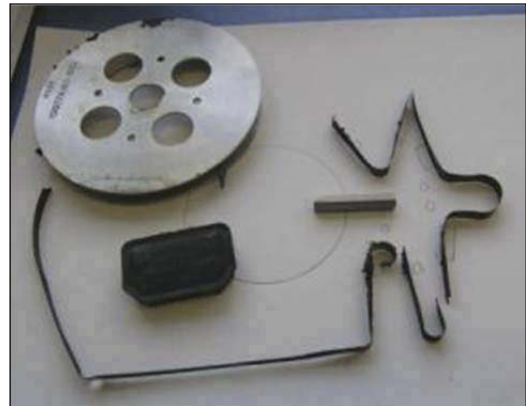
1.11.1.2 Data from the FDR was recovered by the Air Accidents Investigation Branch (AAIB-UK) at Farnborough. When the FDR was opened, it showed clear signs of having been exposed to higher temperatures and for a longer time than it was designed to withstand pursuant to the certification criteria. After having made every possible effort, the specialists at the laboratory had to acknowledge that most of the FDR data was lost as a result of heat damage (see Figure 16 and Figure 17).

Figure 17: Magnetic tape sections from which data could be recovered.

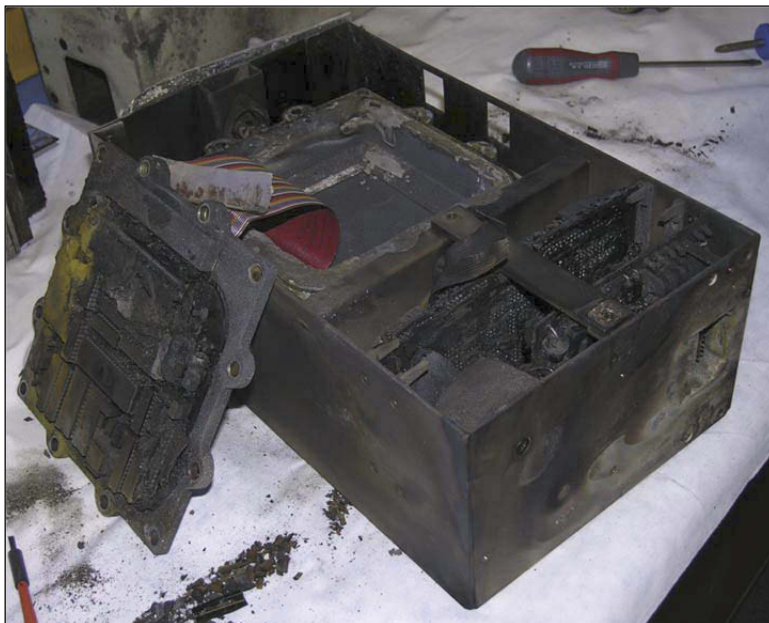
- 1.11.2.1 Pursuant to current regulatory requirements, the aircraft type shall have a cockpit voice recorder that stores data from the last 30 minutes. OY-CRG was fitted out with a cockpit voice recorder (CVR) of the type Fairchild A100S, with part number S10008000 and serial number 00654. The CVR was a solid-state recording device.
- 1.11.2.2 The Air Accident Investigation Branch (AAIB-UK) tried to recover the CVR data. Despite considerable effort by highly skilled personnel, they did not succeed in recovering any of the CVR data. This was mainly because the connections on the storage unit's circuit board had been destroyed due to heat damage (see Figure 18).

- 1.11.2.3 The AIBN therefore brought the storage unit on to the manufacturer L3 Communications in Sarasota, Florida, USA, where they were able to repair the circuit board and recover the data stored on it.
- 1.11.2.4 The quality of the CVR recording was good. The recording was of the pilots' communication amongst themselves, their two-way communication with the various Air Traffic Control units and cockpit sounds. The recording was of 30 minutes duration as expected, and covered everything from starting the plane at Sola until the power supply failed as a result of the accident.

Figure 18: Cockpit voice recorder.

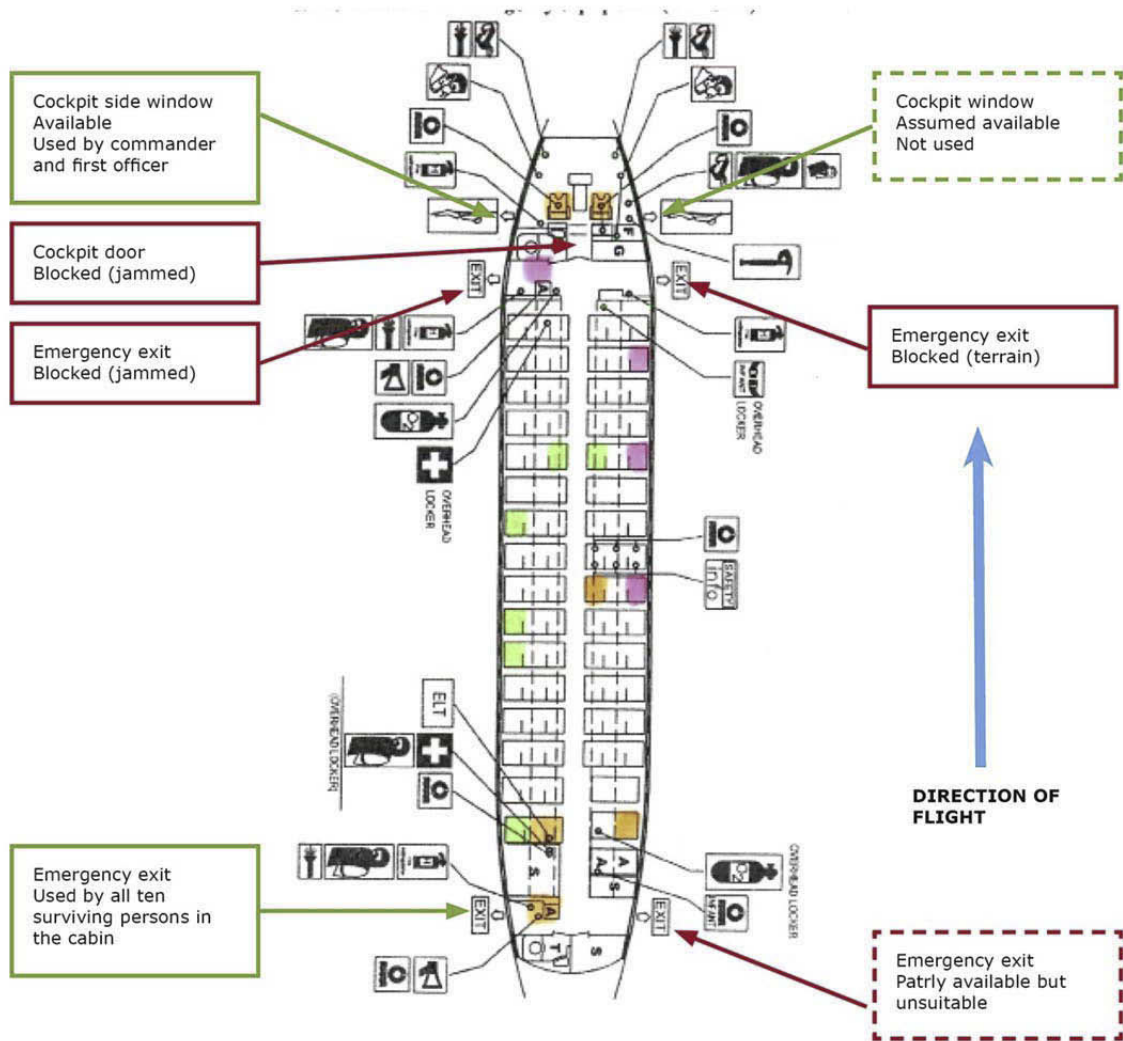
Based on the statements of those involved, it took some time before the fire spread to the interior of the cabin. Hence those in the forwardmost part of the cabin had some time to

escape through the cockpit or forward emergency exits (provided that these had been accessible/were not blocked). Cabin crew member no 1 and one of the passengers were found dead just behind the cockpit door.

Figure 32: Position²⁶ in the aircraft, degree of injury and accessible emergency exits
 Red: Died
 Orange: Seriously injured
 Green: Minor or no injuries

- 2.3.3.4 Information from the survivors indicates that the evacuation of the aircraft started immediately. The position of the door handle on the right forward door shows that someone had tried to open the door. This was unsuccessful because the door was blocked by the terrain outside. The left forward door could not be opened either, when the commander tried it. There are grounds for supposing that problems with opening the cabin doors, in combination with the early outbreak of fire at the forward end of the cabin, explains why all those who died were sitting in the forward half of the cabin (see Figure 32).

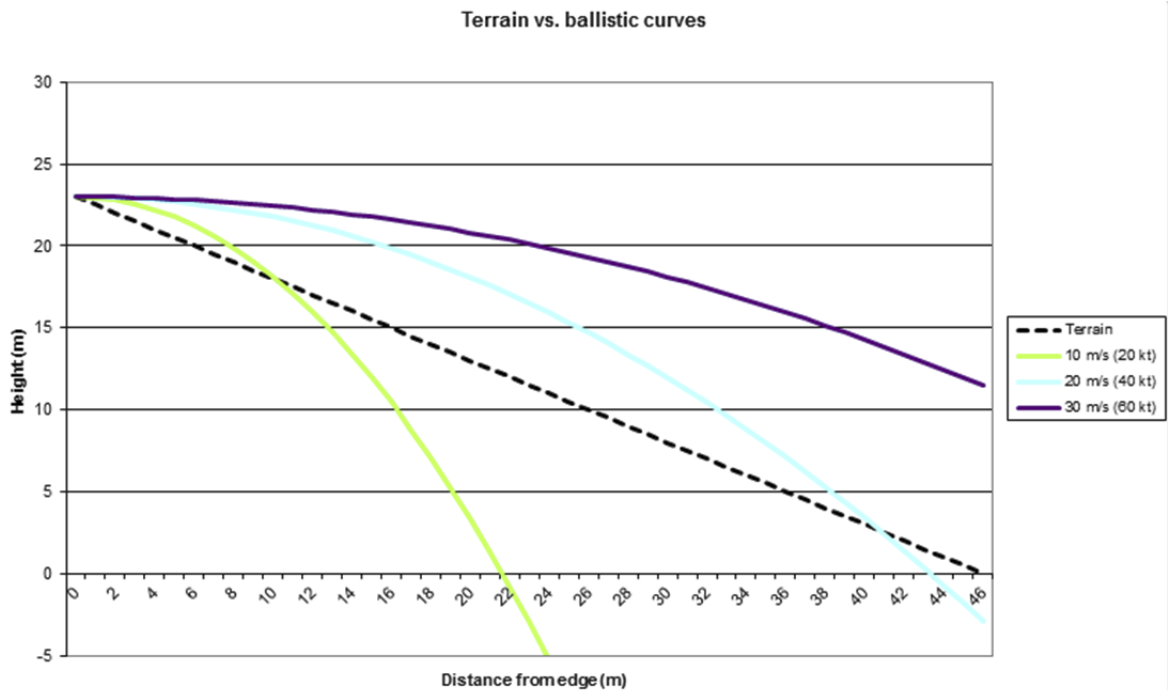
2.2.2.1 Based on radar data and information from the CVR⁴⁷ there is reason to believe that OY-CRG had an airspeed of about 112 kt and, because of the tailwind, a ground speed of about 117 kt, immediately before landing. It is more difficult to determine at what speed the aircraft was travelling when it left the runway. As is evident from information provided by the FAA (see section 1.18.3) reverted rubber hydroplaning can occur right down to speeds of 20 kt or less. Consequently it cannot be ruled out that the speed was in the order of 20 kt when the aircraft went down the slope. Correspondingly, ballistic calculations show that the aircraft must have had a speed of approximately 20 kt or less to be able to follow the terrain down the slope (see Figure 37). These figures, collated with the crew's account, suggest that the plane had a speed of 15-20 kt when it left the runway. This shows that the aircraft's speed was reduced by 97-102 kt during the landing and rollout.

Figure 37: Graphical portrayal of the slope seen in relation to the aircraft's ballistic curve at different speeds.

- 2.2.2.2 On the way down the slope the wheel doors and later the outer starboard engine (engine no 4) were ripped off. The starboard wing sustained several cuts as it pulled down trees and the approach lighting. It is probable that the aircraft maintained its speed down the slope and that it was still travelling at a relatively high speed when its nose encountered rising ground. The collision deformed the nose section and distortions arose that jammed the door between the cabin and the cockpit.

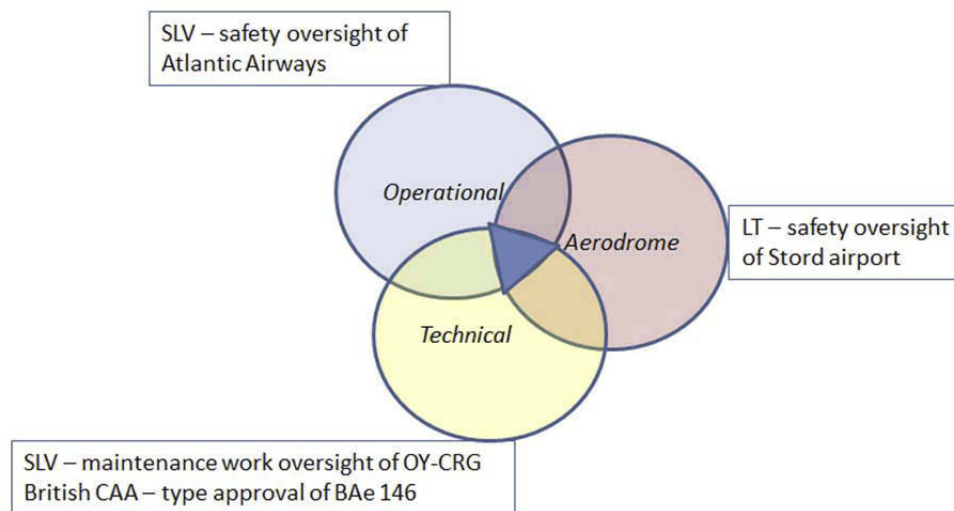
Figure 38: Risk contributors in aviation and the regulatory authorities' associated responsibilities.

- 2.11.1 Figure 38 shows the various risk contributors related to the Stord accident and the regulatory authorities' areas of responsibility. As a starting point, the division of roles between the two regulatory authorities, CAA Norway and CAA Denmark, seems to have been reasonably clear in that CAA Norway had primary safety oversight responsibility for the airport, whilst CAA Denmark had safety oversight responsibility for the airline. CAA Denmark was also the oversight authority for aircraft maintenance on OY-CRG as it was operated by Atlantic Airways, while the British CAA had granted type approval for aircraft type BA 146.

- 2.11.2 Separately and independently each of the risk contributors - the company's operational activity, aircraft technical matters and matters relating to the airport - were accepted and approved by the respective authorities. Atlantic Airways had many years' experience with demanding operations from their main base at the Faroe Islands and had not introduced any special restrictions for Stord airport, the nonconformities from BSL E 3-2 for Stord airport were assessed as not requiring more stringent measures, and the aircraft type's reliance on lift spoilers was fully acceptable. Nevertheless, the AIBN considers that the cumulative effect of the three risk contributors may have been unacceptable.

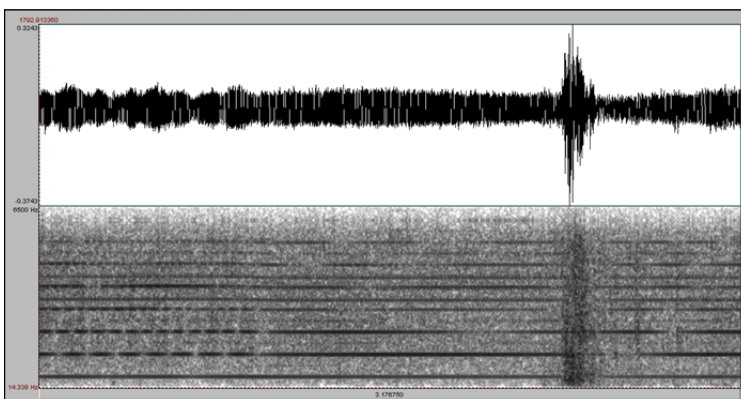
Figure 3 The landing of OY-CRG

The sounds of OY-CRG landing gears were compared to one BAe 146 landing and four landings performed by two different Avro RJ85. The landing sounds of OY-CRG (Figure 3) had similar features as the sounds of Avro RJ85 (best match) performing a hard landing (Figure 4). In general, the touchdown of a nose landing gear is the most prominent sound. This sound masks the other sounds coming from the main landing gear when touching down at the same time or right after the nose landing gear.

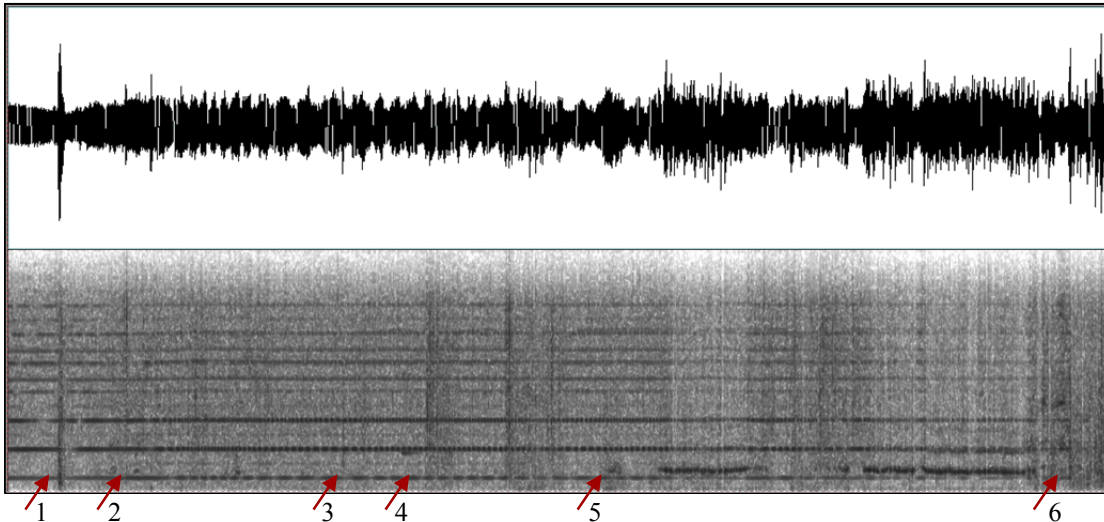
Figure 5 See table 2 for explanations

The times and durations of following events were analyzed from the CVR material. The number correspondent to each event presented in Table 2 is marked into oscillogram and spectrogram in Figure 5. Detailed description of analysis, references and comparisons are presented further.

Event	Duration sec	Event No
Touchdown → Spoiler selection	1,54 sec	1 → 2
Touchdown → Brake system selection	6,6 sec	1 → 3
Brake selection → Chime	1,34 sec	3 → 4
Spoiler selection → Chime	6,4 sec	2 → 4
Brake system selection → Start of squawking	6,2 sec	3 → 5
Brake system selection → Skidding off the runway	16,2 sec	3 → 6
Touchdown → Skidding off the runway (total)	22,8 sec	1 → 6

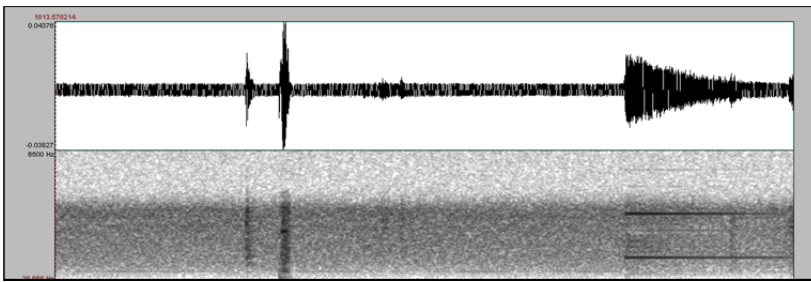
The brake system was selected 6,6 seconds after the touchdown. The sound of the selection is audible and visible in the oscillograms and spectrograms in all three occupied channels (Figures 6a, b and c). However the sound of selection is accompanied with a snap in captain's and co-pilot's channels. This snap is not present in Area channel recording. It is probable that the snap on Captain's and First Officer's recordings is electrically induced.

Figure 6a Brake system selection accompanied with a snap in Captain's channel recording

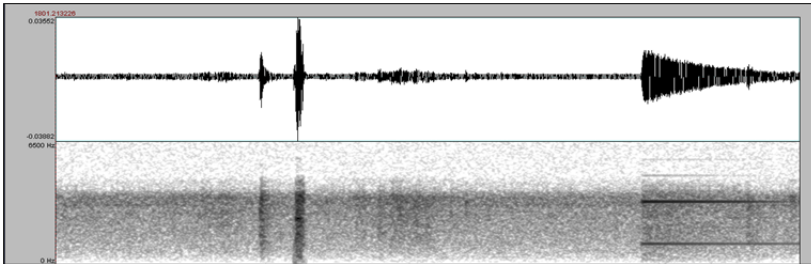
Figure 6b Brake system selection accompanied with a snap in Co-pilot's channel recording

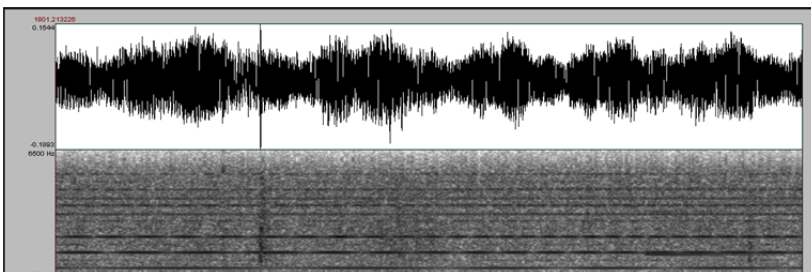
Figure 6c Brake system selection in Area channel recording

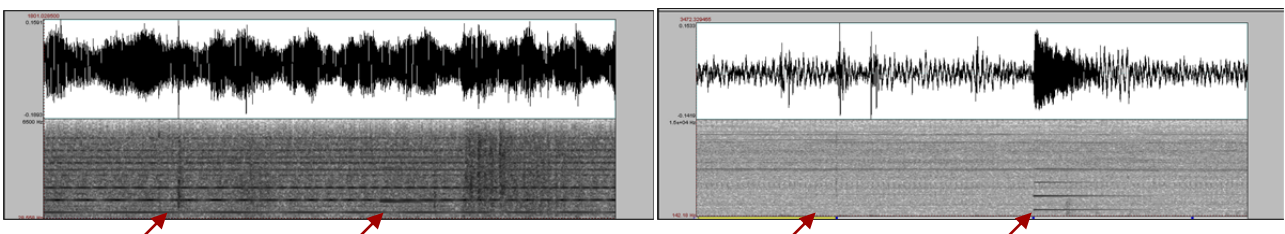
Figure 7 Brake system selection and chime of OY-CRG (left) and Avro RJ85 (right)

A comparison was made to identify and specify the time from the selection of brake system to the appearance of a single chime. In the Figure 7 the sound of selection and chime of OY-CRG (left) and brake system selection and chime of Avro RJ85 (right) are marked with red arrows. According the times presented in Table 4, the selector sound found in the OY-CRG Area channel recording can be identified as a sound of brake system selection. The chime after brake system selection is followed by a chime to warn about the consequences of this selection to the anti-skid system.

Aircraft	Dur, s
OY-CRG	1,34
Avro RJ85	1,36

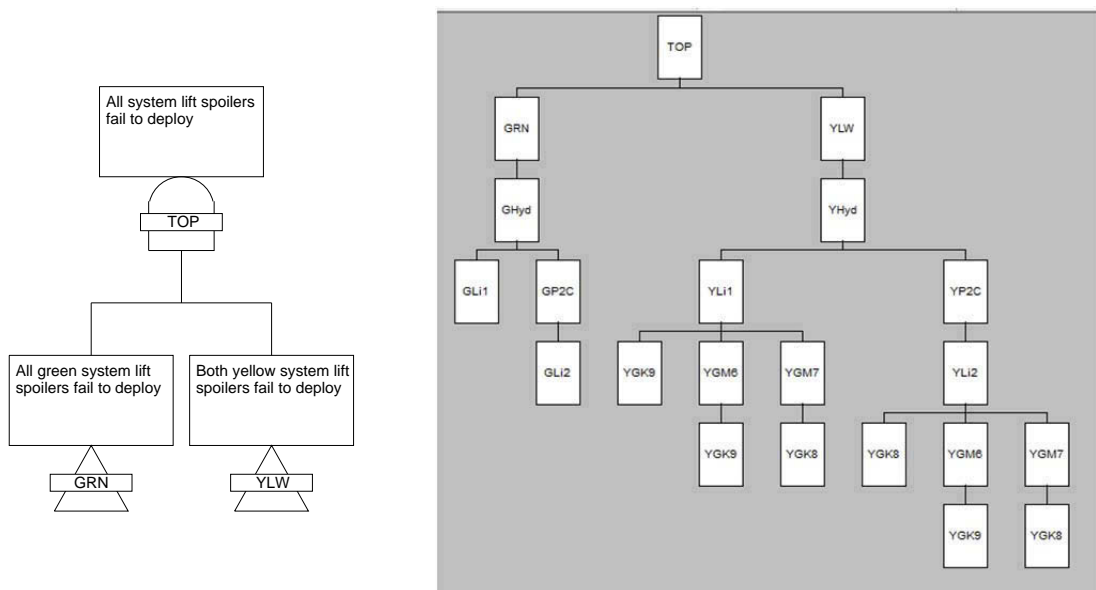
The fault tree consists of 81 basic events (see Appendix C) linked together. The top-event at system level is the failure of all lift spoilers. The fault tree has two distinct sub-systems: green and yellow. The fault tree indicates that the yellow spoiler system is more complicated than the green spoiler system.
