گزارش نهایی بررسی سانحه در فرودگاه بندر ماهشهر

Final Report

State File Number: A981107 EPCPZ

Aircraft Model: MD83

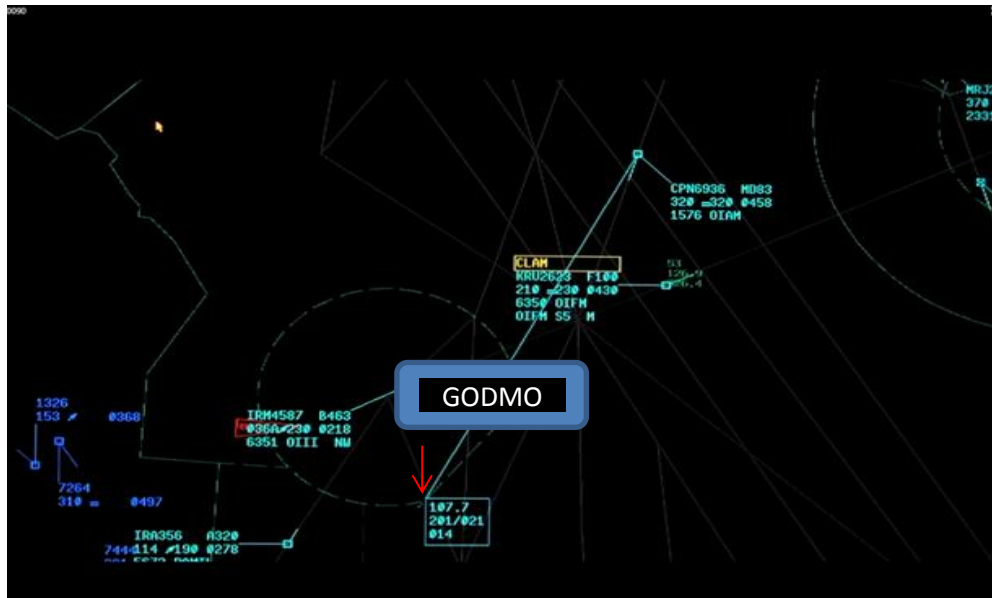
Figure 9- Radar Scope before direct routing

The accident flight was cleared to proceed directly to GODMO because of the departing of an A320, Flight IRA356 from Abadan airport.

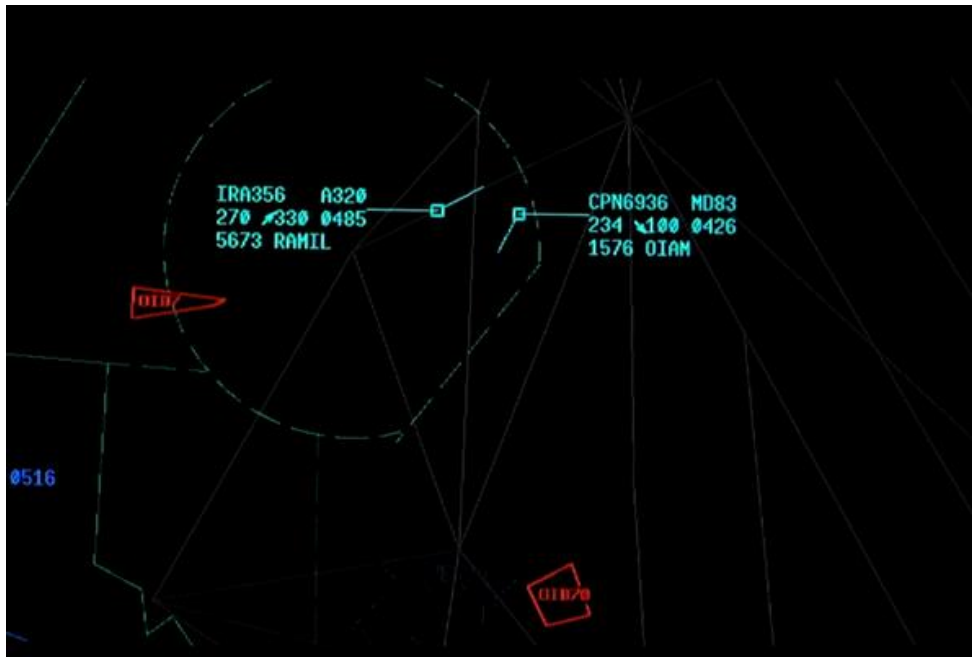
Figure 10- Flight separation

The accident flight had normal separation from A320 while passing FL234.

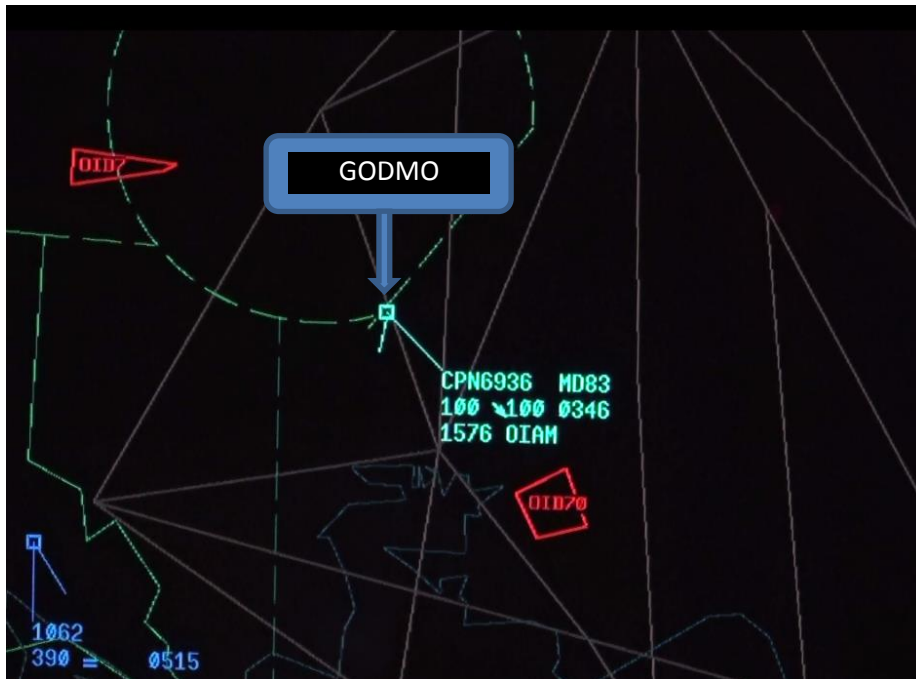
Figure 11- Reaching cleared level

The flight was passing position of GODMO at FL100 in accordance with clearance of THR ACC radar controller.

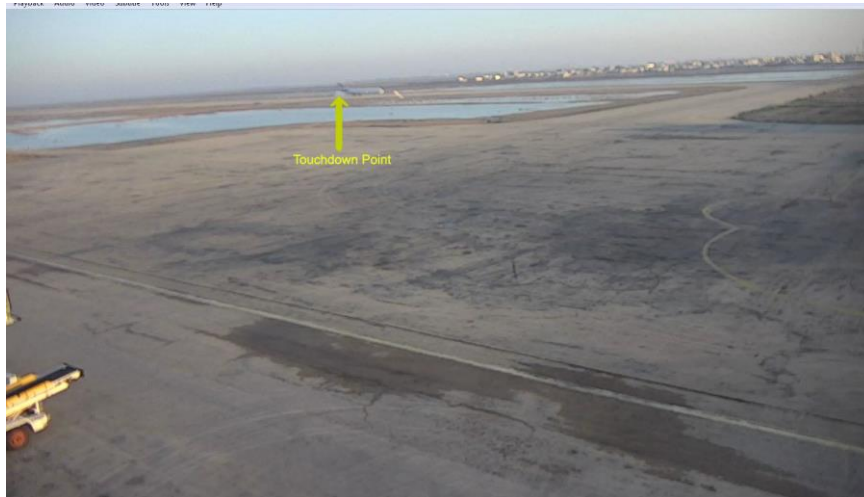
Figure 15- CCTV record of airport

The touchdown occurred about 1695 meters after the threshold of RWY13 with a remaining runway distance of 1000 meters.
