**COMANDO DA AERONÁUTICA**  
**CENTRO DE INVESTIGAÇÃO E PREVENÇÃO DE**  
**ACIDENTES AERONÁUTICOS**

**FINAL REPORT**  
**A - 121/CENIPA/2021**

<b>OCCURRENCE:</b>	<b>ACCIDENT</b>
<b>AIRCRAFT:</b>	<b>PT-ONJ</b>
<b>MODEL:</b>	<b>C90A</b>
<b>DATE:</b>	<b>05NOV2021</b>

During the approach phase, under Visual Meteorological Conditions (VMC), the aircraft collided against a lightning arrester cable of a power grid on the final approach to threshold 02 of Caratinga Aerodrome (SNCT), Uaporanga - MG, resulting in loss of control and the impact of the aircraft against the ground.

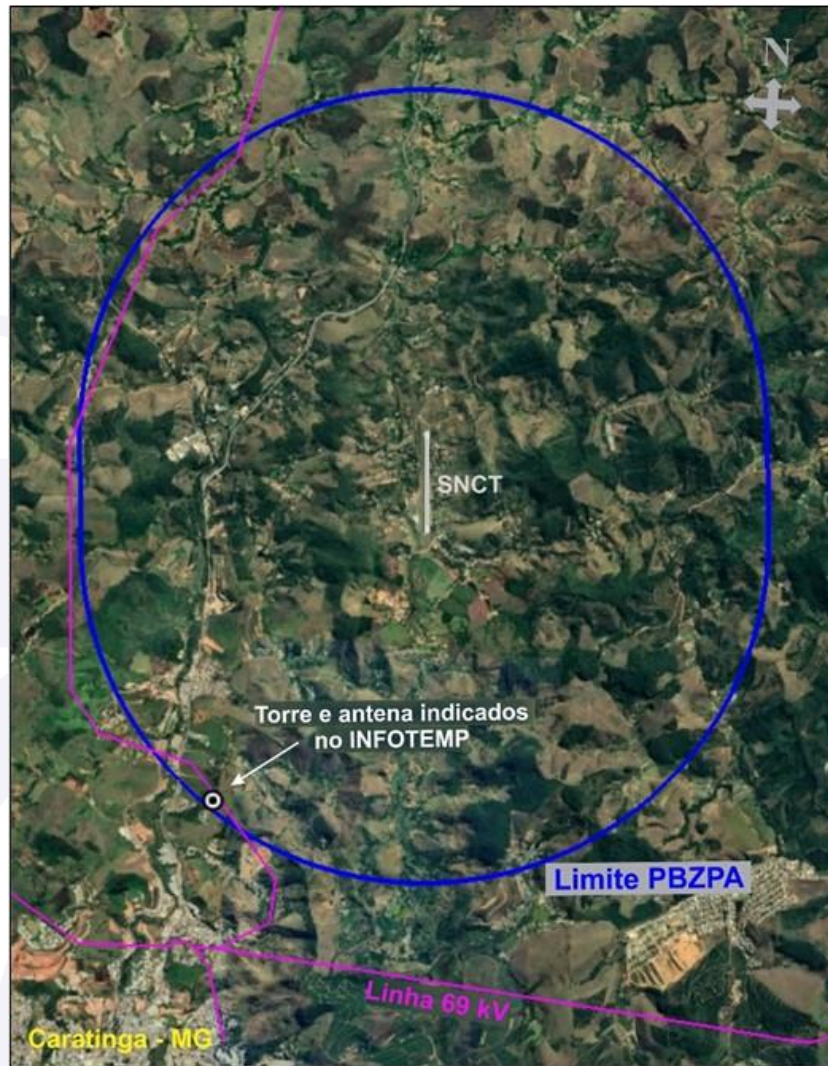
Figure 10 - Tower location indicated in the INFOTEMP.

In addition, the information on the Portal showed, through Temporary Information on Aerodromes and Helipads published exclusively on ROTAER (INFOTEMP), that there were unlit obstacles (tower and antenna), which were violating the PBZPA, at coordinates 19°45'25.28" S /042°07'45.19" W and 19°45'25.81" S/042°07'45.48" W, both with an elevation of 729 m (2,392 ft).

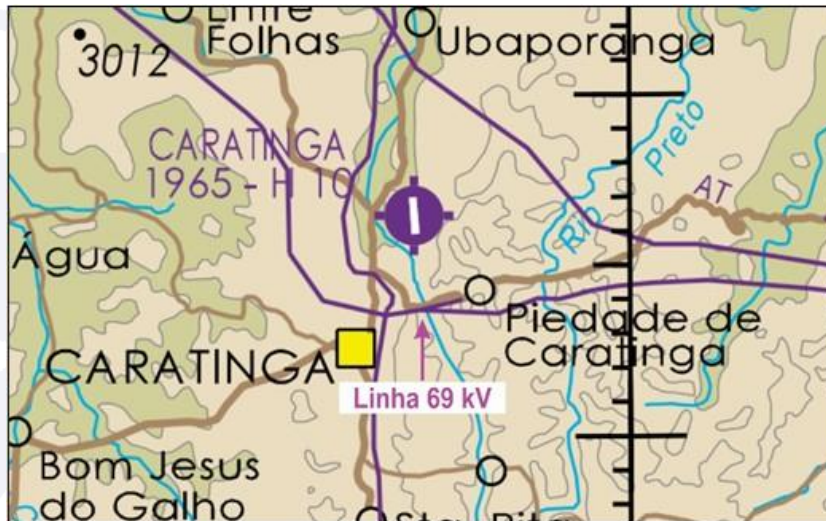
Figure 11 - 69 kV power grid indicated in the WAC 3189.

Since the 69 kV line was outside the limits of the ZPA established by the PBZPA, it was not characterized as an obstacle that could have an adverse effect on the safety or regularity of the air operations at the Aerodrome, not being eligible for publication of information concerning the SNCT Aerodrome.

Although not included in the specific information of the SNCT Aerodrome, the 69 kV power grid on which the PT-ONJ aircraft collided was presented in the WAC 3189 and the CAP 9453 (Figures 11 and 12).

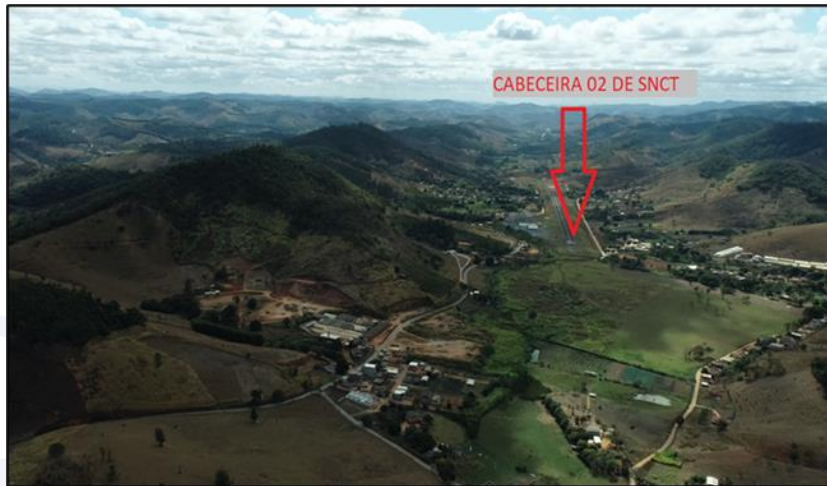
Figure 13 - Relief around the Caratinga Aerodrome observed from the approach sector to threshold 02.

The Aerodrome was located in a mountainous region, with several elevations in the vicinity of the runway.

According to reports from local operators, given the topographic characteristics of the Aerodrome and region, it was common for calm winds to prevail, aligned with the runway.

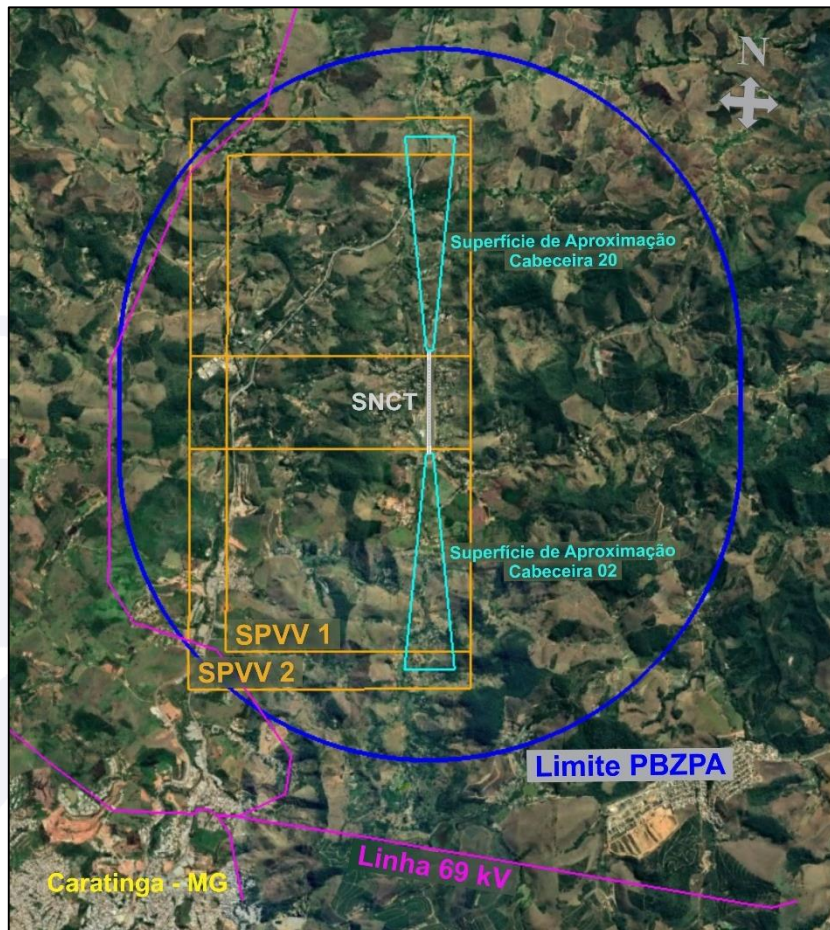
Figure 16 - Representation of the PBZPA at the Caratinga Aerodrome.

Figure 16 illustrates the limits of the SNCT ZPA in blue, together with the SPVV's 1 and 2 represented by the areas inside the rectangles in orange, and the approach surfaces for thresholds 02 and 20 in cyan.

Regarding the distance from SPVV2 and from the approach surface to runway 02, it was verified that the distance corresponded to 1.5 and 1.4 NM, respectively.

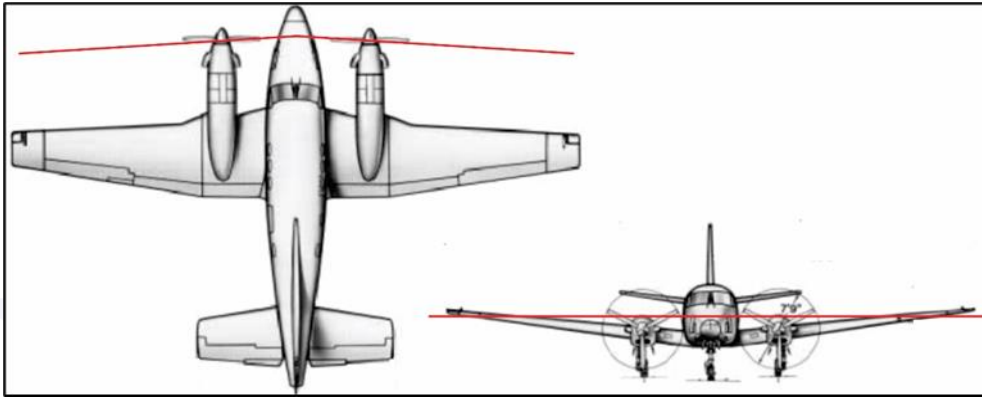
Figure 39 - Illustration of the cable's contact points on the aircraft (the red line represents the lightning arrester cable).

Considering the marks left by the cable on the spinners and the fuselage, it was verified that the aircraft hit the cable with the upper part of the nose, in a position slightly ahead of the projection of the electronic equipment compartment door. This point was located below the pilots' line of sight (Figure 39).

As illustrated in Figure 39 and based on the damage to the spinners, it is concluded that the aircraft had a bank corresponding to that of leveled wings at the moment of impact.

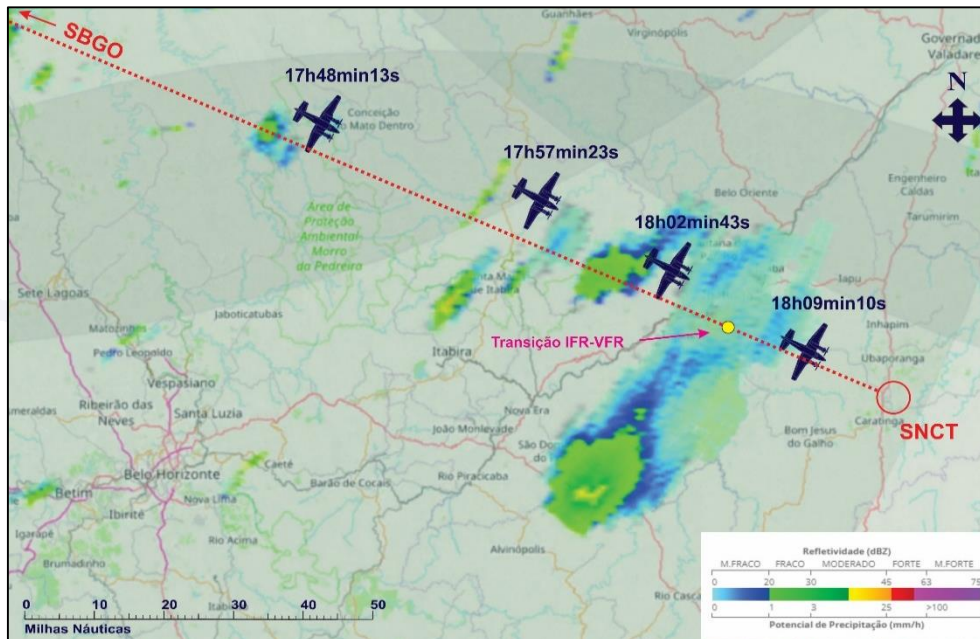
Figure 44 - Route deviation in relation to the areas with precipitation recorded at 18h07min (UTC). The dot indicates the coordinates recorded in the flight plan for the change of rules from IFR to VFR (\*aircraft out of range).

According to the RADAR revisualization, synchronized with the Meteorological RADAR data of 18h07min (UTC), it was observed that the aircraft made deviations of up to 6 NM to avoid areas with low precipitation (Figure 44).

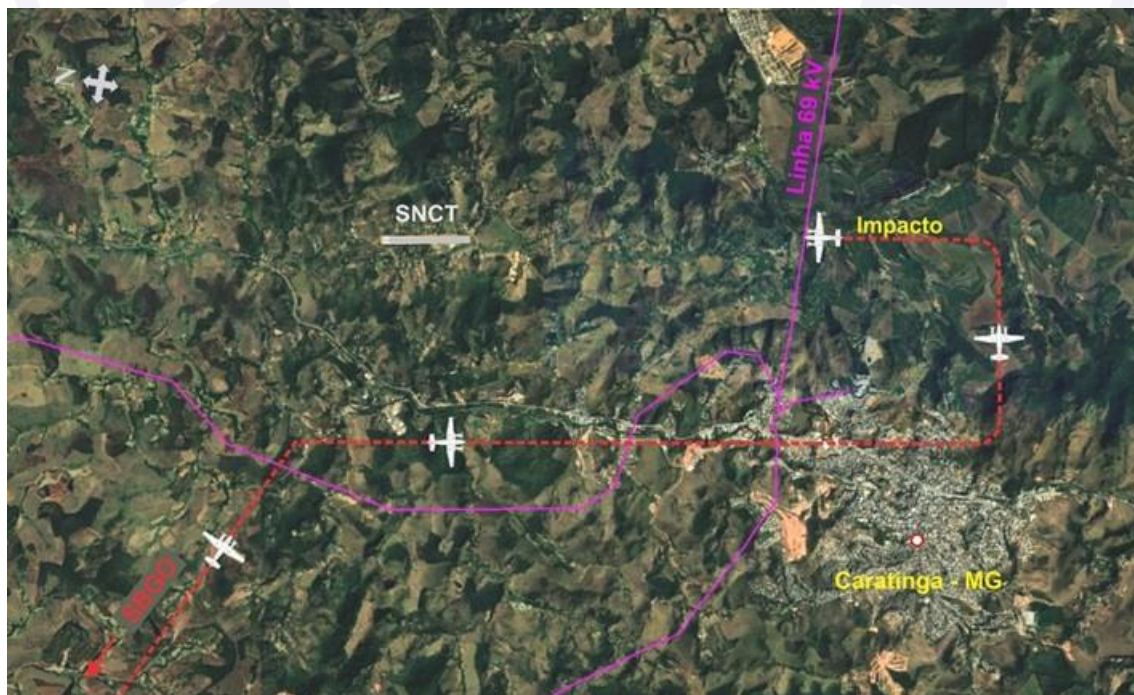
Figure 47 - Estimated trajectory until the impact (aircraft out of range).

Based on the information corresponding to the last RADAR contact; the approach sector concerning SNCT; reports from crewmembers who contacted the aircraft in flight; ground observers who saw PT-ONJ in the traffic circle; and the aircraft impact point, the Investigation Team considered that the PT-ONJ followed a trajectory as estimated in Figure 47.

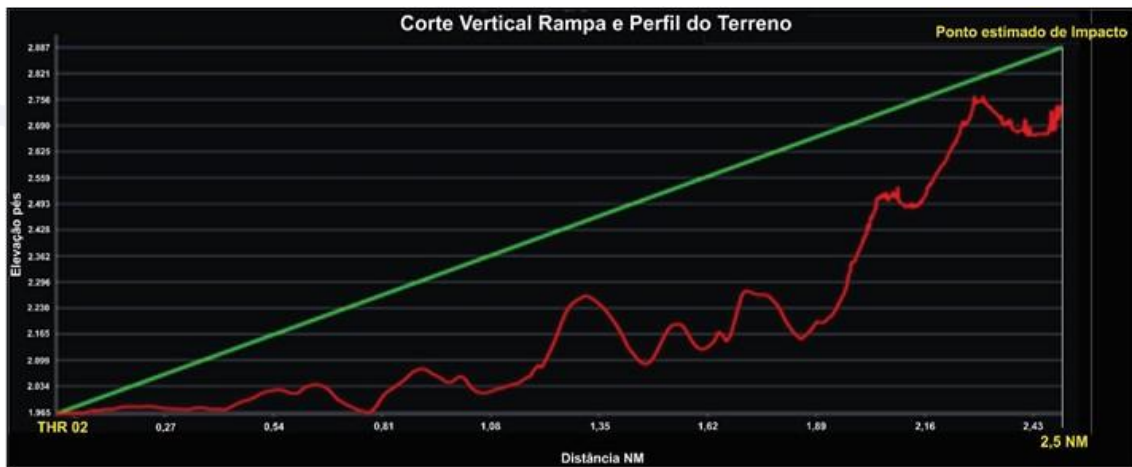
Figure 48 - Vertical section of the terrain and the projected assumed ramp between the estimated point of impact and threshold 02 (THR02).

The collision with the power grid lightning arrester occurred aligned with the SNCT runway extension, at a distance of 2.5 NM from the threshold 02 and at a height of 920 ft. relative to the runway. At that point, the aircraft was at a height of about 115 ft. from the ground and with a 3.46° ramp relative to threshold 02 (Figure 48).

Considering the standard traffic predicted in the operator's PTO, for a downwind leg performed at a speed of 120 kt, the clearance to the start of the base leg frame would correspond to 1 NM. Since the impact against the cables was within 2.5 NM of the threshold, it was found that there was clearance on the downwind leg at a distance exceeding 1.5 NM of that predicted in the operator's program.

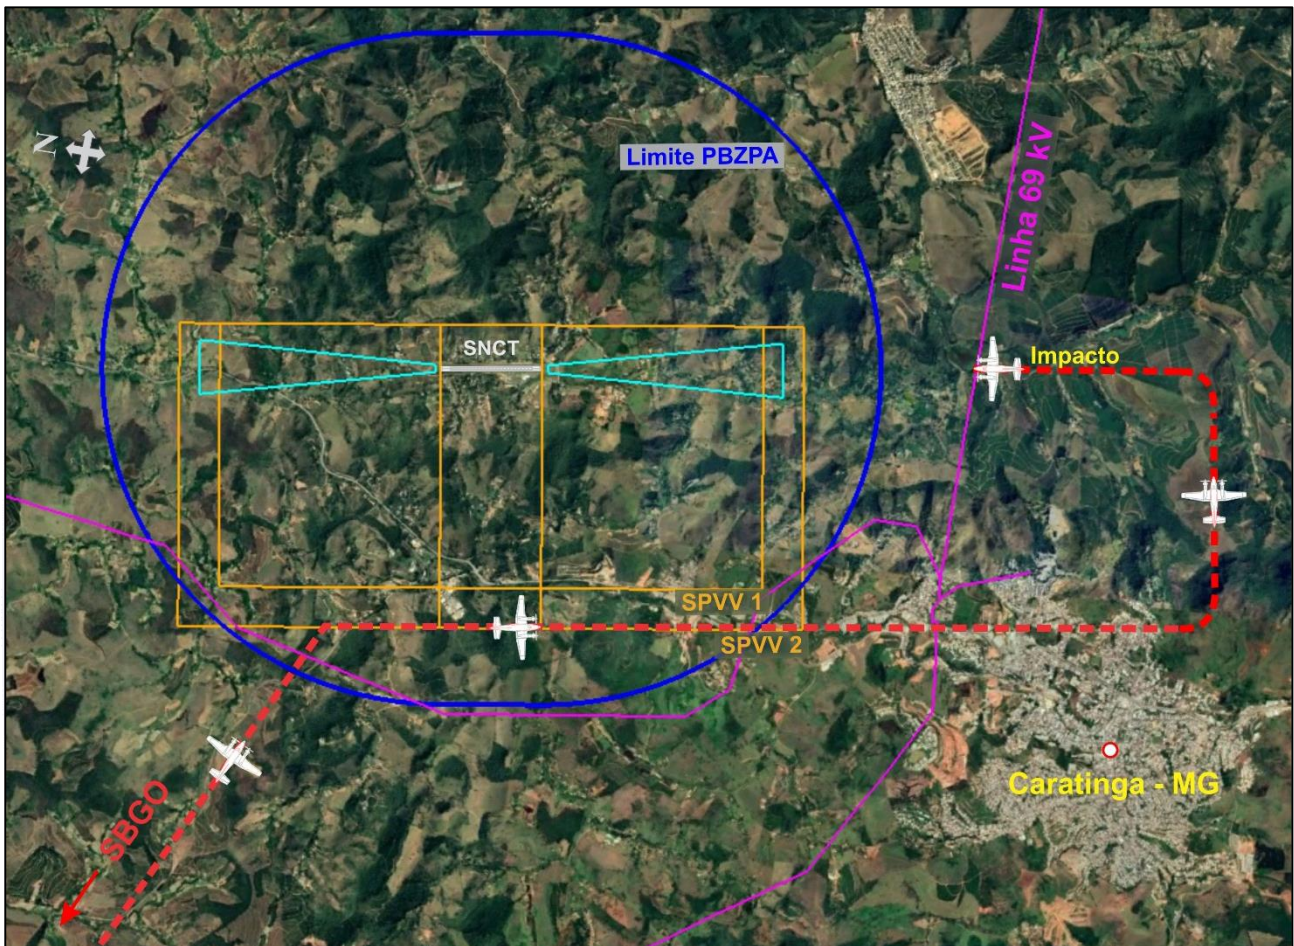
Considering the marks left by the cable on the spinner and fuselage, it was found that the aircraft hit the cable with the top of its nose and was wing-leveled at the time of impact.

Based on the aircraft configuration, banking, and the aircraft position relative to the runway axis, it is inferred that, at the time of the collision, the crew was seeking to fit into a final approach that was longer than the normal pattern for a C90A aircraft (Figure 49).

Figure 1 – Estimated Trajectory of the PT-ONJ in relation to SPVV and the point of impact against the 69 kV power grid.

The collision with the lightning arrester cable resulted in traction forces that pulled out the left engine from its attachment, still in flight, and caused the total loss of control of the aircraft.
