ATSB TRANSPORT SAFETY REPORT
Occurrence Investigation Report AO-2007-001
Final

Microburst event
Sydney Airport, NSW
15 April 2007
VH-OJR
Boeing Company 747-438

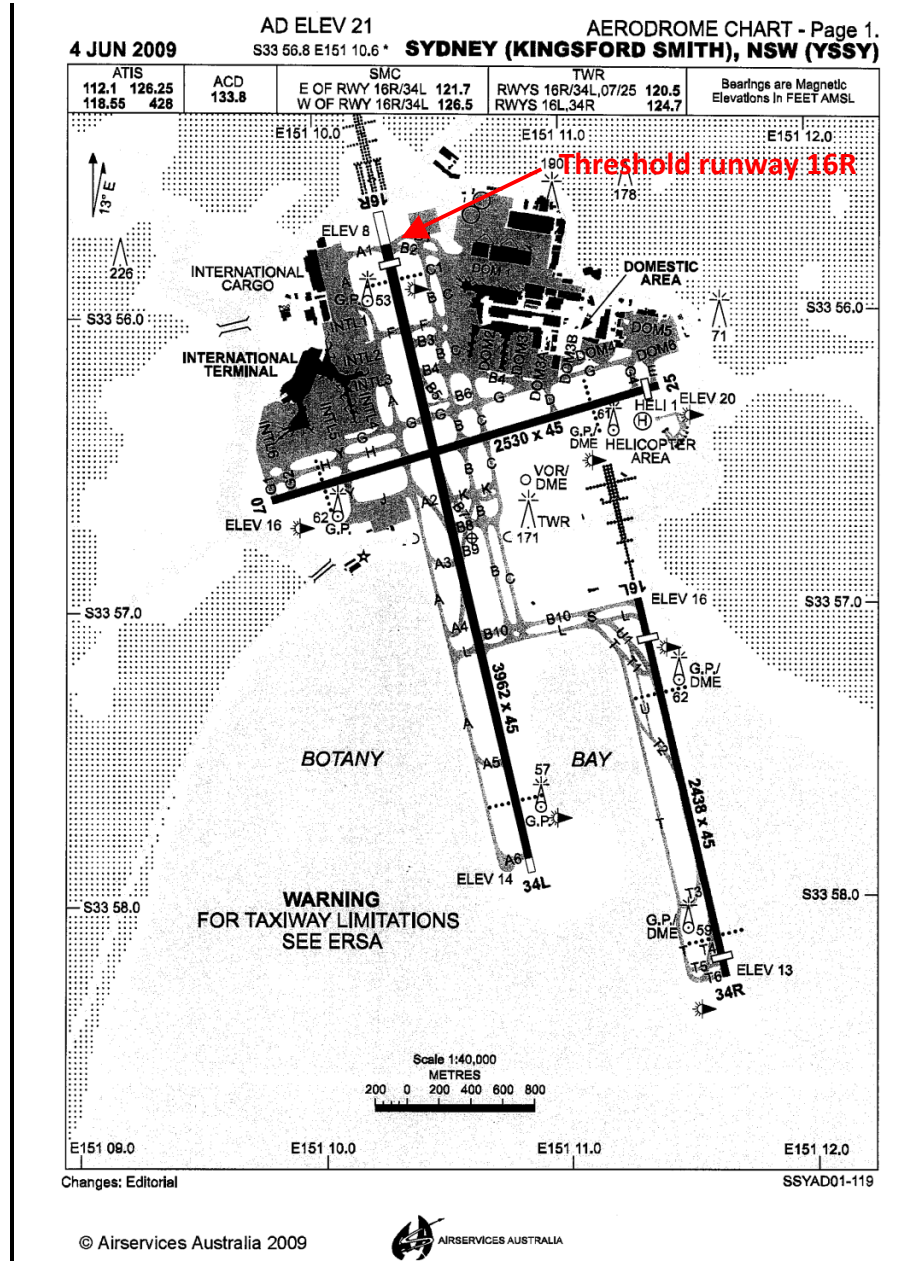
Figure 1: Sydney Aerodrome Chart

The layout of Sydney Airport is shown at Figure 1. Anemometers were positioned adjacent to the threshold of each runway. Wind direction and speed information from those anemometers was displayed in the air traffic control tower console. The information was also recorded.

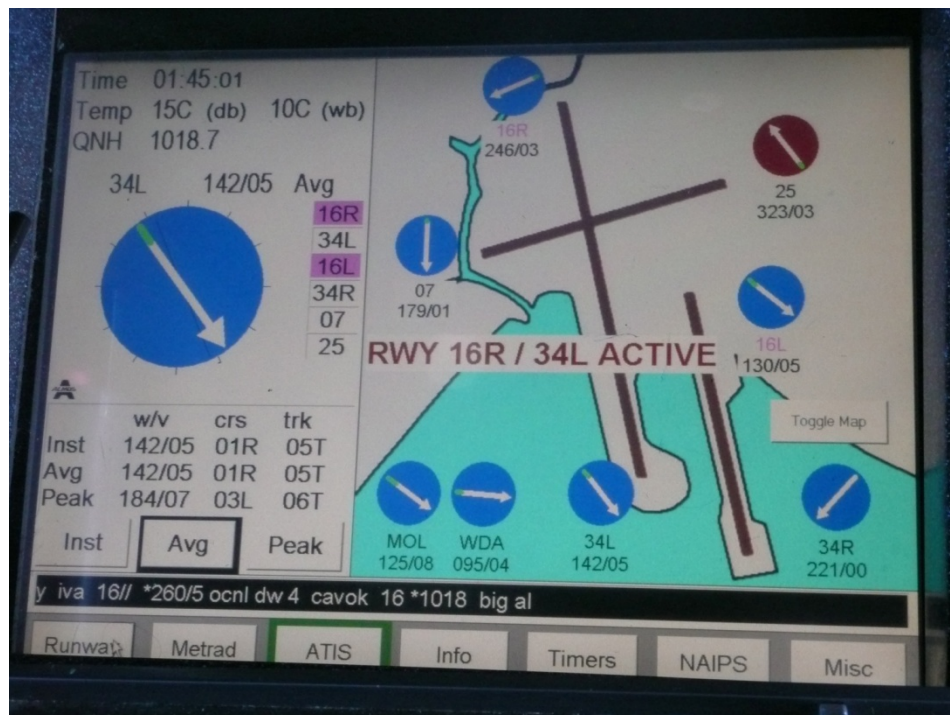
Figure 2: Sydney Control Tower surface wind display

The equipment in Sydney Control Tower included a surface wind display that provided airport wind information. A photograph of the screen taken during normal airport operations is shown at Figure 2. The display included:

The wind information could be selected as either **Inst** (instantaneous – the average wind over the previous 3 seconds), **Avg** (the average wind over the previous 2 minutes) or **Peak** (the peak wind over the previous 10 minutes). The red background colour of the runway 25 sensor indicated that a warning condition applied to that sensor.

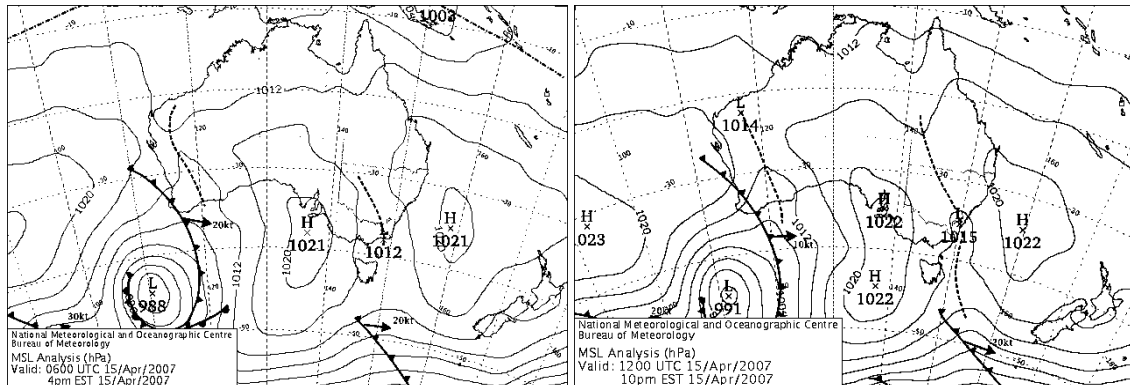
On 15 April 2007, a trough of low-pressure was approaching Sydney from the west (see Figure 1.1). The trough lay in a southeast to northwest orientation, across NSW, and extended beyond its southern and northern borders, and marked the convergent region in-between two high-pressure systems: one centred over the Tasman Sea, and the other, to the west, near Adelaide. The trough's motion was from west towards east – not uncommon for broad-scale weather patterns.

Figure 1.1 Synoptic weather charts show a trough lying across NSW, and its eastward progression between 06Z and 12Z on 15 April 2007.

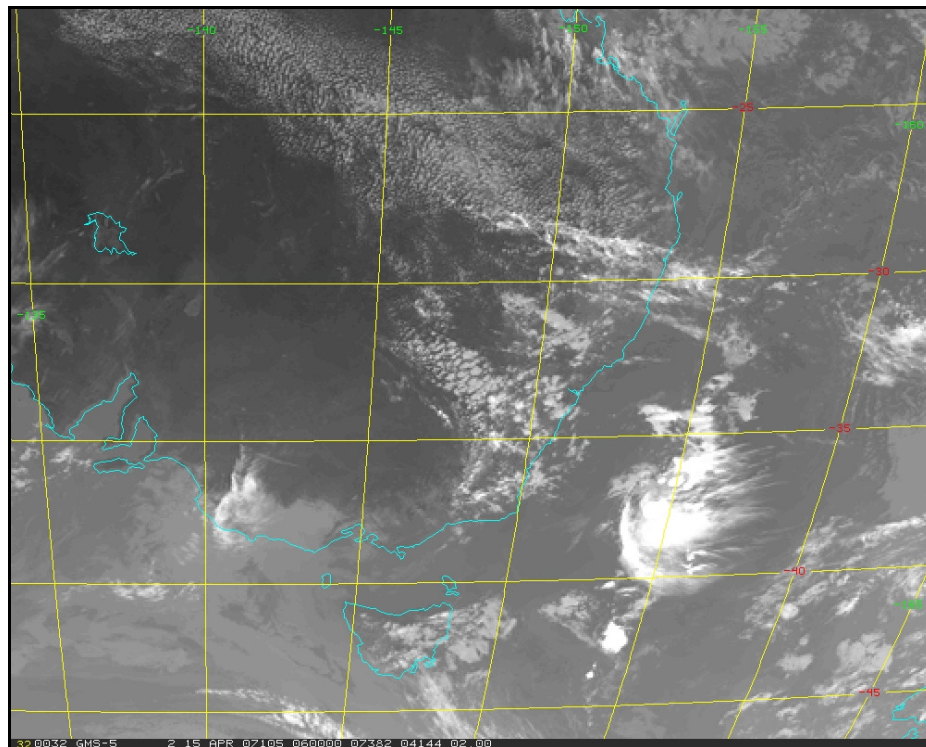
When the trough eventually passed through Sydney, early the next morning, it brought a southerly wind change. During the period before the change, when the high in the Tasman Sea generated northeast winds and the trough was still west of Sydney (on the afternoon and early evening on 15 April), a scattered field of clouds developed across NSW in the zone ahead of the approaching trough (see Figure 1.2).

Figure 1.2 Satellite image shows convective clouds (speckled grey and white) east of the trough position, at 06Z on 15 April 2007 (Satellite image originally processed by the Bureau of Meteorology from the geostationary satellite MTSAT-1R operated by the Japan Meteorological Agency).

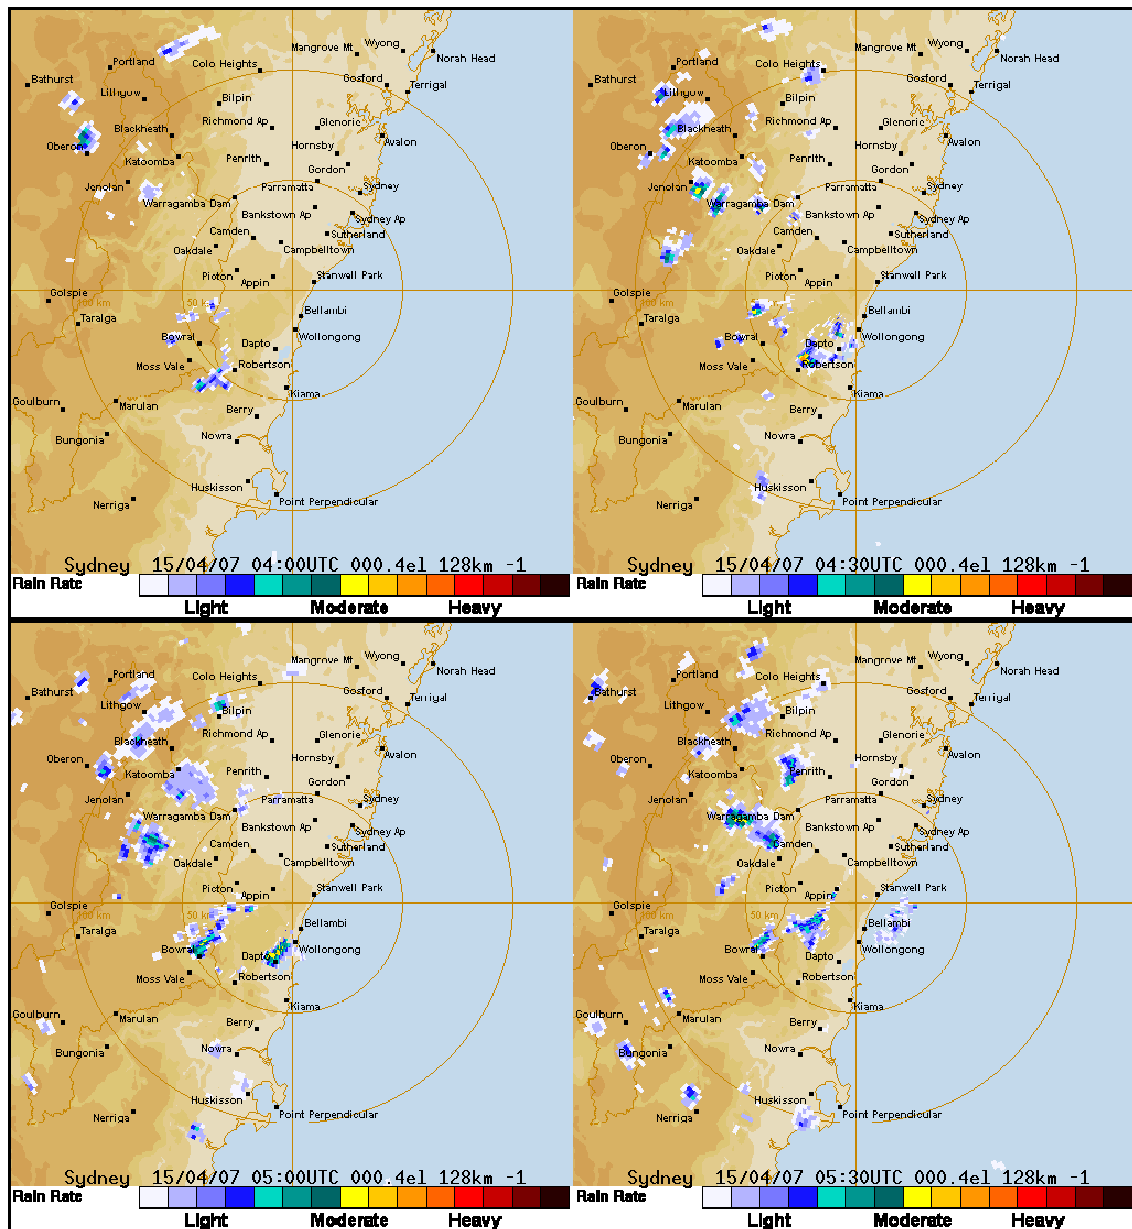
While the sky above the Airport remained mostly free from cloud during the afternoon, cumulus clouds built up in the regions surrounding the Sydney Basin – to the north, west and south – where the low-level inversion was weaker, or non-existent, and failed to trap convection. High-based showers, and isolated thunderstorms, were generated inland and were driven towards the coast at a rate of about 20 knots by the winds above 10000 feet in the atmosphere, which were blowing from the west or southwest. At first, the showers and thunderstorms that approached the coast dissipated over the Sydney Basin as the convective cells were inhibited by the low-level inversion near the coast (see Figure 2.2).

Figure 2.2 Radar images show showers and thunderstorms over elevated terrain between 0400Z and 0530Z, with little or no development over the Sydney Basin.

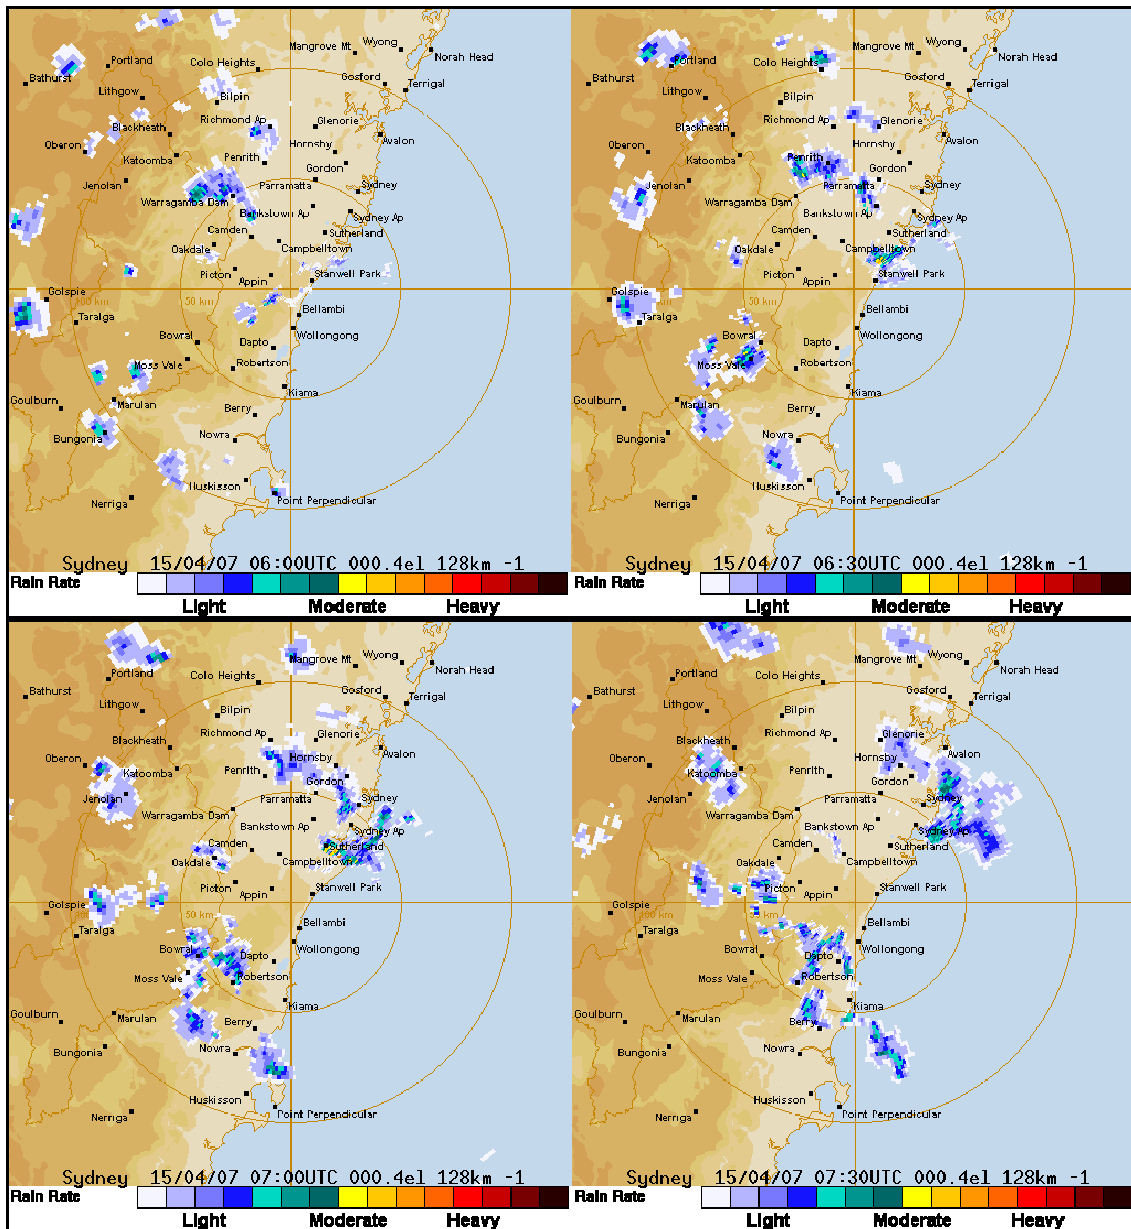
But later, after 06Z, some showers and thunderstorms, which developed to the west of Sydney, continued moving east over the Sydney Basin without dissipating as they moved closer to the coast (see Figure 2.3).

Figure 2.3 Radar images show showers and thunderstorms drifting over the Sydney Basin from west to east between 0600Z and 0730Z.

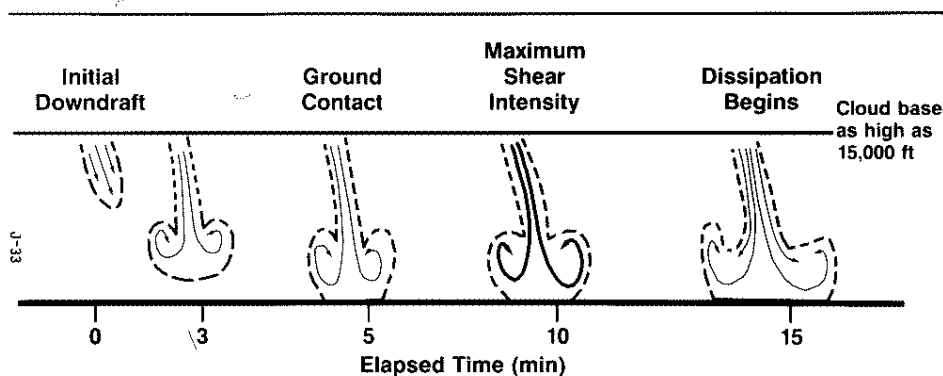
- Microburst winds intensify for about 5 min after ground contact
- Most microbursts typically dissipate about 10 to 20 min after ground contact

Figure 3. Evolution of typical microburst. (Adapted from Wilson et al 1984)

convective downdraft as a microburst when the distance between the maximum radial outflow regions in the initial stages is $\leq 4\text{km}$ and the velocity differential is $\geq 10\text{ m/s}$ (20 kt). They described the evolution of a typical microburst as illustrated in Fig.3 and found the lifetime of a microburst is of the order of 5-15 minutes. A further finding was that in many cases there may be little or no rain at the surface associated with a microburst.

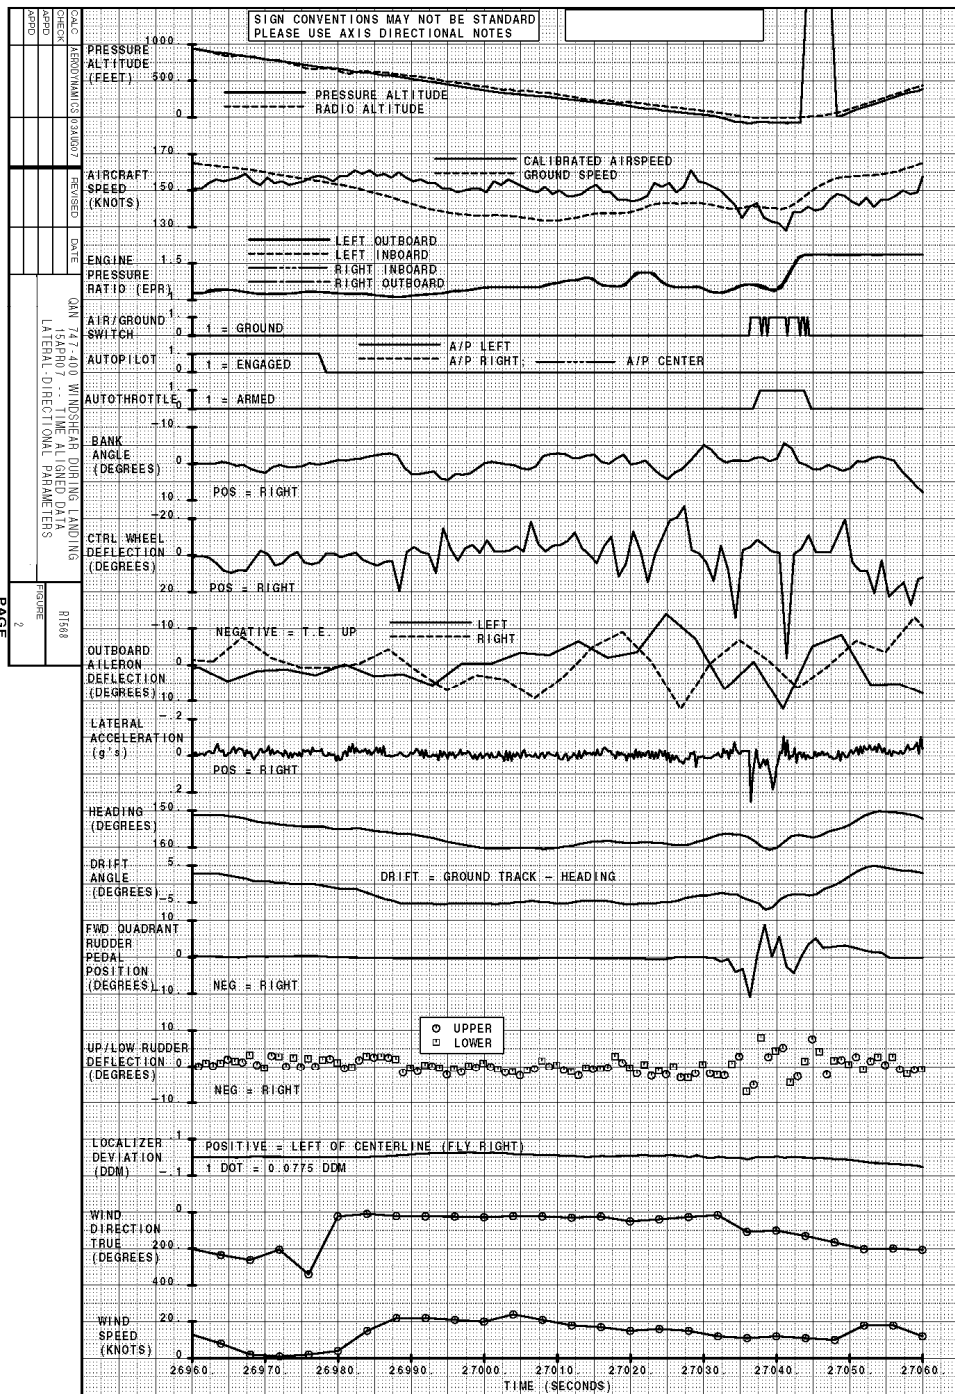
CHECKED: []
 DATE: []
 REVISIONS: []
 DATE: []
 LONGITUDINAL PARAMETERS
 QAN 747-400 W/ NOISEAR DURING LANDING
 15APR07 -- TIME ALIGNED DATA
 FIGURE 1
 R1808

The FDR data for the event landing are plotted on Figures 1 through 4. Figures 1 and 2 show the longitudinal and lateral-directional parameters respectively for the approach and touchdown. Figures 3 and 4 show the longitudinal and lateral-directional parameters respectively for the aircraft right before and during touchdown. Figure 4 includes kinematically calculated winds and vertical speed. Parameter sign conventions were validated using previous on-ground and in-flight maneuvers available in the data.
