Preliminary Observations on the Niigata-Chuetsu Oki, Japan, Earthquake of July 16, 2007

EERI-GEER Web Report 2007-1 v.8
October 9, 2007

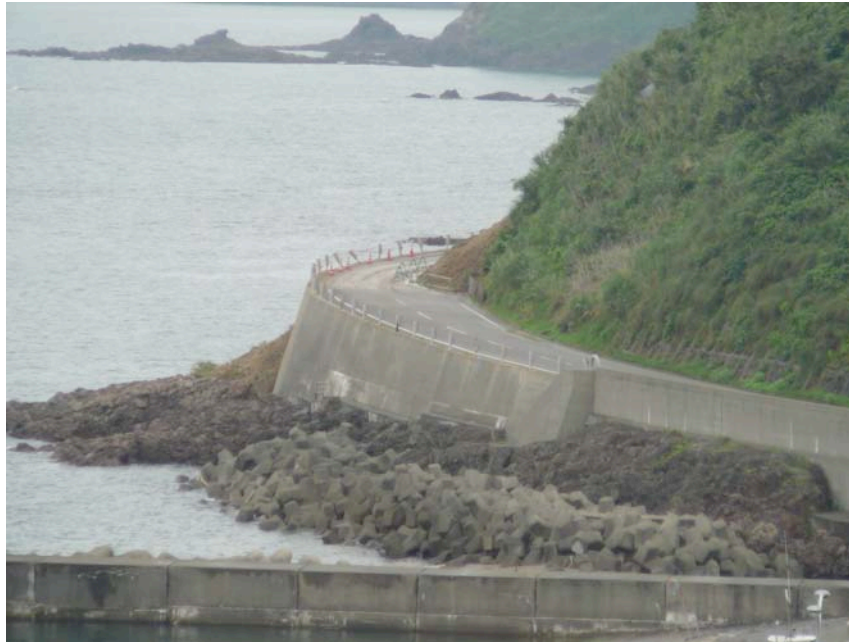
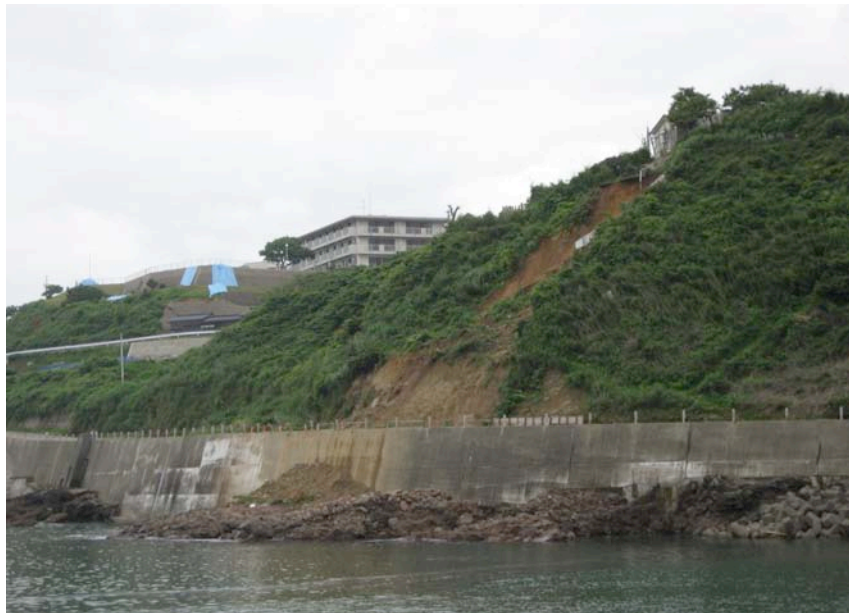
Figure 3.1: Shallow colluvial landslide located just north of the Kasashima Fishing Village, Site RK22/SA10; N37.33802° E138.46995°, photos taken 7/20/07 15:57 (top) and 7/21/07 13:35 (bottom). Dimensions are approximately 36 m wide, 24 m tall, 2 m thick. The lithology is composed of 24 m of weak mudstone overlying 6 m of more indurated, brecciated mudstone, which outcrops at the road. A 10 m tall concrete seawall leads down to the brecciated mudstone shore platform. The slide occurred in weak mudstone/colluvium, sliding over the brecciated mudstone, onto the road, and over the edge of the concrete seawall, spilling debris onto the shore platform at oceans edge.

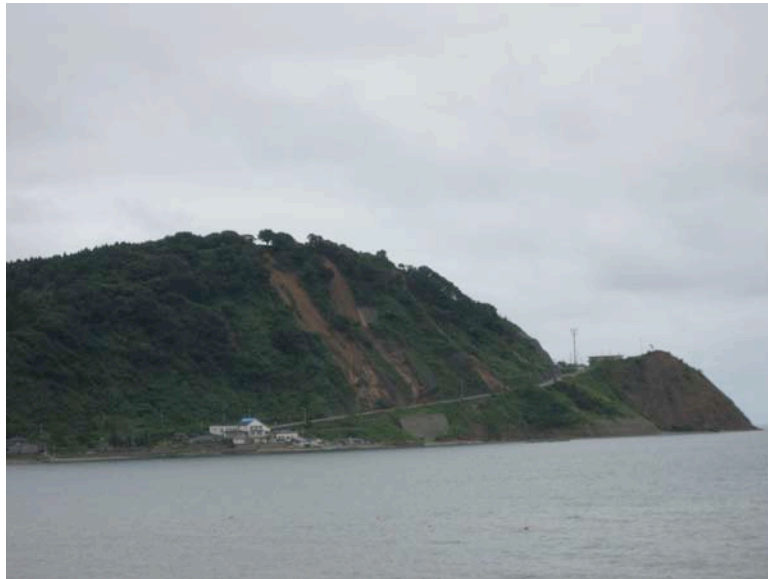
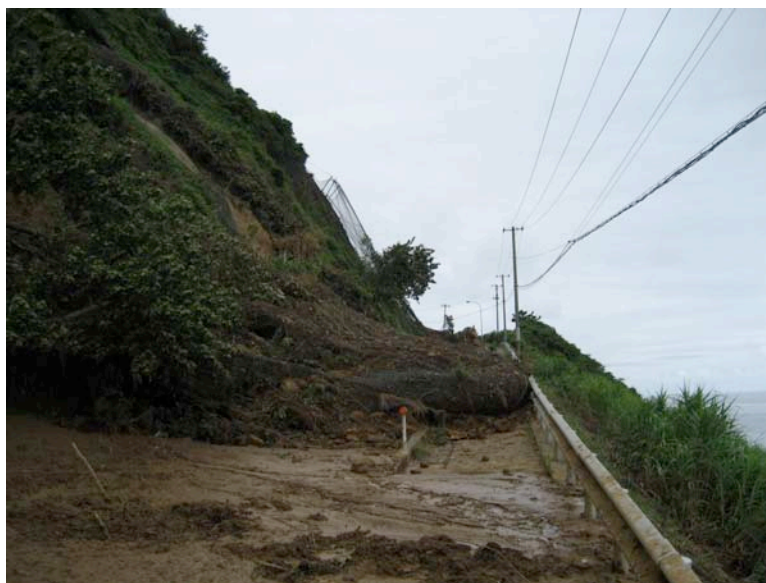
Figure 3.2: Coastal landslides on Highway 352 north of Kashiwazaki-Kariwa Nuclear Power Plant at road closure south of Route 373 (Site RK34; N37.48455° E138.62435°, photos taken 7/22/07 at approx. 10:45). This area consisted of at least eight individual slides. The landslide shown in the bottom photo consists of a slide in an area of previous instability - a shotcrete stabilization system is in effect for the bottom 50 m of this slope (total slope height is ~115 m), and overlain with a wire-mesh rock deflection system. The slide is approximately 50 to 60 m wide, 65 m long, and less than 1 meter thick. The landslide initiated above the shotcrete slope, moved into the wire-mesh and caused failure of the meshing and pull-out of the steel supports. The wire-mesh restrained most of debris, depositing the majority on the road, with only a slight quantity of the debris sliding over the road edge. The failure plane inclination is approximately 60°.

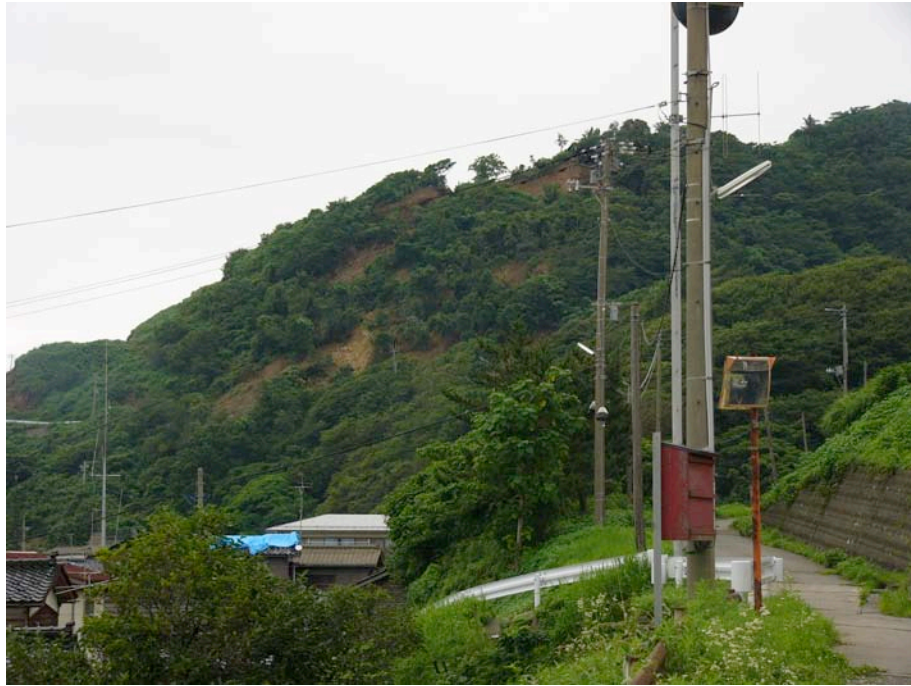
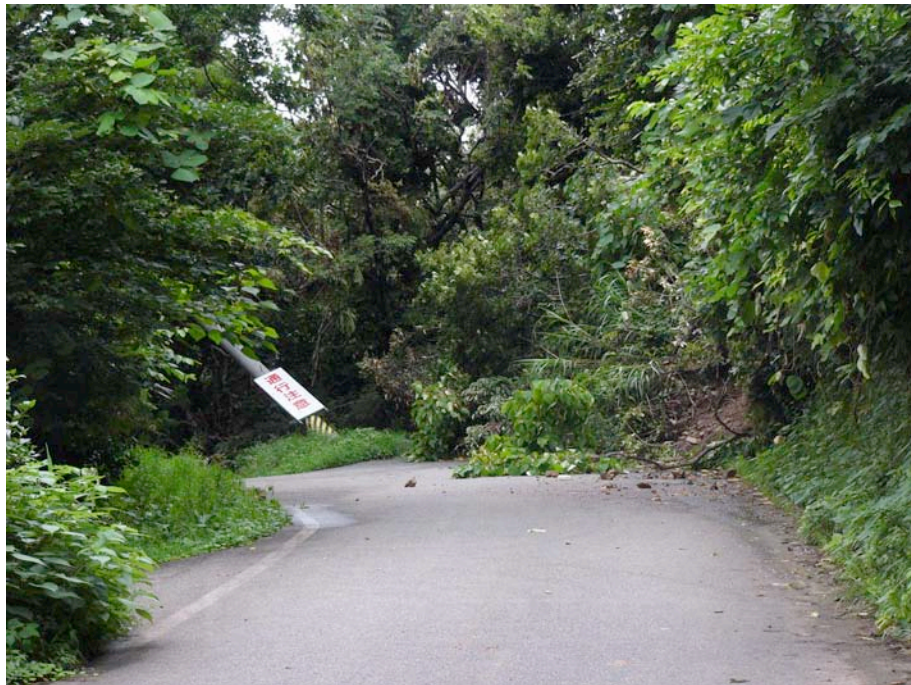
Figure 3.4: Yoneyama Landslide, located south of Kashiwazaki (Site YT17; N37.32223° E138.43828°, photos taken 7/21/07 at approximately 15:20). This slide marked the southwest-most limit of observed landslides along the Sea of Japan coast. The slide extended to the full height of the slope and blocked a paved coastal access road.

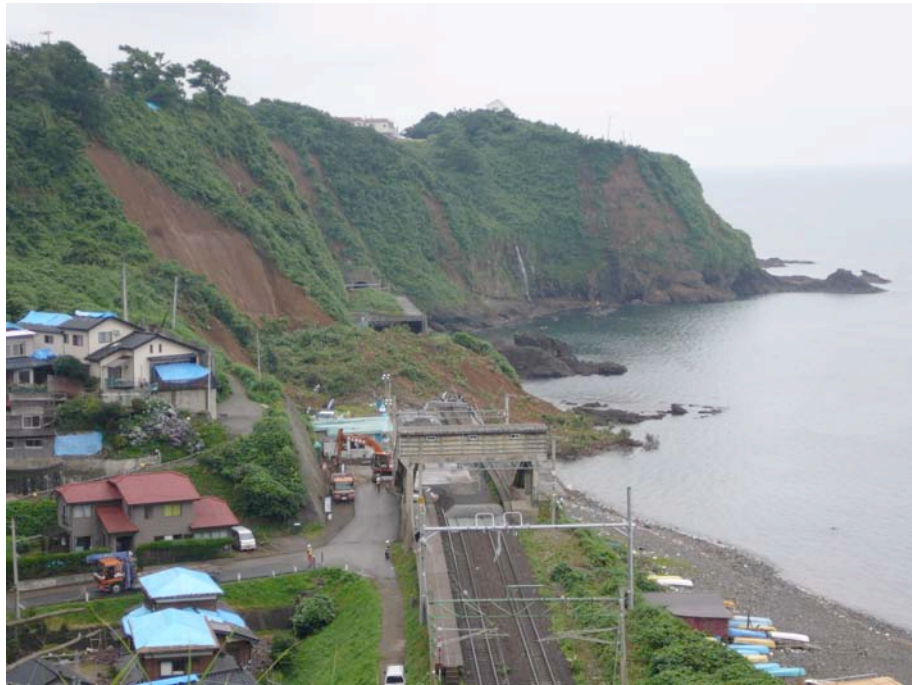
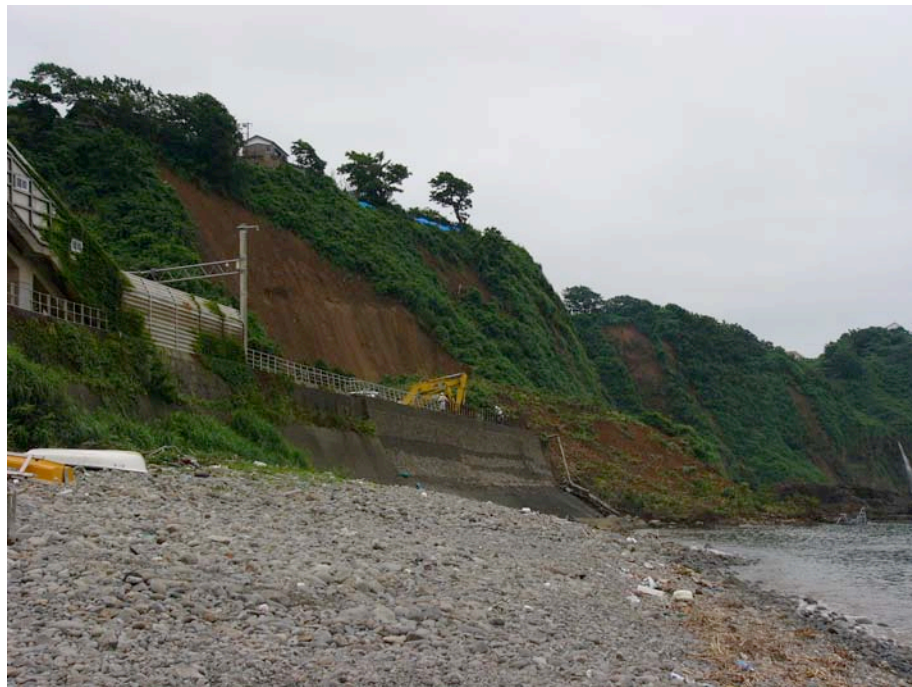
Figure 3.5: Landslide at the Oumigawa Train Station on the Shin-etsu Line (Site RK20/SA9/YT16; N37.34200° E138.48888°, photos taken 7/21/07 12:48 (top) and 7/24/07 15:00 (bottom)). This was among the larger of the coastal landslides to the south of Kashiwazaki. Site access was not possible due to construction repairs. Note that slope stability in this area has been a problem, as seen by the railway tunnel protection structure immediately behind (to the south) of this landslide. Many more smaller landslides were observed to the north and south of this location.

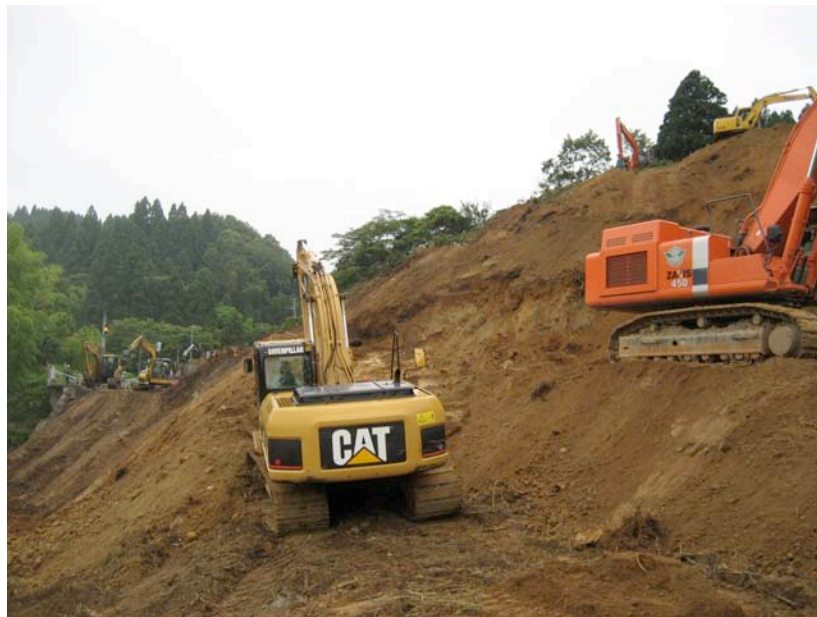
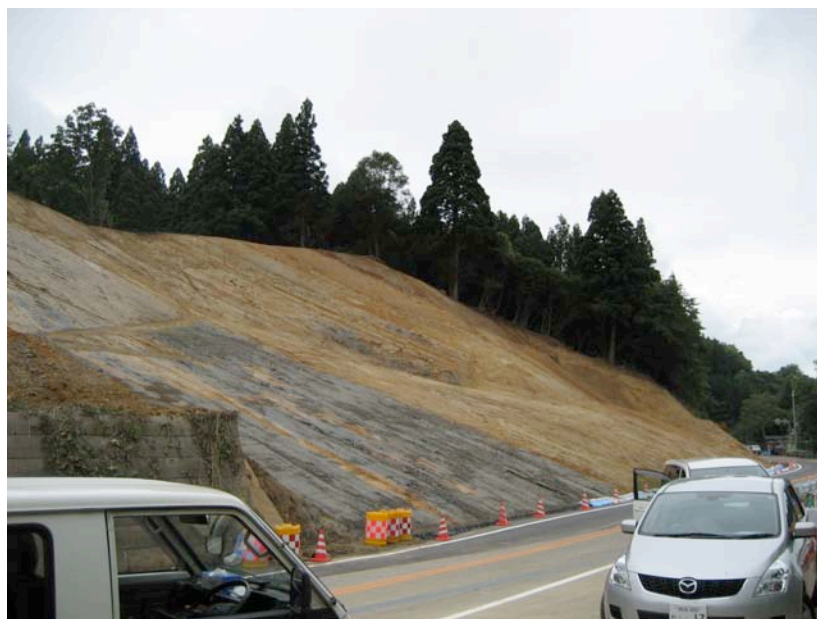
A large, deep, rotational slide occurred in weak mudstones and colluvial materials fairly far (~10 km) inland from the coast. The Ozumi Senbon landslide (Fig. 3.6) consisted of approximately $150,000 \text{ m}^3$ of total displaced material and led to destruction of a large road section on Route 8. According to on-site construction personnel, the slide plane was located at a depth ranging between 6 and 11 meters. Nearby to this site, several debris slumps/colluvial slides were also observed, however these required only

Figure 3.6: Ozumi Senbon Landslide at Highway 8 north of intersection with Route 252 (Site RK1/YT1; N37.41422° E138.71347°, photos taken 7/20/07 10:24 (top) and 7/23/07 13:04 (bottom)). This slide is approximately 150 meter wide, 100 meters long and 10 meters deep. According to construction personnel at the site during the reconnaissance, the slide plane occurred near the colluvial/bedrock interface, at a depth of between 6 and 11 meters. Signs of rotational movement were noted from back-rotated guardrails at the toe of the slide. This landslide forced closure of both lanes of traffic along Highway 8, just north of the intersection with Route 252, however both lanes had been reopened as early as 8 days following of the earthquake when reconnaissance team members revisited the site. Bottom photo shows excavated slide and subsurface bedrock lithology and structure.

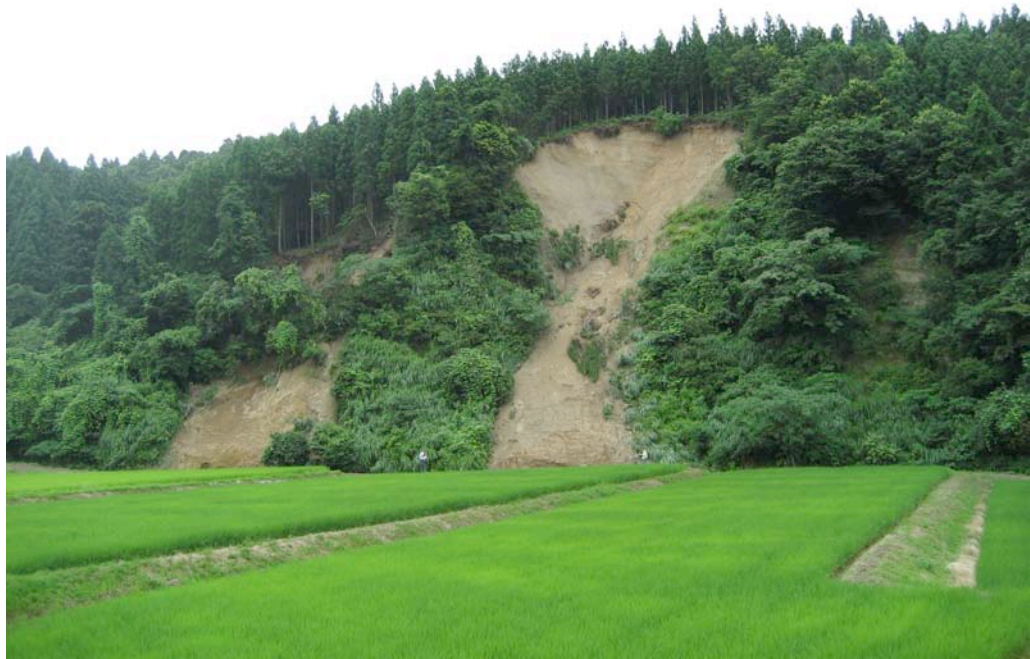
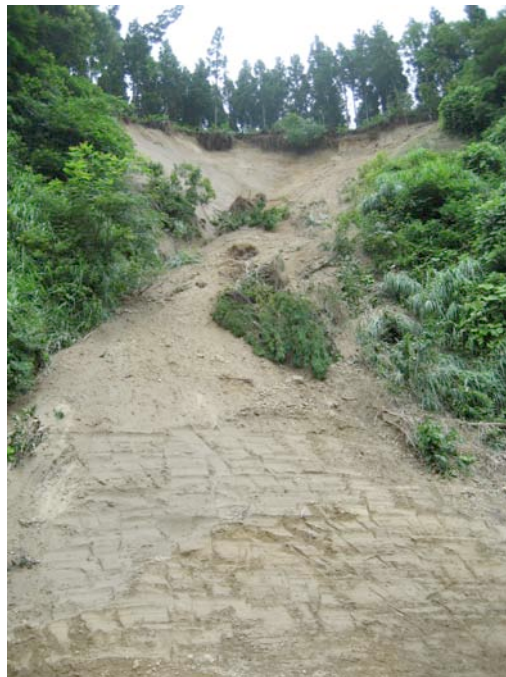
minimal grading efforts and maintenance to keep channels open for rice farming irrigation (Fig. 3.7).

Figure 3.7: Ozumi-Mishimayamachi Landslides (Site RK2/YT2; N37.44057° E138.70467°, photos taken 7/20/07 at approximately 11:30). These slides occurred on a native hill slope and consisted of debris slumps in mudstone/siltstones and colluvium materials. High-resolution, topographic data was collected of these landslides using the terrestrial LiDAR scanning method.

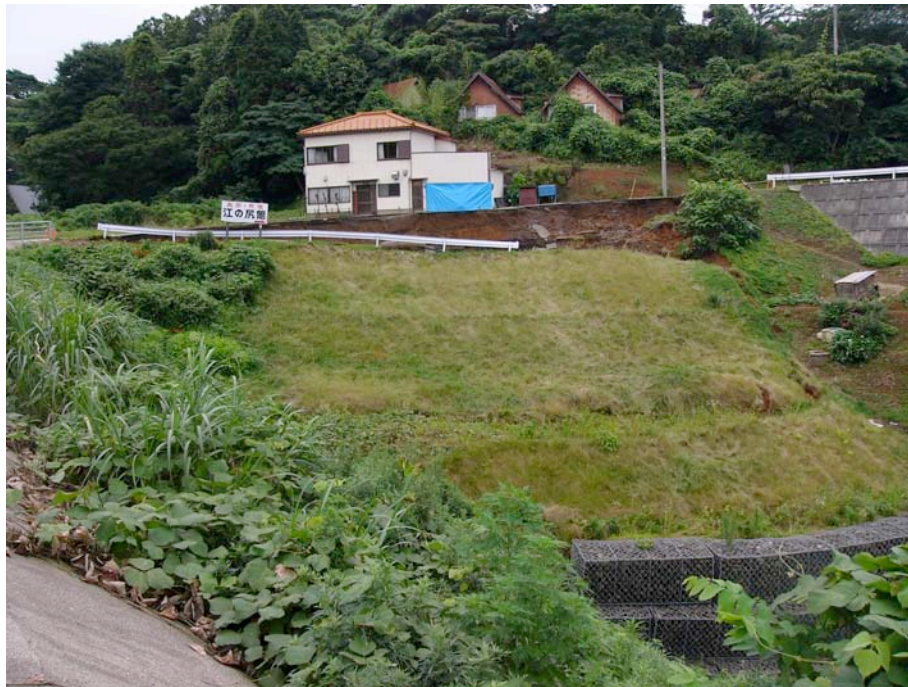
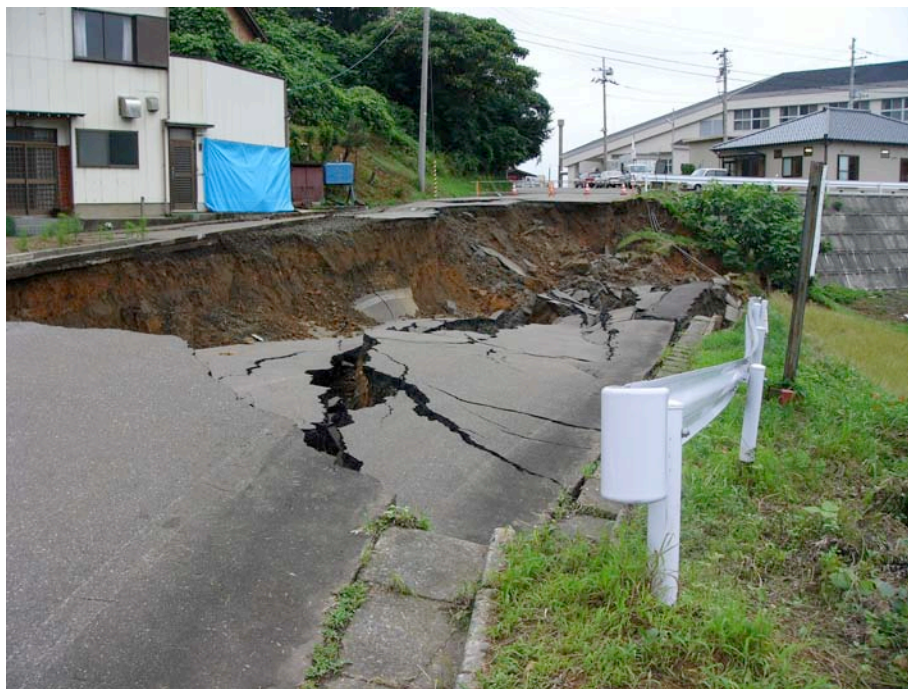
Embankment failures were typical in road fills along the coast (Fig. 3.8), and were also observed at three sites located further inland (e.g. Figs. 3.9 - 3.10). Embankments underwent from 10 cm up to one meter of vertical displacement (Fig. 3.8), extending between 10 and to 60 meters in length. Three embankment failures required full closures of roads, and/or protection with tarps to reduce rainfall infiltration and the associated potential for additional movement. Among these was a 15-meter high, 97.5-meter wide, earth-fill dam located to the east of the region (Fig. 3.9), where cracking through the midpoint of the crest was observed. However, the dam was not storing water at the time of our visit and the reservoir had not been filled recently. Further, from on-site design documents, it appears that the normal water level is typically 8 meters below the crest of the dam. At a water supply dam located southwest of the city of Kashiwazaki (Fig. 3.10), cracking of the crest was also observed along with minor concrete cracking and spalling on the upstream side. Here, the reservoir water level was within several meters of the dam crest at the time of observation.

Figure 3.8: Road embankment failure off Route 8 on the way to Kasashima (Site YT18; N 37.33325 ° E 138.46500°, photos taken 7/21/07 at approximately 15:40). The slope appears to have undergone previous stabilization using slope grading and gabion baskets to support the toe.

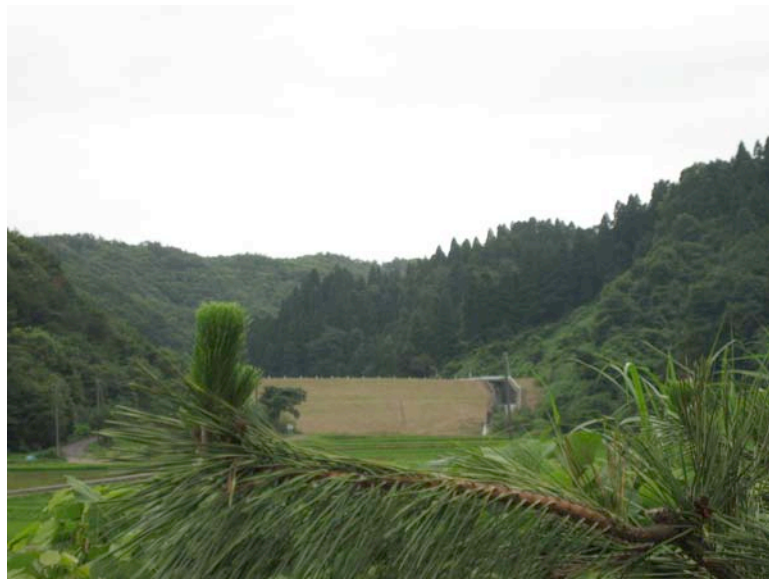
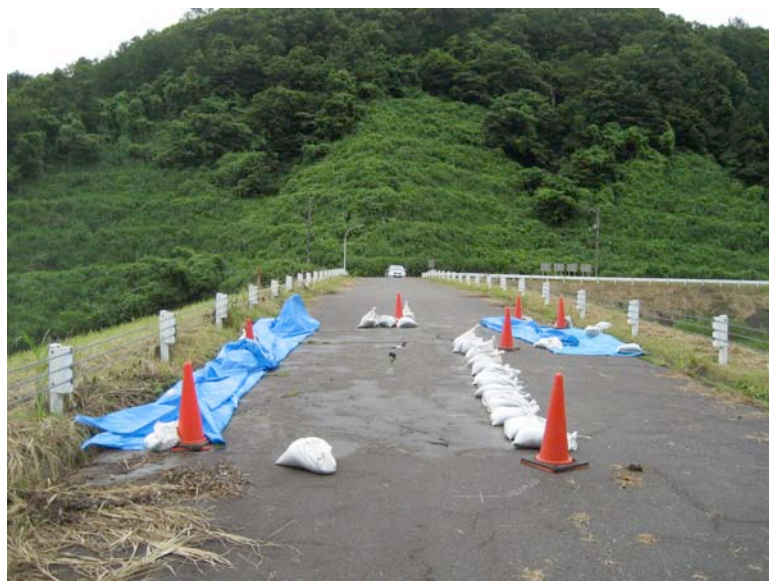
Figure 3.9: Embankment cracking and settlement of South Dam near Miyamo Parking Area along Highway 8, Nagaoka-Shi region (Site RK50; N37.43267° E138.73674°, photos taken 7/23/07 at approximately 11:15). The dam is a 15-meter tall, 97.5-meter wide earth fill structure with 3(H):1(V) downstream and 3.5(H):1(V) upstream benched slopes. Crest elevation is 63 meters and normal pool elevation is 55 meters. Observations were made of an embankment slope failure along the crest of this dam, through half the crest width (~4 m). Settlement and deformation occurred along a 10 m long section with up to 4 cm each of lateral and vertical deformation in the down slope direction. Contour-parallel ground cracking (2-4 cm wide, 1-2 m long) along the ground-spillway interface were also observed, two-thirds of the way down the dam face. The reservoir was empty and appeared to not have been filled in some time judging by the height of vegetation growing in the reservoir area.

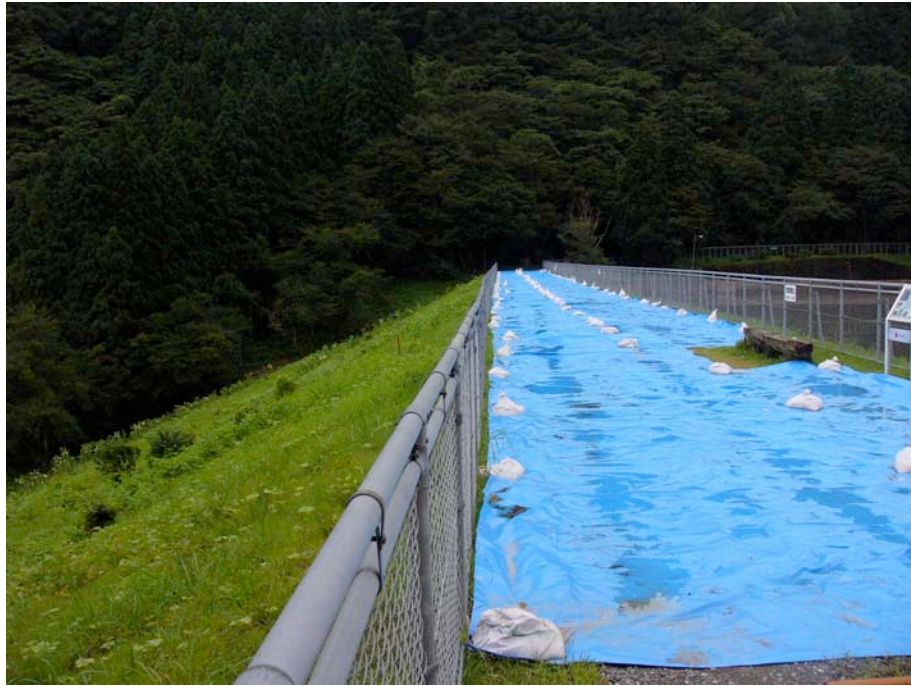
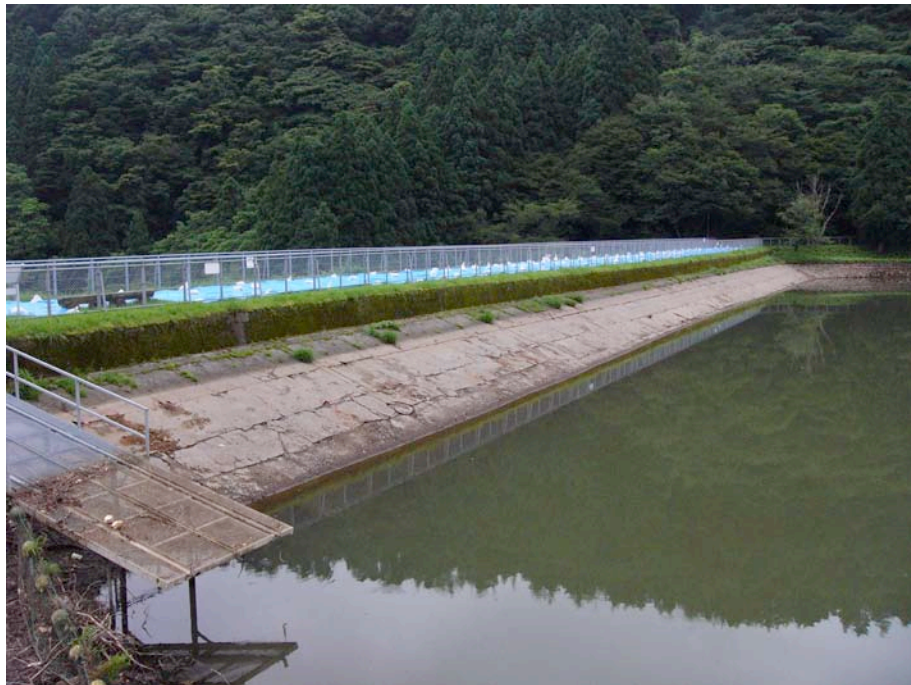
Figure 3.10: Embankment cracking at the crest of Kawauchi Dam, constructed in 1938. (Site YT19; N37.33635° E138.52410°, photos taken 7/21/07 at approximately 16:20).

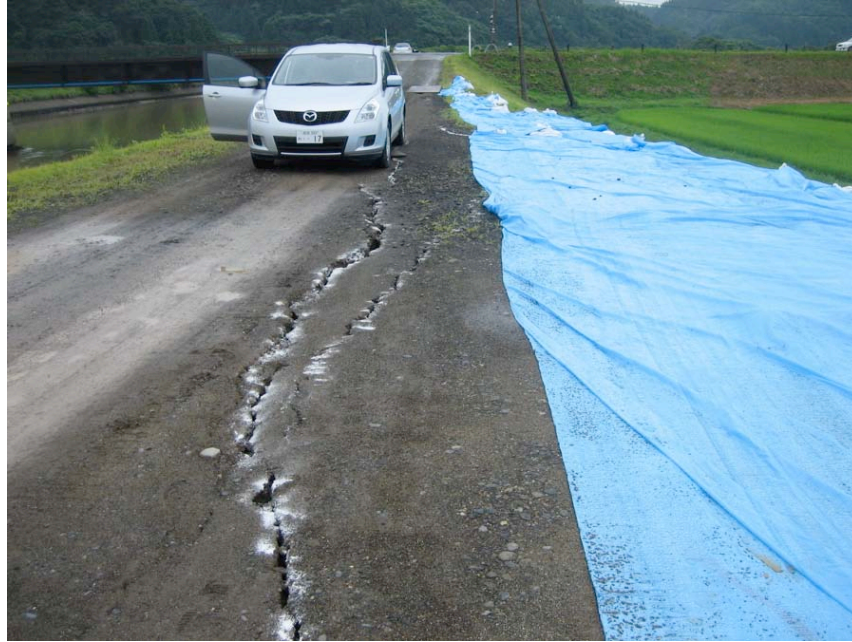
Extensive cracking of levee embankment. Repairs were taking place to the levee/weir intersection with sand bags to support an embankment failure. We observed good performance of the weir, with no signs of damage. The control building suffered damage to the foundation with settlement of fill beneath the structure: 15 cm on downstream side of building at the retaining wall, 30 cm at the building, and 30 cm at the upstream side retaining wall that formed contributory channel. Three to four sets of transverse cracks parallel to the river ran through the embankment fill that the structure was built upon. Liquefaction and lateral spreading with ground cracks were observed upstream of the operations building and the contributory channel to the south.

Figure 4.1: Fujii Weir downstream from Tashiou Bridge crossing of river. (Site RK16; N 37.34875° E 138.61670° , visited 7/21/2007 11:28 am UTZ+8). Extensive cracking of levee embankment.

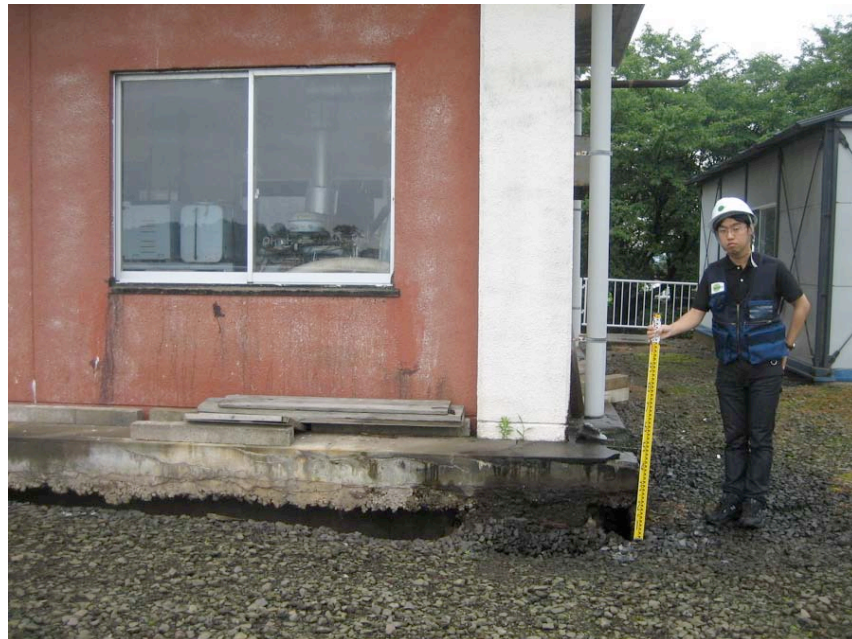
Figure 4.2: Fujii Weir downstream from Tashiou Bridge crossing of river. (Site RK16; N 37.34875° E 138.61670° , visited 7/21/2007 11:28 am UTZ+8). The control building exhibited damage to the foundation with settlement of fill beneath the structure.

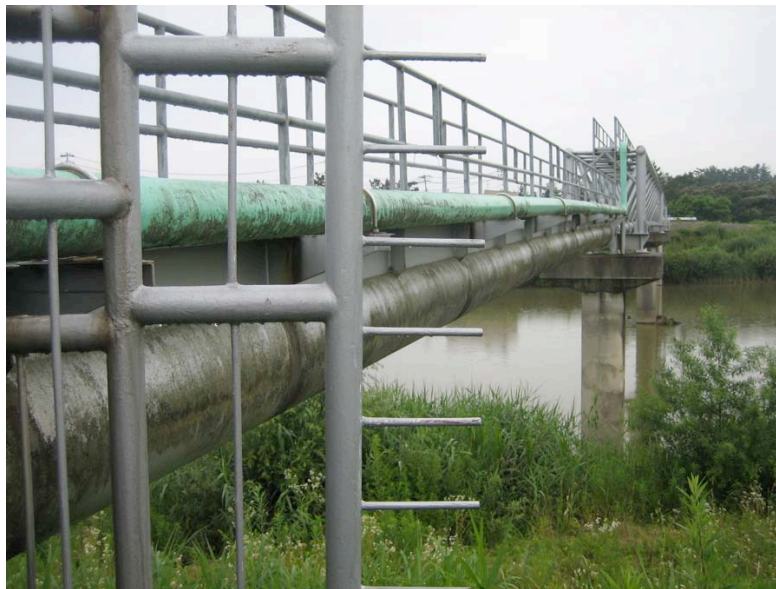
This area experienced liquefaction, lateral spreading, bridge-ground differential settlement, pavement cracking, structural damage, and embankment failure. We observed approximately one meter of ground extension consisting of several 10-20 cm wide cracks (covered by tarps) in a river levee embankment over a distance of 45 meters associated with lateral spreading. Near an adjacent bridge, we measured pipeline rupture and pipe offsets of 13 cm in the horizontal direction, 10 cm in the vertical direction, and with 40 cm of associated nearby settlement between the pipeline and the ground. In a nearby house to the south, extensive signs of liquefaction were observed with sand boils, uplifted manholes, and large-scale ground cracking. A nearby home had been red-tagged due to distortions that appeared to line up with ground cracks.

Figure 4.3: Kai-Un Bridge over Sabaishi River (Site RK4 N37.39233°,E 138.58063°, 7/19/2007, 1:40 p.m.). A water pipeline rupture was found with pipe offsets of 13 cm in the horizontal direction, 10 cm in the vertical direction, and with 40 cm of associated nearby settlement between the pipeline and the ground.

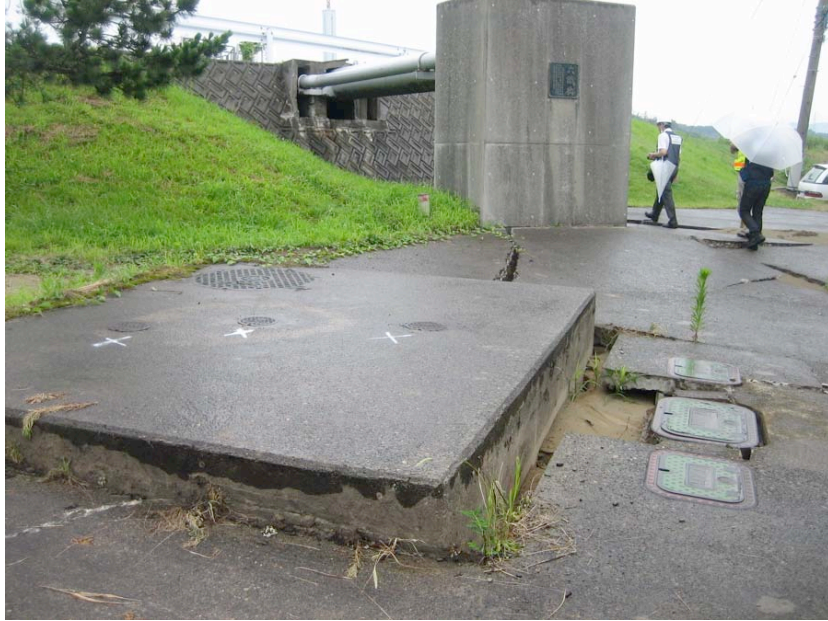
Figure 4.4: Kai-Un Bridge over Sabaishi River (Site N37.39233°, E138.58063°, 7/19/2007, 1:40 p.m.). A water cistern near the pipeline rupture uplifted in liquefied ground.

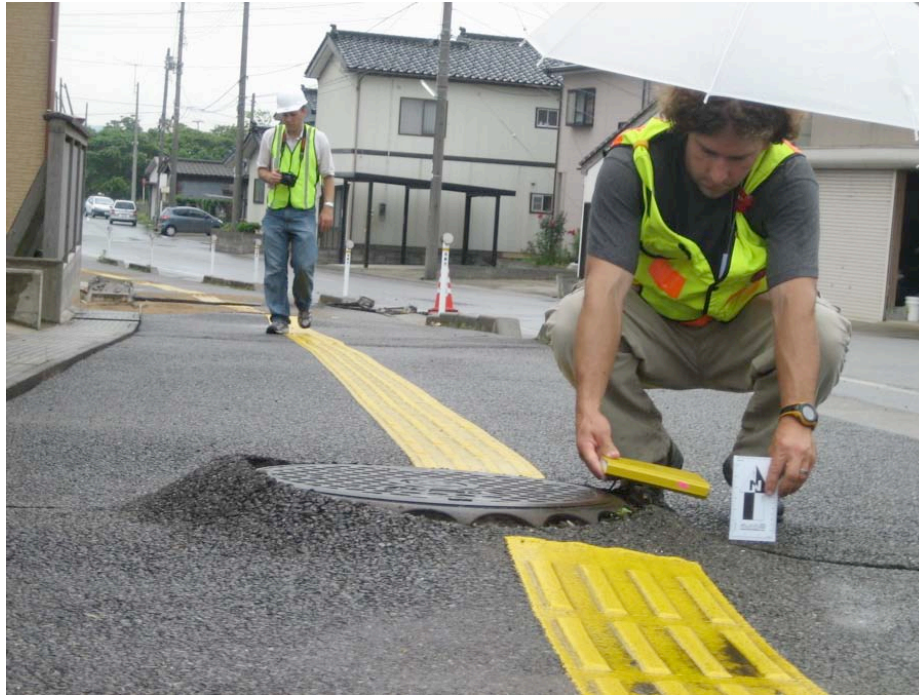
Figure 4.6: Kai-Un Bridge area Sabaishi River (Site RK4 N37.39233° E138.58063°, 7/19/2007, 1:40 p.m.). Numerous manholes on the southeast bank near the Sabaishi River uplifted in liquefied ground.

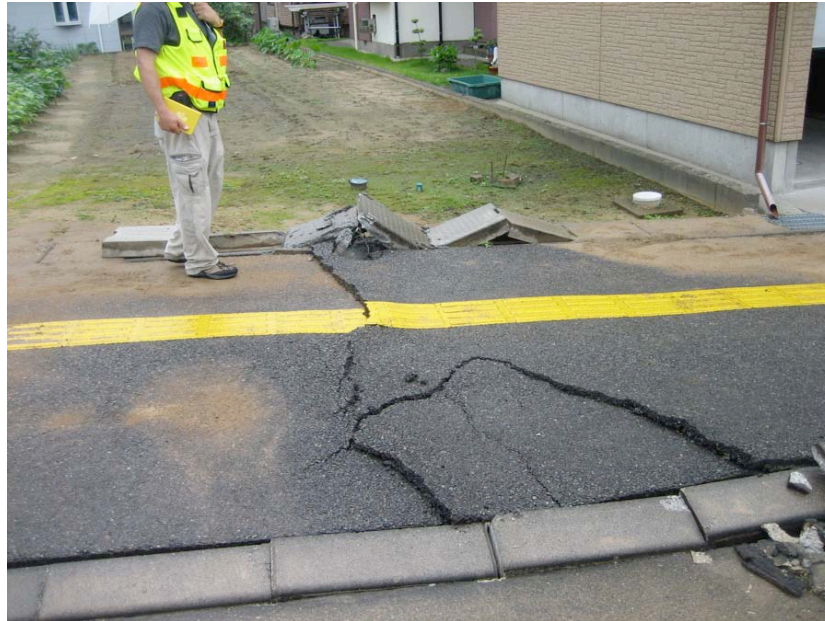
Figure 4.7: Kai-Un Bridge area Sabaishi River (Site RK4 N37.39233° E138.58063°, 7/19/2007, 1:40 p.m.). A sub-linear zone of lateral spreading, sand boils and settlement that may be associated with a buried shoestring sand deposit from the former channel of the Sabaishi River resulted in damage in the neighborhood immediately south of the Kai-Un Bridge.

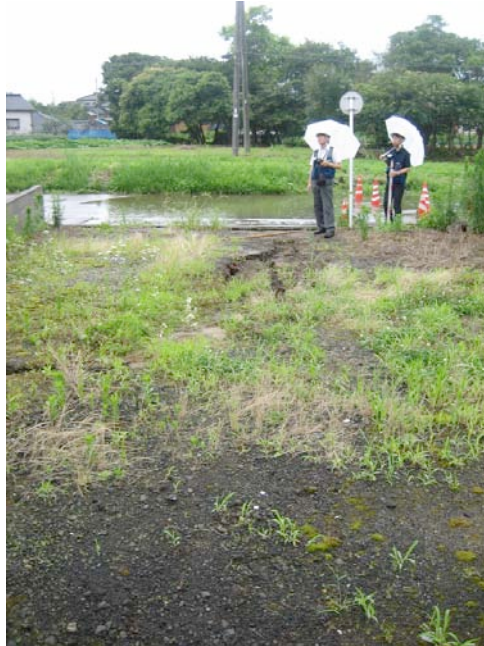
Figure 4.8: Kai-Un Bridge area Sabaishi River (Site RK4 N37.39233° E138.58063°, 7/19/2007, 1:40 p.m.). A sub-linear zone of lateral spreading, sand boils and settlement that may be associated with a buried shoestring sand deposit from the former channel of the Sabaishi River resulted in damage in the neighborhood immediately south of the Kai-Un Bridge.

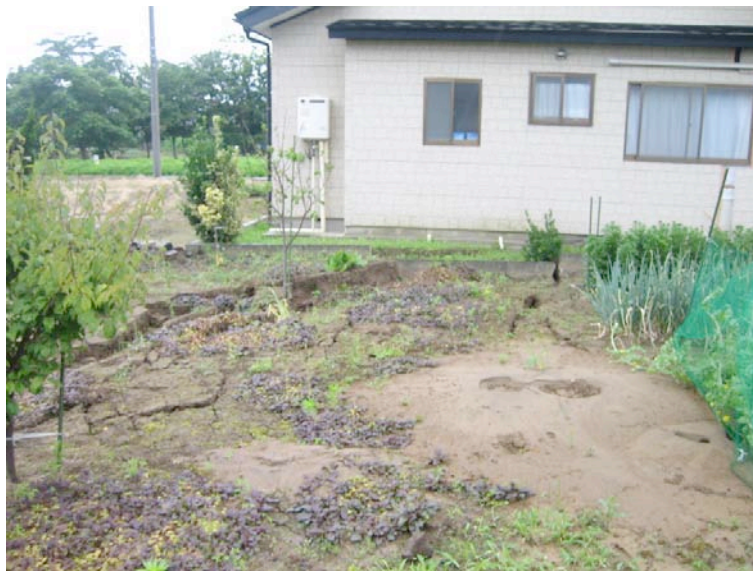
Figure 4.9: Kai-Un Bridge area Sabaishi River (Site RK4 N37.39233° E138.58063°, 7/19/2007, 1:40 p.m.). A sub-linear zone of lateral spreading, sand boils and settlement that may be associated with a buried shoestring sand deposit from the former channel of the Sabaishi River resulted in damage in the neighborhood immediately south of the Kai-Un Bridge. Here, settlement caused damage to a residential structure.

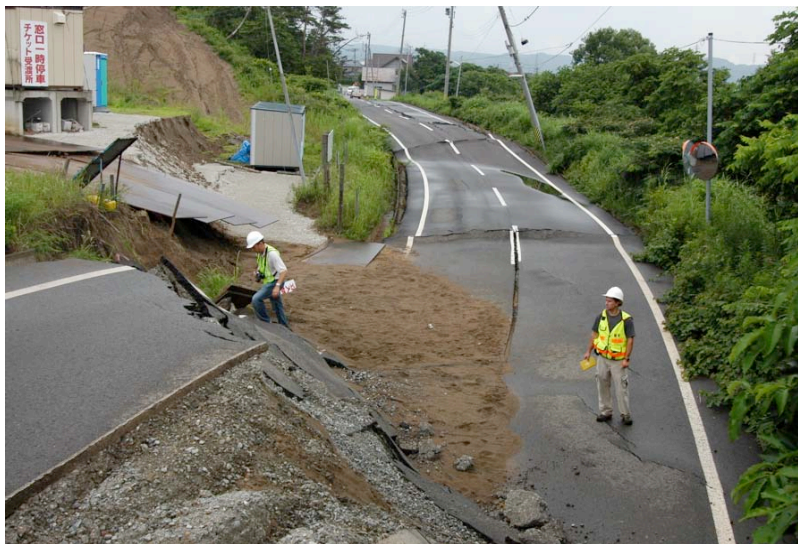
We observed lateral spreading, liquefaction, slope failures, and associated retaining wall failures at this site. This site was scanned with terrestrial LiDAR for documentation purposes and for further analysis. A massive embankment failure was observed to have occurred from liquefaction and lateral spread slope movement in aeolian sands. Movement was from north to south, from sand quarry area towards river. Vertical displacement of head scarp was a maximum of 2.8 m and diminished in height moving away from road crossing of head scarp. Measurements were made of total lateral displacement along a representative track-line through the failure representing the maximum likely displacement of the failure ~10 m over 55 m distance between head scarp and river edge (approximately 18% strain). The inclination of slope from road to river was measured to be approximately 14°. Nearby, a slope lateral spread caused failure of a 2.6-meter-tall, concrete block, gravity retaining wall, that resulted in the red-tagging of an otherwise undamaged home. The damaged retaining wall section was 25 meters in length and constructed of 40 cm by 30 cm by 100 cm sized concrete blocks. No backfill, drainage, or tieback reinforcement were observed.

Figure 4.11: North side of Kai-Un Bridge area of the Sabaishi River - Lateral Spread on road to Kashiwazaki Municipal Incinerator (Site RK6, N37.39343° E138.58555°, 7/19/2007). A zone of lateral spreading, sand boils and settlement crossing the present-day Sabaishi River, and that may be associated with a buried shoestring sand deposit of a former channel, resulted in failure of a road on the north side of the river adjacent to the Kashiwazaki Municipal Incinerator.

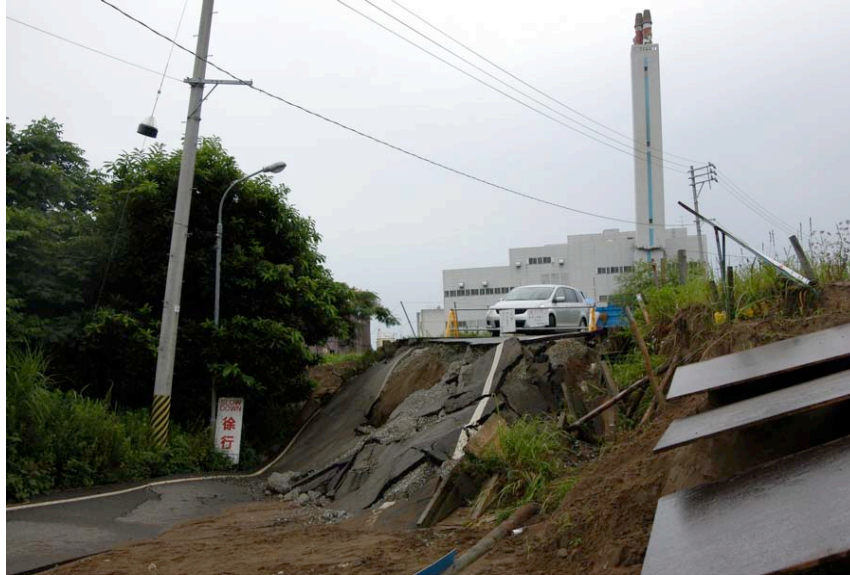
Figure 4.12: North side of Kai-Un Bridge area of the Sabaishi River - Lateral Spread on Road to Kashiwazaki Incinerator (Site RK6, N37.39343° E138.58555°, 7/19/2007). A zone of lateral spreading, sand boils and settlement crossing the present-day Sabaishi River, and that may be associated with a buried shoestring sand deposit of a former channel, resulted in failure of a road on the north side of the river adjacent to the Kashiwazaki Municipal Incinerator.

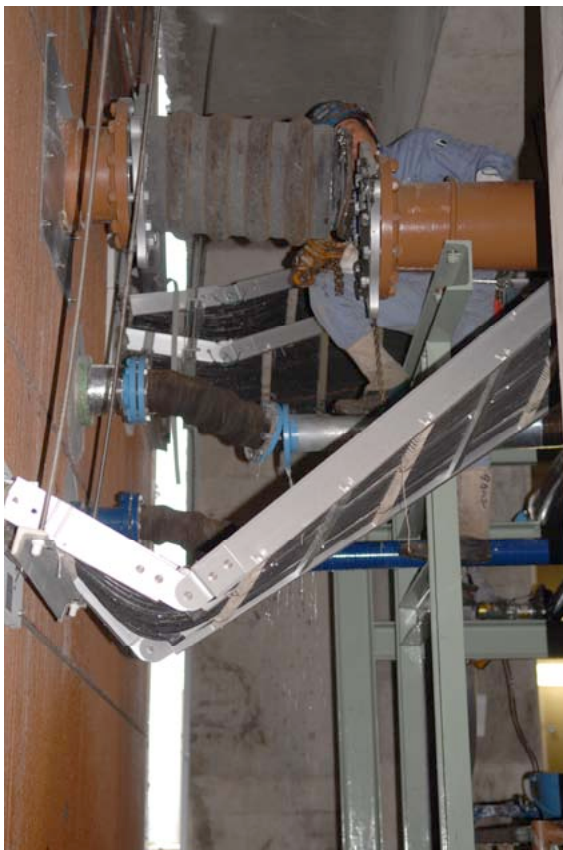
Figure 4.16b: Kashiwazaki Wastewater Treatment Plan on the south side of Sabaishi River near its outlet to the Sea of Japan (Site RK9 N37.38748° E138.56587°) Pipe breaks are due to separation of two adjacent building sections (Photo taken at 7/21/07 9:15)

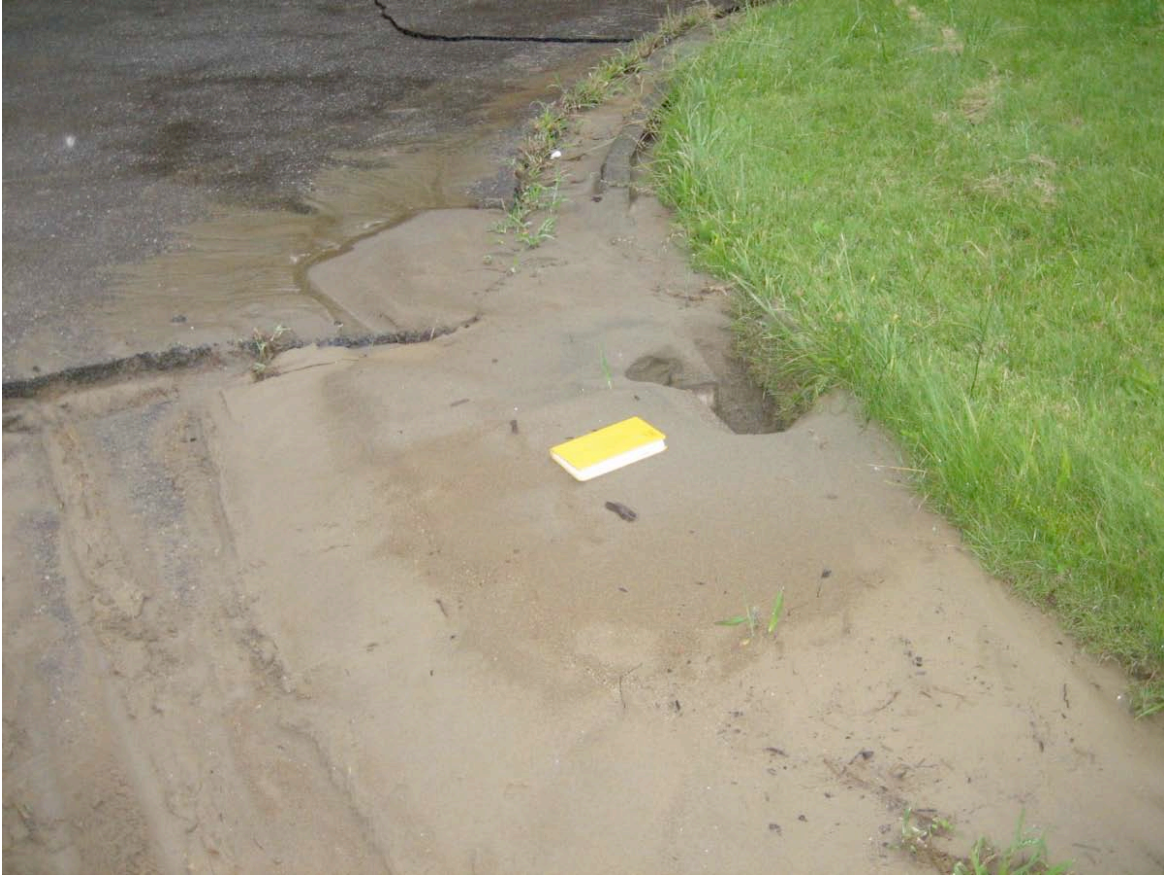
Figure 4.17: Kashiwazaki Wastewater Treatment Plant on the south side of Sabaishi River near its outlet to the Sea of Japan (Site RK9 N37.38748° E138.56587°, 7/19/2007). Liquefaction features were abundant near the wastewater treatment facility.

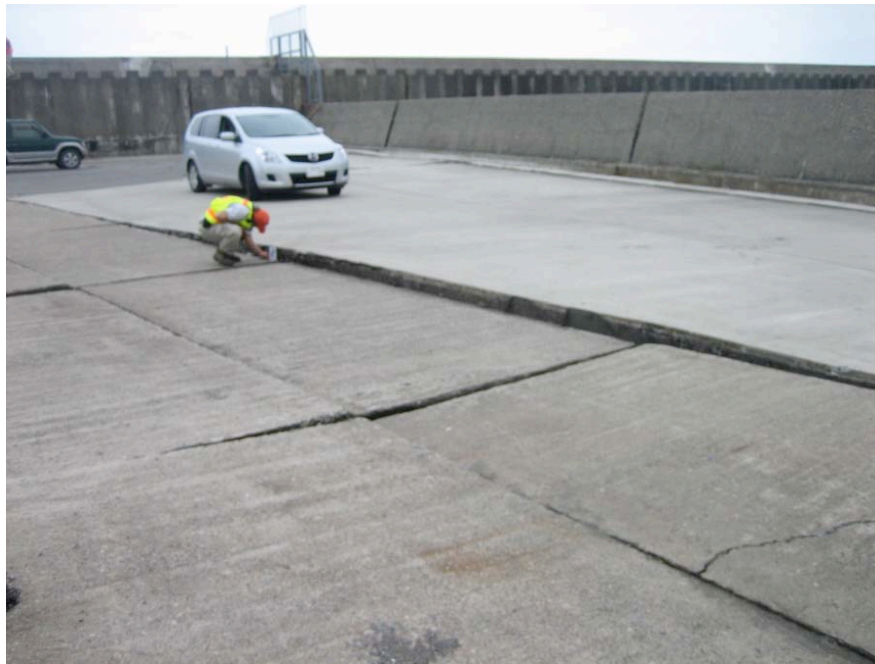
This area experienced ground damage from liquefaction induced lateral spreading. We observed sand boils in the grassy area behind the port office building and on the west end of the pier between separated pier slab sections. Some areas of concrete had 15 cm of vertical and 20 cm of lateral displacement. A track-line measurement was performed with a cloth tape. Measurements indicate that 0.7 m of lateral displacement occurred over 79 meters resulting in 0.9% strain, as measured between the seawall on the west to the edge of the pier to the east. The displacement direction was inland to the east. Terrestrial LiDAR scanning was performed at this site.

Figure 4.18: Kashiwazaki Harbor - South area experienced ground damage from liquefaction induced lateral spreading and settlement of separated pier slab sections (Site RK25, N37.36713° E138.53210°, 7/20/2007).

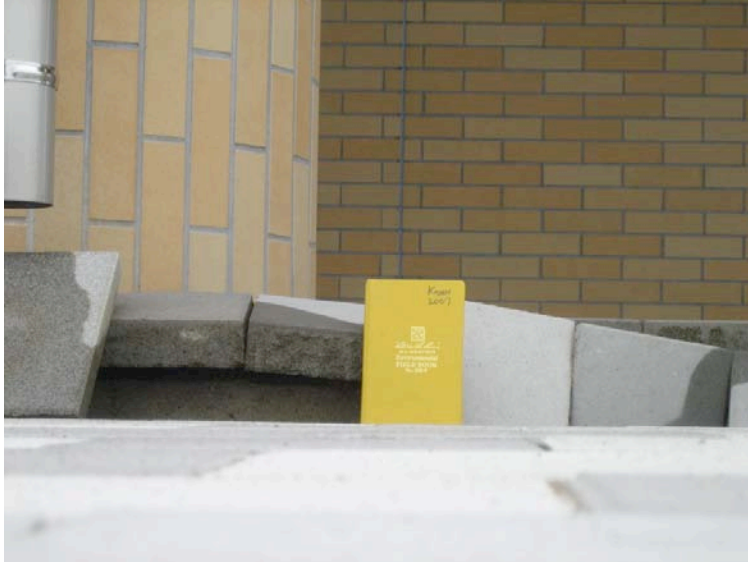
Figure 4.19: Kashiwazaki Harbor - South area experienced ground damage from liquefaction-induced lateral spreading and settlement immediately adjacent to the pile-supported port office building. (Site RK25, N37.36713° E138.53210°, 7/20/2007).

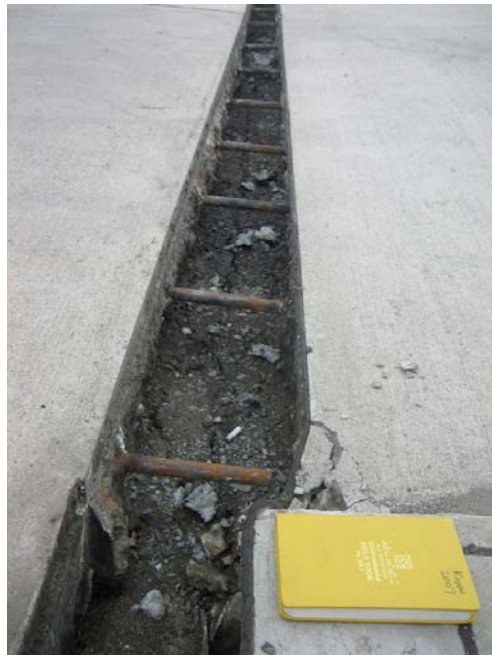
Figure 4.20: Kashiwazaki Harbor - South area experienced ground damage from liquefaction-induced lateral spreading resulting in separated pier slab sections (Site RK25, N37.36713° E138.53210°, 7/20/2007).

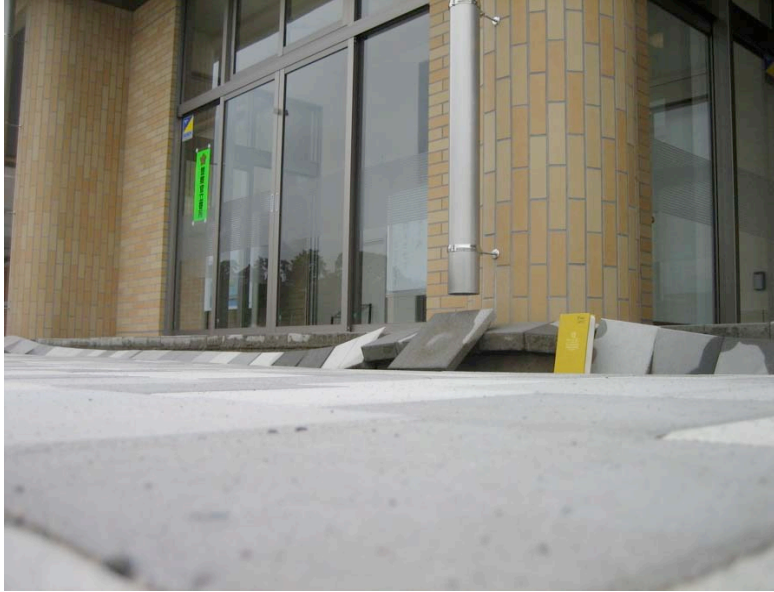
Figure 4.22: Kashiwazaki Harbor - The southern area experienced ground damage from liquefaction-induced lateral spreading and settlement. We observed settlement immediately adjacent to the pile supported port office building. (Site RK25, N37.36713° E138.53210°, 7/20/2007).

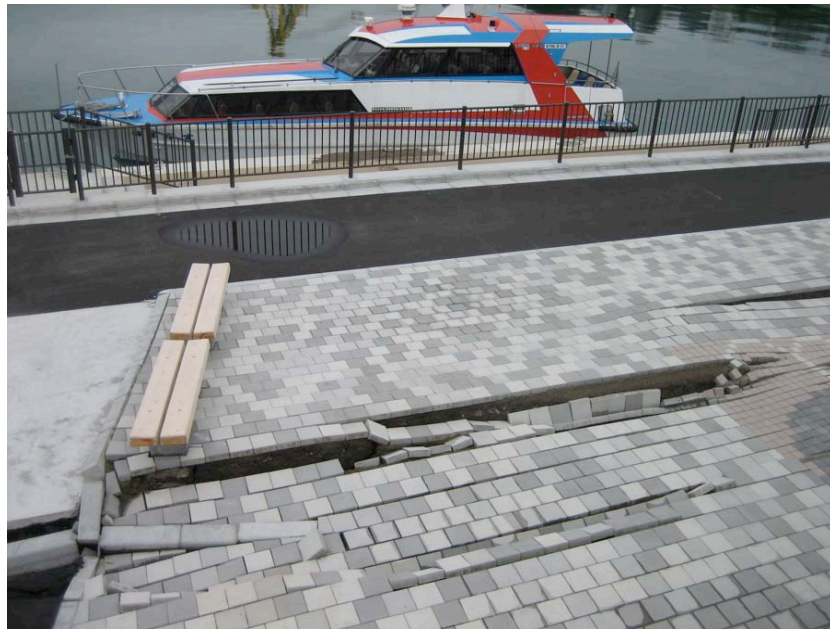
Figure 4.23: Kashiwazaki Harbor - The southern area experienced ground damage from liquefaction-induced lateral spreading and settlement. A harbor-front caisson rotated toward the harbor, uplifting the asphalt and tiled section shown here and initiating lateral displacement of the soil behind it, between the caisson and port building (Site RK25, N37.36713° E138.53210°, 7/20/2007).
