Preliminary Observations on the Niigata-Chuetsu Oki, Japan, Earthquake of July 16, 2007

EERI-GEER Web Report 2007-1 v.8
October 9, 2007

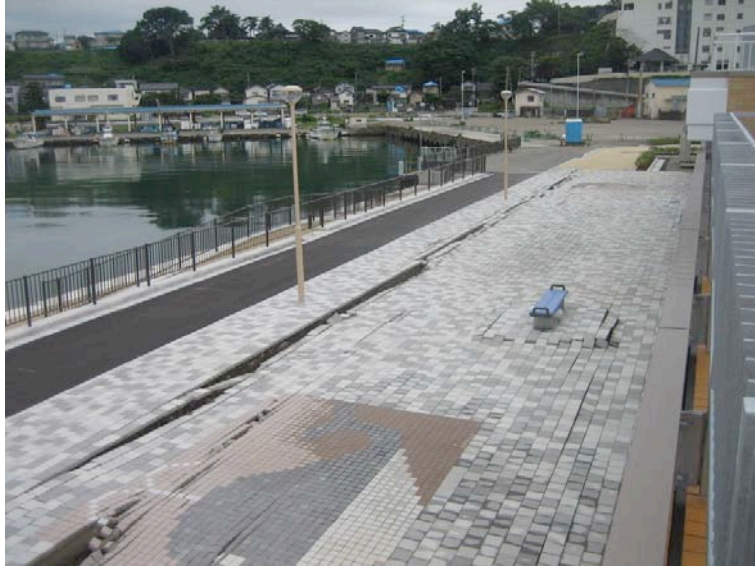
Figure 4.25: Kashiwazaki Harbor - South area experienced ground damage from liquefaction-induced lateral spreading and settlement. A harbor front caisson rotated toward the harbor, to the left of the photo, initiating lateral displacement of the soil behind it, between the caisson and port building. Settlements can also be seen in this photo. (Site RK25, N37.36713° E138.53210°, 7/20/2007)

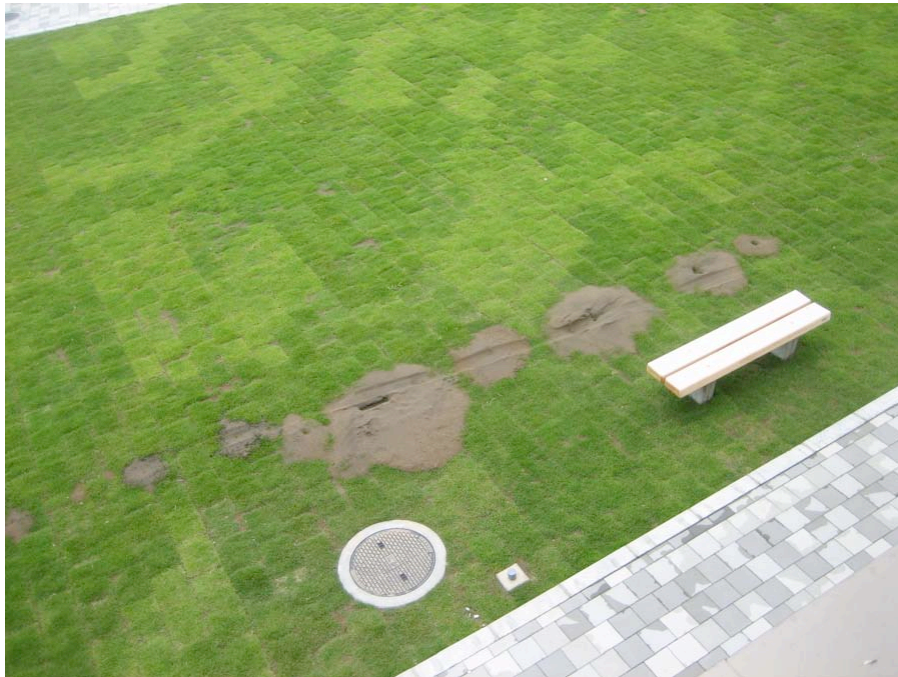
Figure 4.26: Kashiwazaki Harbor - South area exhibited surficial features of liquefaction on all sides of the port building. (Site RK25, N37.36713° E138.53210°, 7/20/2007).

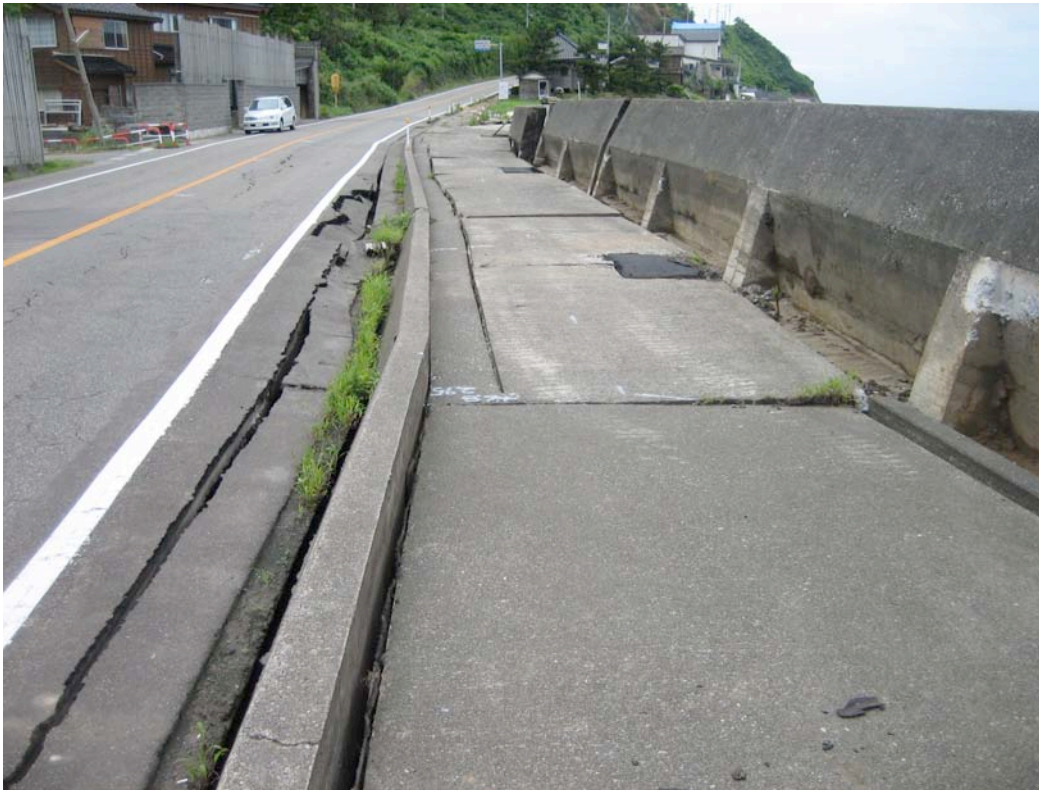
Liquefaction of beach sand led to lateral spreading of a road embankment and both rotation and translation of a 30-meter-long segment of concrete seawall. Deformations were on the order of 25 cm vertical, and up to 64 cm horizontal, with a component of rotation as measured by 32 cm lateral deformation at the base of wall and 64 cm lateral deformation at 2m height of wall.

Figure 4.27: Liquefaction of beach sand led to lateral spreading of a road embankment and both rotation and translation of a 30-meter-long segment of concrete seawall. (Site RK35, N37.48497° E138.62645°, 7/22/2007).

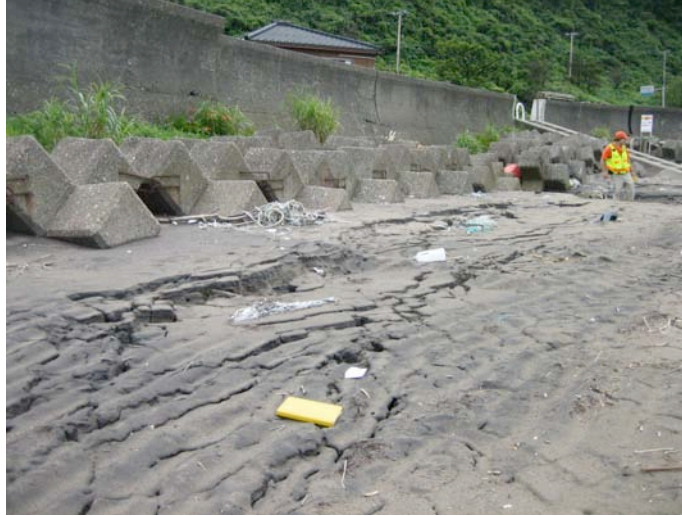
Figure 4.28: Liquefaction of beach sand resulted in lateral spreading, above, in front of a 30-meter-long segment of concrete seawall. (Site RK35, N37.48497° E138.626°, 7/22/2007)

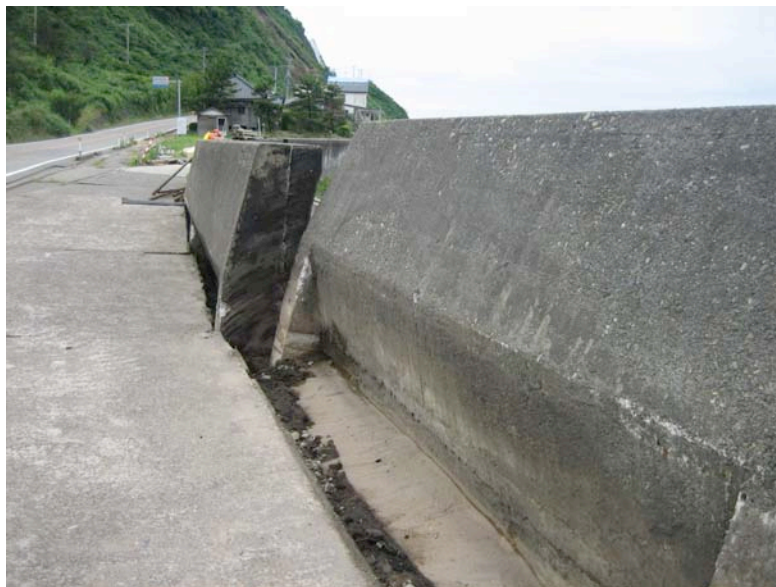
Figure 4.29: Liquefaction of beach sand led to lateral spreading of a road embankment and both rotation and translation of a 30-meter-long segment of concrete seawall. (Site RK35, N37.48497° E138.62645°, 7/22/2007). Deformations were on the order of 25 cm vertical, and up to 64 cm horizontal, with a component of rotation as measured by 32 cm lateral deformation at the base of wall and 64 cm lateral deformation at 2 m height of wall.

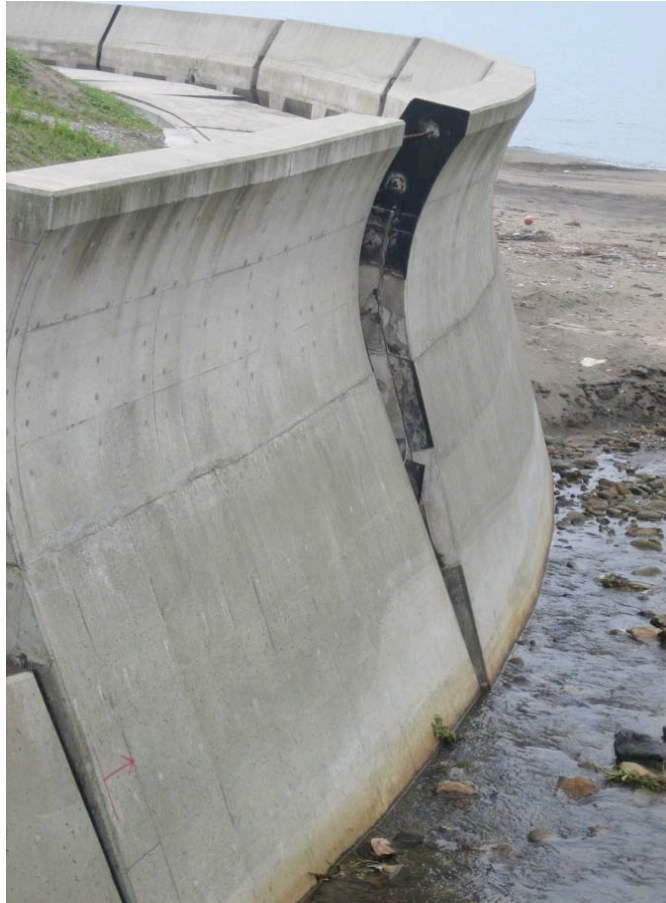
Embankment failure and lateral spread from liquefaction of beach sands at toe of seawall. We measured 21 cm of vertical displacement and 55 cm of horizontal displacement of a wall section from an adjacent non-failed wall section. The total length of failed sections was 40 m.

Figure 4.31: Seawall Failure as a result of embankment movement into a seawall founded on top of liquefied beach sands. (Site RK37, N37.45478° E138.60927°, 7/22/2007).

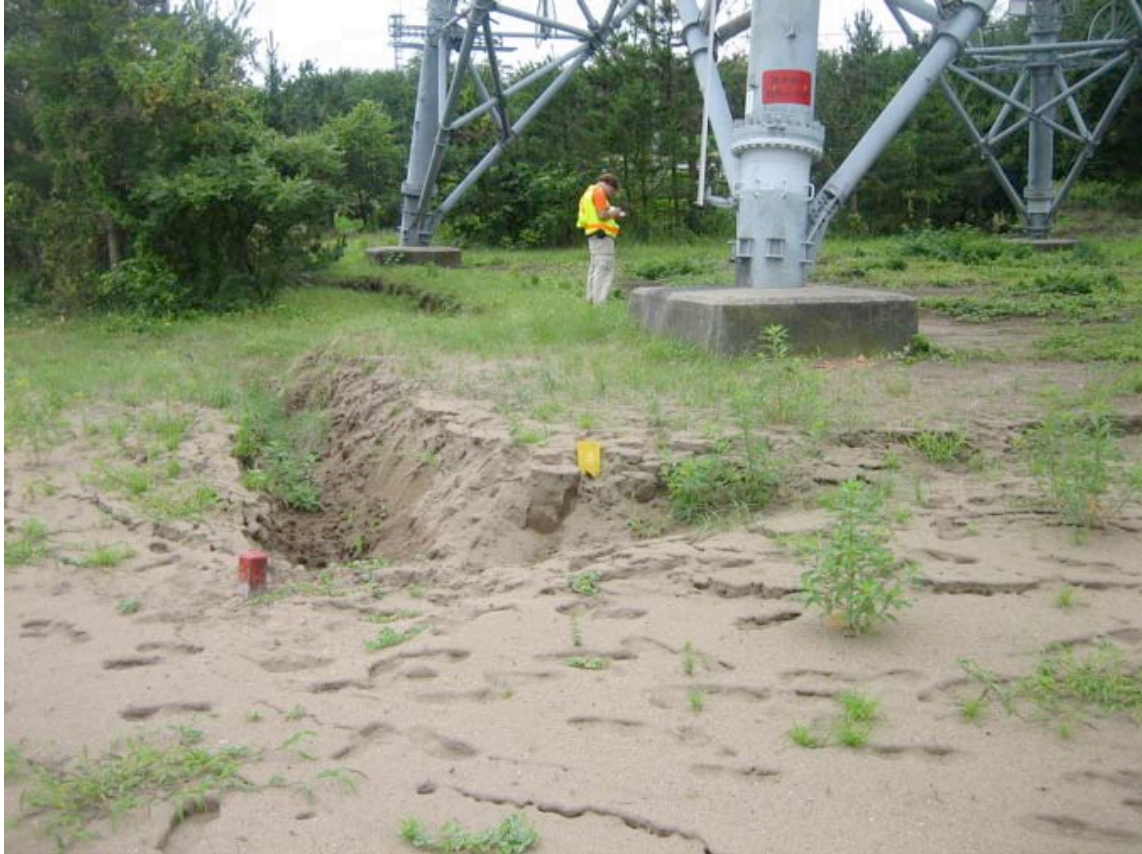
Liquefaction and lateral spread of dune sand adjacent to tower footings. We measured 40 cm of vertical displacement and 12 cm of horizontal displacement over a 20-meter track-line moving away from the footing for 0.6% of measured ground strain.

Figure 4.33: Liquefaction and lateral spread of ground adjacent to High Voltage Transmission Line Tower (Site RK40, N37.41633° E138.60792°, 7/22/2007).

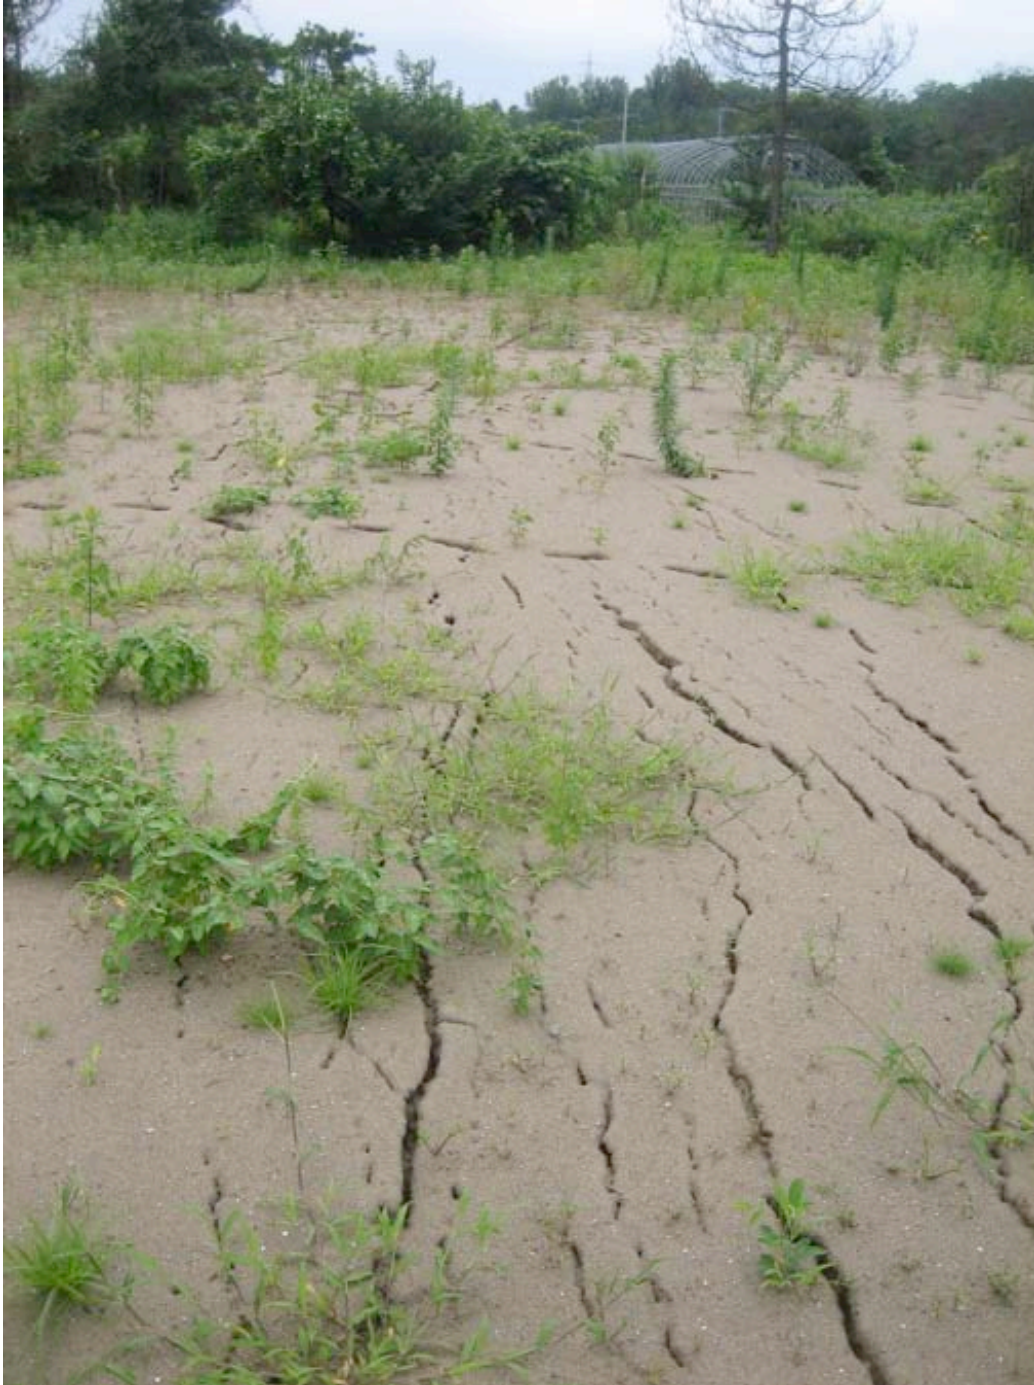
Figure 4.34: Lateral spreading in dune sand down slope of high voltage power transmission tower. We measured 0.6% of ground strain at the site. (Site RK40, N37.41633° E138.60792°, 7/22/2007).

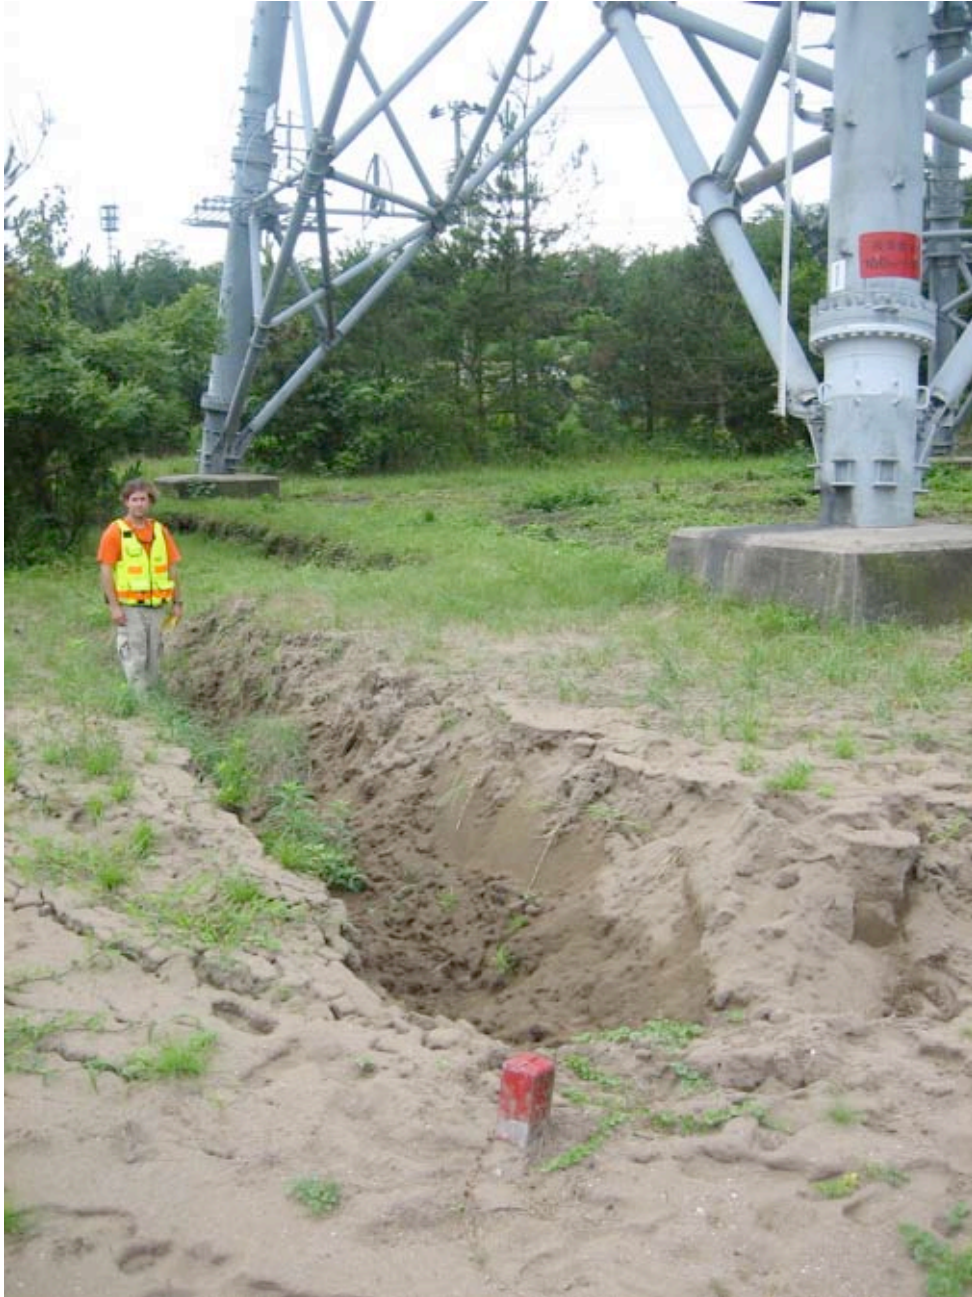
Figure 4.35: Settlement of ground adjacent to grade beam between footings of a high voltage transmission line tower (Site RK40, N37.41633° E138.60792°, 7/22/2007).

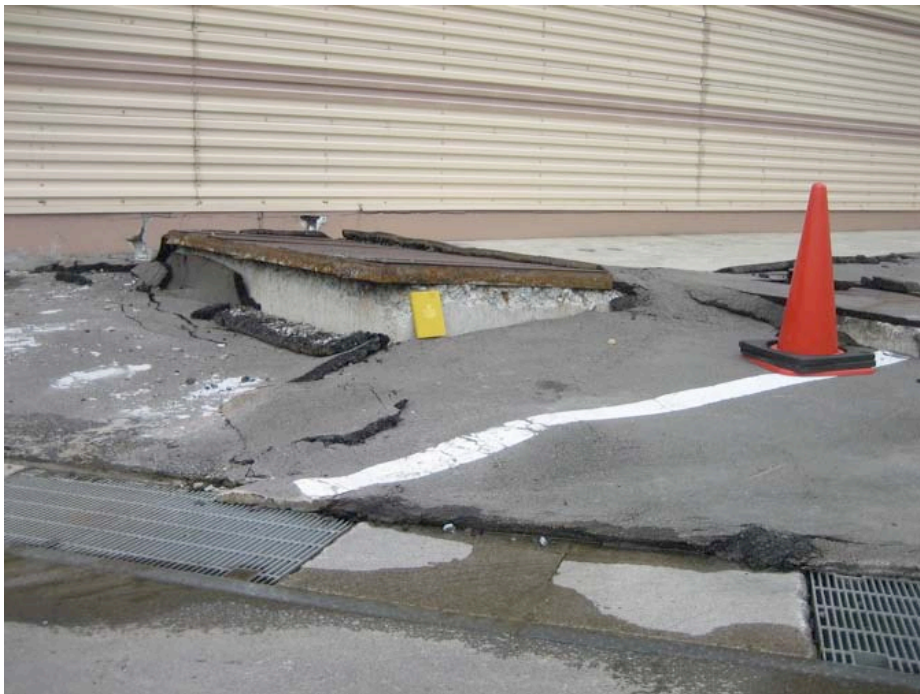
We observed structural damage and ground settlement of a large warehouse-type department store. The interior columns were deformed and leaning, and the interior floor slab reinforcing bars had buckled and were exposed. Reinforcing bars and concrete also failed at a corner of the building. Ground settlement was observed around the building and an underground storage tank had been uplifted (this was the only obvious sign of liquefaction).

Figure 4.36: Plant 5 Store - Ground settlement in dune sand was observed around the building and an underground storage tank had been uplifted (Site RK41, N37.41468° E138.6084°, 7/22/2007).

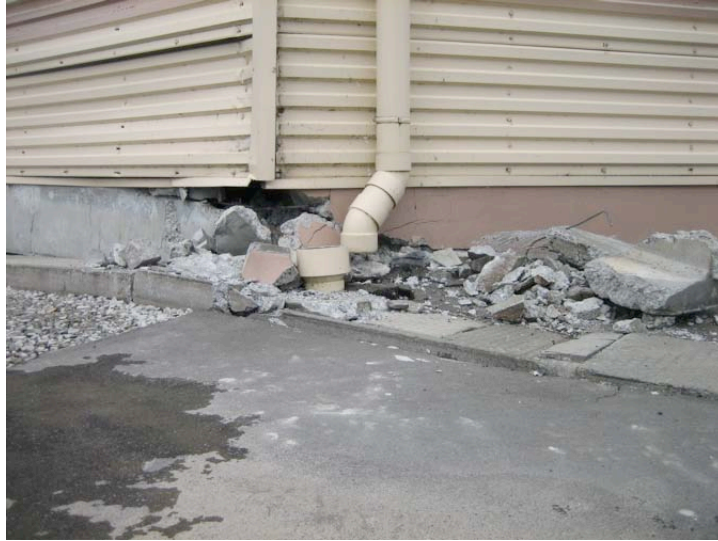
Figure 4.37: Plant 5 Store showing foundation corner area of failed reinforced concrete. (Site RK41, N37.41468° E138.60840°, 7/22/2007).

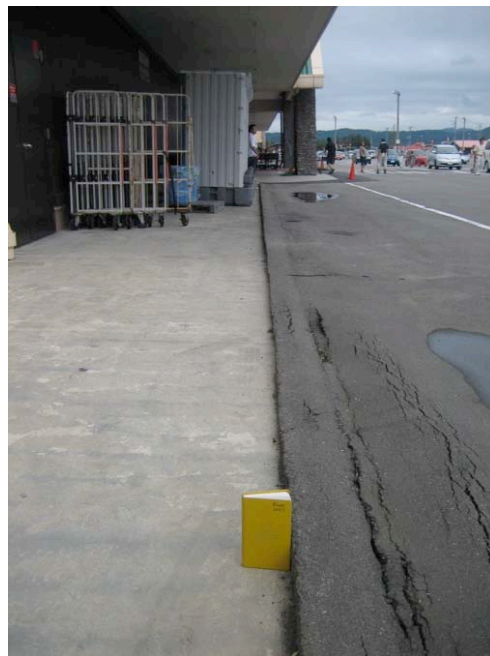
Figure 4.38: Plant 5 Store - Ground settlement in dune sand was observed around the building and an underground storage tank had been uplifted (Site RK41, N37.41468° E138.60840°, 7/22/2007).

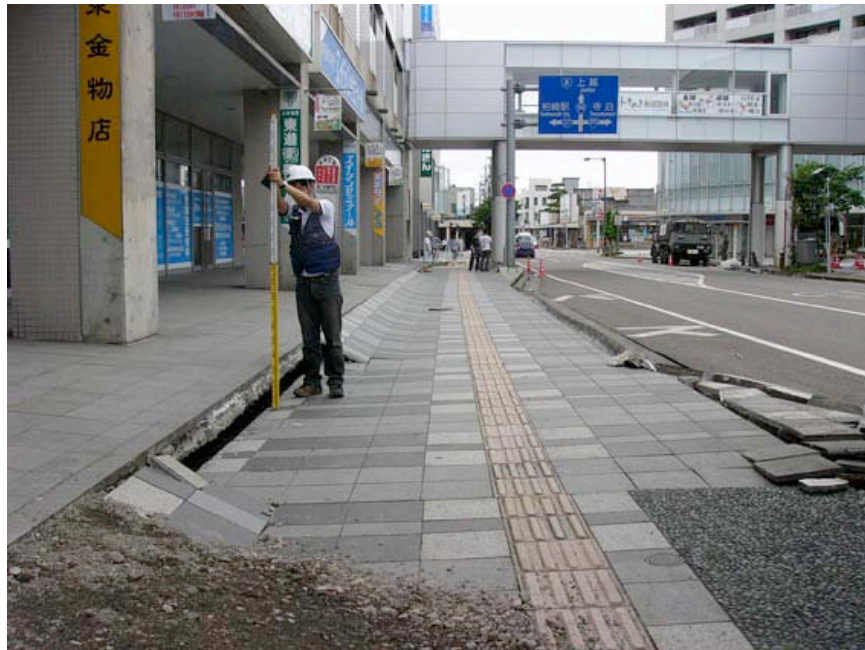
Fig. 4.41: Downtown Kashiwazaki Lateral Spread (SiteYT24, N37.36949°, E138.5541°, photo taken 7/22/07, SiteYT24_YT_19 as shown in Fig. 4.40).

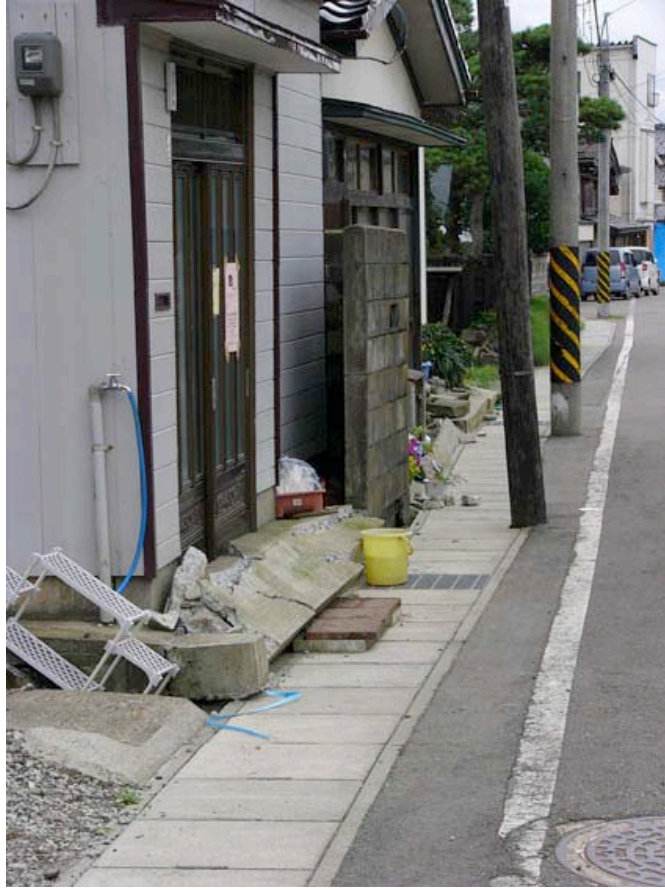
The reconnaissance was made to define the extent of such a deep-seated lateral flow from ground surface distortions. Fig. 4.42 (Site YT24-YT_03 in Fig. 4.40) shows damage at the north-western limit, whereas Fig. 4.43 (Site YT24-YT_14 in Fig. 4.40) shows damage at the south-eastern limit. Thus, the area covered between Fig. 4.42 and Fig. 4.43 may have suffered deep seated lateral flow from higher ground to lower ground. The damages due to such lateral flow extend to the north-eastern direction of downtown. The arcaded street next to (east) Fig. 4.43 (Site YT24-YT_14 in Fig. 4.40) was closed because of heavy structural damages of shops along the street.

Fig. 4.42: Downtown Kashiwazaki Lateral Spread (SiteYT24, N37.36963°, E138.5486°, photo taken 7/22/07, SiteYT24_YT_03 as shown in Fig. 4.40).

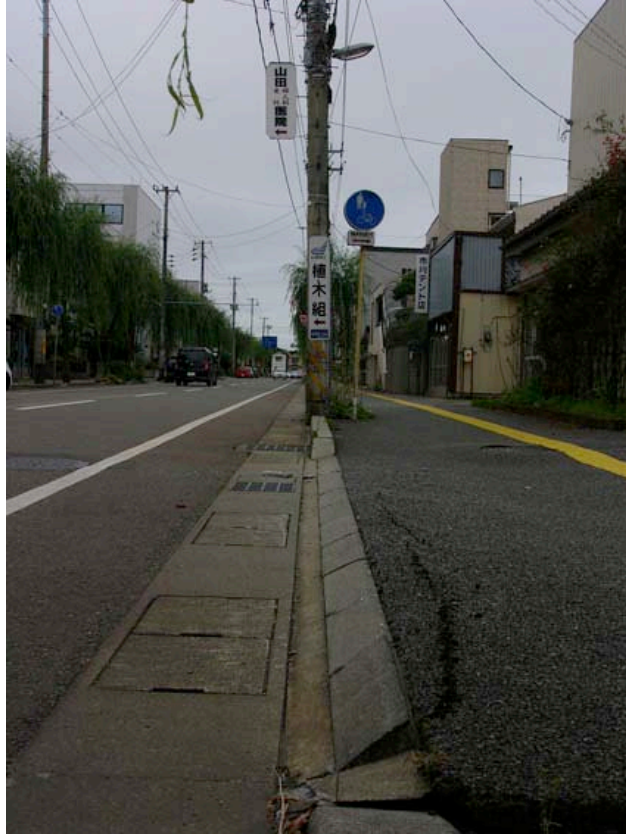
Fig. 4.43: Downtown Kashiwazaki Lateral Spread (SiteYT24, N37.36731°, E138.5522°, photo taken 7/22/07, SiteYT24_YT_14 as shown in Fig. 4.40).

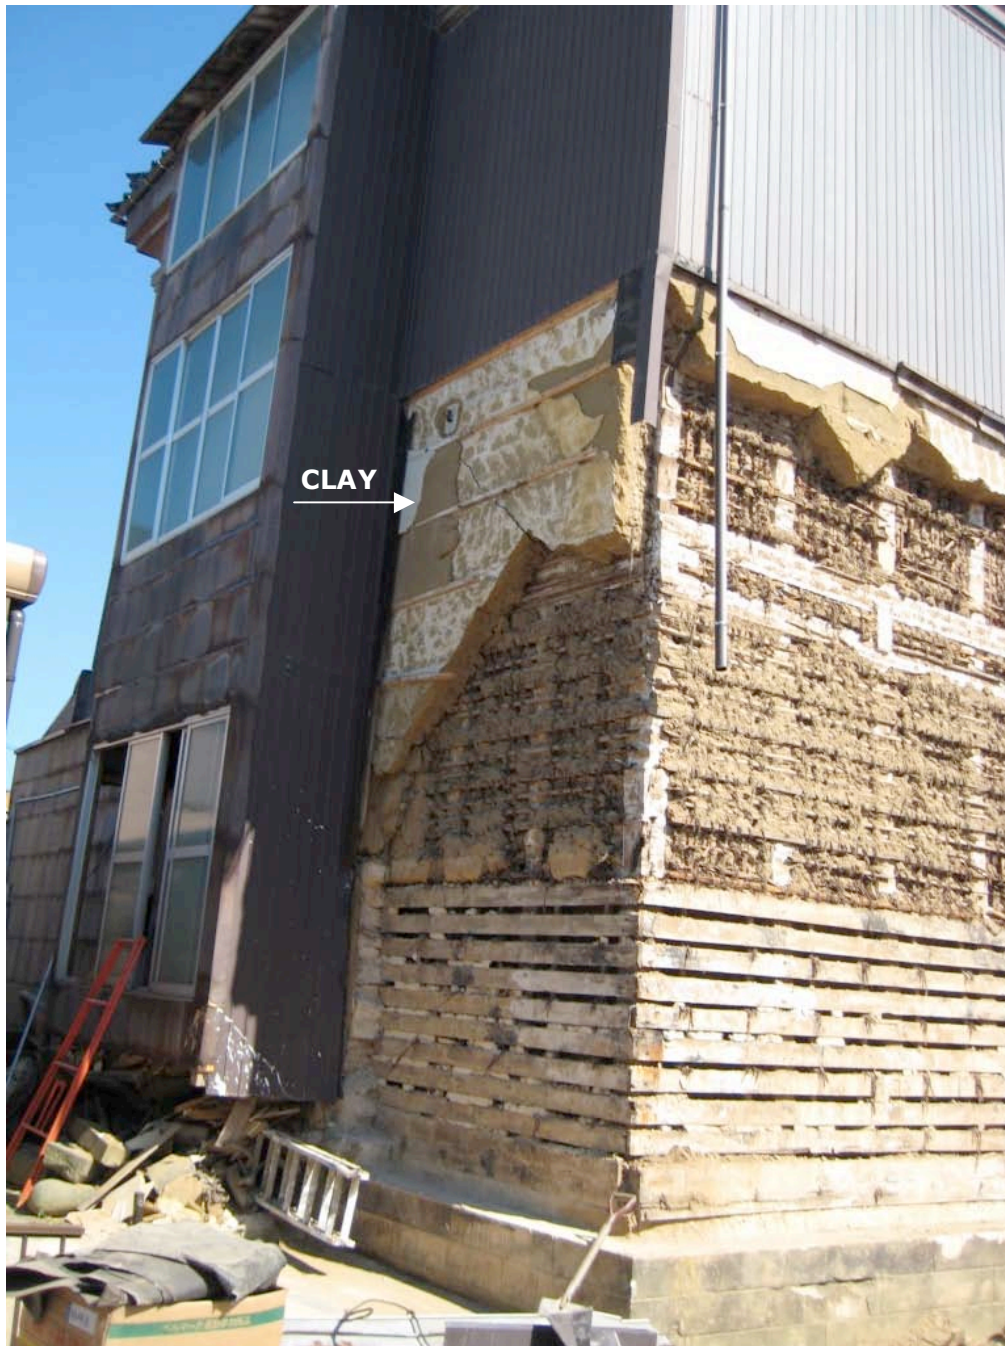
A large fraction of the houses affected were of old-style heavy clay-tile kawara roofs with walls constructed of wood, and walls of soil and bamboo-lathe known in Japanese as *tsuchi-kabe* or “soil wall” (Fig. 5.11). The clay-wood combination can be used effectively if provided with braces for lateral strength and stiffness, however in general, results in heavy and brittle building components. Soft story collapses were observed in buildings with open businesses on the ground floor. The business arcade of Higashi-Honcho Dori was particularly hard hit, accompanied by ground movement/settlement on the south side of the street that was located on the shoulder of sand dunes.

Figure 5.11: Traditional Japanese tsuchi-kabe (“soil wall”) construction technique (Site SP13, N37.37056°, E138.55694°).

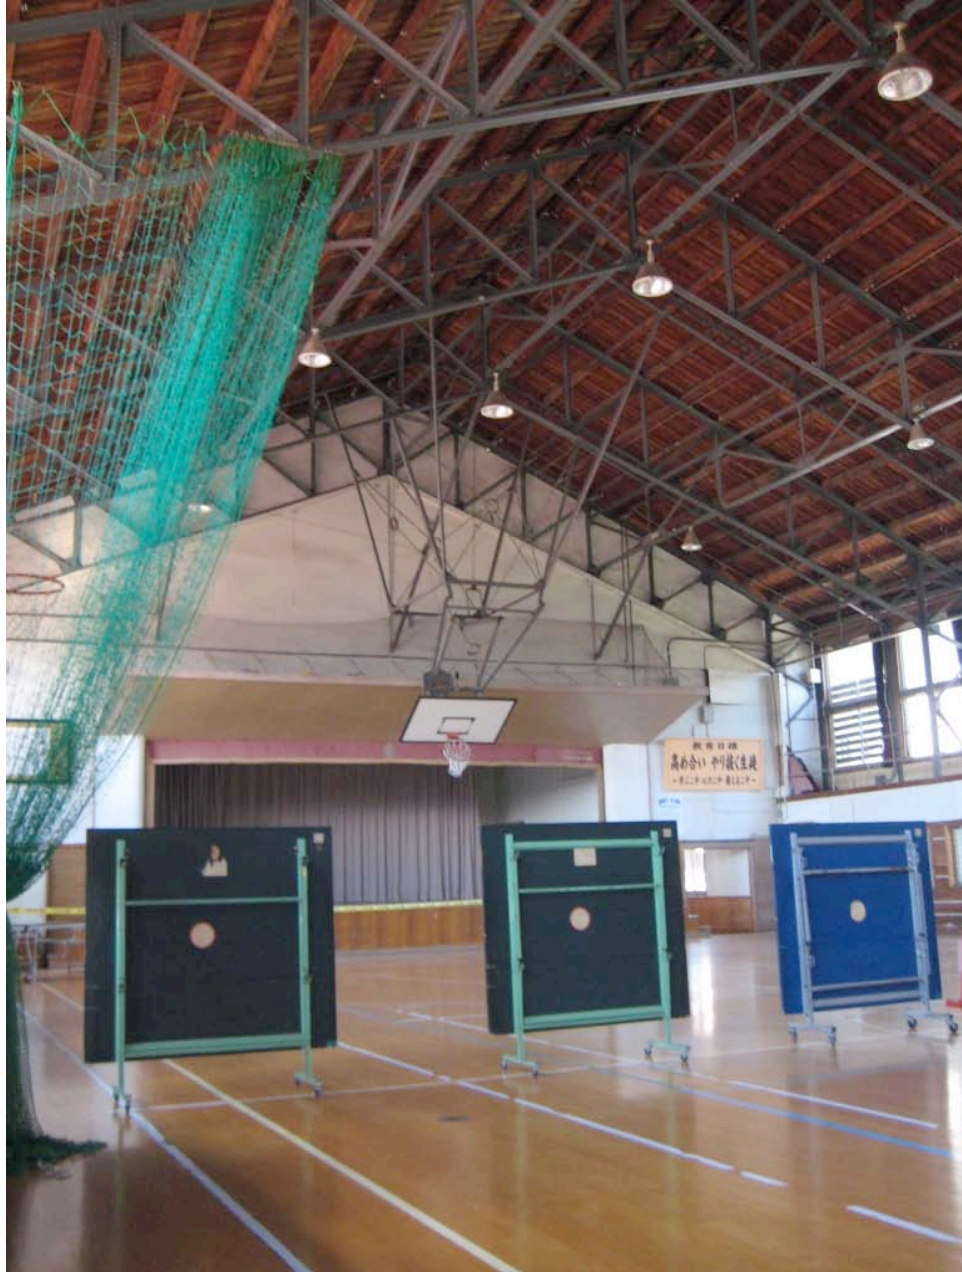
In Kashiwazaki, steel structures were not as common as concrete structures at the time of our visit. None of the few steel structures we saw collapsed. One of these structures was a gymnasium built in the 1950's (Site SP2), located 1.1 km away from the K-NET NIG018 station. The structure was composed of a series of 2D trusses running in the EW direction. Trusses running NS connected the EW trusses at the roof (Fig. 5.12). Finishes did not allow viewing of additional structural elements. But windows along the NS direction made it evident that, at least in this direction, the structure was provided with no braces. The structure survived the earthquake with an estimated permanent drift ratio of 2.5% to the north.

Figure 5.12: Gymnasium at Jr. High School No. 2, Kashiwazaki (Site SP2, N37.3728° E138.5709°).

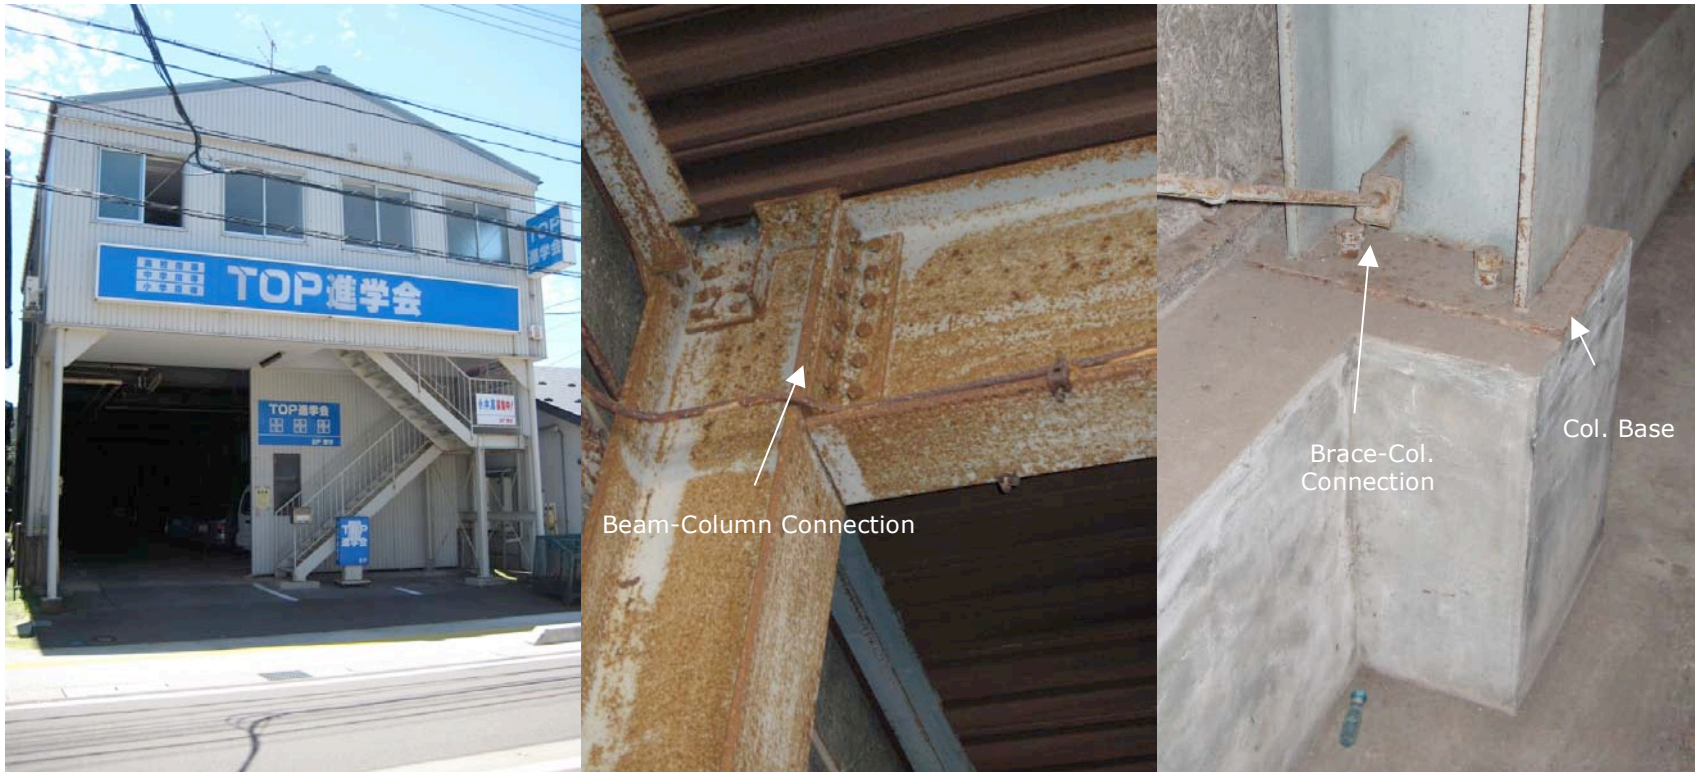
Another example of a surviving steel structure is illustrated in Fig. 5.13 (Site SP29). This structure was located at approximately 270 m from the K-NET NIG018 station, which measured PGV=100m/s. The two-story structure included nine, one-bay

Figure 5.13: Parking structure in Kashiwazaki (Site SP29, N37.3707° E138.5566°).

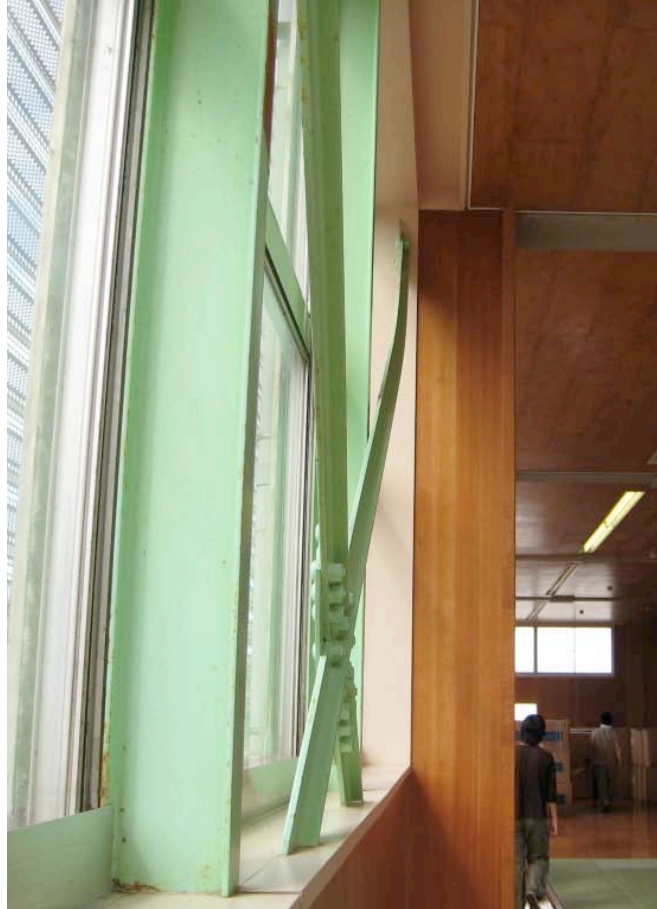
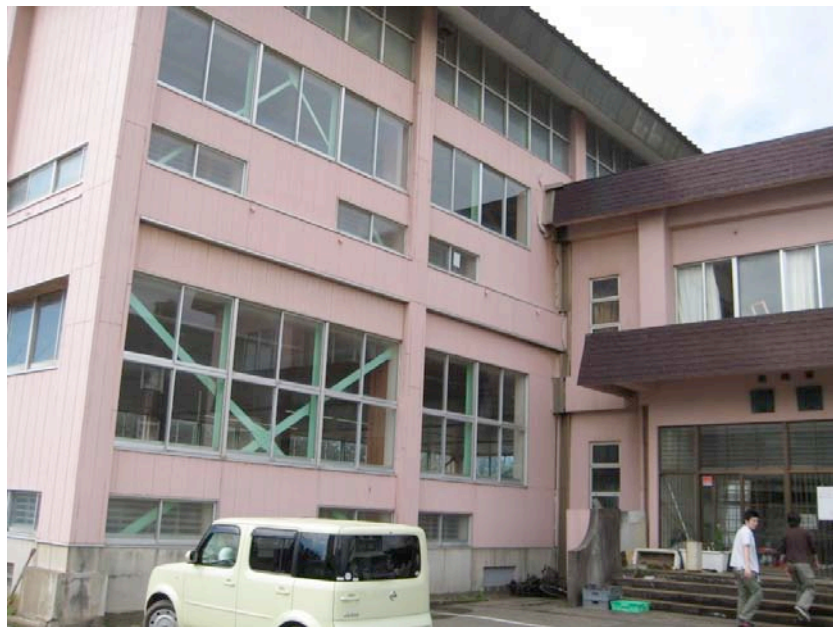
We inspected another gymnasium (Fig. 5.14 - Site SP7) with a steel structure. In this structure, located 430 m from the K-NET station, we observed buckling of steel braces in the lower of the two stories in the structure. The braces had T-shape cross sections with a thickness of 12 mm. The flange measured 150 mm, and the stem 45 mm. The braces had a slope of 2/3 with respect to the horizontal. Four pairs of braces reinforced each story in the NS direction. The floor plan was approximately 20 m in the EW direction and 33 m in the NS direction.

Figure 5.14: Buckling of braces in gymnasium in Kashiwazaki (Site SP7, N37.3755° E138.5541°).

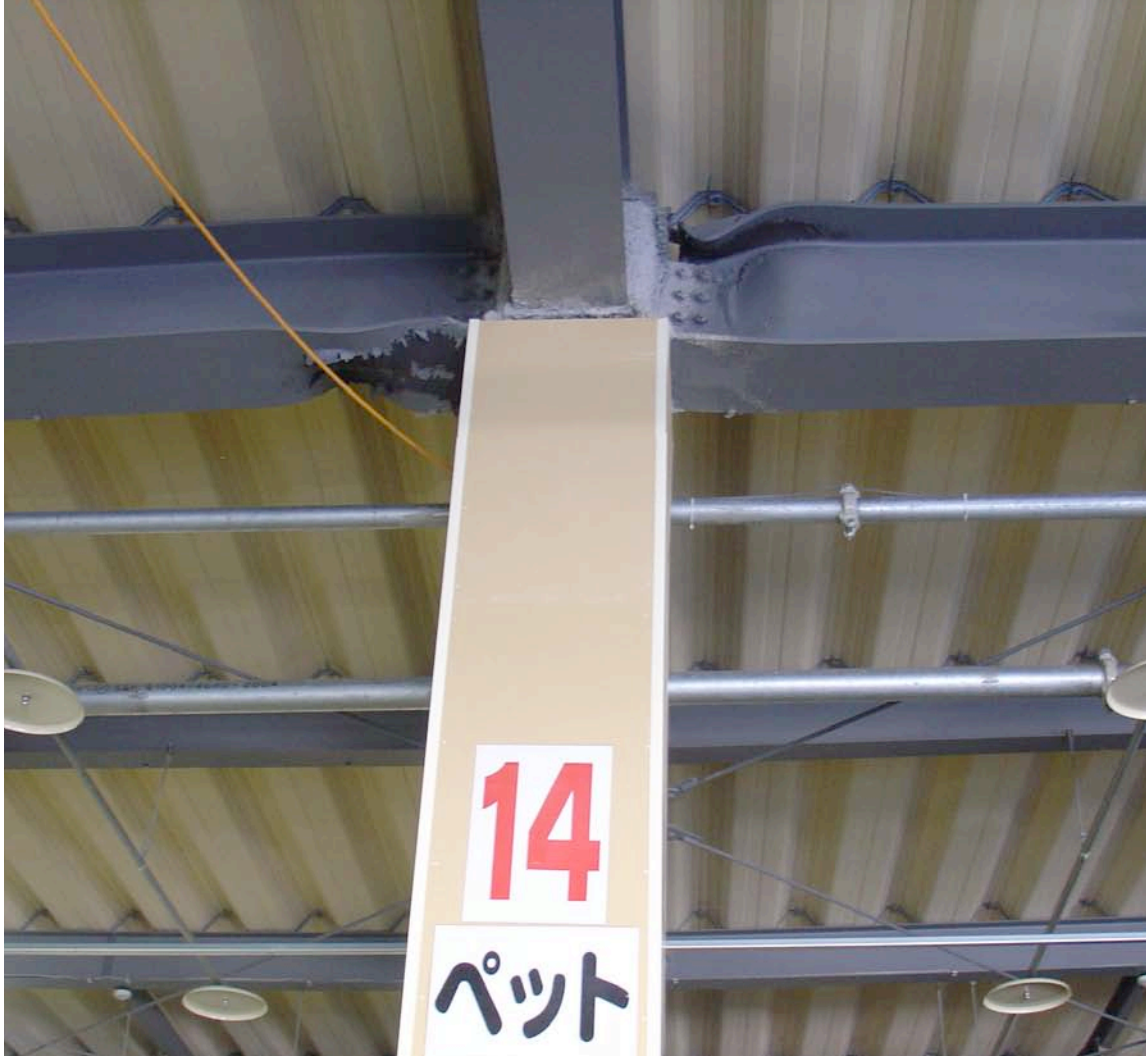
The storage at site RK41 was affected by large ground distortion (see Section 4). At this site, we observed buckling of flanges of beams at bolted connections (Fig. 5.15).

Figure 5.15: Buckling of beam flanges (Site RK41, N37.41472° E138.60833°, photo by Peter Yanev).

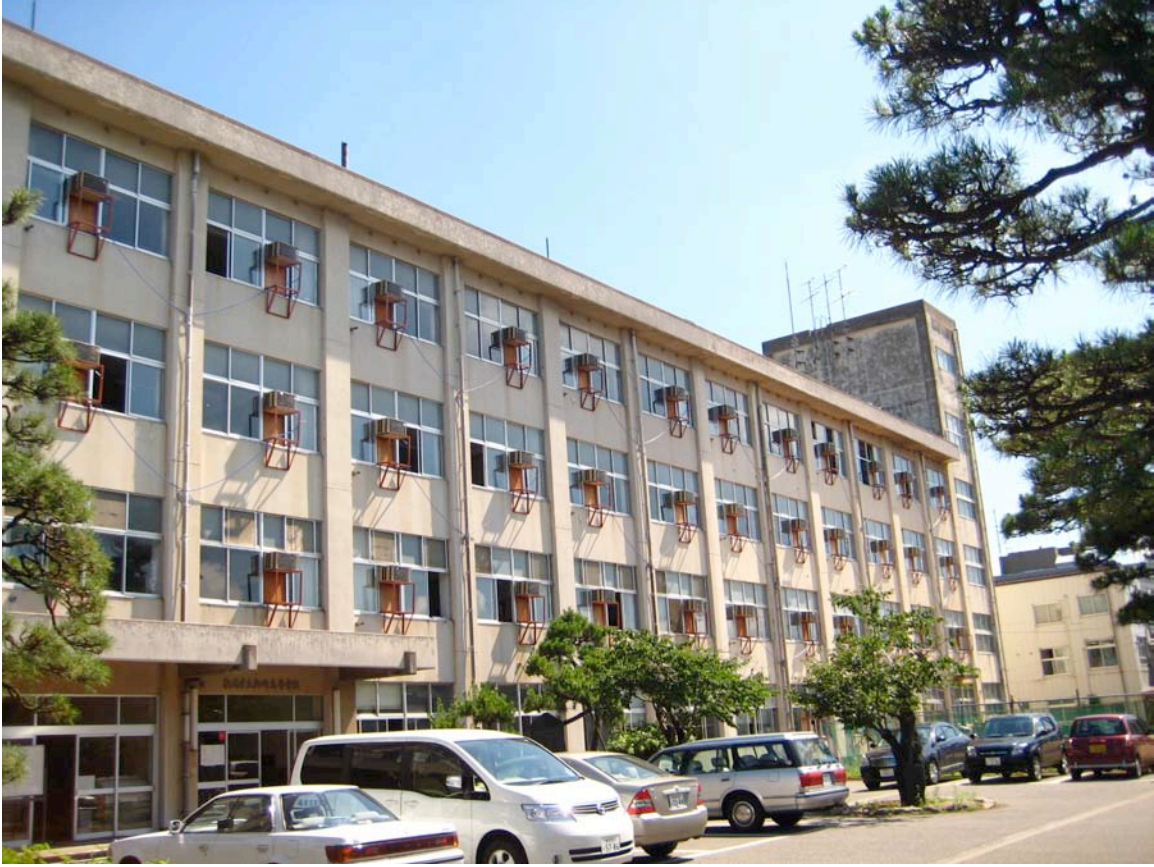
We observed 1-mm thick inclined cracks in a column and 1 to 2.5-mm-thick inclined cracks in reinforced concrete walls in the Kashiwazaki High School (Site SP11), located at 100 m from the K-NET NIG018 station. The high school facilities included two reinforced concrete buildings (Figs. 5.16 to 5.20). We observed the south building to be a four-story building with shear walls in the NS direction and moment-resisting frames in the EW direction. The walls with cracks filled bays in one of the frames parallel to the EW direction in the south building and had a thickness of 12 cm. These walls were reinforced with bars with a diameter of 10 mm, spaced at 20 cm in the vertical and

Figure 5.16: Kashiwazaki High School, south building (Site SP11, N37.3721° E138.5569°).

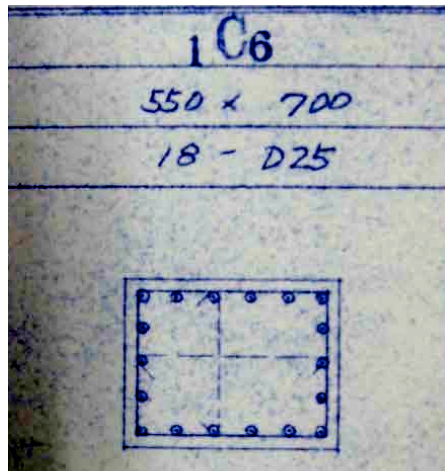
The column observed to have an inclined crack had a clear height of 1.3 m. Other columns in the building had clear heights ranging from 1.3 to 3 m. The column with an inclined crack was located at the intersection of column lines C and 19. The cross section of column C-19 was rectangular with dimensions of 70 cm and 55 cm in the EW and NS directions, respectively (Fig. 5.21). Ties were specified to be 13 mm in diameter and to have an even spacing of 10 cm. A maximum tie spacing of 10 cm has been mandatory in Japan since 1972. In drawings of buildings built before 1972, one may find specifications calling for larger tie spacing (30cm). Cross ties with a diameter of 9 mm were to be provided every 50 cm. Column C-19 supported a single level (a slab that serves as roof beyond column line 18). Averages obtained for buildings from the same vintage indicate that concrete strength is likely to be close to 3 ksi. The yield stress of the reinforcement is estimated to be $f_y = 45$ ksi.

Figure 5.21: Column in first story of The Kashiwazaki High School, cross section and observed crack pattern (Site SP11, N37.3721°, E138.5569°).

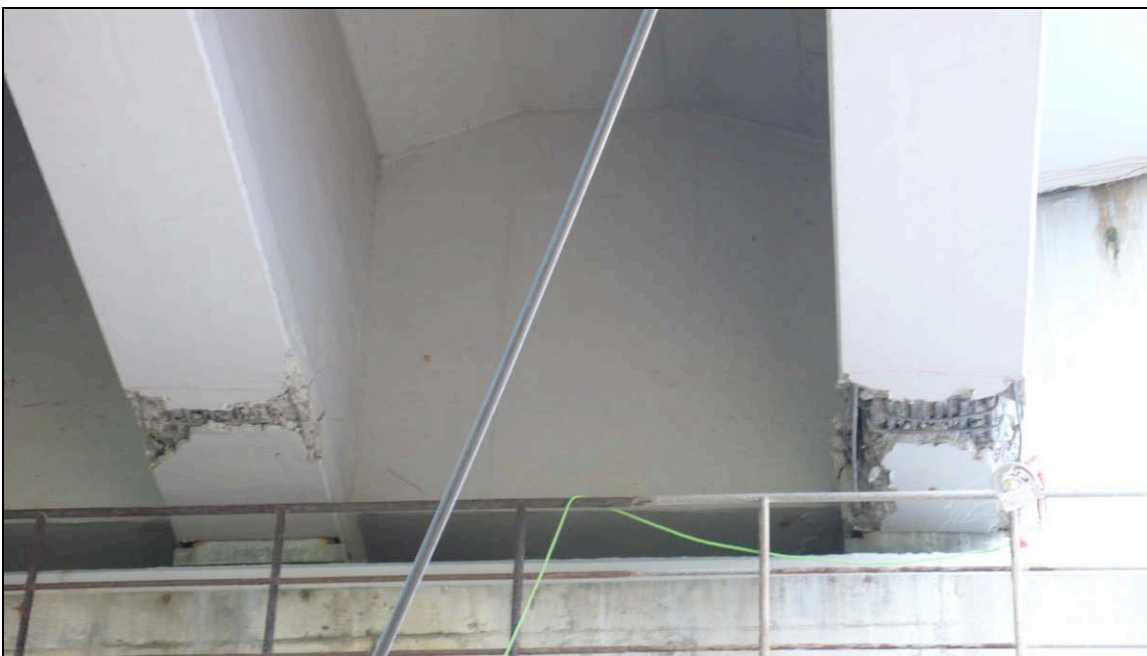
During the earthquake, the embankments moved downhill, exposing the wingwalls (Fig. 6.3). The girders are supported by fixed bearings at the abutment and it is thought that the shear force exceeded the shear strength of girder at the bearing connection. There was a spall at the bottom of the girders about 0.6m from the abutment backwall and on the other side of the bearing. Perhaps, as the abutment moved downward, large shear forces in the girders caused them to spall (Fig. 6.4). The damage occurred at the north end of the west bridge (small cracks were observed on the east bridge).

Fig. 6.4. Closer view of girders on the west Hachisaki Bridge.

When we arrived at the scene (on August 5th), both directions of traffic had been diverted to the east bridge, they had finished driving sheet piles around the abutment to stabilize the soil, and were casting a large pad at the west bridge so that they could jack up the southern three spans and repair the girders and bearings.

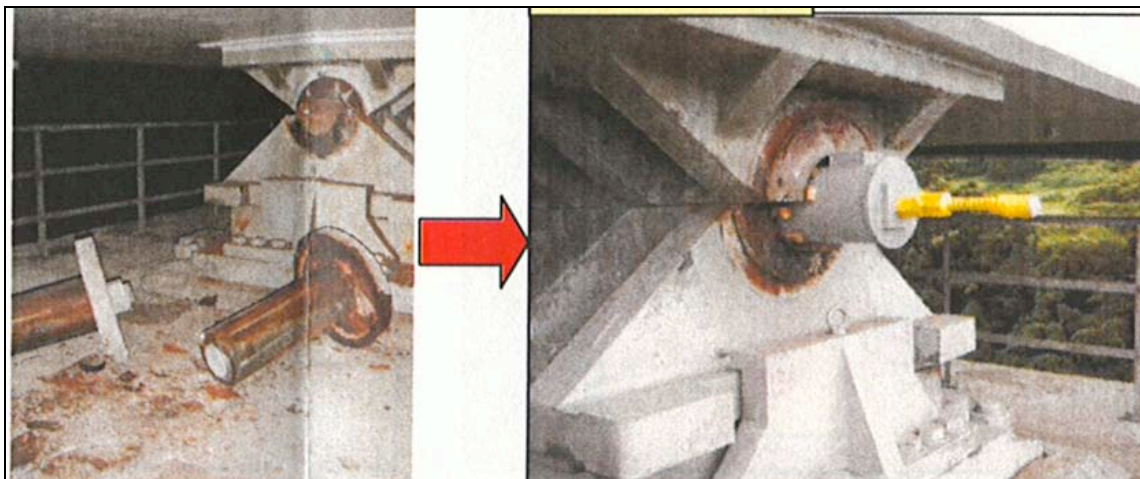
These are two haunched, three-span, segmentally-constructed cast-in-place, concrete box girder bridges on very tall hollow, reinforced concrete piers (Fig. 6.5). Like several other bridges in the same area, the superstructures moved enough during the earthquake to break the fixed steel bearings (Fig. 6.6). Perhaps the weakest member, in this case the steel bearings, acted as fuses to protect the structure from more catastrophic damage. Jacking up these long, continuous superstructures is no easy task, and jacking them back transversely is also a lot of work, but it's also one of the most common types of bridge damage that occurs during earthquakes.

Fig. 6.6. Damage and Repair to Omigawa Bridge (photo courtesy of the Nippon Expressway Company.).

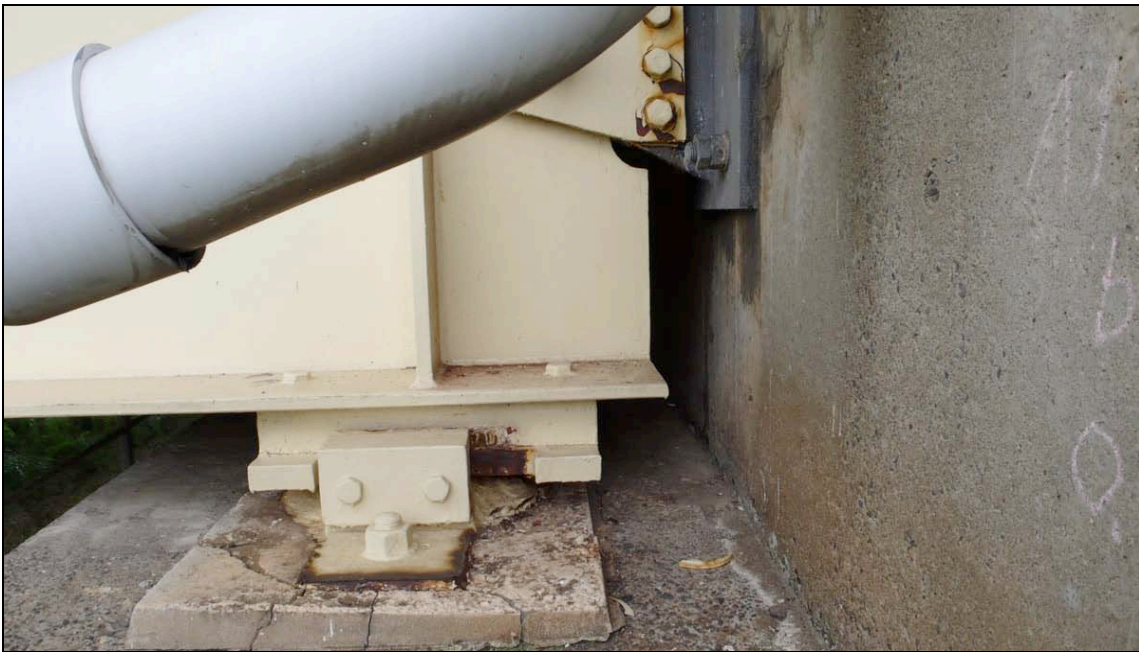
These are two, long steel I girder bridges on single column bents and seat-type abutments. The bridges were being retrofit at the time of the earthquake (Fig. 6.7). Expressway bridges are built with an approach slab that is pinned to the abutment backwall, but this connection broke due to the ground shaking combined with the approach settlement (Fig. 6.8). The only other noticeable damage was the grout plate that the steel abutment bearing was seated on had shattered as the steel girders banged against the steel longitudinal keys that were to limit movement (Fig 9).

Fig. 6.9. Bearing at south abutment of Yoshiigawa Bridges.
