Preliminary Observations on the Niigata-Chuetsu Oki, Japan, Earthquake of July 16, 2007

EERI-GEER Web Report 2007-1 v.8
October 9, 2007

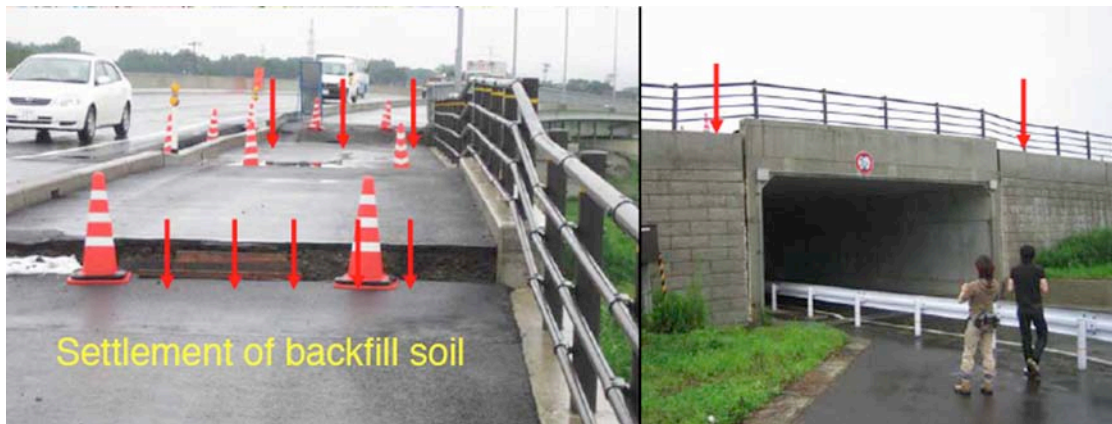
undamaged by the earthquake. However, both bridge approaches settled about half a meter during the earthquake. A rigid box structure, that allowed vehicle access through the west bridge embankment, was now half a meter above the road surface, closing the highway (Fig. 6.13). The riverbanks and abutments moved towards the river and the superstructure moved to the northwest (Fig. 6.14). As a result of this movement the elastomeric bearings experienced some shear (Fig. 6.15). However, because the bearings take up to 70% shear strain for temperature change, 150% for a mild earthquake, and 250% for large earthquake they still have much more shear capacity.

Fig. 6.13. Settlement of west embankment (courtesy G. Watanabe, Tokyo Institute of Technology).

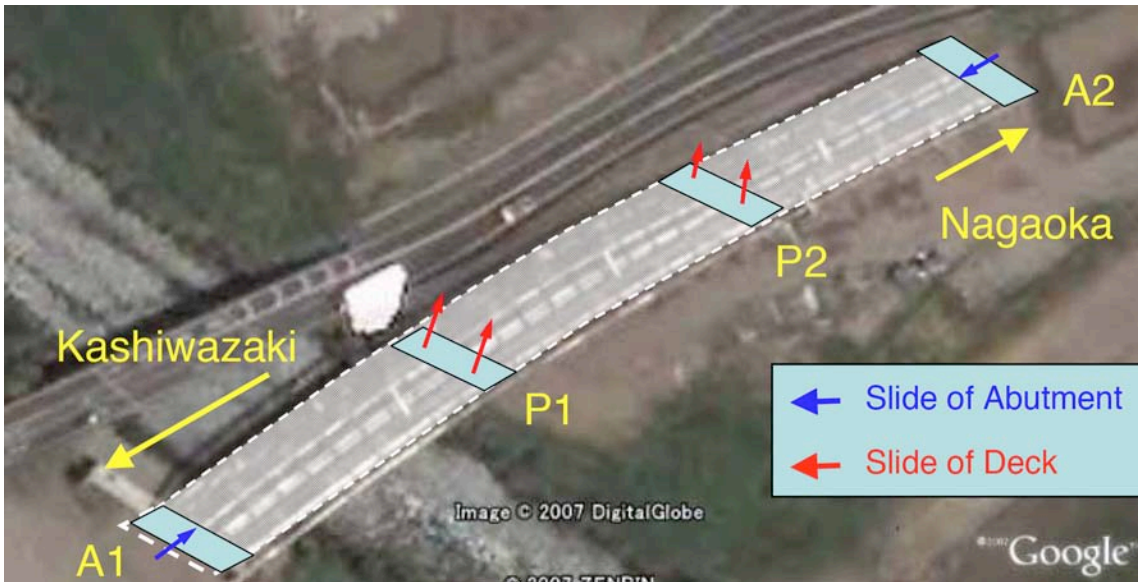
Fig. 6.14. Movement of Toyota Bridge (courtesy G. Watanabe, Tokyo Institute of Technology).

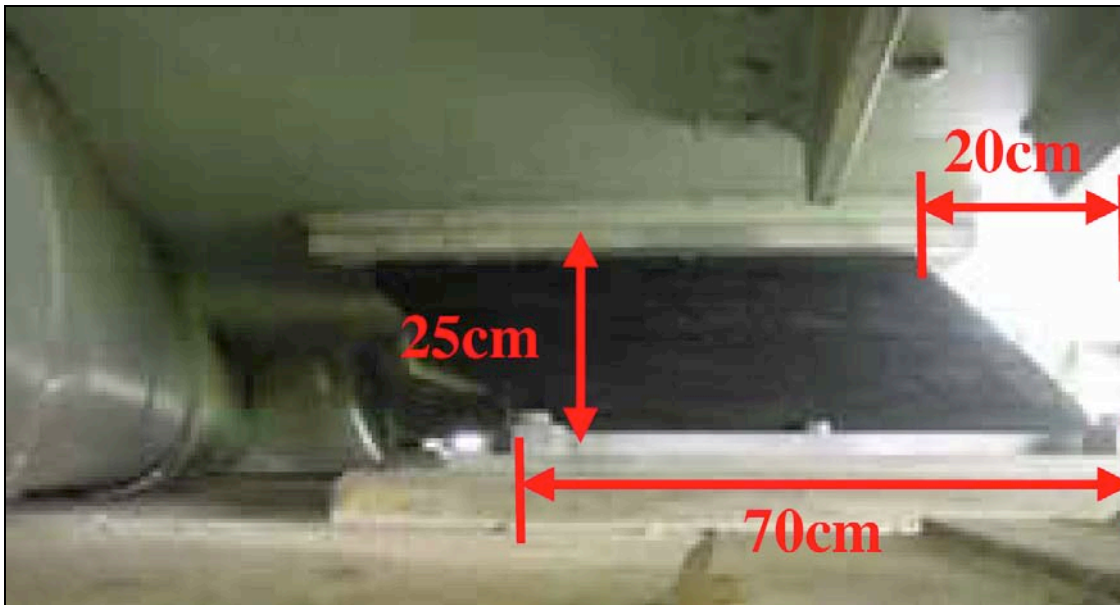
Fig. 6.15. Displacement of Bearing Bridge (courtesy G. Watanabe, Tokyo Institute of Technology).

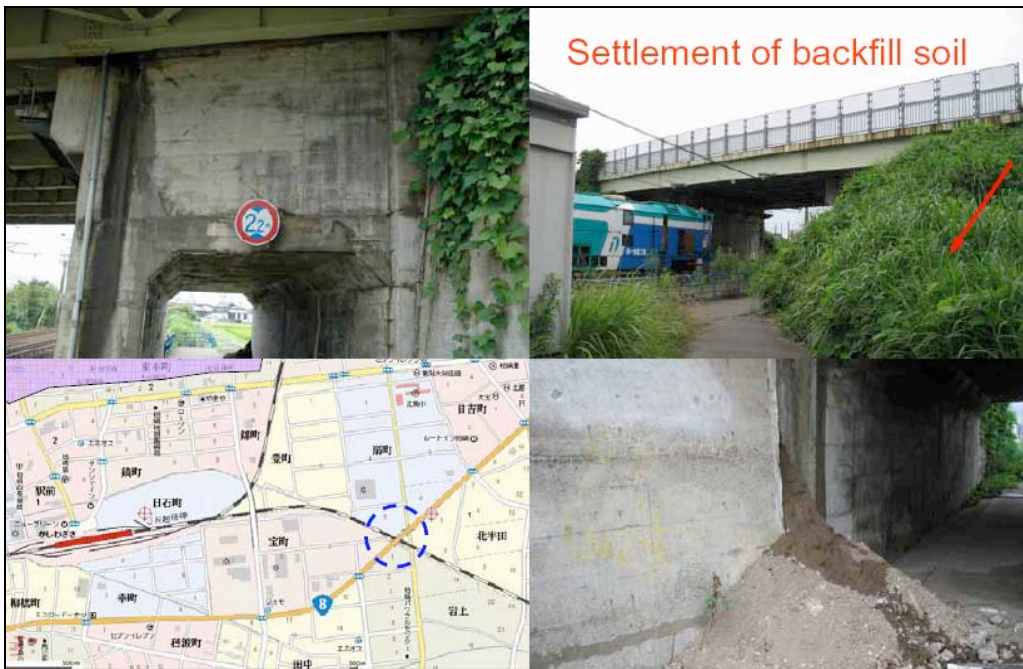
In downtown Kashiwazaki, on Highway 8 there are a couple of older bridges that are beginning to be maintenance problems. However, the only noticeable damage from the earthquake was some embankment damage behind the abutments on the Route 522 and the Japan Rail Bridges (Fig 6.16 and 6.17).

Fig. 6.17. Damage and repairs where railway crosses Highway 8 Bridge (courtesy G. Watanabe, Tokyo Institute of Technology).

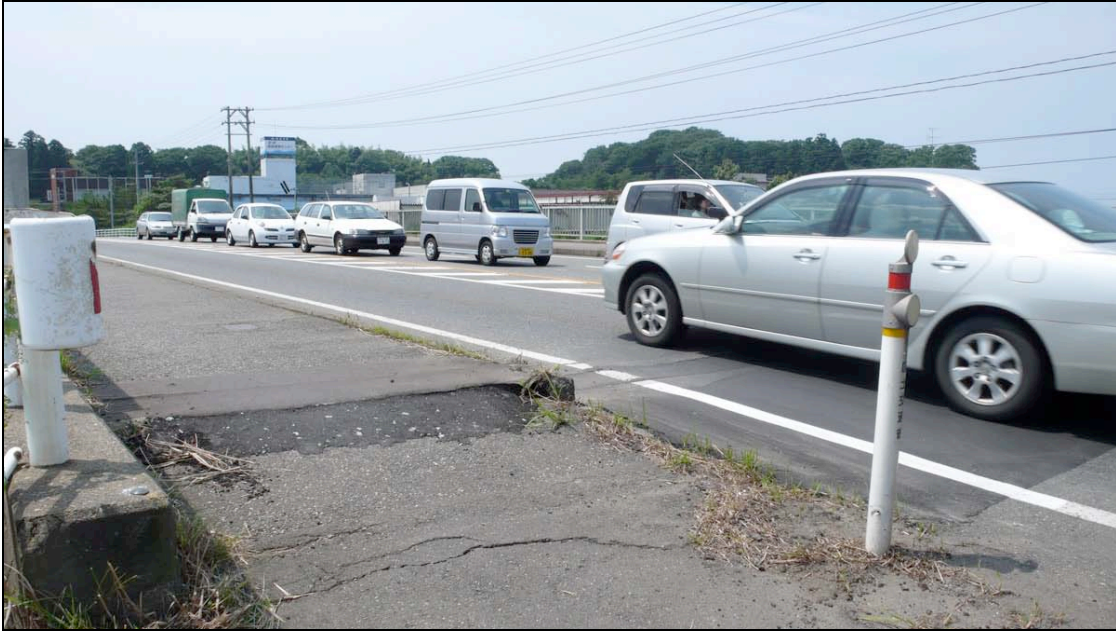
This is a two-span concrete I girder bridge on a pier wall and seat-type abutments (Fig. 6.18). Although bridges closer to the mouth of the Ugawa River sustained damage due to lateral spreading, this bridge (about 1.2 km upstream) had just a little bit of embankment settlement that was quickly repaired (Fig. 6.19). Just north of the bridge were several manholes raised above another roadway's surface and a nearby stonecutter's shop had toppled statuary suggesting a $PGA > 0.25g$. and that liquefaction was a problem at this site . However, the embankment settlement was only about 10cm and continued to decrease upstream, suggesting better soil and/or weaker accelerations.

Fig. 6.19. Slight (10cm) settlement at bridge approaches.

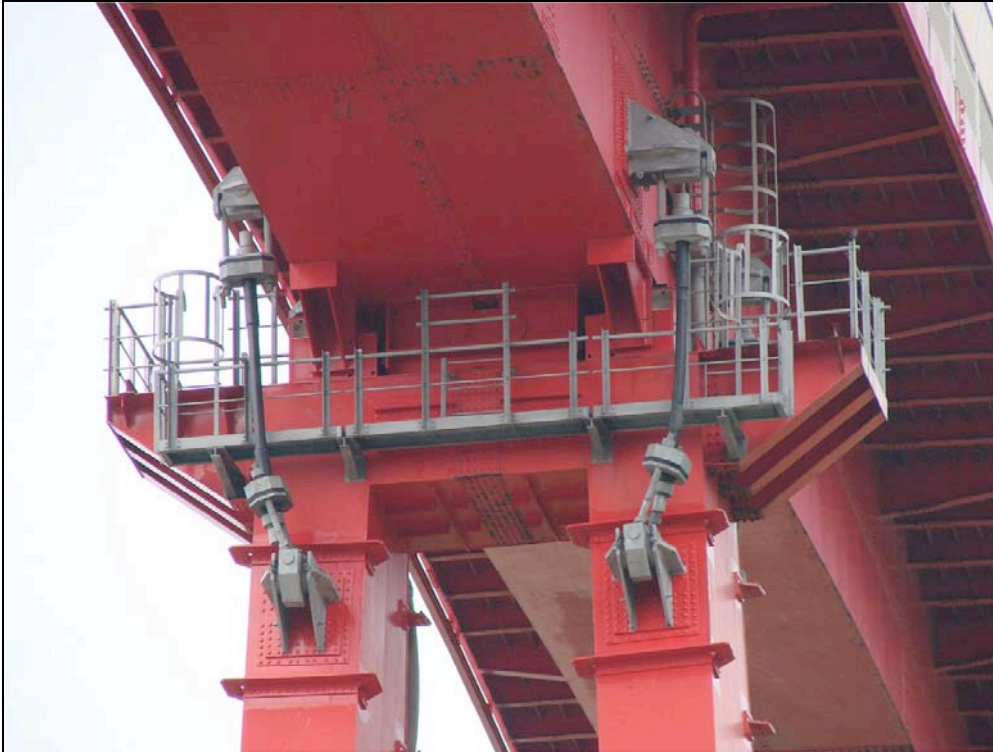
The bridge had been retrofit before the earthquake, which may have helped reduce the amount of damage that occurred. Lateral and vertical restrainers and stoppers were added at the superstructure (Fig. 6.22). The steel towers had been filled with concrete and stiffeners and doubler plates had been added to make the towers very stiff and strong.

Fig. 6.22. Retrofitted bent cap at Yoneyama Bridge (courtesy of S. Unjoh, PWRI).

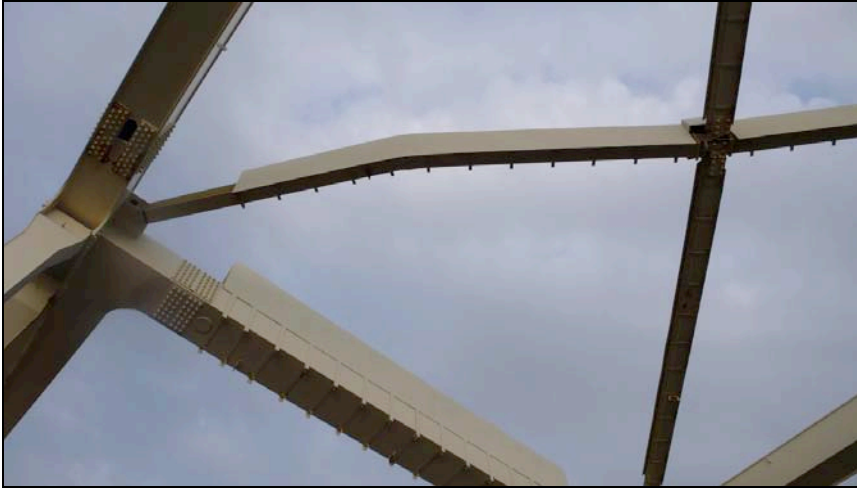
When we visited the bridge (on Aug. 4th) we saw many of its members had buckled (Fig. 6.25) and some of its connections were damaged (Fig 6.26) along with its bearings (Fig. 6.27). Still, the bridge remained in service. Metal boxes were placed around the bearings to support the bridge in case a strong aftershock occurs. This is a very common bridge type. However, the struts and bracings need to be designed against lateral wind force and lateral earthquake force. It appears that the earthquake force during this earthquake exceeded the design force. A deck arch bridge, the Agewa Bridge immediately to the north was undamaged by the earthquake (Fig. 6.28). It might be possible to retrofit the Yonahime bridge for large earthquakes, possibly by supporting it on isolation bearings. Certainly, these fixed bearings, which we saw damaged on several of the longer span bridges, are a lot of trouble to replace.

Fig. 6.25. Buckled cross bracing on Yonahime Bridge.

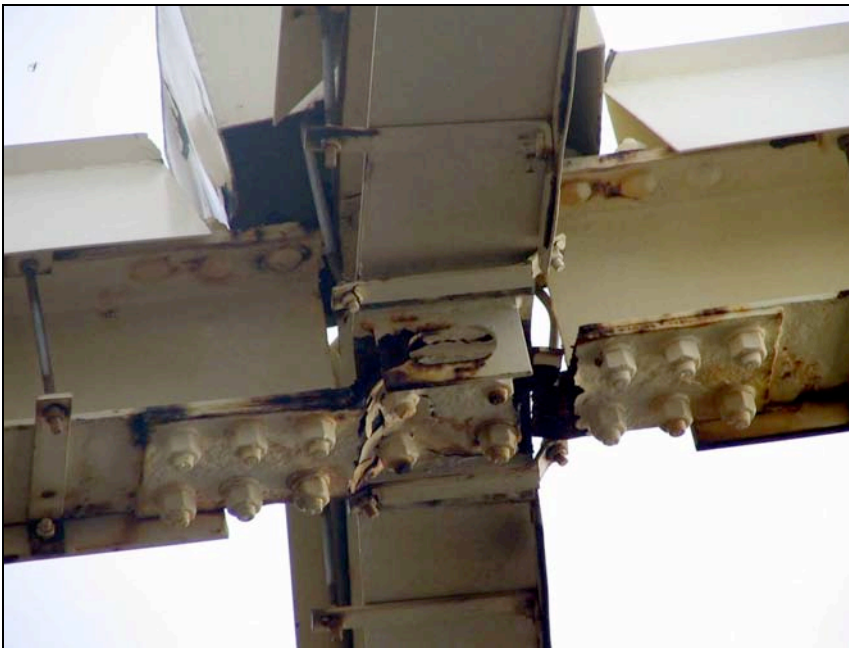
Fig. 6.26. Torn cross bracing connection on Yonahime Bridge.

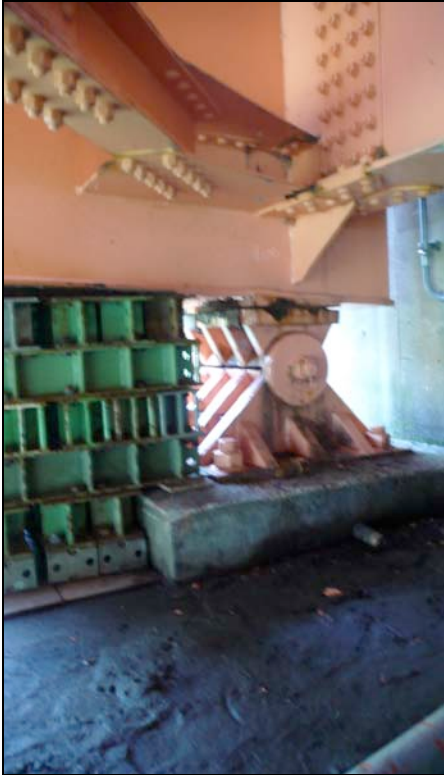
Fig. 6.27. Damage of set bolts and the additional steel box support to prepare the aftershocks)

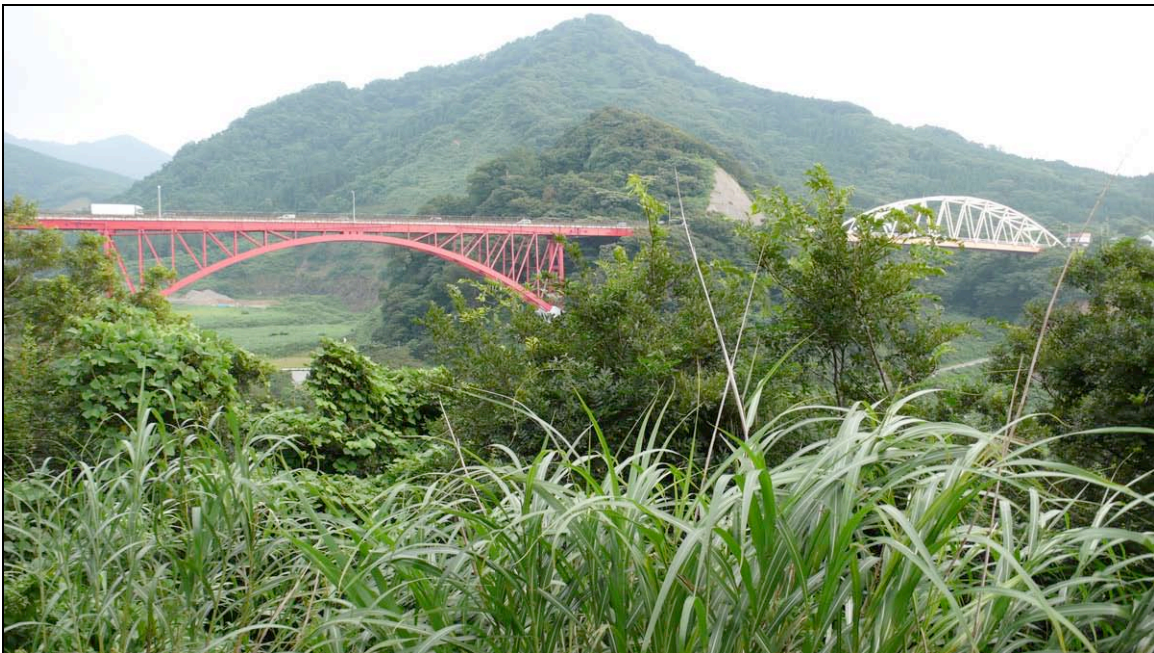
Fig. 6.28. Undamaged Agewa (Deck Arch) Bridge just north of damaged Yonahime Bridge.

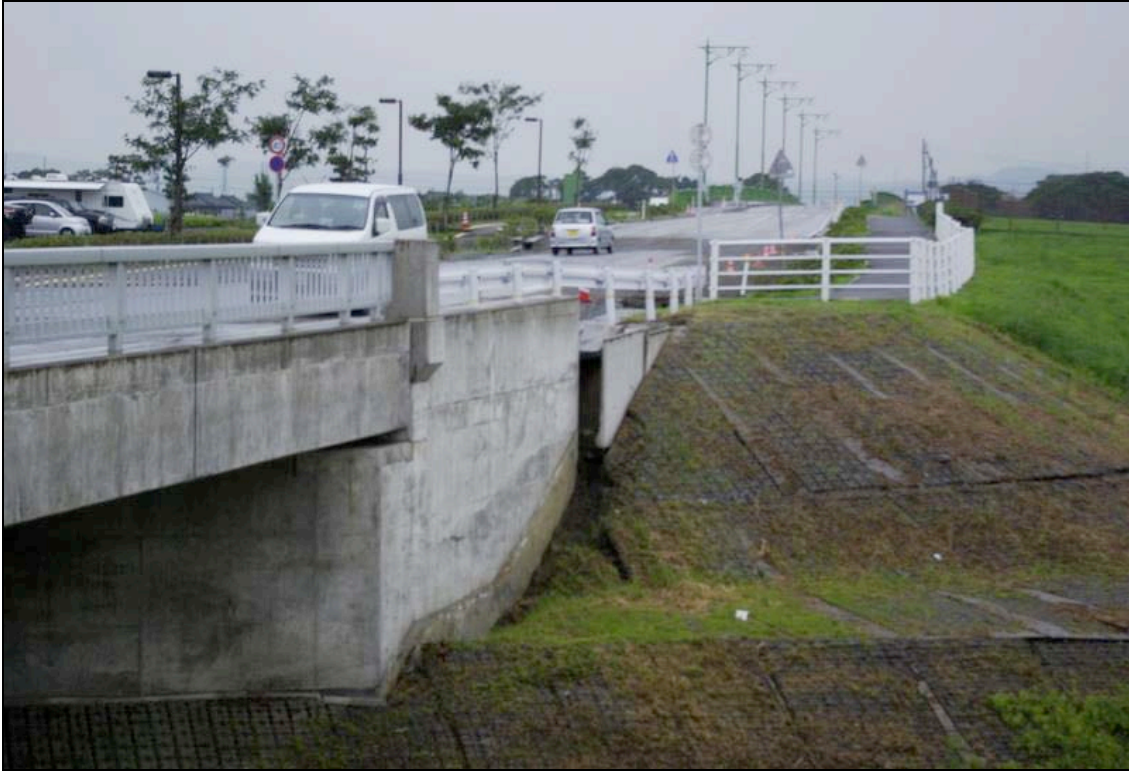
During the earthquake, the south bridge embankment settled as the bank spread into the river. The wingwalls weren't attached to the abutment (which was on piles) and moved with the embankment (Fig. 6.31). The lateral spread was the result of liquefaction of the island (Fig. 6.32). Figure 33 shows about 400 cm settlement of the south embankment.

Fig 6.31. Looking southeast at Heisei bridge abutment, settled embankment, and the island.

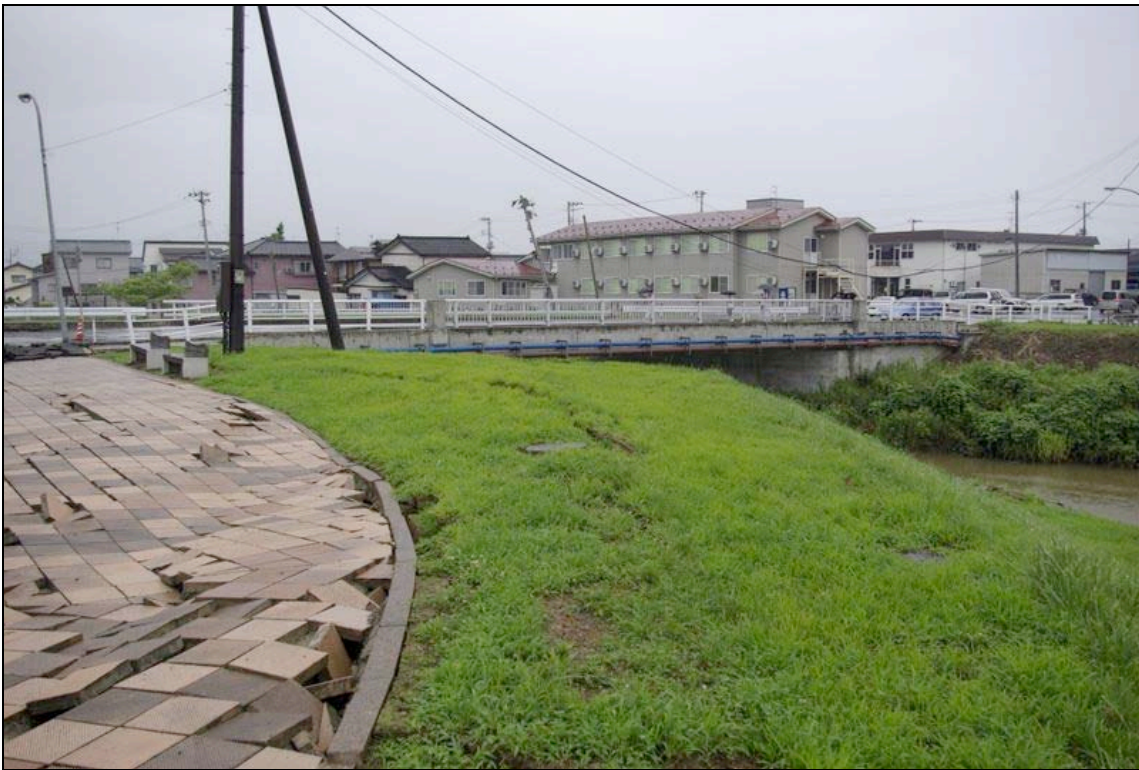
Fig. 6.32. Looking northwest at liquefaction of island and the Heisei Bridge.

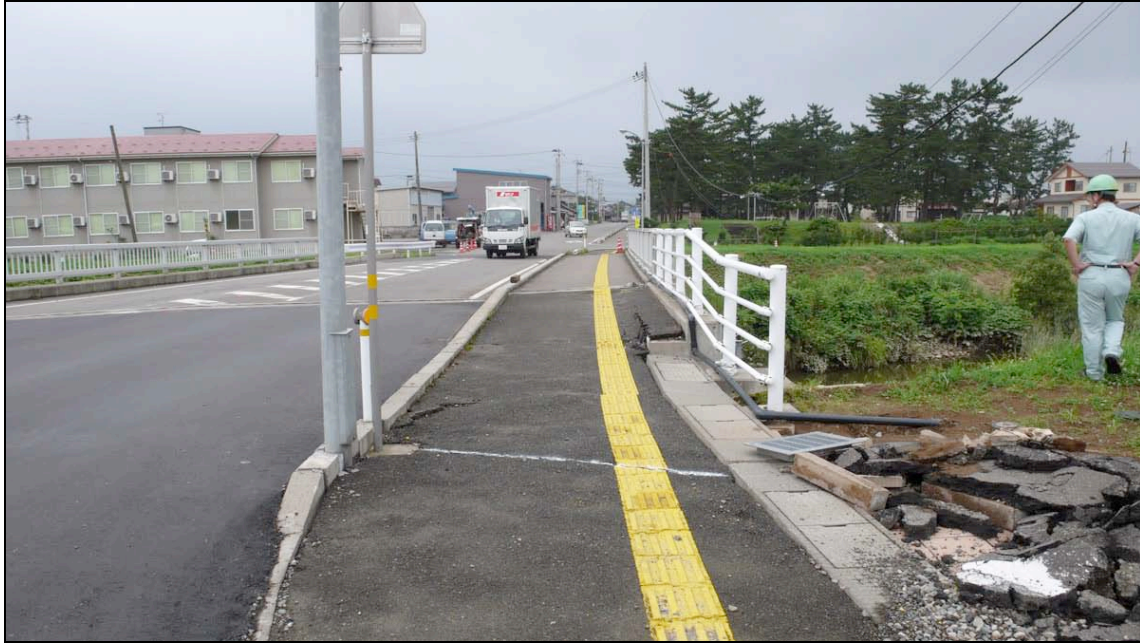
Fig. 6.33. Looking north from island at Hashi bridge deck.

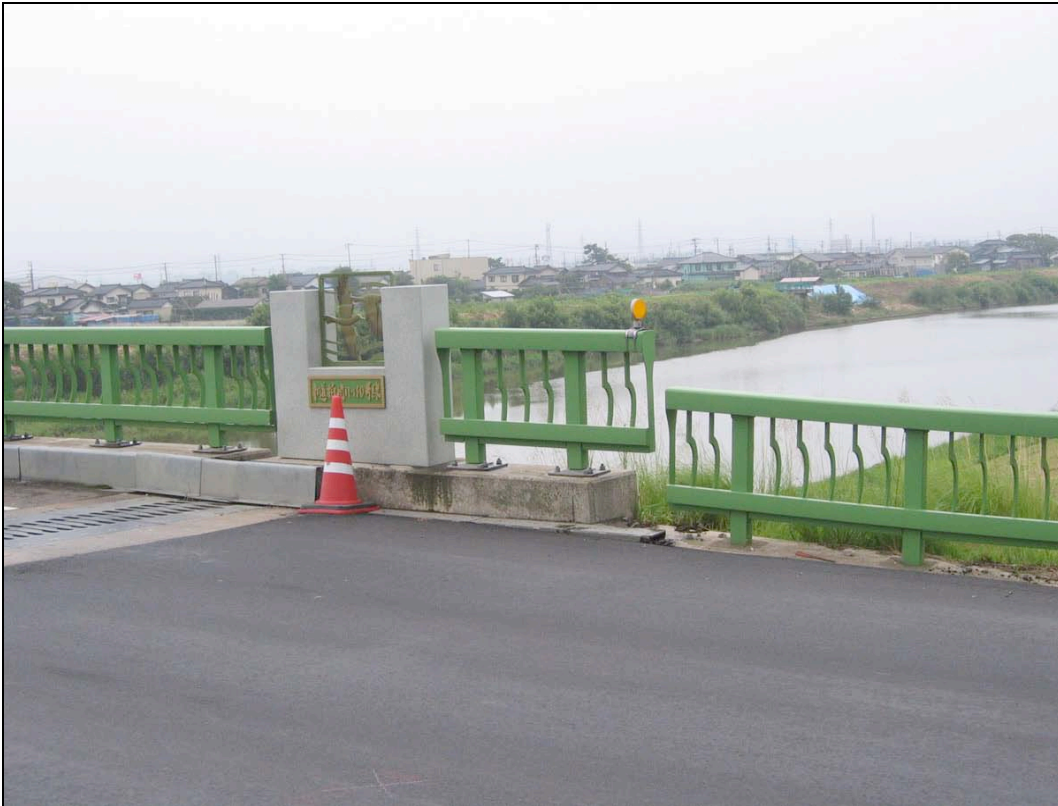
This is a continuous, two-span, concrete box girder bridge supported on seat abutments and a pier wall (Fig. 6.34). During the earthquake, the north bridge embankment settled about 40 cm (Fig 6.35). There were also signs that the bridge underwent shaking and pounding (Fig. 6.36). Although the abutments were on piles, the bearings were distorted, indicating that the abutments had been pushed toward the river (Fig. 6.37).

Fig. 6.35. Settlement of north bridge approach.

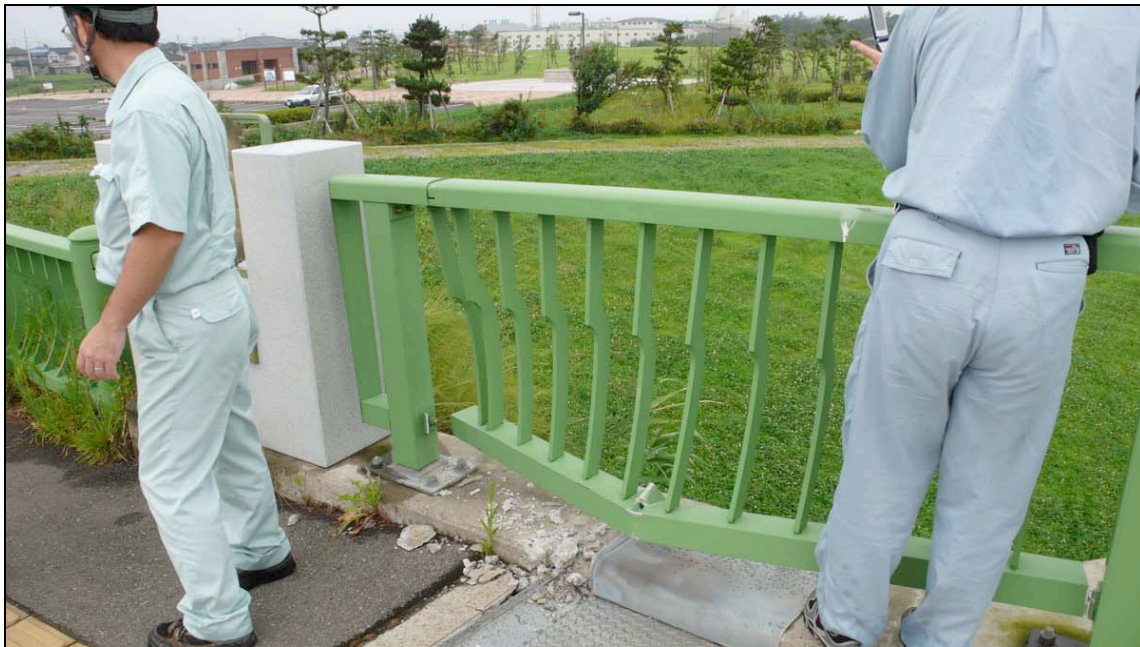
Note that unlike the north Heisei Bridge, there are apparently piles under the short wingwalls on the south Heisei Bridge. Figures 6.38 and 6.39 show the wingwalls at the same height as the abutment and they also show signs of pounding between them.

Fig. 6.38. Pounding between abutment and wingwall.

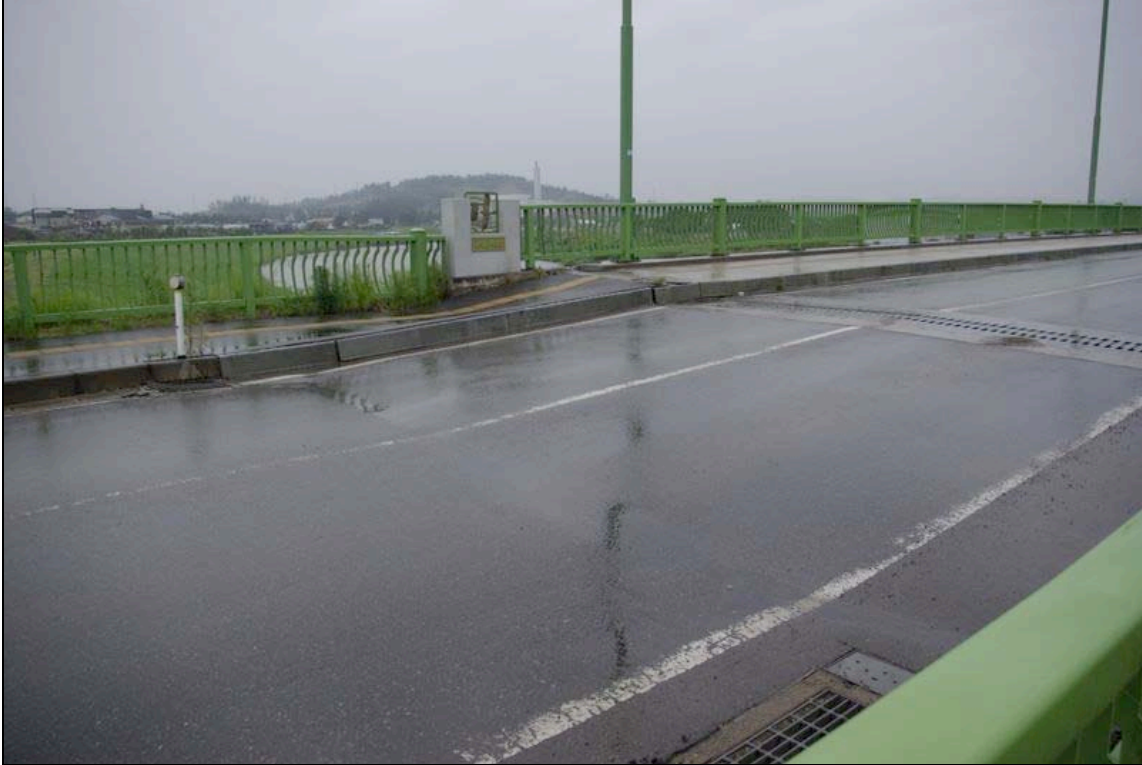
Fig. 6.39. Settlement of north bridge abutment.

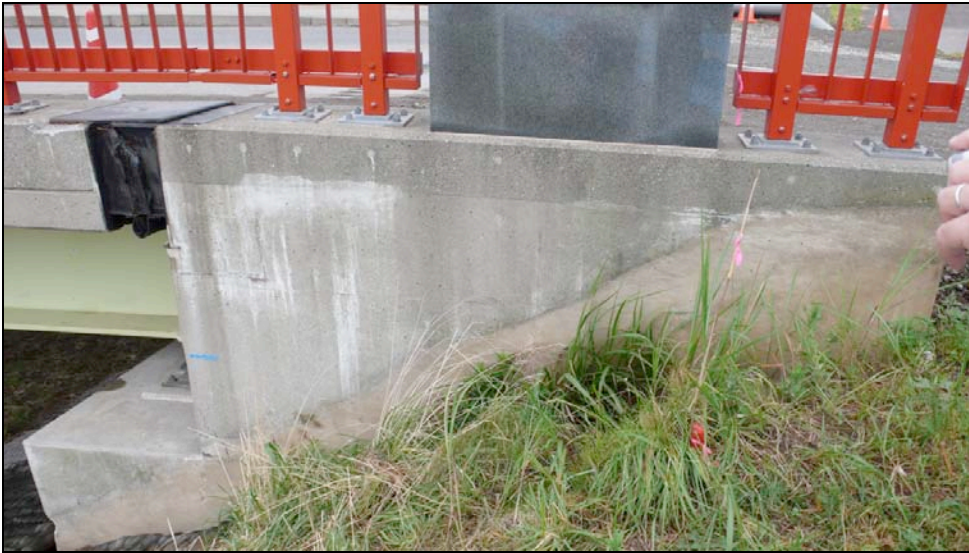
Like the other Sabaishi bridges, this settlement was caused by the riverbank spreading

Fig. 6.42 The soil around the south abutment moved towards the river during the earthquake.

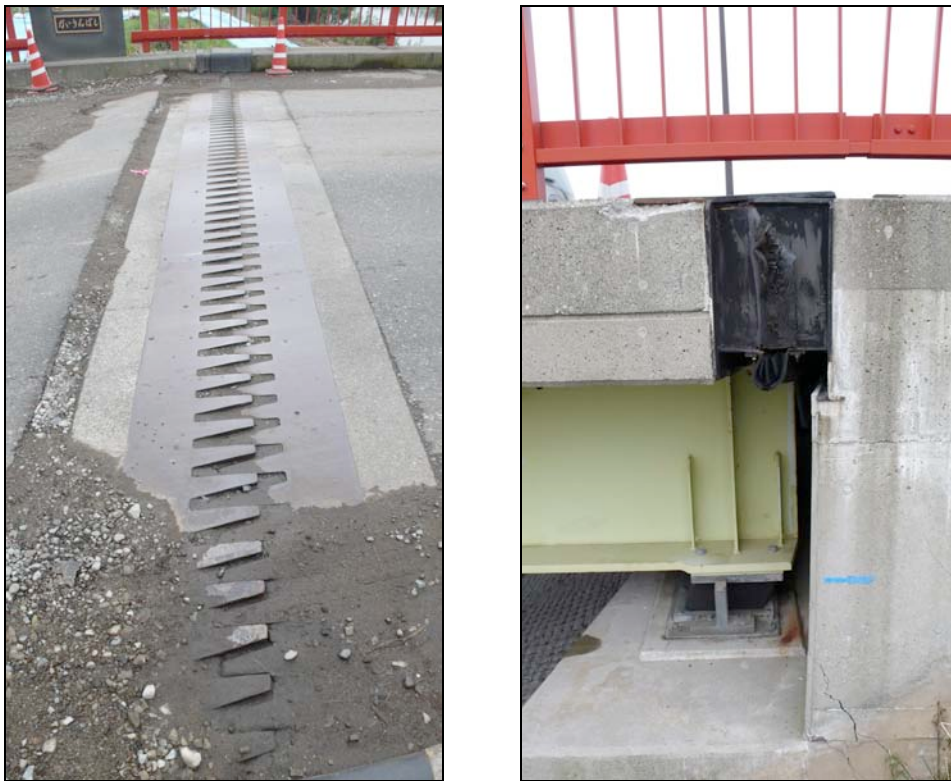
toward the river (Fig. 6.42). Although the expansion joint, the abutment, and the bearings should have been isolated from this movement by the pile supports, they were distorted as shown in Fig. 6.43 during the earthquake, perhaps due to the ground shaking.

Fig. 6.43. Distortion of expansion joint, bearings, and abutment on Kaiun Bridge.

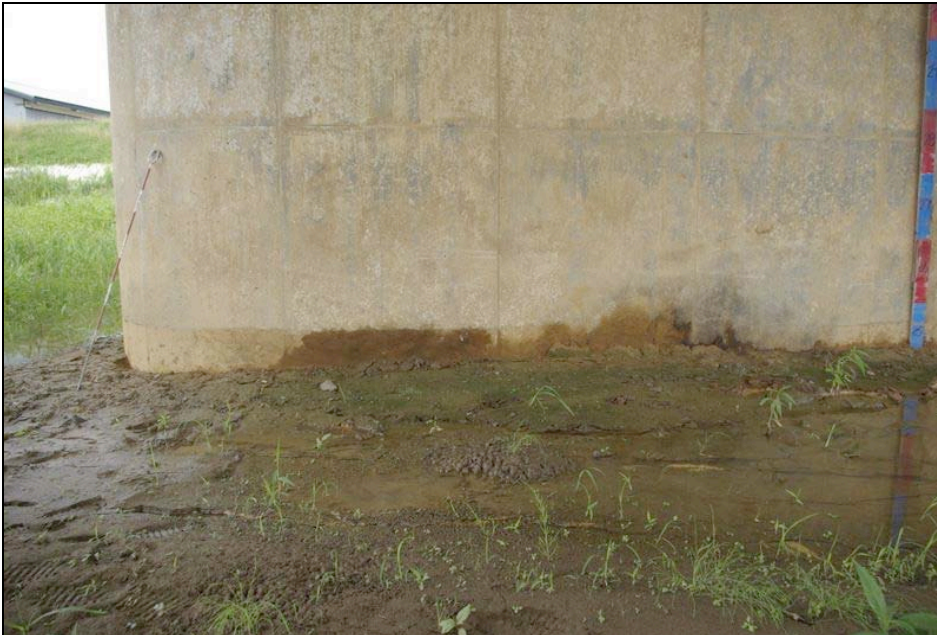
This is a three span steel girder bridge on pier walls and seat-type abutments (Fig. 6.44). There was evidence of fine grain soil being ejected at depth to the ground surface (along with settlement) at the saturated riverbanks (Fig. 6.45). There was damage to the abutment backwall (Fig. 6.46) and to the bridge approaches (Fig. 6.47).

Fig. 6.45. Soil settled around pier in riverbank (photo courtesy of Scott Brandenburg).

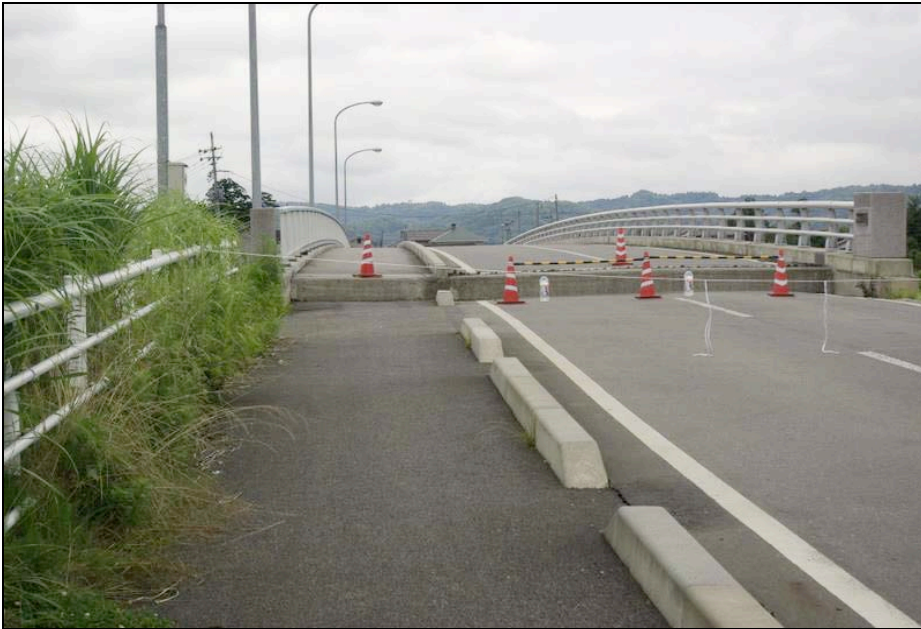
This is the last Sabaishi River bridge that had a big approach settlement (Fig. 6.48).

Fig 6.48 Genji Bridge (photo courtesy of Scott Brandenburg).

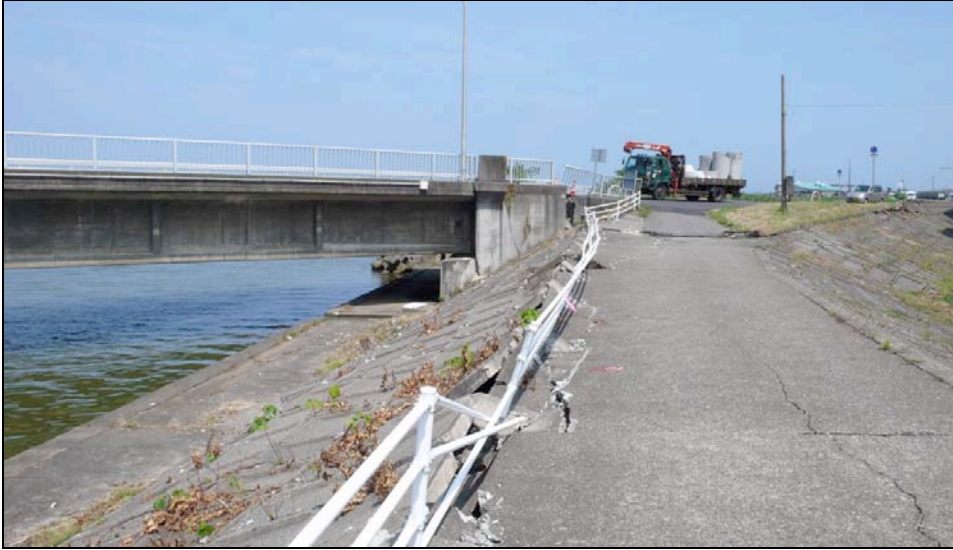
This is a two span concrete I girder bridge on seat abutments and a single column bent with a hammerhead cap at the mouth of the Ugawa. This location had the most lateral spreading on the Ugawa. The entire levee was dragged toward the river (Fig. 6.50) and the abutment was damaged and separated from the wingwall (Fig. 6.51).

Fig 6.50. Rinko Yasaka Bridge at the mouth of the Ugawa.

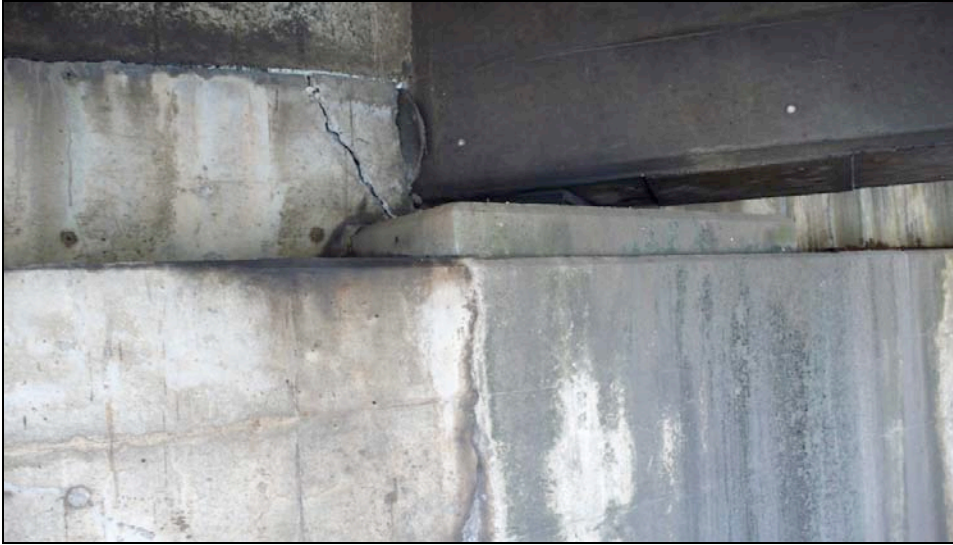
The concrete I girders broke the abutment backwall (Fig. 6.52), the bridge approaches were damaged but quickly repaired (Fig. 6.53), and it appeared that repair work was going on at the center pier (Fig. 6.54).

Fig. 6.52. Backwall-Diaphragm damaged by earthquake.

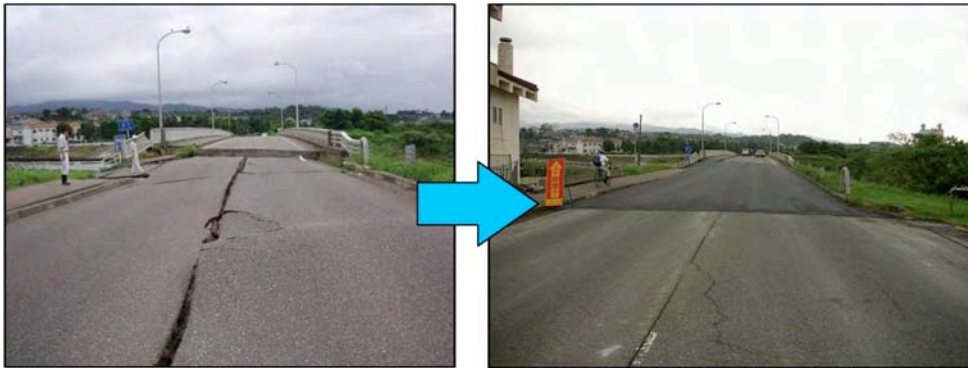
Fig. 6.53. Before and after views of approach and bridge deck.

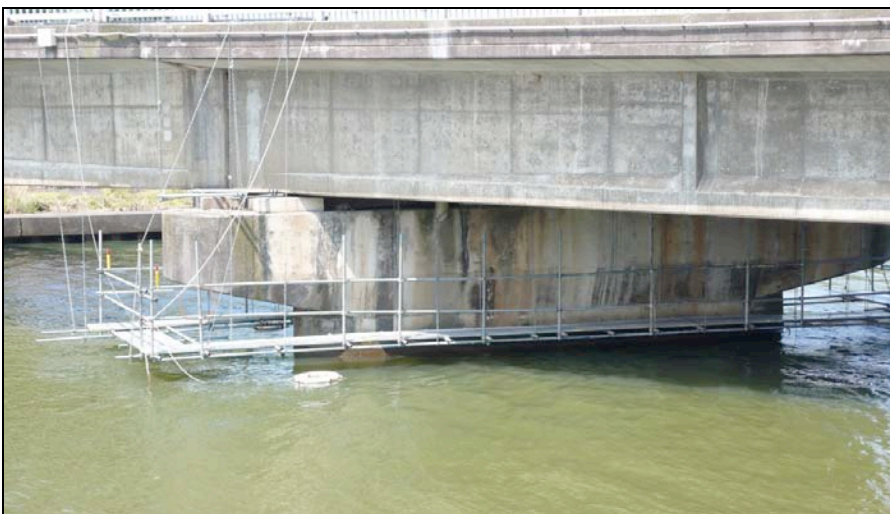
Fig. 6.54. Pier supporting Rinko Yasaka Bridge.

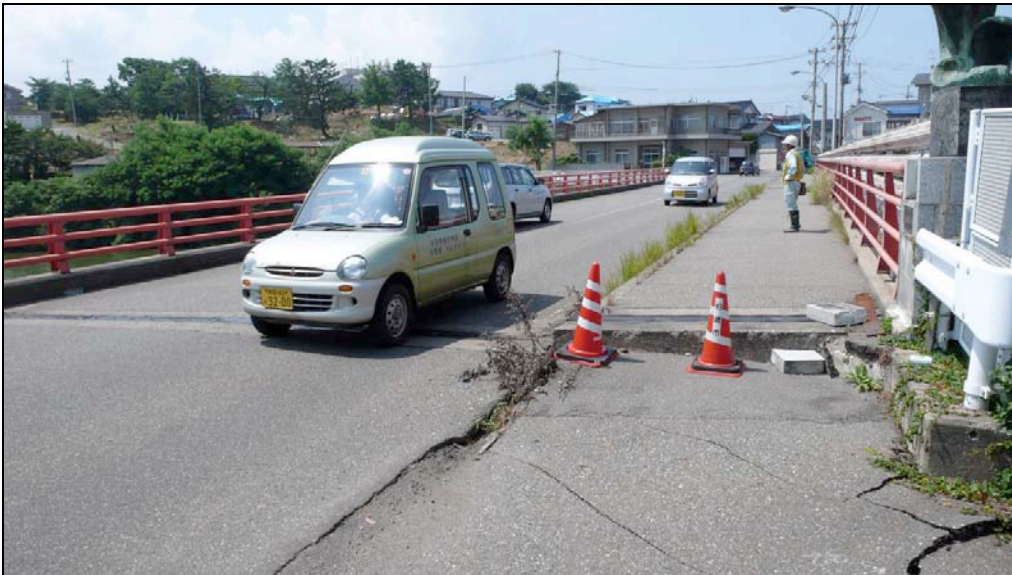
Like most of the bridges over the Ugawa, this is a two span, simply-supported river crossing, but with steel girders, and supported on a pier wall and seat-type abutments (Fig. 6.55). It is about 200 meters from the more heavily damaged Rinko Yasaka Bridge, but the soil was much firmer at this site, there was less than 100 cm of settlement at the approaches, and no damage to the abutments or wingwalls (Fig. 6.56).

Fig. 6.56. Approach and deck of Yasaka Bridge.

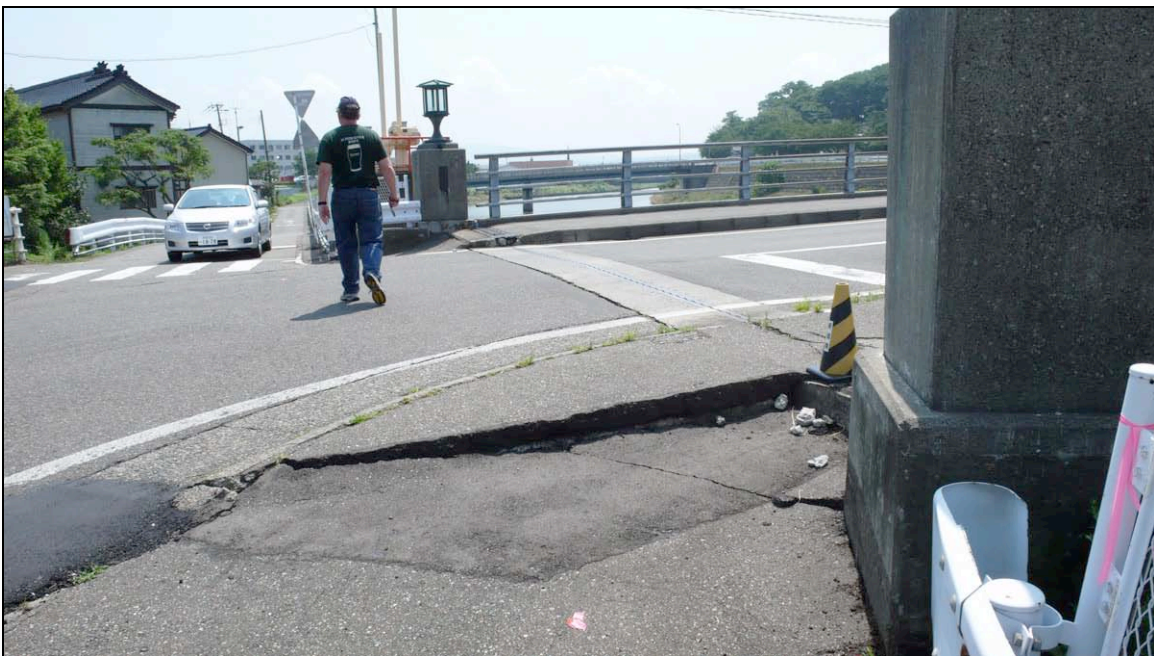
Continuing to walk upstream another 300 meters, we came to the third bridge crossing the Ugawa. The Ukawa bridge is a two (simple) span 'I' girder bridge supported by a pier wall and seat-type abutments (Fig. 6.57). All of these bridges are about 60 meters long. As seen in Figure 6.58 the only damage was some settlement of the sidewalk on the south end of the bridge.

Fig. 6.58. Approach to Ukawa Bridge.

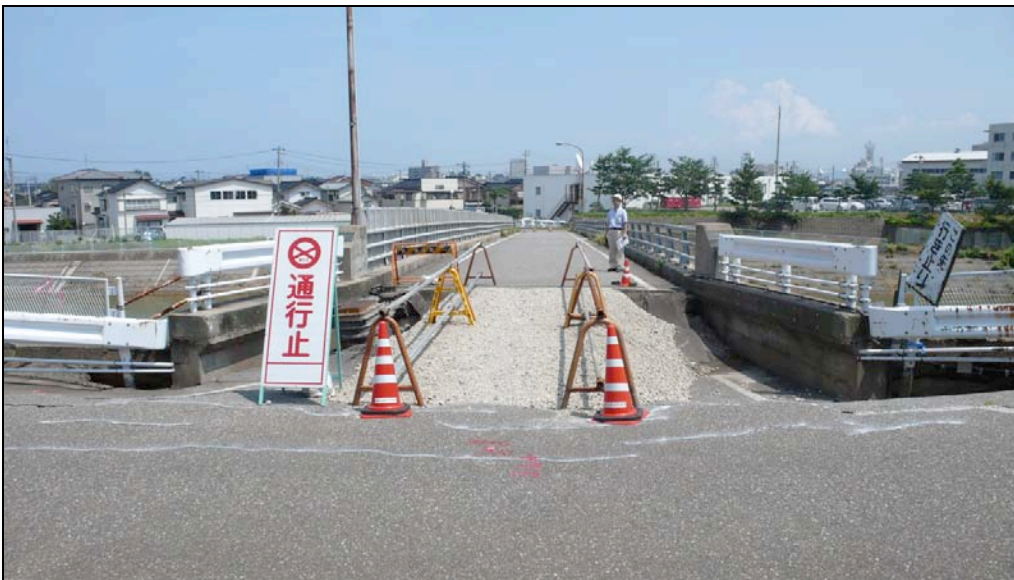
The fourth crossing, a narrow (6 m wide) two-span concrete box girder bridge on a single-column bent and tall and short abutments (Fig. 6.59) had more damage. Although the south levee moved very little, the embankment between the levee and the bridge settled a meter (Fig. 6.60) and there was damage to the abutment including a leaking waterline (Fig. 6.61). Figure 6.62 provides a closer view of the settled embankment.

Fig. 6.60. Looking north at the south approach to Osu Bashi.

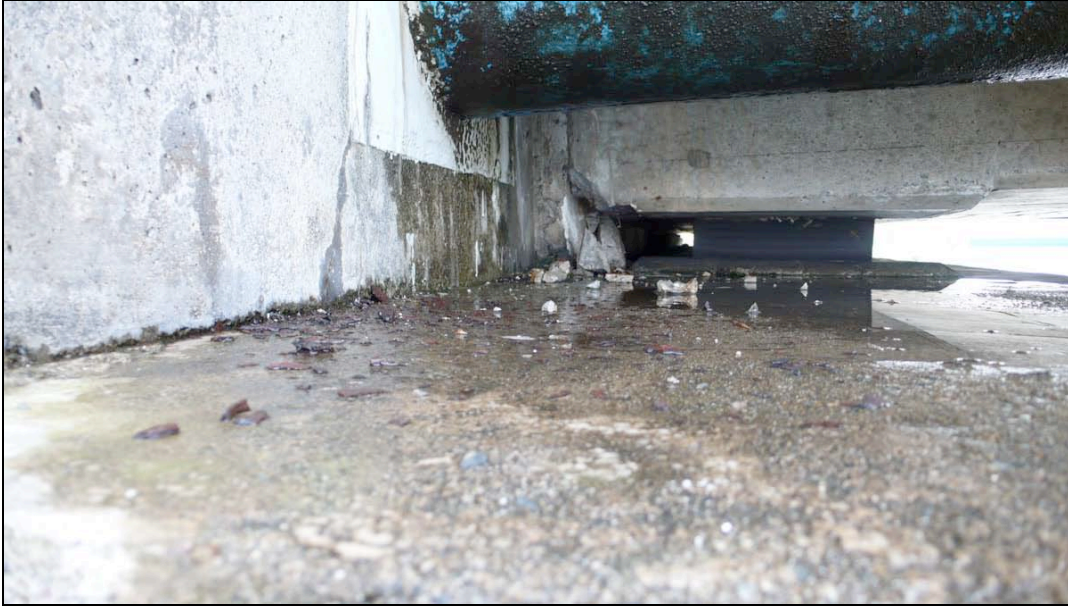
Fig. 6.61. The superstructure is supported on a single bearing (note waterline).

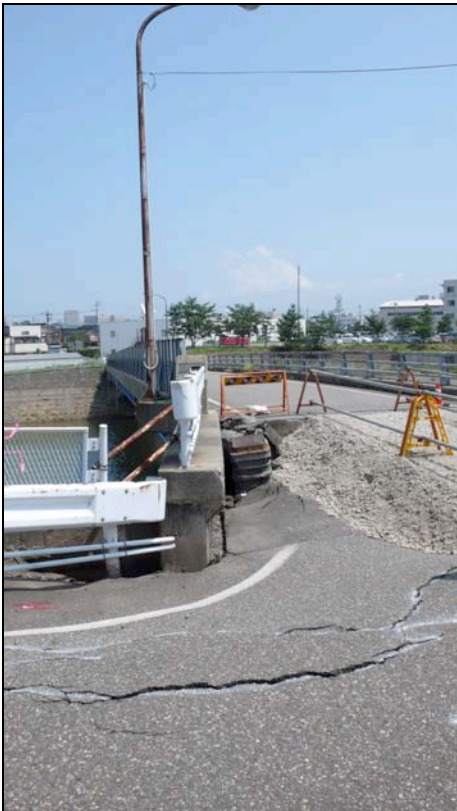
Fig. 6.62. Closer view of settlement at south abutment.

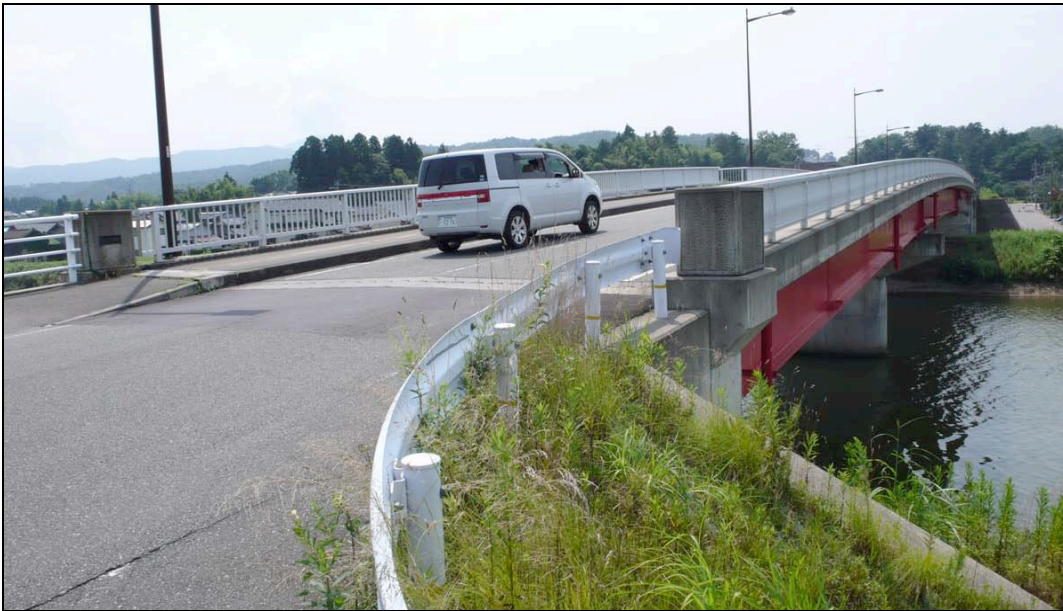
This was the last bridge across the Ugawa where we saw any sign of approach settlement. It's a four-simple span steel 'I' girder bridge that crosses over the river, the levees, and a river road. We walked past a lot of flood control facilities along the river including the flood gate seen in Figure 6.65. This bridge has a long embankment on the south side. Figure 6.66 shows a very slight settlement at the north approach.

Fig. 6.66. Looking at the north approach.

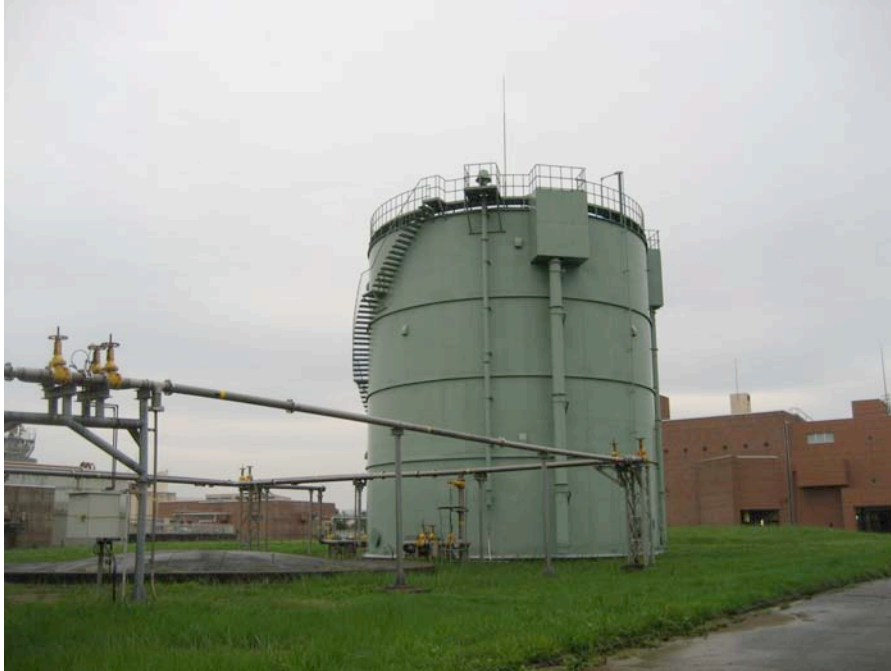
- Wastewater tanks at a site of extensive liquefaction. Both concrete and steel tanks were observed at the Ansei-Chou waste water treatment plant adjacent to the Sabaishi River (Figure 7.1). Sand boils and ground settlement adjacent to the tanks were observed, however the concrete tanks appeared undamaged. A large steel tank exhibited a section with very minor ripples along the wall that may have been due to the earthquake (Figure 7.2). Overall it appeared to be in good condition and maintained full operation.

Figure 7.1: Steel tank at the Ansei-Chou waste water treatment plant (Site RK9, N37.38748°, E138.56587°, photo taken 7/20/07 16:40). Sand boils and slight overturning of the support member to the far-most right of the photograph were observed, as was extensive lateral spreading and road damage. Indications of minor distress of the tank was identified but for the most part appeared in good service.

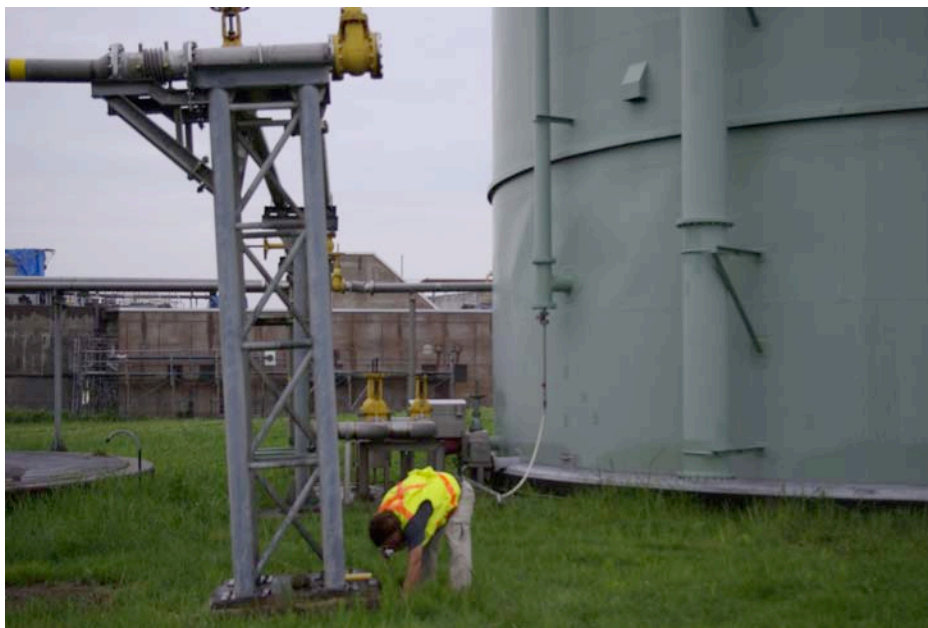
Figure 7.2: Steel tank at the Ansei-Chou waste water treatment plant (Site RK9, N37.38748°, E138.56587°, photo taken 7/20/07 16:40). Minor distress to the wall was observed roughly 3 m above the base of the tank.
