Preliminary Observations on the Niigata-Chuetsu Oki, Japan, Earthquake of July 16, 2007

EERI-GEER Web Report 2007-1 v.8
October 9, 2007

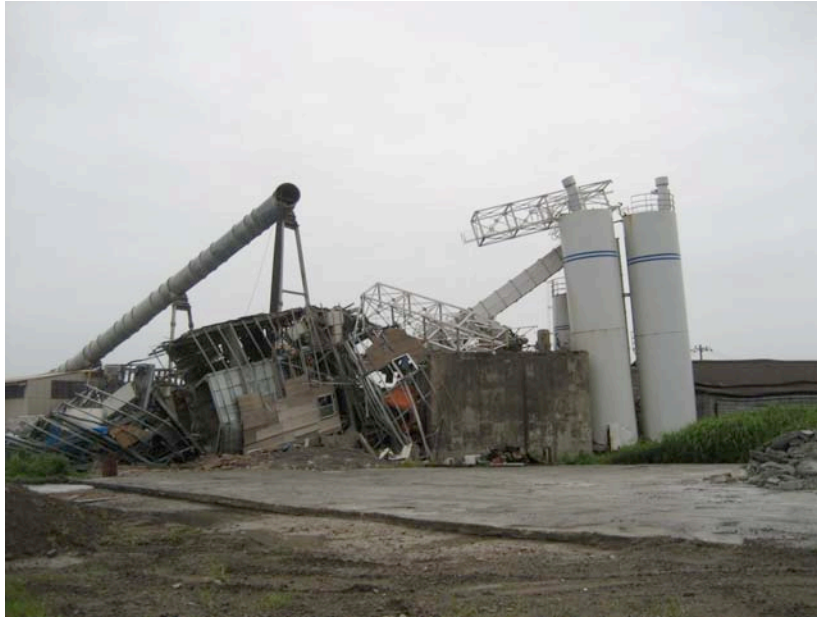
- Failure of two cement-plant storage tanks. Buckling failure of the tank bases was observed in an area of extensive liquefaction damage (Figures 7.3 and 7.4). Mast-structures perched above the tanks also failed at the mast-tank connection. The tanks, although recently painted and appearing to be operational, were also empty at the time of investigation, possibly indicating that the tanks were not currently in use or maintained.

Figure 7.3: Damage to steel tanks at the cement plant located adjacent to the mouth of the Sabaishi River (Site RK10, N37.38795°, E138.56508°, photo taken 7/20/07 17:10). Tank damage likely caused by the cumulative effects of inertial loading, ground failures, and lateral loads due to the failure of appurtenant structures.

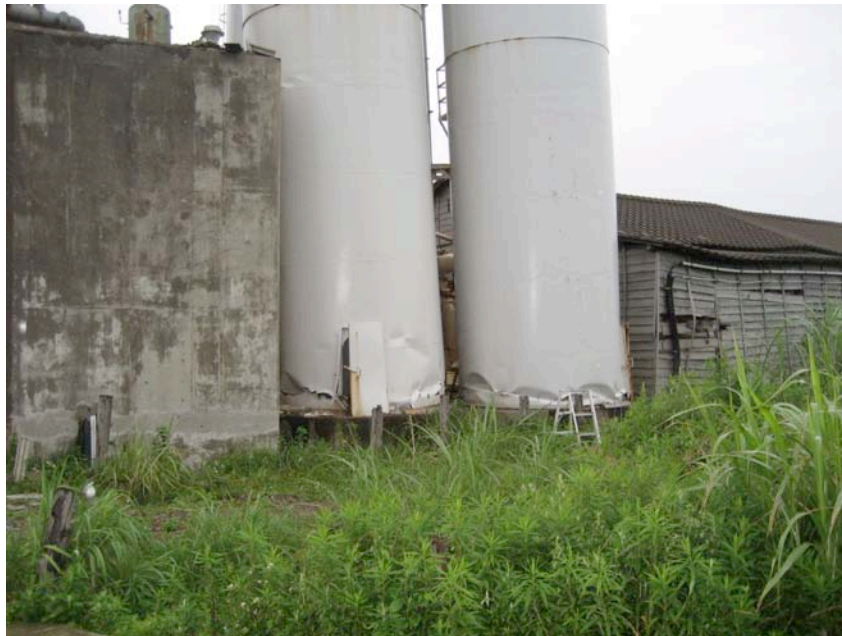
Figure 7.4: Close-up of damage to steel tanks at the cement plant located adjacent to the mouth of the Sabaishi River (Site RK10, N37.38795°, E138.56508°, photo taken 7/20/07 17:20). Buckling at the base of the tanks is evident.

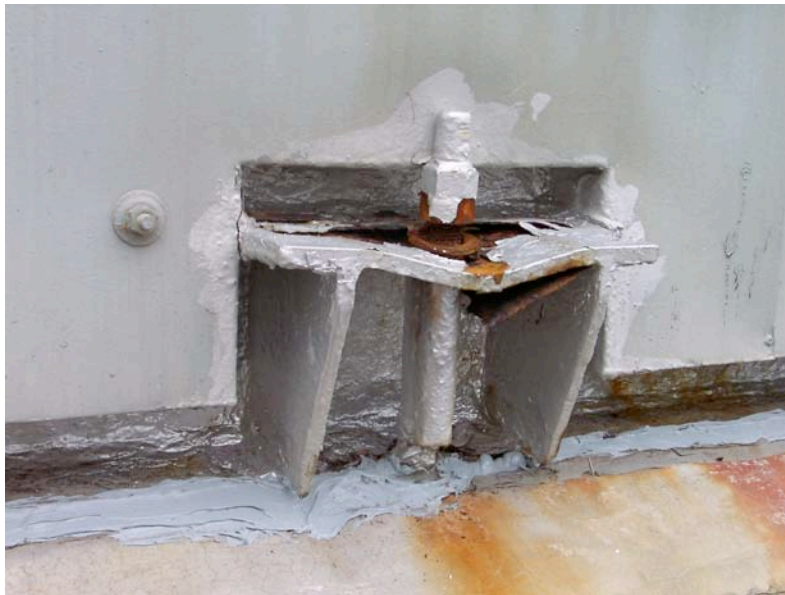
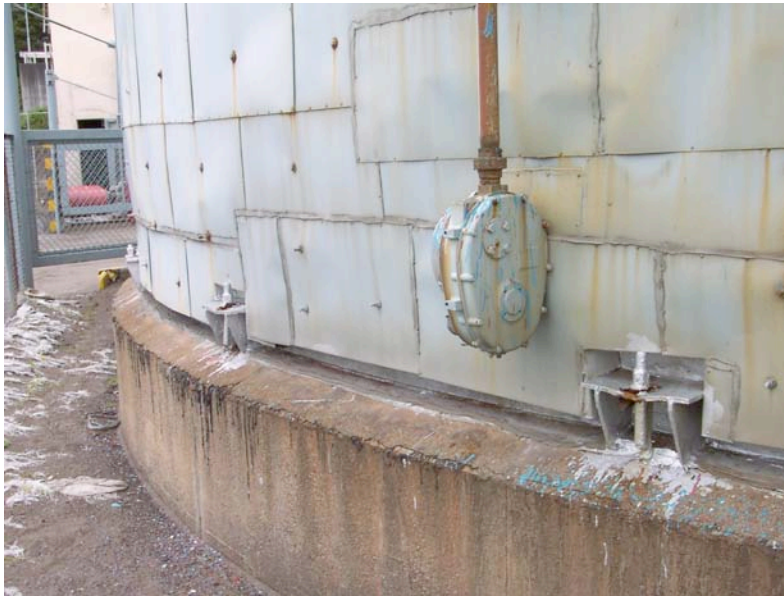
- Asphalt storage tank located in the western portion of the Port of Kashiwazaki (Take Naka Facility). The facility was in operation at the time of the reconnaissance and the inspection focused on the performance of a large, insulated asphalt holding tank (Figure 7.5). The tank is secured at its base by a bolt and flange detail (Figure 7.6). Many of the flanges were bent, however none of the bolts appeared to have failed. No “elephant’s foot” bulking of the tank was noted, although the exterior of the tank is covered with a layer of insulation which prohibited a more thorough inspection (Figure 7.7). The tank structure and appurtenant pipes appeared to be undamaged except for minor failures of the tank anchor system. This structure is also addressed in the section on Port and Harbors.

Figure 7.6: Kashiwazaki Port - Anchorage of asphalt storage tank (Located near Site RK25, N37.36713° E138.53210°, photo taken 7/22/07 12:37).

Figure 7.7: Kashiwazaki Port - Anchorage of asphalt storage tank (Located near Site RK25, N37.36713° E138.53210°, photo taken 7/22/07 12:37).

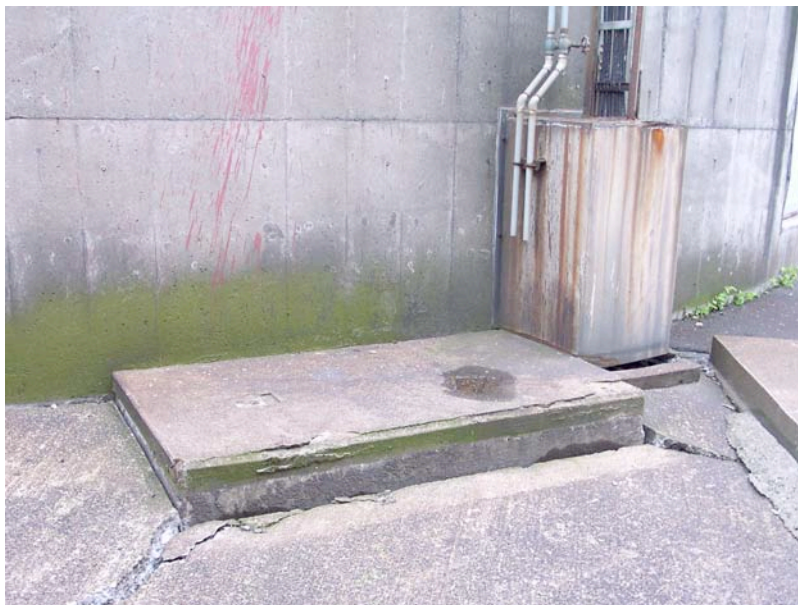
Figure 7.8: Kashiwazaki Port (Taiheiyo Cement Facility) - Evidence of minor to moderate settlement of sandy fill adjacent to one of the large diameter tanks (Site SD 9, approximately N37.36665° E138.53983°, photo taken 7/22/07 15:48).

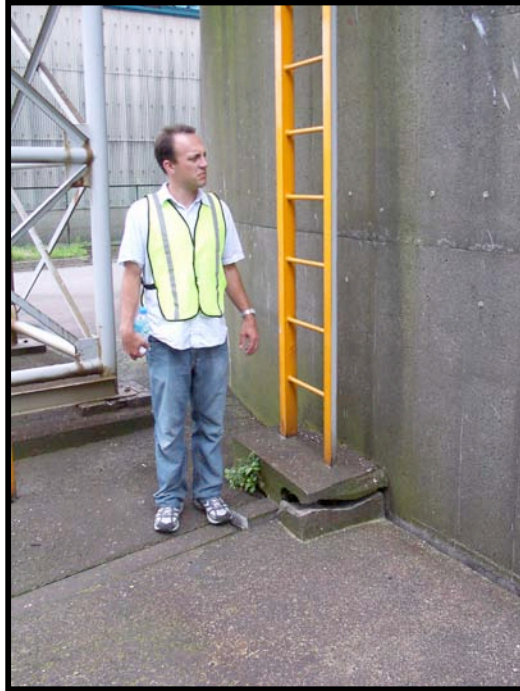
Figure 7.9: Kashiwazaki Port (Taiheiyo Cement Facility) - Evidence of minor to moderate settlement of sandy fill adjacent to one of the large diameter tanks (Site SD 9, approximately N37.36665° E138.53983°, photo taken 7/22/07 15:48).

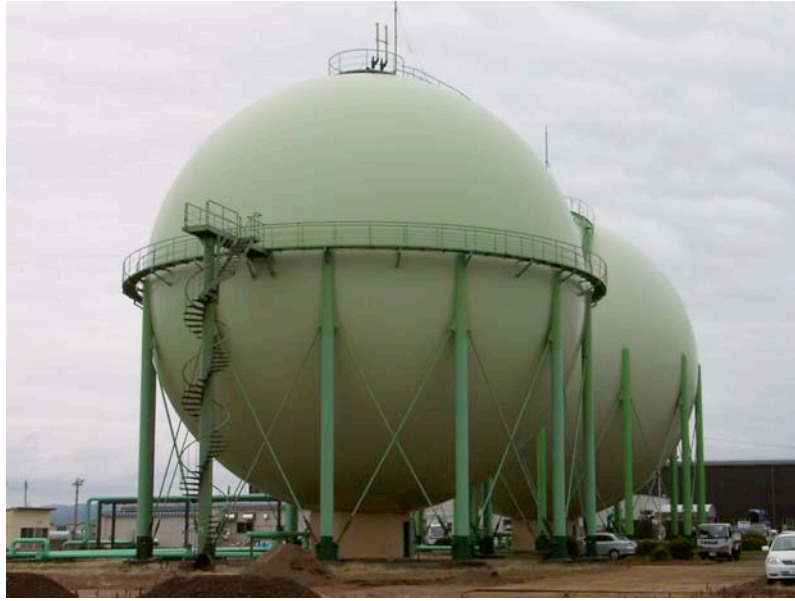
Figure 7.10: Steel natural gas tanks undergoing inspection by the operator and engineering consultants (Site SD13/RK57, N37.37253°, E138.59488°, photo taken 7/23/07 12:37). Trenching and below grade inspections had already taken place prior to the field investigation. No damage was observed to the tanks, pipe connections, or mains, however observations were made from the perimeter of the facility, a short distance from the structures.

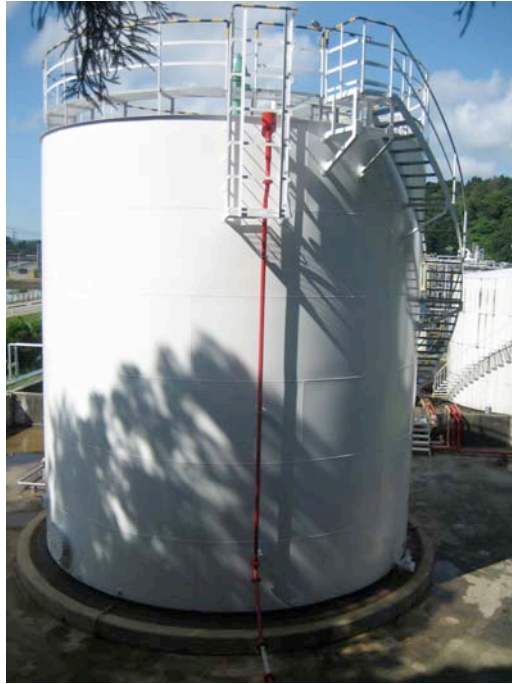
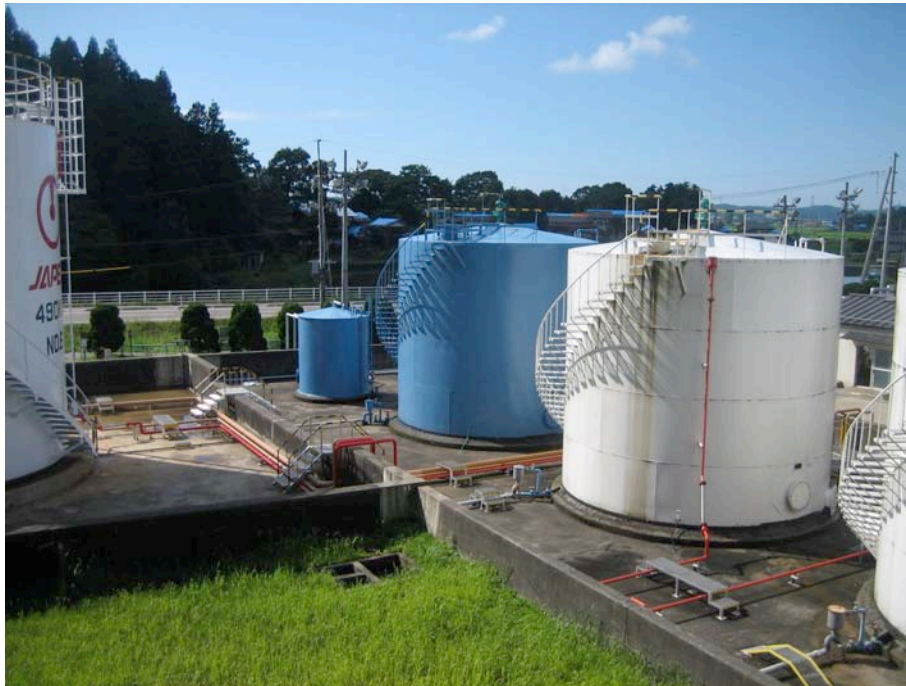
Figure 7.12: Oil storage tanks (Site RK55, N37.38917° E138.63377°, photos taken 7/23/07 12:30). No damage was observed at this site.

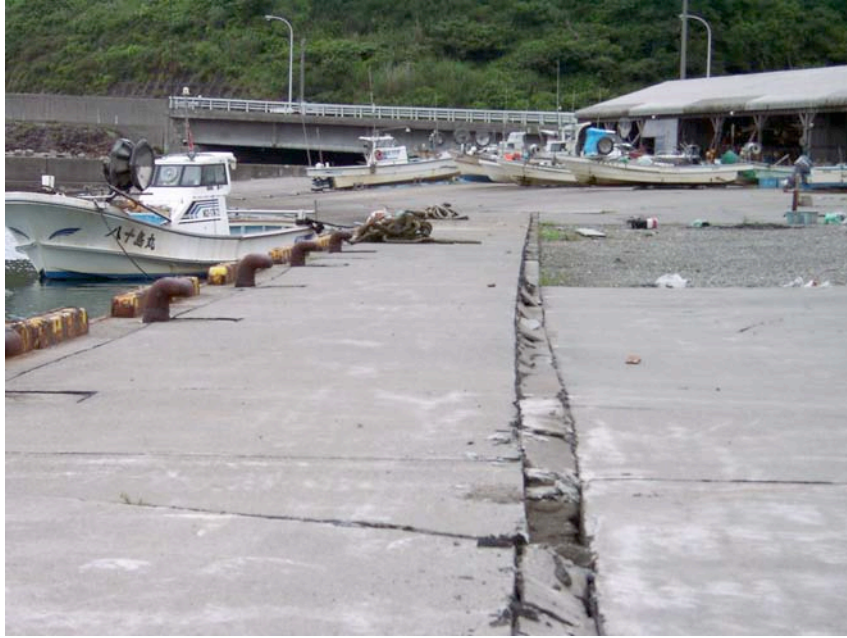
The Kasashima harbor exhibited negligible to very minor evidence of ground deformation and seismic effects to coastal infrastructure (e.g. quay walls, seawalls, breakwaters). Trace remnants of very small, localized ground deformations were observed, and it appears that the ground motions in this area were just strong enough for incipient lateral deformation of the ground and waterfront earth retention structures (Figure 8.1). This site is useful for investigating the regional extent of liquefaction-induced ground failure at ports located southwest of the meiseismic region. Lateral spreading of 7 cm to 12 cm was observed in beach deposits with lateral deformation of short concrete quay walls of 1 cm to 2 cm. No movement of larger caisson-type quay walls or breakwaters was observed. Settlement of paved aprons of roughly 10 cm to 12 cm was noted behind the short quay wall (Figures 8.2 and 8.3). The investigation team did not inspect coastal facilities located southwest of Kasashima harbor. It is possible that very minor evidence of liquefaction occurred to the west, however in the absence of significantly different site effects, the impact on coastal infrastructure is likely minimal. The investigation team did not receive reports of significant damage to coastal facilities west of Kasashima, despite the occurrence of several moderate to large landslides in cut slopes for highways and rail routes in this area.

Figure 8.2: Kasashima Harbor - Ground settlement and minor lateral deformation adjacent to quay walls (Site RK21, N37.33702° E138.46680°, photo taken 7/21/07 14:40).

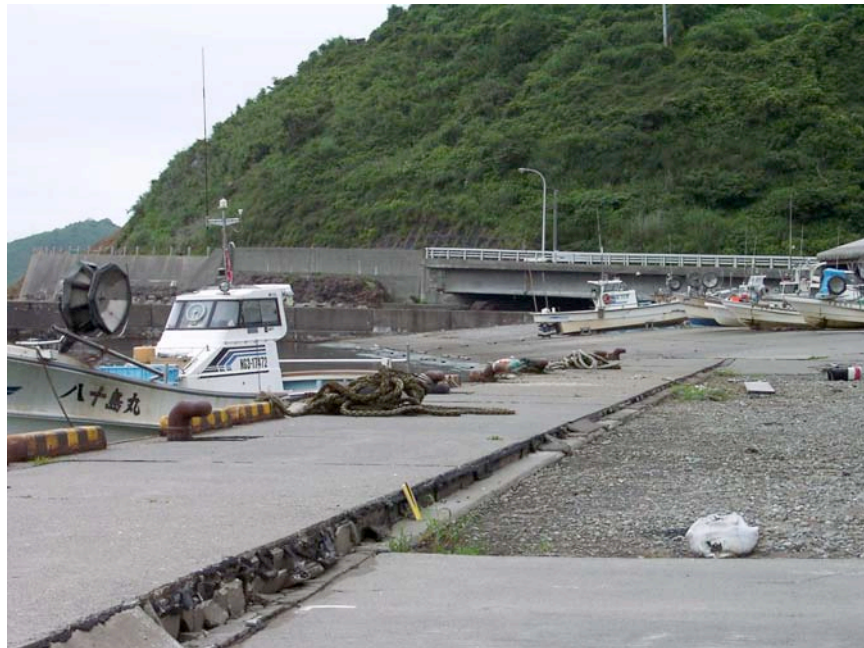
Figure 8.3: Kasashima Harbor - Settlement of fill behind quay walls (Site RK21, N37.33702° E138.46680°, photo taken 7/21/07 14:48).

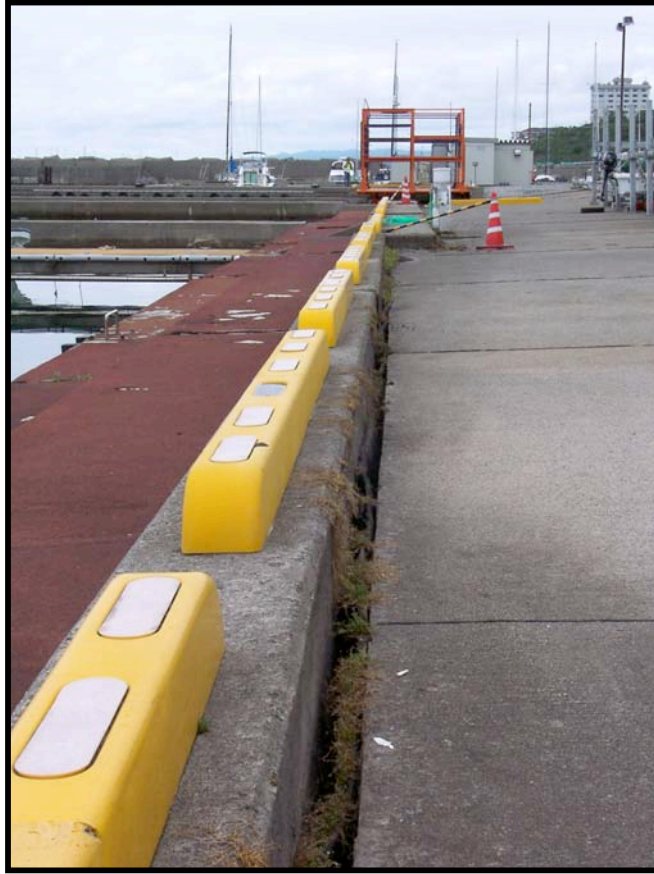
From Kasashima the reconnaissance moved eastward toward the epicentral region. The Kashiwazaki Marina was inspected and considered a site of minor damage. Evidence of ground deformation was observed in the form of minor lateral movement (generally 2 cm to 7 cm) of short quay walls and maximum ground settlements adjacent to quay walls of roughly 7 cm to 15 cm (Figures 8.4 and 8.5). Small sand boils were observed in isolated portions of the boat storage yard. The alignment of the quay walls was very good indicating fairly uniform, minor lateral movement. Estimates of maximum lateral wall movement are 6 cm to 10 cm. Minor ground cracking and lateral deformation was observed around the perimeter of the marina property. Paved and unpaved parking areas located in filled areas adjacent to the facility exhibited very minor cracks with cumulative displacements on the order of 3 cm to 5 cm. A park with a multi-story observation structure is located immediately to the west of the marina property (Onodachi Seaside Park). The structure appears to be located on fill, although the foundation type is not currently known to the team. The sloping, grass-covered fill at this site exhibited very minor cracking indicating incipient ground failure.

Figure 8.4: Kashiwazaki Marina - Evidence of minor lateral movement of quay walls and associated settlement of the paved apron (Site SD3, N37.36093° E138.52027°, photo taken 7/22/07 12:59).

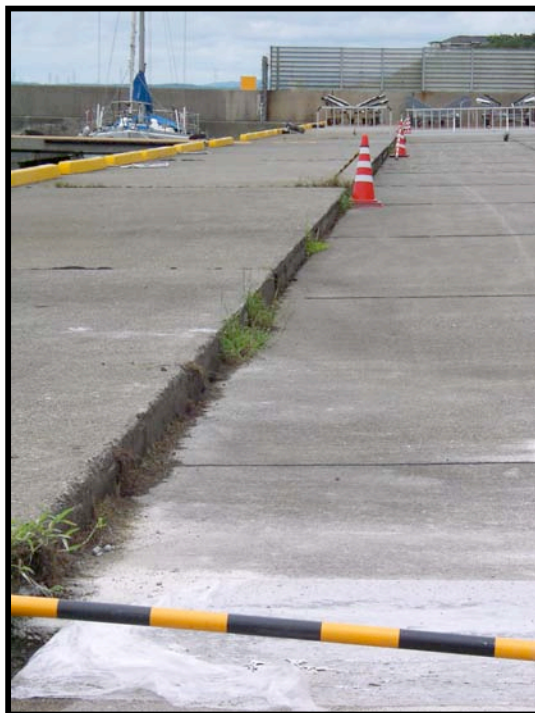
Figure 8.5: Kashiwazaki Marina - Evidence of minor settlement behind quay walls (Site SD3, N37.36093° E138.52027°, photo taken 7/22/07 13:12).

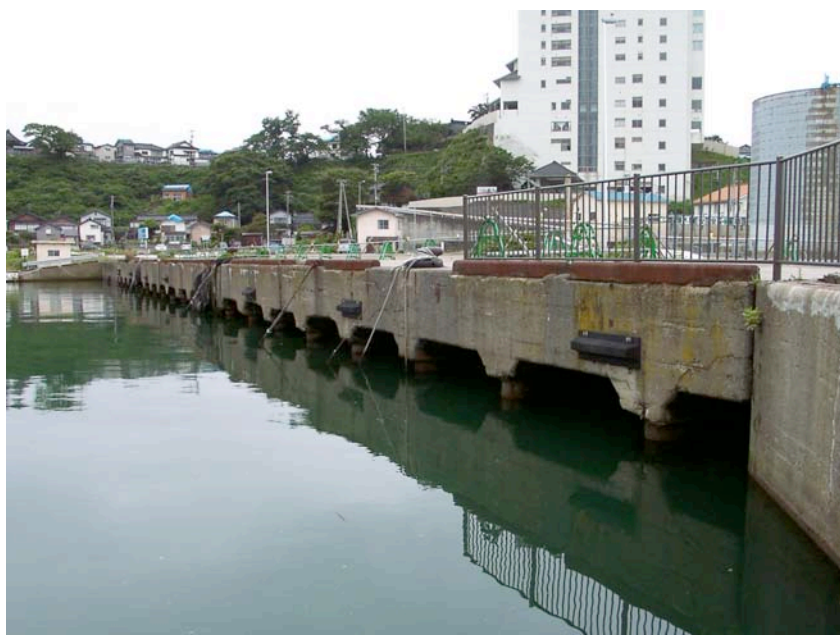
Figure 8.6: Kashiwazaki Port - Older, undamaged pile-supported wharf located in the western portion of the port facility (Site RK25/SA25/YT4, N37.36713° E138.53210°, photo taken 7/21/07 16:12).

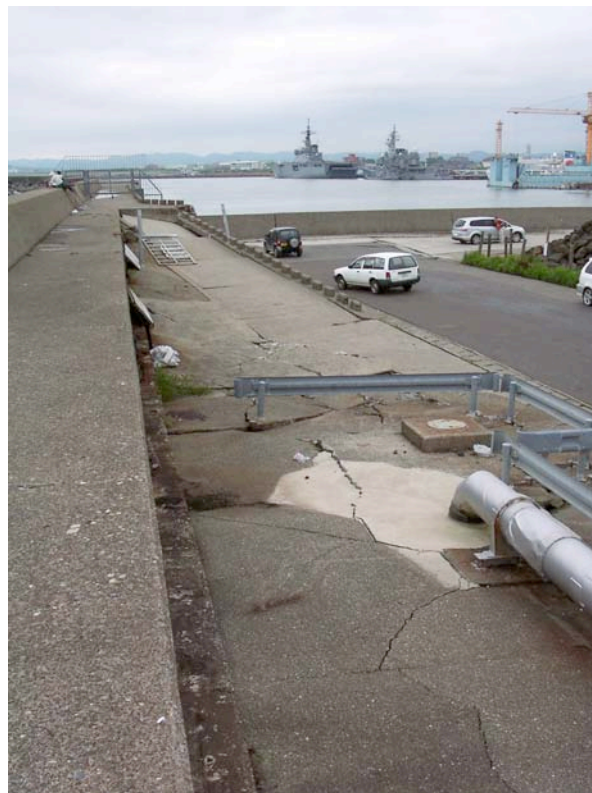
Westernmost section – From the landward portion of this section of the port to the outer harbor this area includes; (a) an older portion of the berth that appears to be relatively unused, (b) an asphalt heating and pumping facility, (c) a new facility that includes sightseeing boat mooring and a single-story office building, (d) an outer harbor-front quay wall, and (e) the major seawall and breakwater that extends from the beach into the harbor a total length of approximately 2.4 km. The landward portion of the berth (a) appears to include both concrete caissons and a wharf deck supported by vertical concrete piles (Figure 8.6). No lateral movement of this portion of the wharf was noted and no damage to the piles was noted, although only the waterfront row of piles was visible during the investigation. The Take Naka asphalt facility (b) exhibited very little damage (Figures 8.7 - 8.9). The facility was in operation at the time of the reconnaissance and the inspection focused on the performance of the large, insulated asphalt holding tank. The tank is secured at its base by a bolt and flange detail. Many of the flanges were bent, however none of the bolts appeared to have failed. No “elephant’s foot” bulking of the tank was noted, although the exterior of the tank is covered with a layer of insulation prohibiting a more thorough inspection. The asphalt distribution pipe, which is slightly elevated above the ground, did not exhibit signs of distress despite extensive ground failure along the adjacent area near the sightseeing facility (Figure 8.10).

Figure 8.10: Kashiwazaki Port - Seawall and exposed end of the elevated asphalt pipe (Located near Site RK25, N37.36713° E138.53210°, photo taken 7/21/07 15:51).

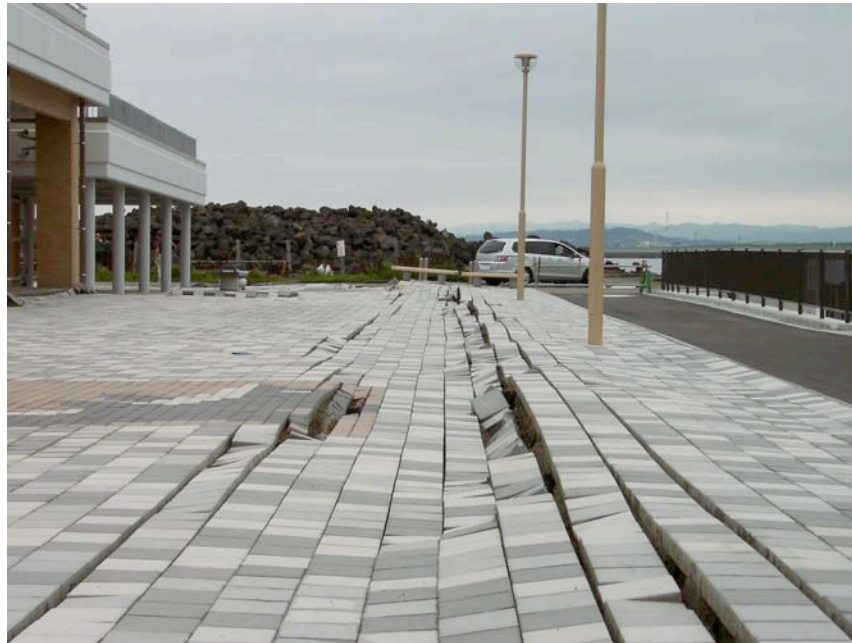
The new sightseeing facility (c), including a new single-story structure, associated pedestrian areas, and wharf, were subjected to the effects of widespread liquefaction, lateral spreading and settlement. The structure performed very well, but did exhibit minor distress along two pedestrian-accessible roof areas on either side of the main structure. It is believed that the distress is due to adjacent lateral spreading and differential settlement between the ground and structure. The paved areas and walkways surrounding the building were extensively damaged (Figure 8.11). Settlements exceeded 30 cm in many areas and a pronounced graben formed between the building and the waterfront quay wall. The quay wall has moved laterally and tilted a minor amount (Figure 8.12). This area was extensively investigated by the team and it was the focus of a ground-based LiDAR survey.

Figure 8.11: Kashiwazaki Port - Liquefaction-induced damage to the sightseeing wharf (Site RK25/SA25/YT4, N37.36713° E138.53210°, photo taken 7/21/07 16:03).

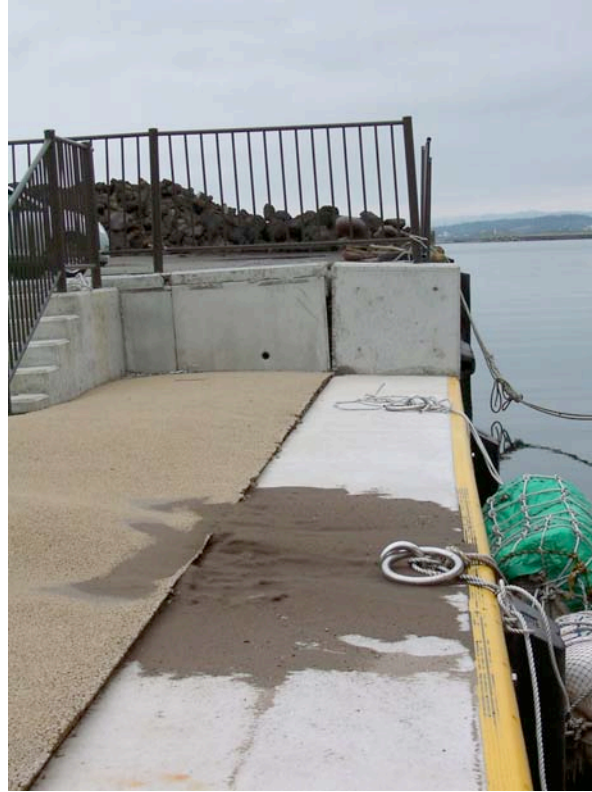
Figure 8.12: Kashiwazaki Port - Liquefaction-induced damage to the sightseeing wharf with minor displacement of the caisson quay wall (Site RK25/SA25/YT4, N37.36713° E138.53210°, photo taken 7/21/07 16:09).

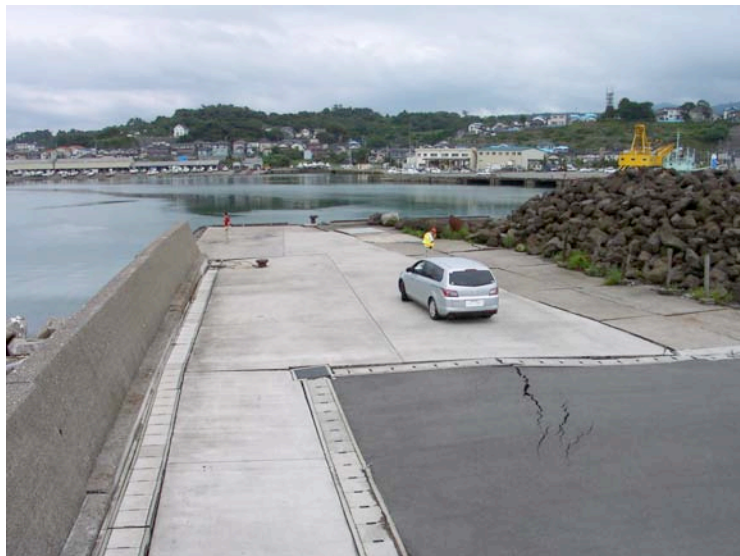
The outer quay wall area has been subjected to large lateral ground deformation and settlement due to liquefaction (Figures 8.13 and 8.14). The seawall/breakwater was inspected landward from the beach adjacent to the asphalt handling facility to the outer quay area. The breakwater exhibited negligible to very minor displacement adjacent to the beach. The waterfront side of the seawall is armored with concrete tetrapods. The tetrapods appear to be unreinforced and numerous units showed damage due to rocking during the earthquake (Figure 8.15). This type of damage to tetrapods and other wave armor units was noted throughout the Kashiwazaki Port and long seawall located northeast of the Sabaishi River.

Figure 8.13: Kashiwazaki Port - Evidence of lateral ground deformation adjacent to the outer quay wall (Located near site RK25/SA25/YT4, N37.36713° E138.53210°, photo taken 7/21/07 15:49).

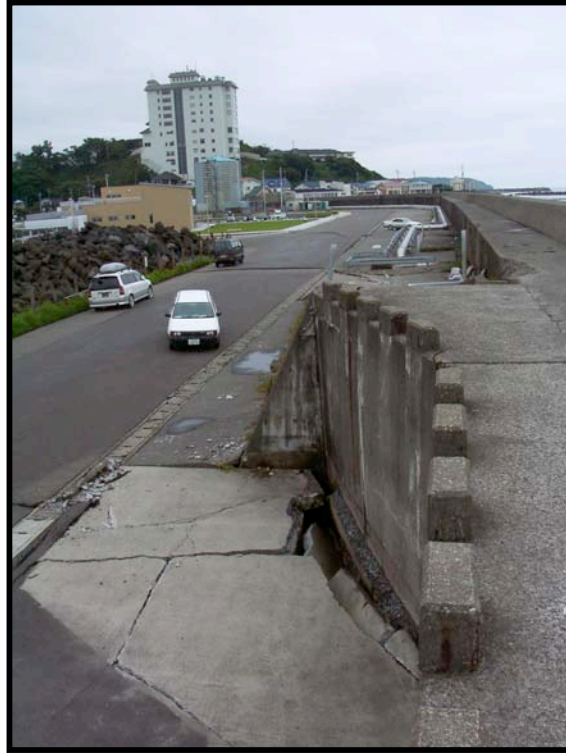
Figure 8.14: Kashiwazaki Port - Evidence of ground failure adjacent to the seawall at the outer quay wall area (Located near site RK25/SA25/YT4, N37.36713° E138.53210°, photo taken 7/21/07 15:50).

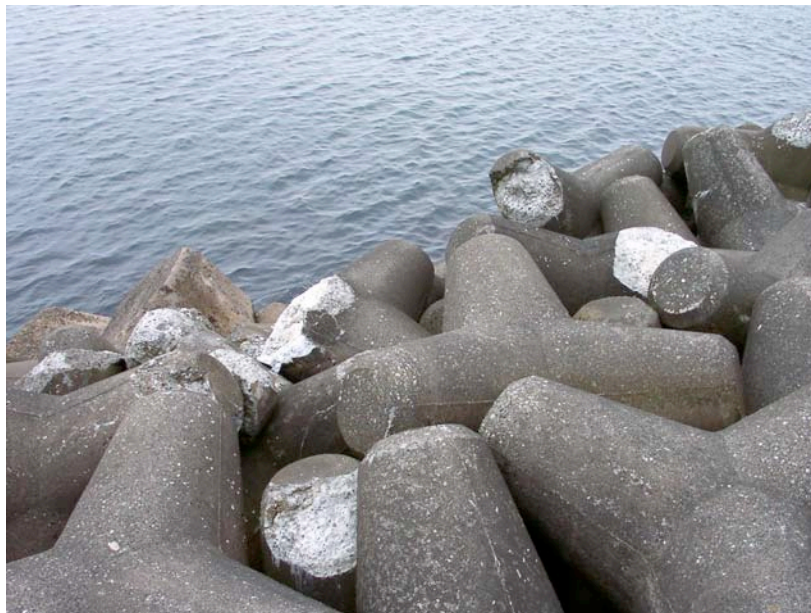
Figure 8.15: Kashiwazaki Port - Likely earthquake-related damage to tetrapod wave armor units (Located near site RK25/SA25/YT4, N37.36713° E138.53210°, photo taken 7/21/07 15:53).

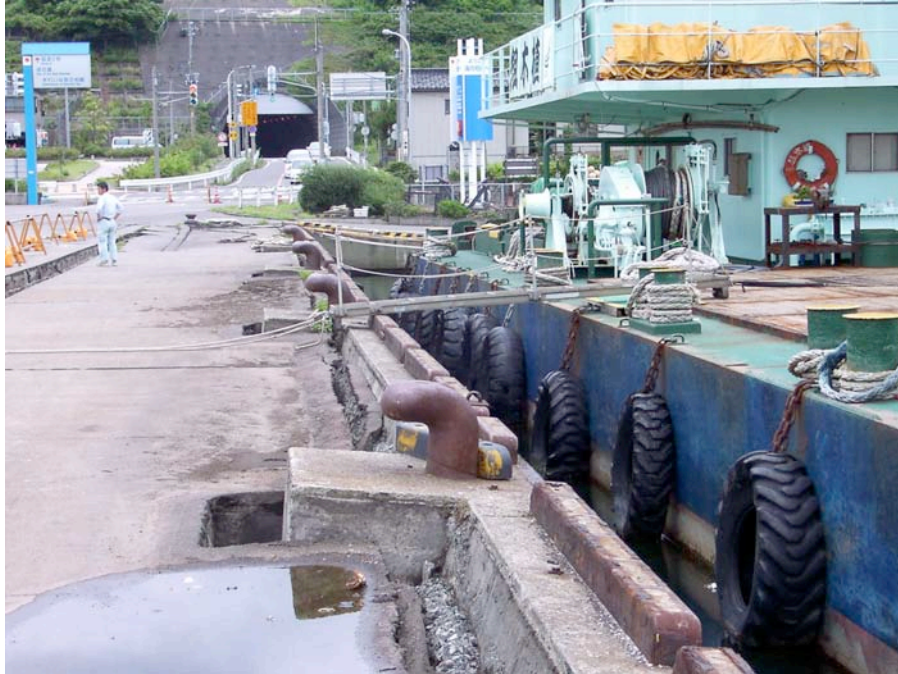
Southwestern pier – The portion of the Port of Kashiwazaki referred to herein as the “southwestern pier,” appears to be a shallow water terminal used along one berth as a staging area for a dredging barge and on the opposite side of the terminal as a fishing and/or light cargo handling area. This berth exhibited extensive liquefaction-induced damage. Lateral movement of the quay wall (anchored sheetpile wall) along the western face was approximately one meter with settlements of roughly 0.5 m to 0.6 m (Figures 8.16 and 8.17). The quay wall tilted roughly 5°. The lateral deformation along the eastern face was much less pronounced (roughly 0.3 m), although the settlement of the backfill was equally severe (0.6 m) (Figure 8.18). It appears that the eastern portion of the terminal has been constructed of concrete caissons. It is believed that a portion of the difference in the observed lateral quay wall movement is due to the use of different structures during construction of the terminal. The heights of the sheetpile walls and caissons could not be discerned during the reconnaissance.

Figure 8.16: Kashiwazaki Port - West facing portion of the “Southwestern Pier” showing displacement of the sheet pile wall and ground settlement due to liquefaction of sandy backfill (Site SD5, N37.36532° E138.53213°, photo taken 7/22/07 13:57).

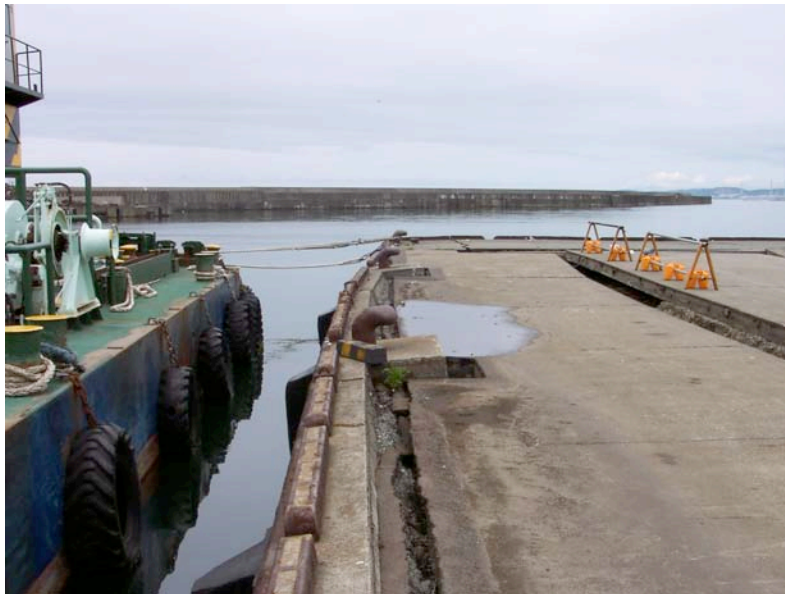
Figure 8.17: Kashiwazaki Port - West facing portion of the “Southwestern Pier” showing displacement of the sheetpile wall and ground settlement due to liquefaction of sandy backfill (Site SD5, N37.36532° E138.53213°, photo taken 7/22/07 13:58).

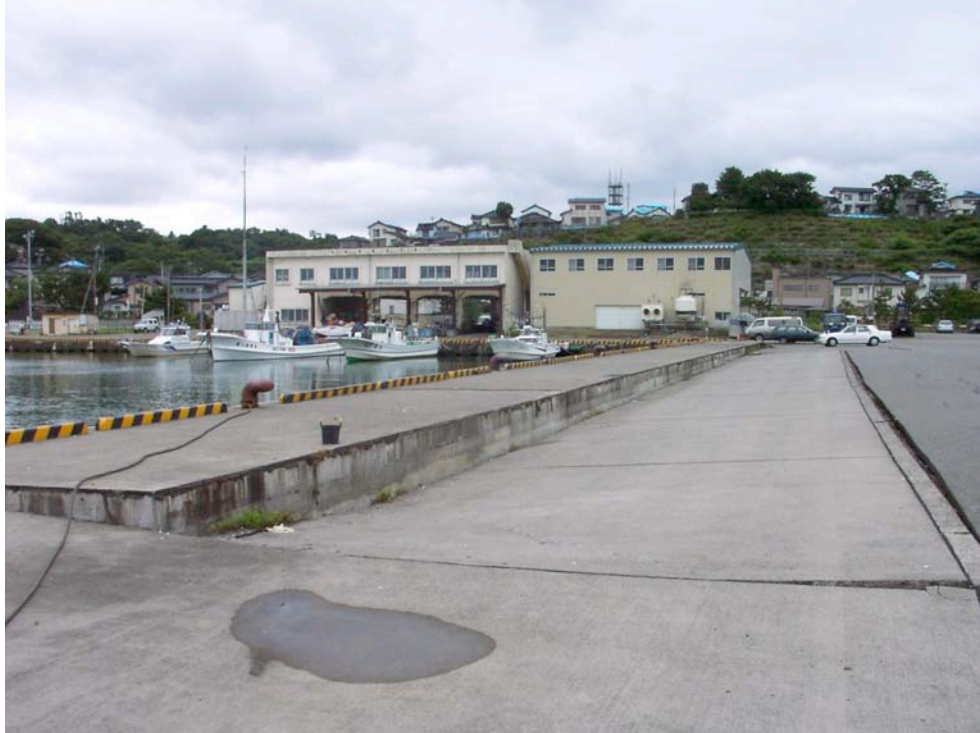
Figure 8.18: Kashiwazaki Port - East facing portion of the “Southwestern Pier” showing pronounced ground settlement (Site SD5, N37.36532° E138.53213°, photo taken 7/22/07 14:05).

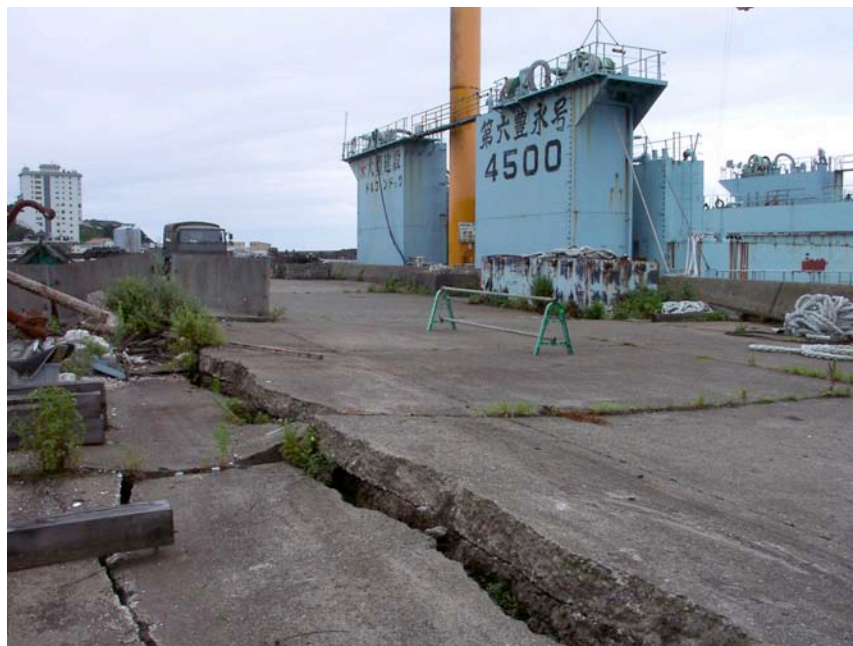
Steel Scrap Handling Facility – Moving eastward along the port complex the next major industrial facility is a steel scrap handling and transport wharf. Sand boils, ground cracks and liquefaction-induced settlement were pervasive throughout this facility, particularly around the waterfront perimeter. Waterfront settlements up to approximately 35 cm were noted and lateral wall movements varied between 2 cm and 30 cm depending on the orientation of the quay wall (Figures 8.19 and 8.20). Pronounced pavement disruption and ground cracks in the landward section of the facility indicated lateral deformation of the anchor system for the sheetpile walls (Figure 8.19). Lateral movement and rotation of near-shore concrete blocks with bollards and damage to wave armor units were also observed.

Figure 8.19: Kashiwazaki Port - Steel Scrap Transport Facility showing evidence of ground failure due to liquefaction of sand fill and damage to concrete aprons (Site SD6, N37.36668° E138.53565°, photo taken 7/22/07 14:46).

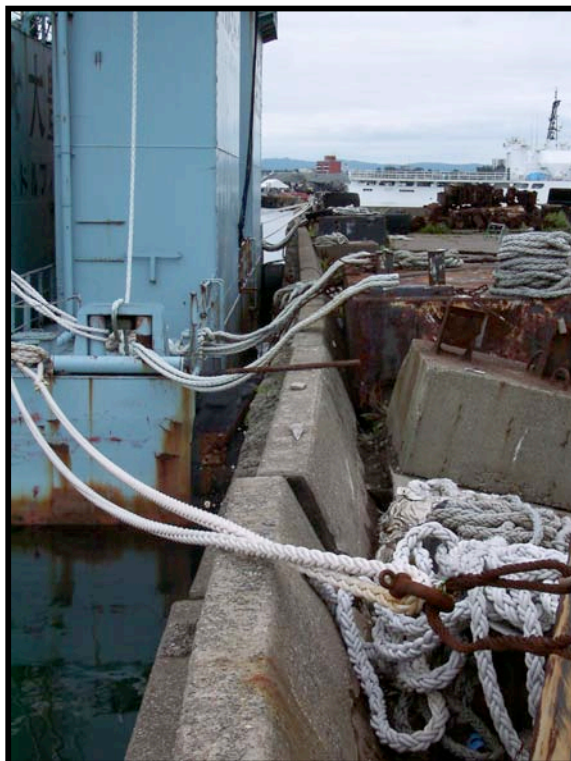
Figure 8.20: Kashiwazaki Port - Steel Scrap Transport Facility showing caisson displacement (Site SD6, N37.36668° E138.53565°, photo taken 7/22/07 14:56).

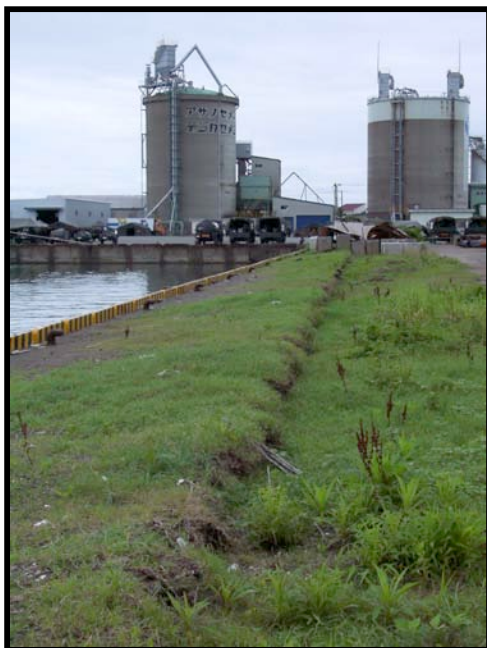
Interior, north facing quay wall (end of Coast Guard Berth) – This landward and short length of quay wall is located between the Steel Scrap Handling Facility and the terminal that was being used at the time of the reconnaissance by the Japan Coast Guard described in the following subsection. The water depth in this portion of the port is relatively small although the exact depth of water and height of caissons was not determined during the investigation. The caissons were laterally displaced roughly 30 cm to 45 cm (Figure 8.21). The caissons are approximately 4.5 m wide.

Figure 8.21: Kashiwazaki Port - North facing, landward quay wall exhibiting lateral movement and rotation of caissons (Site SD7, N37.36593° E138.53692°, photo taken 7/22/07 15:12). The Taiheiyo Cement Tanks are in the background.

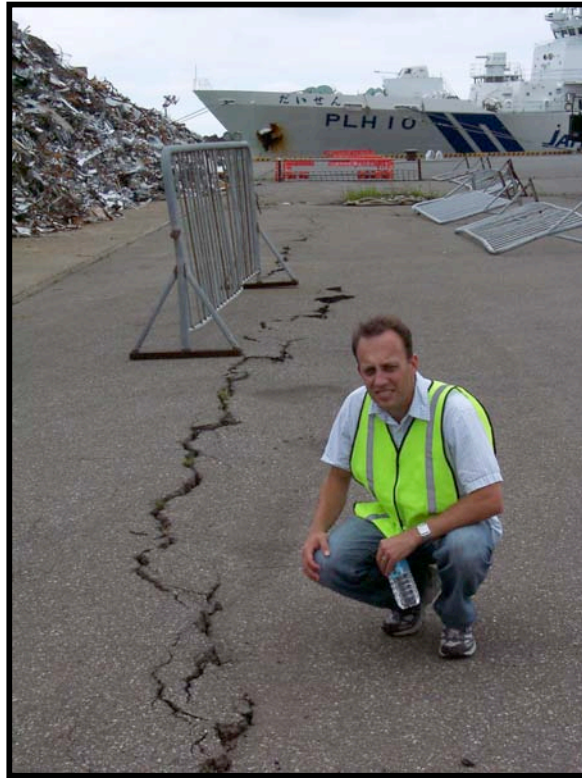
Figure 8.22: Kashiwazaki Port - Minor ground cracks located parallel to the western quay wall used as the berth for the Japan Coast Guard (Site SD8, N37.36680° E138.53825°, photo taken 7/22/07 15:17).

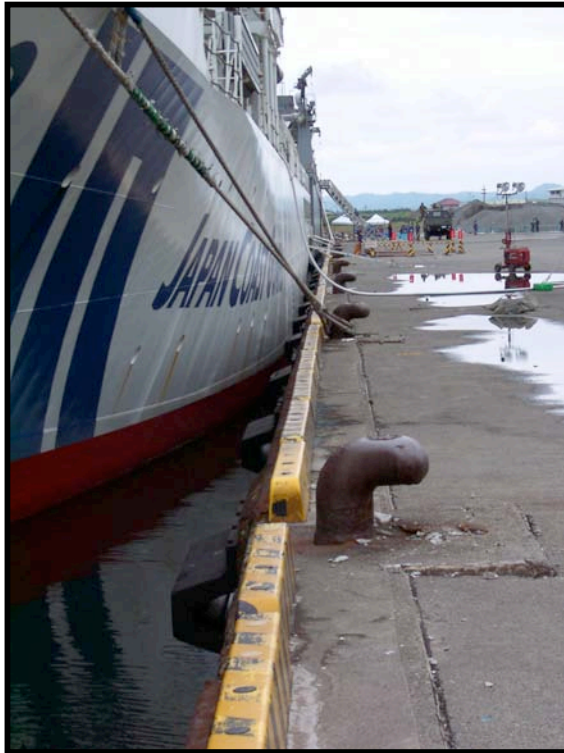
The west end of the north facing quay was also utilized by the Japan Coast Guard. This portion of the quay exhibited negligible lateral displacement (≤ 4 cm) and minor settlement (Figures 8.23 and 8.24). Overall, the seismic performance of this portion of the terminal was very good. The middle to eastern end of the quay was being used to berth a ship of the Japan Self Defense Forces at the time of the survey. The effects of liquefaction were similarly minor with localized apron cracking and minor lateral displacement along much of the berth (Figure 8.25). It is interesting to note however that the evidence of liquefaction-related ground failure and quay wall displacement increased along the berth to the east (i.e. closer to the eastern boundary of the berth at the mouth of the U River, Figure 8.26). Within roughly 100 m of the U River the effects of liquefaction became pronounced. Significant damage was observed to the quay wall with lateral displacement and failure of the upper portion of the wall (Figures 8.27 and 8.28).

Figure 8.23: Kashiwazaki Port - Evidence of very minor lateral movement of quay walls and minor settlement located along the northern face of the terminal used as the berth for the Japan Coast Guard (Site SD8, N37.36680° E138.53825°, photo taken 7/22/07 15:22).

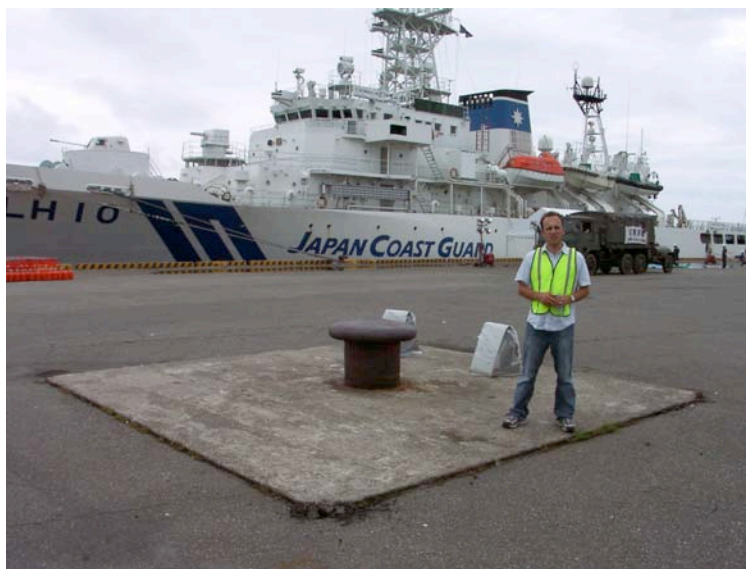
Photo 8.24: Kashiwazaki Port - Evidence of minor settlement adjacent to a pile-supported (?) bollard anchorage located along the northern face of the terminal used as the berth for the Japan Coast Guard (Site SD8, N37.36680° E138.53825°, photo taken 7/22/07 15:21).

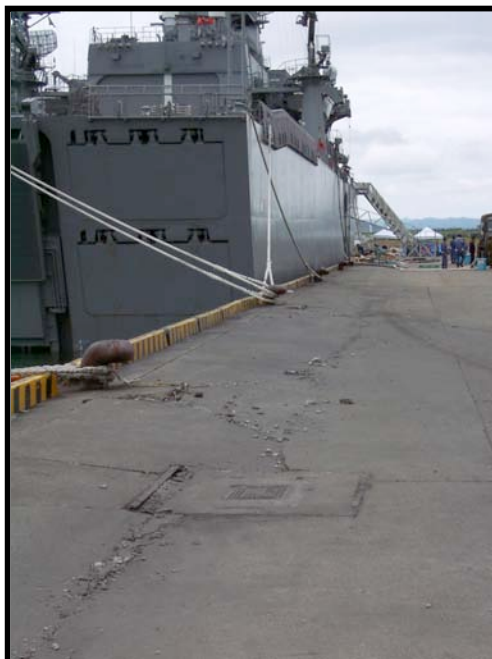
Figure 8.25: Kashiwazaki Port - Evidence of very minor lateral movement of quay walls and minor settlement located along the northern face of the terminal used as the berth for the Japan Self Defense Force (Site SD8, approximately N37.36680° E138.53825°, photo taken 7/22/07 15:24).

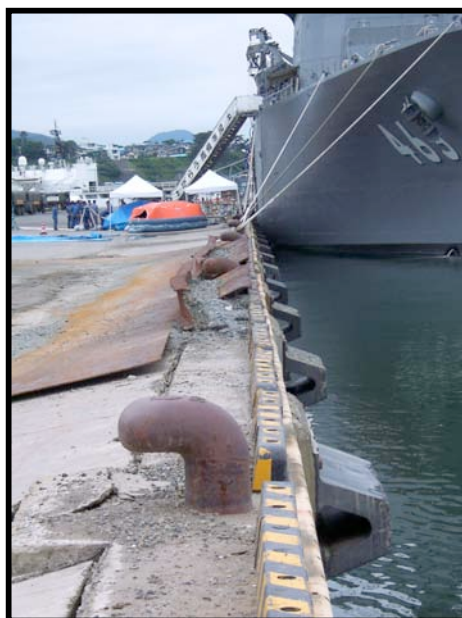
Figure 8.26: Kashiwazaki Port - Evidence of more extensive lateral caisson displacement and ground settlement adjacent to the quay wall located along the eastern end of the north face of the terminal (Site SD8, approximately N37.36680° E138.53825°, photo taken 7/22/07 15:36).

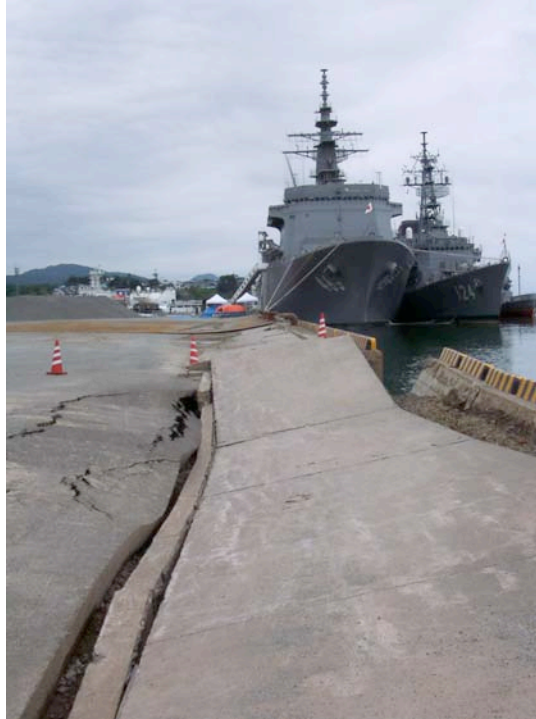
Figure 8.27: Kashiwazaki Port - Significant liquefaction-related damage to the quay walls located at the eastern edge of the terminal adjacent to the mouth of the U River (Site SD8, approximately N37.36680° E138.53825°, photo taken 7/22/07 15:32).

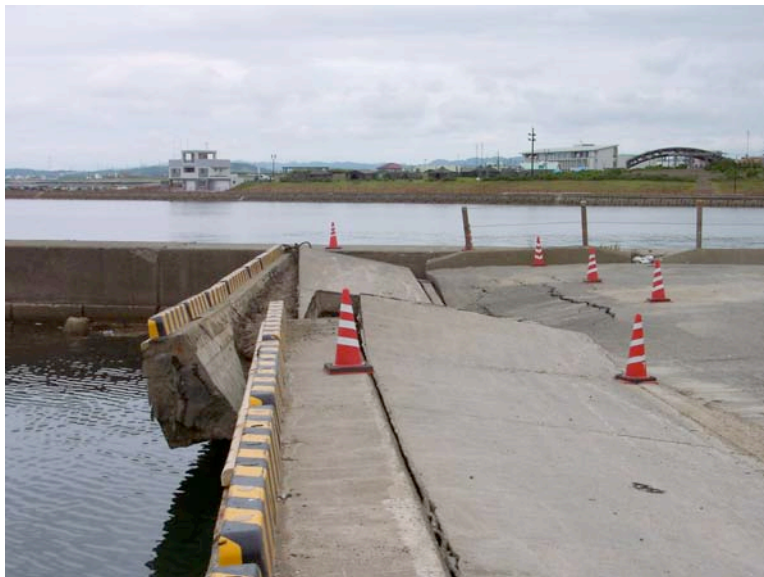
Figure 8.28: Kashiwazaki Port - Significant liquefaction-related damage to the quay walls located adjacent to the U River (Site SD8, approximately N37.36680° E138.53825°, photo taken 7/22/07 15:36).

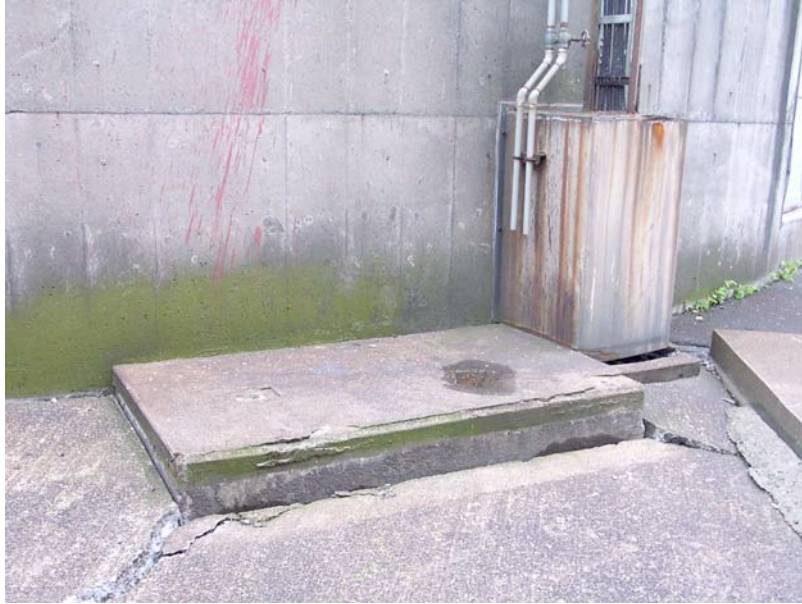
Taiheiyo Cement Tanks – This facility is located in the backland portion of the terminal and it is the site of two large cement tanks. Inspection of the tank foundations revealed minor ground settlement of 5 cm to 12 cm adjacent to the tank foundations (Figures 8.29 and 8.30). Liquefaction effects are negligible in this area. The tanks and appurtenant piping appeared to be in good shape with negligible damage.

Figure 8.29: Kashiwazaki Port (Taiheiyo Cement Facility) - Evidence of minor to moderate settlement of sandy fill adjacent to one of the large diameter tanks (Site SD9, approximately N37.36665° E138.53983°, photo taken 7/22/07 15:48).

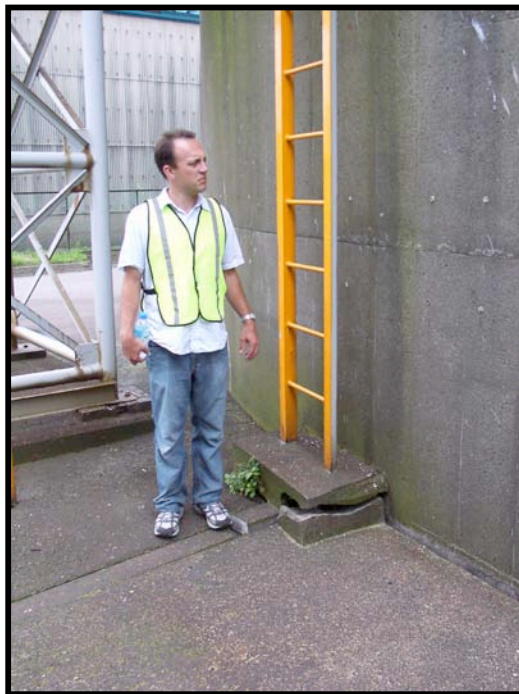
Figure 8.30: Kashiwazaki Port (Taiheiyo Cement Facility) - Evidence of minor to moderate settlement of sandy fill adjacent to one of the large diameter tanks (Site SD9, approximately N37.36665° E138.53983°, photo taken 7/22/07 15:48).

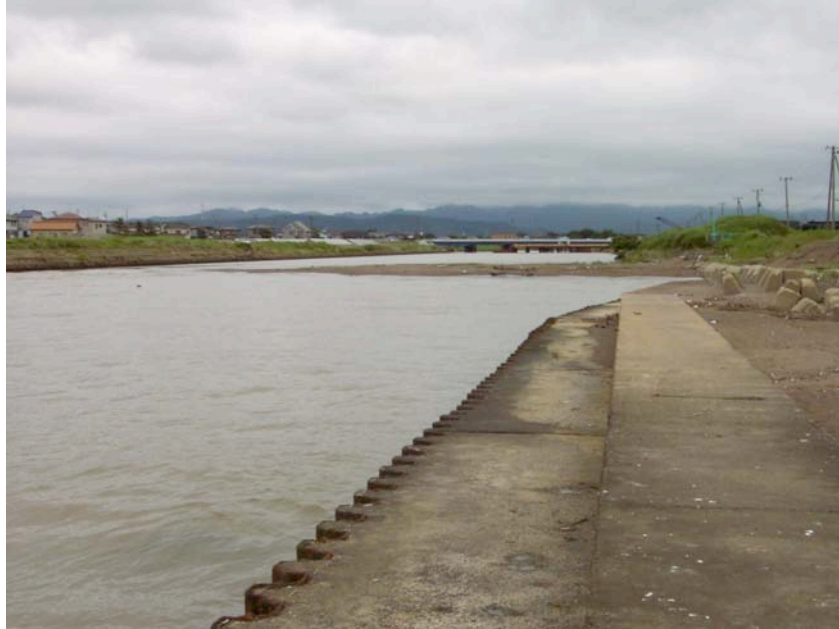
The mouth of the Sabaishi River is protected along its southwest bank by a wall constructed of sheet piles with concrete filling (Figure 8.31). Negligible lateral movement of the riverfront wall was noted and roughly 5 cm to 7 cm of settlement was noted adjacent to the sheet pile wall. Evidence of approximately 30 cm of lateral spreading in the sand deposits behind the sheet pile shore protection was observed. Minor lateral deformation and damage to the concrete slope armor panels was observed across the river from this site.

Figure 8.31: Mouth of the Sabaishi River showing the erosion control measures (Site SD 1, approximately N37.38868° E138.56508°, photo taken 7/22/07 11:07). The Ansei Bridge (Sites SA6/SD2/RK8) is visible in the background.
