Preliminary Observations on the Niigata-Chuetsu Oki, Japan, Earthquake of July 16, 2007

EERI-GEER Web Report 2007-1 v.8
October 9, 2007

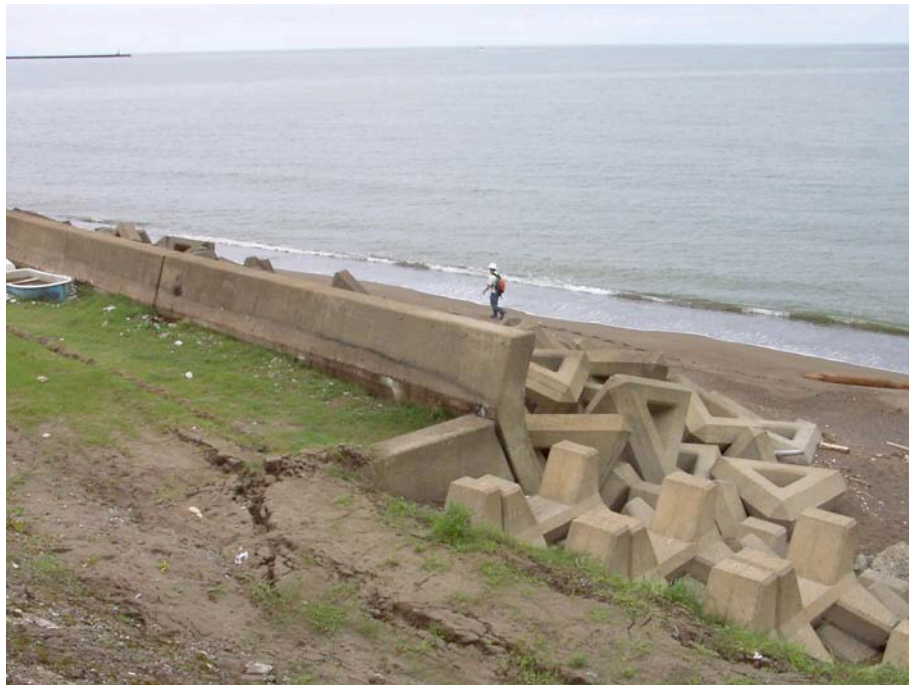
roughly 2.0 km towards the Minatomachi Seaside Park. This seawall was inspected for over a 1 km length. Observations were made from the river mouth southwest to an armored rockfill breakwater located roughly 900 m from the cement plant site. The initial portion of the seawall is located along a narrow beach with wave armor units. This portion of the seawall exhibited lateral deformation, rotation, and structural damage along the counterfort ends of several of the individual wall sections (Figure 8.32).

Figure 8.32: Eastern end of the seawall located adjacent to the damaged cement plant and mouth of the Sabaishi River (Site SD1, approximately N37.38868° E138.56413°, photo taken 7/22/07 10:56). Lateral spreading behind the wave armor units, as well as ground settlement and minor sea wall damage was widespread.

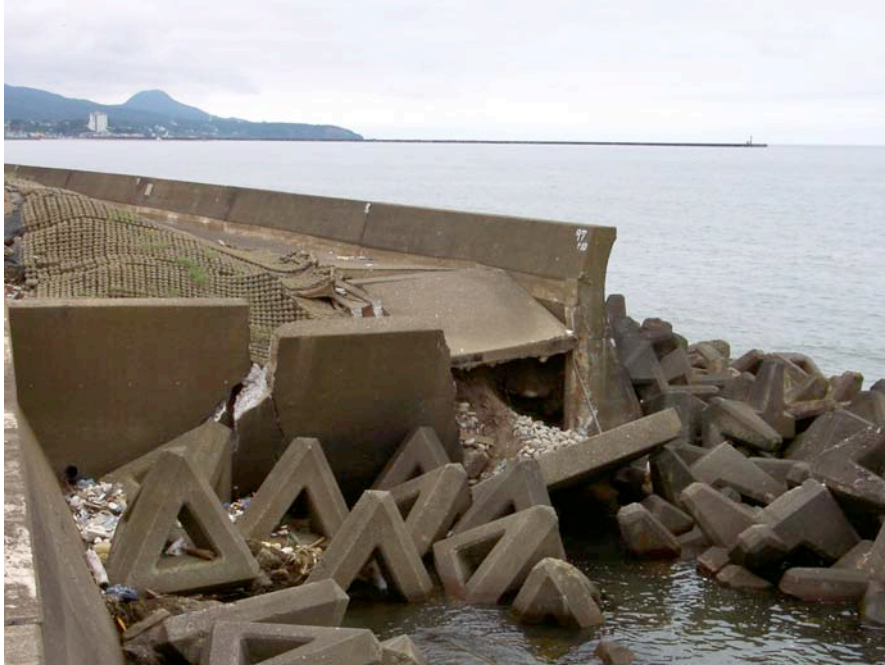
There is a seaward step in the seawall located immediately southwest of the cement plant site. This point was the location of a seawall failure that included a collapsed section of wall, significant settlement and cracking of the backfill, and settlement of the concrete panels located behind the seawall (Figure 8.33). The backfill adjacent to the seawall is composed of clean, rounded cobbles (diameter > 15 cm) (Figure 8.34). The lateral wall movement in this area was roughly 0.6 m.

Figure 8.33: Partial collapse of a portion of the seawall located at the lateral, seaward step in alignment just west of the damaged cement plant (Site SD1, N37.38868° E138.56413°, photo taken 7/22/07 11:18).

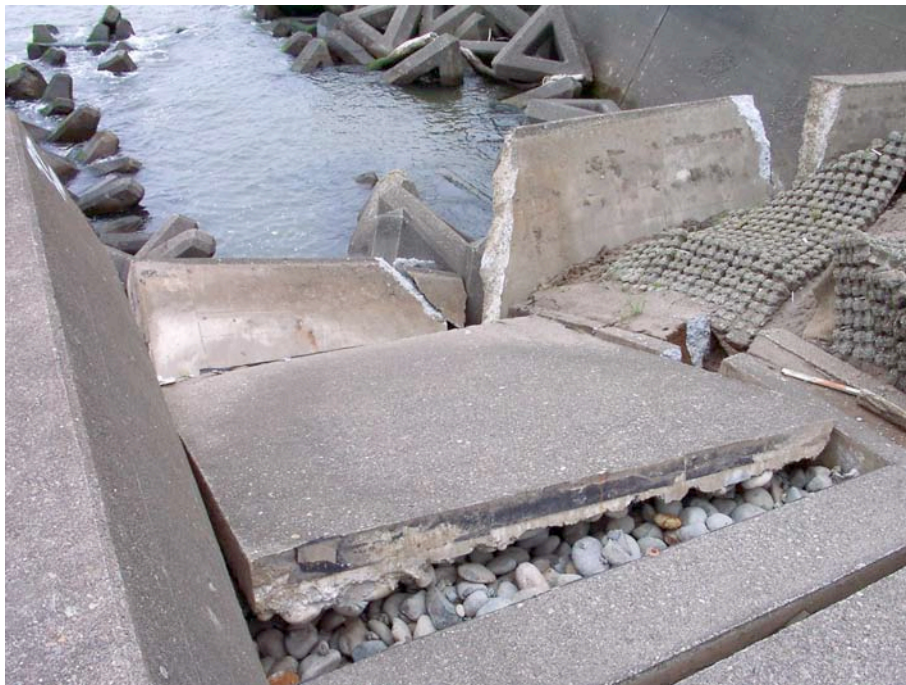
Figure 8.34: Close-up of the collapsed portion of the seawall showing the clean cobble backfill (Site SD1, N37.38868° E138.56413°, photo taken 7/22/07 11:23).

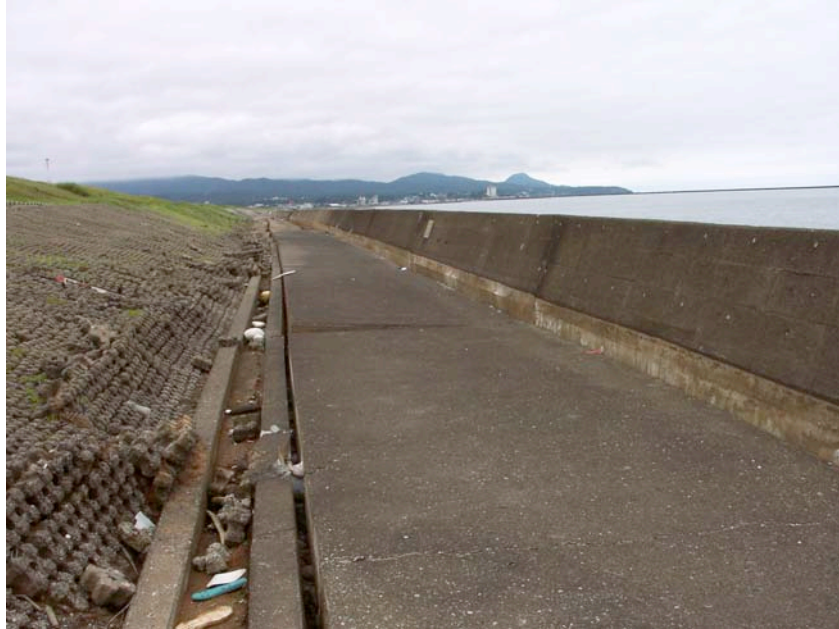
Figure 8.35: Evidence of seawall rotation, ground settlement, and longitudinal cracking of the benched embankment (Moving southwest of Site SD1, approximately N37.38868° E138.56413°, photo taken 7/22/07 11:25).

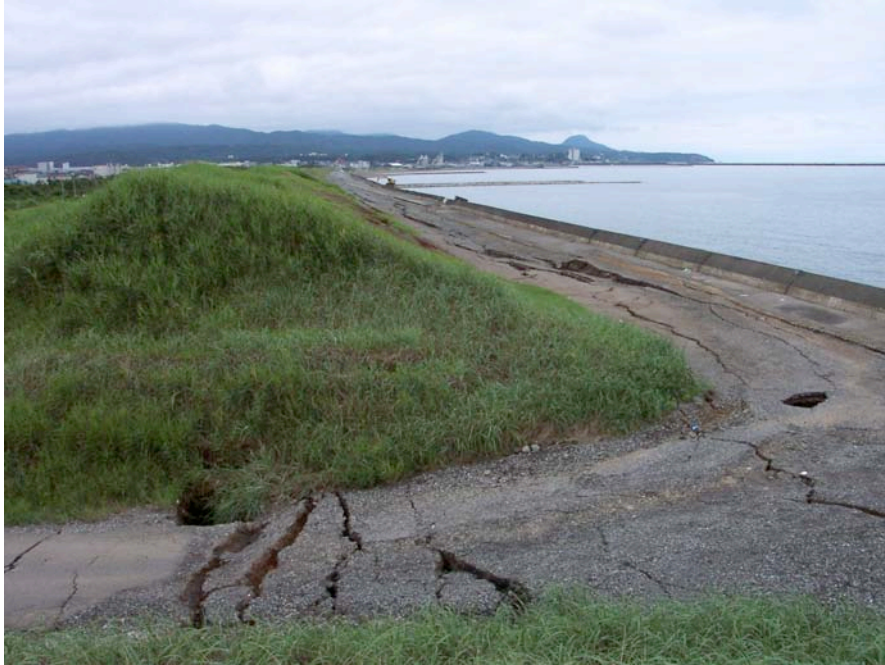
Figure 8.37: Ground deformations adjacent to the embankment and seawall (Location is southwest of Site SD1, photo taken 7/22/07 11:41).

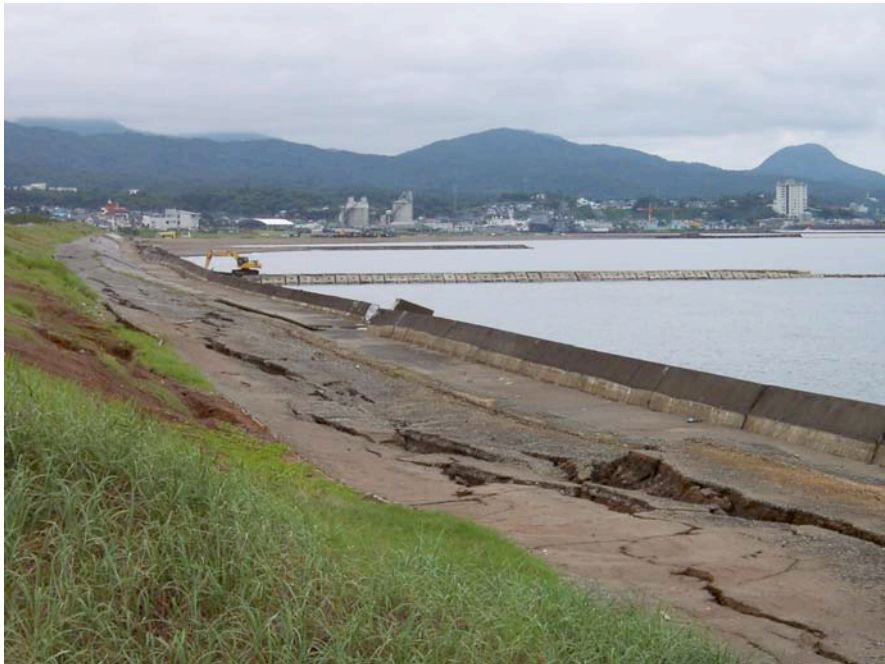
The lateral ground deformation associated with these embankment and foundation failures impacted the seawall and contributed to the development of larger displacements (Figure 8.38). At one location near the southwestern end of this area ground settlement and lateral movement of the seawall was accompanied by the failure of the top of the wall (Figure 8.39). The inspection of the seawall was terminated at the location of an armored groin structure (possibly an outfall structure). At the time of the investigation a track-hoe was being utilized to move rockfill between the seawall and the concrete armor blocks that overlie the rockfill offshore (Figure 8.40).

Figure 8.38: Ground deformations adjacent to the embankment and seawall (Location is southwest of Site SD1, photo taken 7/22/07 11:42).

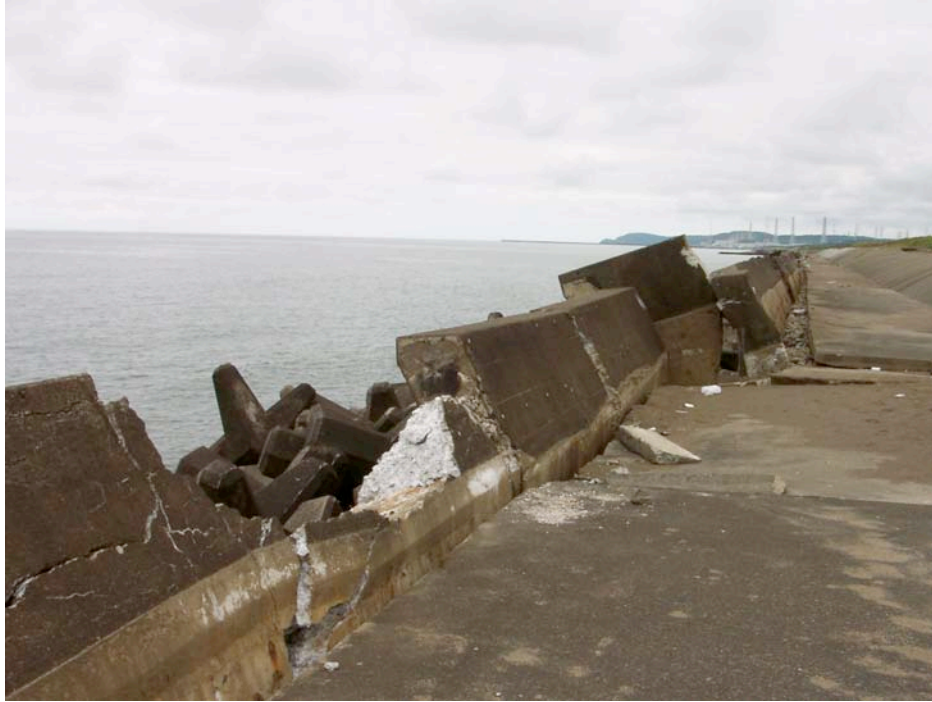
Figure 8.39: Lateral displacement, rotation, and structural damage to the seawall (Location is southwest of Site SD1, photo taken 7/22/07 11:45).

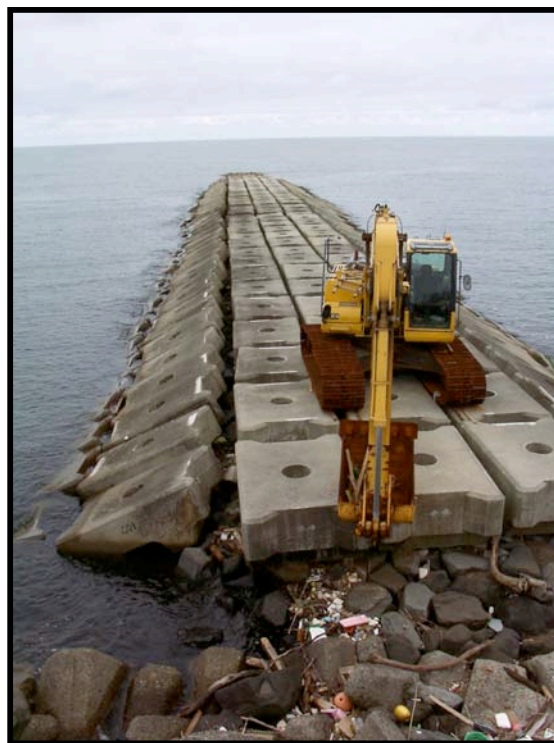
Figure 8.40: Repair of an armored, rockfill breakwater (possibly an outfall structure). (Location is southwest of Site SD1, photo taken 7/22/07 11:49).

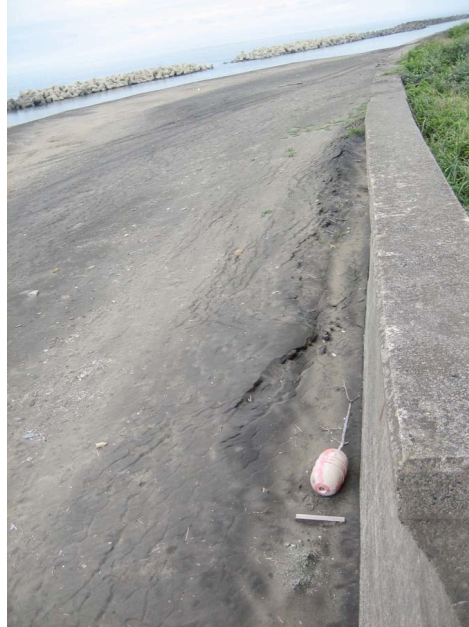
Figure 8.41: Evidence of minor liquefaction and lateral spreading in sandy beach deposits adjacent to the seawall (Site RK37, N37.45478°, E138.60927°, photo taken 7/23/07).

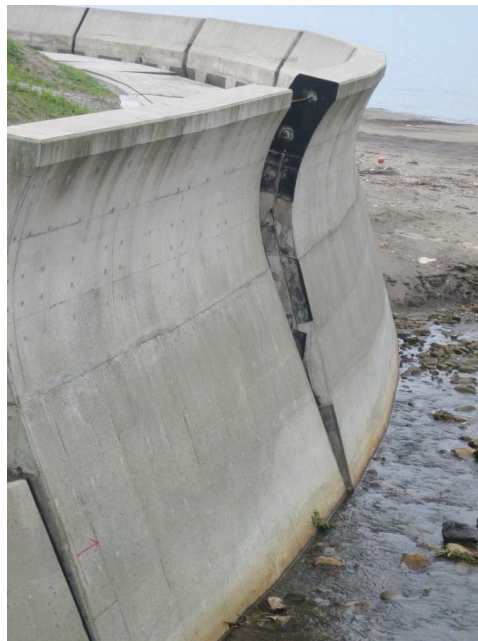
Figure 8.42: Rotation and lateral displacement of the concrete seawall (Site RK37, N37.45478°, E138.60927°, photo taken 7/23/07).

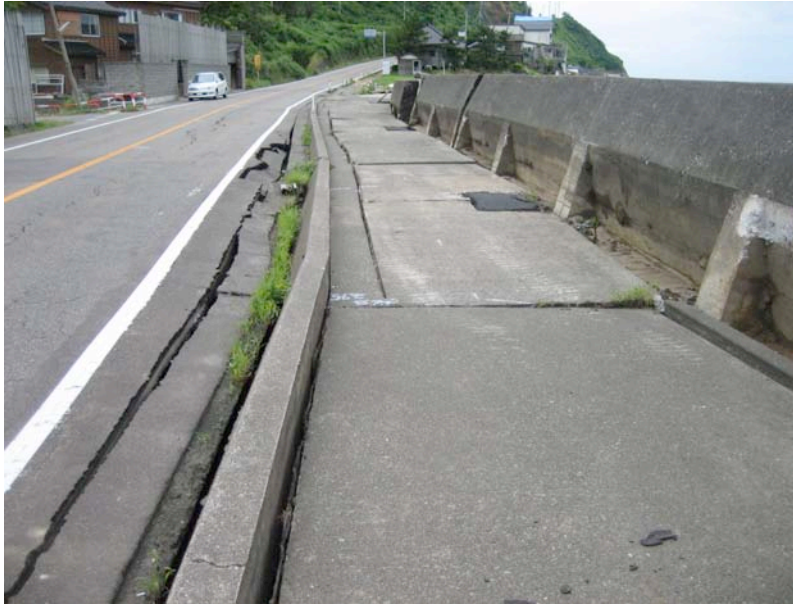
Figure 8.43: Liquefaction-induced damage to the seawall and adjacent roadway (Site RK35, N37.48497°, E138.62645°, photo taken 7/23/07).

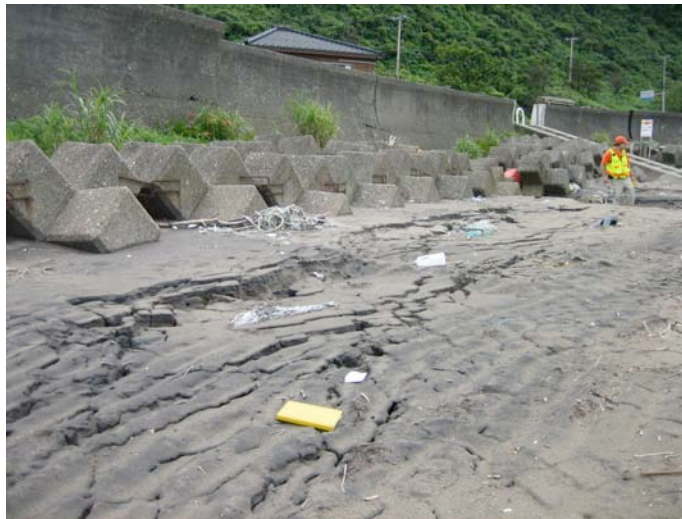
Figure 8.44: Lateral spreading associated with liquefaction of beach sand (Site RK35, N37.48497°, E138.62645°, photo taken 7/23/07).

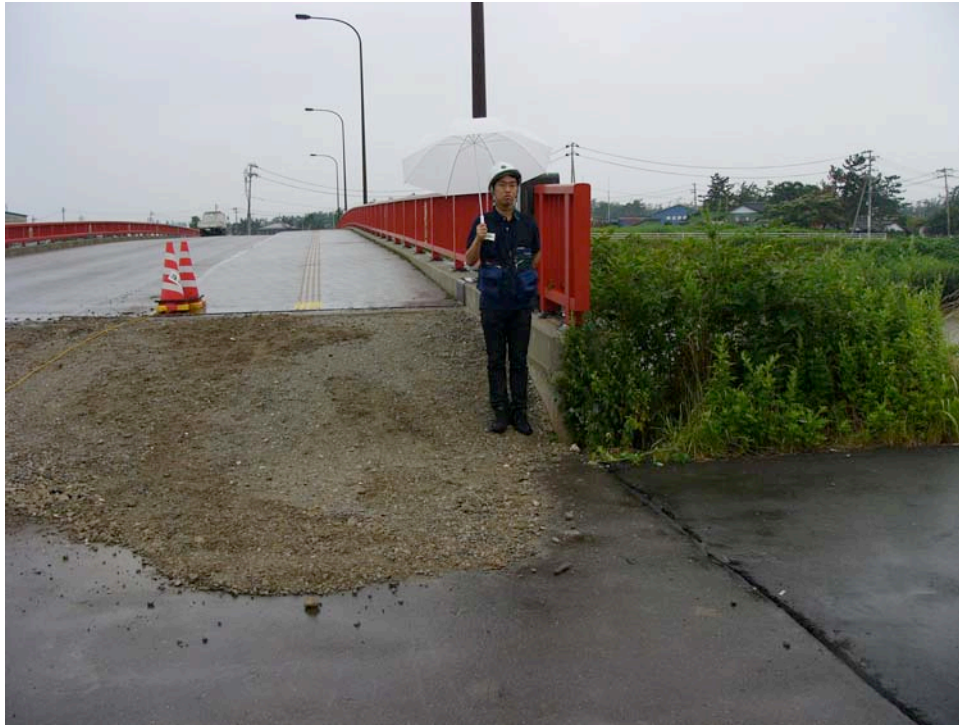
Settlement of soils at bridge approach fills caused vertical offsets at many bridges by as much as one meter (Figs 9.6 and 9.7, additional details are provided in the “Bridges Section”). The offsets required placement of gravel or asphalt pavement to maintain a smooth transition for traffic flow onto the bridges. At the beginning of the reconnaissance mission during July 20-24, 2007, fill had been placed at nearly all of the bridges requiring such repair and only two bridges remained closed. It is not clear how the bridge offsets affected traffic during the first three days following the earthquake.

Figure 9.6: Vertical offset at the approach of Kai-Un Bridge that has been temporarily repaired with gravel fill to permit access (Site YT3, N37.39232° E138.58063°, photo taken 7/20/07 12:42). A vertical offset of 33 cm was measured at the adjacent abutment (left of this photo).

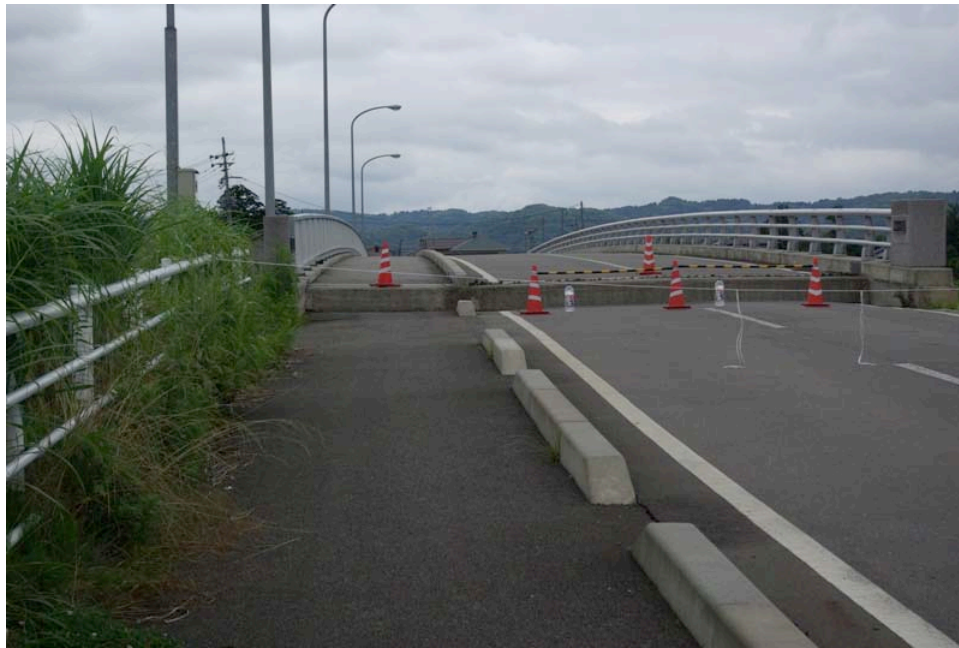
Figure 9.7: Vertical offset at approach of rural bridge that has not yet been repaired (Site SA22 N37.38439° E138.60083°, photo taken 7/21/07 15:00).

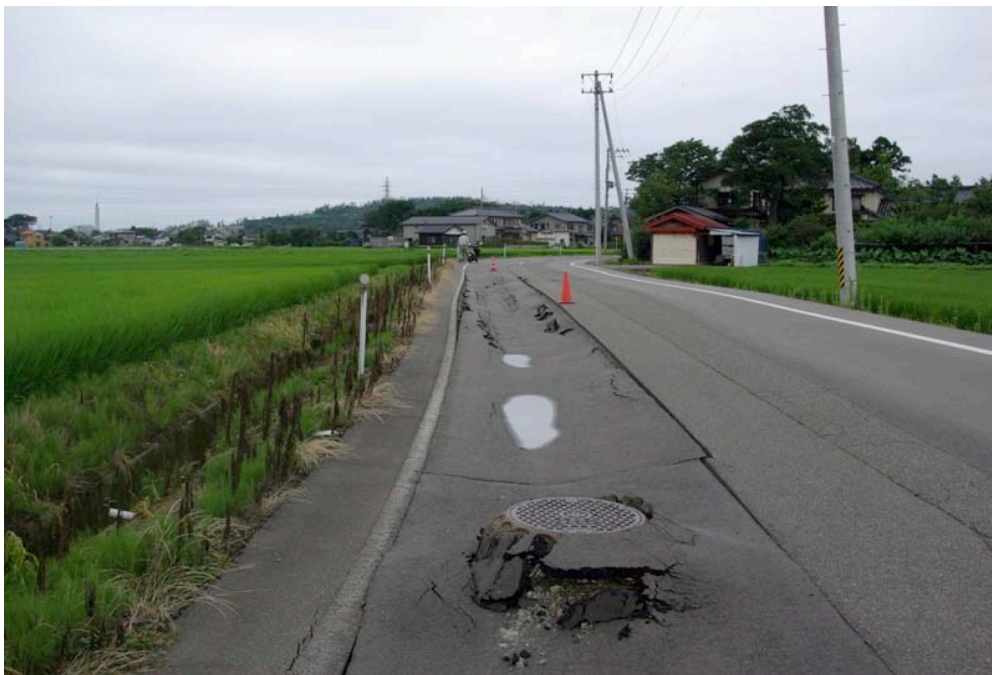
A common cause of pavement damage was liquefaction of utility trench fills, and/or uplift of buried utilities due to buoyancy in liquefied ground. Fig. 9.9 is an example of this widespread pavement damage mechanism. Such damage typically caused closure of one lane of traffic, and in only a few cases were closure of entire roadways necessary due to utility trench fill liquefaction failures.

Figure 9.9: Pavement damage caused by utility trench liquefaction (Site SA21, N37.38950° E138.59662°, photo taken 7/21/07 14:57).

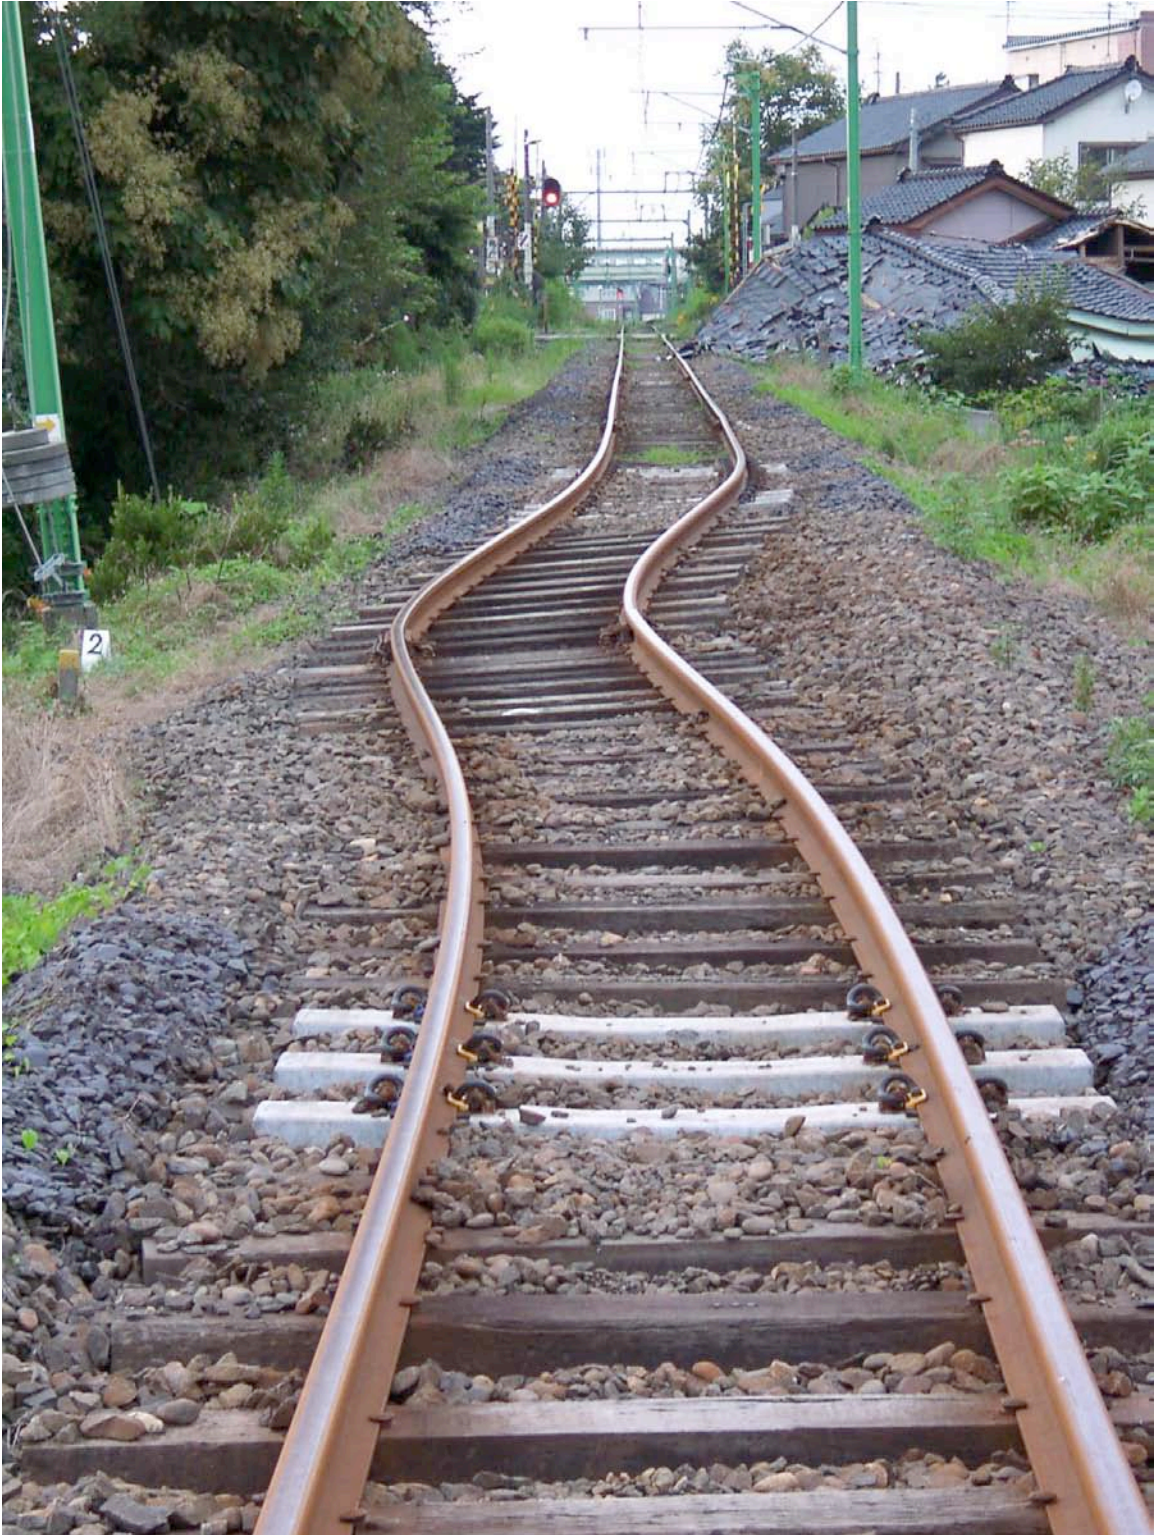
Figure 9.13: Lateral railway buckling (Site RK28, N37.37037° E138.56475°, 7/21/07 18:01).

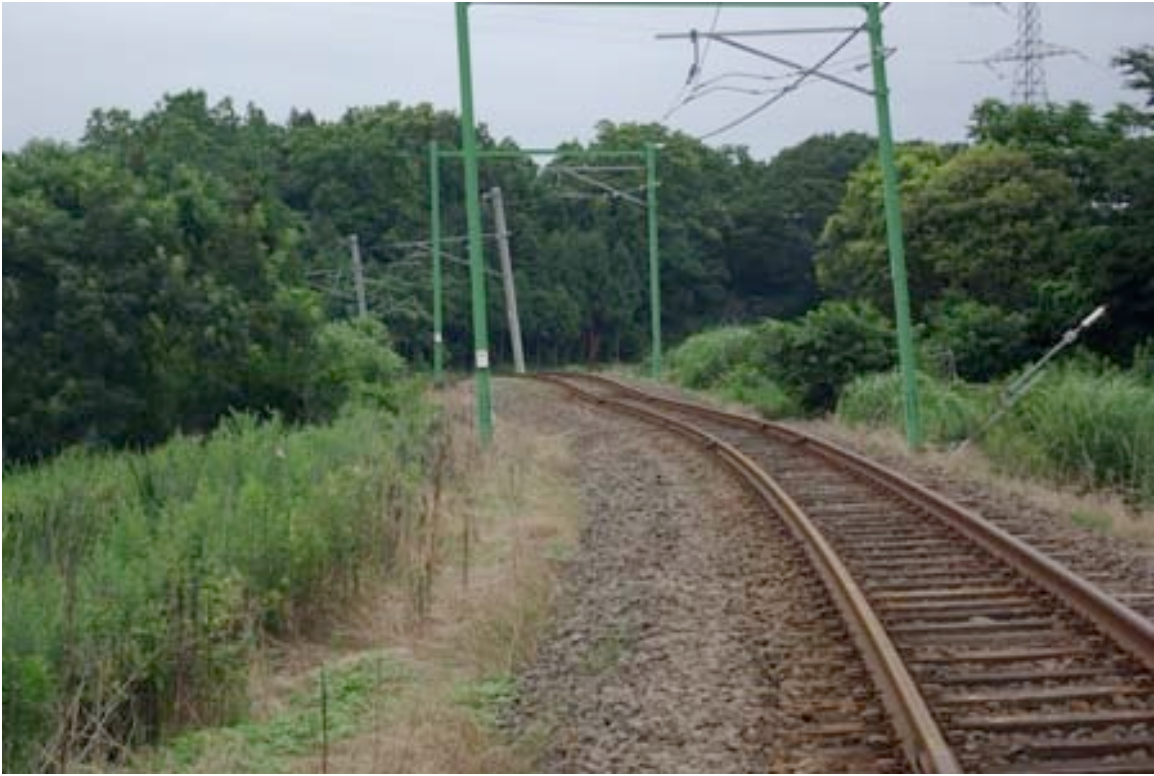
observed in the railway (Fig. 9.14). Numerous other rail disruptions due to foundation settlement and permanent ground deformations were observed by the reconnaissance team. In most cases the deformations were minor, yet significant enough to preclude rail traffic during the period of the reconnaissance. During this time, rail crews were observed making inspections of several rail lines in order to place them back into service.

Figure 9.14: Vertical deformation in train tracks (Site SA24, N37.39323° E138.59520°, 7/21/07 15:44).

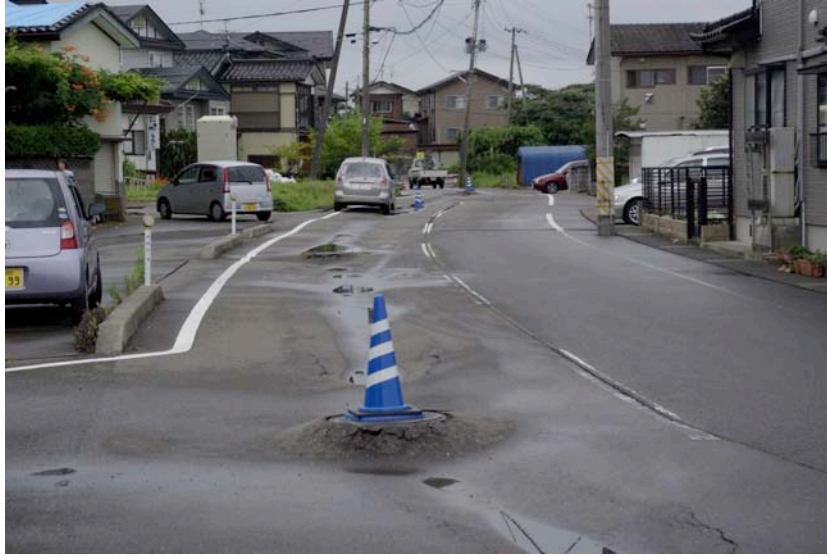
Figure 10.1: Example of an elevated manhole caused by settlement of road fill. The depression caused by densification of lightly compacted trench backfill during cyclic loading was evident along extensive sections of the roadway. This area was conspicuous for pipe breaks associated with ground deformation (Site SD11, N37.36650° E138.58868°, photo taken 7/23/07).

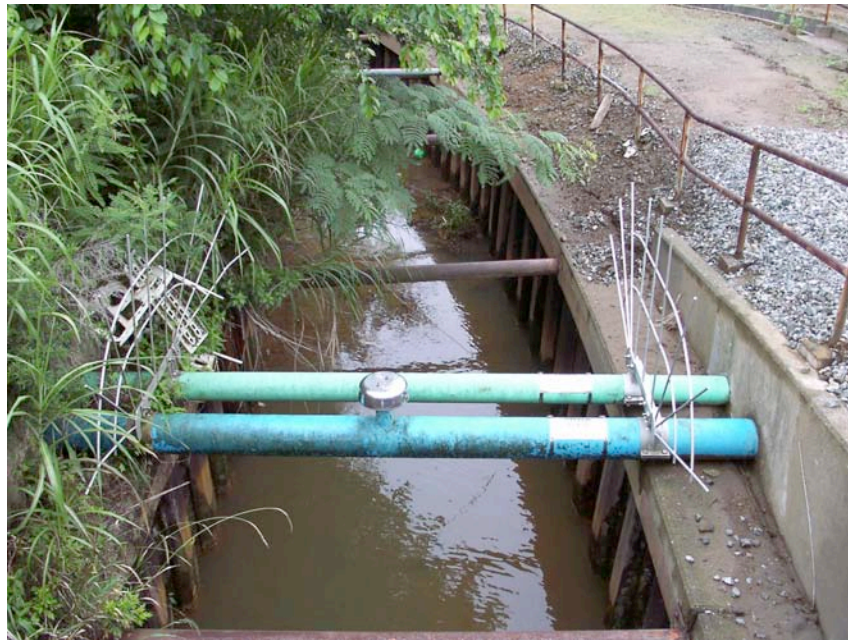
- Numerous water and gas pipes were observed at stream crossings. Many unsupported pipes were observed spanning small, channelized streams. No pipe breaks were observed at the small to moderate stream crossings despite evidence of minor lateral and vertical ground deformations (Fig. 10.2).

Figure 10.2: Example of short span pipes (water and gas) across a channelized stream exhibiting very minor ground deformation. No damage to the pipes was observed (Site SD12, N37.36663° E138.59223°, photo taken 7/23/07).

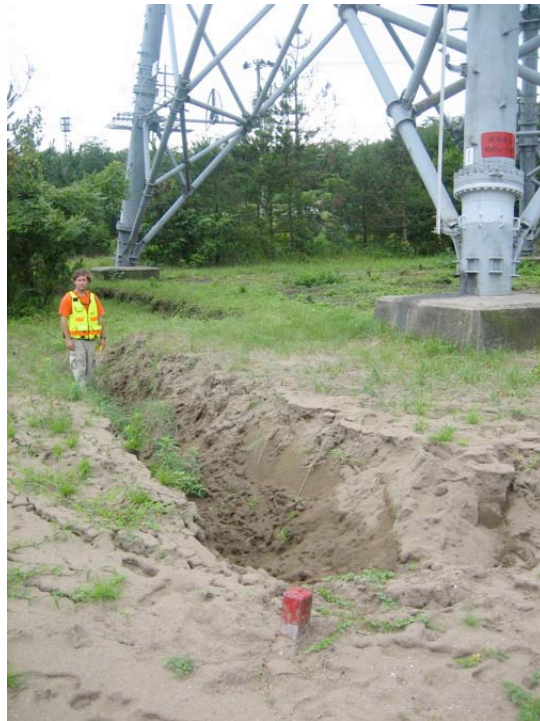
Figure 10.5: Ground failures at the site of a high voltage tower (Site RK40, N37.41633° E138.60792°, photo taken 7/24/07). No evidence of structural damage to the towers was observed.

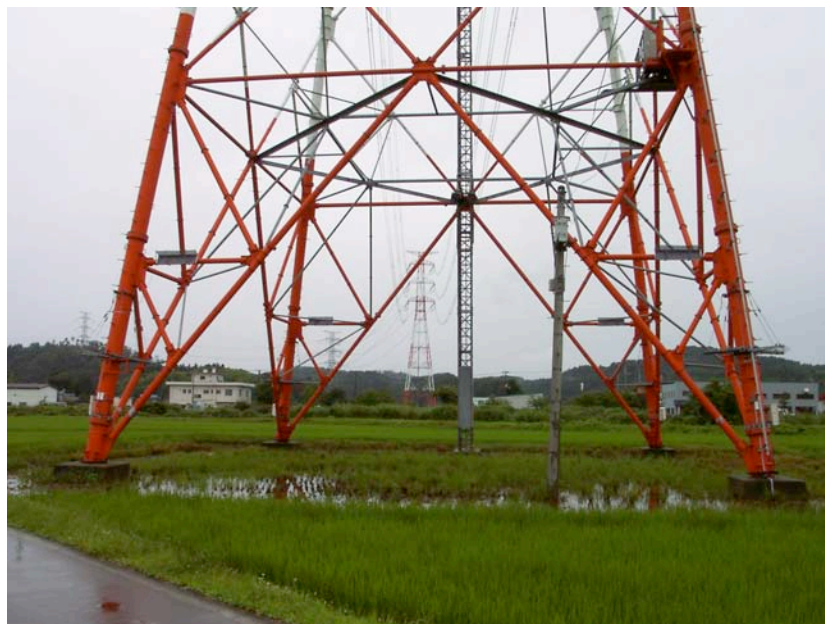
Figure 10.6: High voltage power line towers located in the Kashiwazaki area (Site RK12, N37.44113° E138.63390°, photo taken 7/21/07). No evidence of structural damage to the towers was observed.

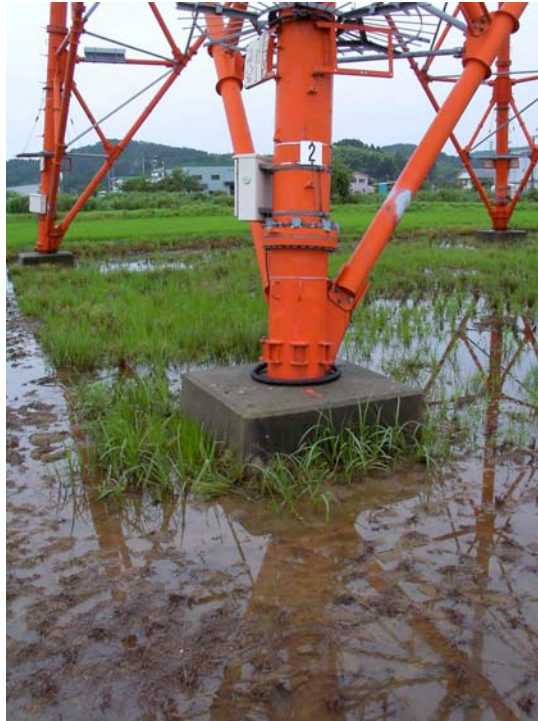
Figure 10.7: High voltage power line towers located in an area of soft ground (Site RK12, N37.44113° E138.63390°, photo taken 7/21/07). No evidence of ground failure, settlement, or structural damage to the towers was observed.

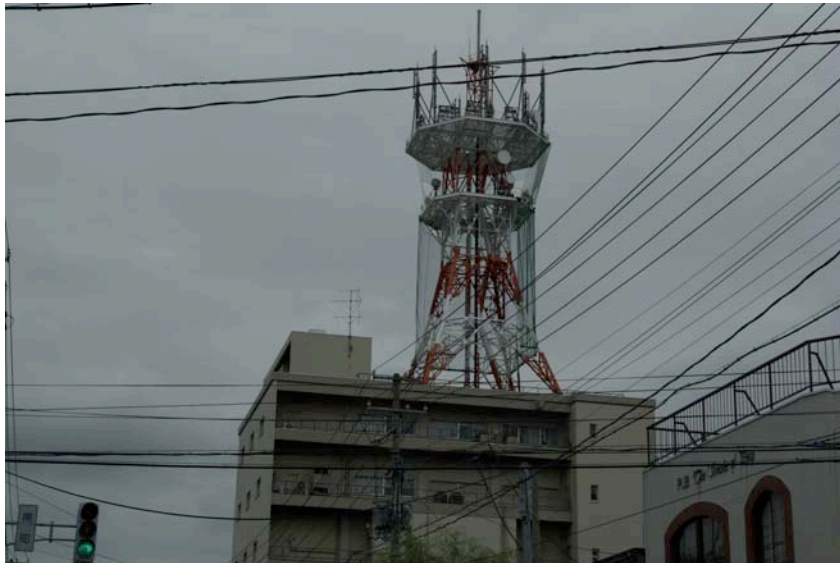
Figure 10.8: NTT communications building in downtown Kashiwazaki (Site SD20, N37.36847° E138.55813°, photo taken 7/23/07). No evidence of major structural damage to the tower was observed however no information on the performance of the electronics was available at the time of the investigation.

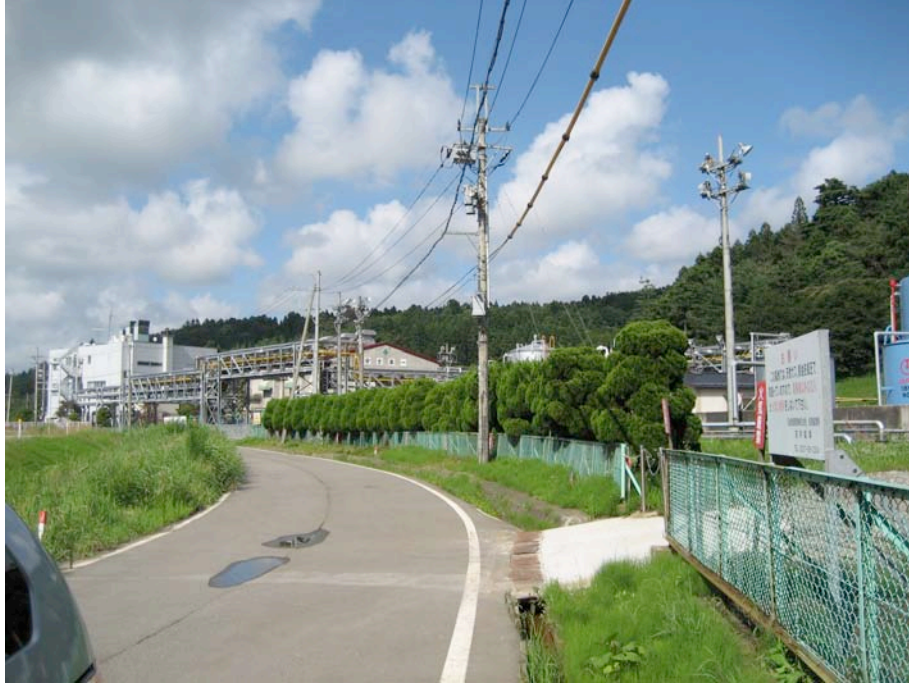
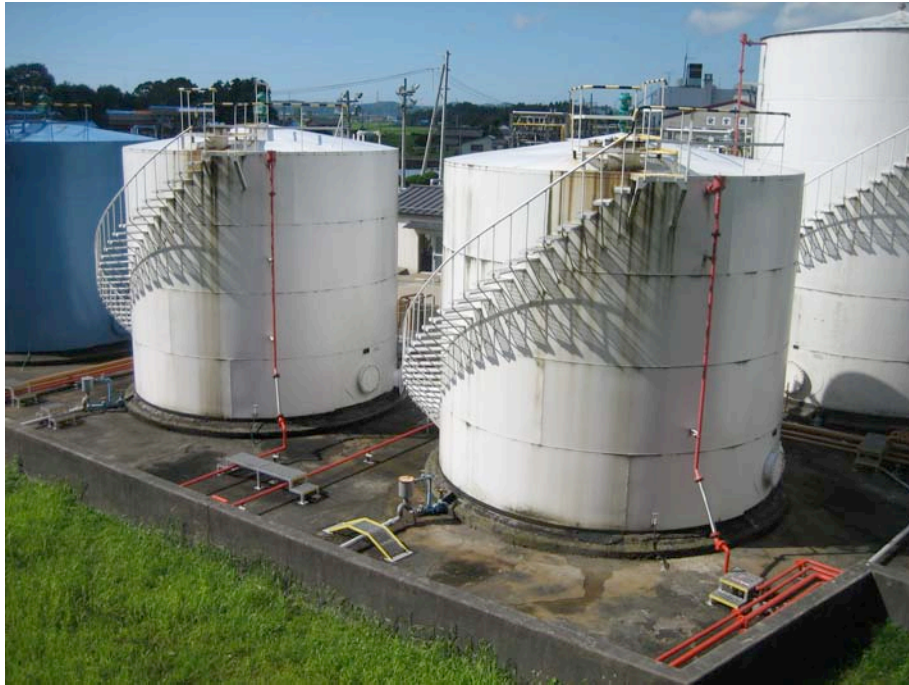
Figure 10.10: Oil storage and distribution facility (Site RK55, N37.38917° E138.63377°, photos taken 7/23/07 12:30). No damage was observed at this site.

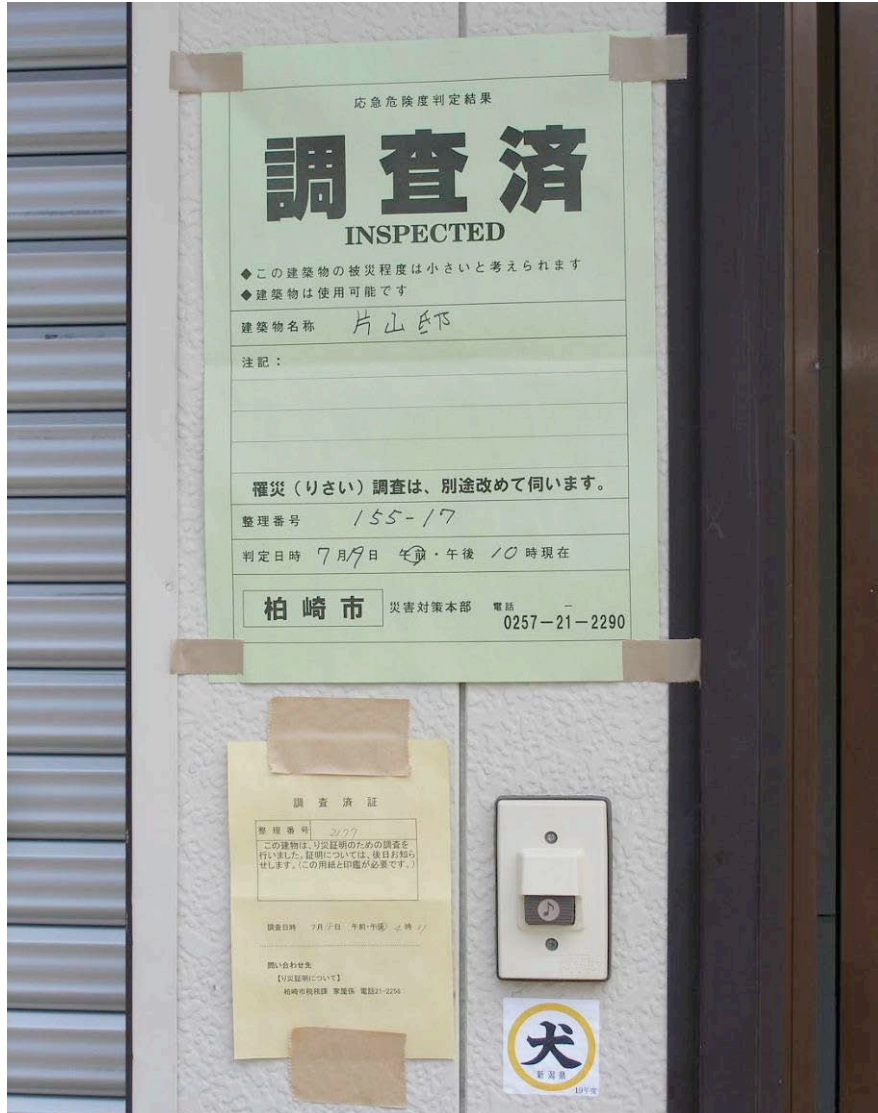
Figure 11.7: A building in Kashiwazaki city that has been through two surveys, with both a green tag as well as a standard yellow notice that the damage certification survey has also been completed.
