**UNITED REPUBLIC OF TANZANIA
MINISTRY OF WORKS AND TRANSPORT**

**AIRCRAFT ACCIDENT AND INCIDENT
INVESTIGATION BRANCH
TANZANIA**

PRELIMINARY REPORT

Accident No. CAV/ACC/6/22

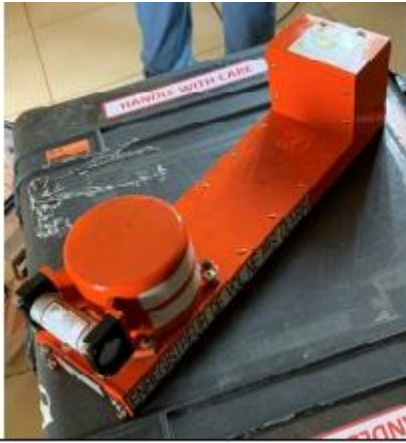
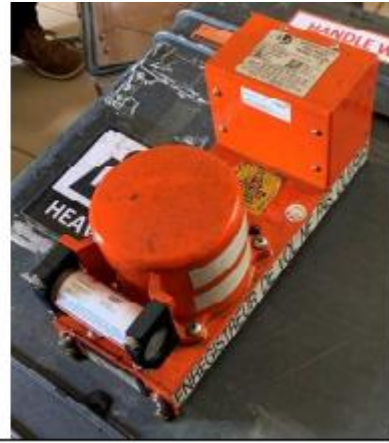
Both recorders were recovered from the wreckage and examined at the BEA, Le Bourget, France. Downloading and analysis was performed by the experts from BEA with the presence of the Tanzania AAIB investigation team.
