Wairoa Airport Plan

1 Foreword

The Wairoa Airport plan is a strategic planning tool with an aim to ensure the most effective and efficient development of the airport’s land holdings and infrastructure over time. It is intended that all future decisions relating to the airport should take into consideration and be managed appropriately through this plan. The plan should be subject to continuous review to take into consideration the circumstances prevailing at the time and changes to airport/air transport policy.

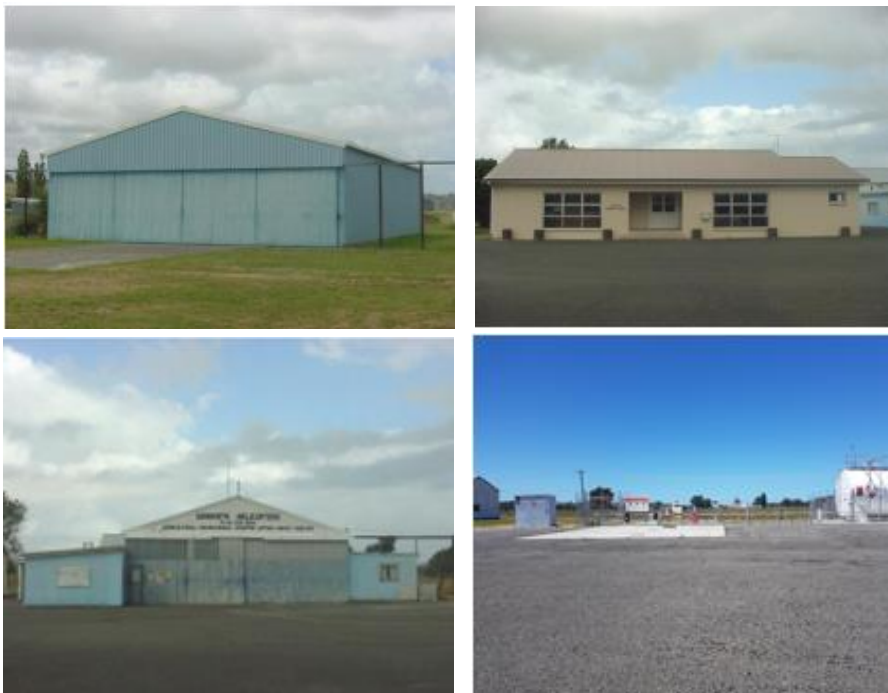
Images 1 – 4 (Left to right - Aero Club Incorporated Hanger, Terminal Building, Cookson's/Ashworth Helicopters Hanger, Z Refuelling area

Z Energy has a Jet A1 gas supply at the airport adjacent to the terminal. There is currently no aviation gas supply at the airport for light aircraft.

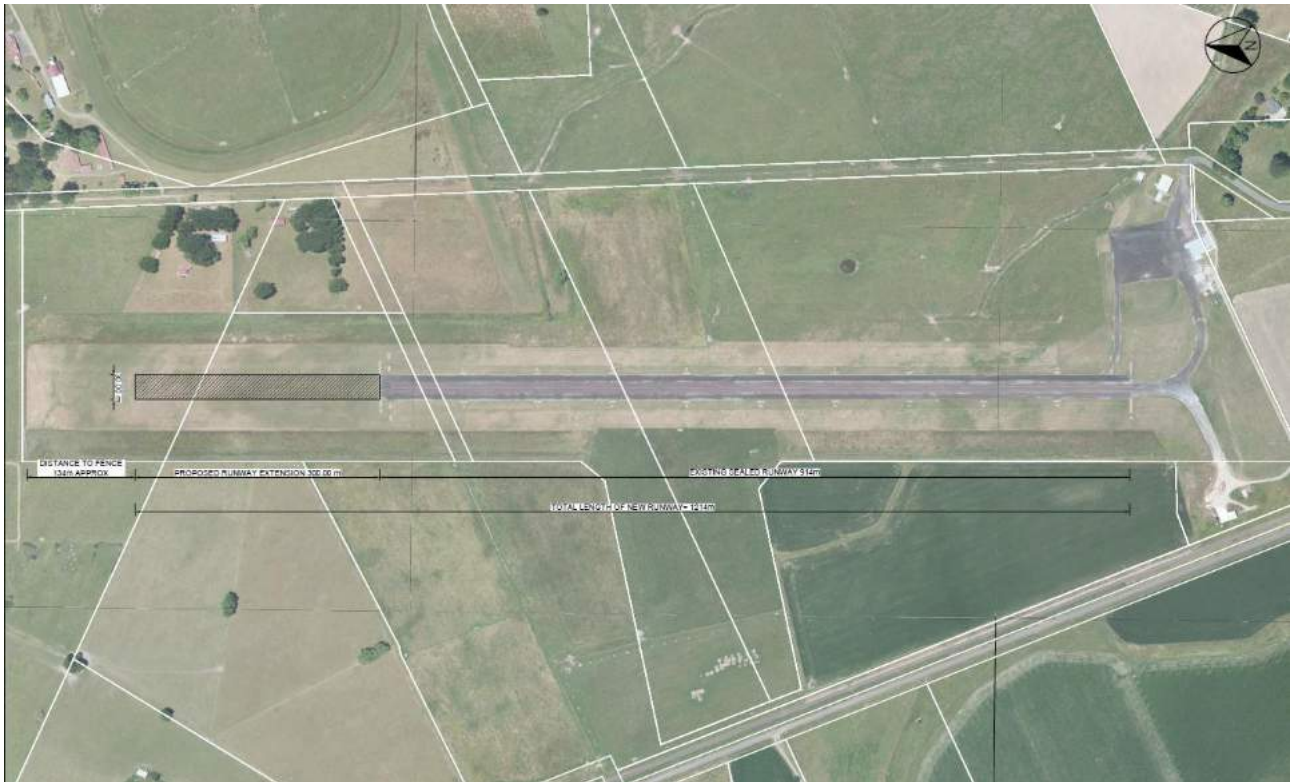
Image 5 – Proposed Runway Extensions

Image 5 below and Appendix D show potential runway extension of 300m which will increase the length of the runway to 1200m. Civil aviation regulations require a minimum clear zone at the end of the runway of 240m. The Land Requirement Plan (C06-B) in Appendix E and Image 6 below shows additional land which is currently not owned by Wairoa District Council but which is needed to provide for this 240m clear zone (2.55ha). Part of the existing carparking area is located on private land (see Image 7 below).

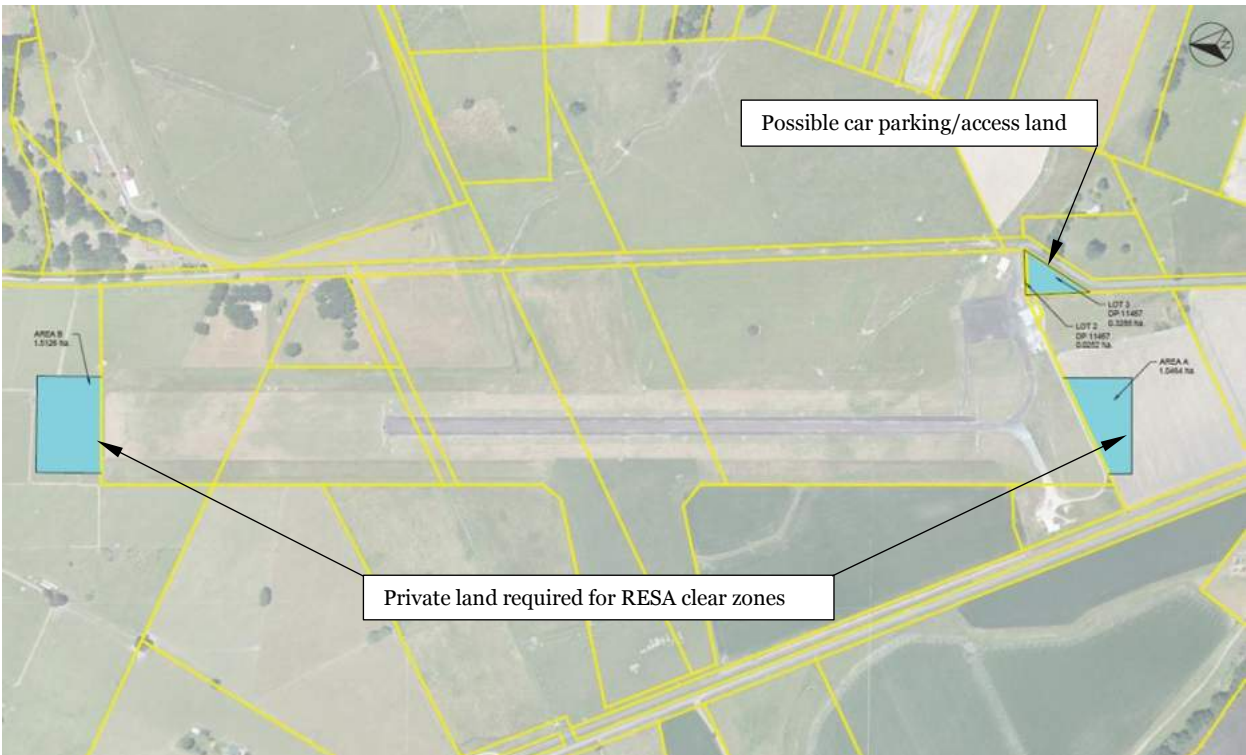
Image 6 – Land requirement Plan (Lot boundaries shown in yellow)

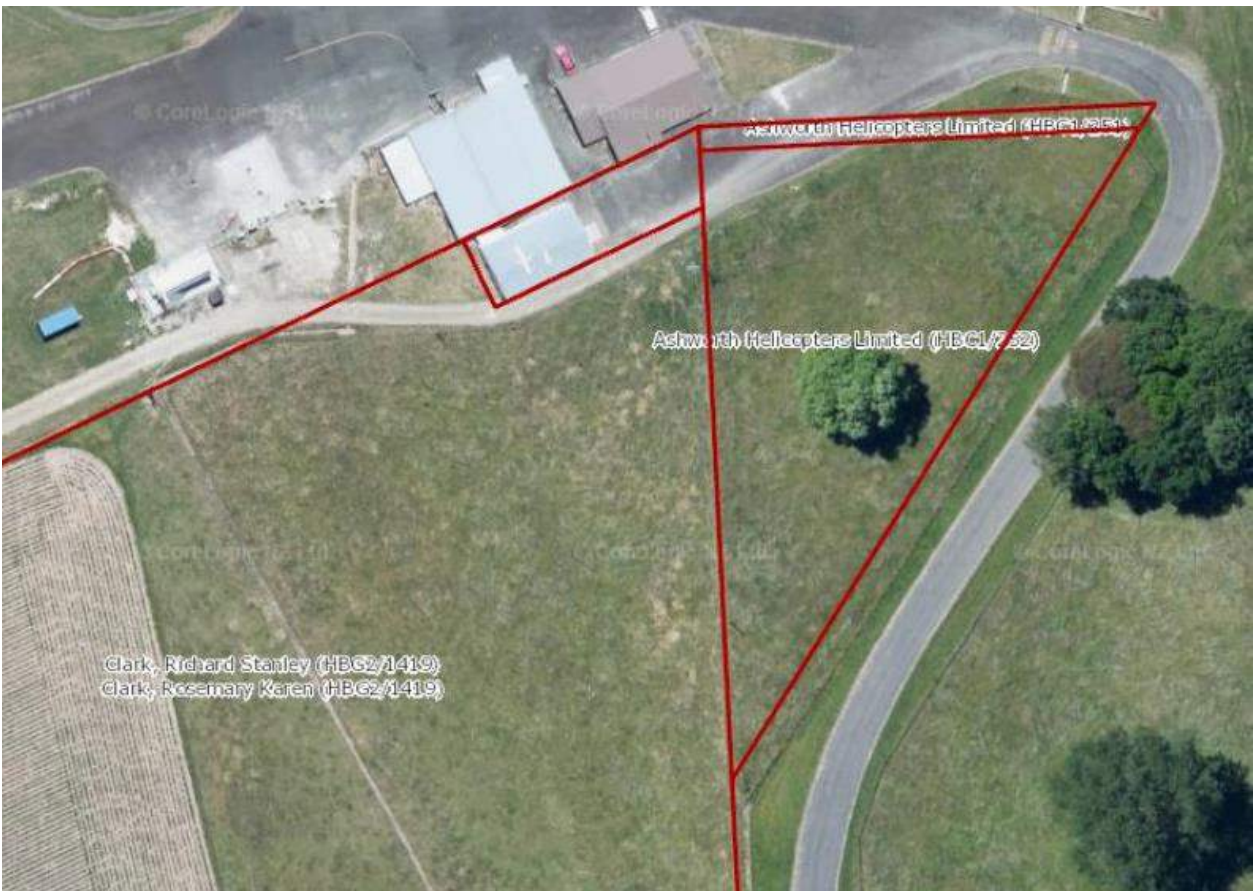
Image 7 – Aerial showing the portion of the airport car park located in private ownership (shown in red)

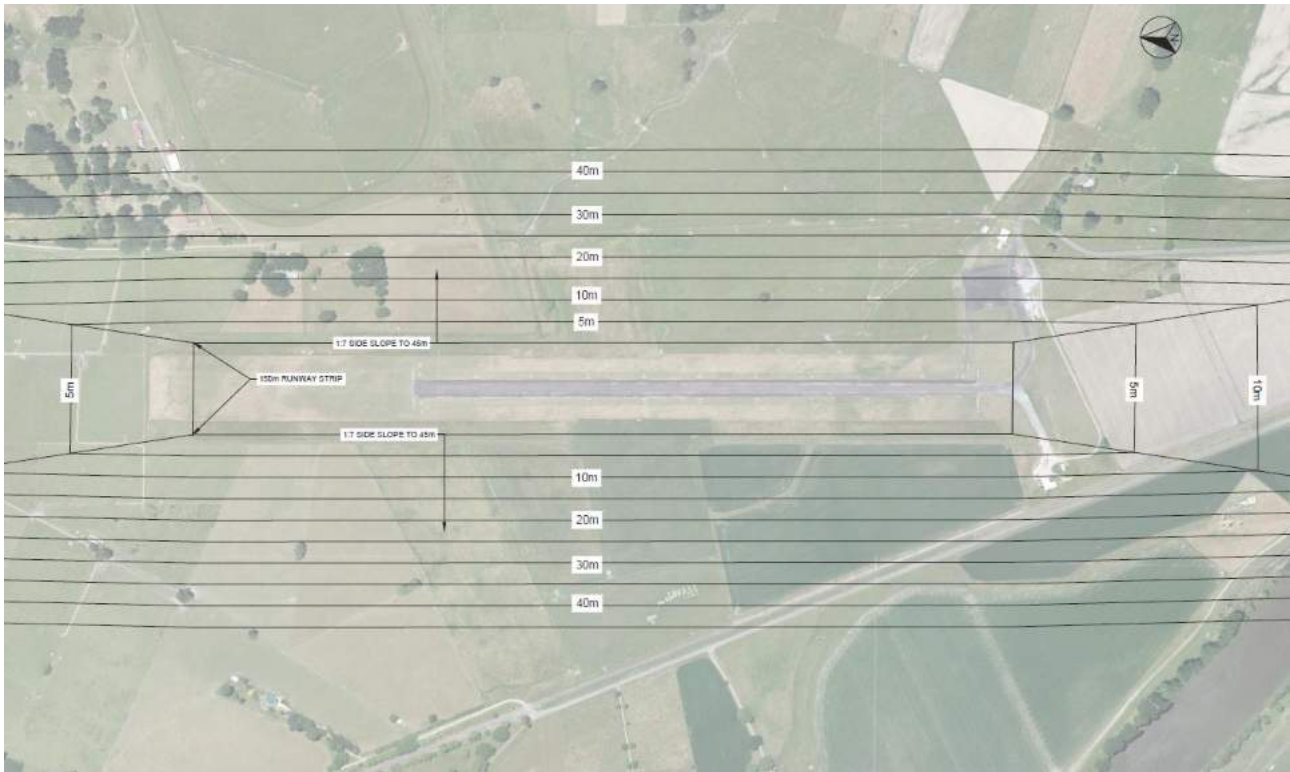
Image 9 – Obstacle Limitation Surfaces for Wairoa Airport (the contours show the maximum height limits for structures and vegetation).

The obstacle limitation surface for the Wairoa Airport, which essentially defines the maximum heights for trees and structures, is shown on plan C08-C09-B in Appendix C and Image 9 below. No buildings, structures or trees should exceed the maximum heights as indicated on Image 9. It is recommended that the Wairoa District Council incorporate these height limitation surfaces into the Wairoa District Plan.

The greatest risk to the breach of these height limits is likely to be new buildings or structures within the airport land; new farm buildings on adjacent properties; or new telecommunication masts.

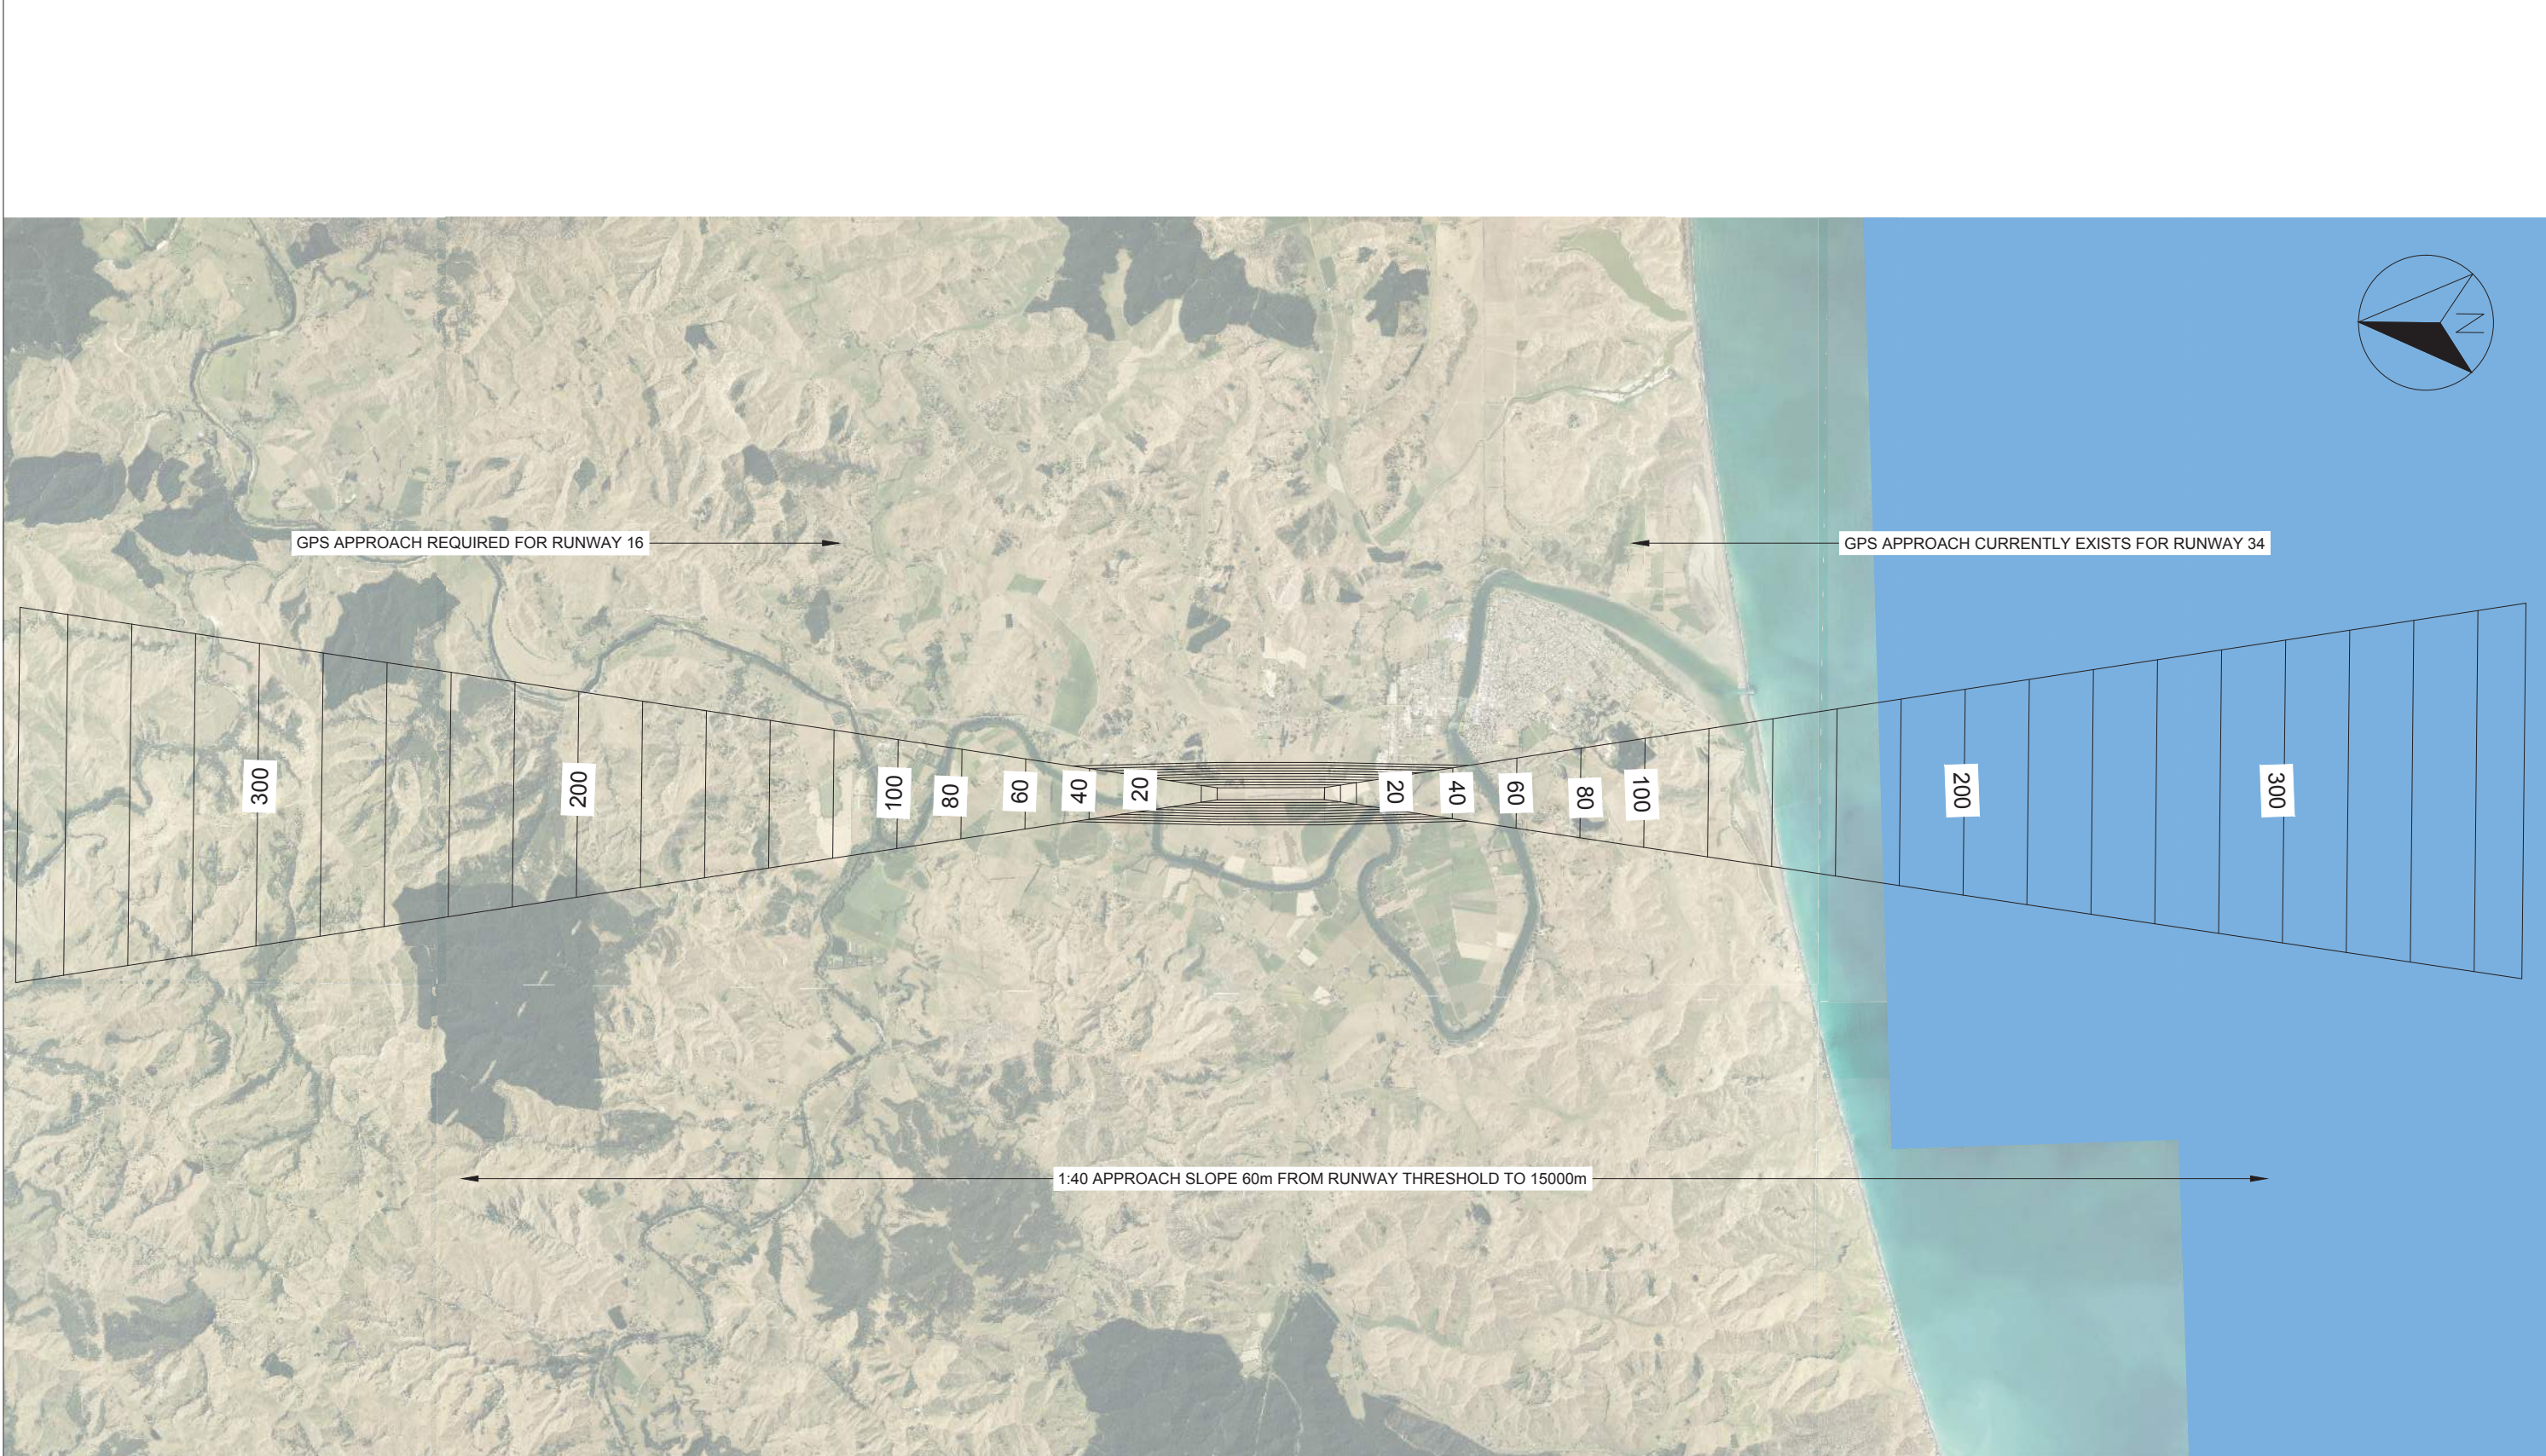
Project WAIROA DISTRICT COUNCIL WAIROA AERODROME RUNWAY EXTENSION	
Sheet TRANSITIONAL SLOPE OBSTACLE LIMITATION SURFACE	
Project No. 2-S5091.VT	Sheet No. Revision C08 B

NOTE: LEVELS SHOWN ARE HEIGHT FROM RUNWAY CENTRELINE LEVEL

NOTE: FOR FULL OBSTACLE LIMITATION SURFACE DETAILS REFER TO CAA AC 139-6, SECTION 4 - OBSTACLE RESTRICTION AND REMOVAL

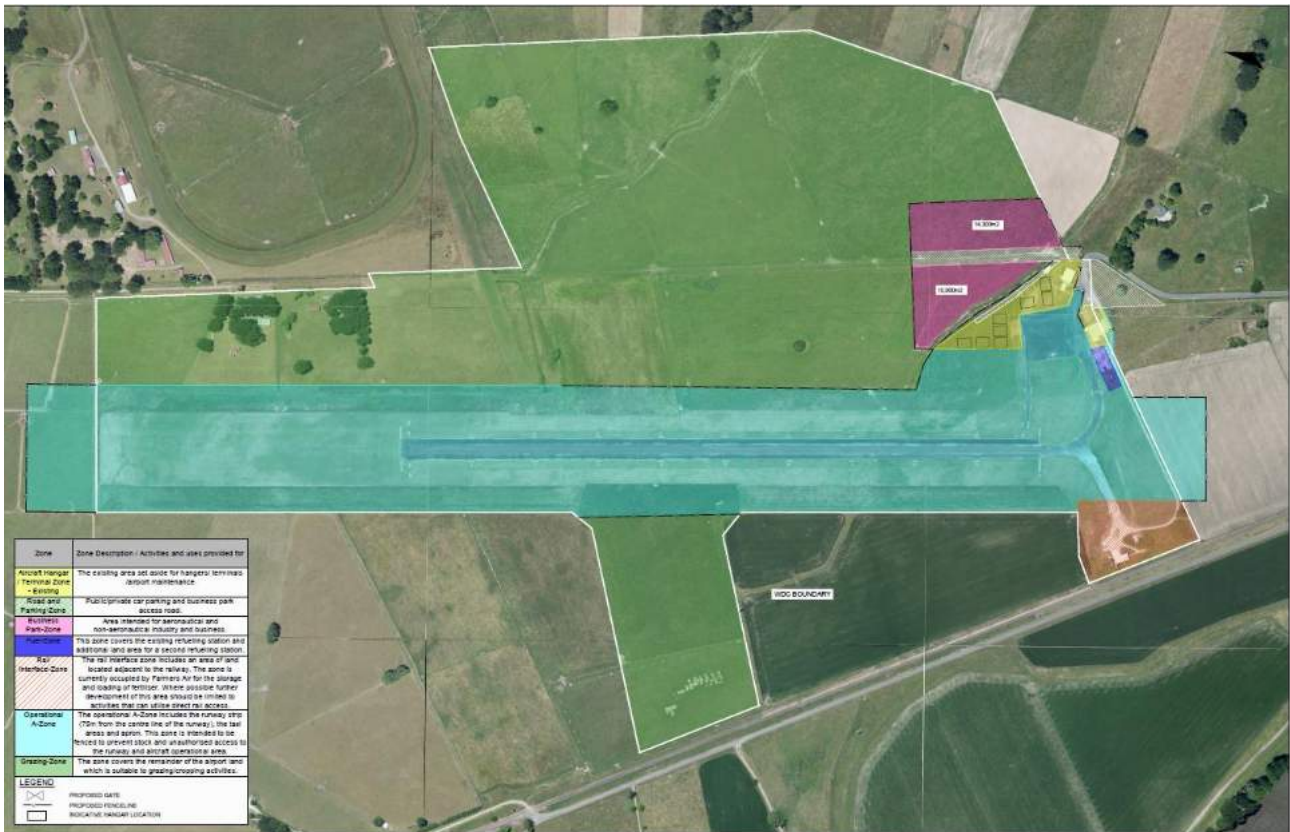
Figure 1 : Airport Internal Zoning Plan

Opus International Consultants Ltd (the consultant) was engaged by Wairoa District Council (the Council) to carry out geotechnical investigations for the potential future development of Wairoa Aerodrome (the site). The site is located at the end of Airport Road, Wairoa.

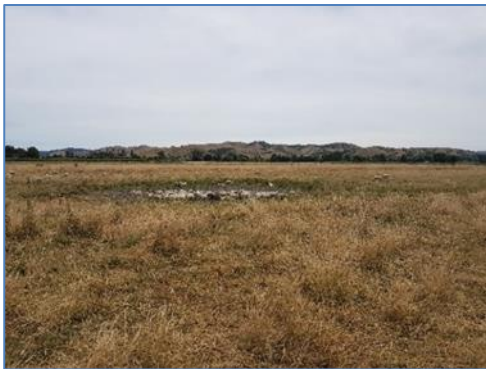
Figure 2 Dry pond in shallow depression

The site is located on a flood plain in the lower reaches of the Wairoa River valley. The site is generally level, incised with two surface drains approximately 2 to 3 m in depth, as shown in Figures 2 and 3. A lower area of 1 to 2 m depth several metres wide runs north to south through the site. A shallow pond and rush bushes growing along the floor suggests this area is normally wet. The investigations reported herein were completed during very dry summer conditions.

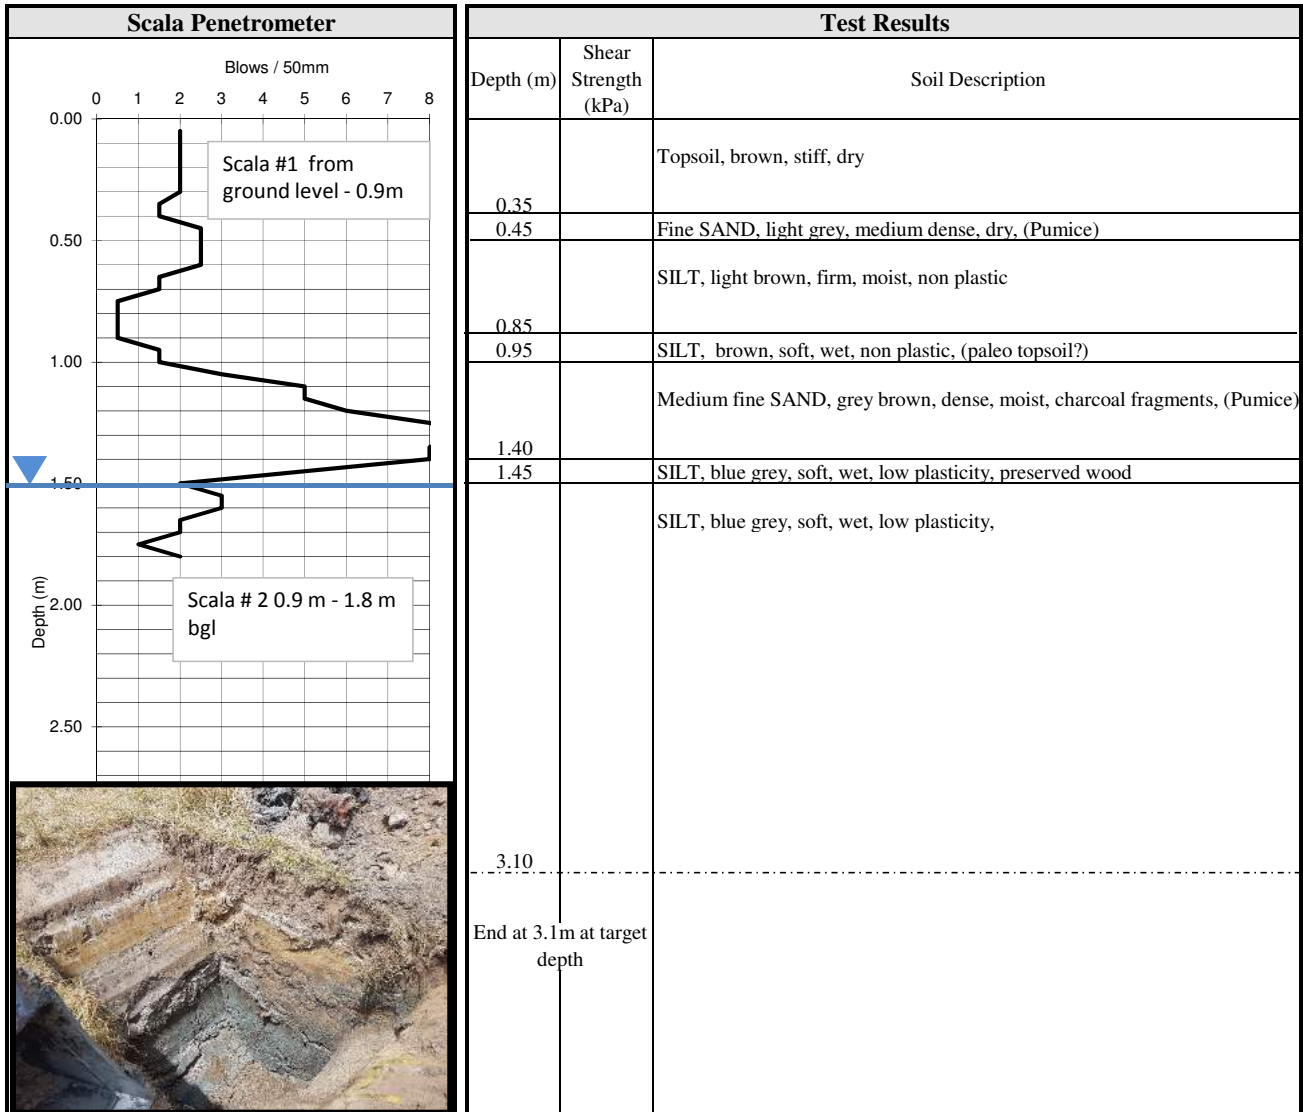
Project : **Wairoa Airport Development**
 Location : **39°046.1 S 177°24'25.5E 4m WGS 1984**
 Client : **Wairoa District Council**
 Contractor : **Opus - Napier**
 Test number : **3**
 Shear vane number : **DR955**
 Shear vane correction : **1.655**
 Water level (m): **1.5**
 Reduced level (m): **Existing Ground**

Test Methods	
Determination of Penetration Resistance of a Soil, NZS 4402 : 1988, Test 6.5.2 Shear Strength using a Hand Held Shear Vane: NZ Geotechnical Soc Inc 8/2001	Field Descriptions of Soils and Rocks by NZ Geotechnical Society Dec 2005

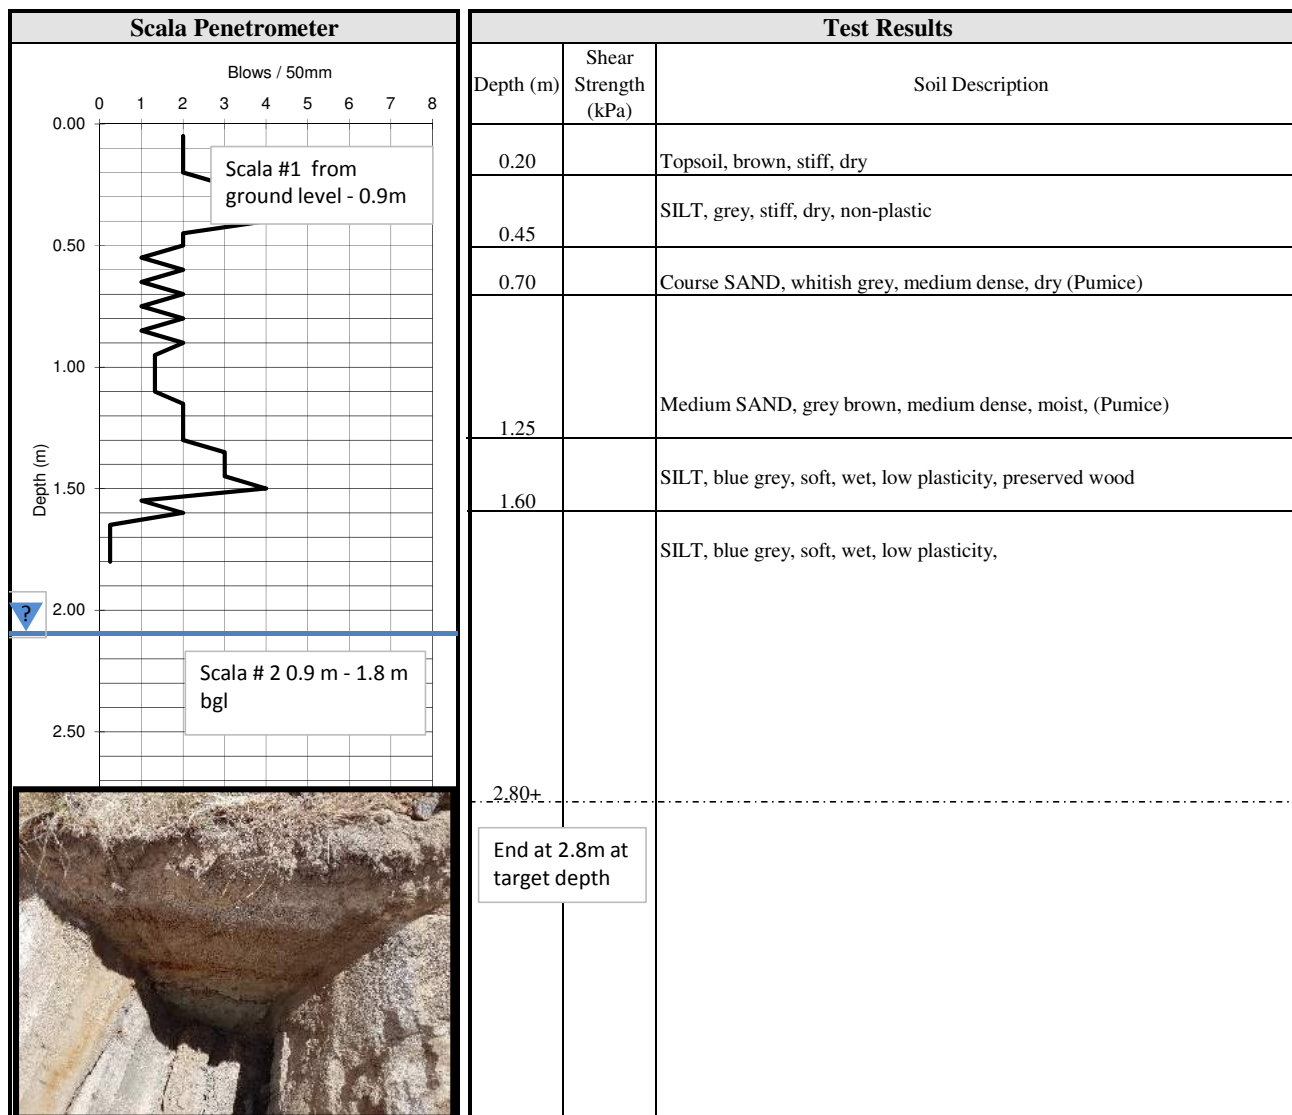
Project : **Wairoa Airport Development**
 Location : **39°051.6 S 177°24'25.0E 4m WGS 1984**
 Client : **Wairoa District Council**
 Contractor : **Opus - Napier**
 Test number : **4a**
 Shear vane number : **DR955**
 Shear vane correction : **1.655**
 Water level (m): **Some seepage at 2.1m**
 Reduced level (m): **Existing Ground**

Test Methods	
Determination of Penetration Resistance of a Soil, NZS 4402 : 1988, Test 6.5.2 Shear Strength using a Hand Held Shear Vane: NZ Geotechnical Soc Inc 8/2001 Field Descriptions of Soils and Rocks by NZ Geotechnical Society Dec 2005	Note: TP4 was not completed as directed by archaeologist

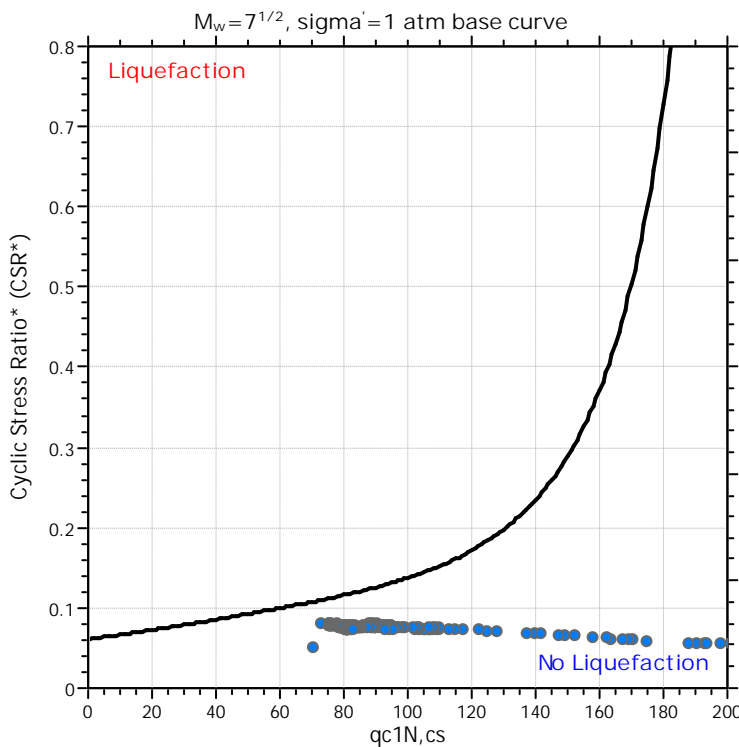
CPT basic interpretation plots (normalized)

Analysis method:	B&I (2014)	G.W.T. (in-situ):	1.98 m	Use fill:	No	Clay like behavior applied:	Sands only
Fines correction method:	B&I (2014)	G.W.T. (earthq.):	1.98 m	Fill height:	N/A	Limit depth applied:	No
Points to test:	Based on Ic value	Average results interval:	3	Fill weight:	N/A	Limit depth:	N/A
Earthquake magnitude M_w :	6.20	Ic cut-off value:	2.60	Trans. detect. applied:	Yes	MSF method:	Method
Peak ground acceleration:	0.09	Unit weight calculation:	Based on SBT	K_G applied:	Yes

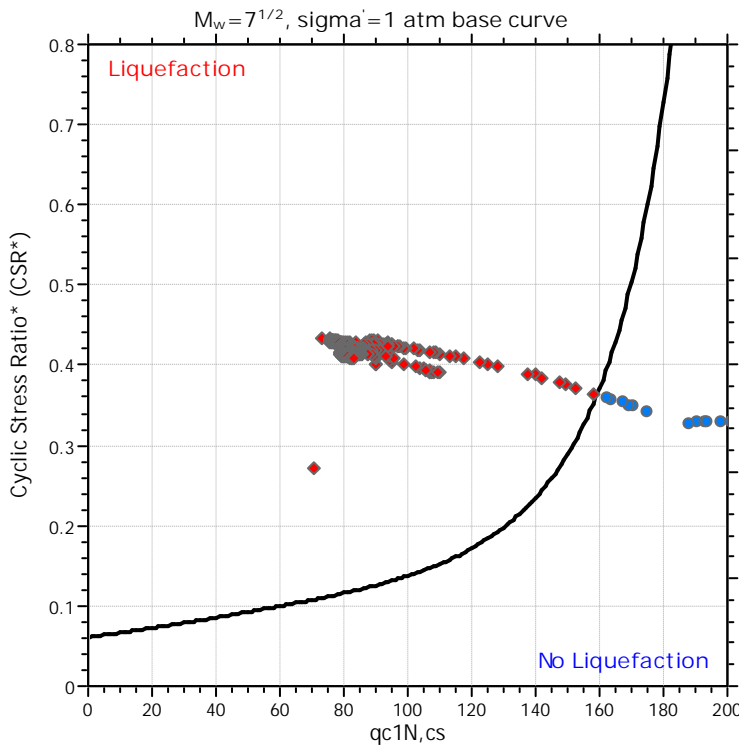
CPT basic interpretation plots (normalized)

Analysis method:	B&I (2014)	G.W.T. (in-situ):	1.98 m	Use fill:	No	Clay like behavior applied:	Sands only
Fines correction method:	B&I (2014)	G.W.T. (earthq.):	1.98 m	Fill height:	N/A	Limit depth applied:	No
Points to test:	Based on Ic value	Average results interval:	3	Fill weight:	N/A	Limit depth:	N/A
Earthquake magnitude M_w :	6.50	Ic cut-off value:	2.60	Trans. detect. applied:	Yes	MSF method:	Method
Peak ground acceleration:	0.47	Unit weight calculation:	Based on SBT	K_g applied:	Yes

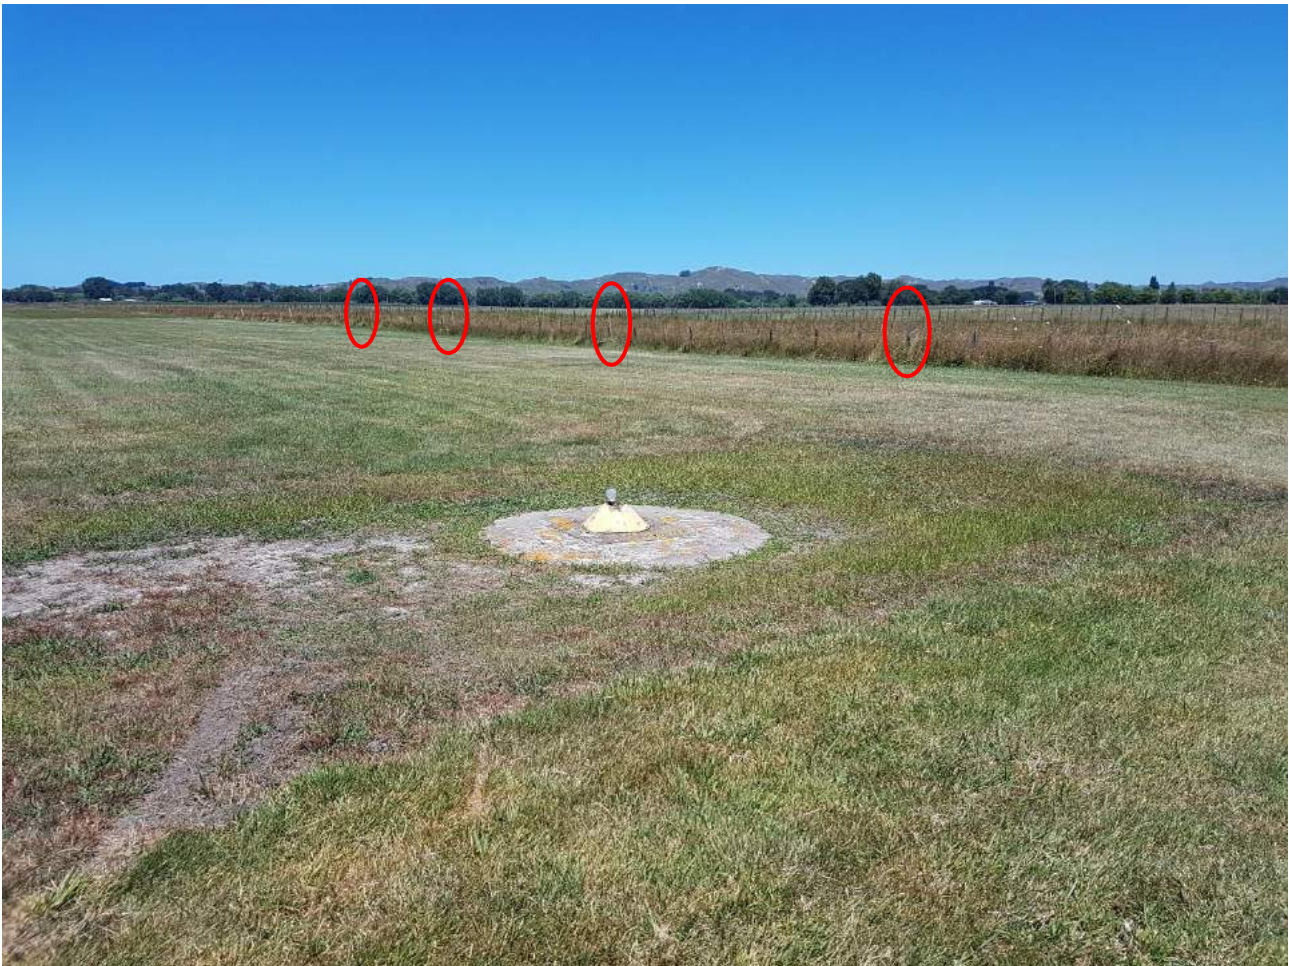
The existing post and wire perimeter fencing for the Airport currently ranges in condition, from very good to very poor condition. (*I.e. not stock proof*). It is recommended that the entire perimeter fencing is checked and upgraded to ensure it is stock proof. It may be possible to install new posts and batons as required, while restraining the existing wire as a lower cost alternative. The northern 3rd of the runway appears to be partially buried as can be seen in the attached photo. (*Note: - extension of fence height using battens*).

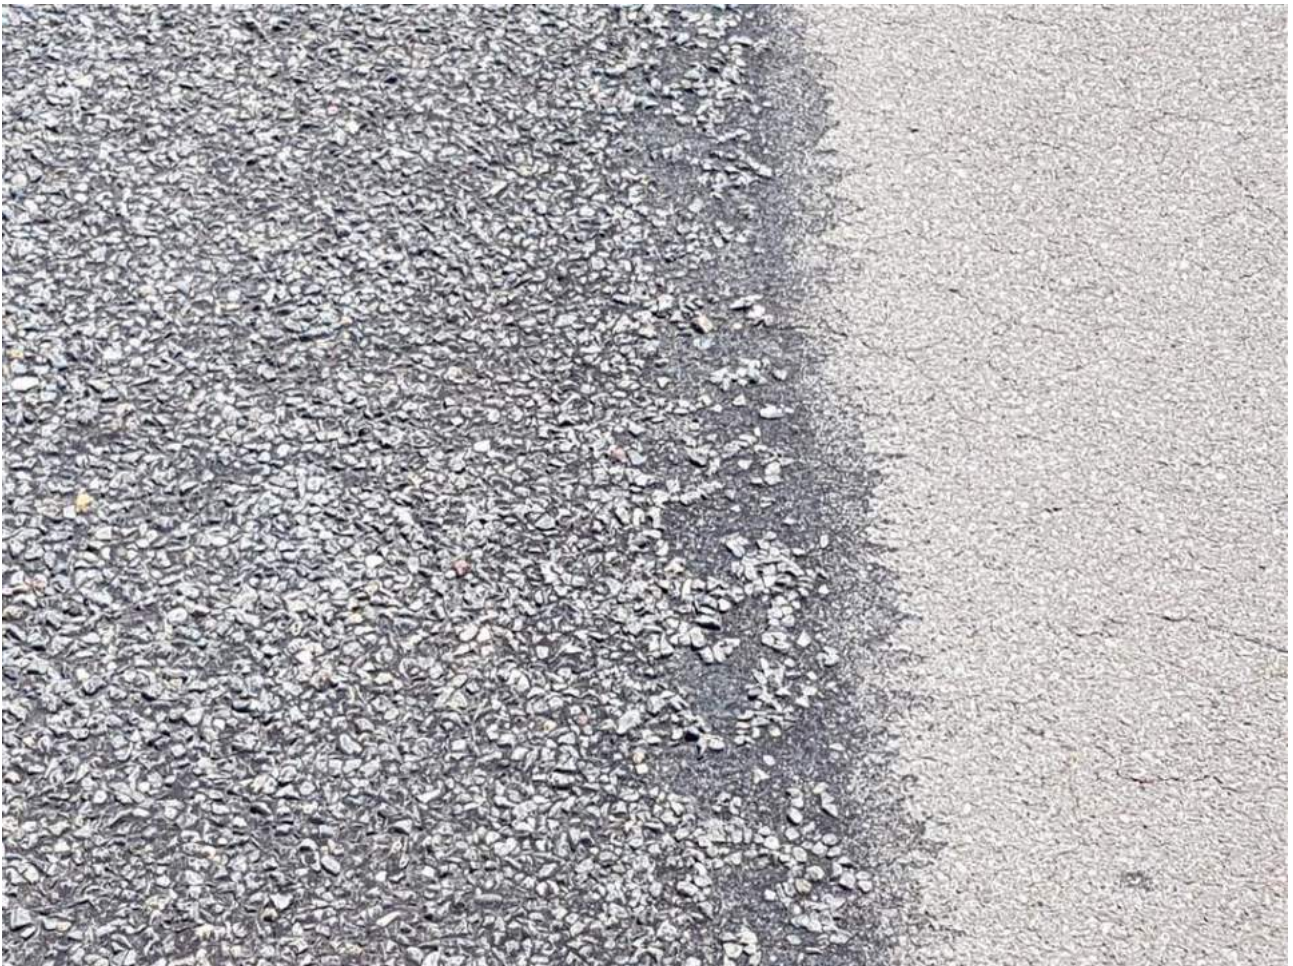
Photo showing Grade 3/5 chipseal and AC surfacing

The existing all weather runway is 914m long and 30m wide comprising 6m grade 3/5 chipseal, 18m asphaltic concrete (AC) and 6m grade 3/5 chipseal. The sides of the runway were sealed in 2014, but the age of the AC is approaching 30+ years and showing signs of fatigue with extensive cracking. Options for resurfacing the central runway and sides have been considered taking into account the likelihood of the runway being extended.

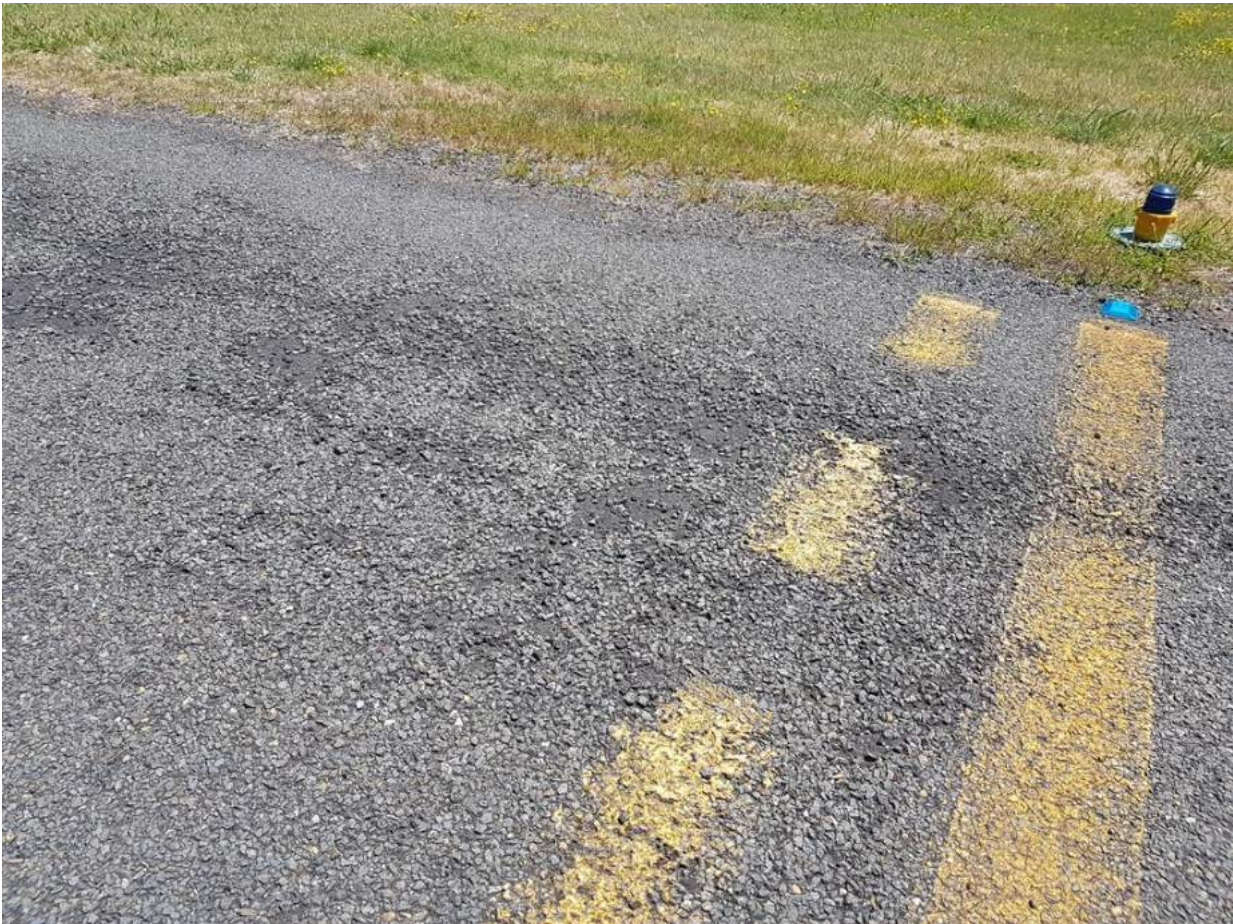
Photo showing chip loss on Taxiway

This option is the least expensive surfacing but provides an economic solution to minimising the chip loss and creating a smoother surface than existing still providing for easier pedestrian and health care patient mobility and transfer. Some maintenance texturizing of areas where chip has been lost maybe required prior to applying the grade 6 seal. Predicted life expectancy 10-15 years

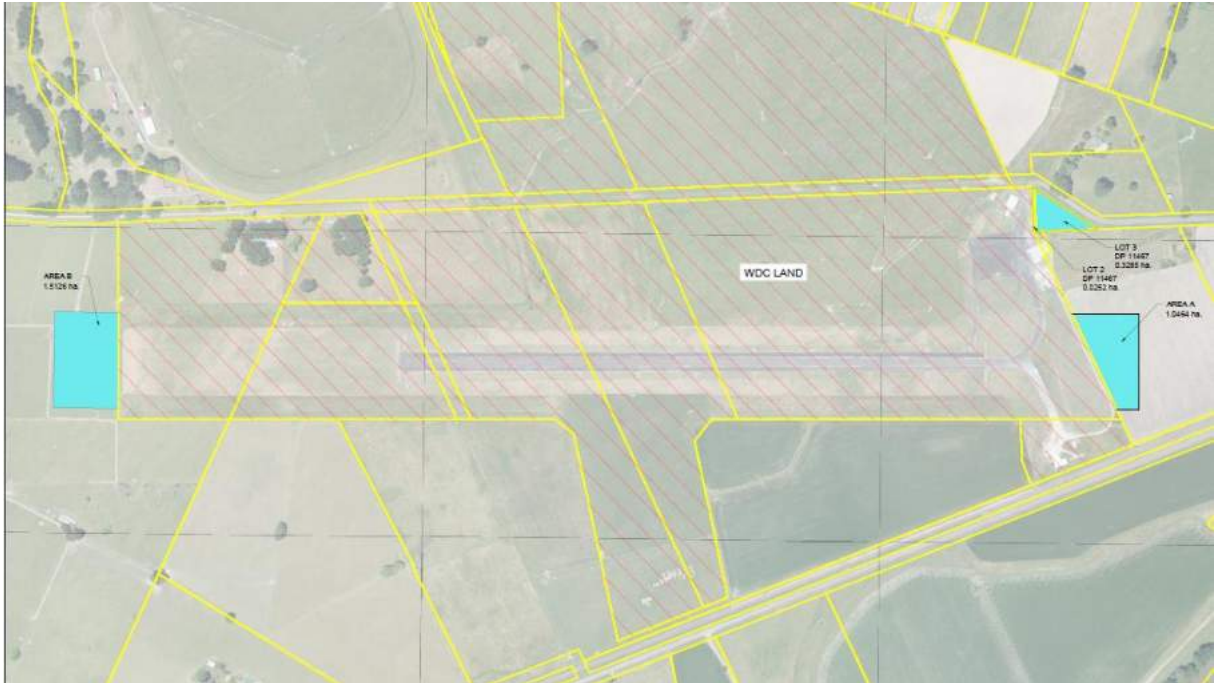
- 1.0.3 The feasibility study relates to the taking of three parcels of land as outlined in the map and table below.

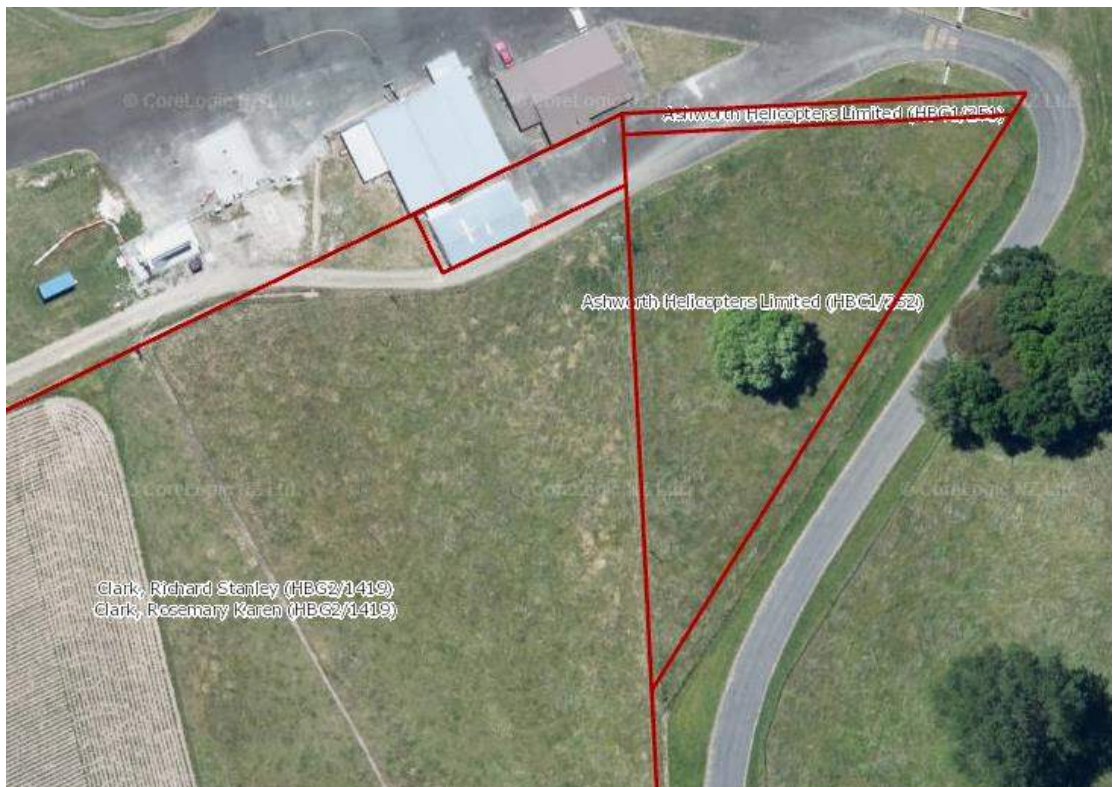
1.0.11 The access to the southern end of the runway also appears to currently run over the Clark’s land, with no easement apparent. We would recommend that this be addressed as part of the proposed land takes. This area is shown in the aerial below. (Source: Property-guru).
