Performance of Tall Buildings During the 2/27/2010 Chile Magnitude 8.8 Earthquake -- A Preliminary Briefing --

Los Angeles Tall Buildings Structural Design Council

Performance of Tall Buildings During the 2/27/2010 Chile Magnitude 8.8 Earthquake -- Santiago --

Performance of Tall Buildings in Viña Del Mar 2/27/2010 Chile Magnitude 8.8 Earthquake

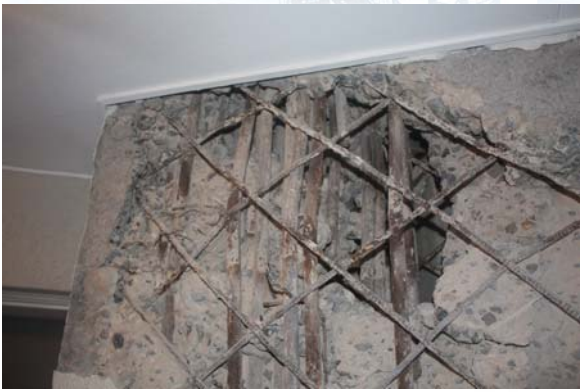
Acapulco ¹³

- Diagonal shear reinforcing outside of "end of wall" zone
- vertical reinforcing
- End of wall reinforcing not enclosed in ties

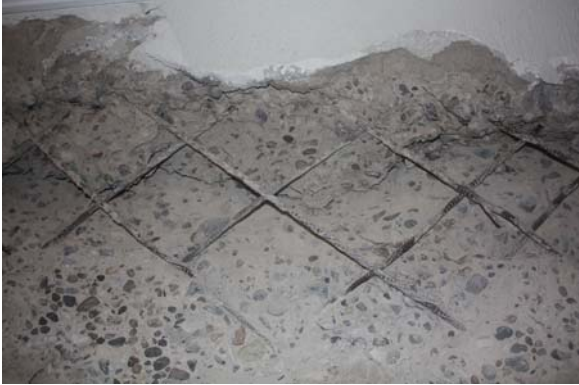
Acapulco

- Cross ties not apparent
- Wall has vertical load along full length
- Aggregate moderately large and rounded

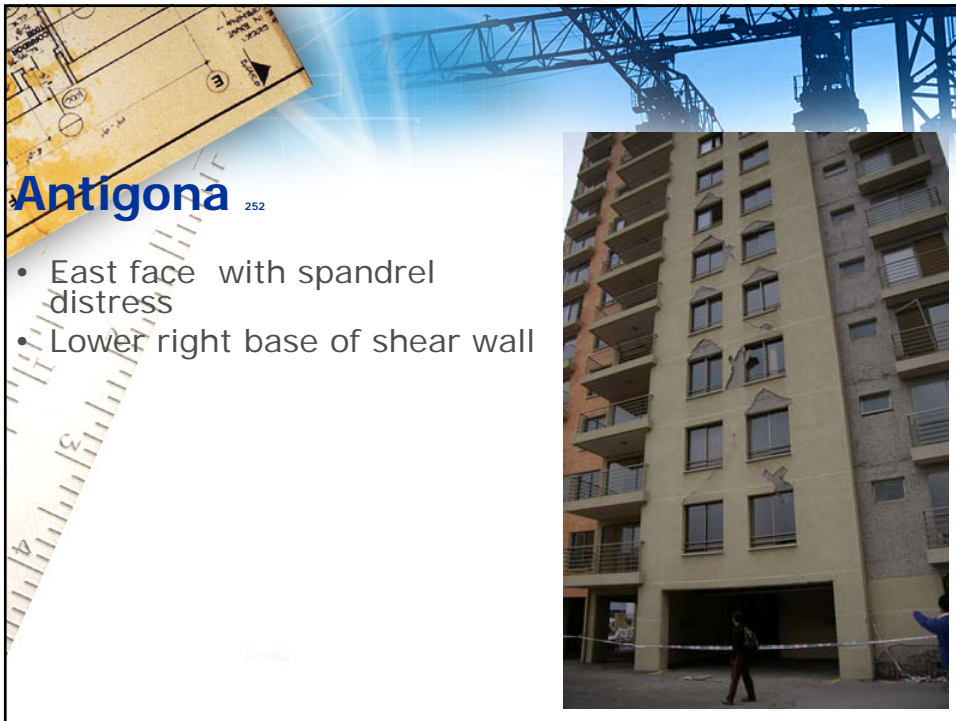
Antigona ²⁶⁷

- 5 Oriente 260
- 16 stories 2 Basements
- Thin "brick" cladding mortar set

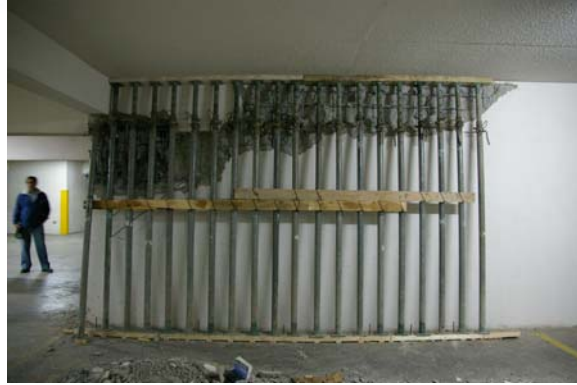
Antigona ¹⁴⁴

- Basement shear wall with severe crushing at end of wall

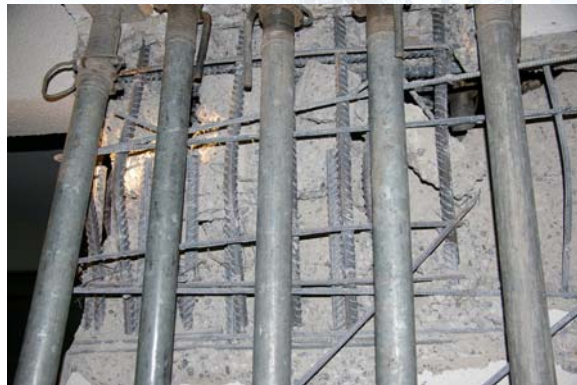
Antigona ¹³⁷

- Basement wall at end
- Some end of wall enclosing ties are apparent
- Horizontal reinforcing not anchored inside end of wall zone

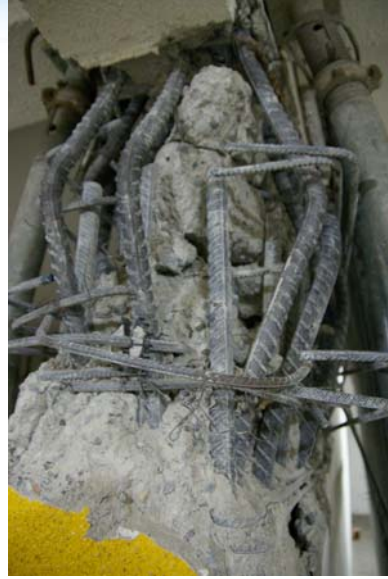
Antigona ¹⁴³

- End of wall with top of dowels
- Horizontal reinforcing with 90 hooks
- End of wall enclosing reinforcing with 90 hooks

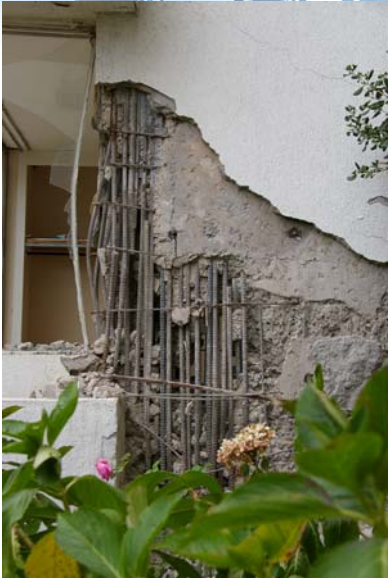
Festival⁶³

- End of shear wall reinforcing
- Wide spacing of ties
- Ties are horizontal shear reinforcing
- With 90 hooks

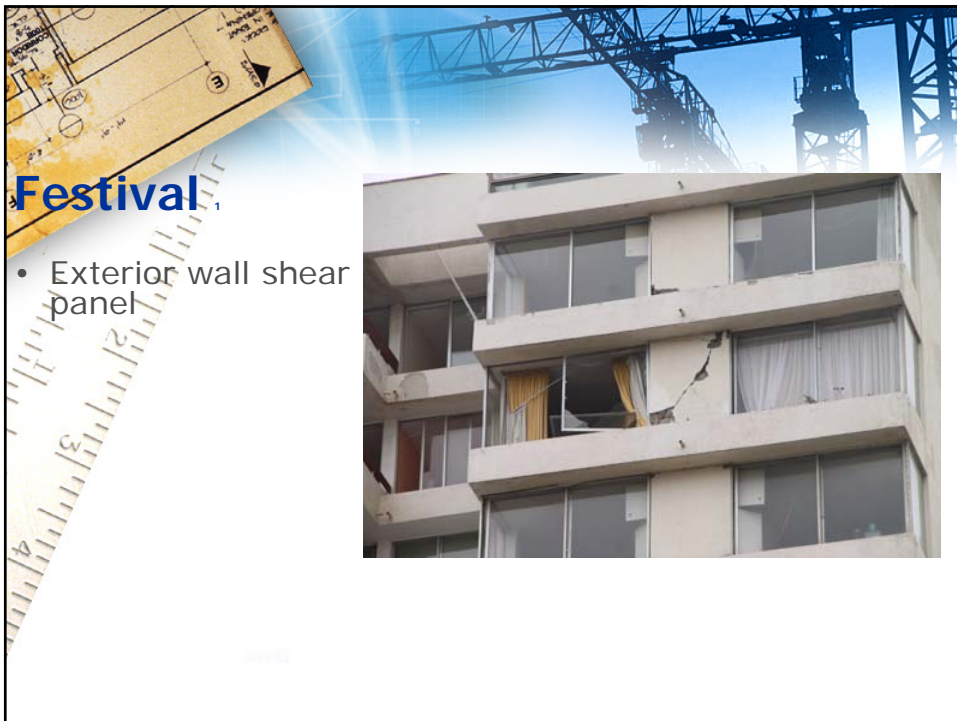
Festival⁵⁶

- Longitudinal shear wall
- Without significant openings

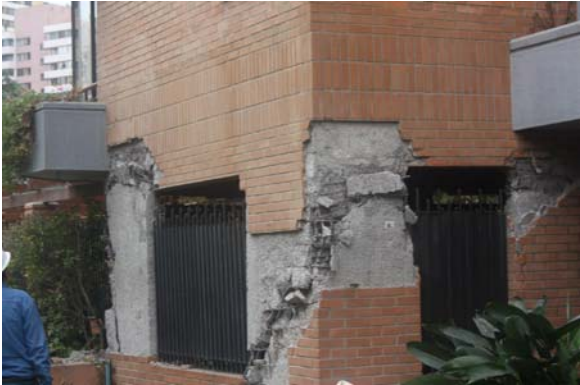
Rio Petrohue ¹⁸⁵

- Corner at L shaped "column"

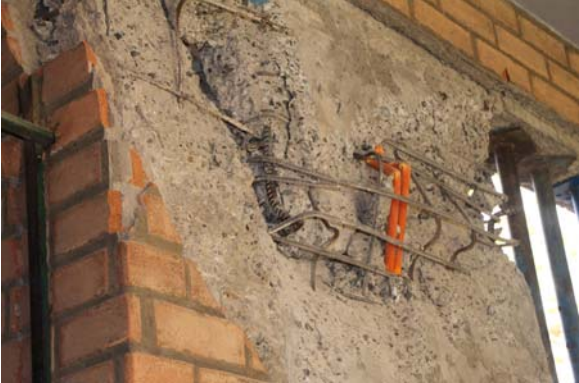
Rio Petrohue 96

- End of shear wall crushing
- Some end of wall ties at wide spacing
- Horizontal shear reinforcing 90 hooks

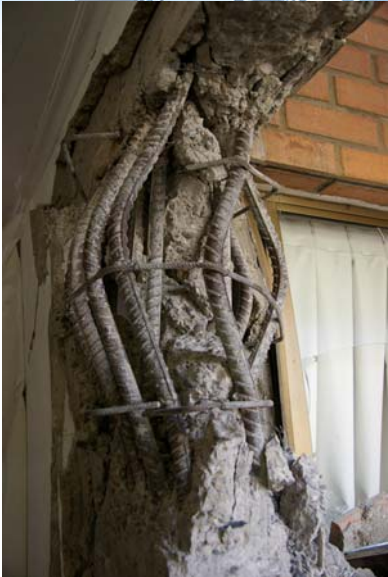
Rio Petrohue 179

- Column ties wider spacing
- Cross ties not apparent

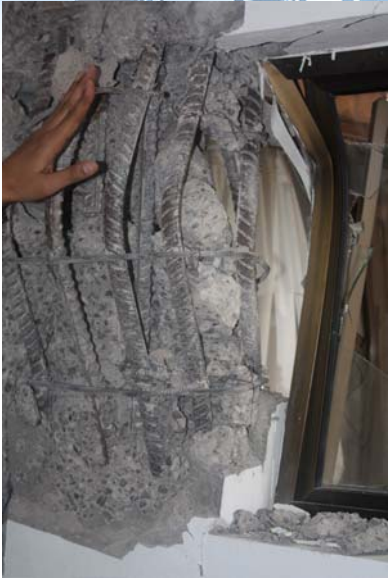
Rio Petrohue ¹⁵⁸

- Basement shear wall end with "gravity" beam

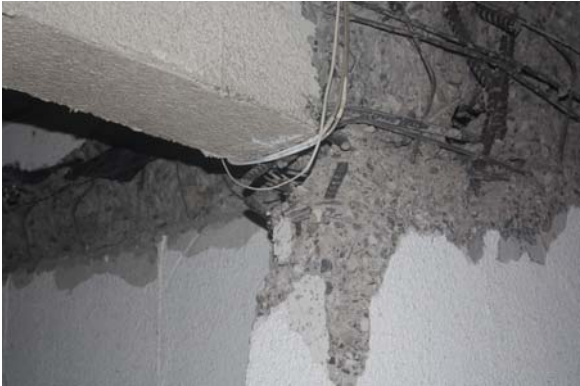
Rio Petrohue ¹⁶¹

- End of basement shear wall
- Fractured vertical reinforcing

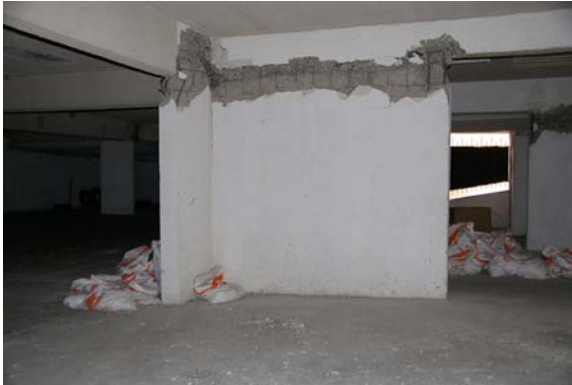
Rio Petrohue ⁶⁵

- End of basement shear wall at narrow end (opposite end with T)

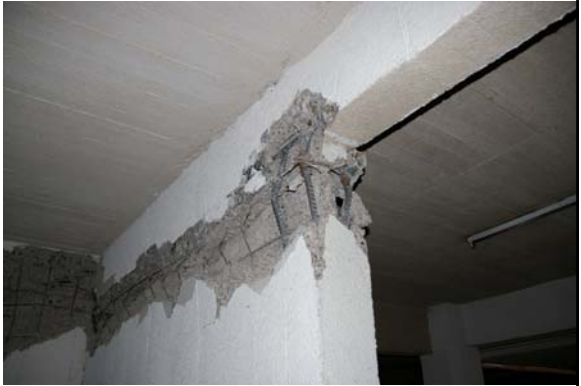
Rio Petrohue ⁶³

- Short shear wall in basement
- Crushing at both edges
- Beam reinforcing outside of wall "cage"
- Cross ties not apparent over the depth of the beam

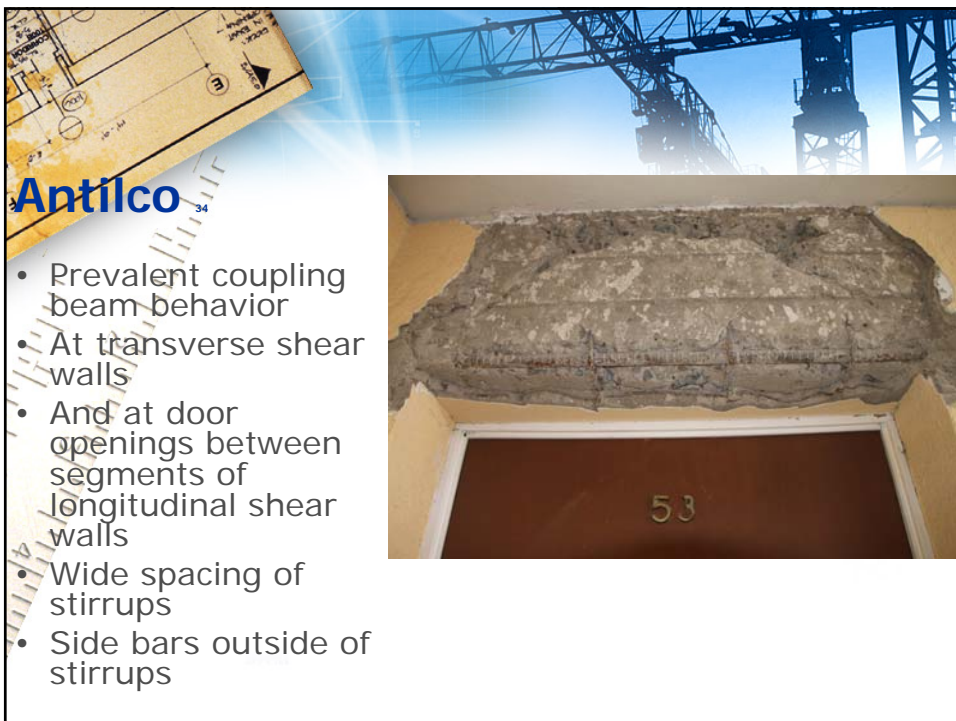
Antilco

- Moderately large aggregate with rounded shapes

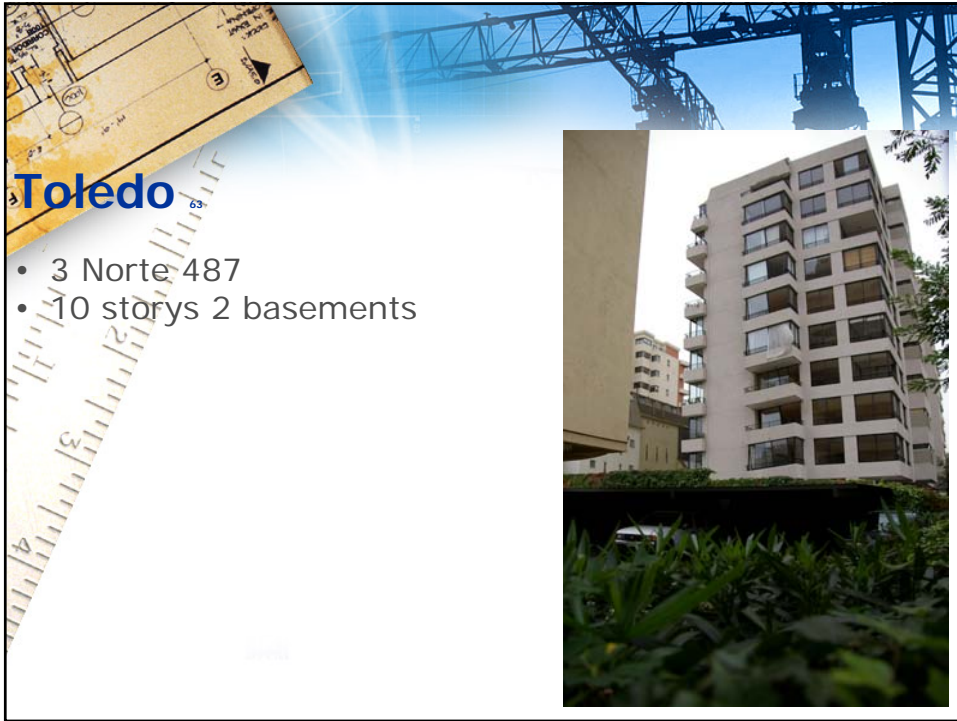
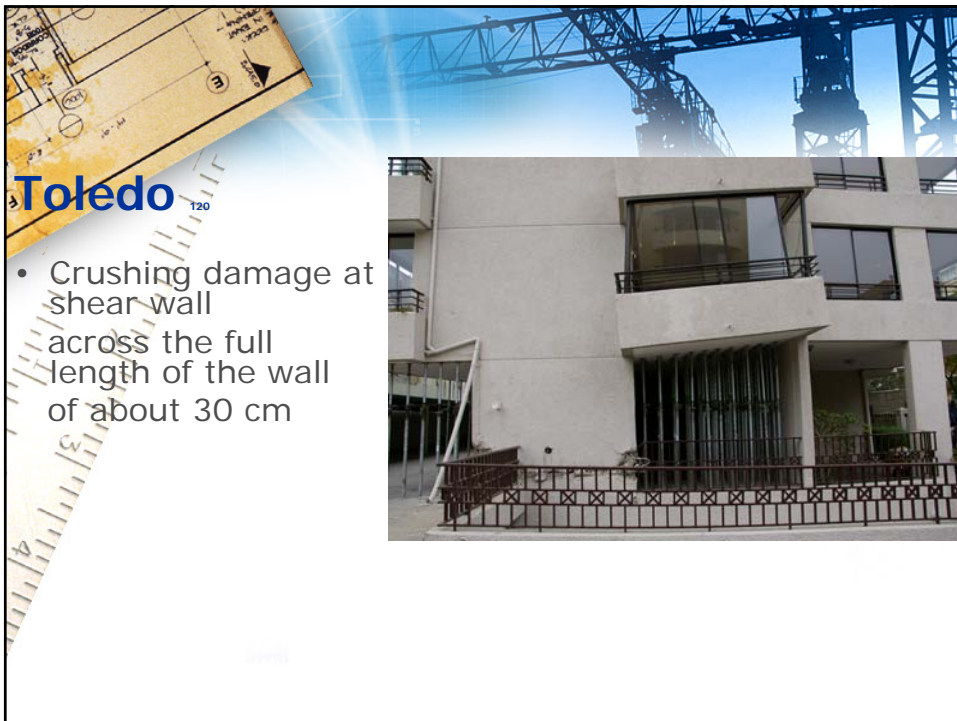
Toledo 108

- Shear wall overall crushing damage

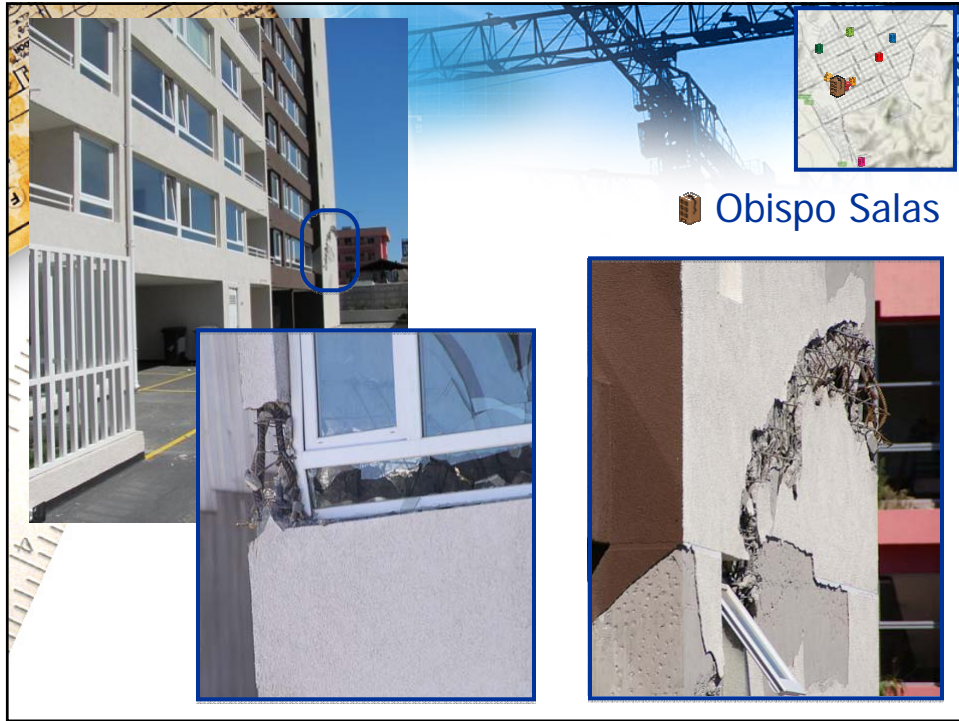
Obispo Salas
Salas 445

- 24 Stories + 2 Underground Levels, Housing
- Built in 2009

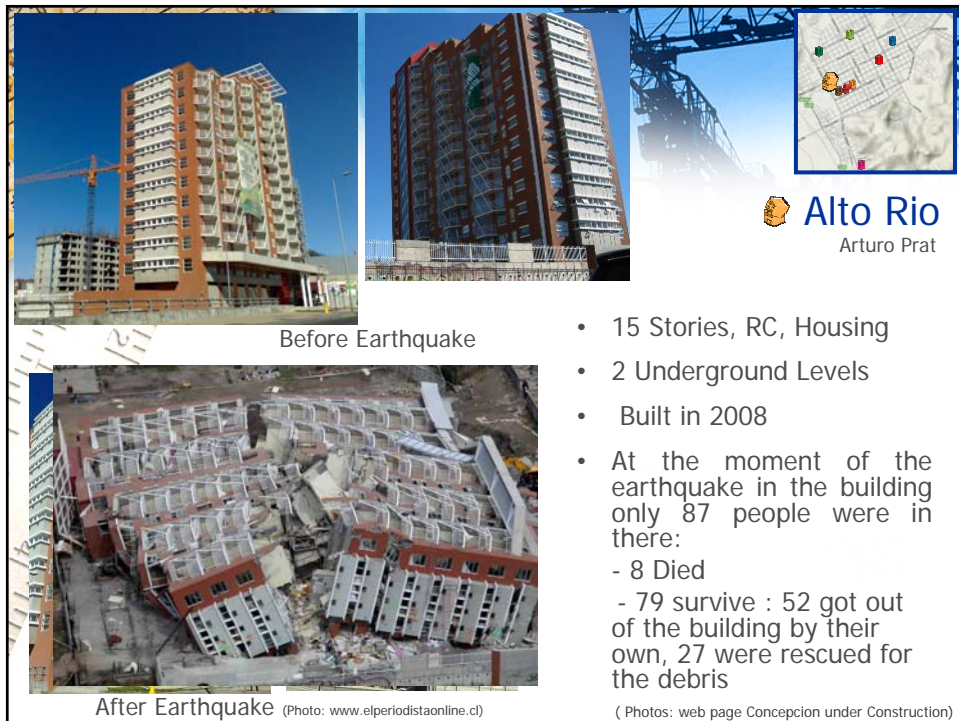
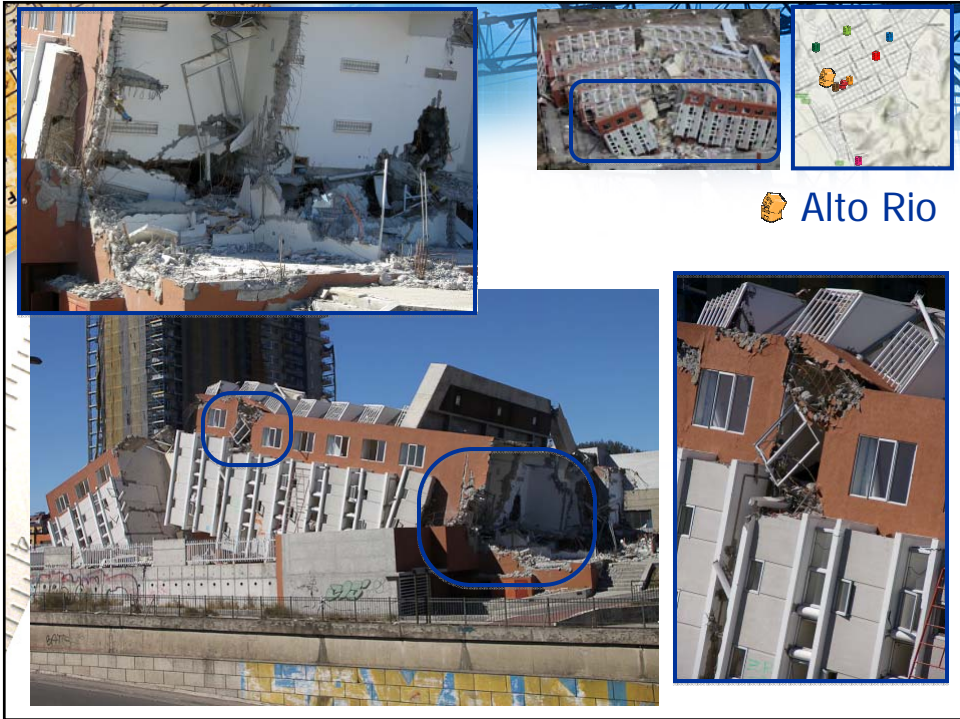
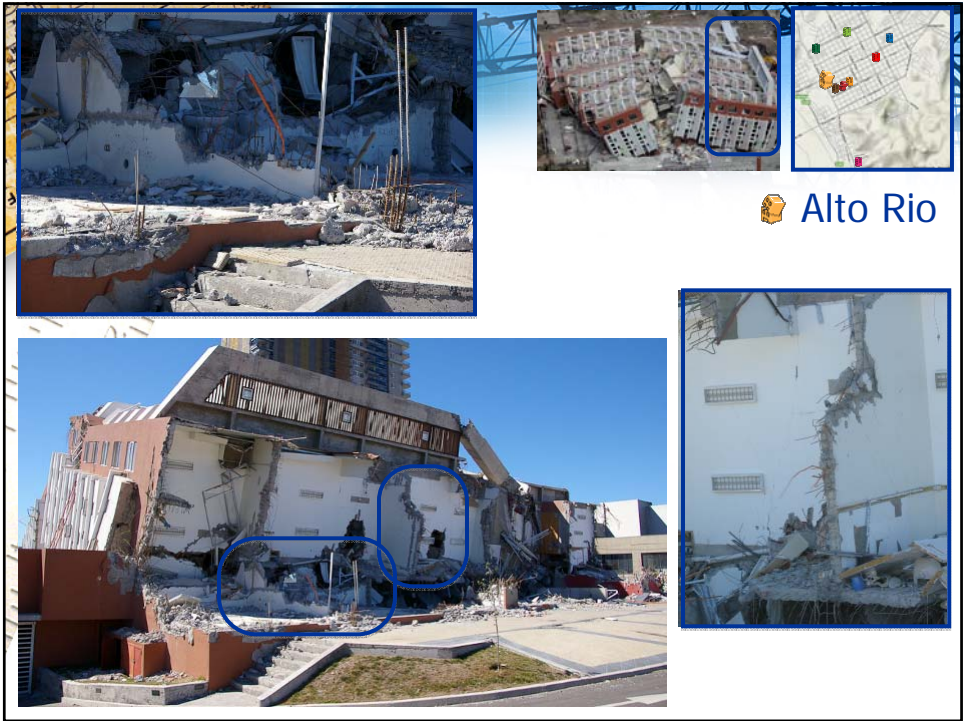
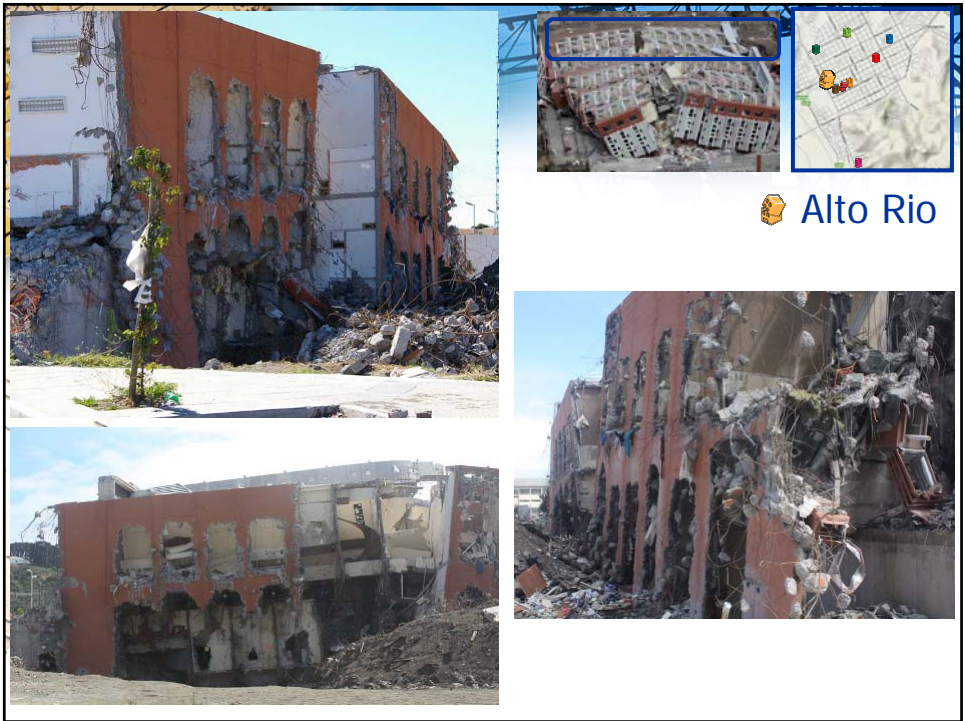
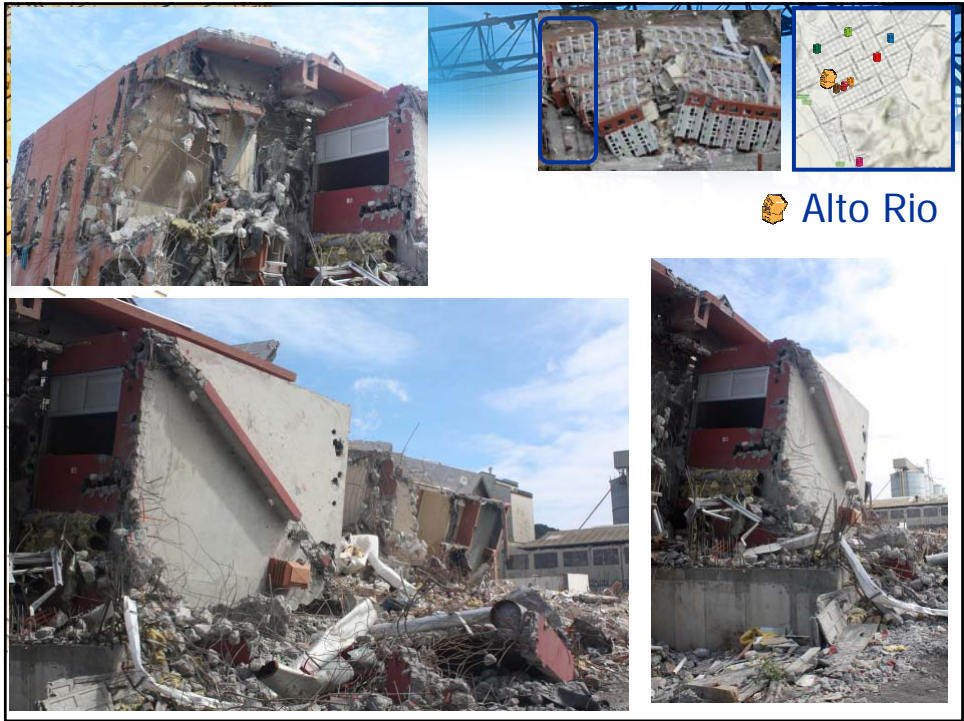
Alto Rio
Arturo Prat

- 15 Stories, RC, Housing
- 2 Underground Levels
- Built in 2008
- At the moment of the earthquake in the building only 87 people were in there:
 - 8 Died
 - 79 survive : 52 got out of the building by their own, 27 were rescued for the debris

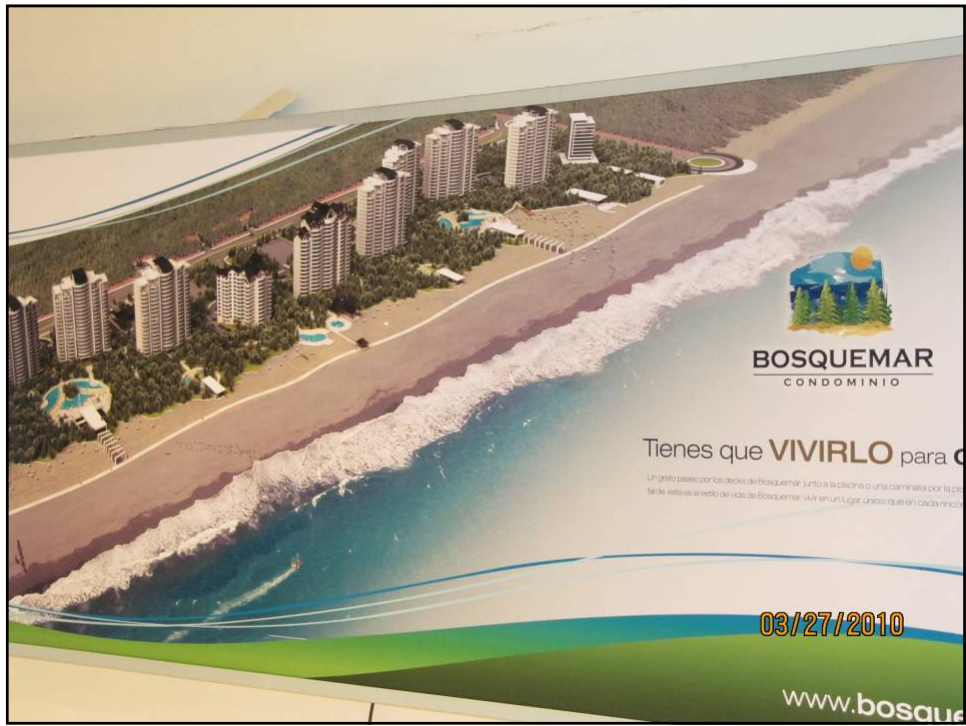
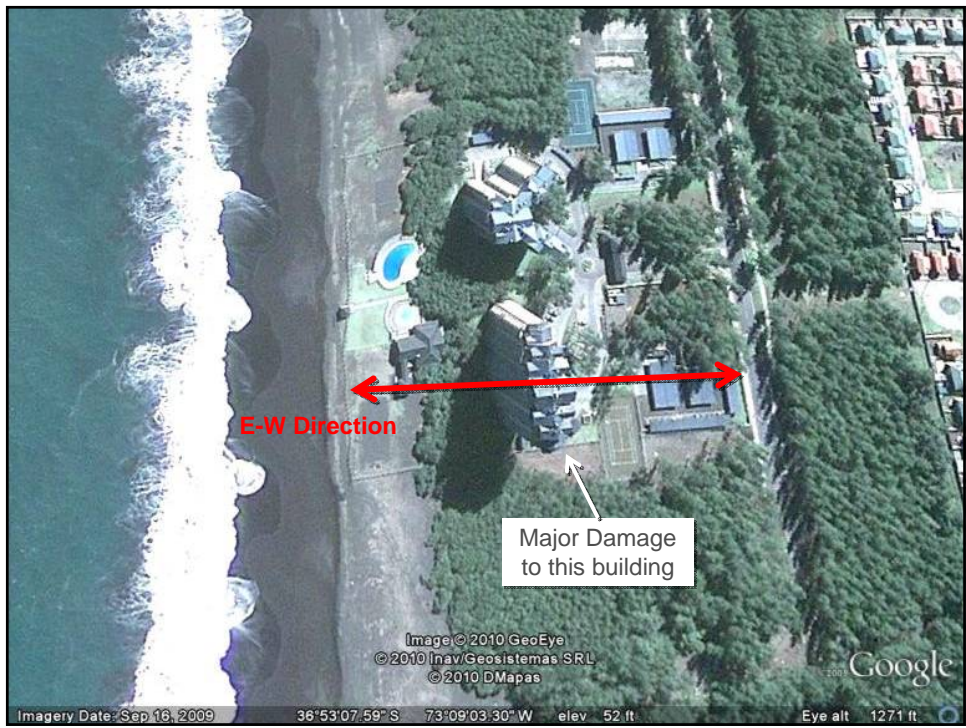
Bosquemar – Damage Observations

- Located very close to beach shoreline.
- Soft soils; type III to IV = classification D.
- Two separate condominium towers with different configurations–
- One saw a great deal of damage, the other saw very little
- Shear Wall Crushing
- “Outrigger” Wall Effect at Lobby
- Slab Coupling

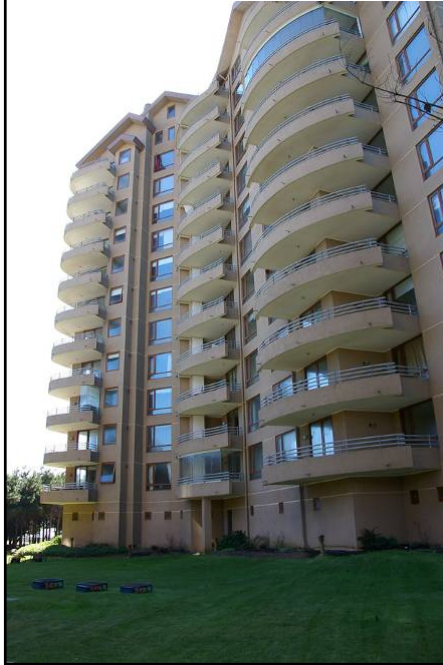
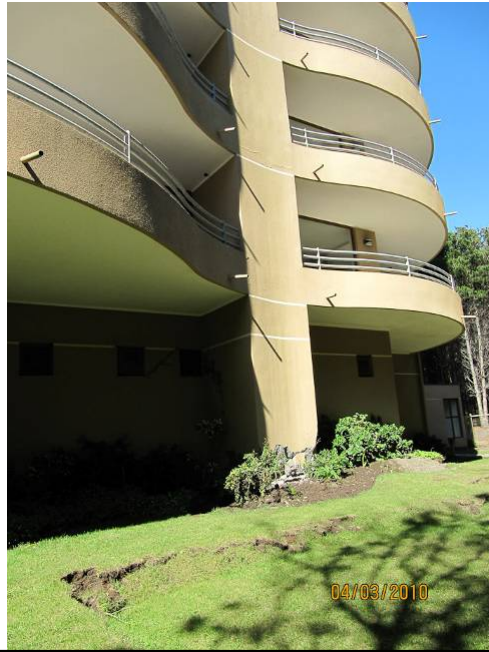
Exterior Damage

- Thin shear wall
- Story-high opening through wall
- Compressive/flexural crushing of concrete – leading to failure of rebar

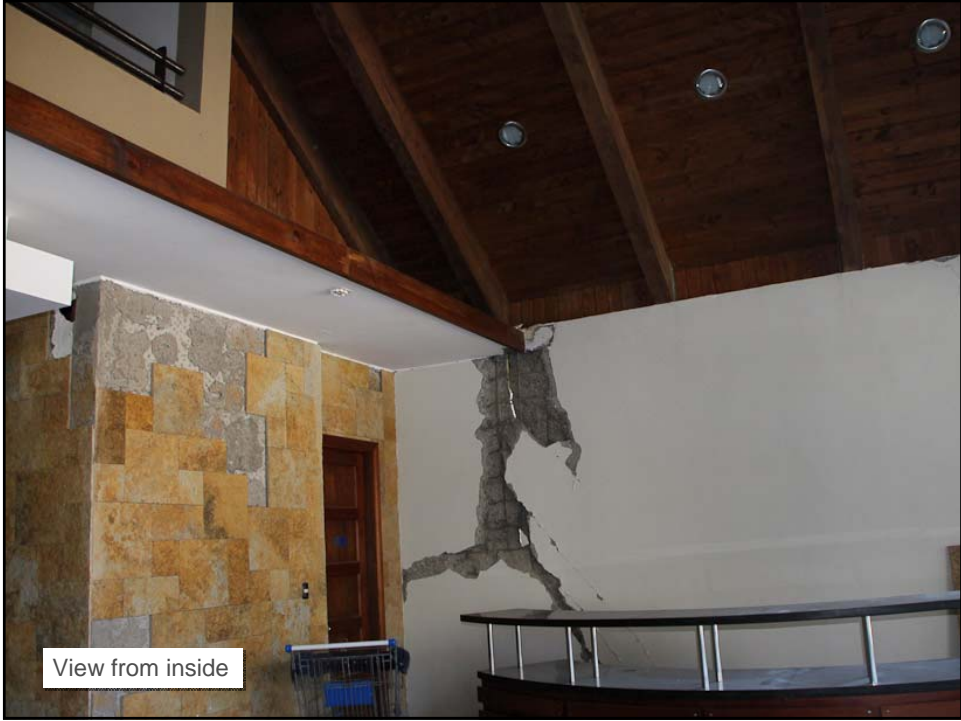
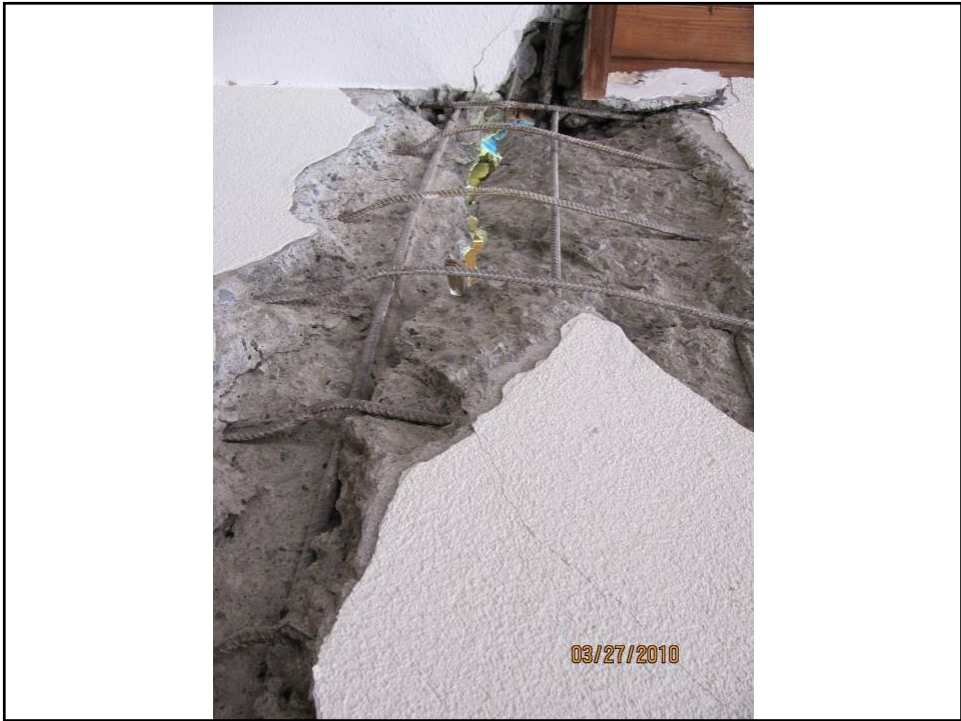
“Outrigger” Walls

- Thin shear walls & no confined boundaries = compressive/flexural failures
- Possible outrigger effects at the ground floor
- Closely spaced longitudinal walls create the potential for slab coupling perpendicular to the walls

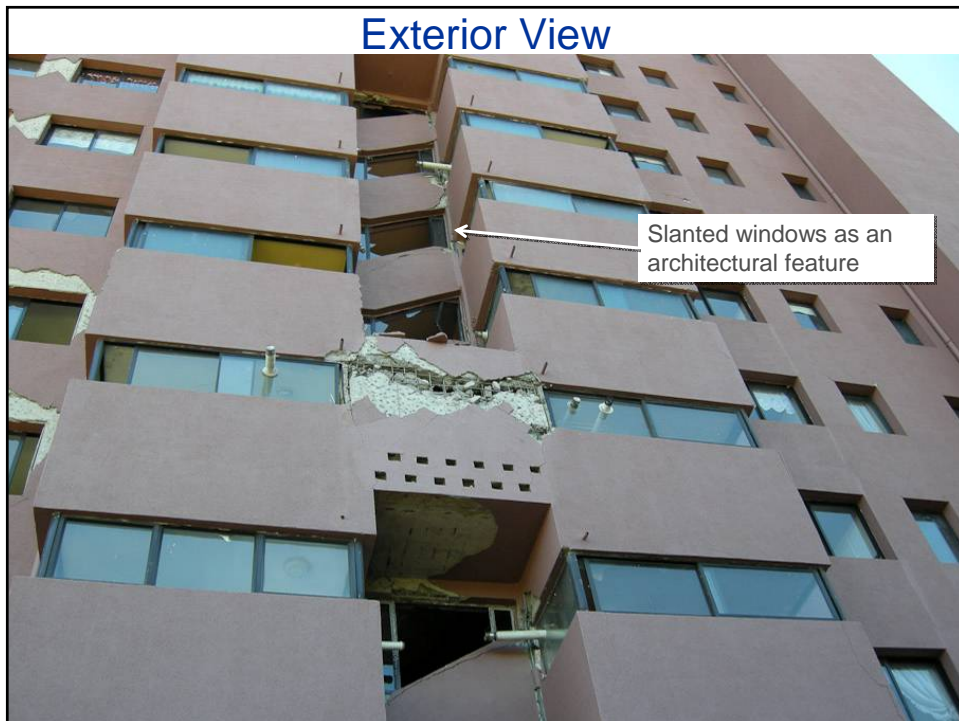
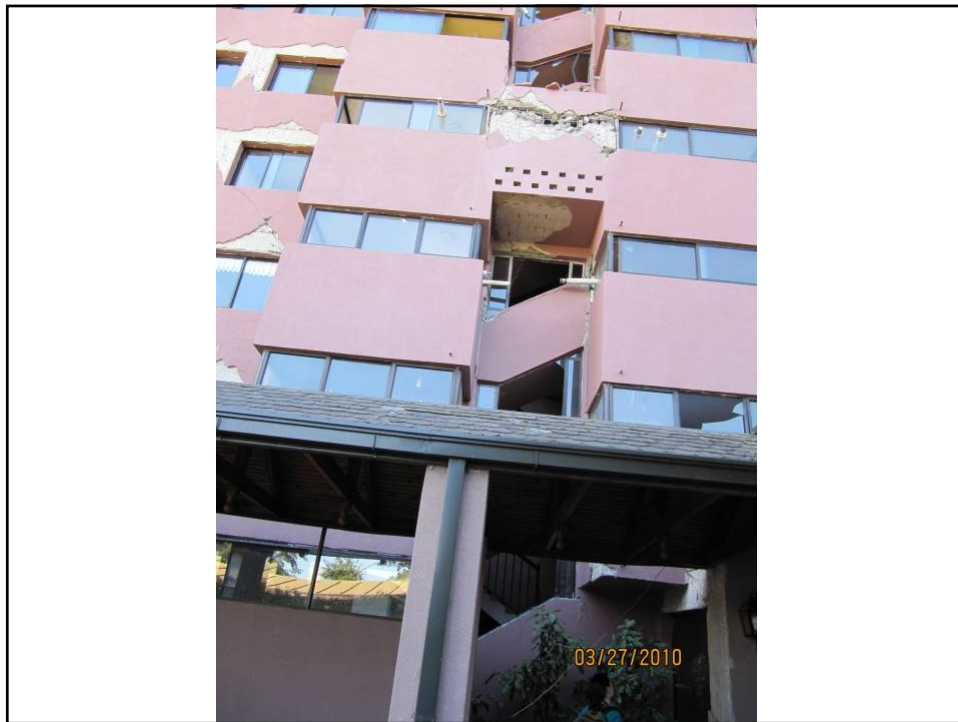
Exterior View

- Pedro de Valdivia in Concepcion
- Architectural stairway windows create unintended structural effects

-Evidence of damage caused by unintended coupling demands

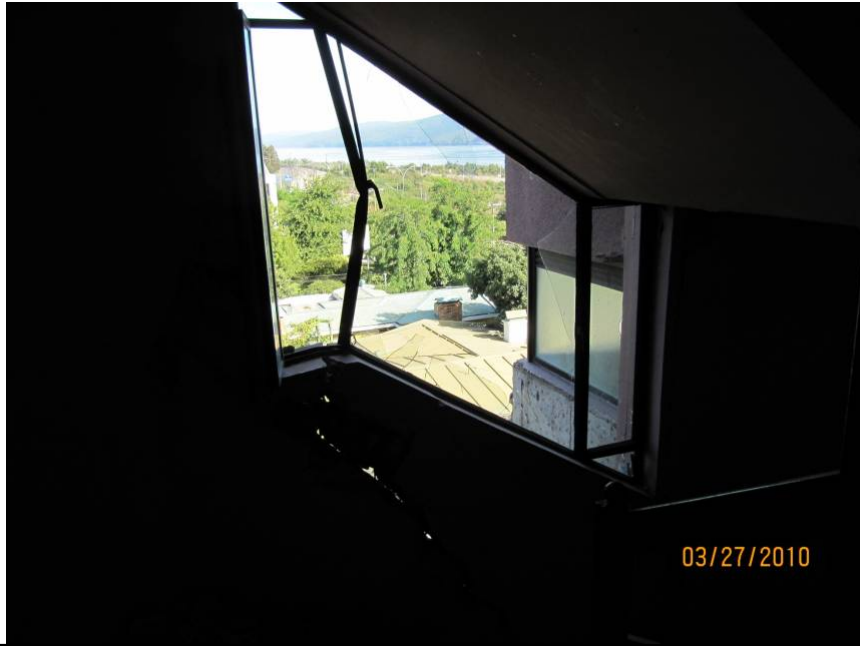
Interior View

-How does the coupling beam interact (or not) with the diaphragm?

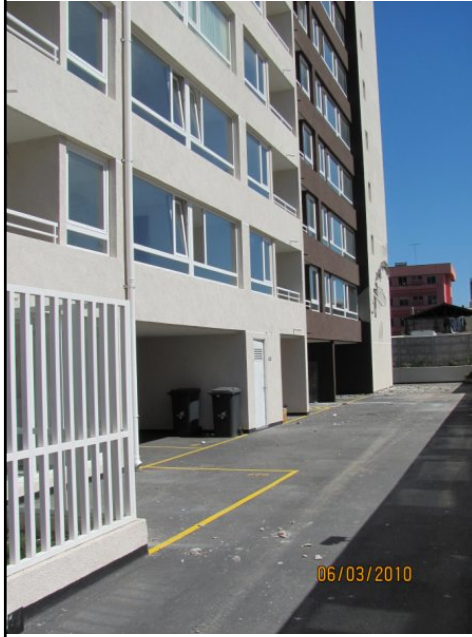
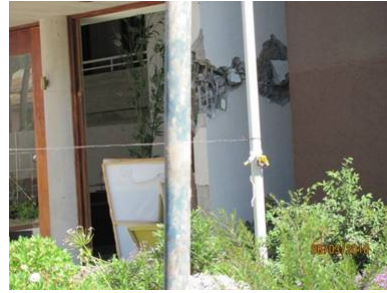
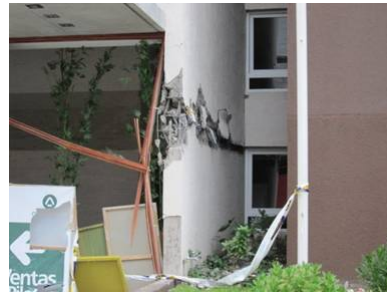
Photos and comments from Mr. Francisco

In attachment I am sending you pictures of some deteriorated buildings of Concepción.
